Bushby House Greystoke

Historic Building Record

JB Heritage Consultancy was commissioned by Carrock Design Build Ltd to carry out a Level 3 Historic Building Record of Bushby House, Greystoke, Cumbria on 10 February 2012 prior to development work being carried out. The inspection of the property was carried out by Mr John Bargh MSc IHBC on 30 February and 9 March 2012. The report was written by John Bargh. Plans and Elevations are provided by Carrock Design Build Ltd.

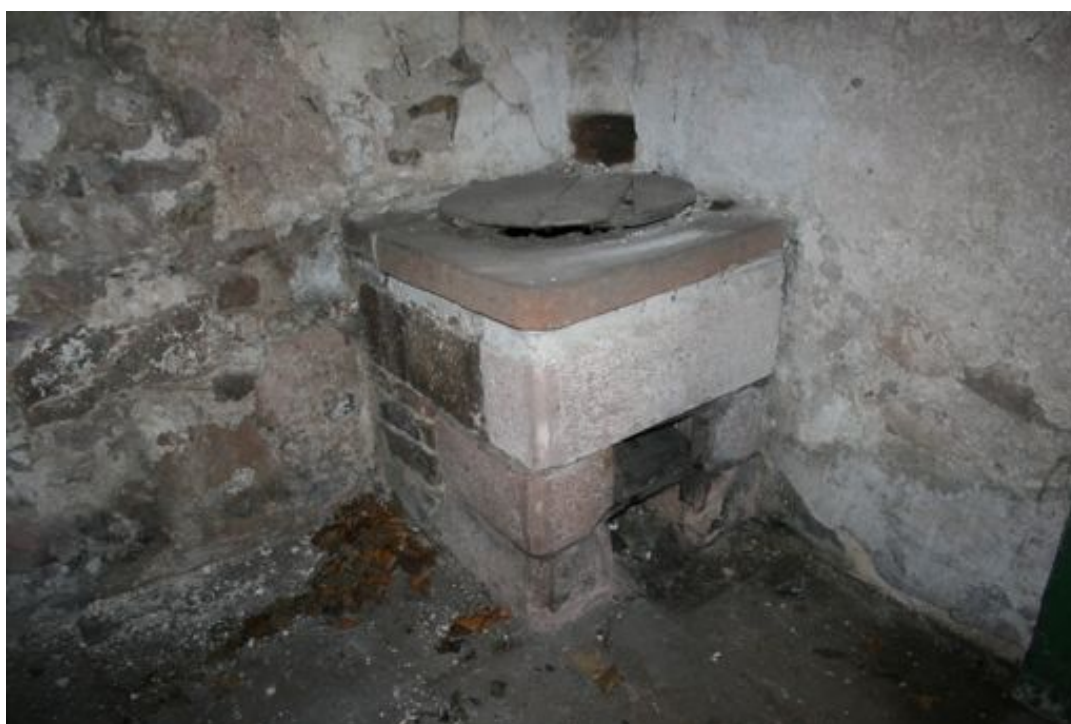
Beyond a passage at the rear of the house there is a separate room. In this room is a copper once used for boiling large amounts of water for domestic purposes (Plate 38). These generally appeared from the late eighteenth century.⁶⁹ The copper has a square dressed stone base (size: 800mm w x 800mm deep x 850mm h) that houses the circular cast iron receptacle to hold the water. Under this receptacle is an open chamber where the fire was lit. On top of the stone base is a sandstone slab with aperture and circular timber lid giving access to remove the water. Before the extension above, the wash house may have had a mono-pitched slated roof. The west facing stone wall appears to have been rebuilt. To note at this point is the 'Pump' in the rear garden noted on the 1899 Ordnance Survey map. This does not appear to exist today but at one time may have been a source of water.

Plate 38. Stone Copper

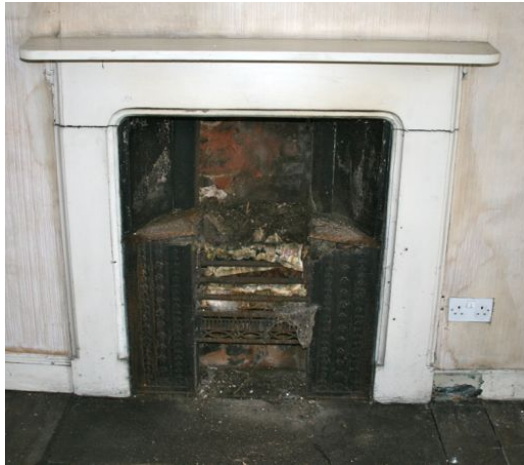
Plate 39. Dressing Room

cast iron fireplace with hob grate has a plain stone surround and timber mantle (size to outside of surround: 1250mm w x 1200mm h). The six-panel door has an original latch with intricate key that fits into a round hole in the lock (Plates 14 and 15). On the side facing into the master bedroom the panels to the door are flush with the frame and the deep skirting to the walls continues along the face of the door. There is also no architrave giving the effect that this doorway was intended to be inconspicuous (Plate 16).

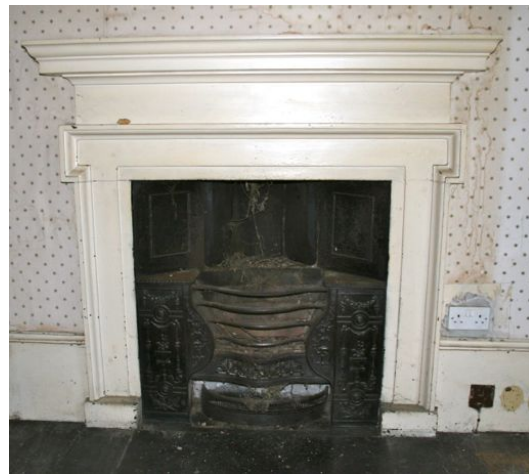
Plate 40. Master Bedroom

The ceiling is finished with fibrous plaster foliage moulding (Plates 18, 19 and 20). There is a timber picture rail. The vertical sliding sash window frame appears not to be original and is fitted with shutters. The cast iron fireplace with hob grate has a plain stone surround and stone mantle (size to outside of surround: 1300mm w x 1400mm h). There is an alcove formed within the internal wall with plaster finish, probably a wardrobe. The door to this wardrobe is a six-panelled door with raised and fielded panels. To the left of this door is the door leading to the landing of the same design but has interesting knob furniture (Plate 17). Between the two doors there is a narrow timber vertical fluted pilaster.
