# Agnes Gill, Whinfell Bank Barn

Historic Building Record

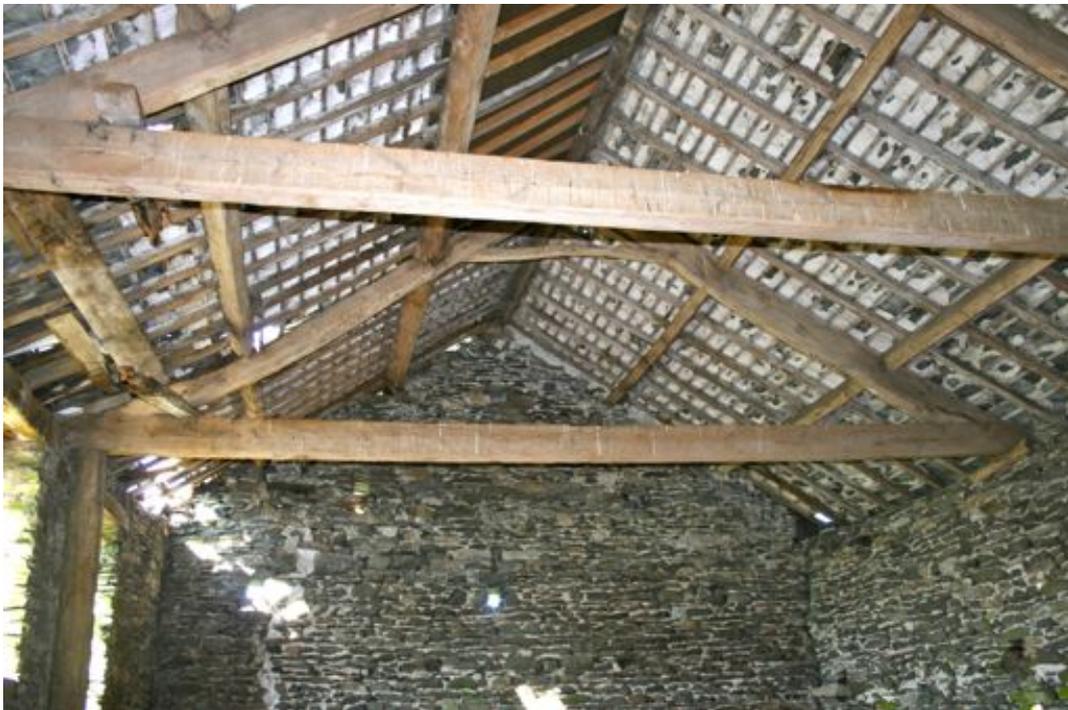
*Plate 1. Roof Construction.*

The roof is covered with Lakeland random diminished slating nailed to battens which are fixed to softwood rafters supported on purlins carried on three tie beam trusses, one of which has a thin collar below the apex (Plate 1). There is a timber ridge linking the trusses at the apex. The main roof timbers appear to be pine and some have saw marks suggesting mechanical preparation. The underside of the slates is torched with lime mortar against the battens to keep out the weather. Externally is a stone ridge on top of the slates.

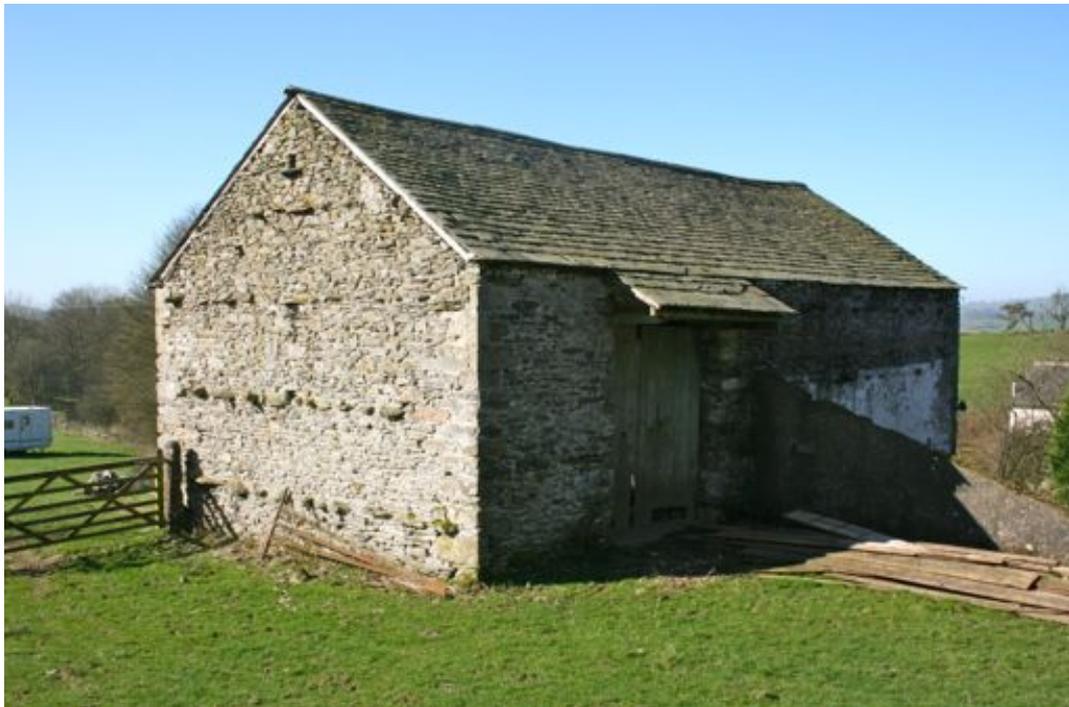
*Plate 2. North East Elevation.*

This wall contains a pair of large timber doors hung on wrought iron pins which project into the floor and also the underside of the oak lintel (Plates 3, 4 and 5). This appears to operate on a similar basis to harr hanging. The doors have chamfered vertical hanging styles and chamfered horizontal rails morticed into the styles. There are no meeting styles at the leading edge of the doors. The doors have vertical timber boarding nailed externally to the rails and some of these boards have a quirk bead moulding along the long edge. Above the doors is a canopy, or pentise to protect the doorway from the weather. It is timber framed and slated with random diminished Lakeland slates (Plate 6). In the centre of the north wall, and set perpendicular to it, is a concrete block wall which appears recent and may have formed the end wall to a former extension. This extension is no longer present. The western part of the main north wall would have formed the inner wall of this extension and is finished with plaster. At ground level is a single ledged timber door with timber lintel.

This is a gable wall and has no specific features. There is an owl hole towards the top of the wall which is visible in Plates 2 and 7.

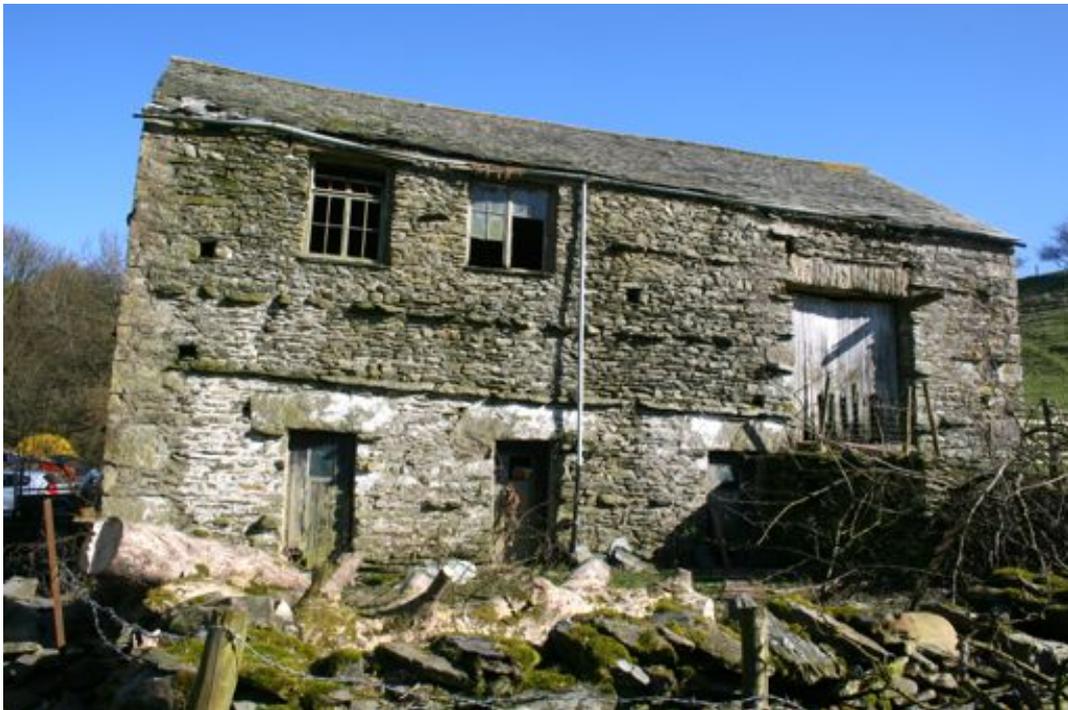
*Plate 8. South Elevation.*

There is another pair of tall timber doors hung on wrought iron pins as those on the north elevation. Over these doors are oak lintels internally and a rough stone soldier arch externally. There are also vestiges of a timber pentise frame at each side at the top of the doorway so this door also had weather protection. Access to this doorway is from higher ground formed as a ramp behind a stone retaining wall. To the west end of the wall at high level are two windows with timber lintels and slate cills, the timber frames probably being of more recent date. One window has a top inward opening hopper and the other is a side hung casement type. There are three timber ledged doors with external vertical boarding serving the lower floor of this elevation each with a glazed upper panel. The lintels over the openings are oak internally with a very large stone lintel externally.

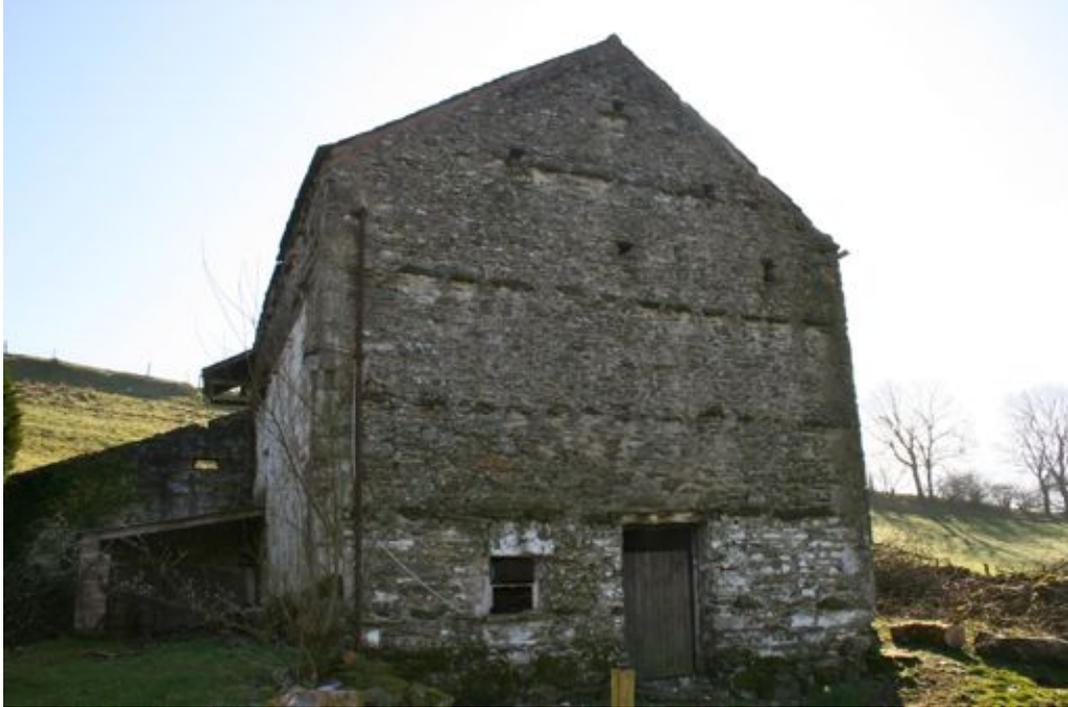
*Plate 9. West Elevation.*

This wall has an owl hole towards the top. There is a ledged vertically boarded stable door at the bottom of the gable with oak lintels over it and to the side is a small window with a large stone lintel over the opening externally.

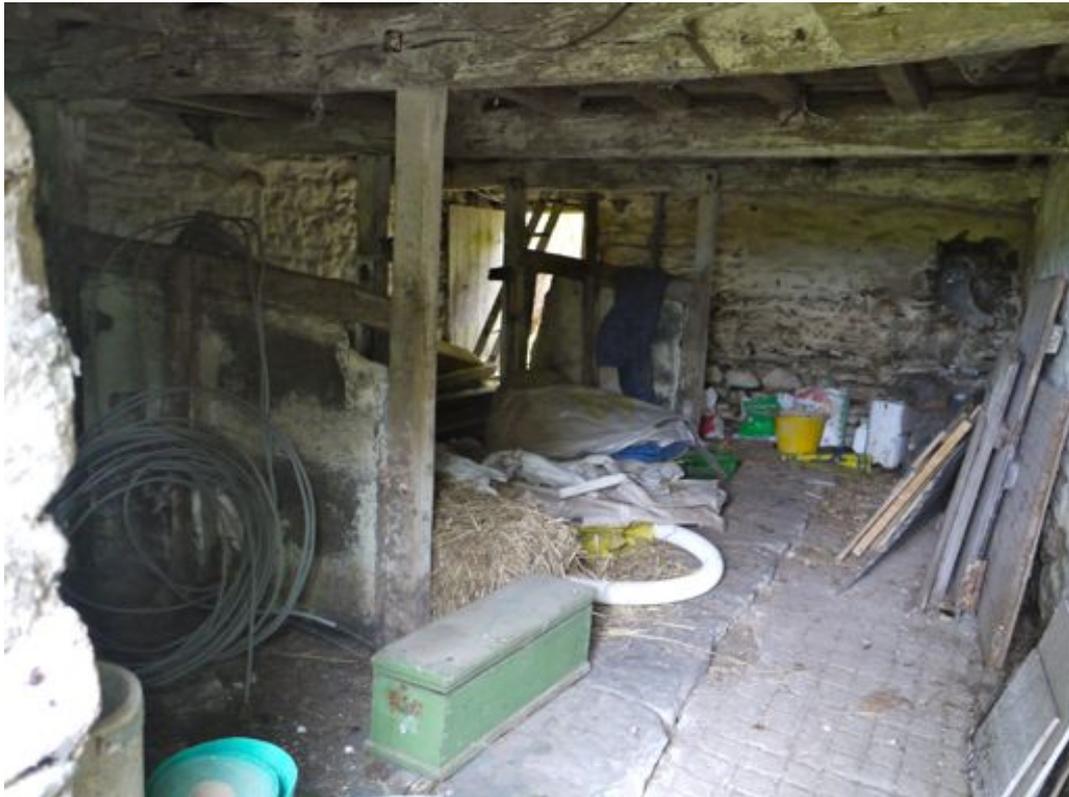
*Plate 10. Internal View of Byre Showing Manure Passage and Boskins.*

The floor to the upper level is solid but has a timber boarded finish. This may have been a threshing floor and one leaf of the large doors possibly opened for winnowing. The floor to the lower level is largely concealed by debris but visual and previous photographic evidence reveal some information. The floor to the byre was partly large uneven pieces of slate within the stall area with a step down to the concrete floor of the manure passage (Plate 10). This split floor level was the usual arrangement in a byre.<sup>29</sup> The ceiling height in the byre is about 1800mm. When constructing a byre, low ceiling heights were usual practice well into the nineteenth century.<sup>30</sup> The stable floor appears to have been stone cobbles. This floor is lower therefore giving a greater ceiling height for horses and helping to confirm that this was used as a stable. It is useful to refer to Brunskill who mentions the taller ceiling height for a stable.<sup>31</sup> The timber suspended upper floor is largely missing due to collapse but evidence and previous photographs provide some information. The floor structure comprised oak beams and possibly oak joists supporting timber floor boards. The beams were probably reclaimed timber, possibly former cruck frames, and built into the walls. The joists were housed into the beams and also built into the main walls. The underside of the floor structure including the boards was coated with lime wash.

The byre area was divided by boskins which were made from oak. These had vertical oak members fixed into an aperture in the floor and bolted or housed into the underside of the floor beams above. In early barns the vertical member was curved and this was a typical feature up to the seventeenth and early eighteenth centuries.<sup>32</sup> However, the vertical members at Agnes Gill were straight, therefore helping to date the barn. A sloping horizontal rail was fixed between the vertical members at about two-thirds height and another one was fixed at ceiling level. The panel between the oak framing was a solid piece of slate about 70mm thick (Plates 10, 13 and 14).

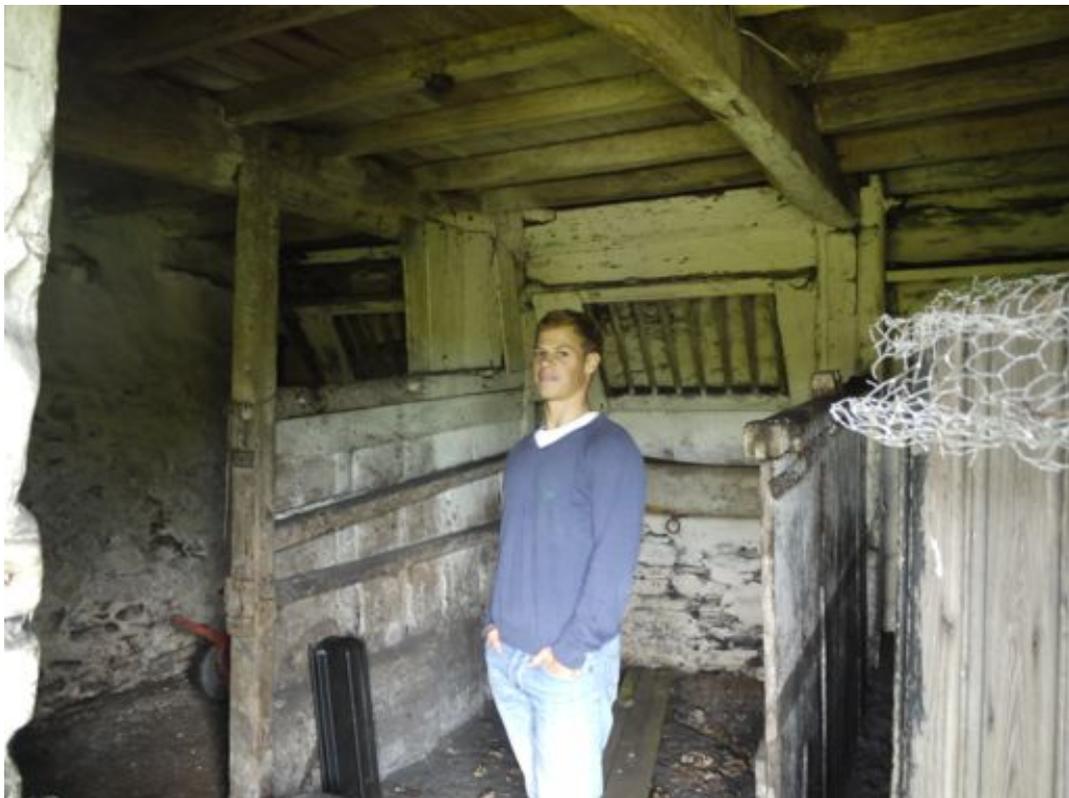
*Plate 11. Underside of Upper Floor Above Stable Also Showing Two Hay Racks.*

The stall divisions to the stable were a similar framed construction but have timber boards instead of slate as an infill. There appears to have been two hay racks with probably wrought iron grilles at high level for hay, probably fed through a trap door from the hay loft above (Plate 11). Brunskill identifies this feature is to be found in a stable compartment.<sup>33</sup>

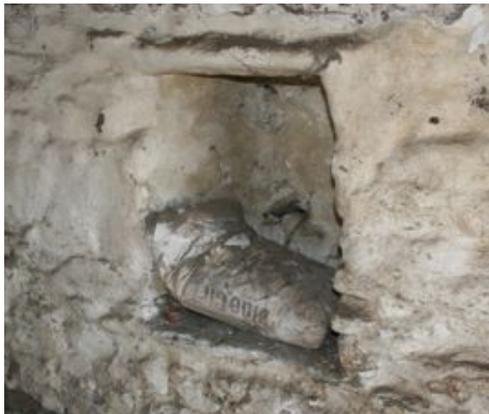
*Plate 12. Recess in Internal Wall.*

The internal surface of the external walls and the internal walls are coated with lime wash. There is a recess in the retaining wall to the threshing floor, size 600mm x 700mm and about 400mm deep, all finished with lime wash (Plate 12). There is a recess internally on the north external wall, size 400mm x 500mm. The 'L' shaped stone rubble wall that formed the stable is 450mm thick. On the byre side the wall was finished with lime wash. On the stable side it was given a rough plaster finish with lime wash.
