## TOPOGRAPHICAL SURVEY AND OBSERVATION & RECORDING REPORT:

### FIVE KNOLLS DUNSTABLE DOWNS BEDFORDSHIRE

on behalf of Chilterns Conservation Board

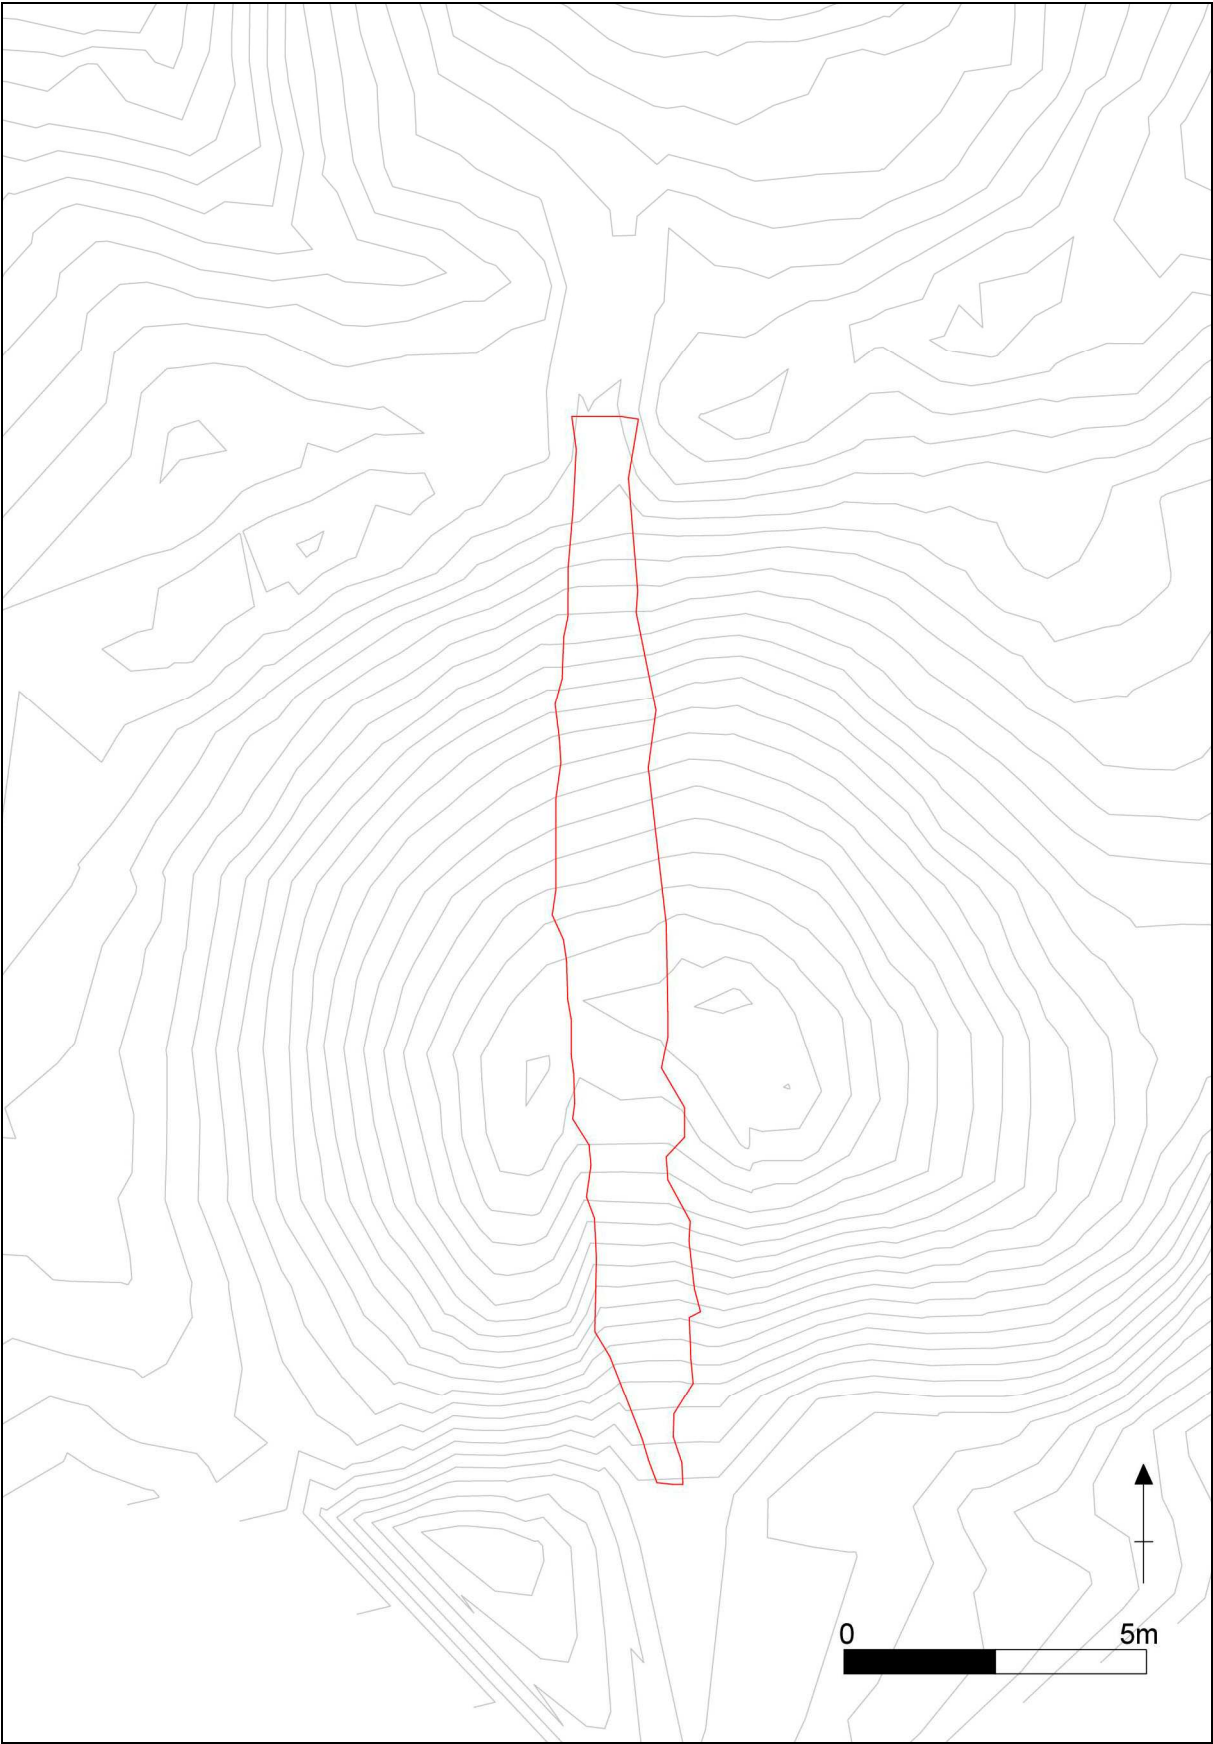
Figure 8: Scar 6 (scale 1:125)

Scar 6 straddled the brow of Barrow 1, and constituted the smallest area of damage, measuring 17m in length and 1.8m at its widest point (Fig. 8). Similarly to Scar 5, it did not breach the top soil, which varied between 0.08-0.2m (Plates 12 & 13). Some 20<sup>th</sup> century artefacts were noted within the topsoil, as were occasional small pieces of chalk. There is a likelihood that this barrow has undergone the same type of earlier repair observed on Barrow 2, but the depth of the present cut was insufficient to expose it.

The edges of each scar were squared off and the loose material removed from the base. The cut was then lined with a geotechnical membrane and backfilled with compacted, locally sourced, chalk. This was then covered with either a layer of topsoil or turf (Plates 14-23).

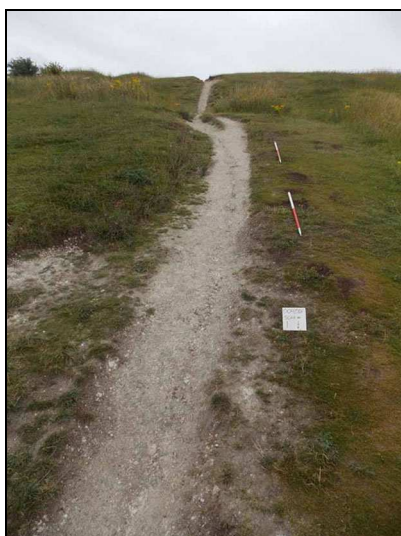
**Scar 1** was the largest single affected area, and was associated with the western pedestrian access gate, located on the north fence, with the scar orientated between Barrows 4 and 5 (Fig. 4). The scar was 29.5m long and 1.58m at its widest point. It varied in depth from 0.08-0.3m, of which typically 0.07m was a sandy, silty clay topsoil, overlying decayed, nodular chalk (Plates 1 & 2). The depth of the scar was due to a combination of the concentration of pedestrian traffic leading up to the gate and the flow of rain water channelled along its length, down the steep northern side of the Downs.

Plate 1: Scar 1, facing south

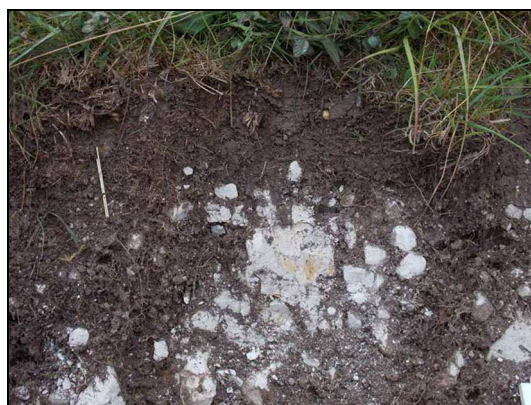
Plate 2: Stratigraphy of Scars 1 & 2

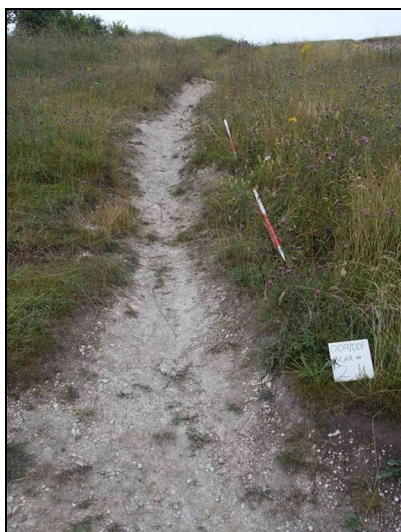
**Scar 2** ran parallel to Scar 1, approximately 7m to the east, and was associated with the eastern pedestrian access on the northern fence (Fig. 4). The erosion damage was less substantial than that of Scar 1, with the affected area being 26.3m, in three separate parts, by 2.3m at its widest point, close to the gate. The depth of the scar varied between 0.04m and 0.15m, the deepest part being closest to the gate (Plate 3).

Plate 3: Scar 2, facing north

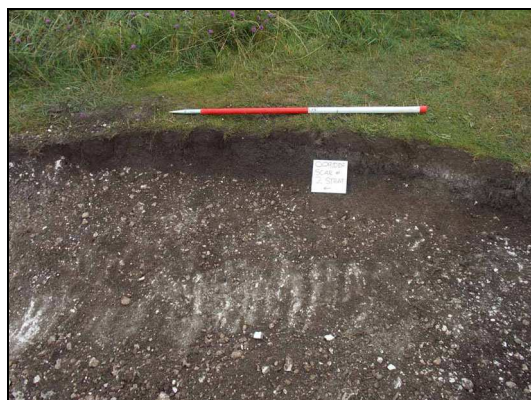
At the southern end of the scar, close to the base of Barrow 4, there is a lessening in the gradient of the slope and a thickening of the topsoil (Plate 4). This may be due to a natural undulation in the underlying geology being filled with a colluvial deposit washed down from Barrow 4. However, the consistency of the matrix appears identical to that of the rest of the monument, and so there is the possibility that the deposit is a result of the reconstruction of the barrow following previous excavation.

Plate 4: Topsoil deposit, Scar 2

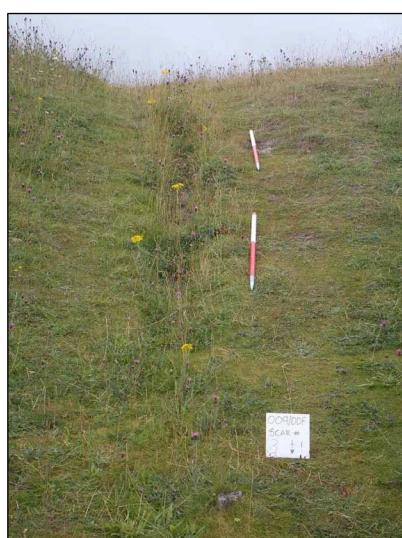
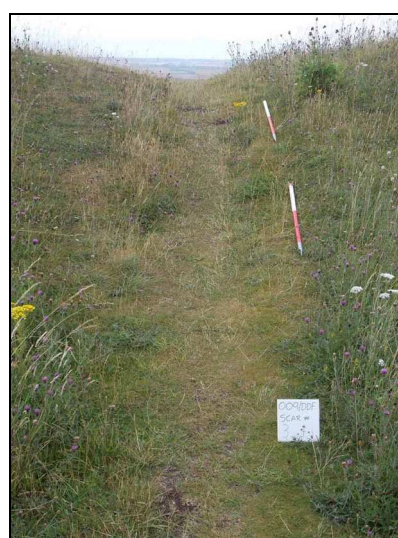
**Scar 3** was a continuous dog-legged cut which crossed the brow of Barrow 4 and formed part of the main pathway which traversed the monument north to south, encompassing 4 of the 5 principal mounds which make up the site (Fig. 5). Measuring 26.3m in length and 1.6m at its widest point, it formed the largest single area of damage to the burial mounds, though it only cut into the underlying chalk and topsoil matrix in relatively small, isolated patches. This was due to the relatively deep layer of overlying topsoil, which in places reached 0.2m (Plates 5 & 6).

Plate 5: Scar 3, facing south

Plate 6: Scar 3, facing north

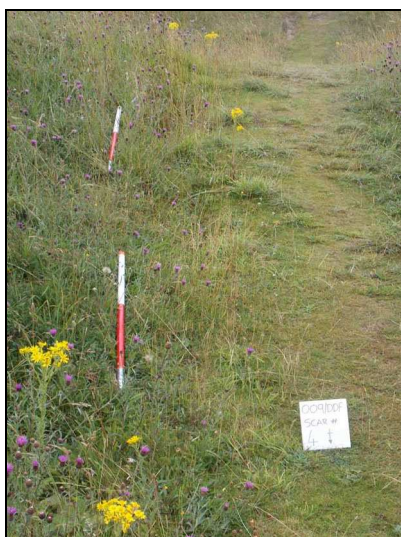
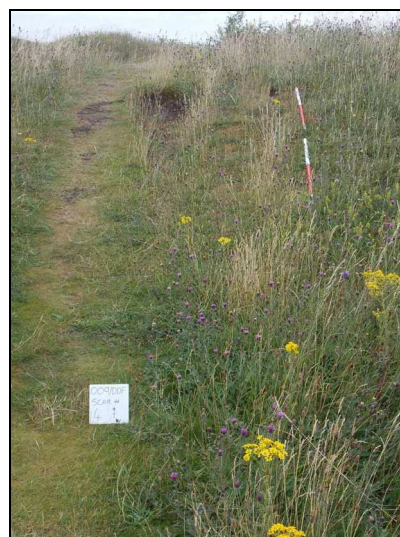
**Scar 4** was similar to Scar 3 in that it only cut through the 0.1-0.25m of topsoil (Plates 7 & 8). It was 19.2m in length and up to 2.2m wide, cutting a straight swathe on both the north and

Plate 7: Scar 4, facing south

Plate 8: Scar 4, facing north

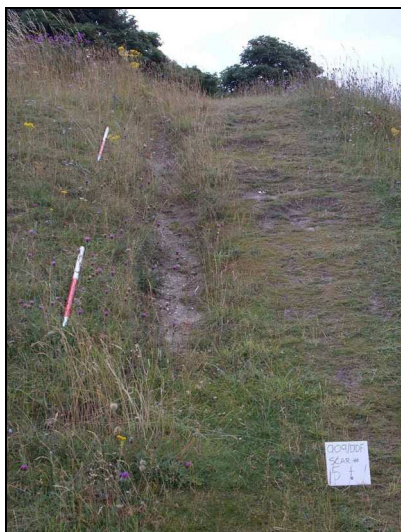
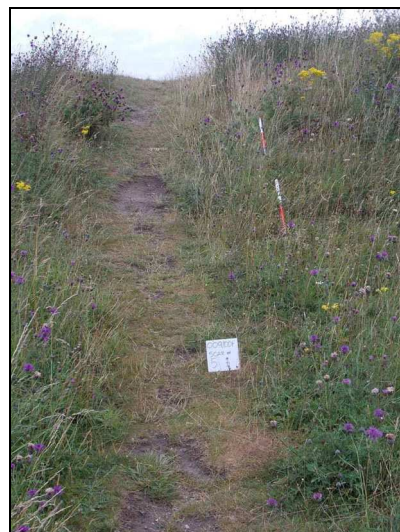
Scar 5 was the largest single affected area of the monument itself, totalling over 40 square meters of erosion. It measured 25.8m in length and reached over 2m in width at several points along its course (Fig. 7). The north side of the scar consisted of c. 0.13m of topsoil overlying nodular chalk, but on the south side no chalk was exposed (Plates 9 & 10). This was due to the presence of a previous, underlying repair contributing to the depth of topsoil and forming a layer at least 0.25m thick (Plate 11).

Plate 9: Scar 5, facing south

Plate 10: Scar 5, facing north

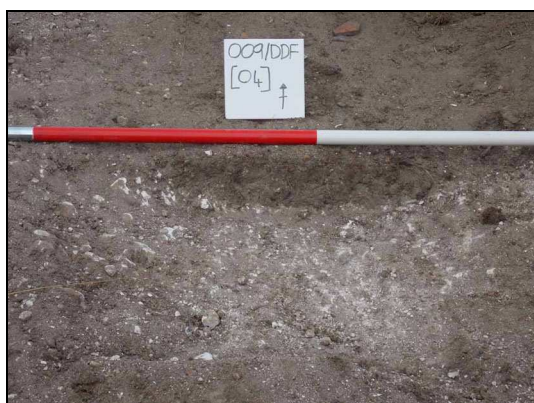
The repair itself was approximately 0.6m wide and 0.08m deep, and was present along the entire length of the south facing slope of Barrow 2. It is likely that it was also present on the north facing slope, but as it was not necessary to remove sufficient quantity of the overlying topsoil to expose the cut at that point. Twentieth century artefacts such as pottery sherds and glass were present in the fill, and it is likely this material was imported onto site specifically for the purpose.

Plate 11: Scar 5, earlier repair

The previous repair identified on Barrow 2 (Scar 5) demonstrates that the current programme of works is a continuation of an ongoing process, and that the recent damage has been dealt with at an earlier stage than in the past. It is likely that there have been other earlier repairs carried out to the monument, but as so little material was removed during the present project the overlying topsoil was not breeched, and therefore evidence of the earlier damage remained covered.

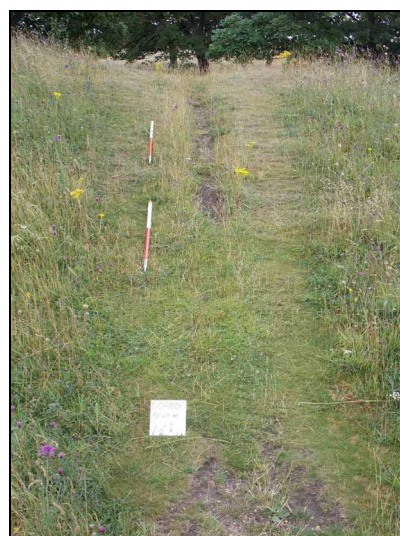
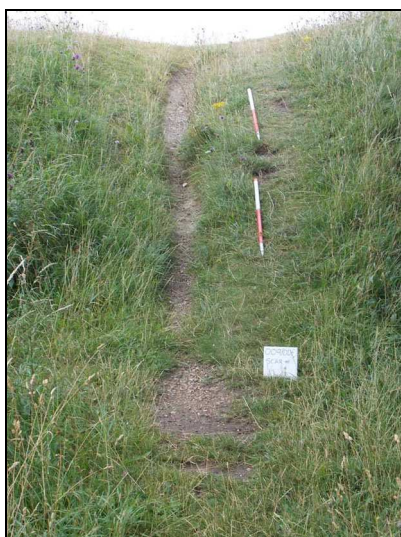
Plate 12: Scar 6, facing south

Plate 13: Scar 6, facing north

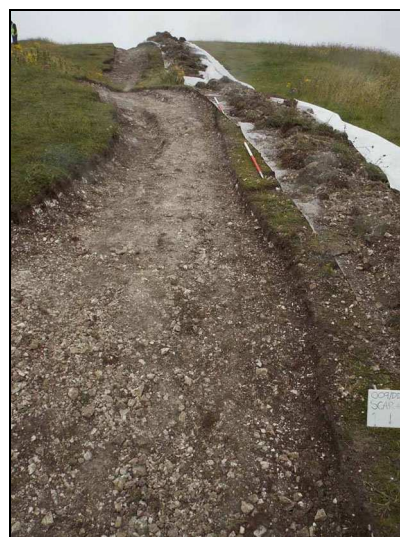
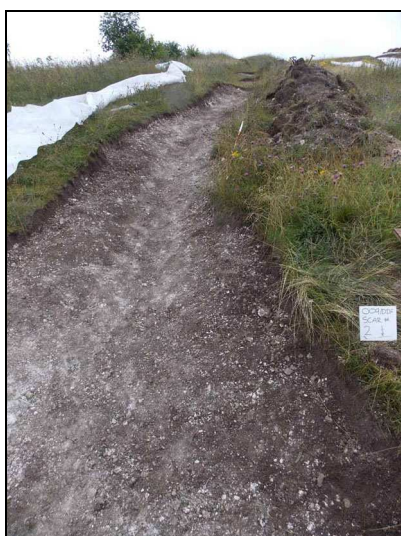
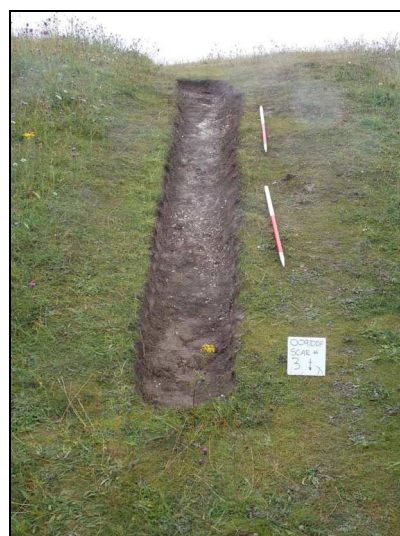
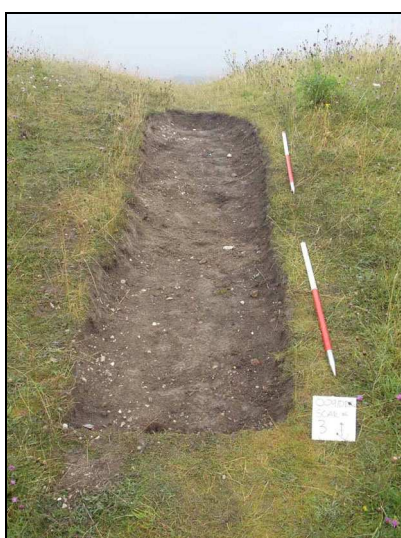
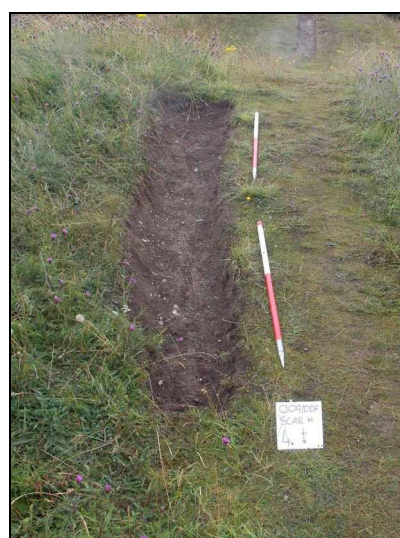
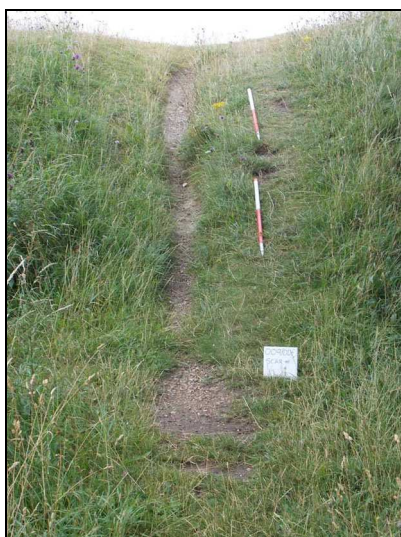
Plate 14: Scar 1, prepared, facing south

Plate 15: Scar 2, prepared, facing south

Plate 16: Scar 3, prepared, facing south

Plate 17: Scar 3, prepared, facing north

Plate 18: Scar 4, prepared, facing south

Plate 19: Scar 4, prepared, facing north

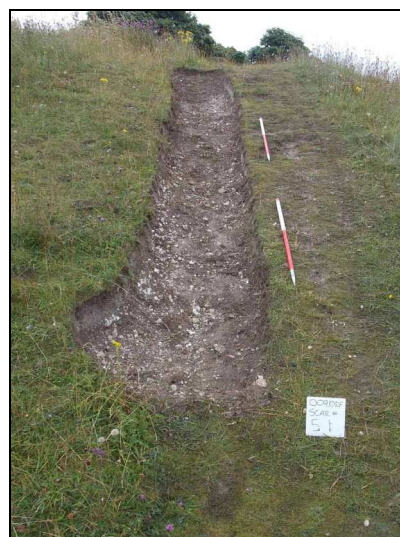
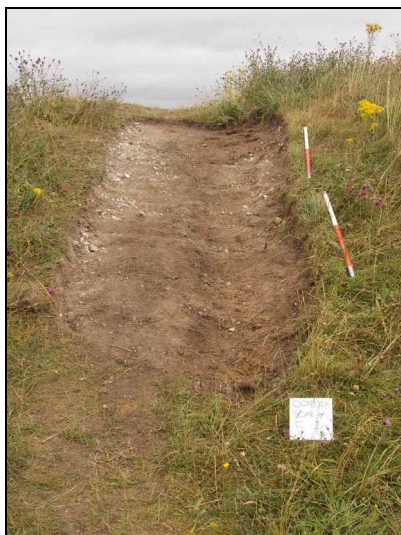
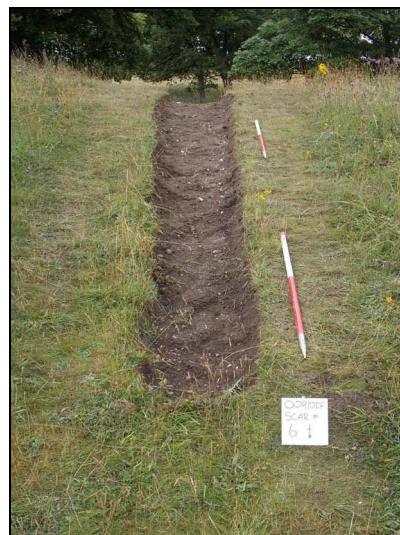
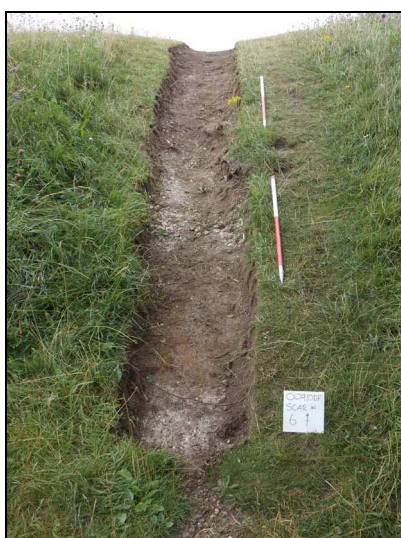
Plate 20: Scar 5, prepared, facing south

Plate 21: Scar 5, prepared, facing north

Plate 22: Scar 6, prepared, facing south

Plate 23: Scar 6, prepared, facing north

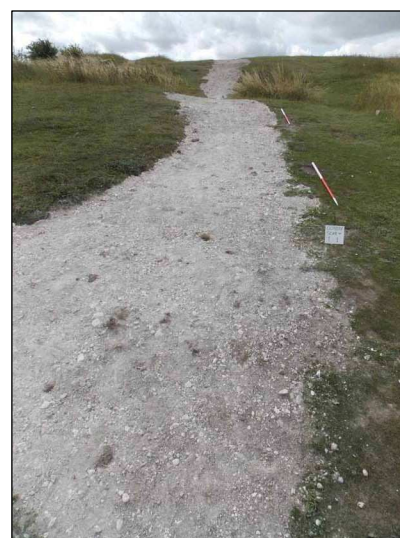
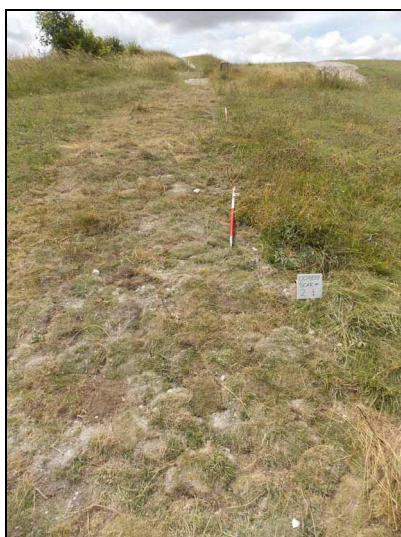
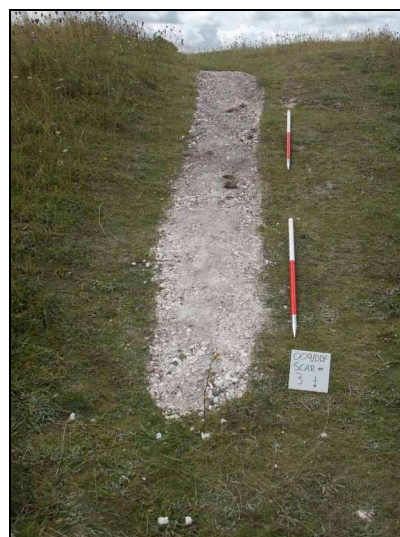
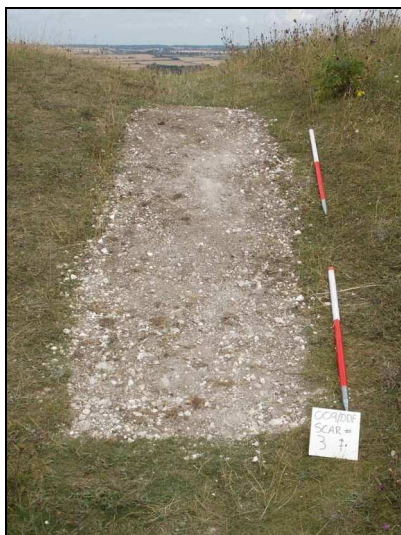
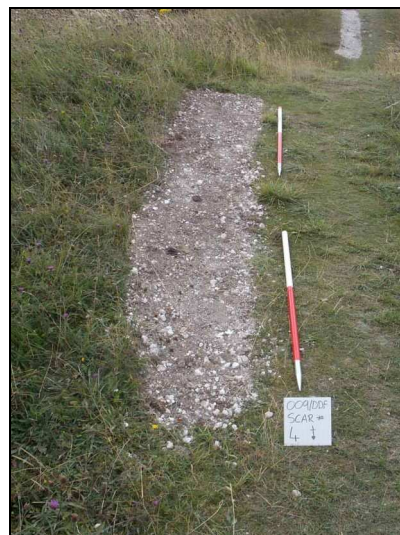
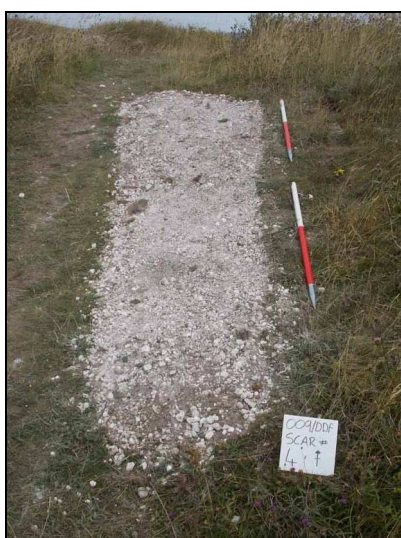
Plate 24: Scar 1, repaired, facing south

Plate 25: Scar 2, repaired, facing south

Plate 26: Scar 3, repaired, facing south

Plate 27: Scar 3, repaired, facing north

Plate 28: Scar 4, repaired, facing south

Plate 29: Scar 4, repaired, facing north

Whilst the topographical survey appears to show the scars straddling the brow of the barrows, the repairs were carried out by removing as little as possible of the monument's fabric. Consequently, in all but Scar 6, only the worst affected areas on the sides of the mounds were cut back and filled (Plates 24-33).

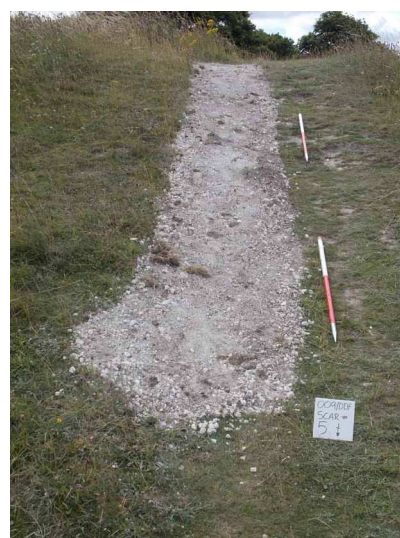
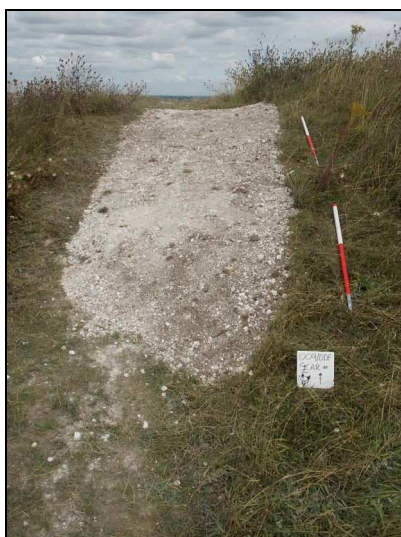
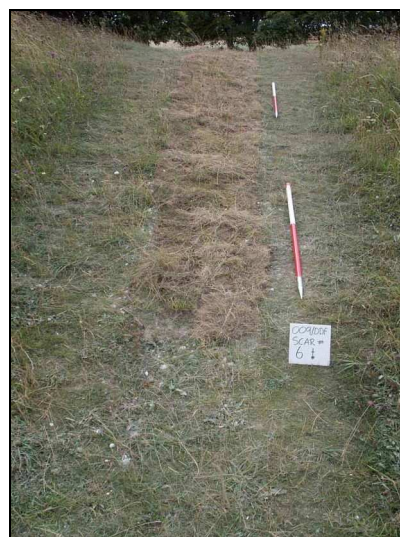
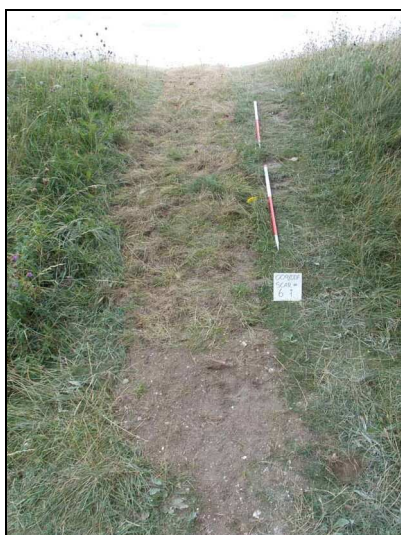
Plate 30: Scar 5, repaired, facing south

Plate 31: Scar 5, repaired, facing north

Plate 32: Scar 6, repaired, facing south

Plate 33: Scar 6, repaired, facing north
