ARCHAEOLOGICAL OBSERVATION & RECORDING REPORT:

DUNTON MANOR HOUSE
HOGGESTON ROAD
DUNTON
BUCKINGHAMSHIRE

KDK: 055/DDM/2

January 2015

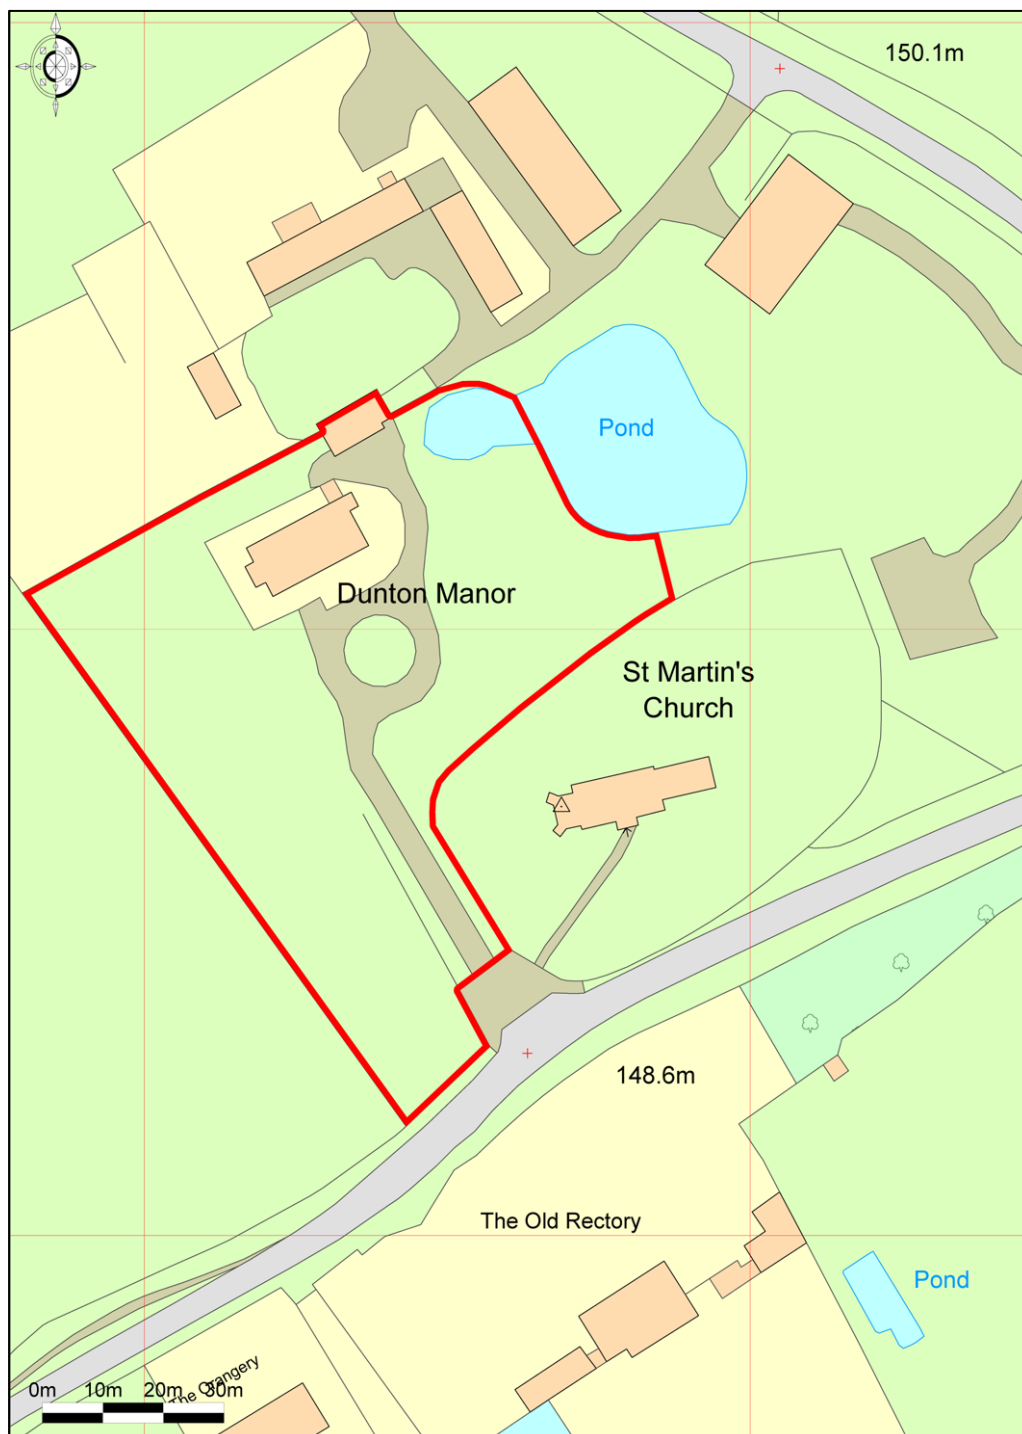
Figure 2: Site location (scale 1: 1250)

The site is set back from the main road, with a single drive from the south providing access. To the north it is bounded by an independent group of buildings, to the east is a field with a large pond, and St Martin's Church to the southeast. Dunton Road bounds the site to the south and to the west are fields with earthworks which probably represent the remains of the deserted medieval village (Fig. 2).

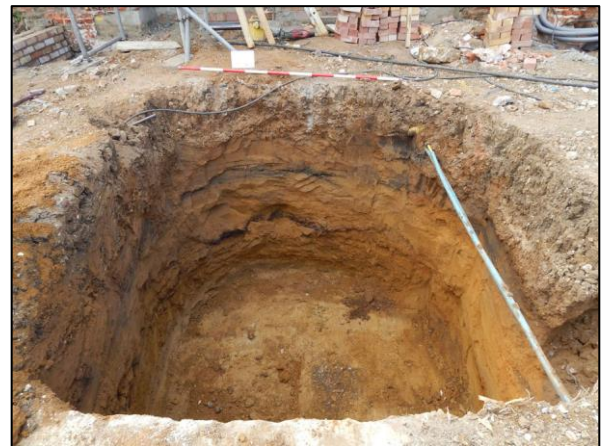
Plate 2: Wine-cellar trench, facing southwest

The general site stratigraphy consisted of upto 0.23m topsoil overlying approximately 0.7m of made ground, which mainly consisted of redeposited sandy natural geology, though lenses of other material such as clay, charcoal and iron panning were also noted (Plate 2). Excavations related to the under pinning of the extant building demonstrated that the redeposited material extended beneath the manor (Plate 3). The undisturbed natural geology consisted of reddish brown, soft to firm, sand to a depth of c. 2.20m, below which a yellowish brown hard clay was present.

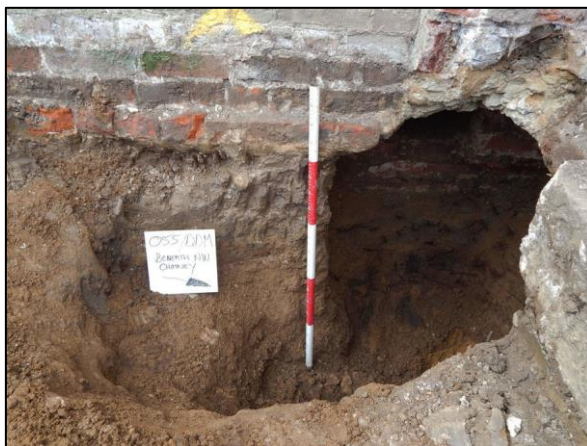
Plate 3: Stratigraphy under northeast corner, facing west

The chimney stacks and brick wall on the northeast elevation of Dunton Manor House are founded directly onto the clay-based upper layer of made-ground, and underlain by the sand-based made-ground on which the main body of the manor appears to be built.
