KDK ARCHAEOLOGY LTD

## Archaeological Observation and Recording Report

10 Rotten Row

Riseley

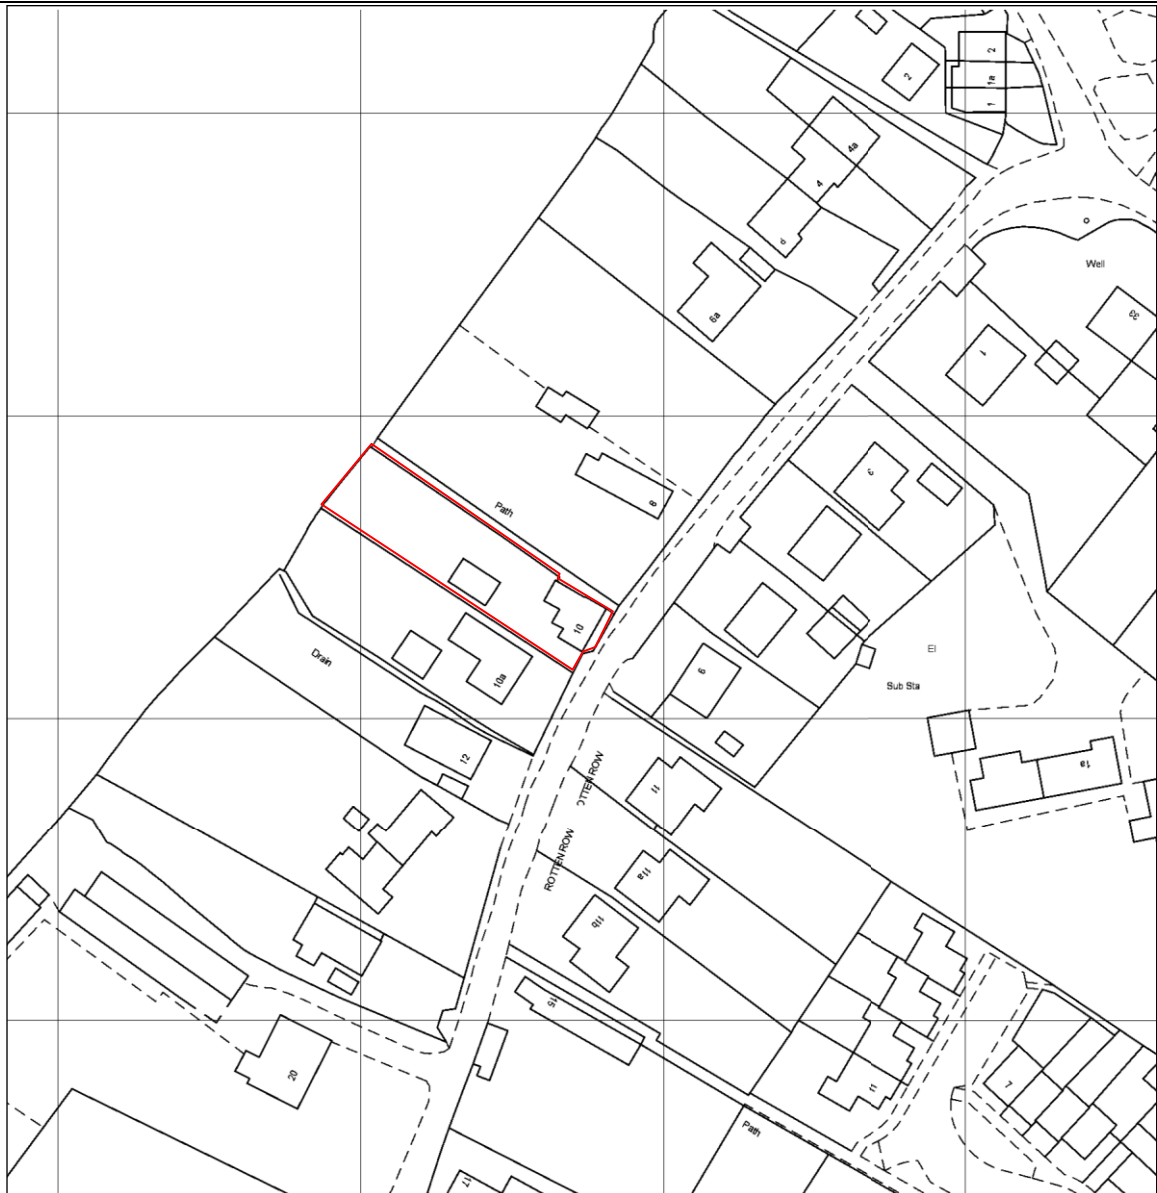
**Figure 2:** Site location (scale 1:1250)

The site is located on the west side of the town of Riseley, which lies in the civil parish of Riseley, and in the administrative district of Bedford Borough. It is centred on National Grid Reference (NGR) TL 03586 62767 (Fig. 1). The site is bounded to the north-east and south-west by the neighbouring properties, to the east by the road, and to the west by the garden of the property, and fields behind (Fig. 2). The site lies at a height of approximately 61mAOD.

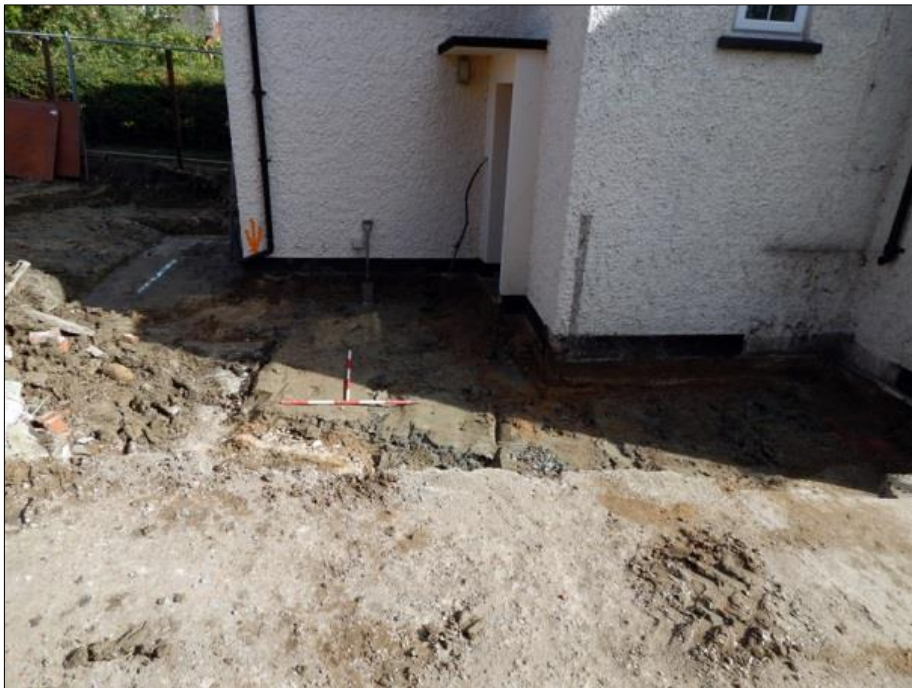
**Plate 2:** South-western area of ground reduction, facing north-east, with 1m scales

Two site visits were made during the Observation and Recording of this site to monitor ground reduction to the north-west of the existing dwelling. An area totalling 31m<sup>2</sup> was monitored, with the ground being reduced by 0.4m, fully exposing the natural geology (Fig. 4, Plates 1 & 2). All excavation was completed by a machine fitted with a toothless bucket. The footings of the extension were excavated within the reduced area, however due to a miscommunication, the footings for the south-western side of the extension were excavated before the ground reduction, without supervision. The area directly surrounding these footings was monitored during the subsequent strip, in addition to the examination of the section directly to the south-west (Plate 3).

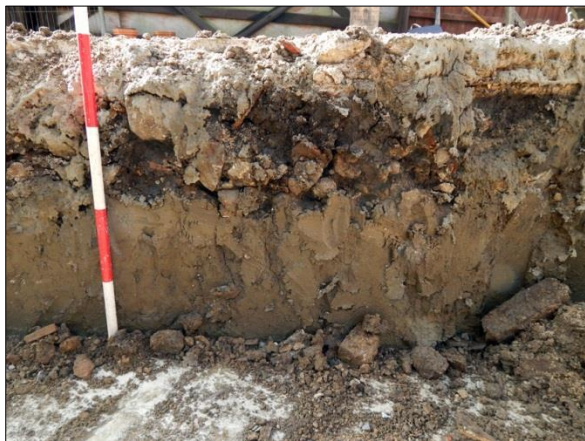
**Plate 3:** Section adjacent to the south-west footings, north-east facing section, with 1m scale

Due to a miscommunication, the footings for the south-western side of the extension were not monitored. An area directly adjacent to these footings was monitored, and the section immediately to the south-west was also examined, with no archaeology observed.

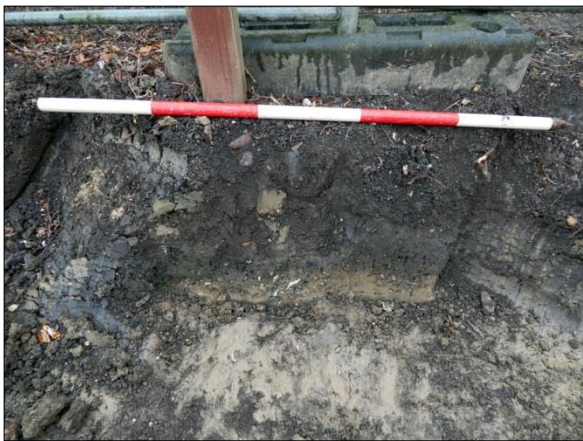
The general stratigraphy of the site comprised 0.3m of dark yellow-brown moderately firm silty clay topsoil with occasional large stones inclusions, overlying the mid yellow-grey firm clay natural geology (Fig. 5, Plate 4). Unstratified finds included large ceramic building materials (CBM) in the form of bricks, as well as animal bone.

**Plate 4:** Site stratigraphy, south-west facing section, with 1m scale

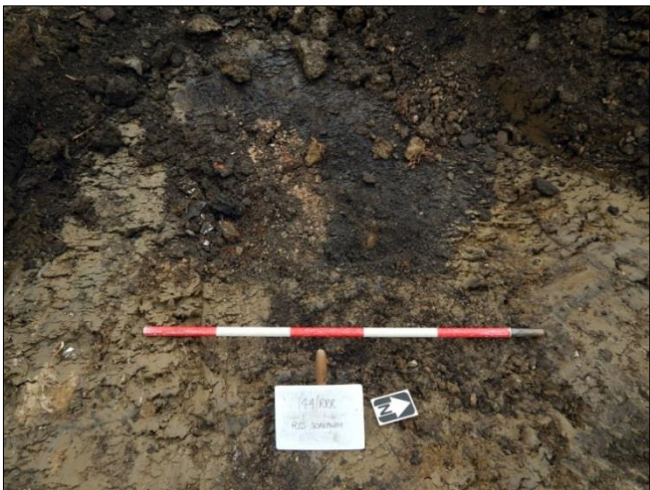
After stripping the area, only one, non-archaeological feature was uncovered; a rectangular soakaway 1m wide, and continuing into the baulk to the north-west (Fig. 4, Plate 5). The fill was black, moderately firm, and tacky, and contained finds such as CBM and modern glass bottles.

**Plate 5:** Soakaway, facing north-west, with 1m scale

The stratigraphy of the site is consistent with its known history as a garden related to the extant building. The soakaway located to the northwest of the building is most likely directly related to the numerous ceramic and plastic drainage pipes uncovered during the ground reduction.
