Archaeological trial trench evaluation of the former Red Lion car park Middleton Cheney, Northamptonshire January 2014

Planning reference S/2012/1449/FUL

Report No. 14/19

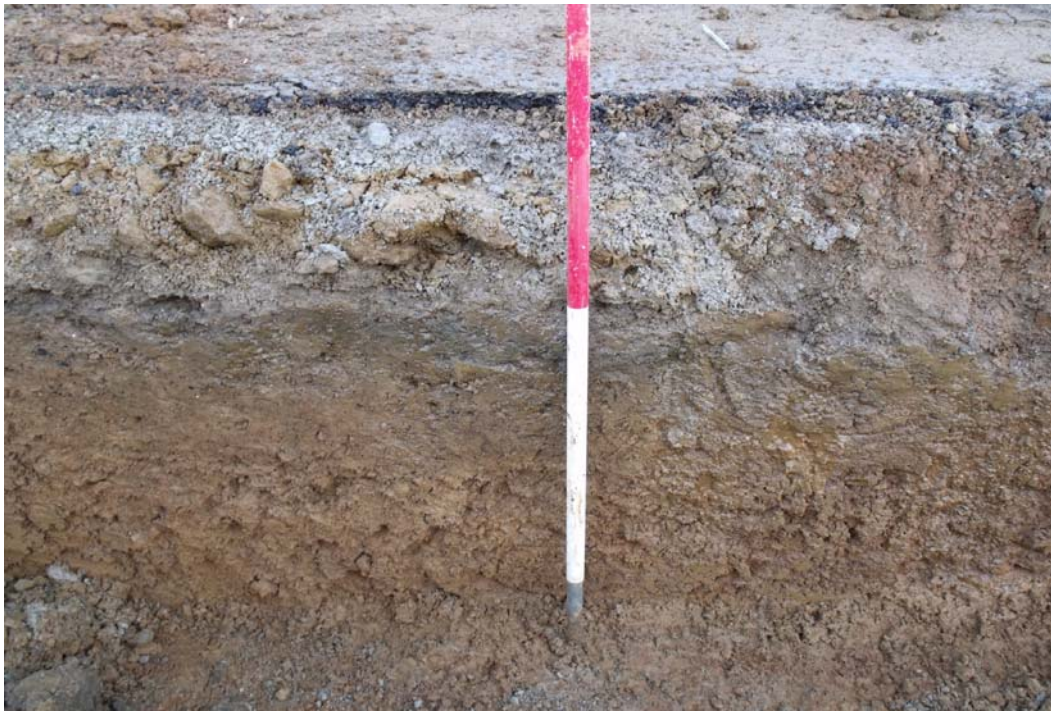
Trench 2, example of stratigraphy, looking north Fig 3

The natural cornbrash geology for the area, yellow-brown ironstone, was encountered at 0.72m below the modern ground surface. There was no topsoil or subsoil present. A number of layers (103)(104)(105) all contained modern material such as brick and glass as well as stones and ash. Layer (106) appeared to be a natural interface, while layers (103)(102) were layers of rubble material for the foundation of the tarmac car park surface.

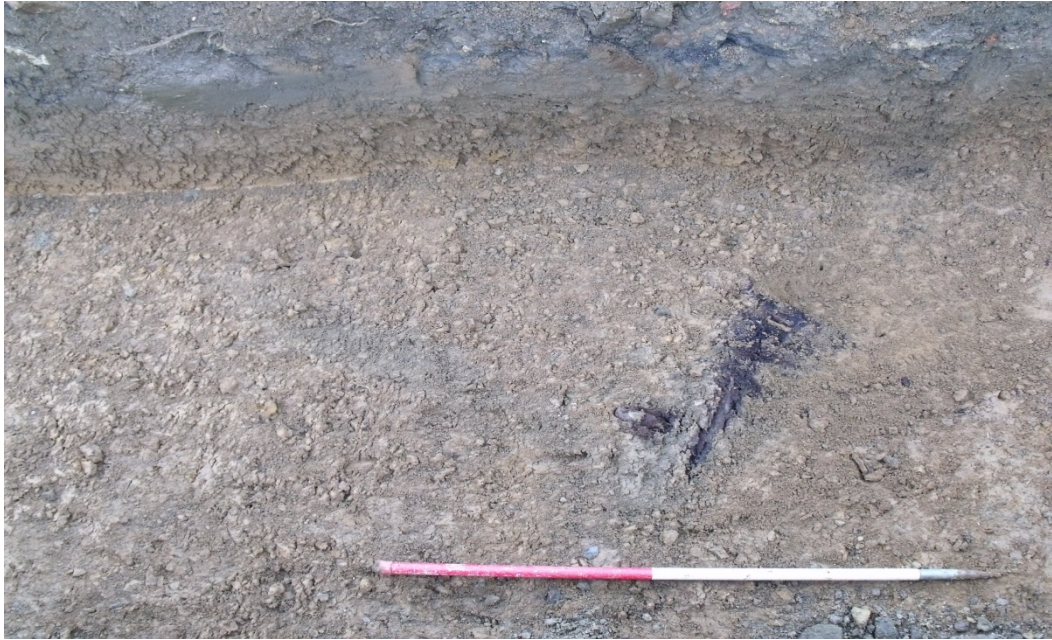
Fig 4

The corner of a U-shaped beam slot [109] in the south-east end of the trench was angled at 90 degrees (Figs 4-6). In the base of the slot, in fill (108), was a timber *in situ*, as well as nails and slate, sealed by deposit (106). The possible beam extends beyond the trench to the north and east. Some iron nails were discovered which indicate that the structure may have been post-medieval. These were not kept.

Beam slot, Trench 1, looking east

The beam slot with surviving timber indicates the presence of a small timber building, possibly of post-medieval date. No archaeological features were found in trench 2 which suggests that the structure did not extend that far north on the east side, but it could extend into the footprint of the proposed new buildings. No earlier features or finds were present.

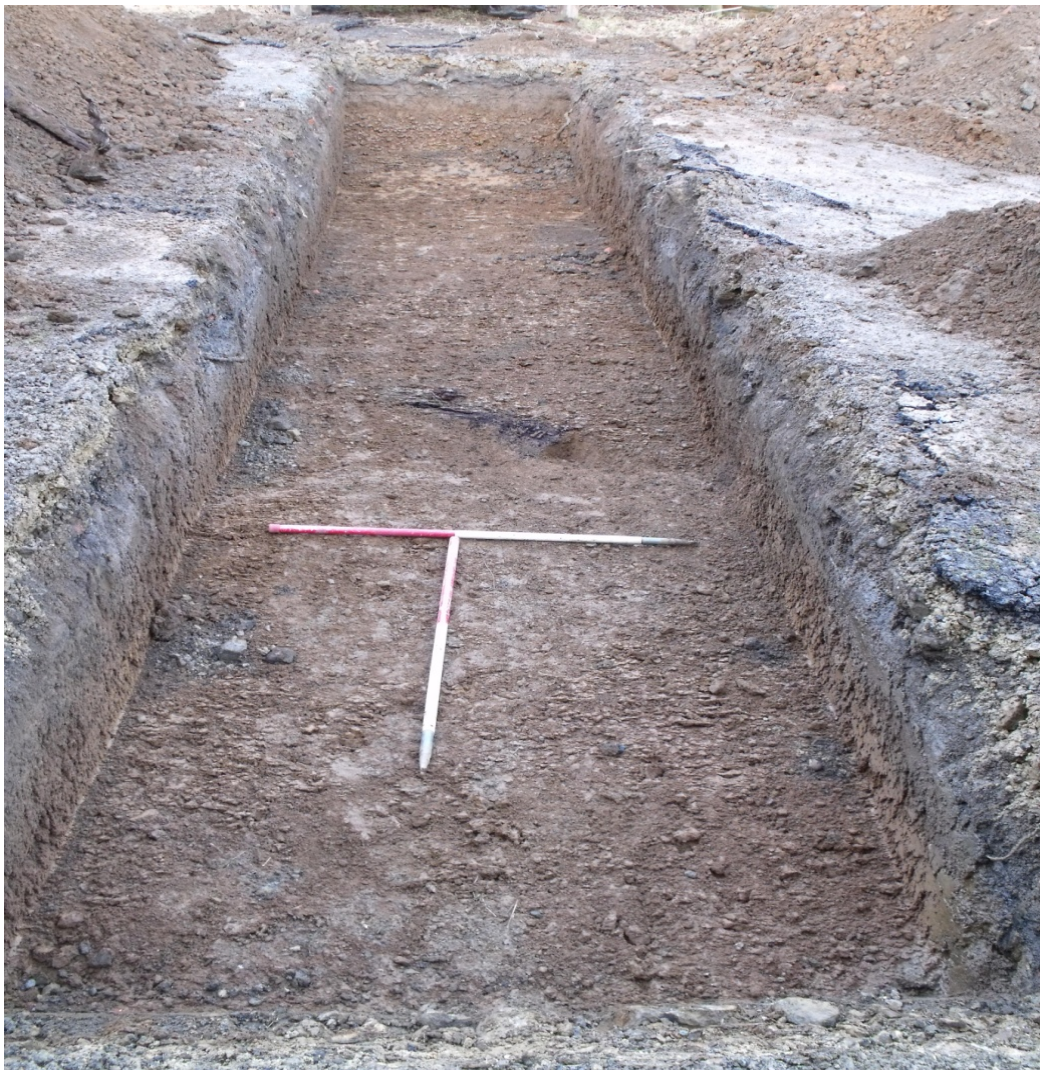
Fig 5

Beam slot, Trench 1, looking north-west

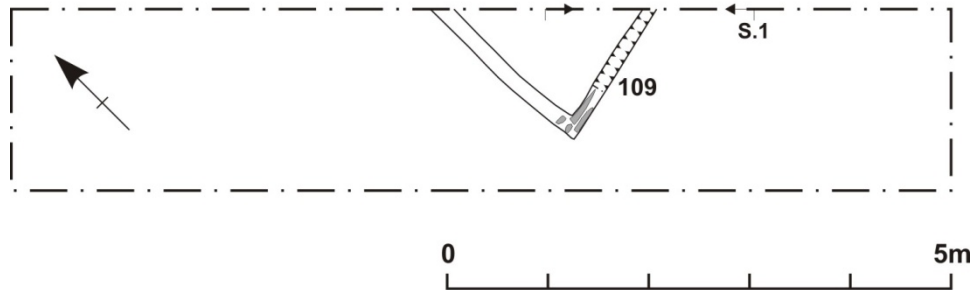
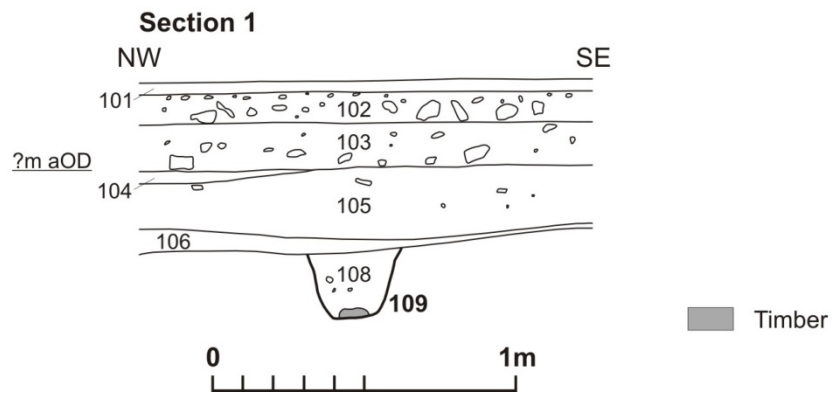
Fig 6

Beam slot, Trench 1, plan and section

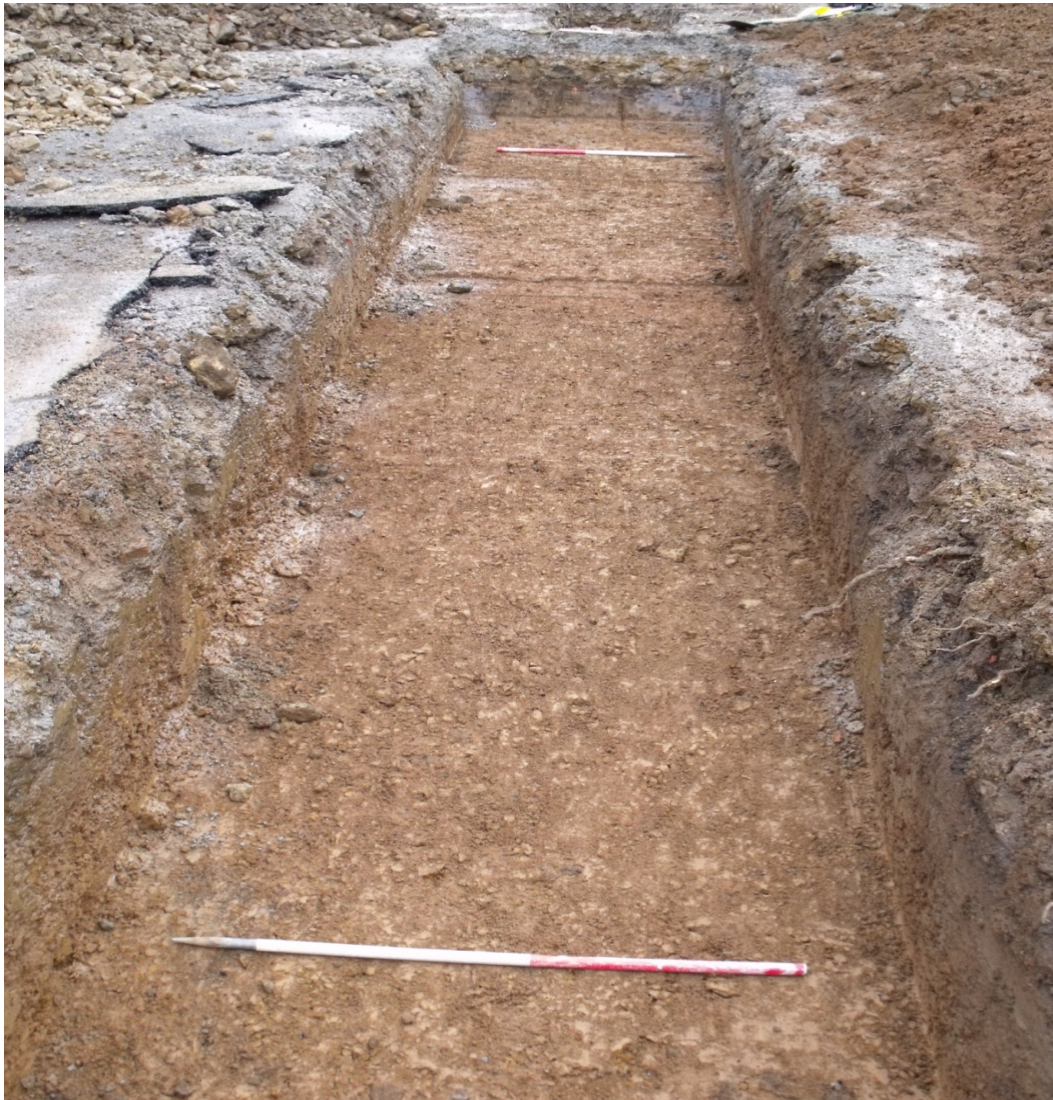
Fig 6

Trench 2 was aligned west-east and was the full 10m in length. No archaeology was present within this trench.

Trench 2, looking east
