Archaeological building recording at The Old Manse High Street, Guilsborough, Northamptonshire December 2013

Planning reference DA/2012/0830(13.5.13)

Report No. 14/1

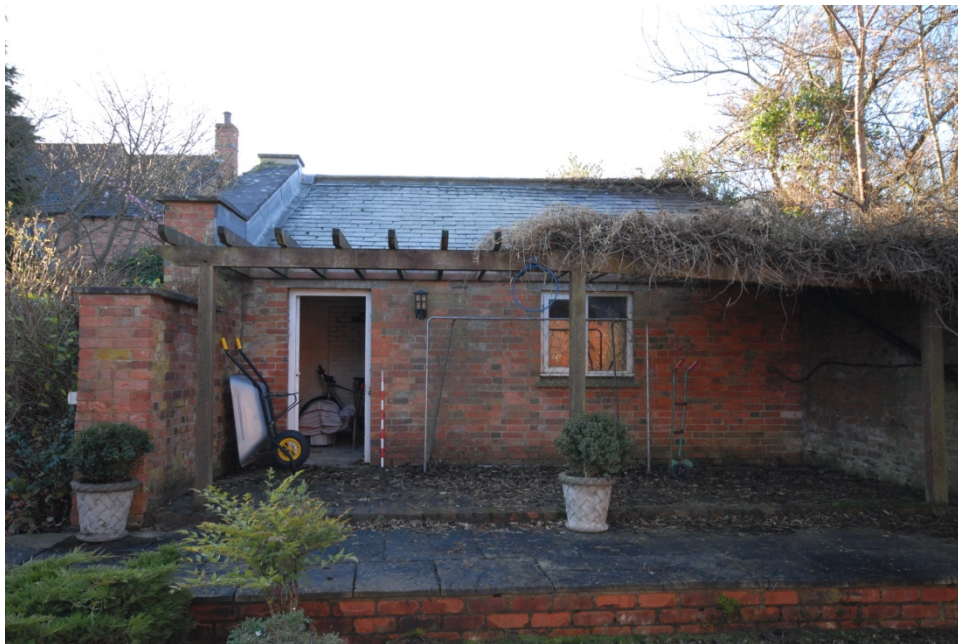
Fig 4

This small detached single storey red brick building is located at the southern end of the garden (Fig 7). The walls are red brick in an irregular bond and the roof is Welsh slate. There is a single entrance on the north side which has a concrete lintel; the door is a modern split stable style door. The single window also on the north side is a modern two light wooden casement also having a concrete lintel (Fig 4). There are two blocked openings on the building, both with segmental brick arches, a former doorway on the south side (Fig 5) and one on the east elevation, which was likely to have been a window. It was not possible to trace the full extent of the blocking due to plant growth.

The detached building, looking south-west

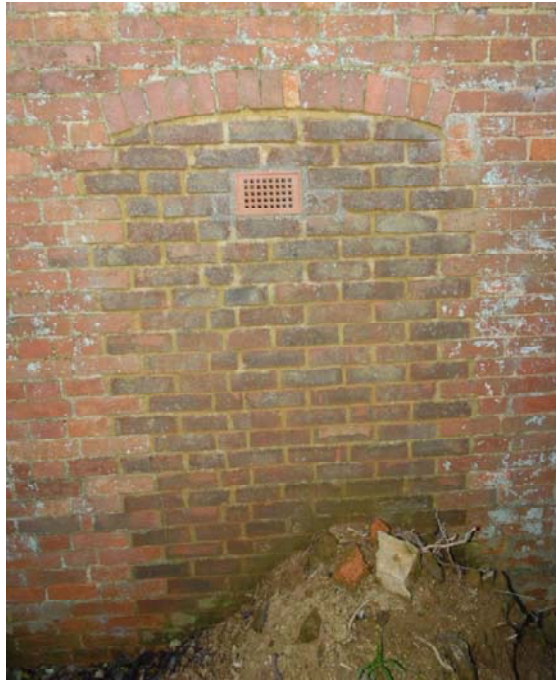
Fig 5

Blocked doorway on the south wall of the detached outbuilding

The survey recorded the detached outbuilding at the southern end of the garden, it was apparent from the survey that this building was quite recent, although it incorporates elements of the former Baptist Chapel which stood in the garden, as can be seen in the blocked opening in the southern and eastern walls.

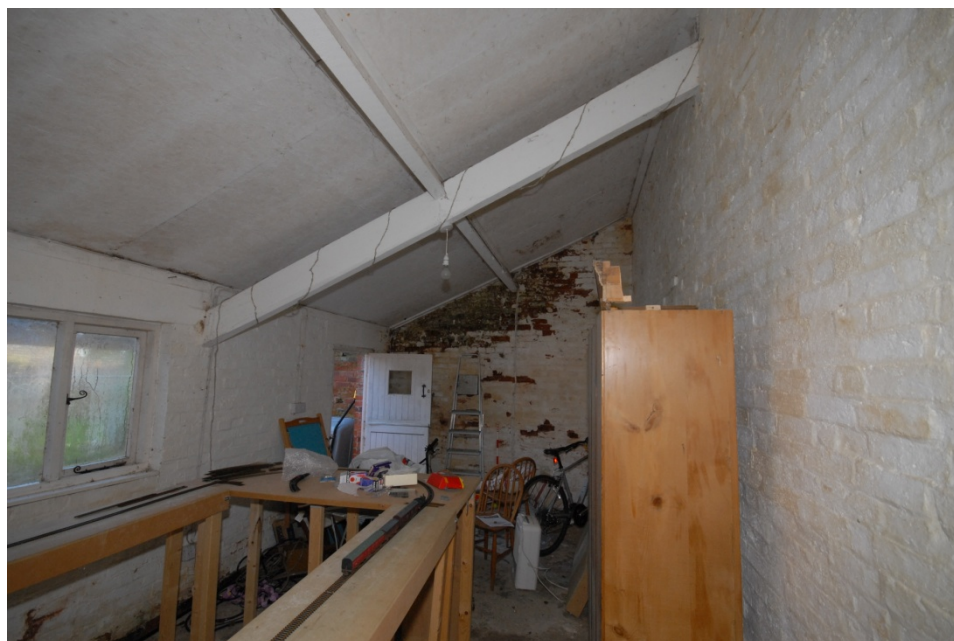
Fig 6

The interior of the building consists of a single room with a concrete floor and white painted brickwork walls. The roof is a simple timber truss and purlin (Fig 6).

The interior of the detached outbuilding, looking east

It is likely that this small building incorporates elements of the former Baptist chapel in its west, south and possibly east walls, otherwise the roof structure and the north elevation with its door and window are modern.

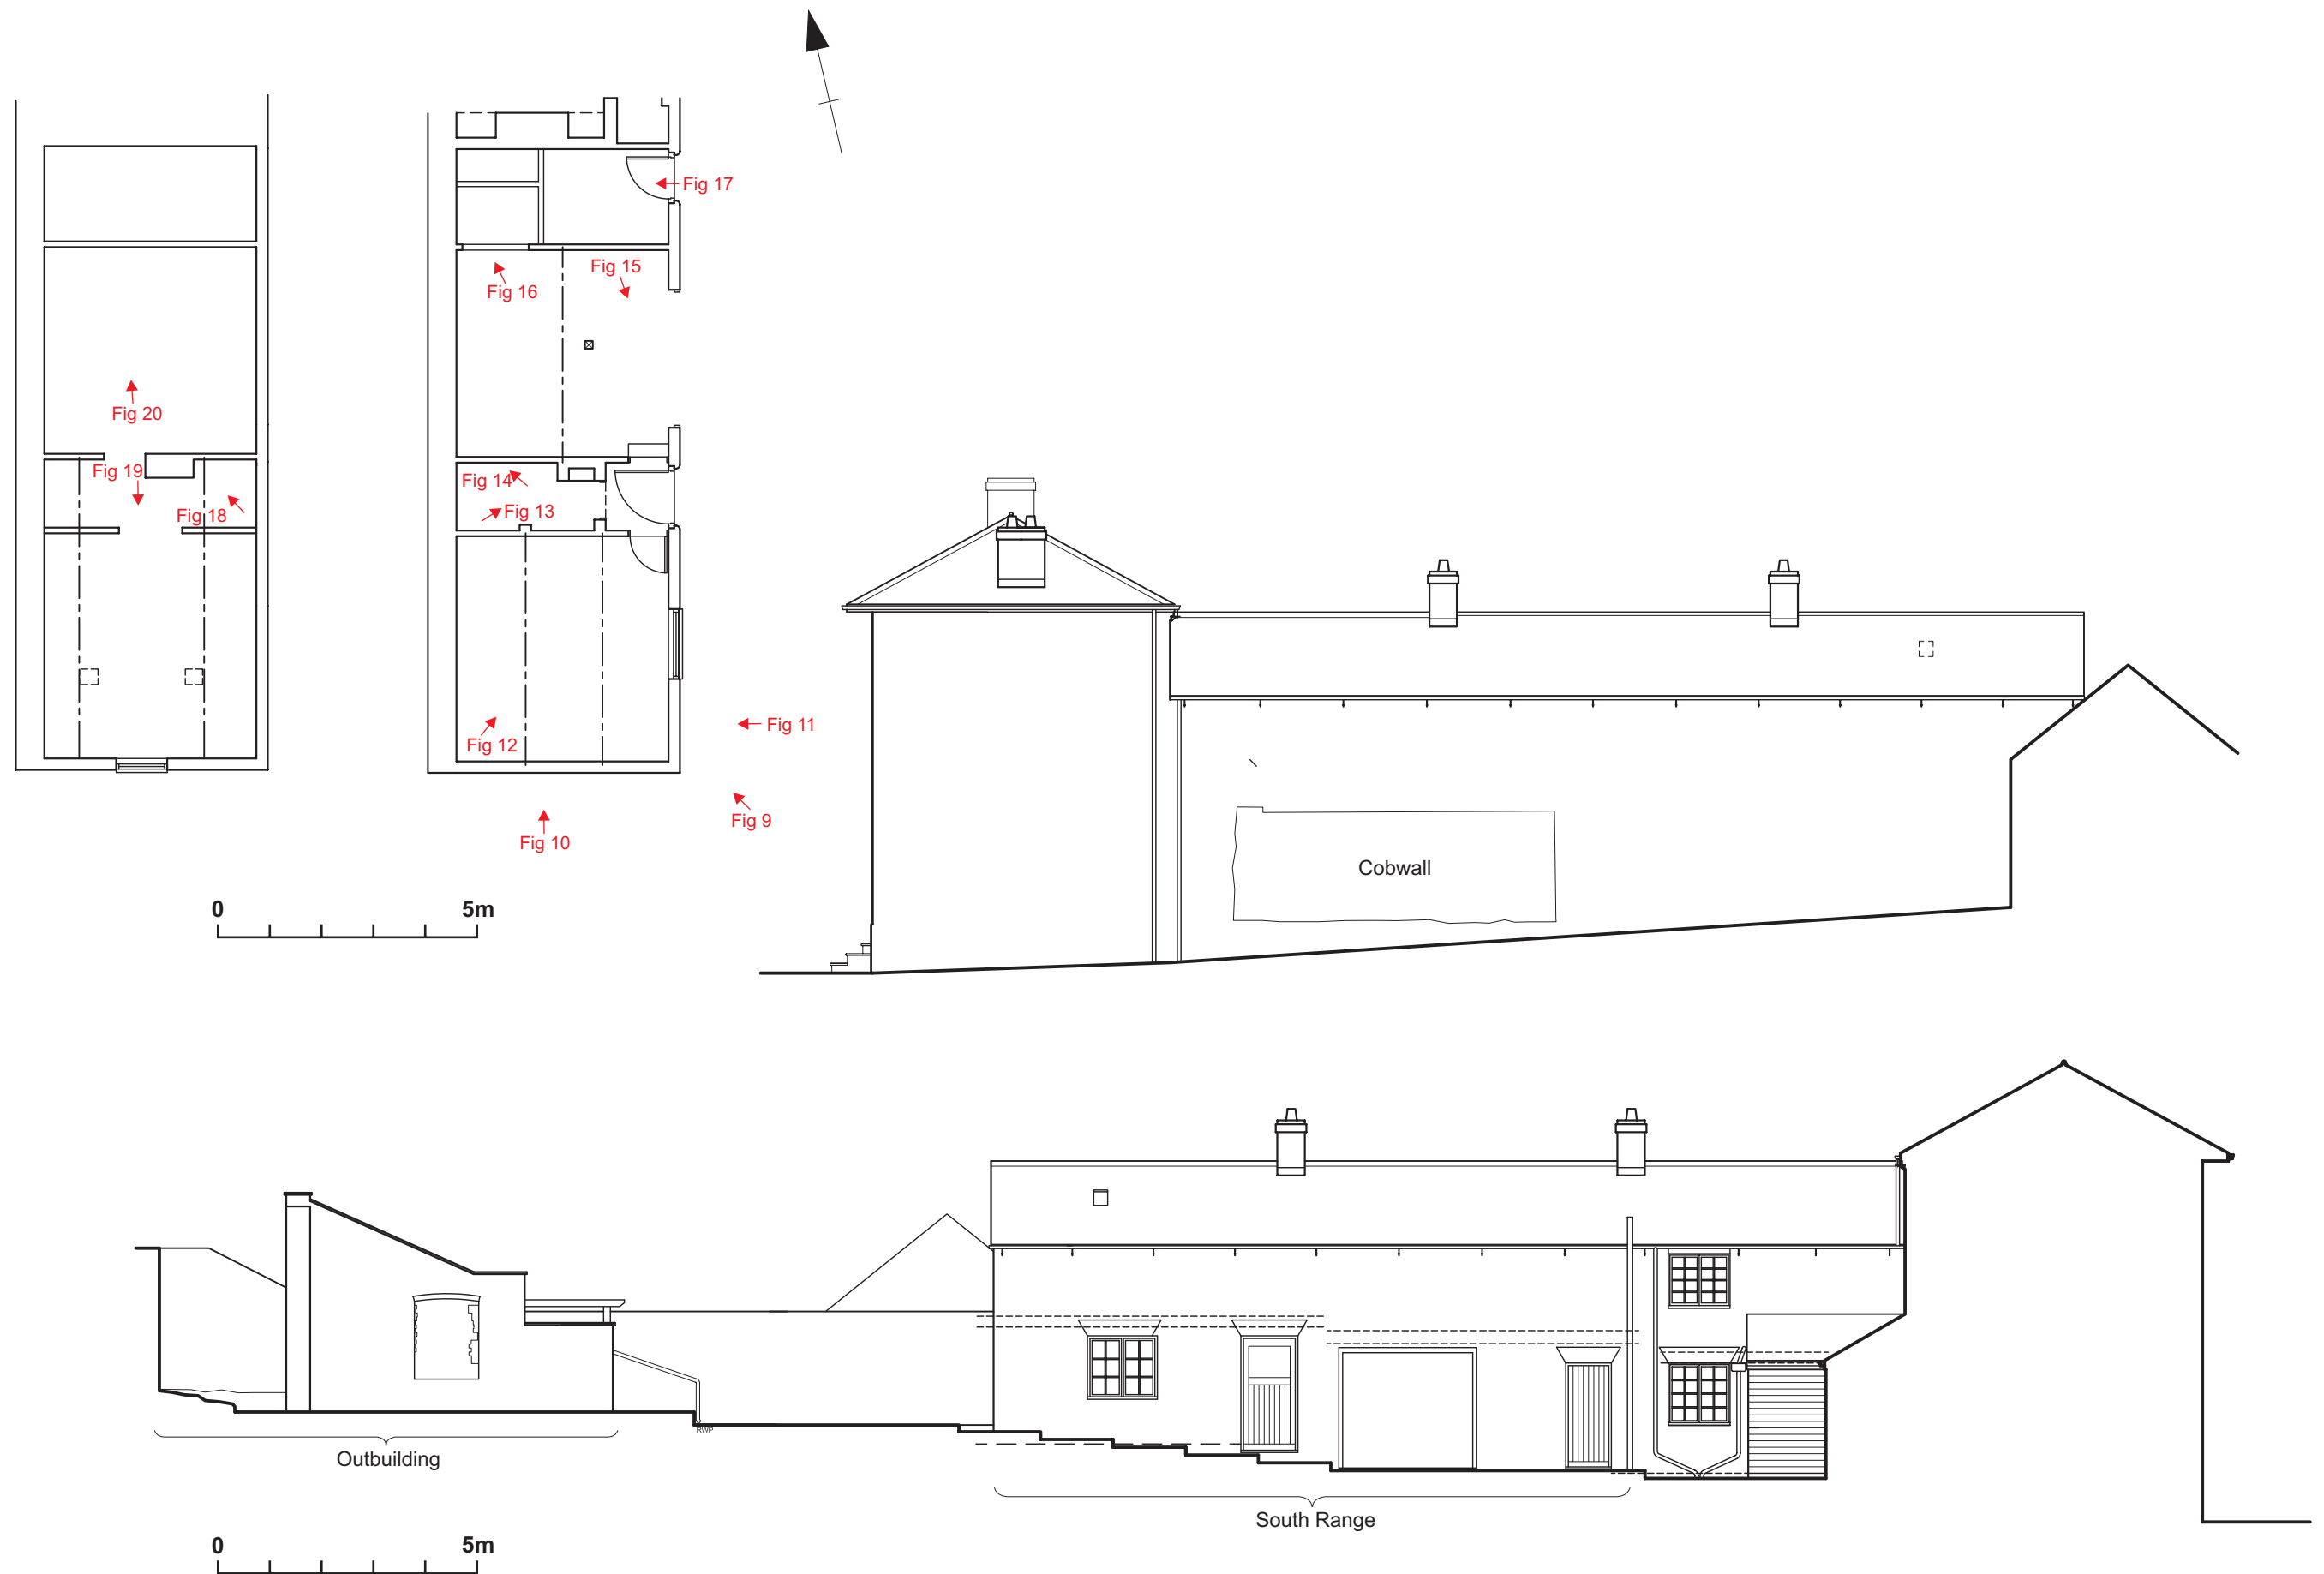
It was only the southern end of the south-west range which fell within the scope of the survey; the range joined onto the back of The Old Manse and was seemingly contemporary with it (Fig 8). The exterior of the range is mostly in red brick with an element of cob wall at ground floor level on the west elevation. The roof is in Welsh slate.

There are three entrances to the range on the east elevation (Figs 8 and 9), the southern of these is taller and wider with curved bricks to either side and a flat brick arch over suggesting that this was the stable entrance for a horse, adjacent to this is a wider opening with a timber lintel, this opens into what was likely to be a small coach room. The final door is a normal-sized door, with a ledged and braced plank door and flat brick arch over. The single window in this elevation was a later alteration as the wooden casement is wider than the flat brick arch over (Fig 11). The southern elevation has a single window at loft level which is inside the reduced opening of the former hayloft entrance (Fig 10).

The ground floor comprises four rooms, the former stable, tack room, coach room and a further small storeroom (Fig 8). The former stable (Fig 12) has a cobble floor with a brick edging, the walls are painted brick and the ceiling is reed and plaster. No visible evidence survives of any divisions for stalls. The door between this room and the tack room is a split stable door.

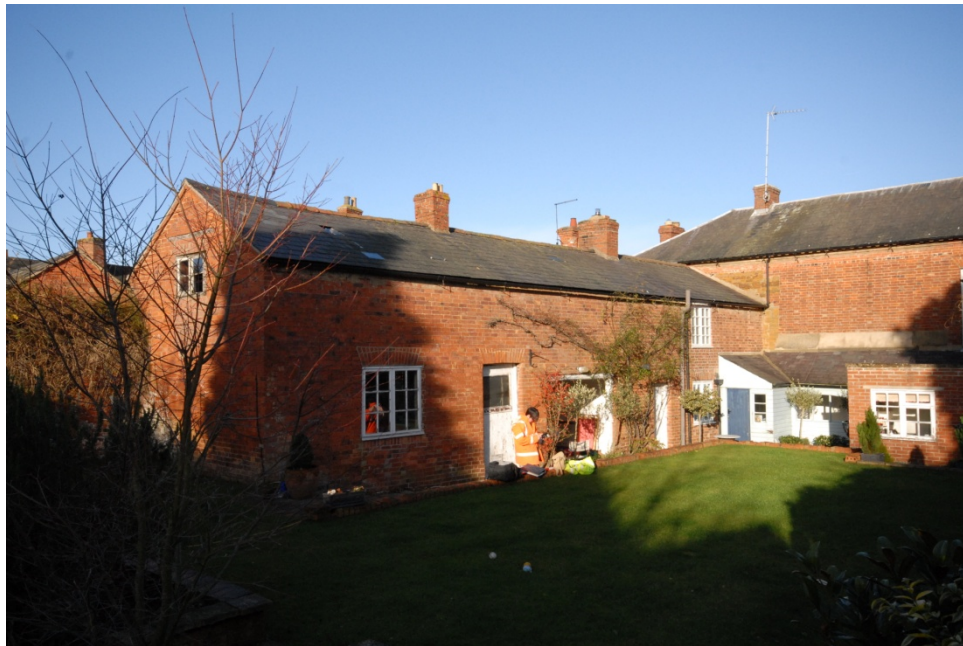
Fig 9

South-west range, looking north

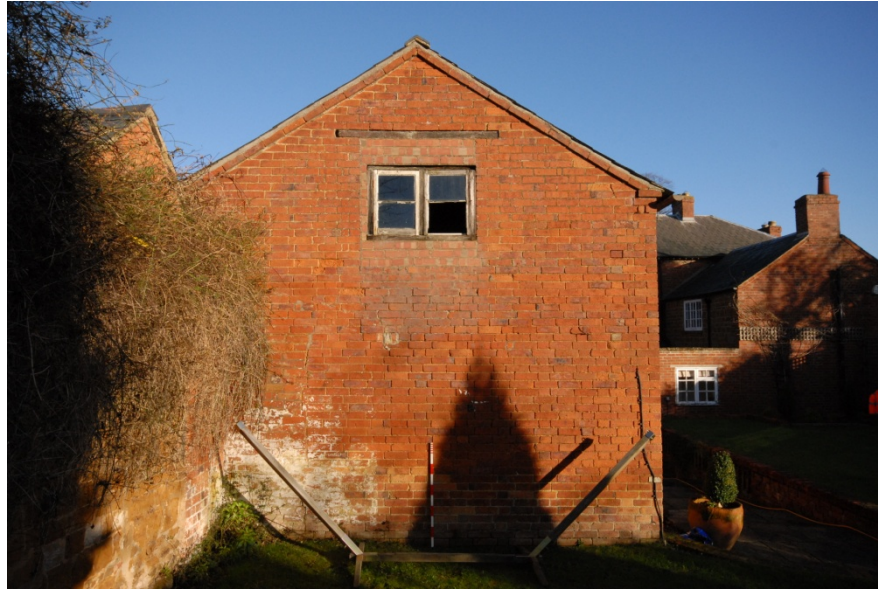
Fig 10

Gable end of south-west range, looking north-east

The south-west range appears to be broadly contemporary with the construction of the 'Old Manse' and would have served as stable, coach room with hayloft and storage over. The survey demonstrated that this building although broadly unaltered internally, had seen alterations to some of the openings with a window replacing the hayloft door and the ground floor window being wider than the brick arch over.

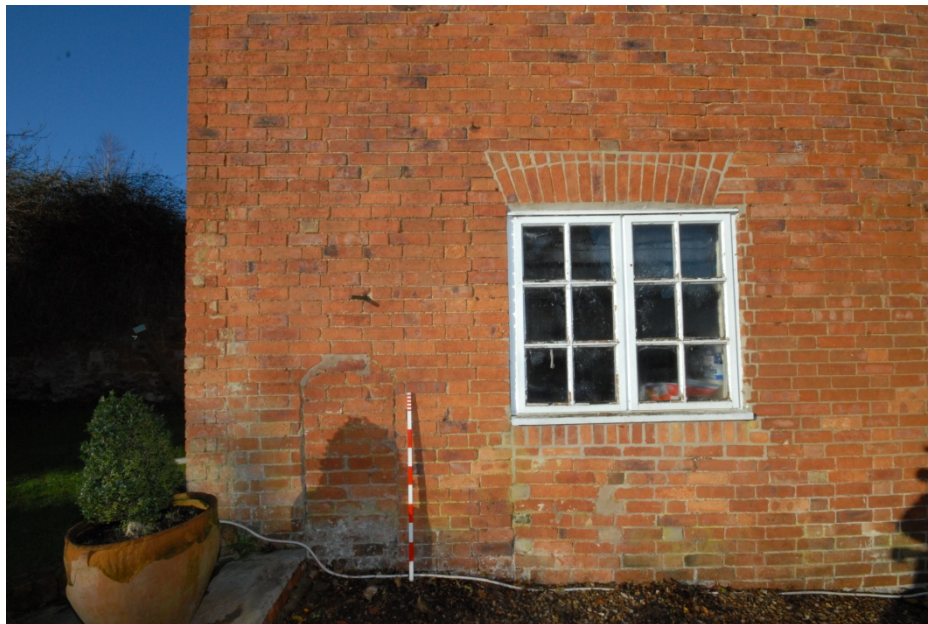
Fig 11

South-west range, detail showing blocked arch

Adjacent to the window on the east elevation is a small blocked arched opening (Fig 11), the opening did not have a brick arch over, the existing courses having been cut to form the arch. The original purpose of this feature is not clear, and there was no visible evidence on the interior of the building to suggest a purpose.

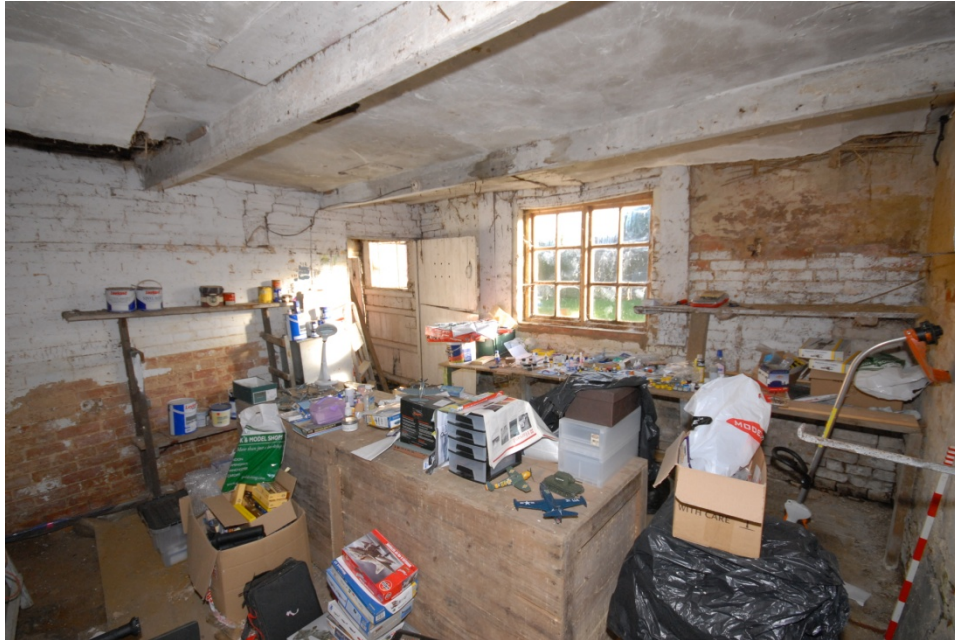
General view of the interior of the former stable Fig 12

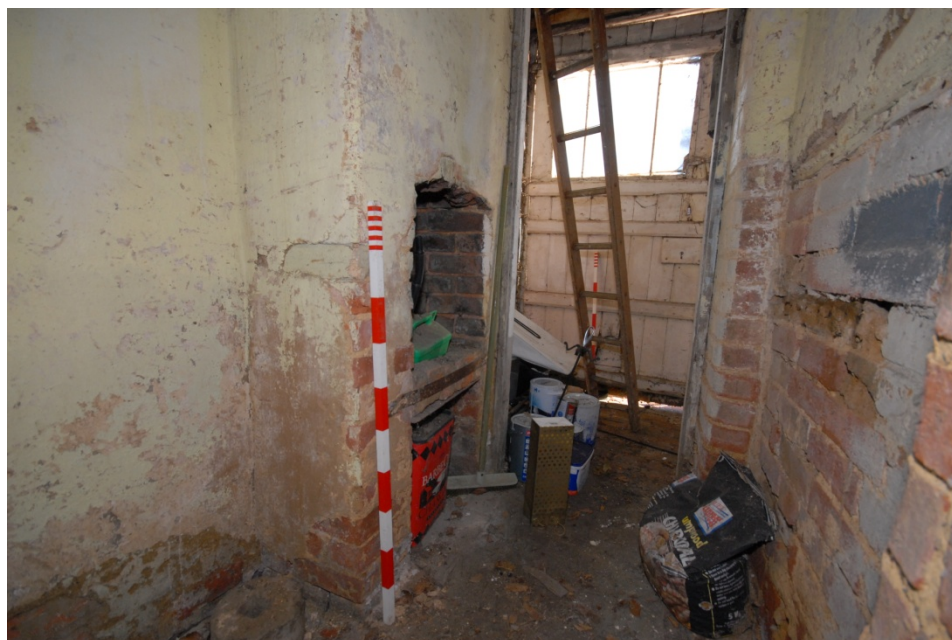
The tack room has a laid brick floor, the walls are painted plaster over brick and the ceiling reed and plaster. This room has a chimney and the opening for a small cast iron stove which has been removed (Fig 13), the wooden tack hooks survive on the wall (Fig 14).

Fireplace opening in the former tack room Fig 13

It is likely that there was originally a door separating the former tack room from the stable entrance lobby, so that the heat from the fireplace was retained in the room. From the entrance lobby there is a door with a step down leading into the former coach room.

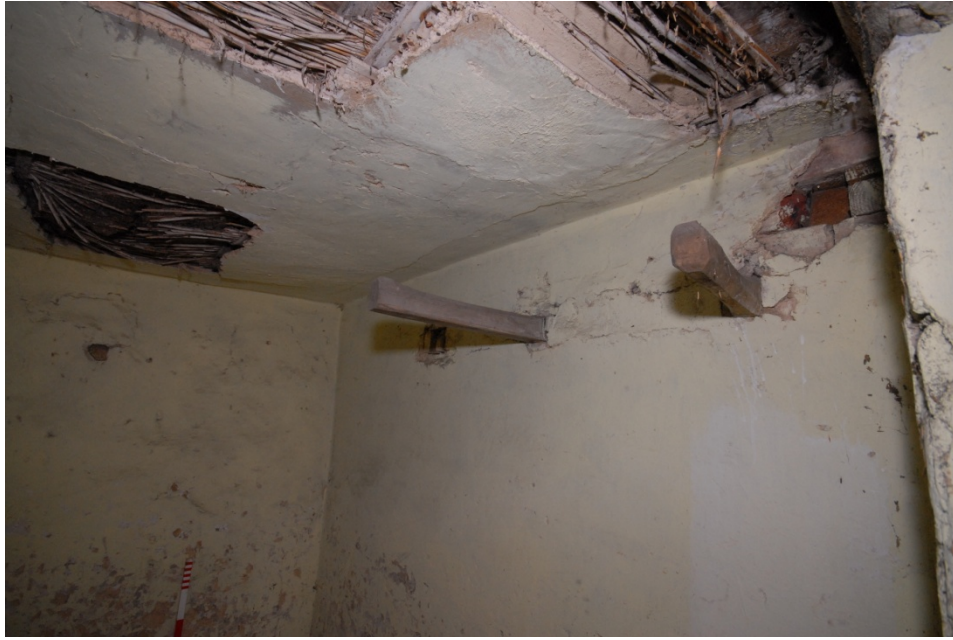
Fig 14

Wooden tack hooks in the former tack room

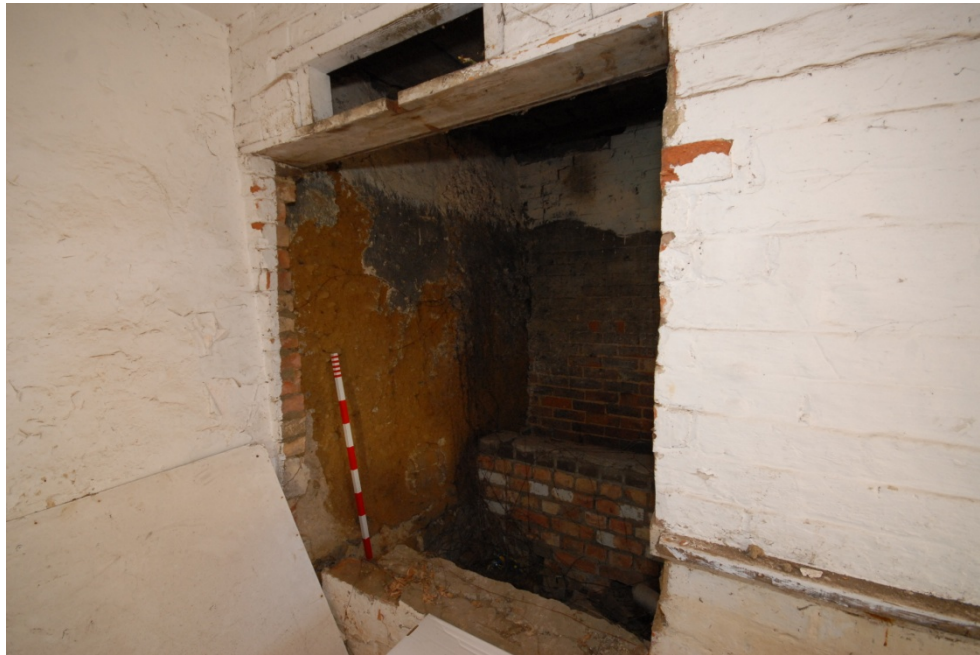
The fourth room on the ground floor was originally separate from the coach room, until an opening was made between the two rooms which is not full height. The room has its own door leading in from the garden. The room currently houses the central heating

boiler, but the presence beyond that of two low separated bays would suggest that an earlier function was perhaps as a coal or wood store for the house. The floor is concrete, the walls are painted brick apart from the rear wall which is cob (Fig 16), the ceiling is the exposed joists and beam for the room above (Fig 17).

The opening from the former coach room to the possible former fuel store, with the exposed cob wall visible Fig 16

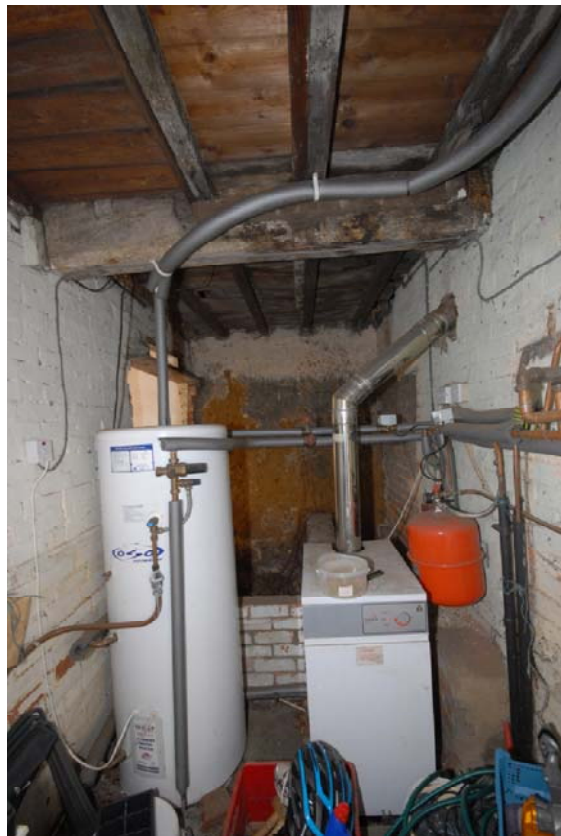
The boiler room Fig 17

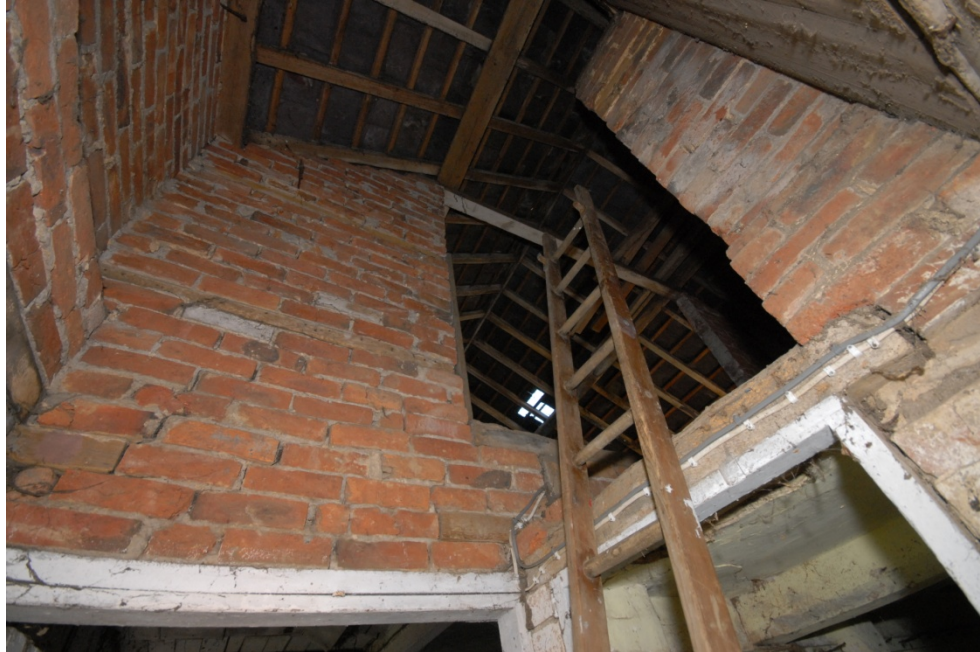
Fig 18

The first floor is currently accessed via a ladder in the lobby outside the former tack room (Figs 8 and 18). Due to the nature of the floor at first floor level the former hayloft was not entered.

The current access to the hayloft

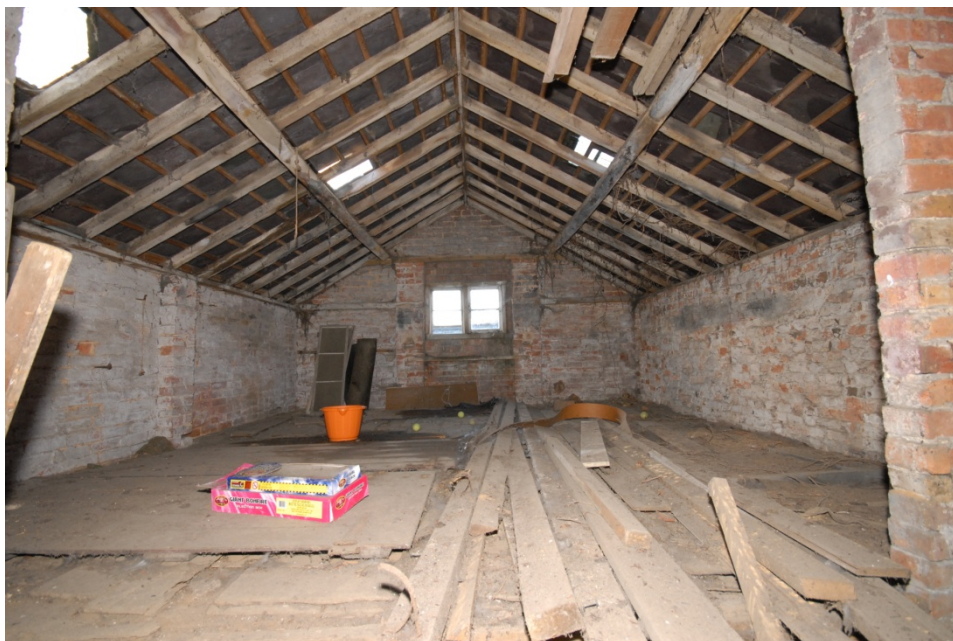
Fig 19

The first floor is split into three rooms with the former hayloft at the southern end (Fig 19). The hayloft has two roof lights and a window set in to the reduced opening of the former doorway at the southern end. The exposed roof structure is common rafters supported on purlins, the common rafters being attached to a timber wall plate.

The hayloft

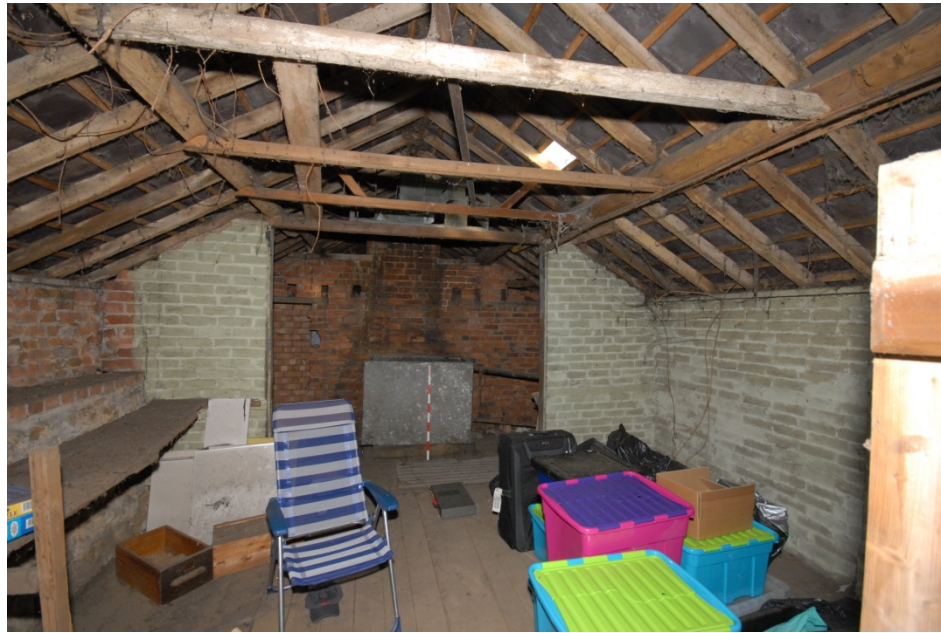
Fig 20

First floor storage

The roof structure in the rest of the first floor has ties between the purlins, but these are separate to the common rafters, so do not form part of a truss (Fig 20). The small room at the northern of the first floor had the cold water tank for the boiler room below.

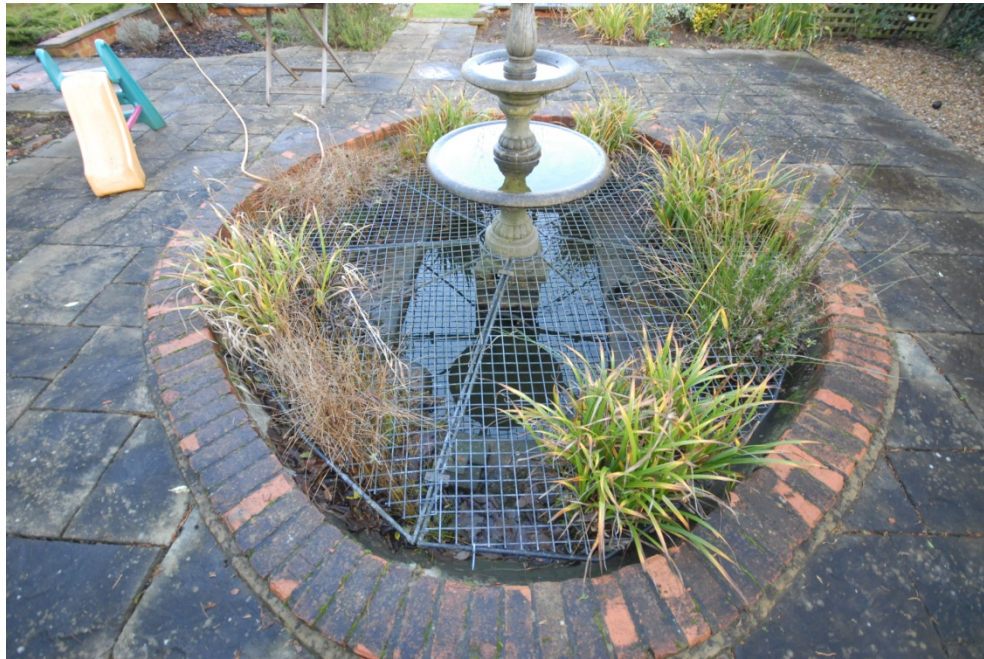
The small brick building in the southern part of the site is within the footprint of the former Baptist Chapel, and may incorporate elements of the south-west corner of the now demolished chapel. The baptistry of the Chapel survives in the garden as an ornamental pond (Fig 21)

Evidence for the now demolished Chapel which stood in the garden was limited to the possible elements incorporated into the detached outbuilding and the garden pond which is the old baptistry for the Chapel (Fig 21).

The garden pond, which has the stonework for the baptistry of the old Chapel visible below the mesh (Fig 21)
