**Archaeological strip, map and sample investigation
at 56 Church Street, Broughton
Northamptonshire
February-March 2014**

Planning application no: KET/2013/0731

Report No. 14/53

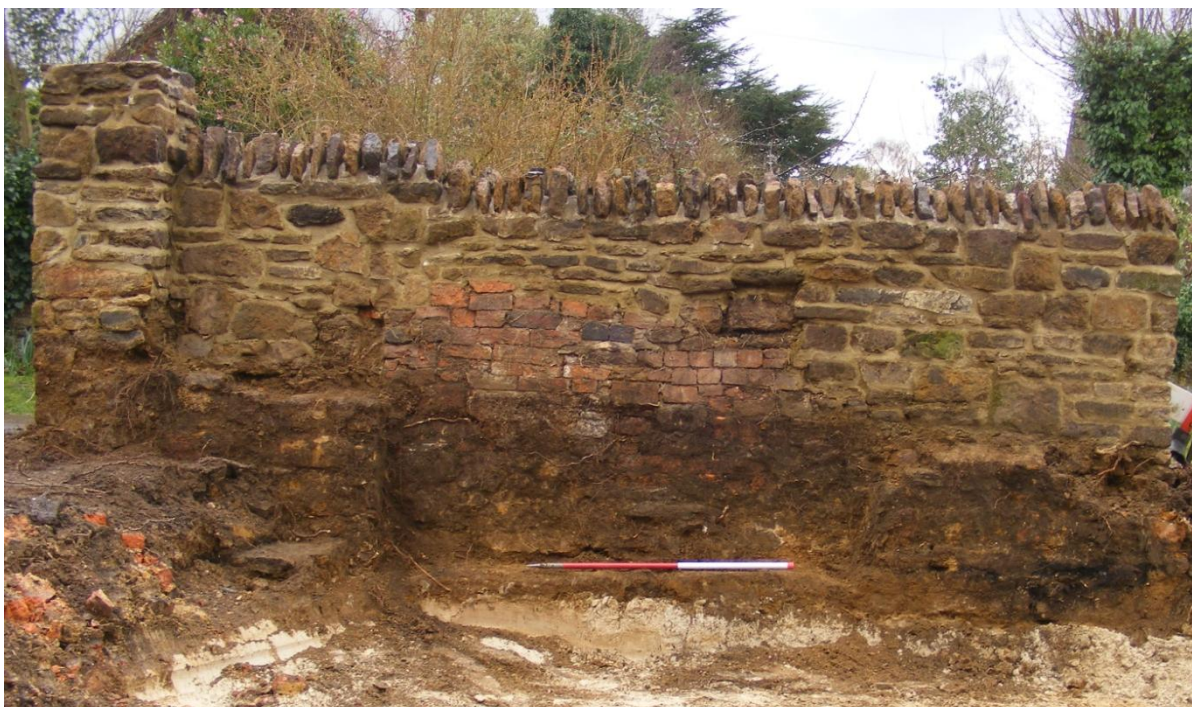
Front cover:	Original cottage frontage (6) with boundary wall construction (5), looking south
Fig 1:	Site location
Fig 2:	Excavation area
Fig 3:	Original cottage frontage (6) with boundary wall construction (5), looking south
Fig 4:	Walls (7) and disturbance (8) within building footprint, looking north-west

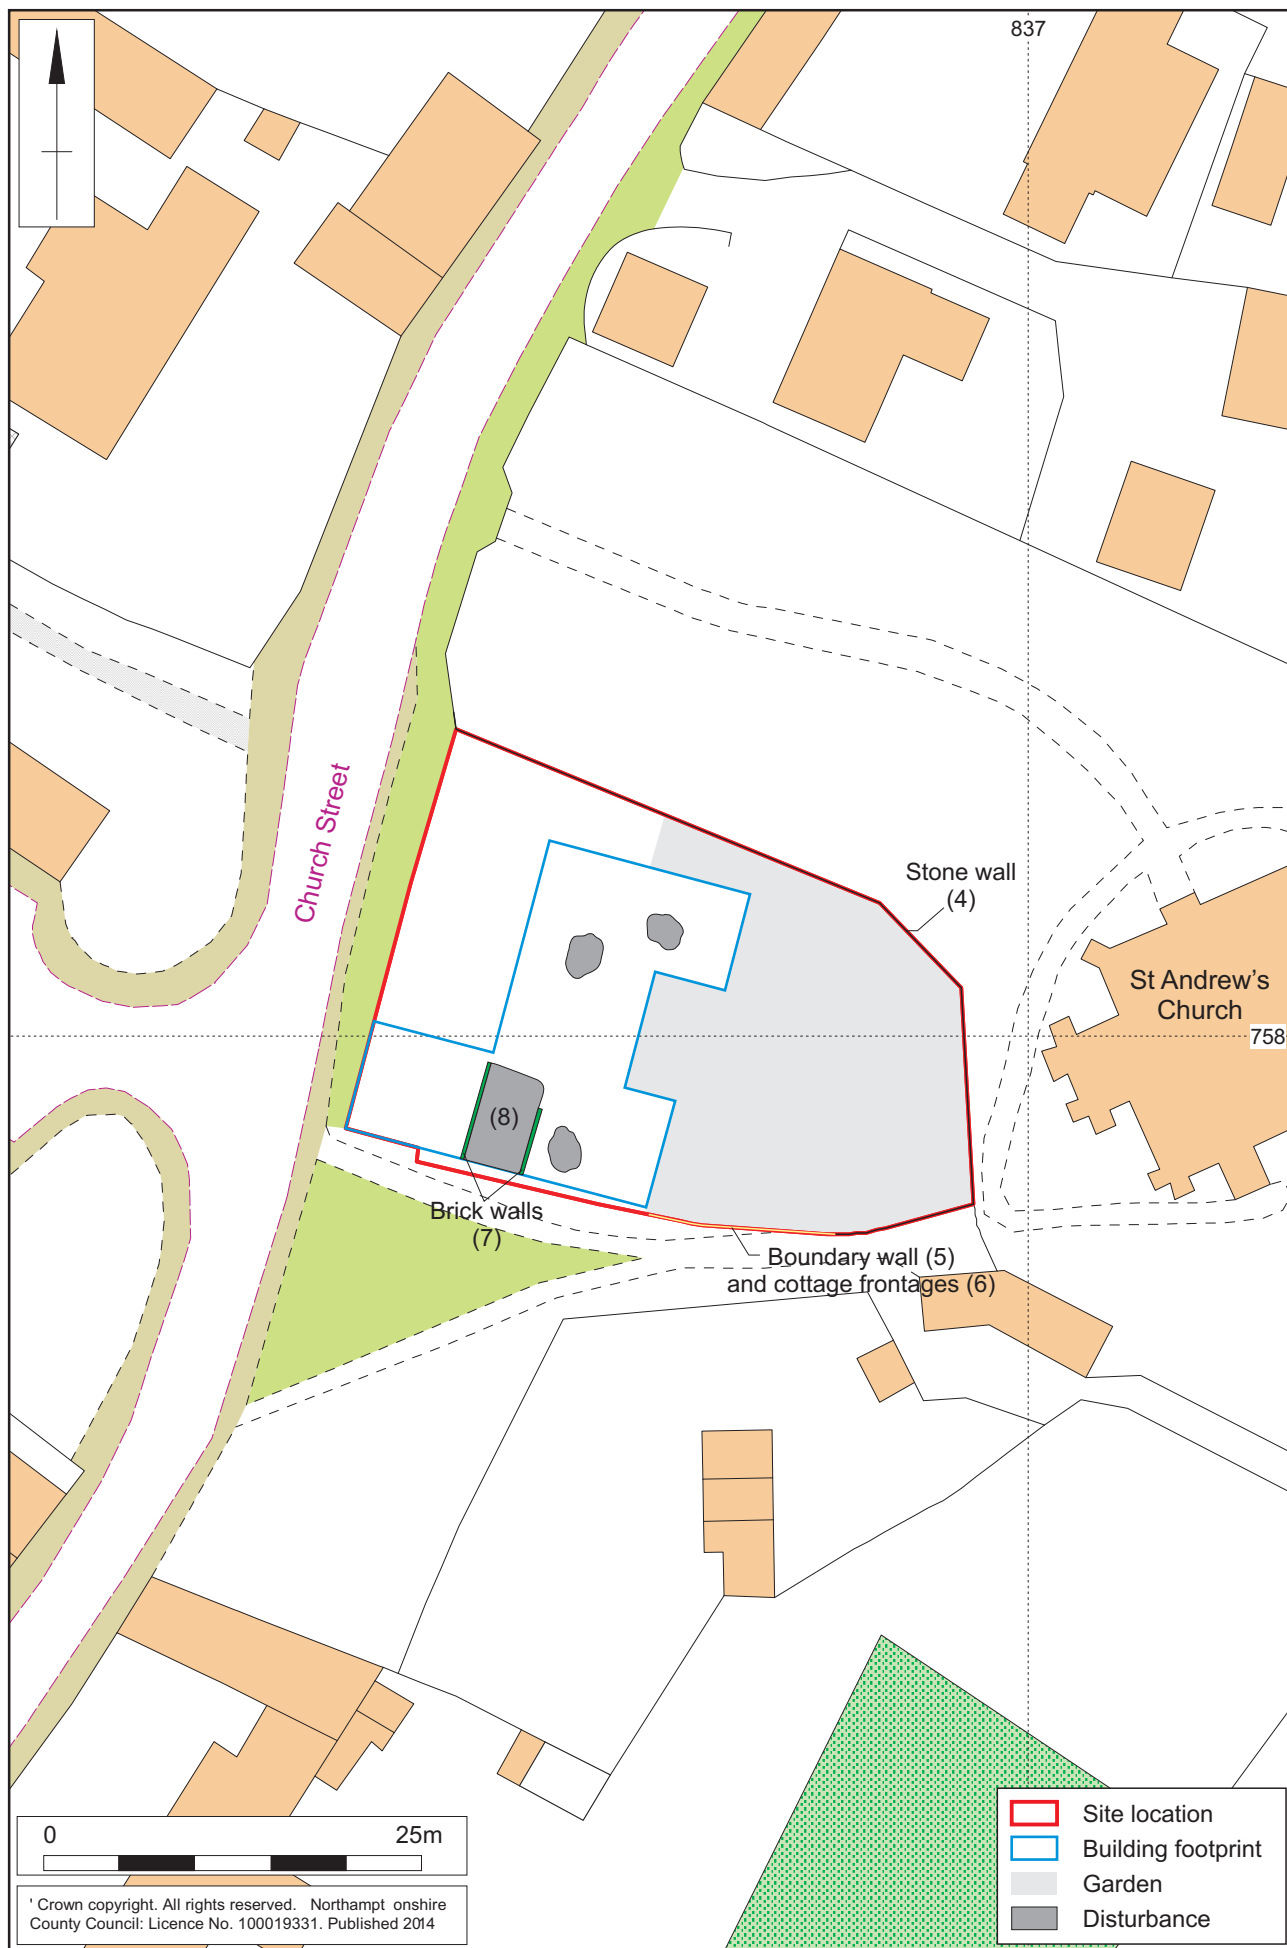
Excavation area Fig 2

Within the building footprint, the topsoil and non-structural post-medieval and later deposits were removed by a mechanical excavator, fitted with a toothless ditching bucket, to reveal significant archaeological remains or, where these were absent, the natural substrate. In the meadow garden, the land was observed once the topsoil was removed, with the exception of an area at the frontage which was stripped of subsoil (Fig 2). Here the stripping was continuously observed.

The north and east boundaires of the site were marked with a stone wall (4) that had been constructed and patched in multiple phases (Fig 2). This was made of sandstone and limestone in irregular coursing.

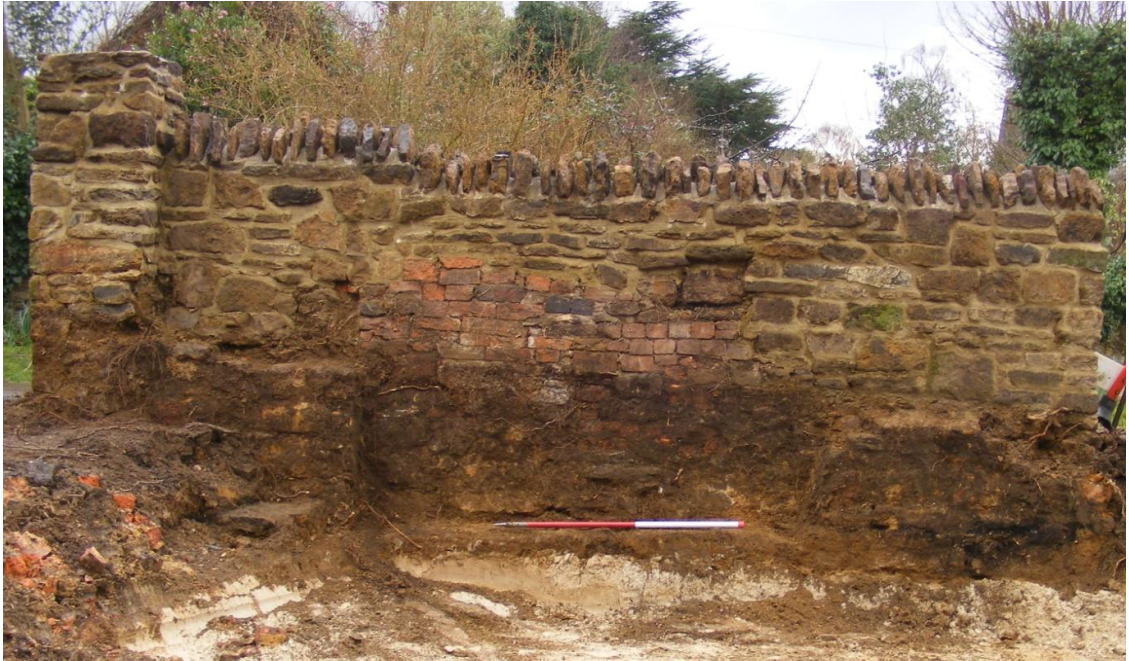
Original cottage frontage (6) with boundary wall construction (5), looking south Fig 3

The southern boundary of site consisted of cottage frontages (6), reconstructed by Mr and Mrs Manning as a boundary wall (5) (Fig 3). The original cottage frontages (6) consisted of sandstone foundations 0.35m-0.40m deep. These were topped with brick and sandstone to make the walls of the cottage fronts, with up to 1.00m surviving. These were recently heightened using sandstone recovered from the site to create a continuation of boundary wall (4).

Standing walls in various conditions were present. These all relate to the cottages which were built on the site during the 19th century, and demolished prior to 1972. Similarly, brick foundations observed in the strip for the new dwelling relate to the 19th century cottage or outbuilding.

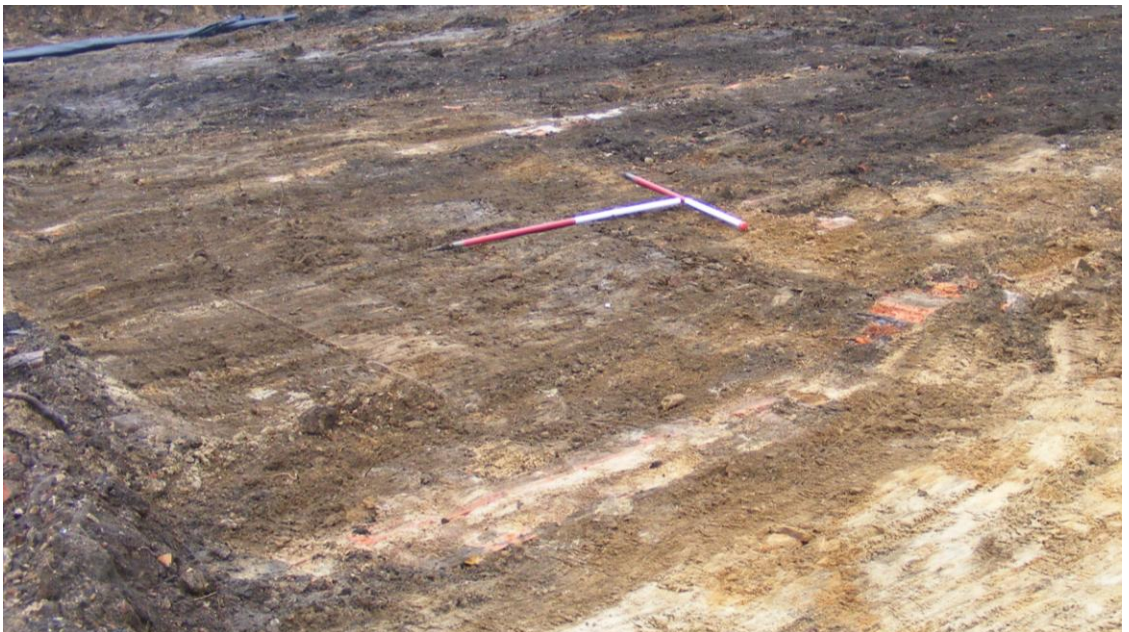
Walls (7) and disturbance (8) within building footprint, looking north-west Fig 4

Within the building footprint, two brick foundations (7) were present, aligned north – south, with only a single course surviving (Fig 4). These were 0.20m wide, and were up to 7m long. Between these was an area of disturbance (8), 4m wide, 7m long, and 0.05m deep. It consisted of mid brown silty sand with 2-3% small sandstone lumps.
