**Archaeological Watching Brief
at Snodhill Castle
Snodhill, Peterchurch
Herefordshire
March - August 2016**

Report No. 16/166

Authors: Dan Barrett
Amir Bassir

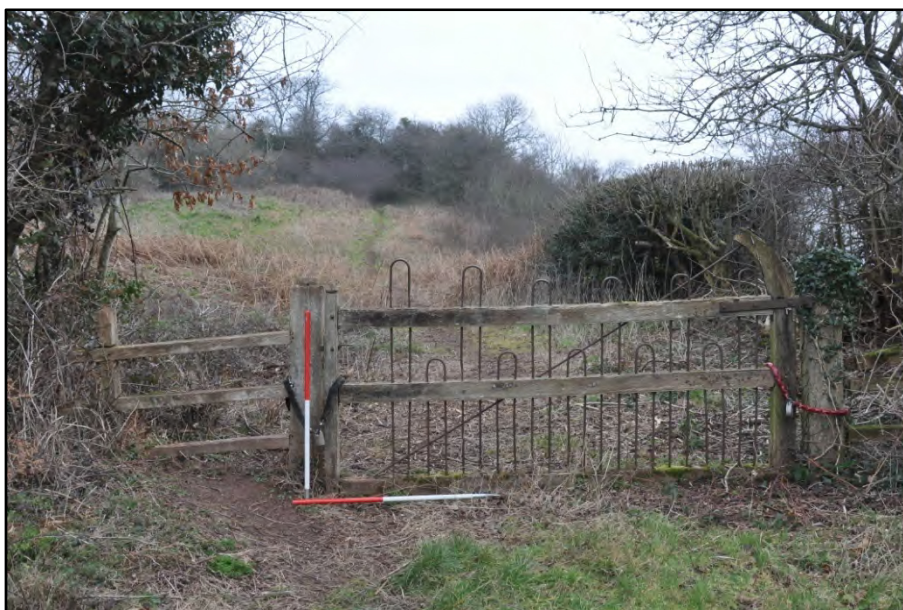
The gate, prior to lifting Fig 4

An oak-built gate, located adjacent to Castle Road at the south-western edge of the site, was lifted in order to carry out repairs and restoration works with the aim of its reinstatement. The gate comprises three horizontal oak rails between oak posts, with iron strap hinges to the hanger post. The gate is strengthened by the use of looping iron bars which are affixed to the inner face of the rails (Fig 4). The southern gate post curves inwards and an iron rod spans from here to opposing corner to further strengthen the structure.

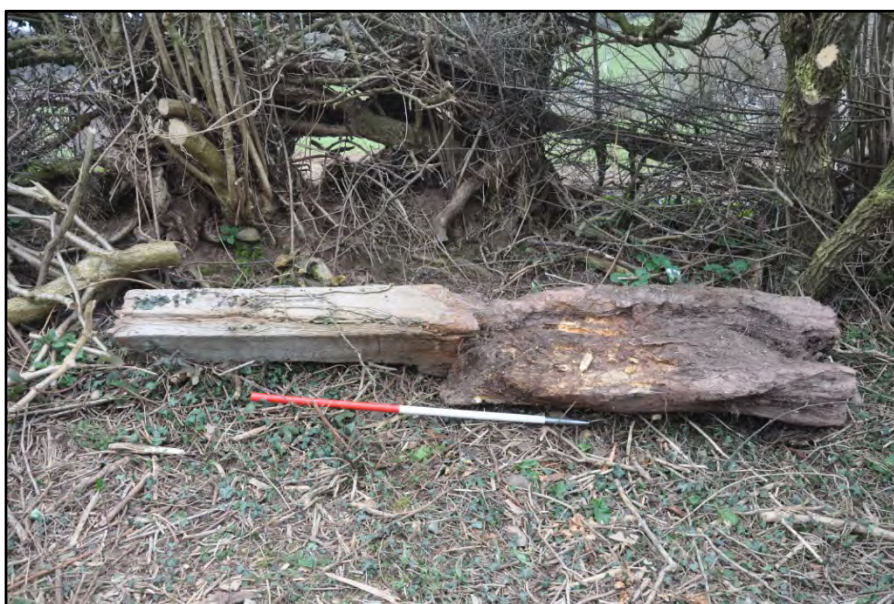
The hanger post, showing the shaped and unshaped portions of the timber Fig 5

Following the removal of the gate, the flanking posts were mechanically lifted using a small lorry crane. The hanger post broke off during removal due to rotting at ground level and was partly left *in situ* (Fig 5). The stop post was successfully lifted intact and can be seen to comprise a length of tree trunk, shaped and squared only above ground level and buried to a depth of 1.45m. The visible, shaped portion is 0.2m in width to a height of 1.15m. It is evident that the post was placed into a prepared posthole rather than having been driven into the ground. Although not seen, it is likely that the hanger post is of a similar style.

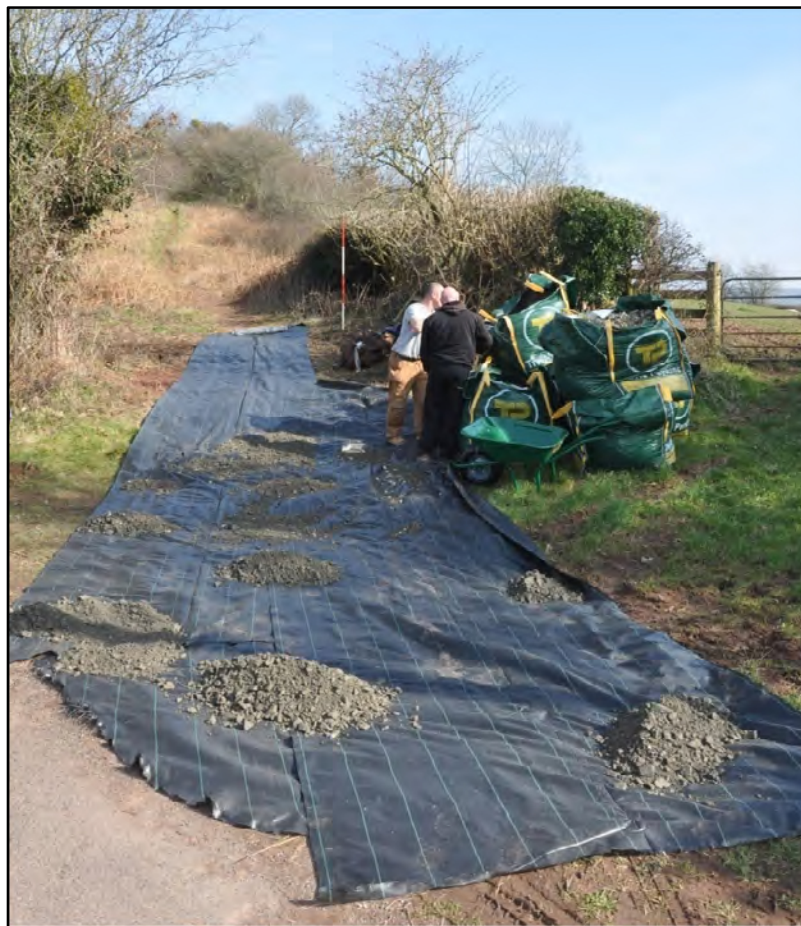
The compound access with protective membrane Fig 6

From the gate a 10m length of track was created, running to a small, fenced, site compound for the siting of a welfare cabin. This required the cutting back of undergrowth but no associated intrusive works. The area was covered in a semi-permeable membrane and gravel to protect the ground from damage by traffic (Fig 6).

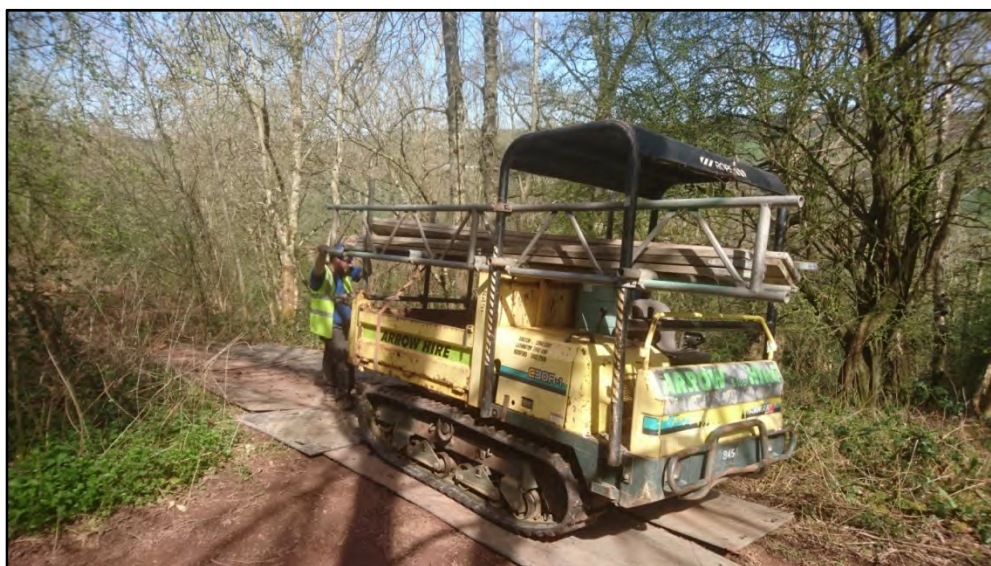
Protection of the access track by wooden boards Fig 7

In addition, an access track was created to enable the transportation of materials to the top of the site via a track-powered barrow and tracked dumper truck. In order to prevent damage to the ground, particularly in wet weather conditions, bog matting and wooden planks were laid down along this route (Fig 7).

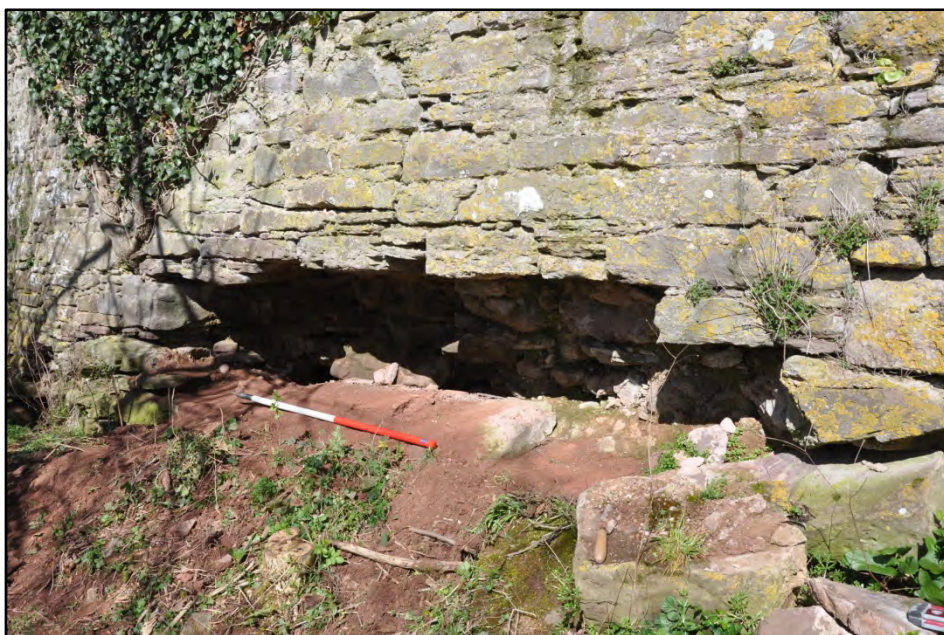
The south curtain wall prior to installation of props Fig 8

The south curtain wall is approximately 25m in length, rising to a height of 1-2m from the bailey surface, and is approximately 5m in height at its southern side. The wall is constructed of rubble masonry and large areas of collapse have been noted. A 3m long void was noted in the condition survey (Fig 8). This void undercuts the wall to a depth of 0.5m and was an area targeted for remediation and stabilisation. The west edge of the wall had also partly collapsed and was subject to mediation works (Fig 10).

The condition of these areas was photographed prior to any works and the areas were cleared of loose material under archaeological supervision. Cement sole plates were placed on sheets of membrane to act as the base of timber props (Figs 9 and 10). This process involved minimal intrusive work to the underlying soil.

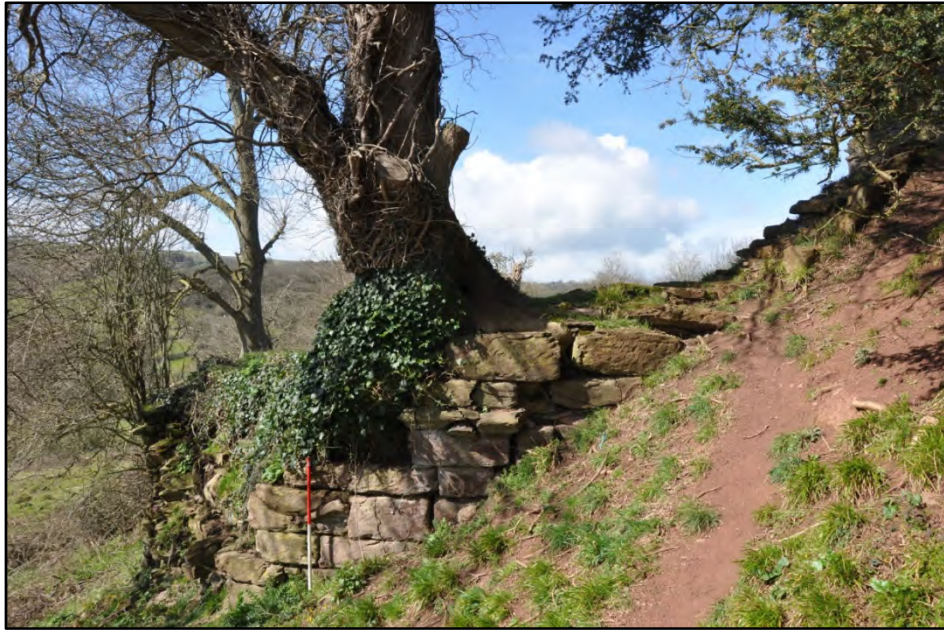
The ash tree, prior to removal Fig 12

A mature, near dead ash was growing on and into the south bastion wall, and a tree surgeon was employed to remove it (Fig 12). A watching brief and photographic record was maintained during the process. The felling was accomplished with no additional damage to the masonry, although it is likely that, following the eventual rotting of the embedded roots, further consolidation work will be required (Fig 13).

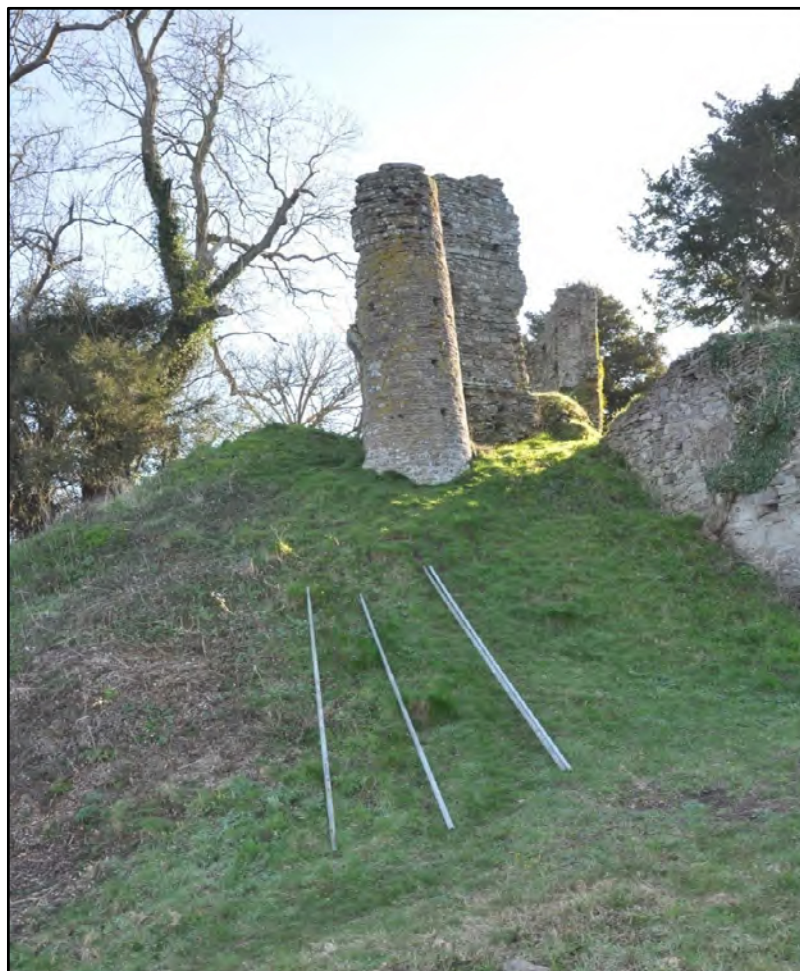
The slope to the gatehouse prior to erection of scaffold Fig 14

To enable transportation of material to the keep a scaffold stair was constructed up the western side of the motte and was angled into the remains of the gatehouse (Figs 14-17 and 21). Construction of the scaffold necessitated the excavation of 18 flat bases for each of the footings posts. The excavations were to a maximum width of 0.25m and the maximum depth of excavation was 0.3m. The majority were excavated only into the topsoil which was an orange-brown sandy loam. Where subsoil was encountered it consisted of a paler orange-brown sandy soil with pea gravel and occasional angular stones.

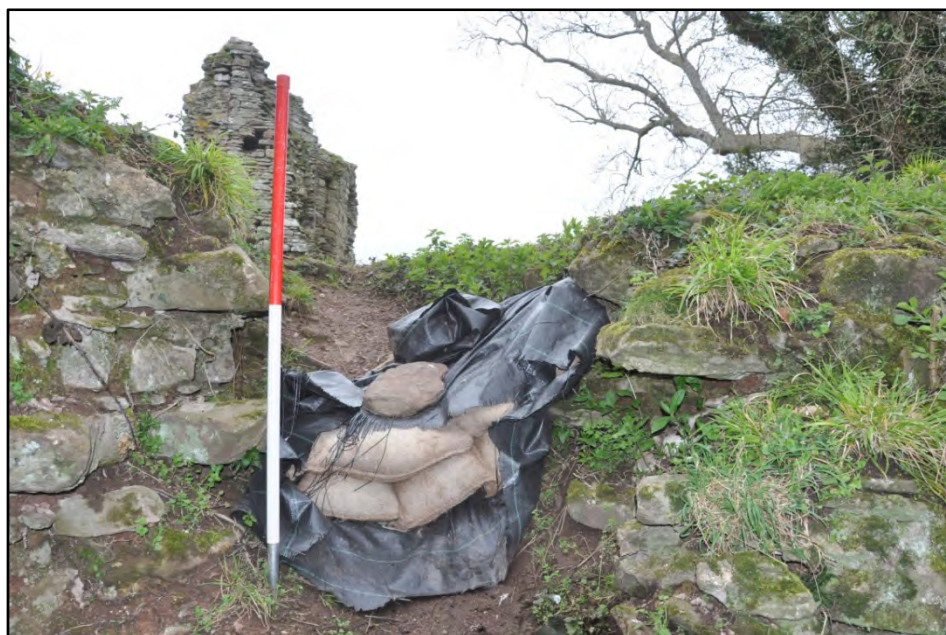
The south-east side of the keep Fig 18

The keep is constructed of rubble with masonry facing and survives to an internal height of 6m. The remaining structure is affected by burrowing and erosion and several sections are designated as being at risk

The south-east side of the keep required the installation of a timber prop, for which a non-intrusive pad was constructed. In addition, a scaffold was erected between the interior and exterior of the structure to enable access for the consolidation work (Figs 18 and 21). This required minimal excavations on the external slope in order to provide level pads for the six scaffold posts. The maximum depth of excavation was 0.2m and all excavations were within topsoil.
