Evaluation at the Black Gate, Castle Garth, Newcastle upon Tyne
NE1 1RQ

(Scheduled Monument No. SM 32753)

December 2011
by
Northern Counties Archaeological Services

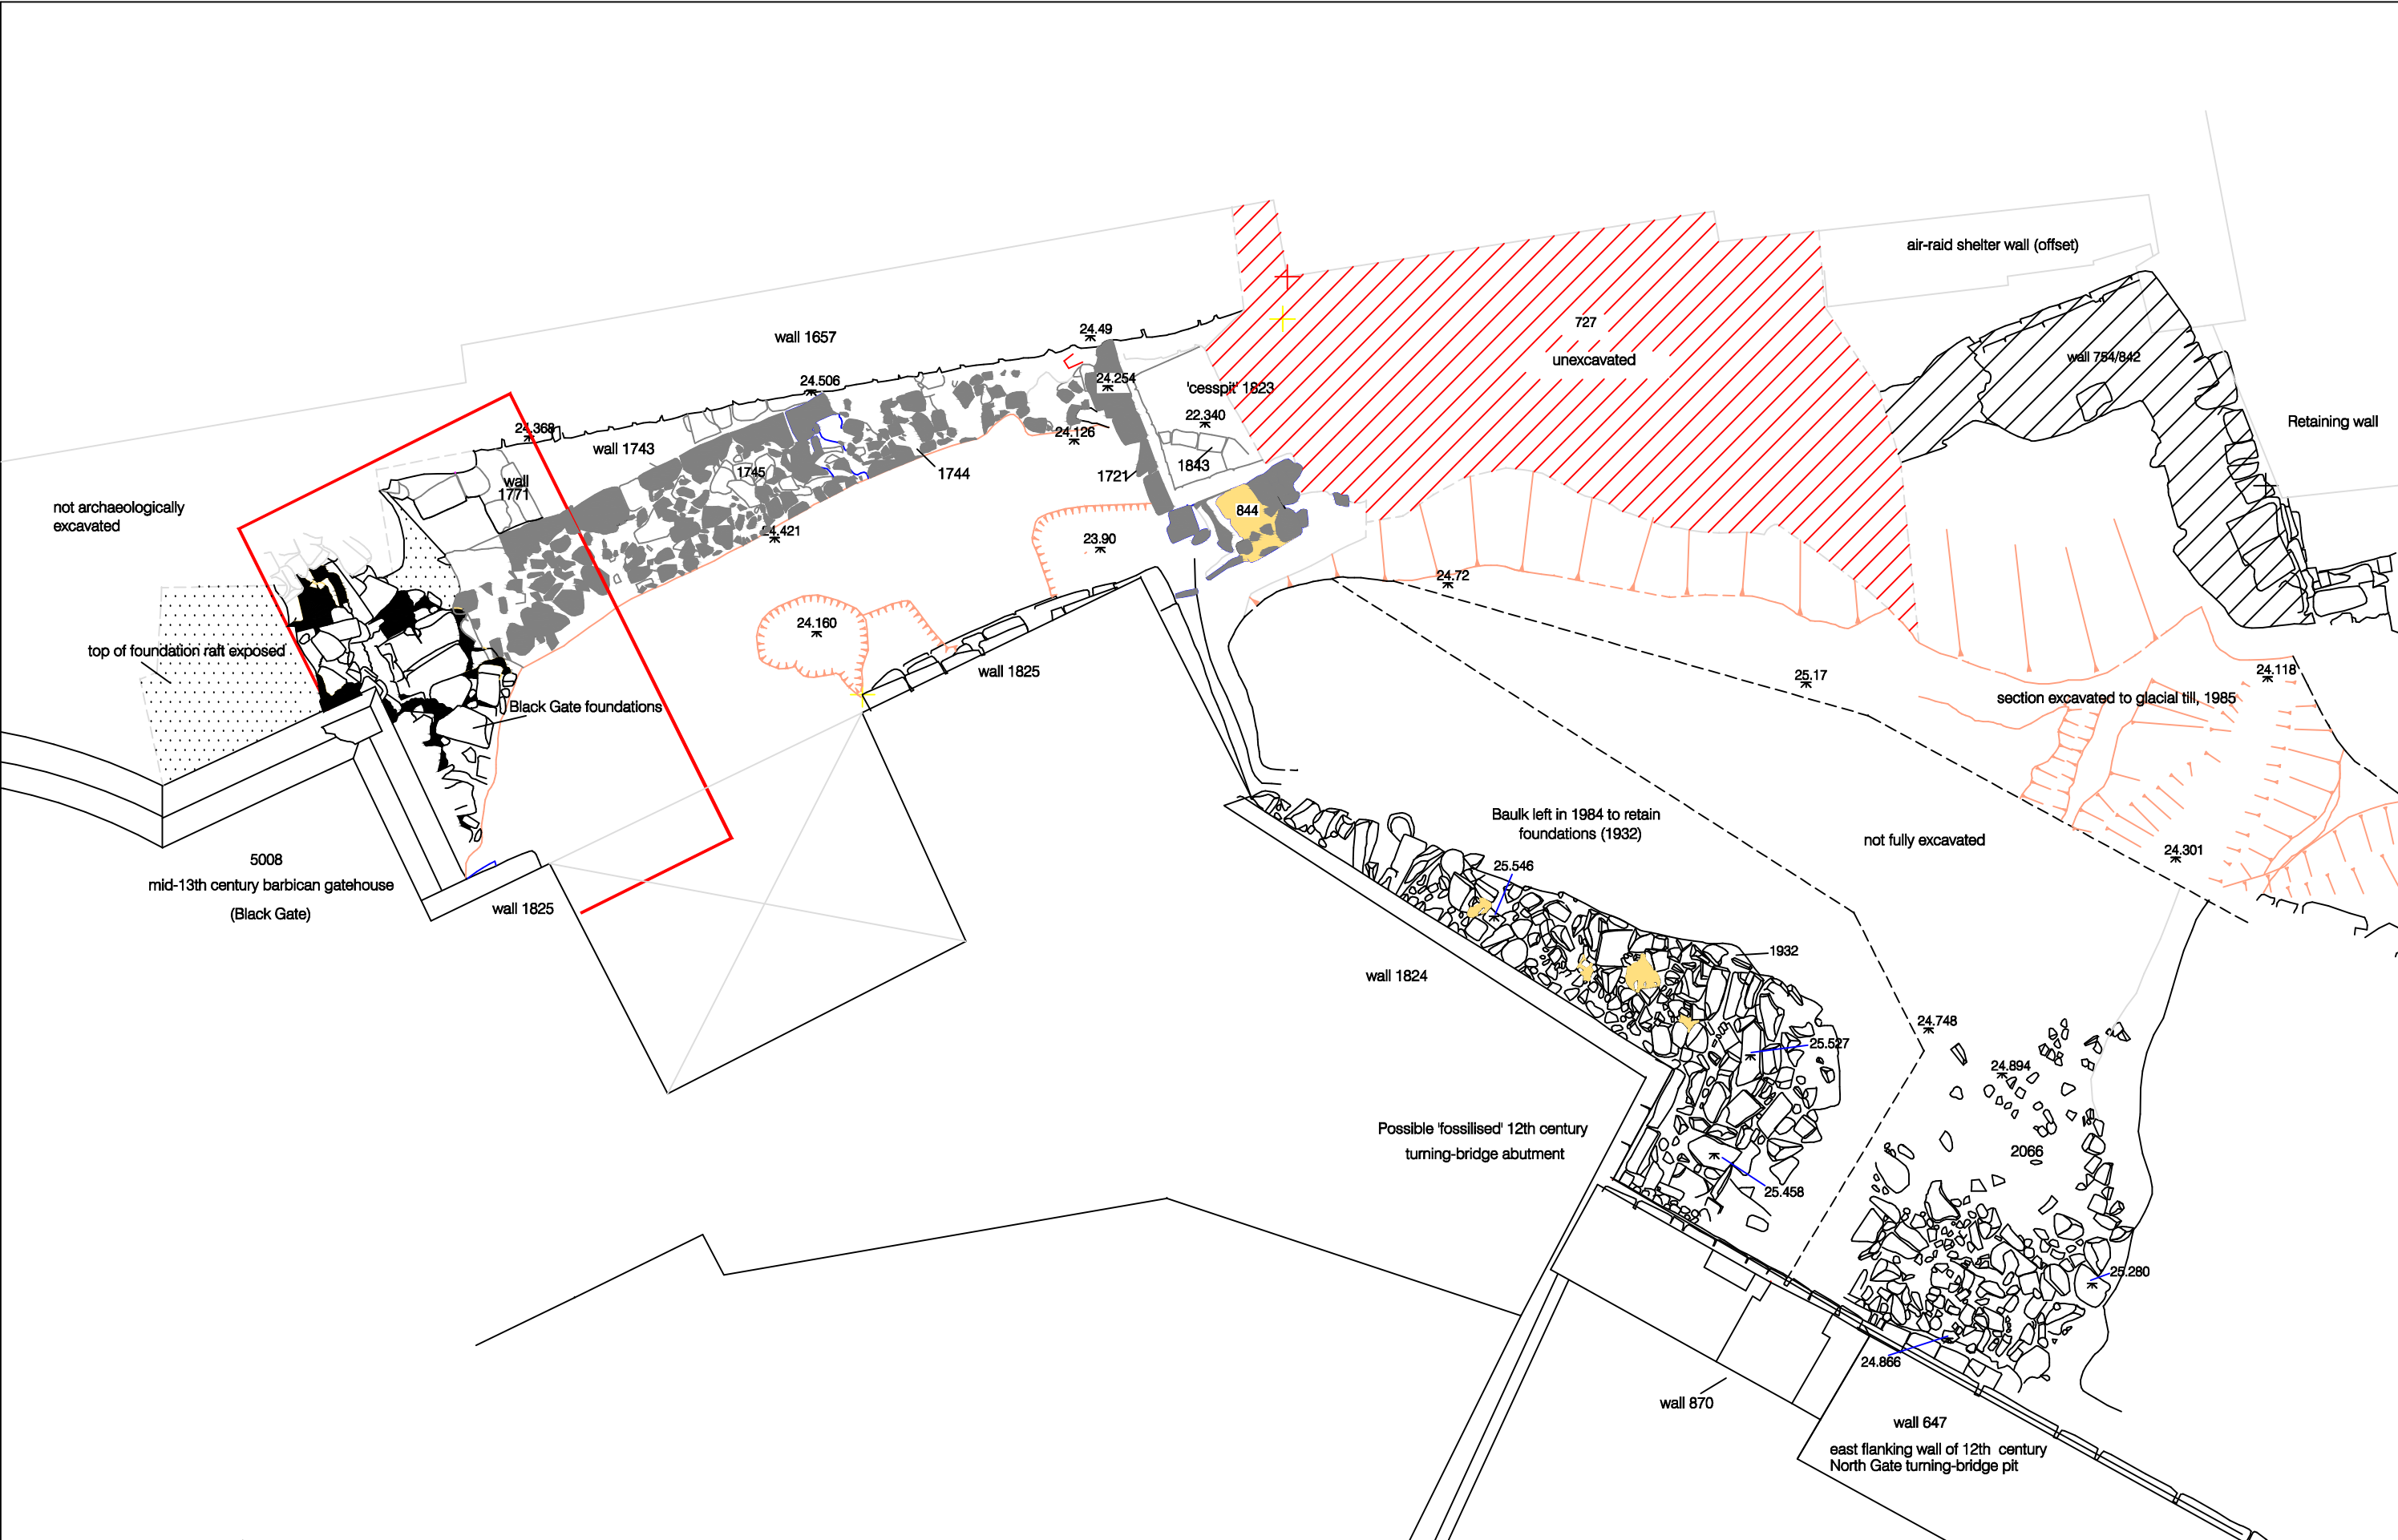
Figure 5
Medieval deposits and features
excavated and recorded in 1984

2.0.3 The remains of the North Gate include a turning-bridge pit (647) and an abutment for the turning bridge is incorporated into wall (1824), part of the later Black Gate (see Figure 5). It is possible that wall (1825) was associated (see Figure 5). A number of medieval sources refer to works possibly in the area of the North Gate, for example in 1221 a *brattice* (a timber tower or palisade) was brought from Nafferton castle and ‘*erected at the gate to the bridge*’ to replace a tower that had collapsed. The North Gate was ‘rebuilt on an improved pattern’ by order of Henry III between 1247-50 [ibid., 114]. This was the additional, forward-standing gatehouse and barbican passage now known as the Black Gate.

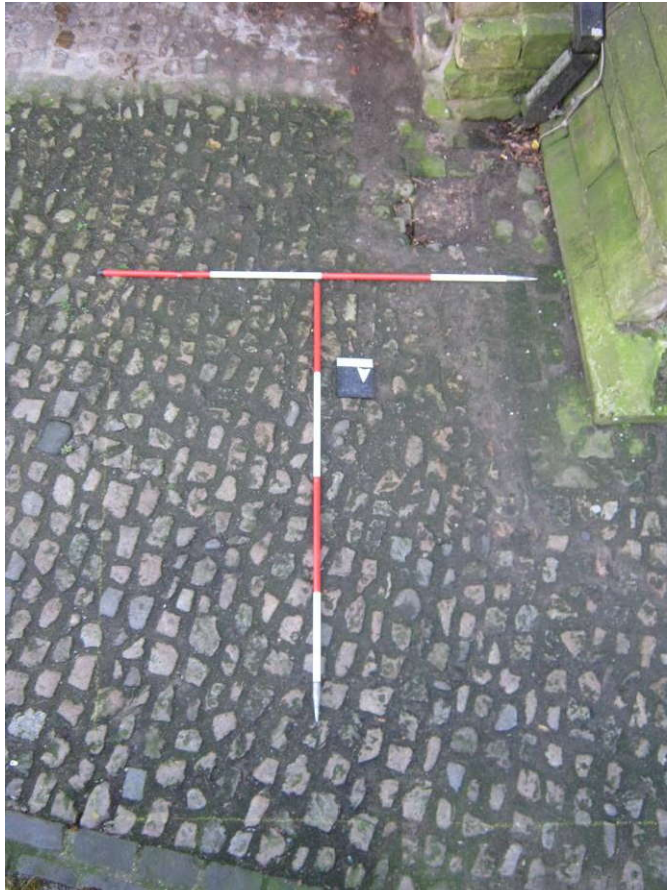
Plate 1. Evaluation trench site before excavation showing the cobbles set in concrete forming part of the 1985 landscaping. View from air-raid shelter ventilator. Scales 2m.

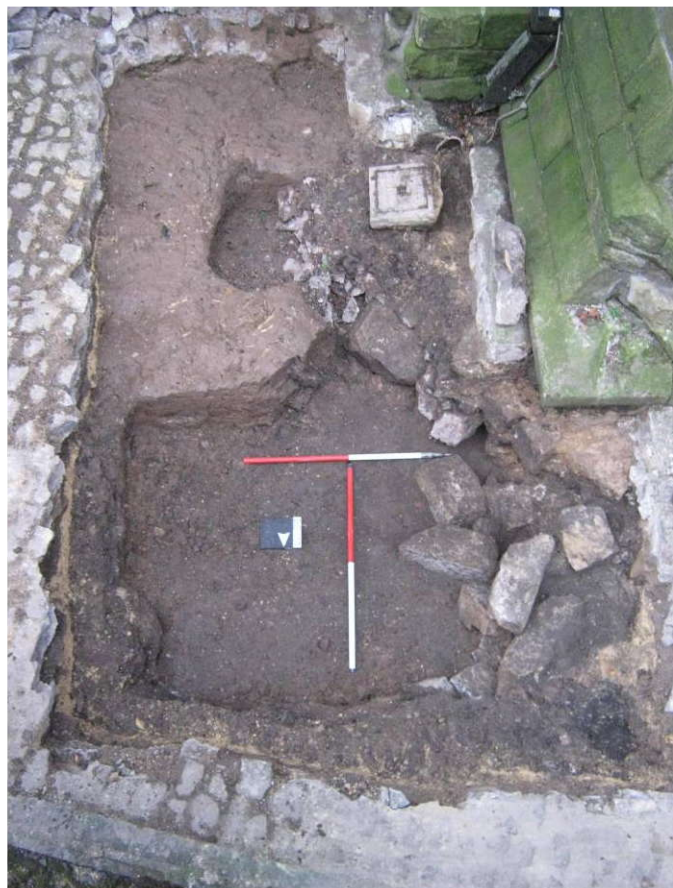
Plate 2. After removal of hard landscaping and sub-base, showing natural boulder clay (glacial till) <5006> (top left) and the edges of cuts for wall (1743) and the Black Gate foundations <5005>. In the foreground is mixed clay, soil and rubble backfill covering the medieval masonry features, and some disturbed stones from the Black Gate foundations. The square box contains a lightning conductor <5007>. View looking from the air-raid shelter. Scales 1m.

3.0.1 Below the bedding for the setts was a layer of dolomite chippings, of variable thickness, some brick and concrete rubble, then a very well-compacted mass of re-deposited moist clay and rubble <5002> (Appendix 1, Plate 2). This mixed deposit was deepest at the north end of the evaluation area, where it overlay a grey-black friable deposit of soil, mortar, and fragments of ceramic building material <5003>.

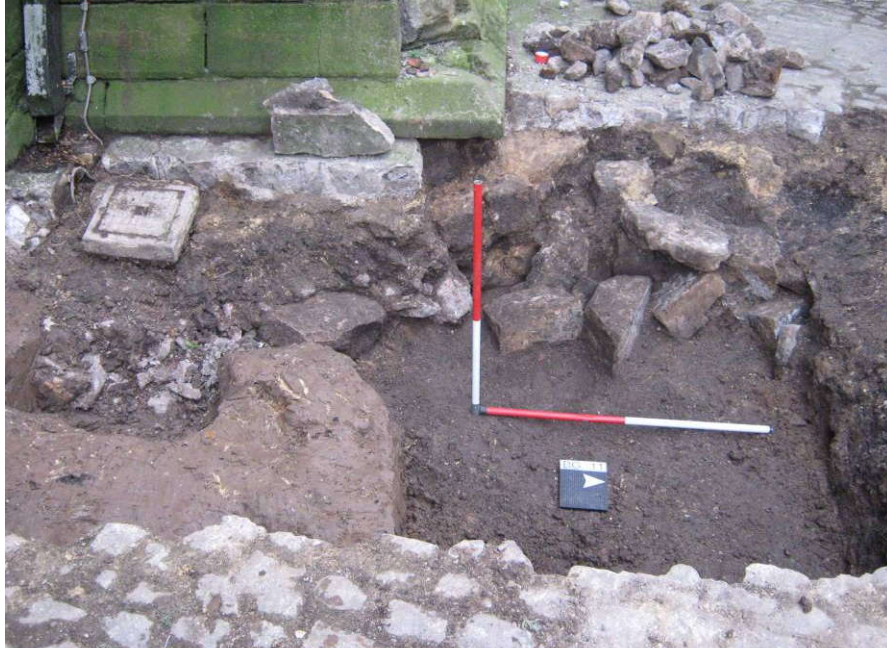
Plate 3. After removal of hard landscaped surface and sub-base, showing glacial till <5006>, lightning conductor <5007>, soil and rubble backfill and disturbed foundation stones from the Black Gate foundation raft. Looking west. Scales 1m.

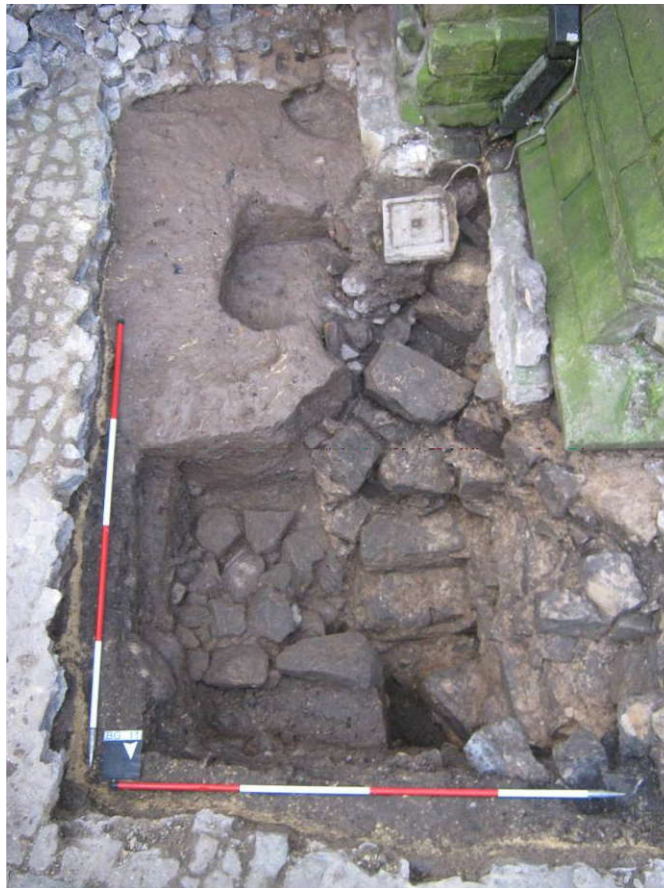
Plate 4. After removal of the 1985 backfill. Wall (1743) (left), with some backfill left to support the face-stones; mid-13th century foundation raft <5005> to the Black Gate (right), both cutting glacial till <5006> (upper left). View looking from air-raid shelter ventilator. Scales 2m.

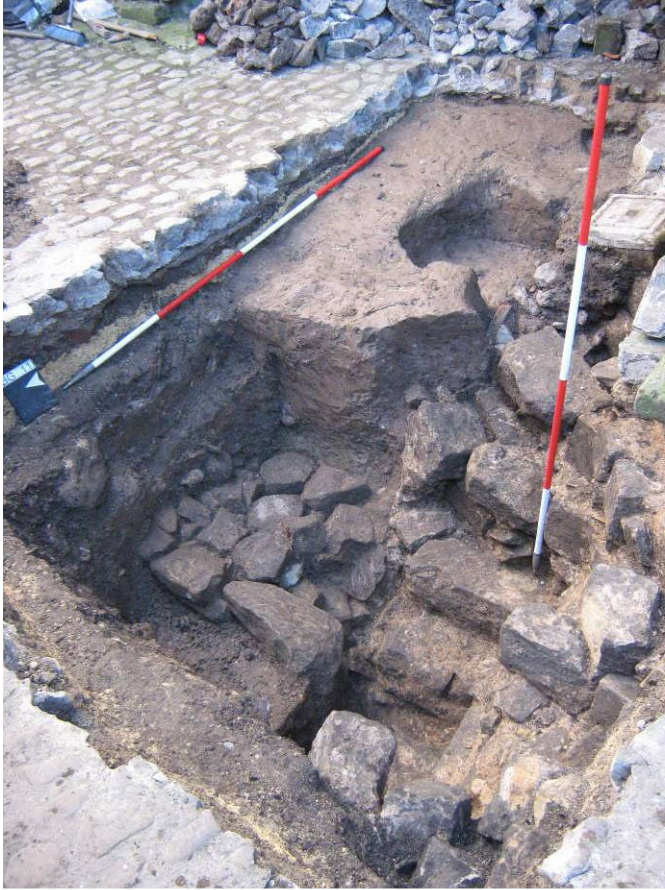
Plate 5. Trench view after removal of 1985 backfill. Part of wall (1743) is visible (left, cut by the foundations of the Black Gate <5005> (right). Both features cut the glacial till <5006>. Looking south-east. Scales 2m.

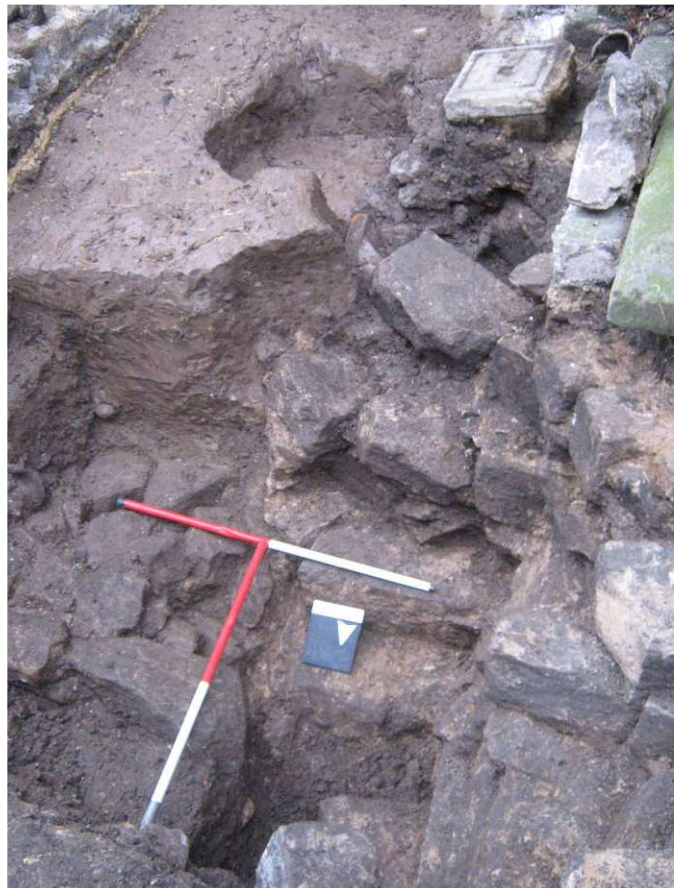
Plate 6. Foundations of Black Gate <5005> cutting wall (1743) (left) and the glacial till <5006> (top left). Looking south-east. Scales 1m.

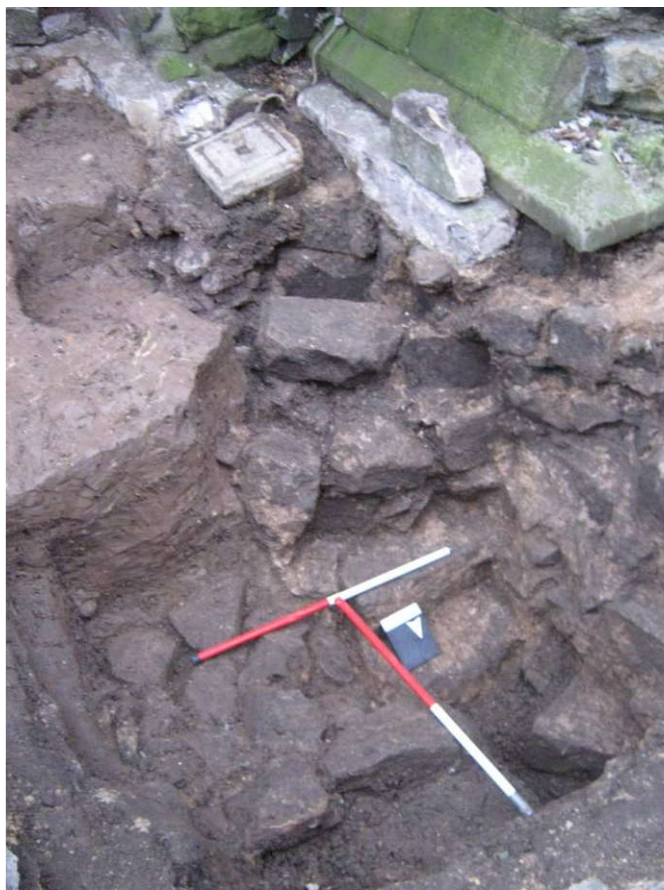
Plate 7. Foundations <5005> to the Black Gate, cutting wall (1743). Looking south-west. Scales 1m.

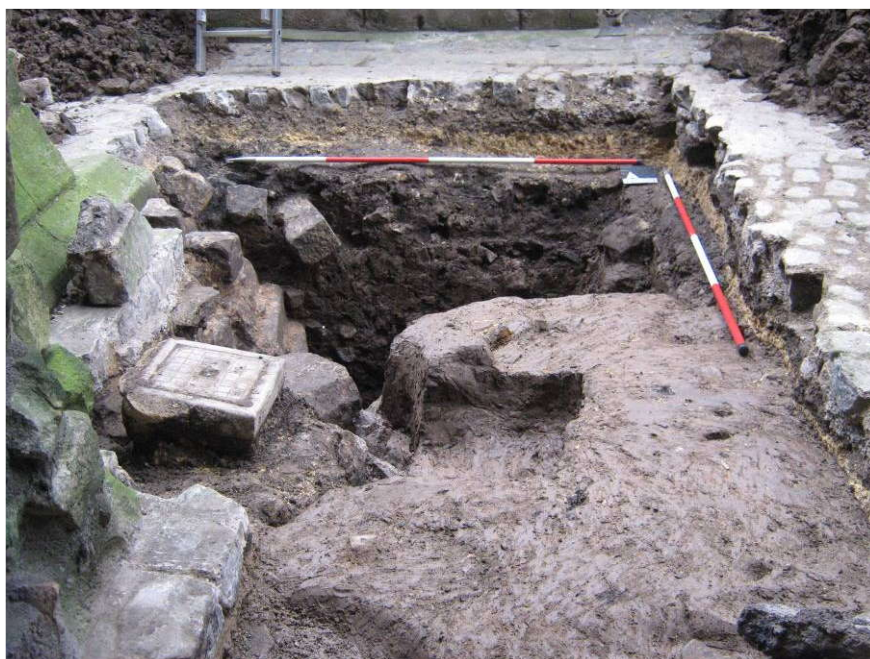
Plate 8. Glacial till <5006> in the right foreground, cut by Black Gate foundations <5005> (left) and wall (1743) (middle), also showing 1985 backfill and landscape surface. Looking north from within the arched opening in wall (1825). Scales 2m.

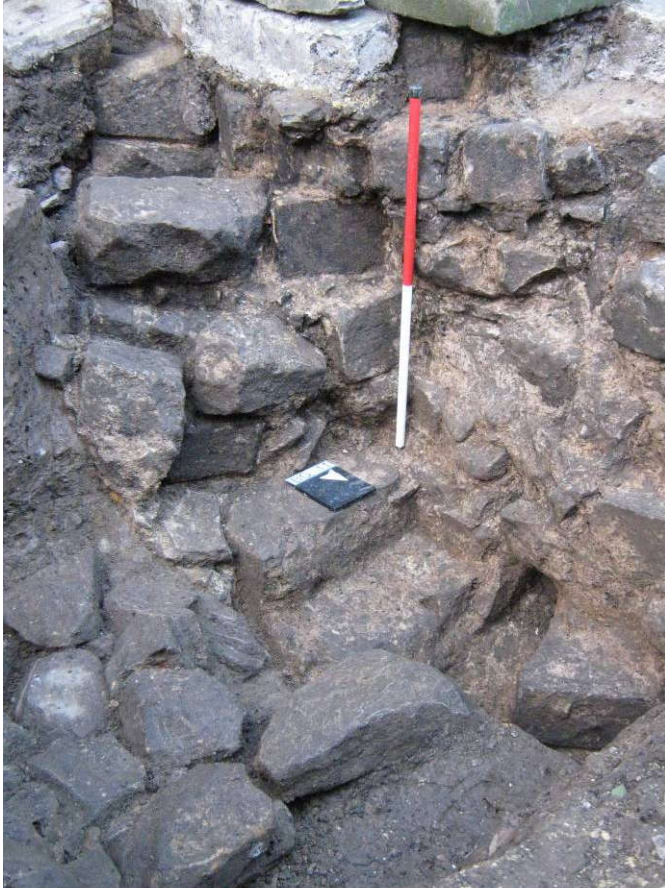
Plate 9. Detail view of part of the mid-13th century Black Gate foundation raft <5005>, showing some re-used faced ashlar. The base chamfer course is just visible at the top right, below which some foundation-work has been removed to accommodate the 1985 landscaping. Wall (1743), cut by <5005>, is bottom left. Looking south-west. Scale 1m.

3.5.0 The foundation raft <5005> is a mass of heavily-mortared small, medium, and large sandstone rubble. Where exposed in the Evaluation, as also noted in 1984, the raft incorporates a number of dressed ashlar facing stones which are presumably re-used building material. The upper surface of the raft was shown in 1984 to be composed of small sandstone fragments and mortar, presumably a levelling course on which the dressed chamfered base courses of the gatehouse could be laid. Within the area of the Evaluation this levelling deposit is now missing, evidently removed in 1985 to accommodate the cobble setts and their concrete bedding (Appendix 1, Plates 3, 7, 9-10).

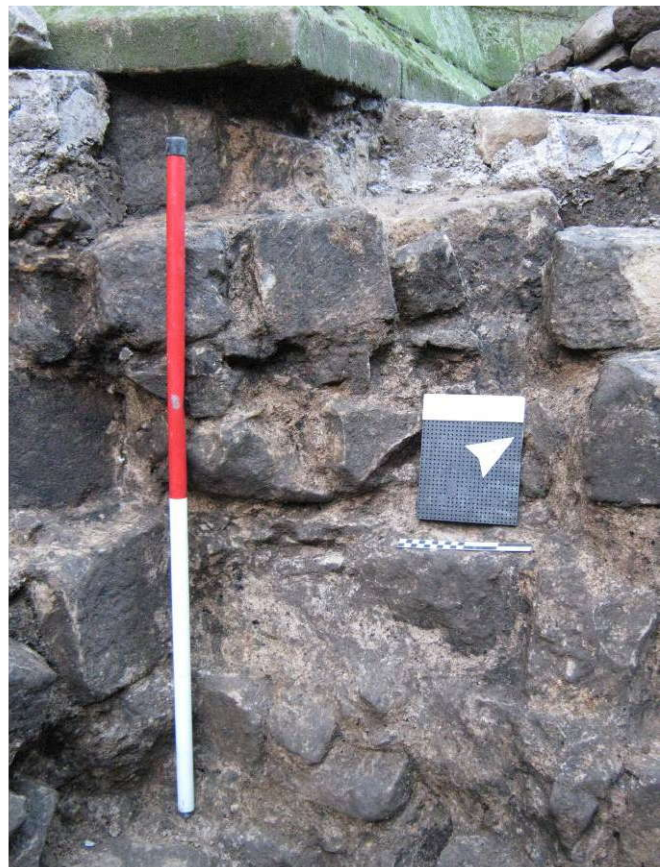
Plate 10. Another detail of the mid-13th century foundation raft (5005), again showing the gap below the base chamfer where medieval foundation-work was been removed in the 1985 landscaping. Looking west. Scale 1m.

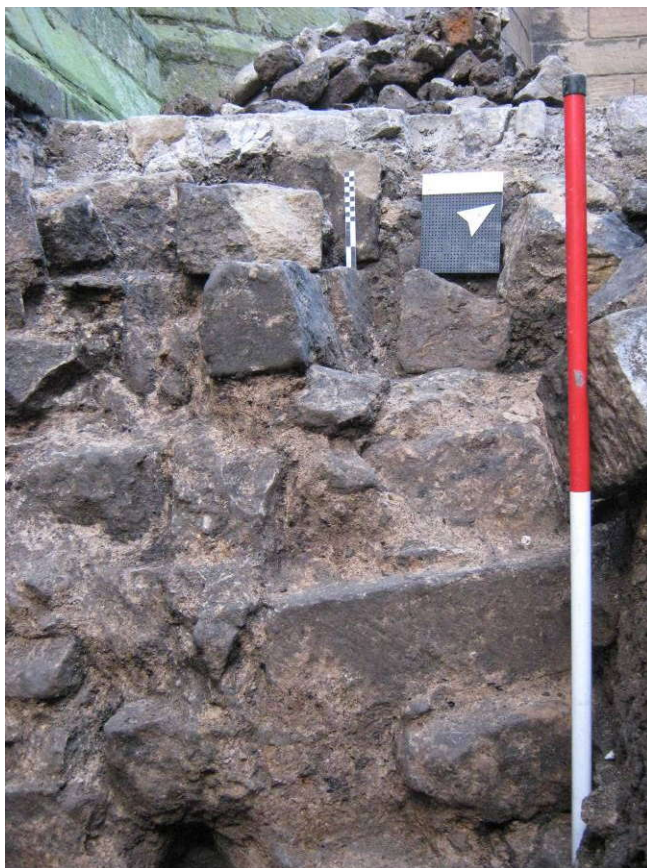
Plate 11. Another detail of the mid-12th century foundation <5005> to the Black Gate, showing faced ashlars re-used as part of the rubble and mortar raft. Looking west. Scale 1m.

3.6.2 The presence of well-dressed, squared, ashlar incorporated into the foundations of the Black Gate <5005> is suggestive of re-use of material from a demolished building. The most obvious source for such recycled material is a structure of which wall (1825) is now a remnant, which was partly dismantled for incorporation into the 1247-1250 drum-towered gateway. The simple arrow-slot in the lower part of wall (1825) and the 'fish-tailed' loops above are forms known to have been in use in the 12th century [Toy 1966, 152-3].

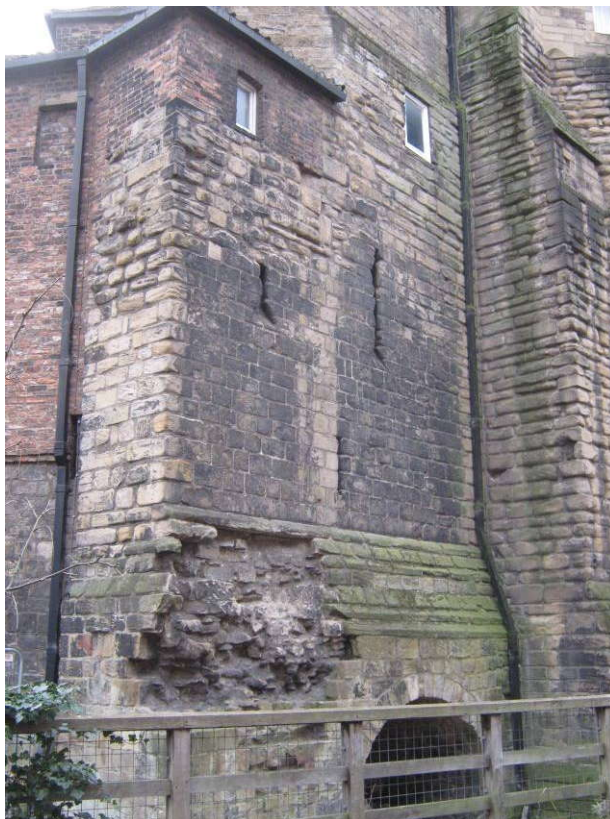
Plate 12. Wall (1825) looking south-west, showing the junction with the mid-13th century Black Gate <5008>.

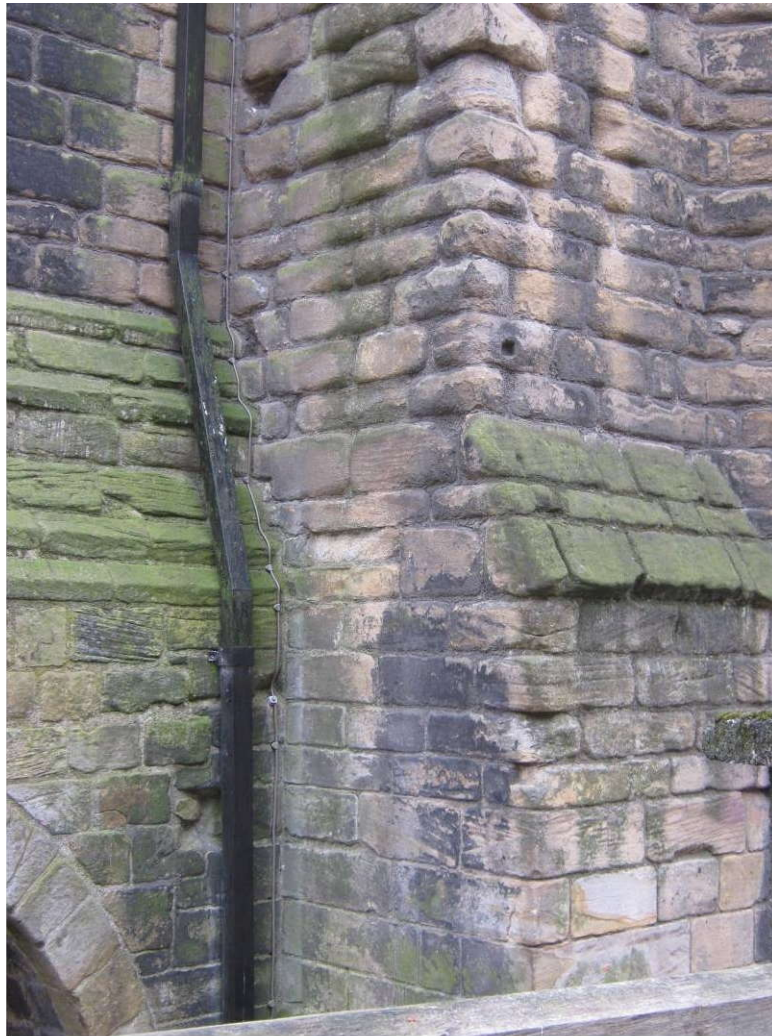
Plate 13. Detail of the junction of wall (1825) on the left, with the mid-13th century Black Gate <5008> (right), showing the masonry of the latter stepping over the chamfer courses of (1825).

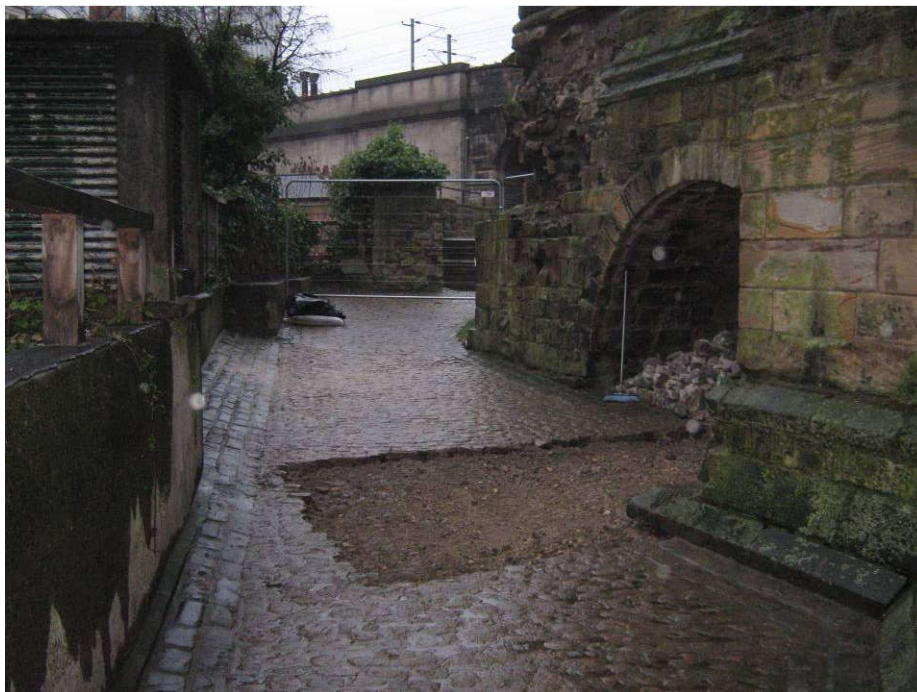
Plate 14. The Evaluation trench on completion of the December 2011 excavation, showing back-filling (over a geotextile membrane). The cobble surface was not required to be re-instated.

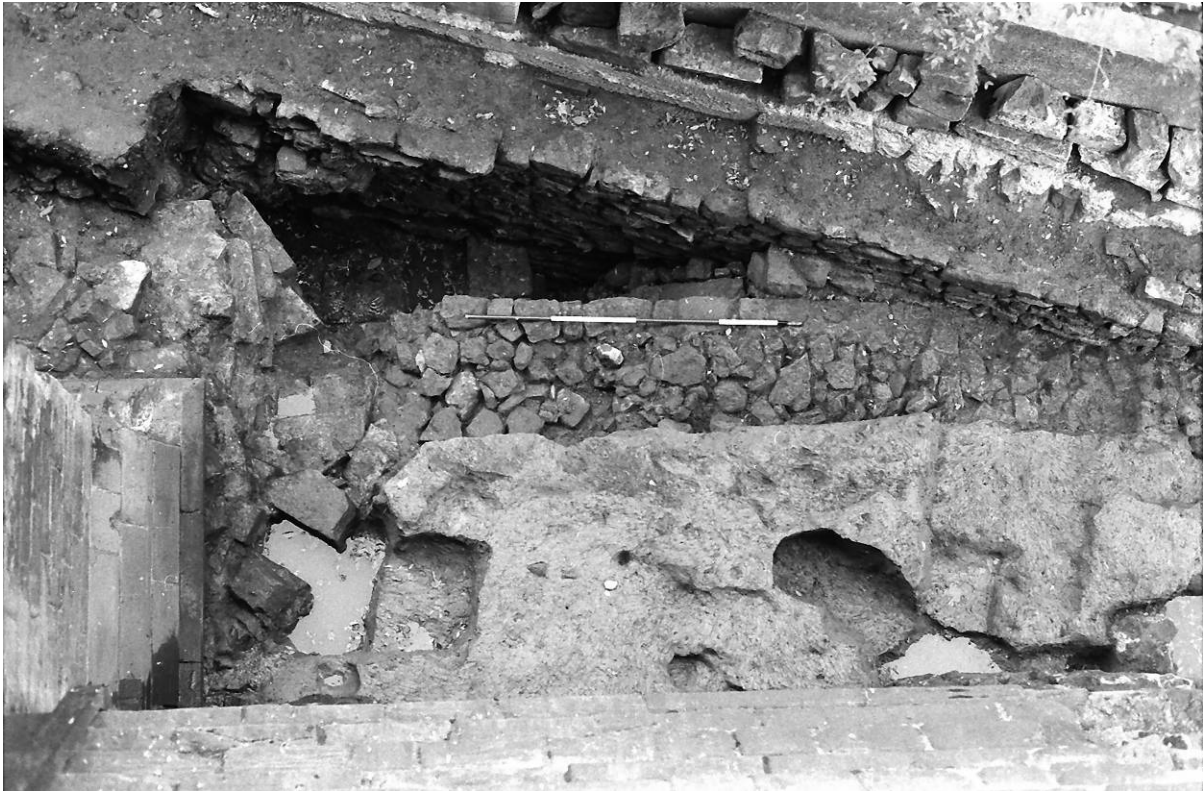
1. Looking down from the 1st floor landing window of the Black Gate, showing (top) wall (1657) cutting wall (1743), the foundation raft <5005> for the Black Gate (left), and the area of natural glacial till cut by pits. Scale 2m. (Film 1984/5/13A)

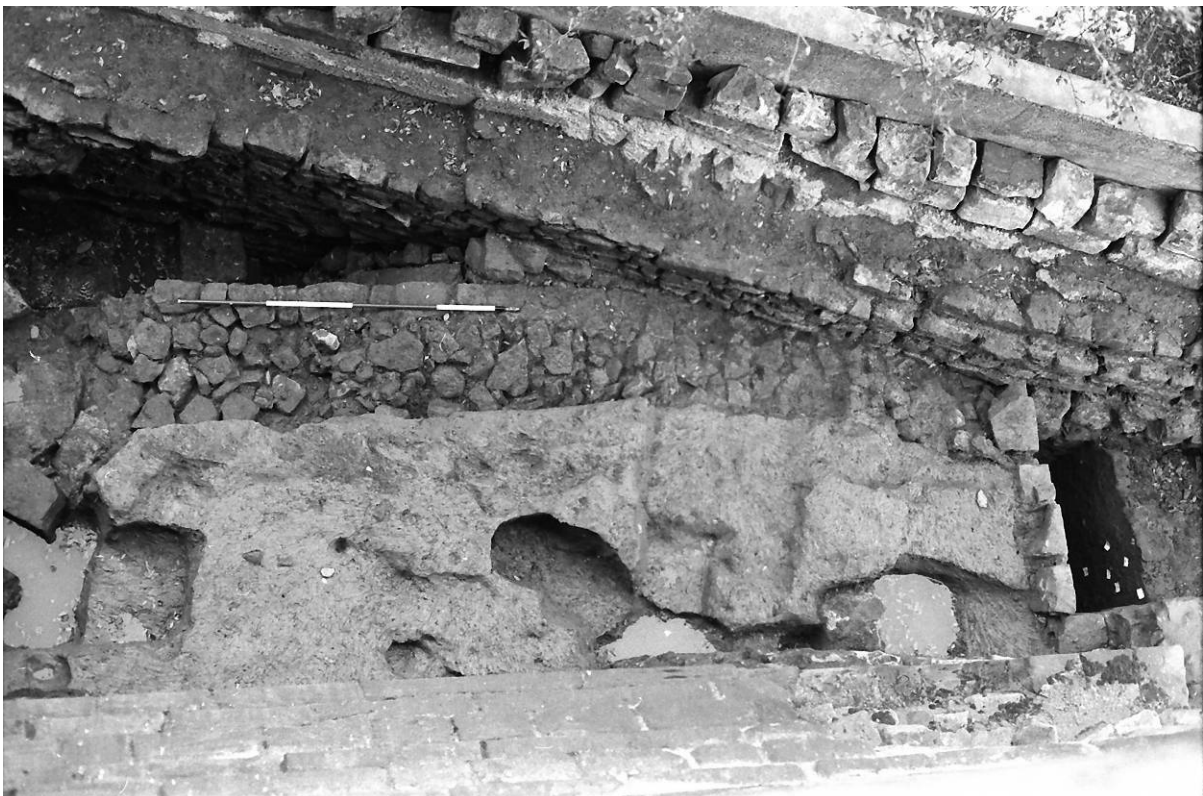
2. The same, but looking further east to include 'cess-pit' (1823) (right). (Film 1984/5/14A)

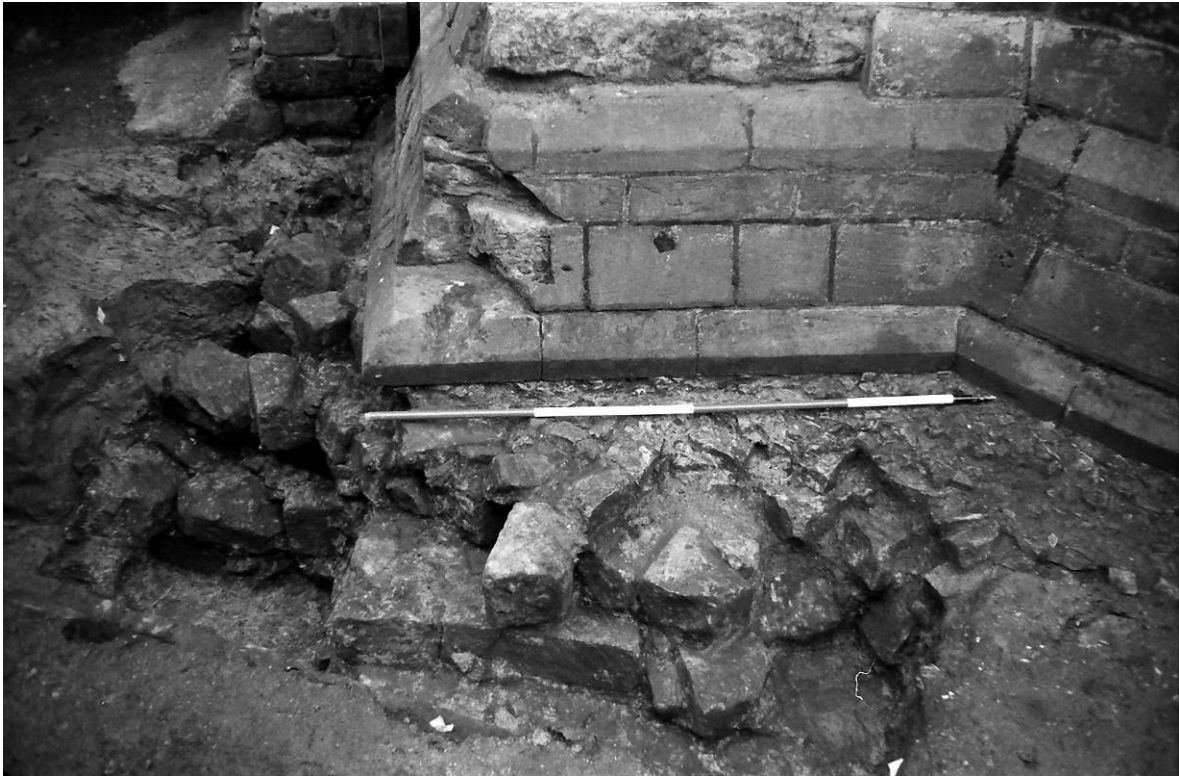
3. Foundation raft ,5005. for the Black Gate during excavation, looking south. This shows the small sandstone chippings and mortar levelling-up surface, removed during subsequent landscaping. Scale 2m. (Film 1984/4/32A)

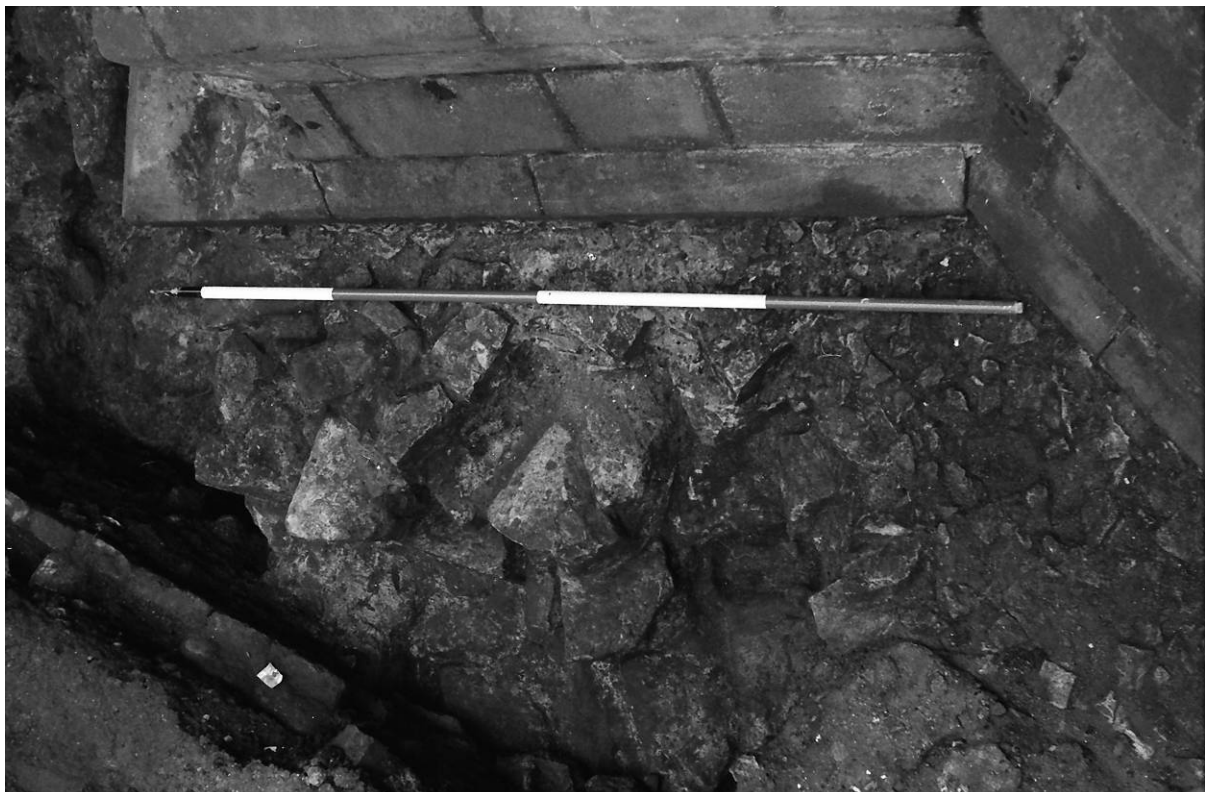
4. Another view of the same, looking down from the air-raid shelter. (Film 1984/4/35A)

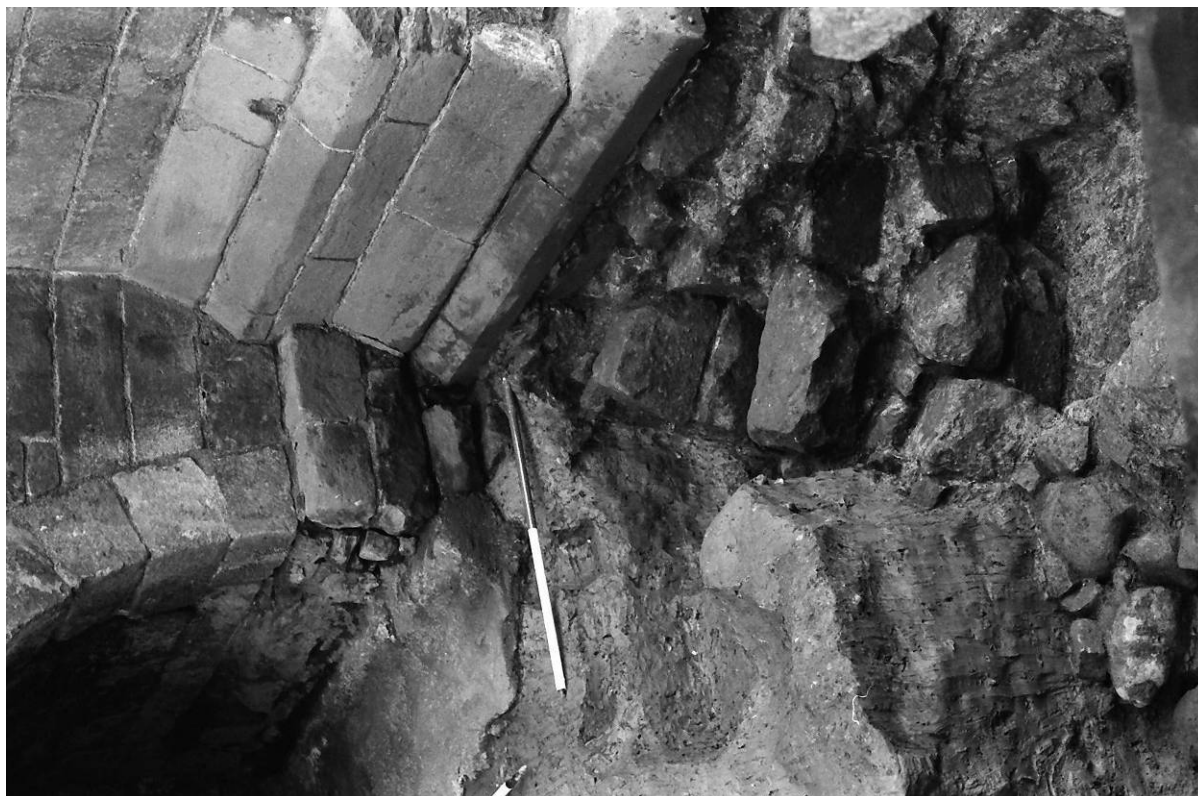
5. *Left* - Junction of wall (1825) and the Black Gate <5008> showing foundation raft of the latter <5005> (Film 1984/3/37)

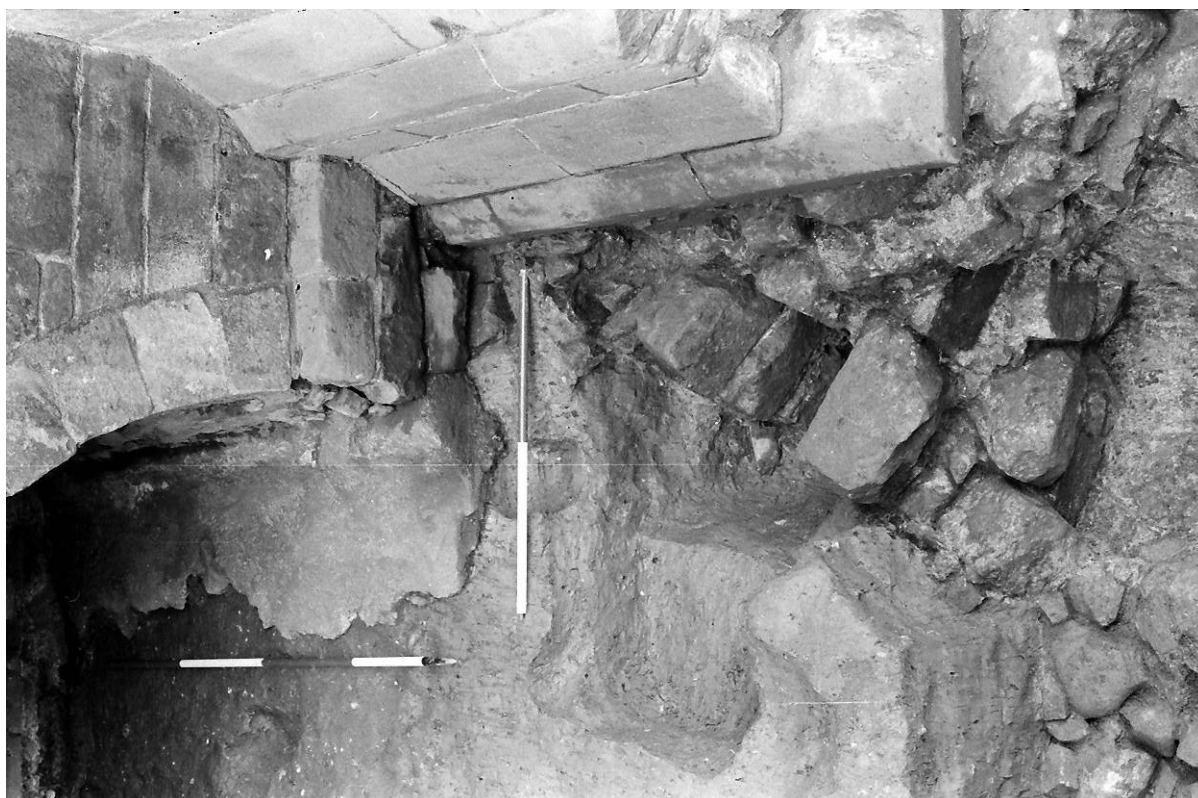
6. *Right* - the same looking south-west. Scale 1m. (Film 1984/3/36)

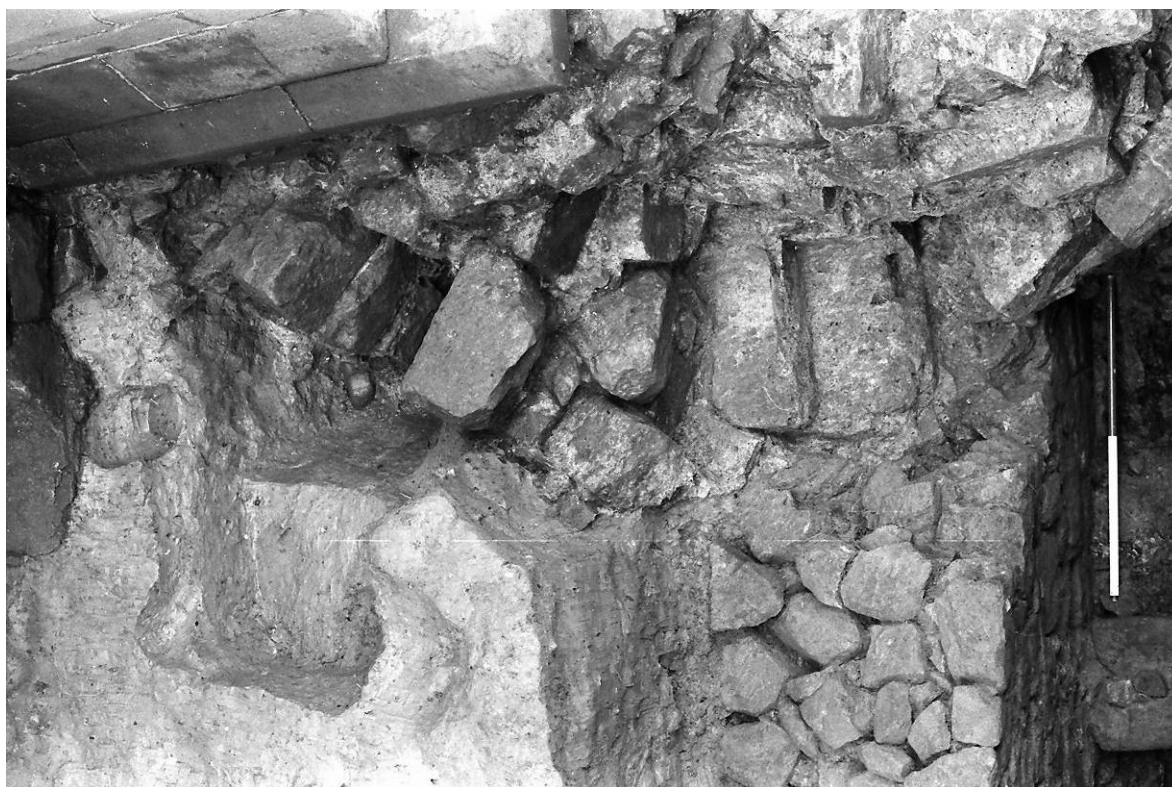
7. *Left* - wall (1743) looking east from its junction with the Black Gate foundations <5005>, showing the cut into the natural glacial till. Scale 1m and 2m. (Film 1984/5/17A)

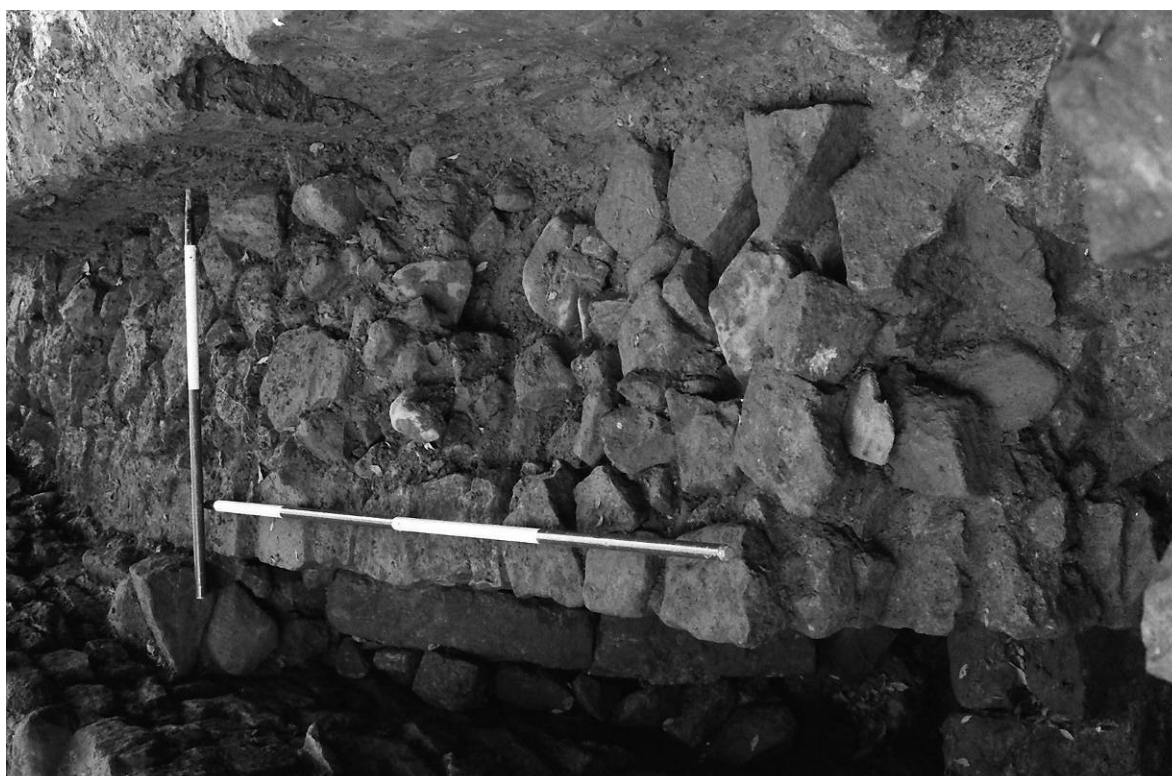
8. *Right* - Junction of wall (1743) and foundations for the Black Gate <5005> looking south. Scale 1m. (Film 1984/5/7A)

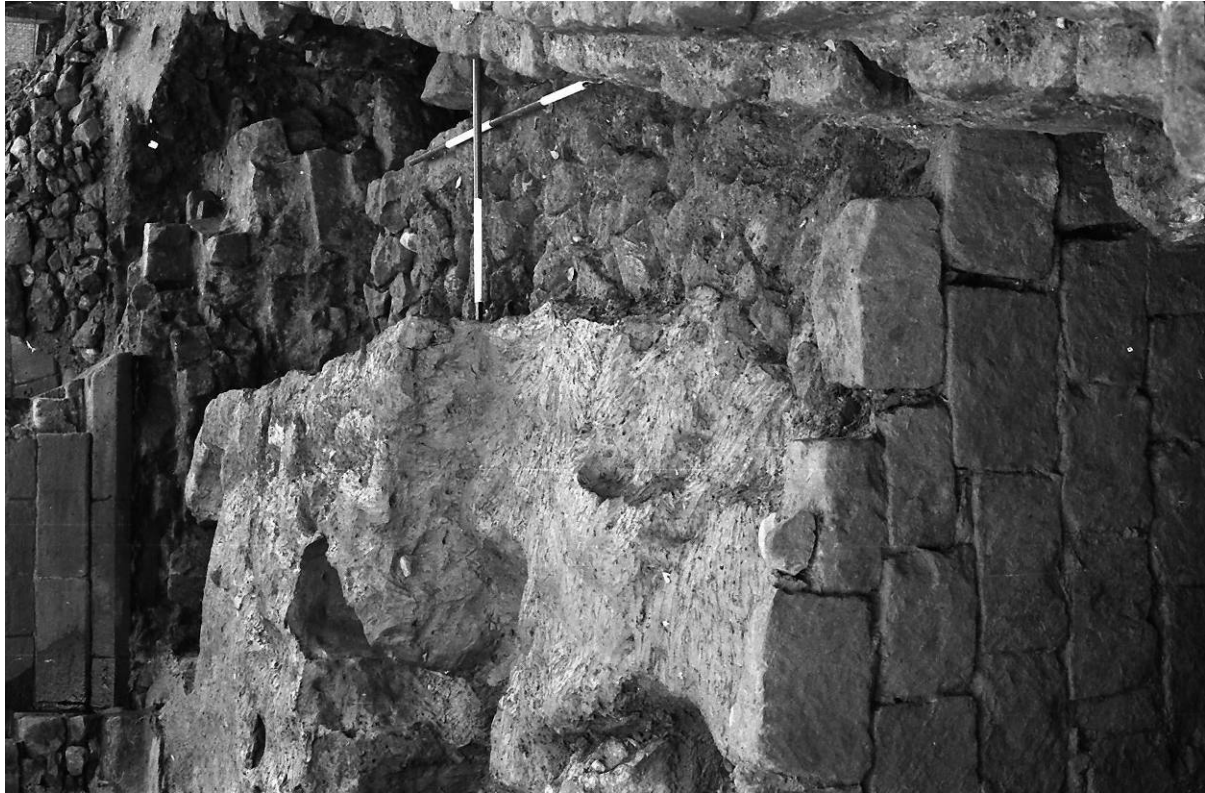
11. *Left* – 'cess pit' (1823) looking west along wall (1743) towards the Black Gate foundations <5005>. Wall (1657) is on the right. (Film 1984/slide 0/84/37)
