Evaluation at the Black Gate, Castle Garth, Newcastle upon Tyne
NE1 1RQ

(Scheduled Monument No. SM 32753)

December 2011
by
Northern Counties Archaeological Services

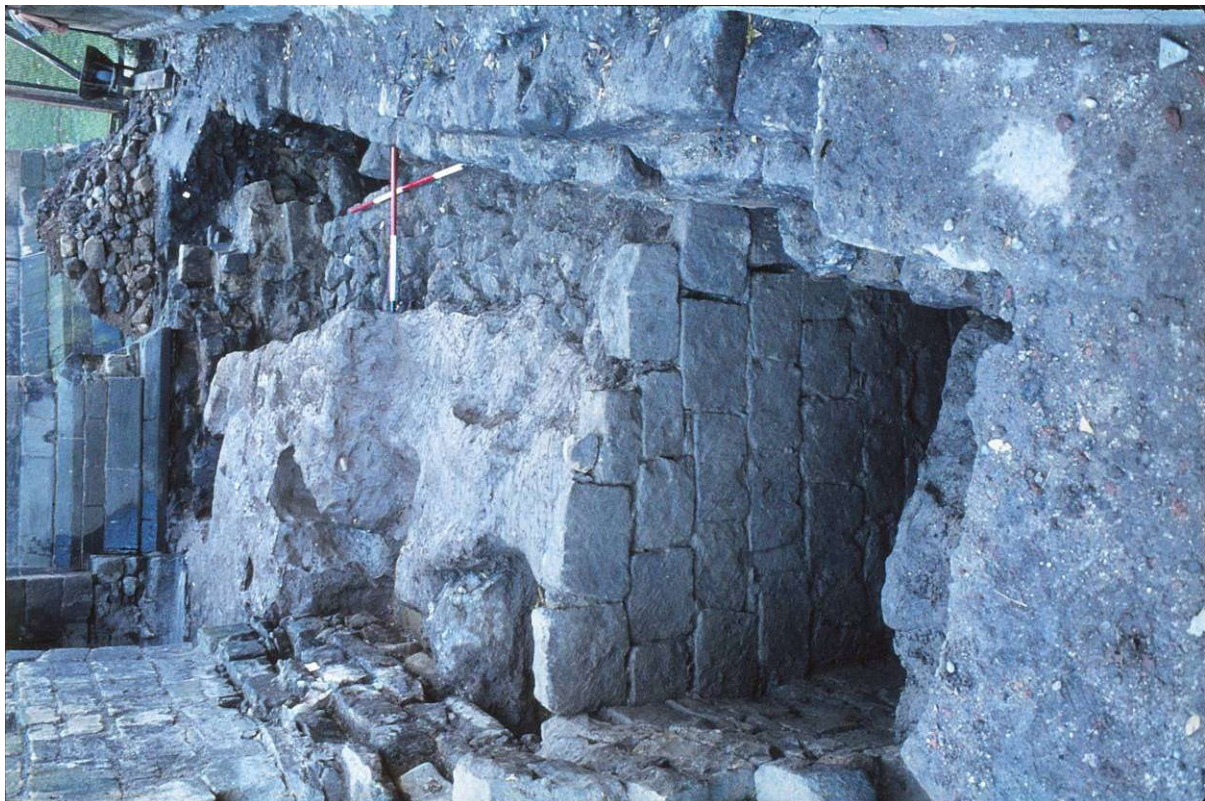
12. *Right* – closer view of the 'cess-pit' west wall (1721), wall (1743) and wall (1657) cutting both. Scales 1m and 2m. (Film 1984/5/18A)

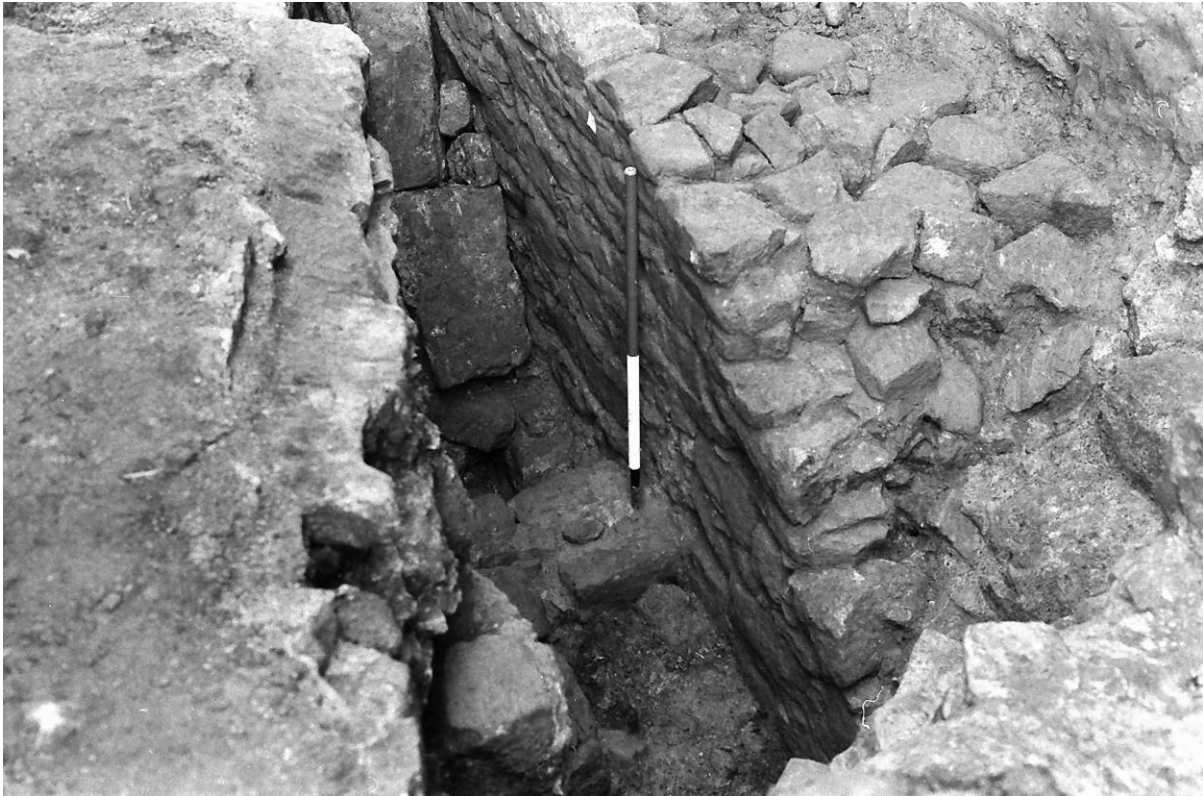
9. Wall (1743) looking south-east from its junction with the Black Gate foundations <5005> showing the 'face' to the north and traces of abutting features. Scale 1m. (Film 1984/5/12A)

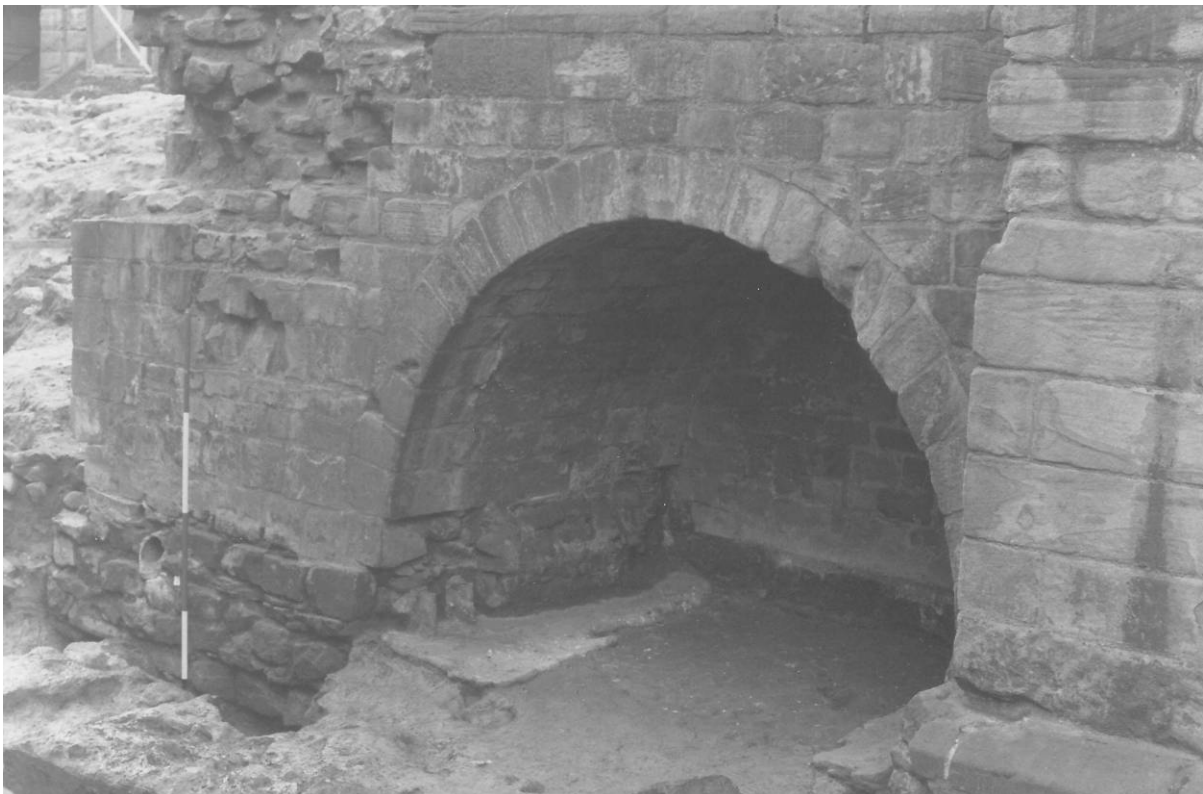
10. Wall (1825) looking south-east, showing the possible relieving arch and rubble foundations on the east side. (Film 1984//5/24A)

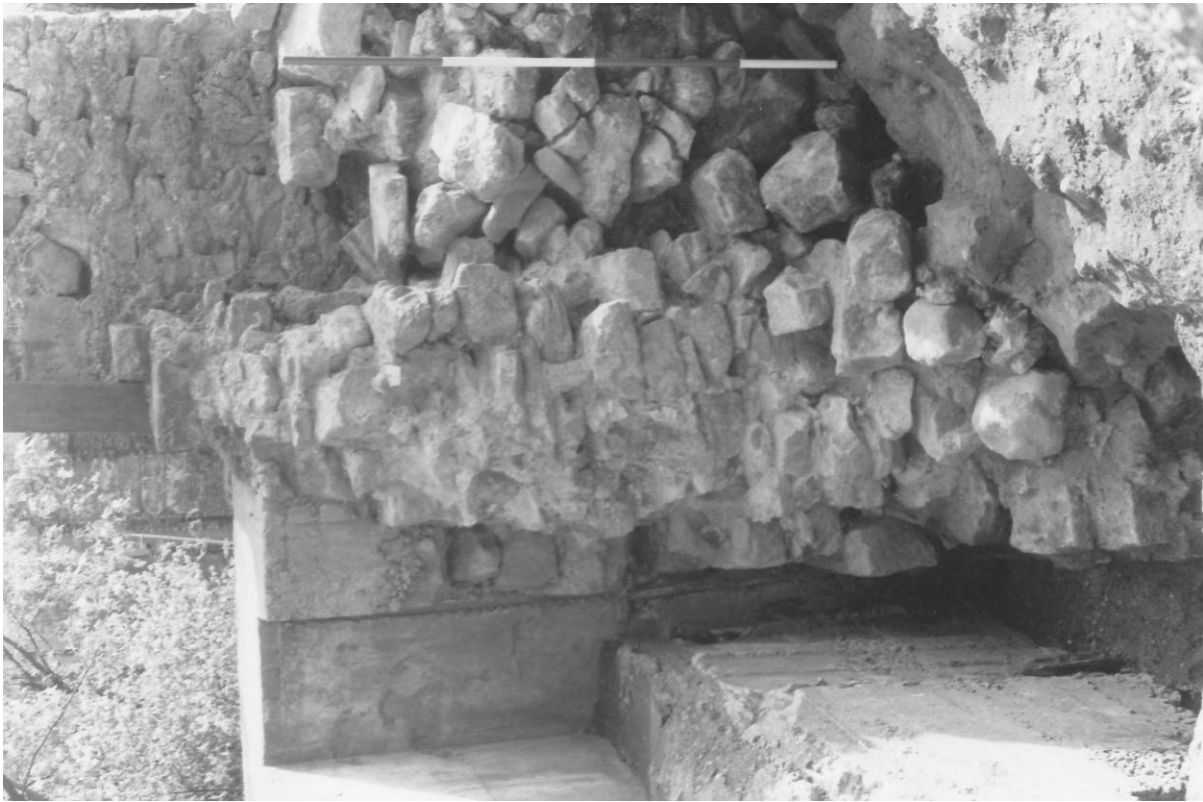
13. *Left* - Masonry arc (1843) in the south-west angle of 'cess-pit' (1823), looking south. Scales 2m and 0.5m. (Film 1984/5/20A)

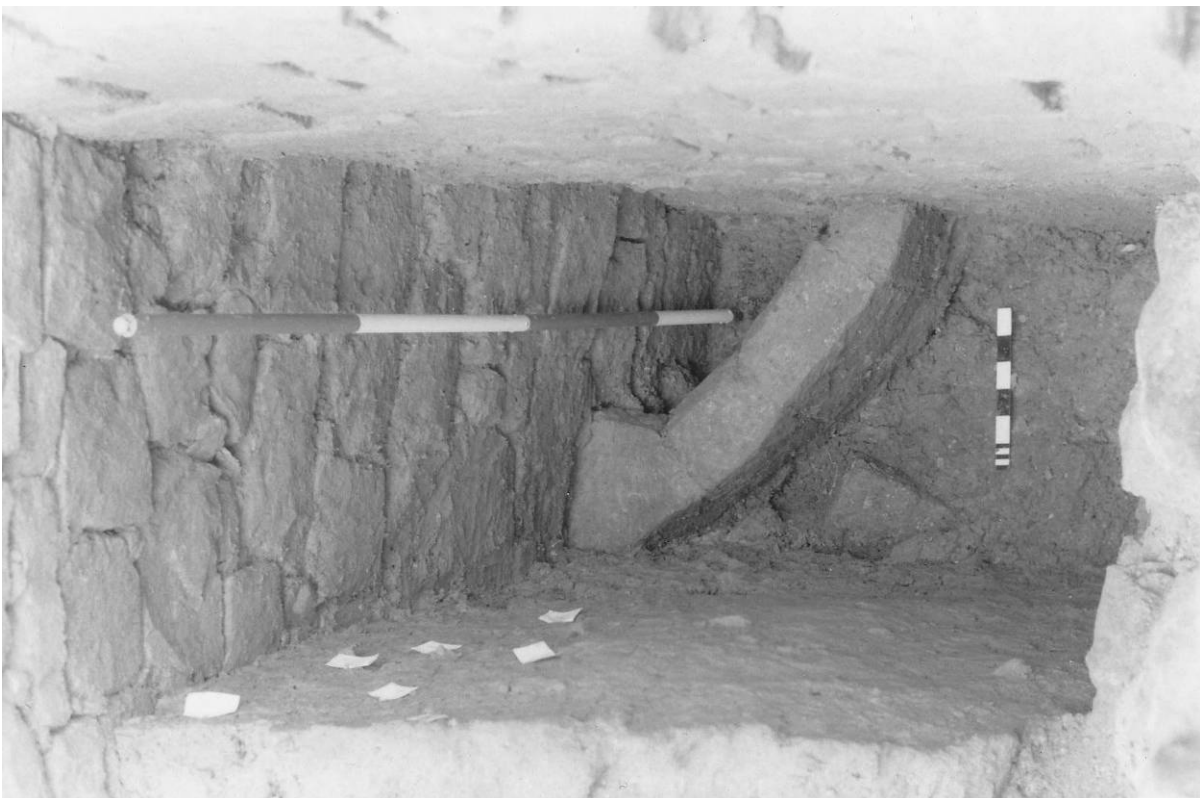
14. *Right* - wall (734/852) looking east, showing rear wall and offset of air-raid shelter and construction cut partly emptied. Scale 2m. (Film 1984/3/7)

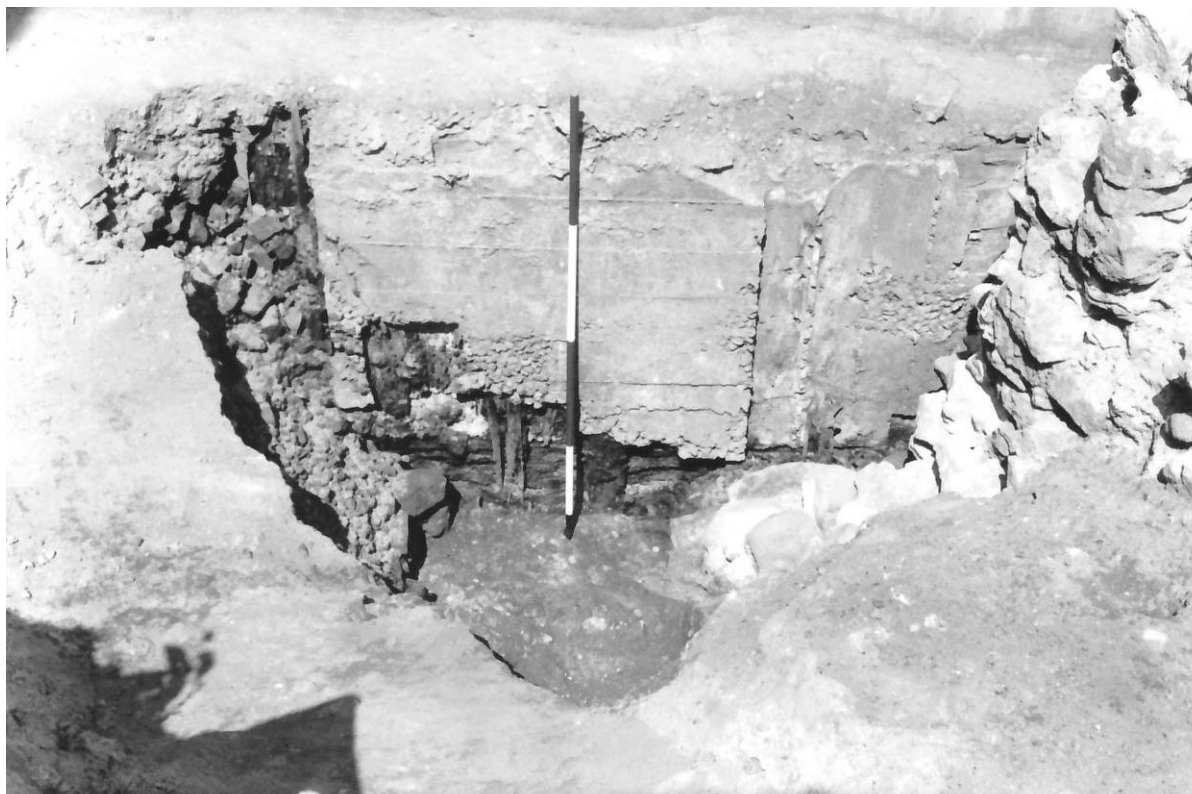
15. Rear wall and offset of the air-raid shelter after removal of part of the construction cut infill, showing offset and remains of shuttering. Wall (734/852) to the right. Scale 2m. (Film 1984/2/32)

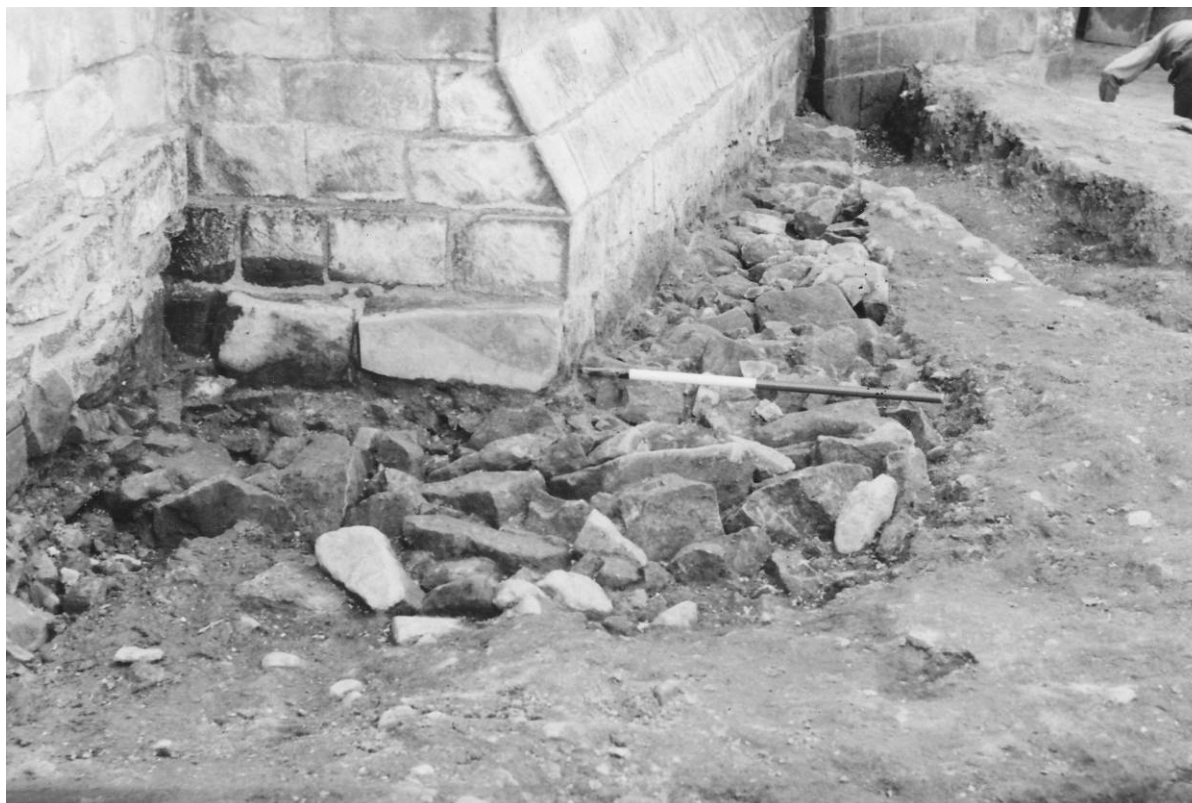
16. The rubble foundation (1932) of wall (1824) looking north to its junction with the east end of wall (1825). This, and the baulk of the ditch deposits abutting, were left undug. Scale 1m. (Film 1985/2/9A)

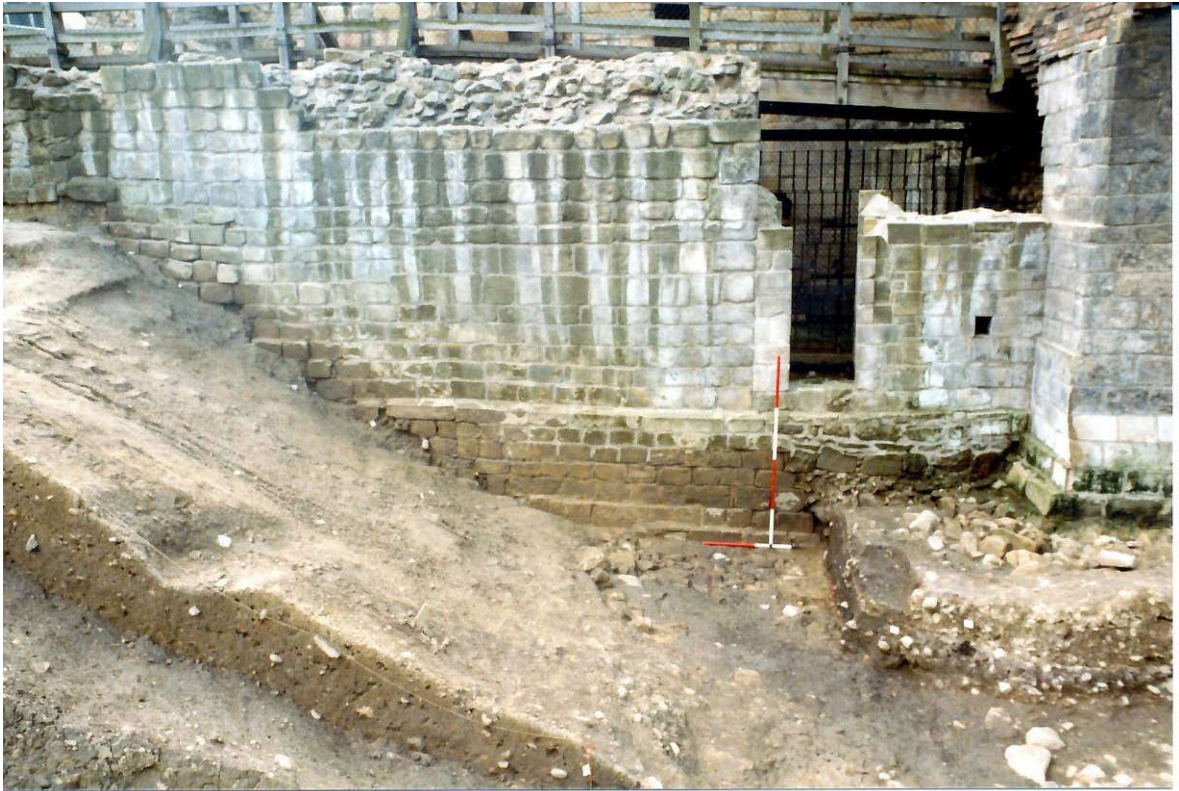
17. Castle ditch, looking west towards wall (647) with rubble foundation (2066). Wall (1824) is extreme right, with blocking wall (870) between the two. Photograph shows the baulk of unexcavated ditch deposits left to retain the foundations of (1824) and the section dug to sample the lower ditch deposits (foreground). Scales 1m and 2m. (Film 1985/2/23).

4.1.0 The excavation of the medieval castle ditch in 1984-5 ceased at the level of a rubble spread forming the foundation for the east wall of the 12th century North Gate turning bridge pit (wall 647) (Appendix 3, photograph 17 and 18). Subsequent excavation of the basal ditch deposits was confined to a narrow section cut close to the eastern side of the area (see Zone 5).

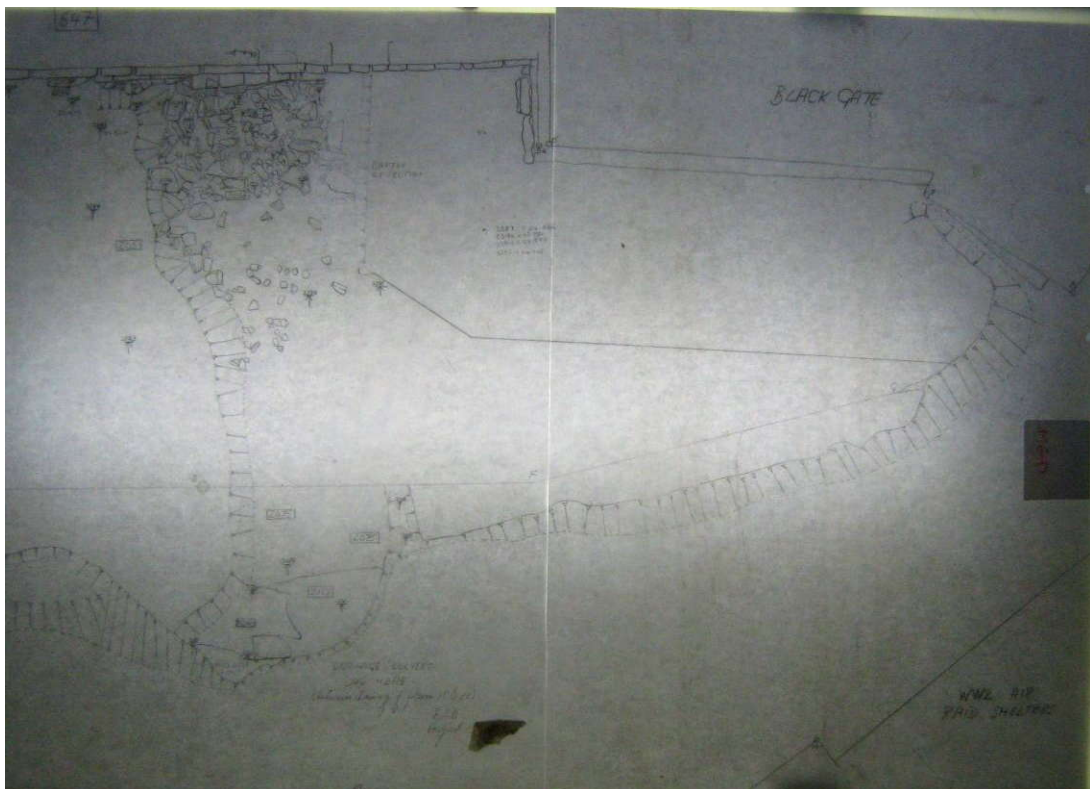
18. Field plan from 1985 (Drg. 85/21) showing the same area. See Figure 5 in this report.

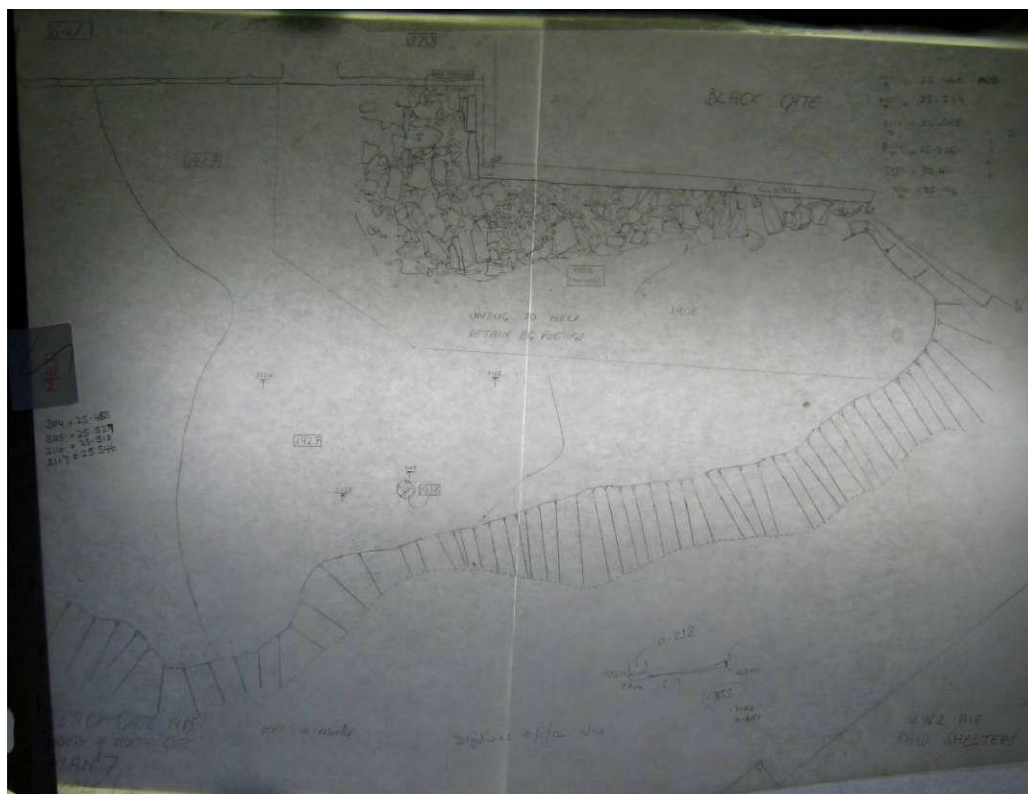
19. Field plan from 1985 (Drg. 85/7) showing (top) foundations (1932) to wall (1824) and the outline of the baulk left to retain them.

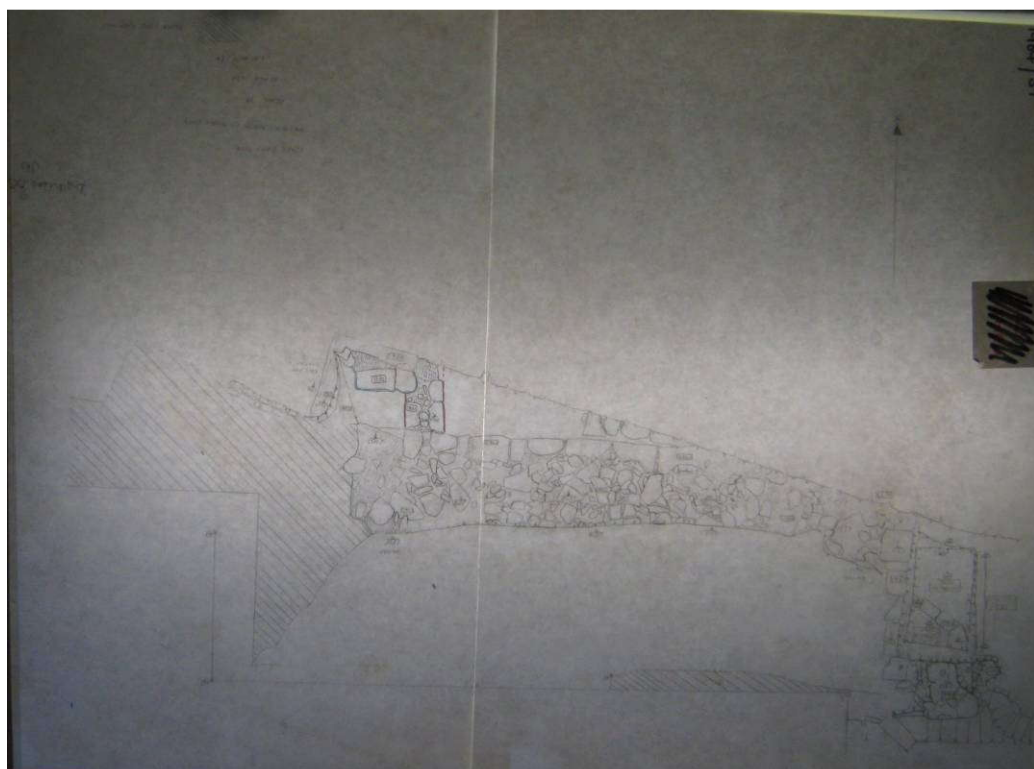
20. Field plan from 1984 (Drg. 84/39) showing wall (1743) and cess pit (1823) fully exposed. North is to the top. See Figure 5 in this report.

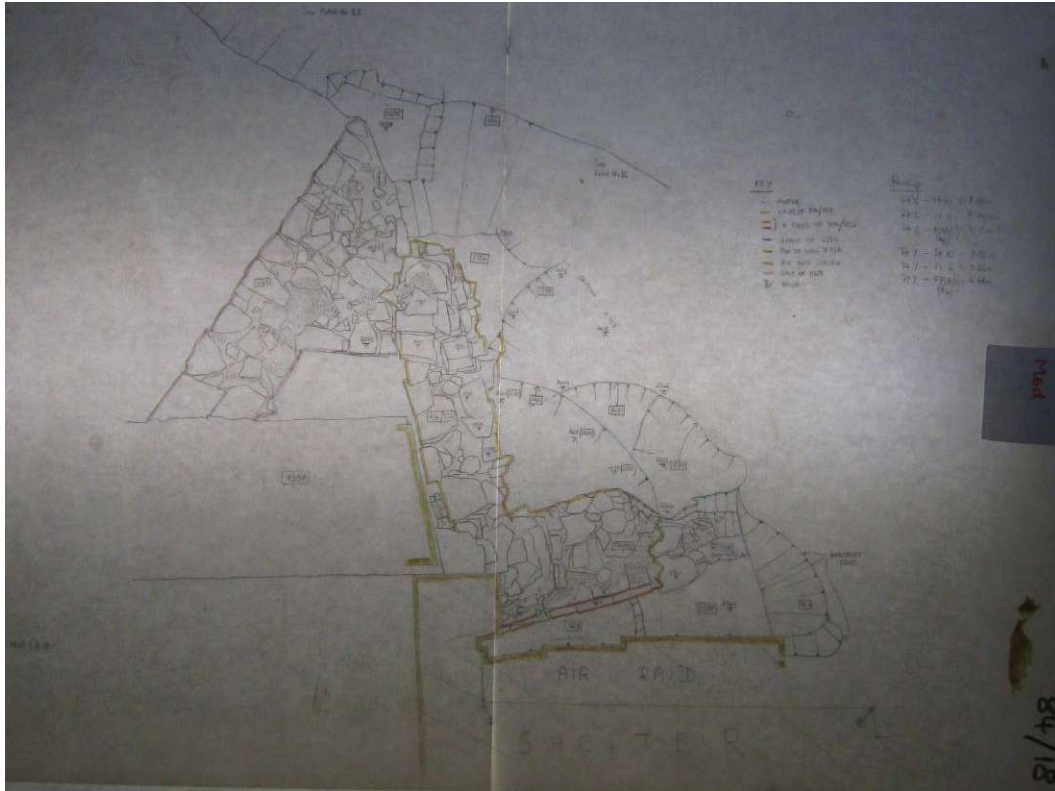
21. Field plan from 1984 (Drg.84/18) showing wall (734/852) and part of the air-raid shelter. See Figure 5 in this report.
