**RESULTS OF A GEOPHYSICAL SURVEY AT
SHINGAY HOSPITALLER COMMANDERY,
CAMBRIDGEHIRE**

NGR REF: TL 3104 4734

DECEMBER 2013 TO MAY 2014

Report prepared by CHRISTER CARLSSON, PhD

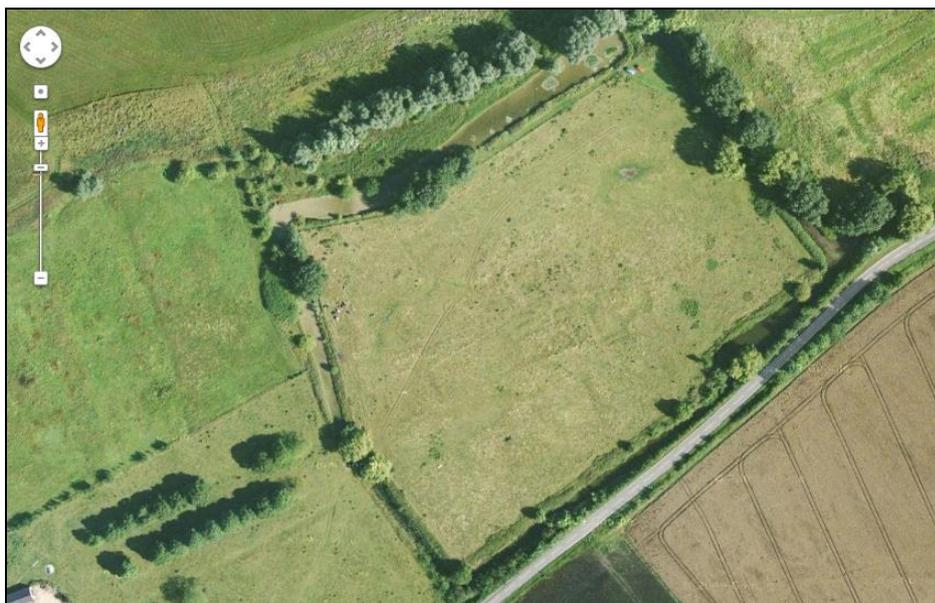
Fig. 2. A modern aerial photo of the site clearly shows the preserved earthworks within the moated enclosure.

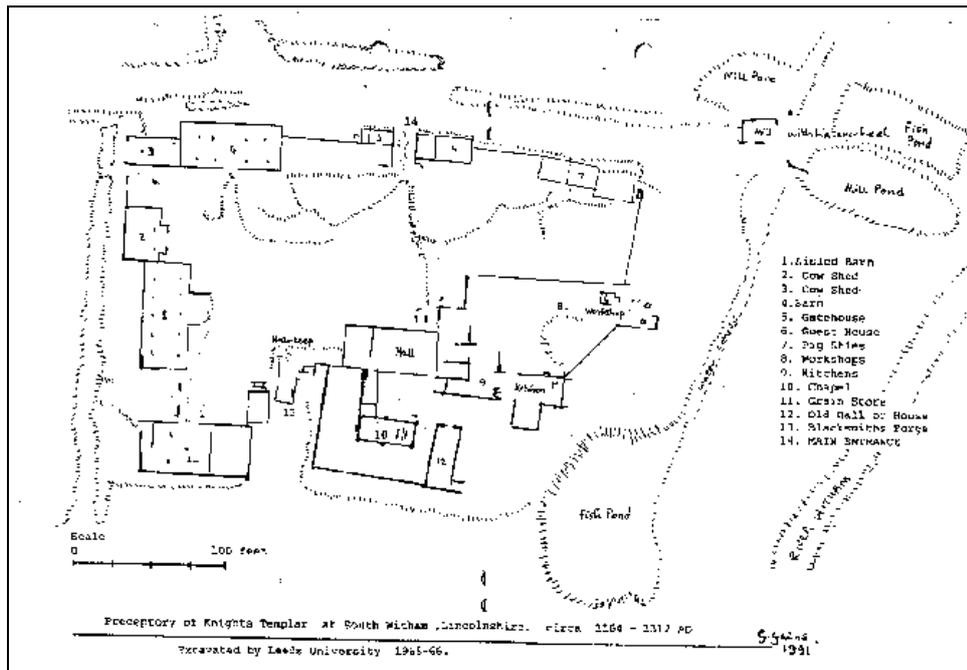
Fig. 3. The fully excavated Templar Preceptory at South Witham in Lincolnshire clearly shows that more than twenty different buildings were present within this medieval site.

There would typically be barns, stables, kitchens, mills, fishponds, dovecotes, brewing houses and other economy buildings in close vicinity to the chapel and the hall. An idea of what may lay hidden beneath the ground in Shingay is given by a number of similar, fully excavated, sites in the UK. The best example would probably be South Witham Templar Preceptory in Lincolnshire. Even if this site belonged to the Templars, rather than the Hospitallers, it can still give us a good idea of what a medieval site belonging to a Military Order would be expected to contain (Fig. 3).

Below is a reconstruction of South Witham based on the results of the fully excavated site. It clearly shows that the most important buildings, such as the hall and the chapel, were situated at the centre of the site, while a whole range of various economy buildings were found closer to the edges. Northern European Military Order sites could have many different layouts, but the same kinds of components were often present.

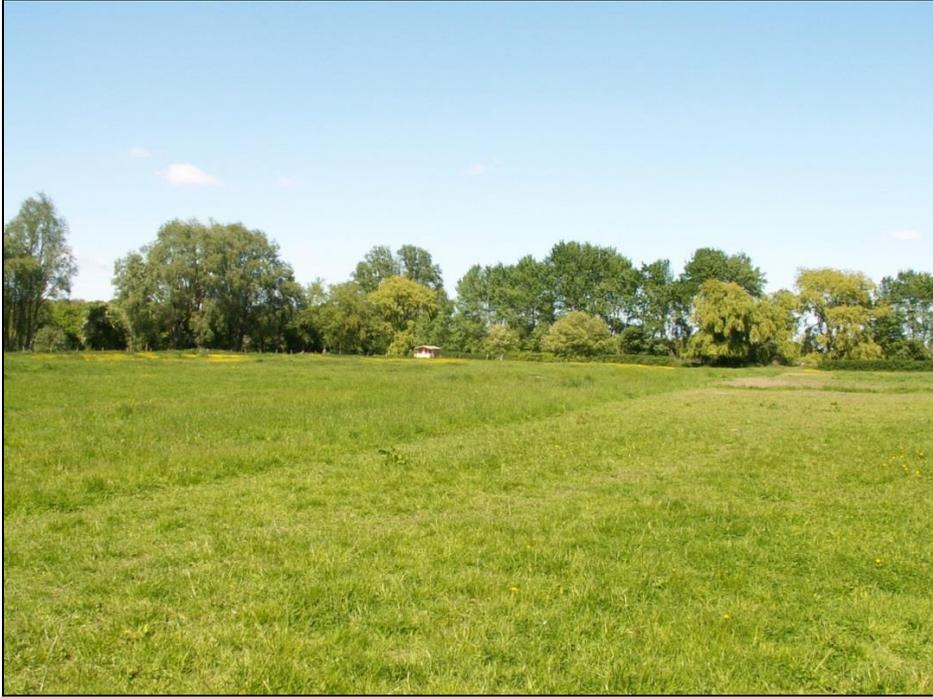
Fig. 4. Photo of the site towards northeast. The earthworks are clearly visible in the central part of the picture. This is where one would expect to find remains of the most central part of the complex.

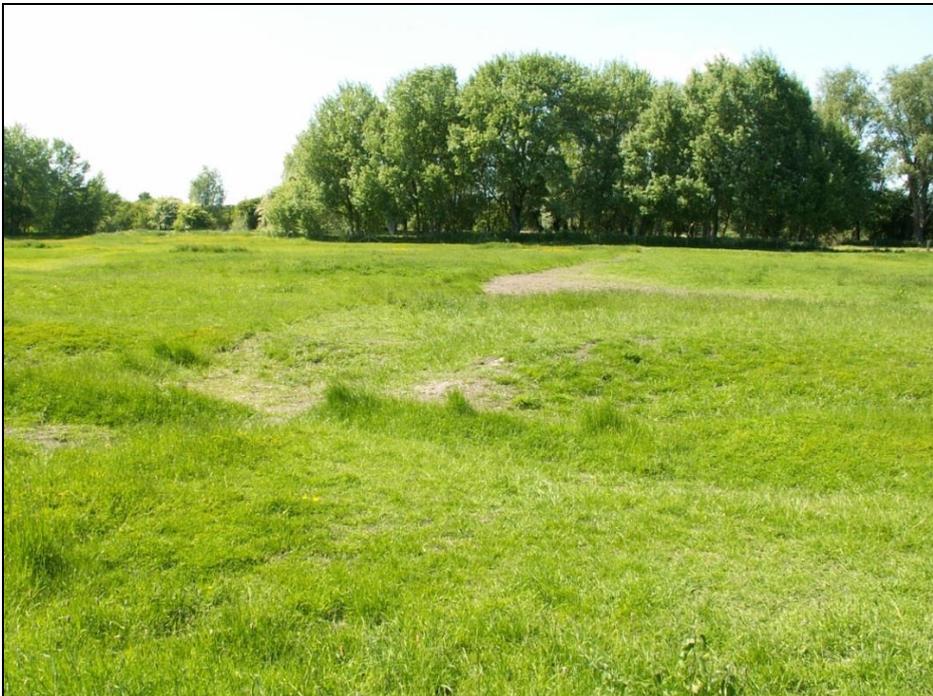
Fig. 5. Photo of the site towards northwest. The earthworks are clearly visible in the central part of the picture. This is where one would expect to find remains of the most central part of the complex.

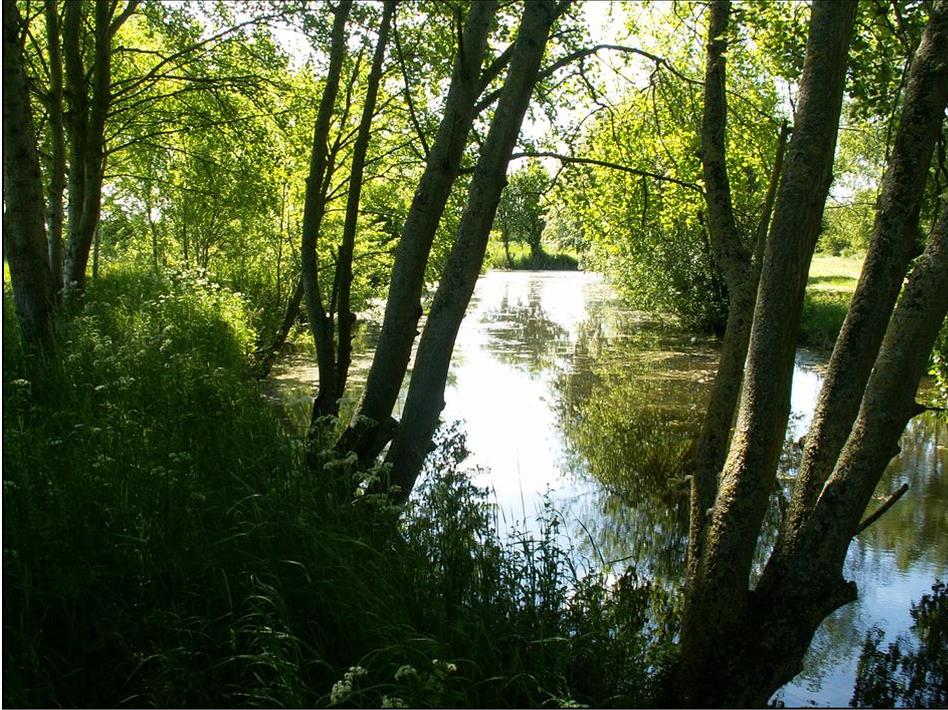
Fig. 6. The northern part of the preserved moat. This section of the moat was in the Medieval period probably a mill race. The remains of a possible mill are preserved some 50m to the northwest of the Scheduled Monument.

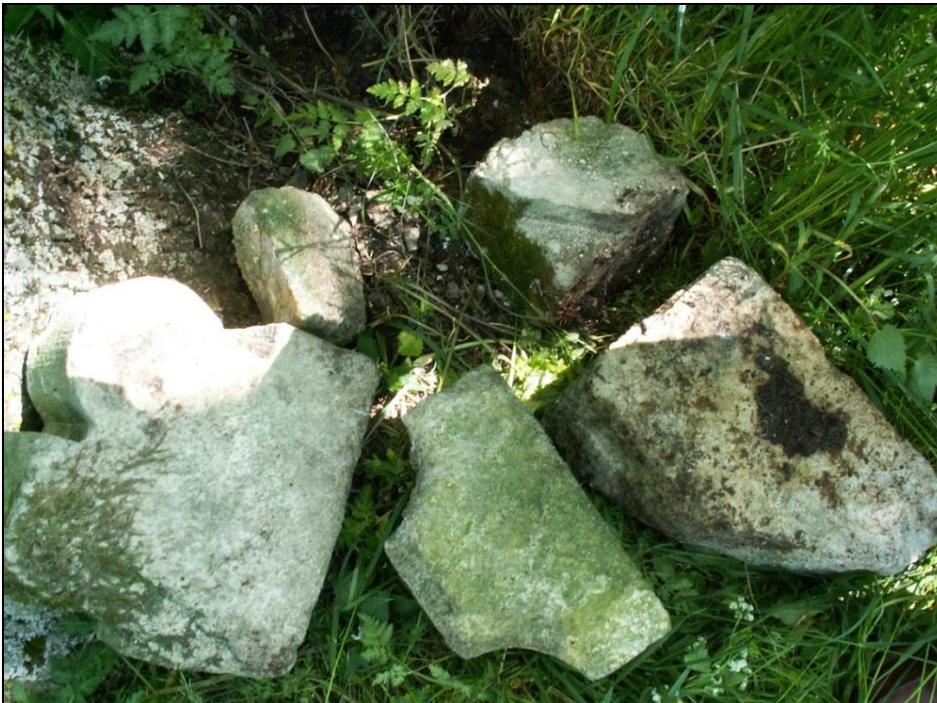
Fig. 7. Worked limestone found in the moat that surrounds the site. These fine architectural details are of a high quality and have probably been inserted in a gothic stone structure belonging to the medieval commandery.

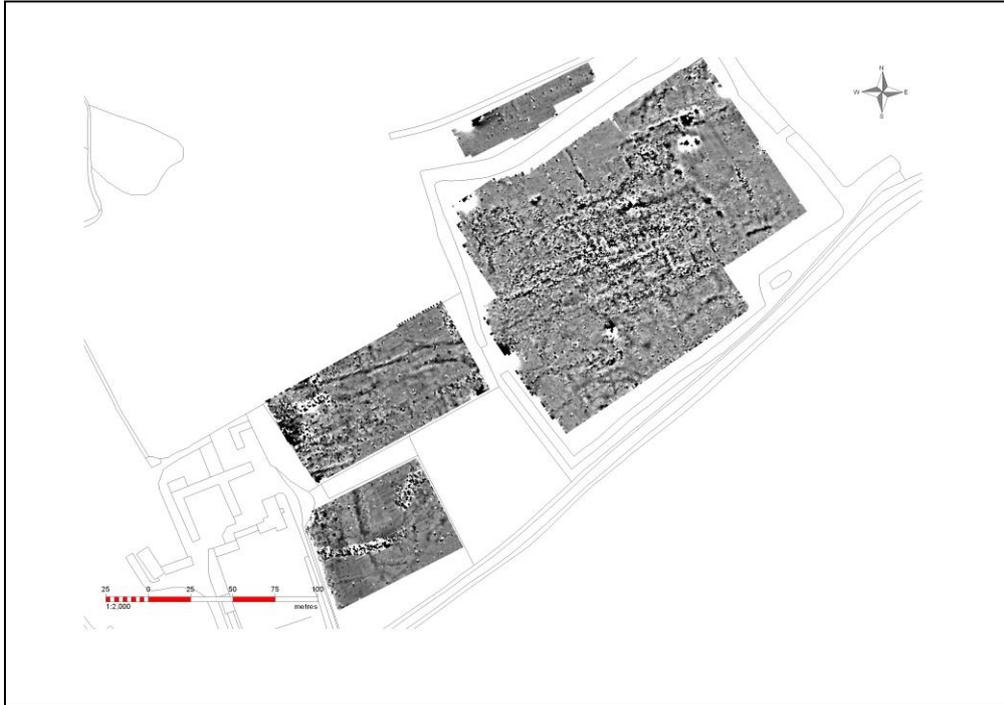
Fig. 8. The results of the magnetometer survey. The black and white fields are areas that were covered by the magnetometer inside, as well as outside, the moated site.

While the gradiometer is quicker to use, and is more likely to pick up magnetic changes in the ground, the resistance meter is slower and is registering changes in resistance in the ground. The research team was therefore able to cover larger areas with the gradiometer (the grey areas outside the moat are actually outside the Scheduled Monument). For this reason the two maps look slightly different, even if some general trends can be seen (Fig. 8-9).

Another tendency that can be seen in the maps is that the gradiometer was able to pick up more debris from the former buildings. Such debris is shown as spreads of black and white dots over the magnetometer map, and is causing the linear features to stand out less clear than on the resistivity map. If such debris consists of fired material, such as bricks, it is likely to show up more clearly on the magnetometer map. The four large white blobs on the magnetometer map are, for instance, most likely modern burning sites. The present owner, Mr Amey, kindly informed the research team that he is sometimes burning dead grass and branches in the area.

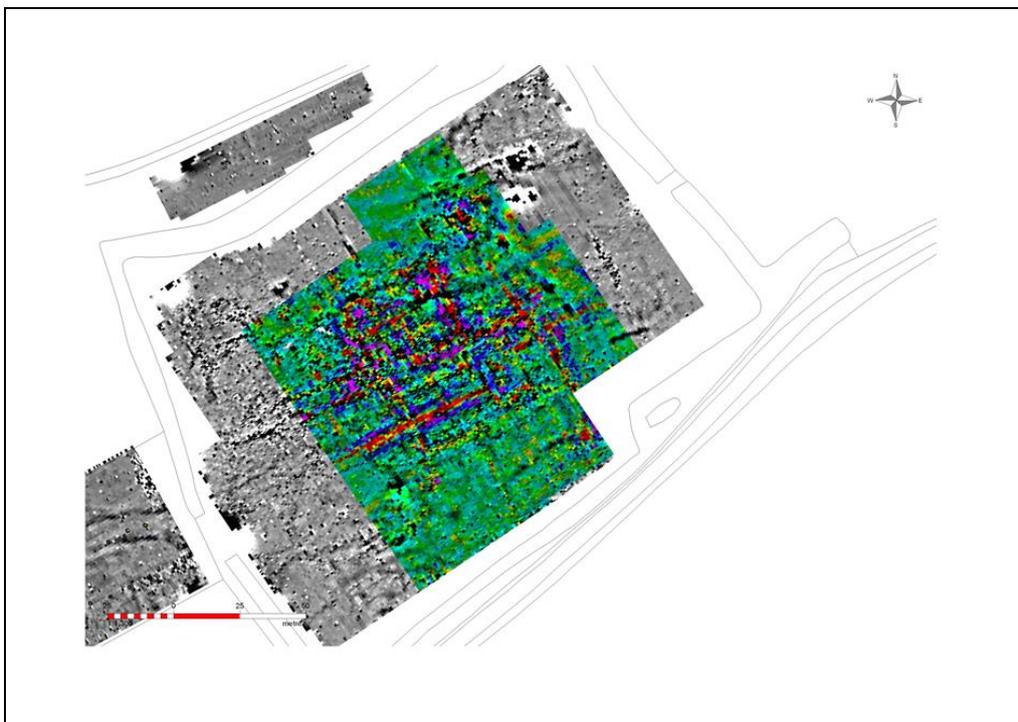
Fig. 9. The results of the resistivity survey (coloured) on top of the magnetometer.

Most of the red and yellow on the resistivity map are, however, probably foundations or paved areas. There may also be a cobbled surface and some other structures bottom right. As few features show up in this area on the magnetometer map it is likely to be a concentration of stones. Some of the darker lines that are running all the way out to the moat are likely to be drainage ditches.

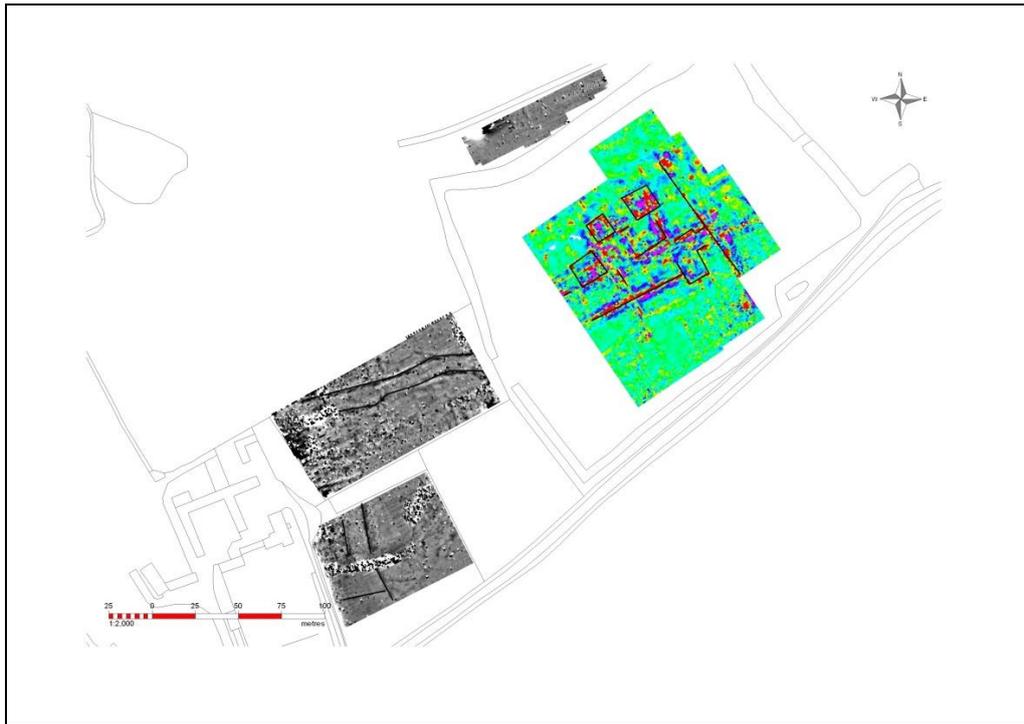
Fig. 10. The most obvious trends in the two maps: A road is leading into the moated area from the west, and a concentration of features, many of them likely to be foundation walls or robbed foundation trenches, are present in the central part of the site. There is also a concentration of features that were picked up by the gradiometer in the south west corner of the site.

Some reasonable interpretations can, however, be made from studying the two maps: The larger features, like the clear linear features that were picked up by both instruments, are likely to be stone- or brick walls and/or robbed foundation trenches. For this reason a new map, showing such general trends from the first two maps, can be created. On this map the most obvious features have been marked with black lines (Fig. 10).
