54A ALDERMANS DRIVE,

# ARCHAEOLOGICAL EVALUATION (OASIS ID: independ1-282266)

**APRIL 2017**

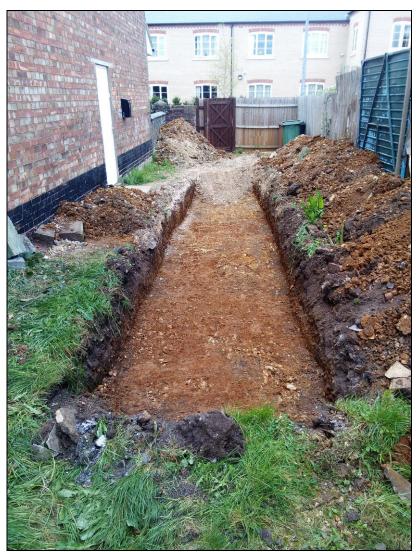
- 7.1 Trench 1 was 10m long, 2m wide and up to 0.45m deep. The lowest level encountered in the trench was the natural deposits, which consisted of yellow-grey Cornbrash with occasional inclusions of roots and stones (Figure 4).
- 7.2 Overlaying the natural deposits was the up to 0.15m thick subsoil (102), consisting of light brown, plastic silty clay with occasional small stones and roots. The subsoil also contained frequent modern material, such as concrete slabs, modern china and bricks. The uppermost layer in Trench 1 was the up to 0.30m thick modern garden soil (101) of dark brown, plastic silty clay with frequent roots and occasional small stones. The garden soil also contained frequent modern inclusions of bricks, concrete and mortar.

Figure 4. Trench 1. Overview. West facing photo.
