Witley Court, Great Witley, Worcestershire Report on Geophysical Surveys, November 2016

WITLEY COURT,
GREAT WITLEY,
WORCESTERSHIRE

REPORT ON GEOPHYSICAL SURVEY,
November 2016

NGR: SO 770 649

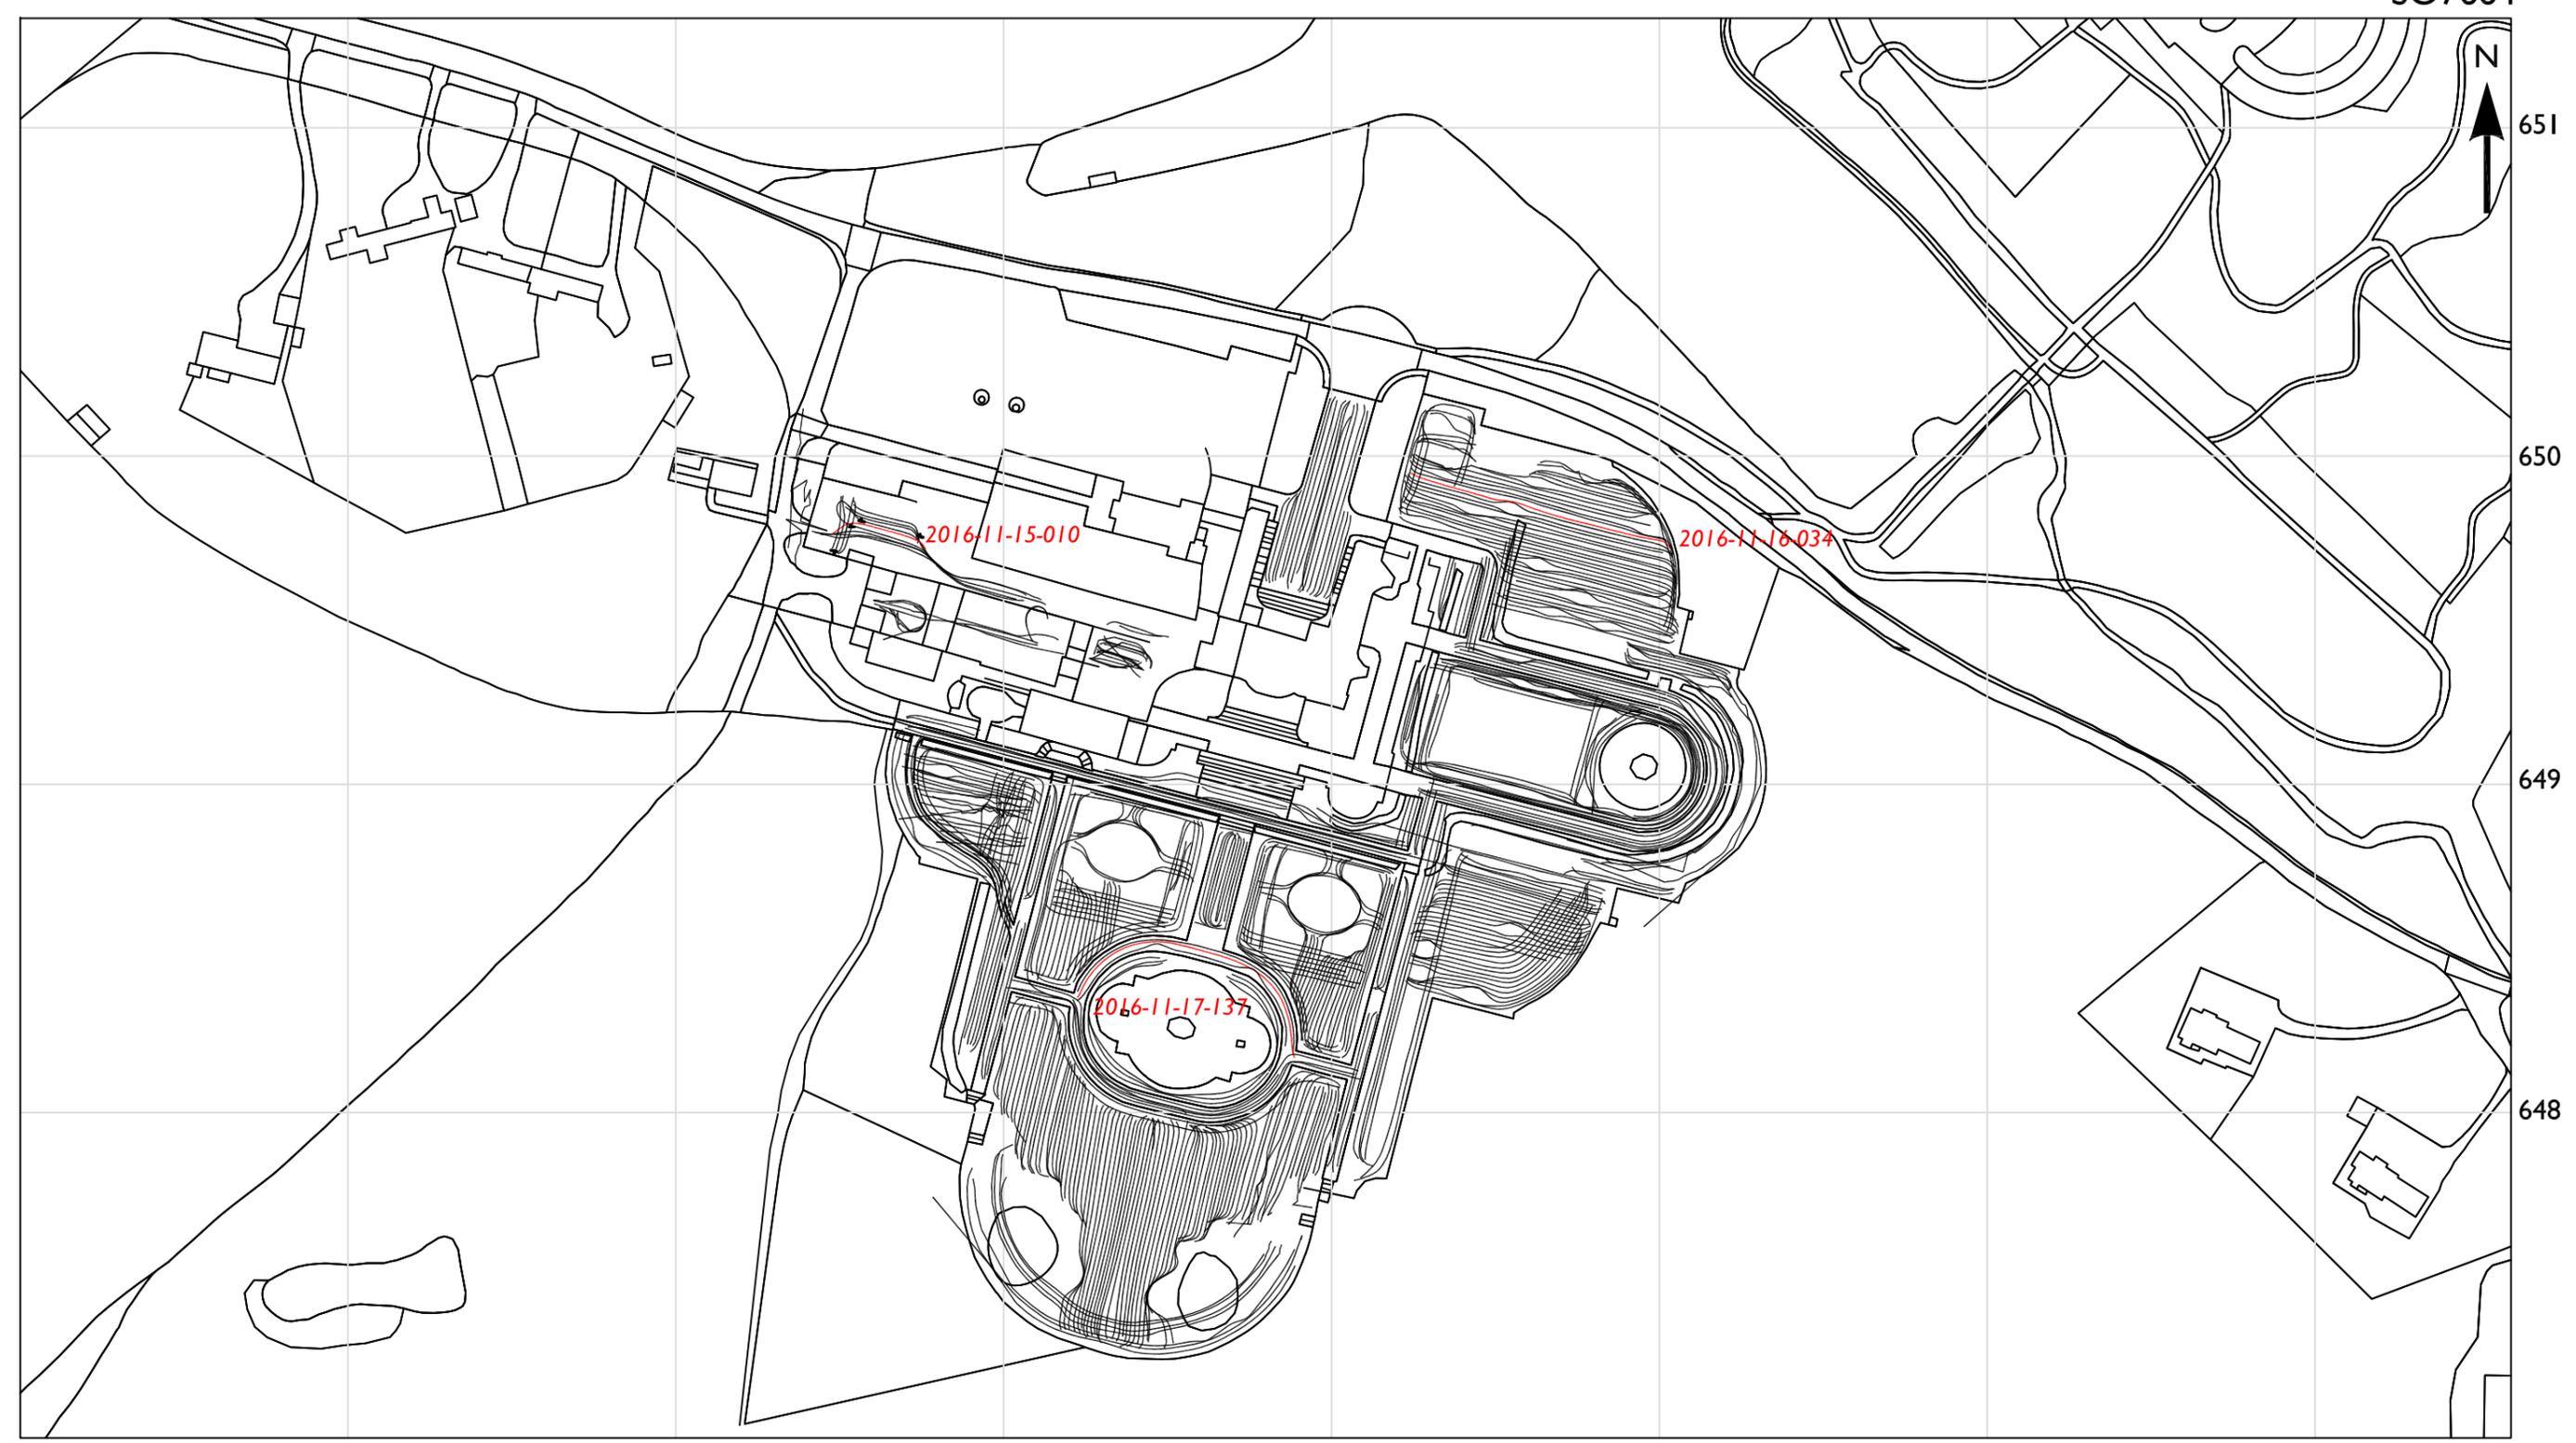
Location of GPR survey swaths, November 2016

- Figure 1* Location of the GPR instrument swaths superimposed over the base OS mapping data (1:2000).
- Figure 2* Greyscale image of the GPR amplitude time slice from between 12.5 - 15.0ns (0.67 - 0.8m) superimposed over the base OS mapping data. The location of the GPR profiles shown on Figure 3 are also indicated (1:2000).

▨ Ground Penetrating Radar survey swaths

control for the survey collected along the instrument swaths shown on Figure 1. Data were acquired at a 0.075m x 0.075m sample interval across a continuous wave stepped frequency range from 60MHz to 2.99GHz in 2MHz increments in the stable yards and 4MHz increments in the gardens, using a dwell time of 2ms. A single antenna element was monitored continuously to ensure data quality during acquisition together with automated processing software to produce real time amplitude time slice representations of the data as each successive instrument swath was recorded in the field (Linford 2013).

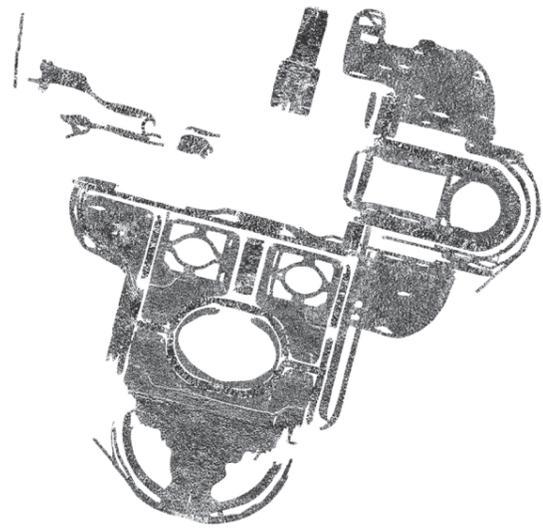
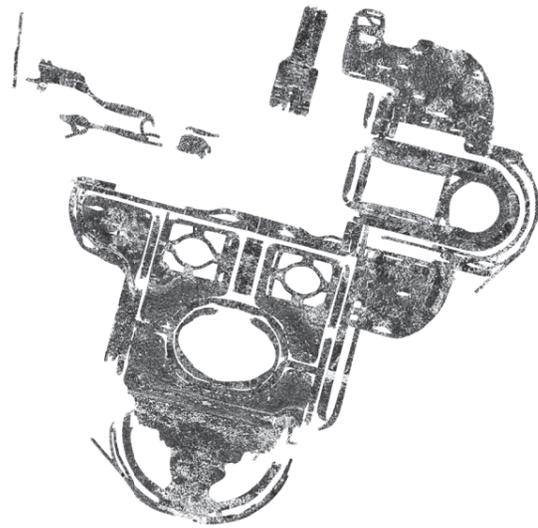
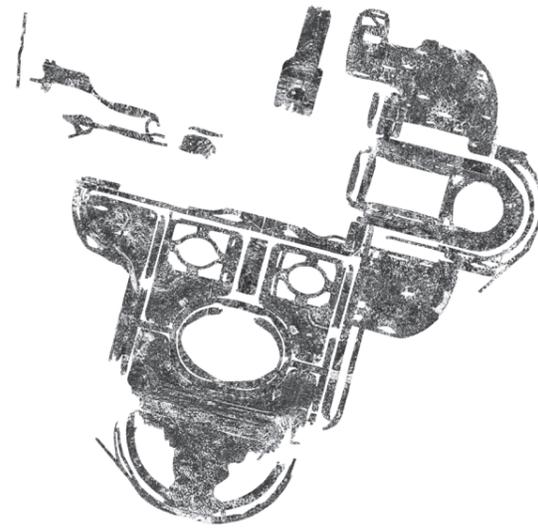
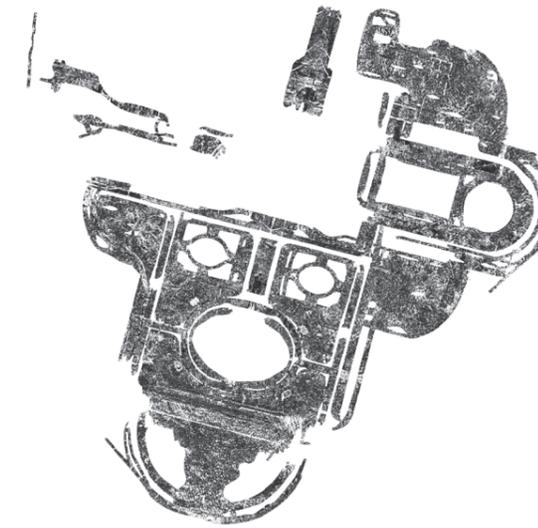
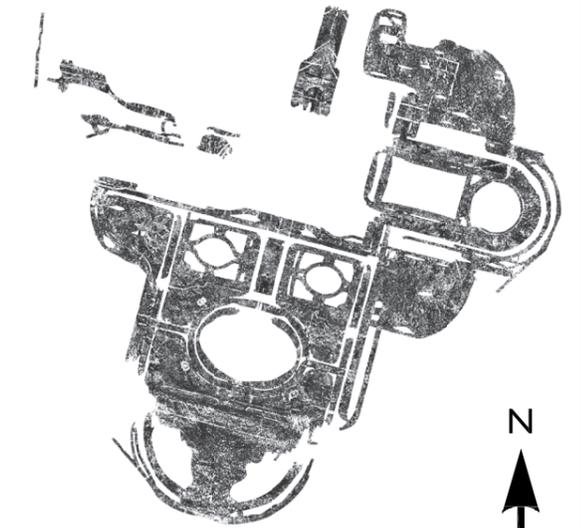
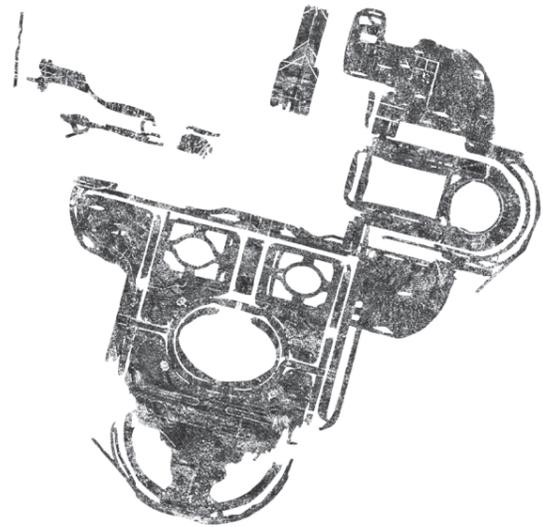
Figure 4

- Figure 4* GPR amplitude time slices between 0.0 and 25.6ns (0.0 to 1.34m) (1:4000).
- Figure 5* GPR amplitude time slices between 25.0 and 50.0ns (1.34 to 2.68m) (1:4000).

WITLEY COURT, GREAT WITLEY, WORCESTERSHIRE
GPR amplitude time slice between 0.0 - 25.0ns (0.0 - 1.34m), November 2016

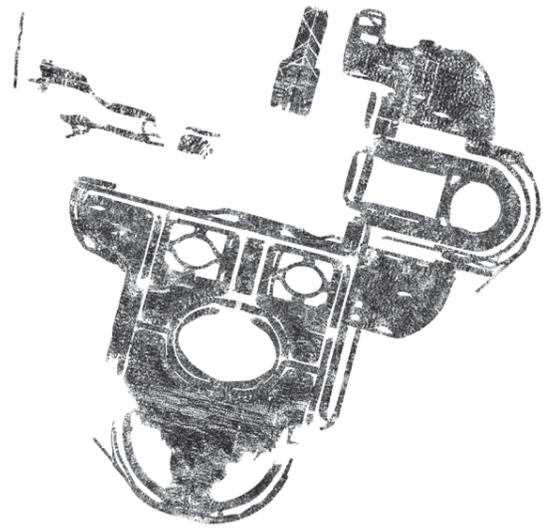
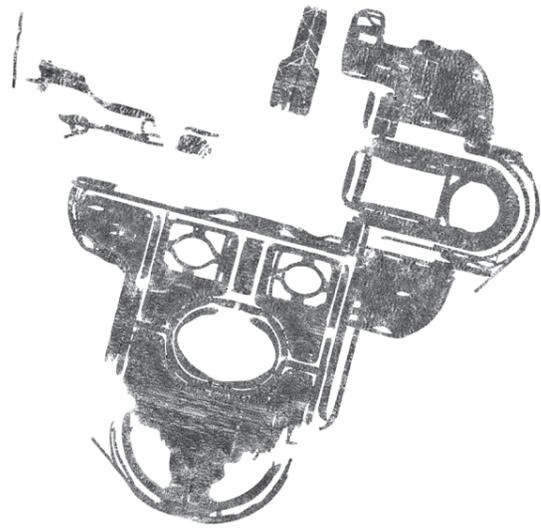
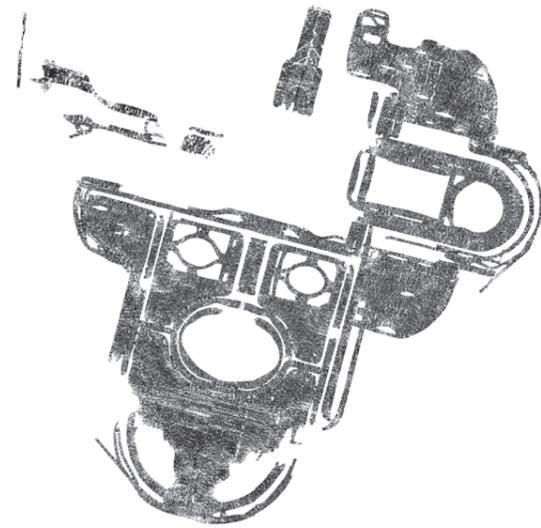
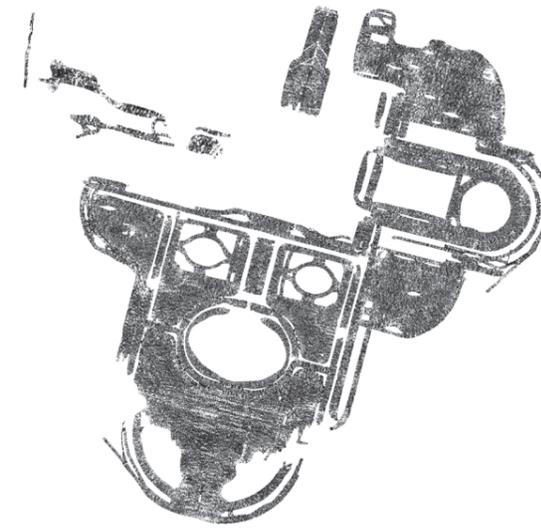
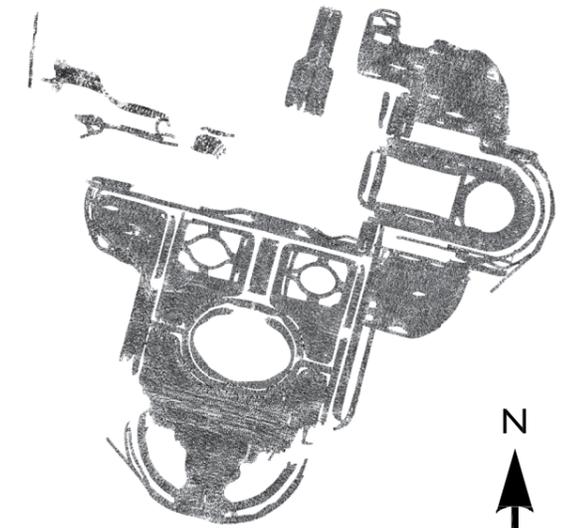
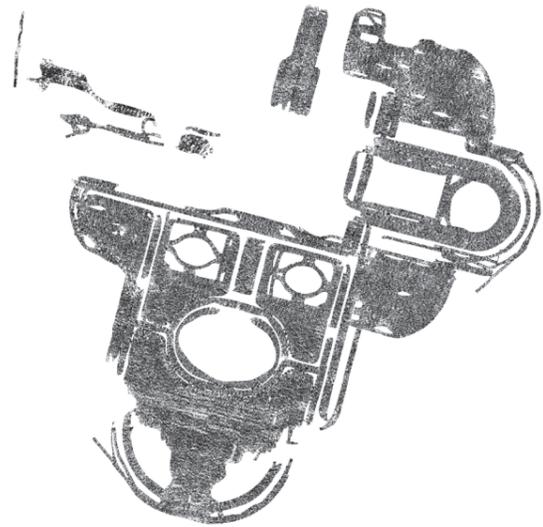
Figure 5

WITLEY COURT, GREAT WITLEY, WORCESTERSHIRE
GPR amplitude time slice between 25.0 - 50.0ns (1.34 - 2.68m), November 2016

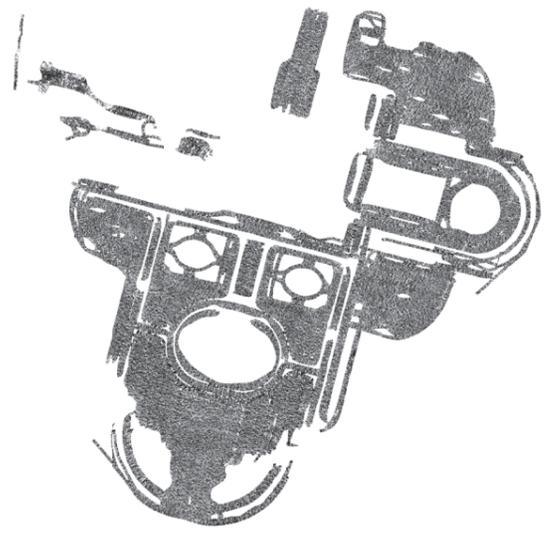
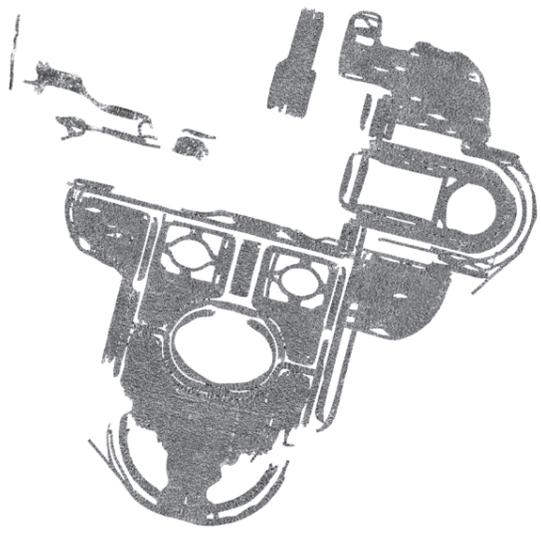
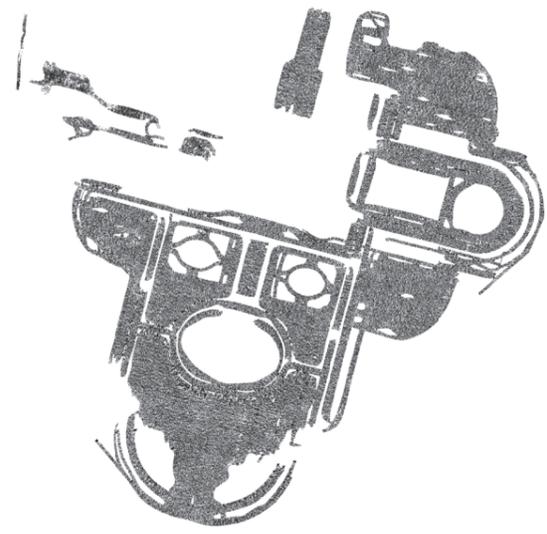
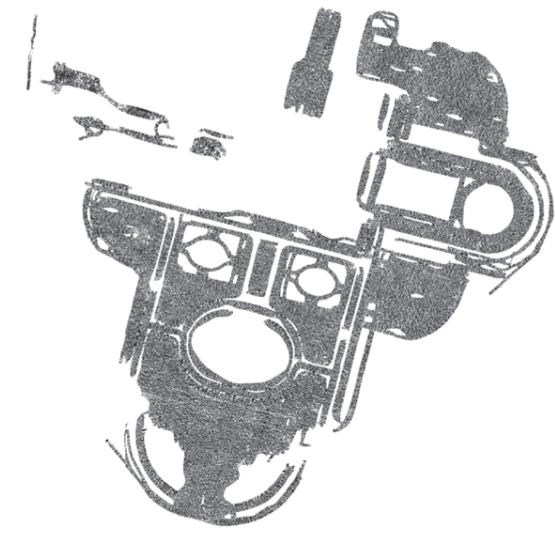
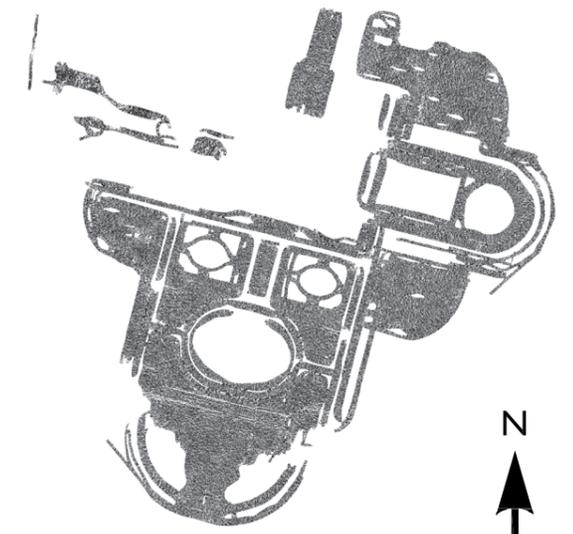
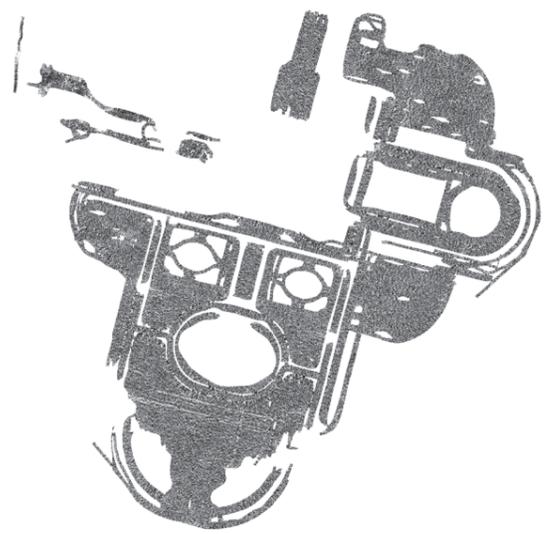
Figure 6

- Figure 6* GPR amplitude time slices between 50.0 and 75.0ns (2.68 to 4.01m) (1:4000).
- Figure 7* Graphical summary of significant GPR anomalies from the Stables Courtyard superimposed over the base OS mapping (1:500).

WITLEY COURT, GREAT WITLEY, WORCESTERSHIRE
GPR amplitude time slice between 50.0 - 75.0ns (2.68 - 4.01m), November 2016

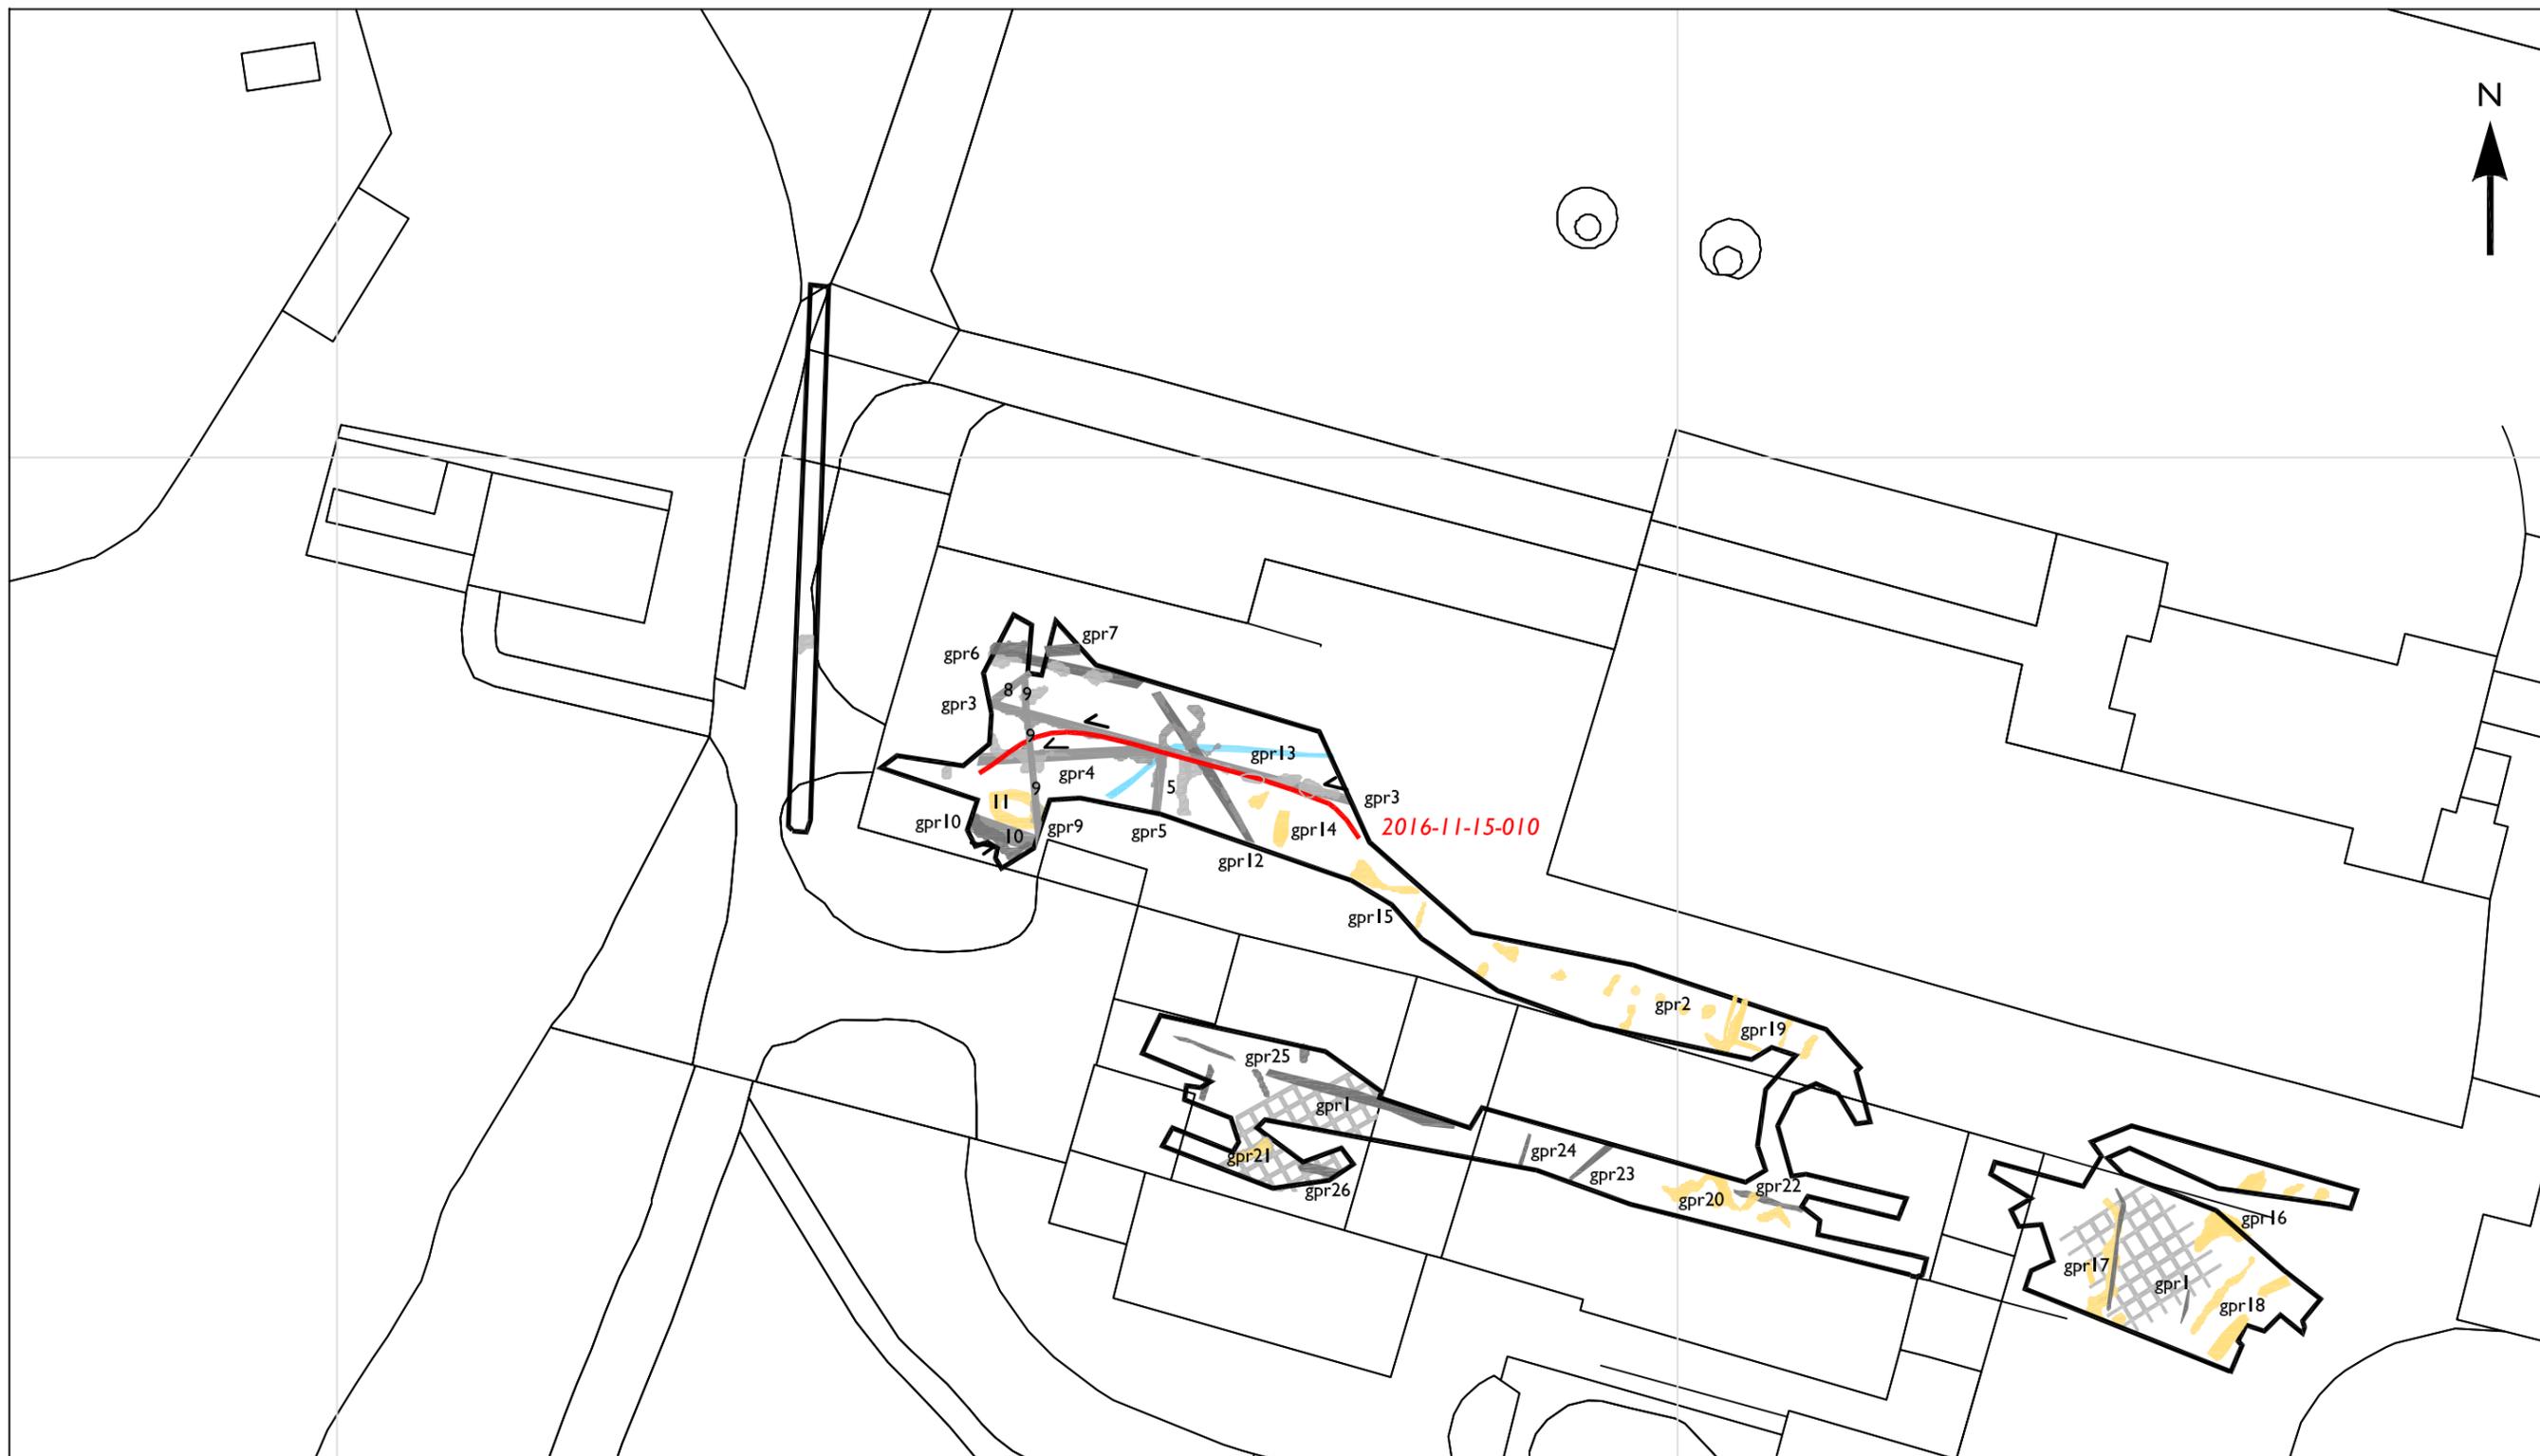
Stable yards, summary of significant GPR anomalies, November 2016

Access within this area was restricted by the presence of standing buildings and a considerable degree of masonry and other material stored in the working yard. The ground surface was metalled throughout, producing good ground coupling, either with cobbles or decorative tiles the pattern of which has been replicated in the near-surface data [**gpr1**] on Figure 7 along with the bollard bases [**gpr2**] in the passage by the stable block. Other near surface linear anomalies appear to relate to visible drain runs and surface gratings in the yard, including a central drain [**gpr3**] (marked by parallel kerb stones on the surface of the yard) branching to the W at [**gpr4**], and with a spur [**gpr5**] running S towards the current welfare Portacabin, found between approximately 5 and 30ns (0.27 to 1.61m). It is difficult to fully interpret the nature of these anomalies from the

GPR data alone, although [gpr3] and [gpr5] both appear to be formed of a single pipe or conduit, with a more complex response from [gpr4], perhaps suggesting a more substantive subsurface feature. The fall of [gpr3] and [gpr4] runs from E to W.

The area of collapse visible against the W wall appears to be associated with a complex group of linear anomalies [gpr6] between approximately 2.5 and 35ns (0.13 to 1.87m), beyond which it becomes a larger, more amorphous response associated with airwave reflections suggestive of a more substantial area of subsurface voiding. Again, other service type responses [gpr7] and [gpr8] appear to cut [gpr6], but may not necessarily be directly associated with the more substantial anomaly as they are found between 12.5 and 20ns (0.67 to 1.07m), perhaps more suggestive of electricity supply cables, or other similar services.

Anomaly [gpr9] runs S from [gpr6] at depth between approximately 12.5 and 20ns (0.67 to 1.07m) towards the current Portacabin. It is unclear whether [gpr9] represents a service supplying the welfare facility, perhaps associated with the brick cabinet against the N wall of the yard close to the fenced area of surface collapse. A more substantial response [gpr10] is partially described in the area available for survey in the immediate vicinity of the current Portacabin site, with a fall of approximately 12.5ns (0.57m) to 20ns (1.07m) W to E beneath the welfare facilities. Anomaly [gpr10] appears to represent a subsurface feature, such as a service pipe or drainage conduit, rather than wall footings, other structural elements of a previous building, or a lean to structure against the S wall, such as the shallow rectilinear response [gpr11] immediately to the N.

Two linear anomalies [gpr12] and [gpr13] cross the yard, but it is unclear whether either of these is associated with the other services identified by the survey. To the E of the yard fragmented responses at [gpr14] and [gpr15] appear more structural, perhaps representing wall footings removed from between the surviving standing buildings.

Access to the other areas of the stable yards towards the main house was more restricted, although a response in the vicinity of the open cellars at [gpr16] appears from approximately 10ns (0.54m) onwards, and may also extend S of the colonnade to [gpr17]. Both [gpr16] and [gpr17] represent more complex anomalies with a linear, service type component in the near surface data developing into more amorphous areas of response in the deeper time slices. An area of surface deformation was noted during the survey in the vicinity of [gpr17] which may suggest some subsurface instability. The response at [gpr18] relates to wall footings and structural elements of the curved wall addition to the main house, which remains partially standing in this area. Some further areas of possible structural remains are found at [gpr19-21] together

with a number of linear responses [**gpr22-26**], possibly related to drainage or services, although the area available for survey limits further interpretation of these anomalies.

In general, the GPR survey has proved successful although the response has varied throughout the site, dependent largely on the ground surface conditions that have been presented. The survey conducted within the stable yards to assist with the location of new site welfare facilities has produced a complex response associated with a series of linear anomalies, representing drain runs, services or cellars. From the GPR data alone it is difficult to determine the precise nature of these anomalies, or identify whether these are likely to be load bearing without danger of future collapse or subsidence. Correlation with existing service plans, if these exist, is recommended together with further invasive investigation of GPR anomalies falling within the footprint of any new structures.

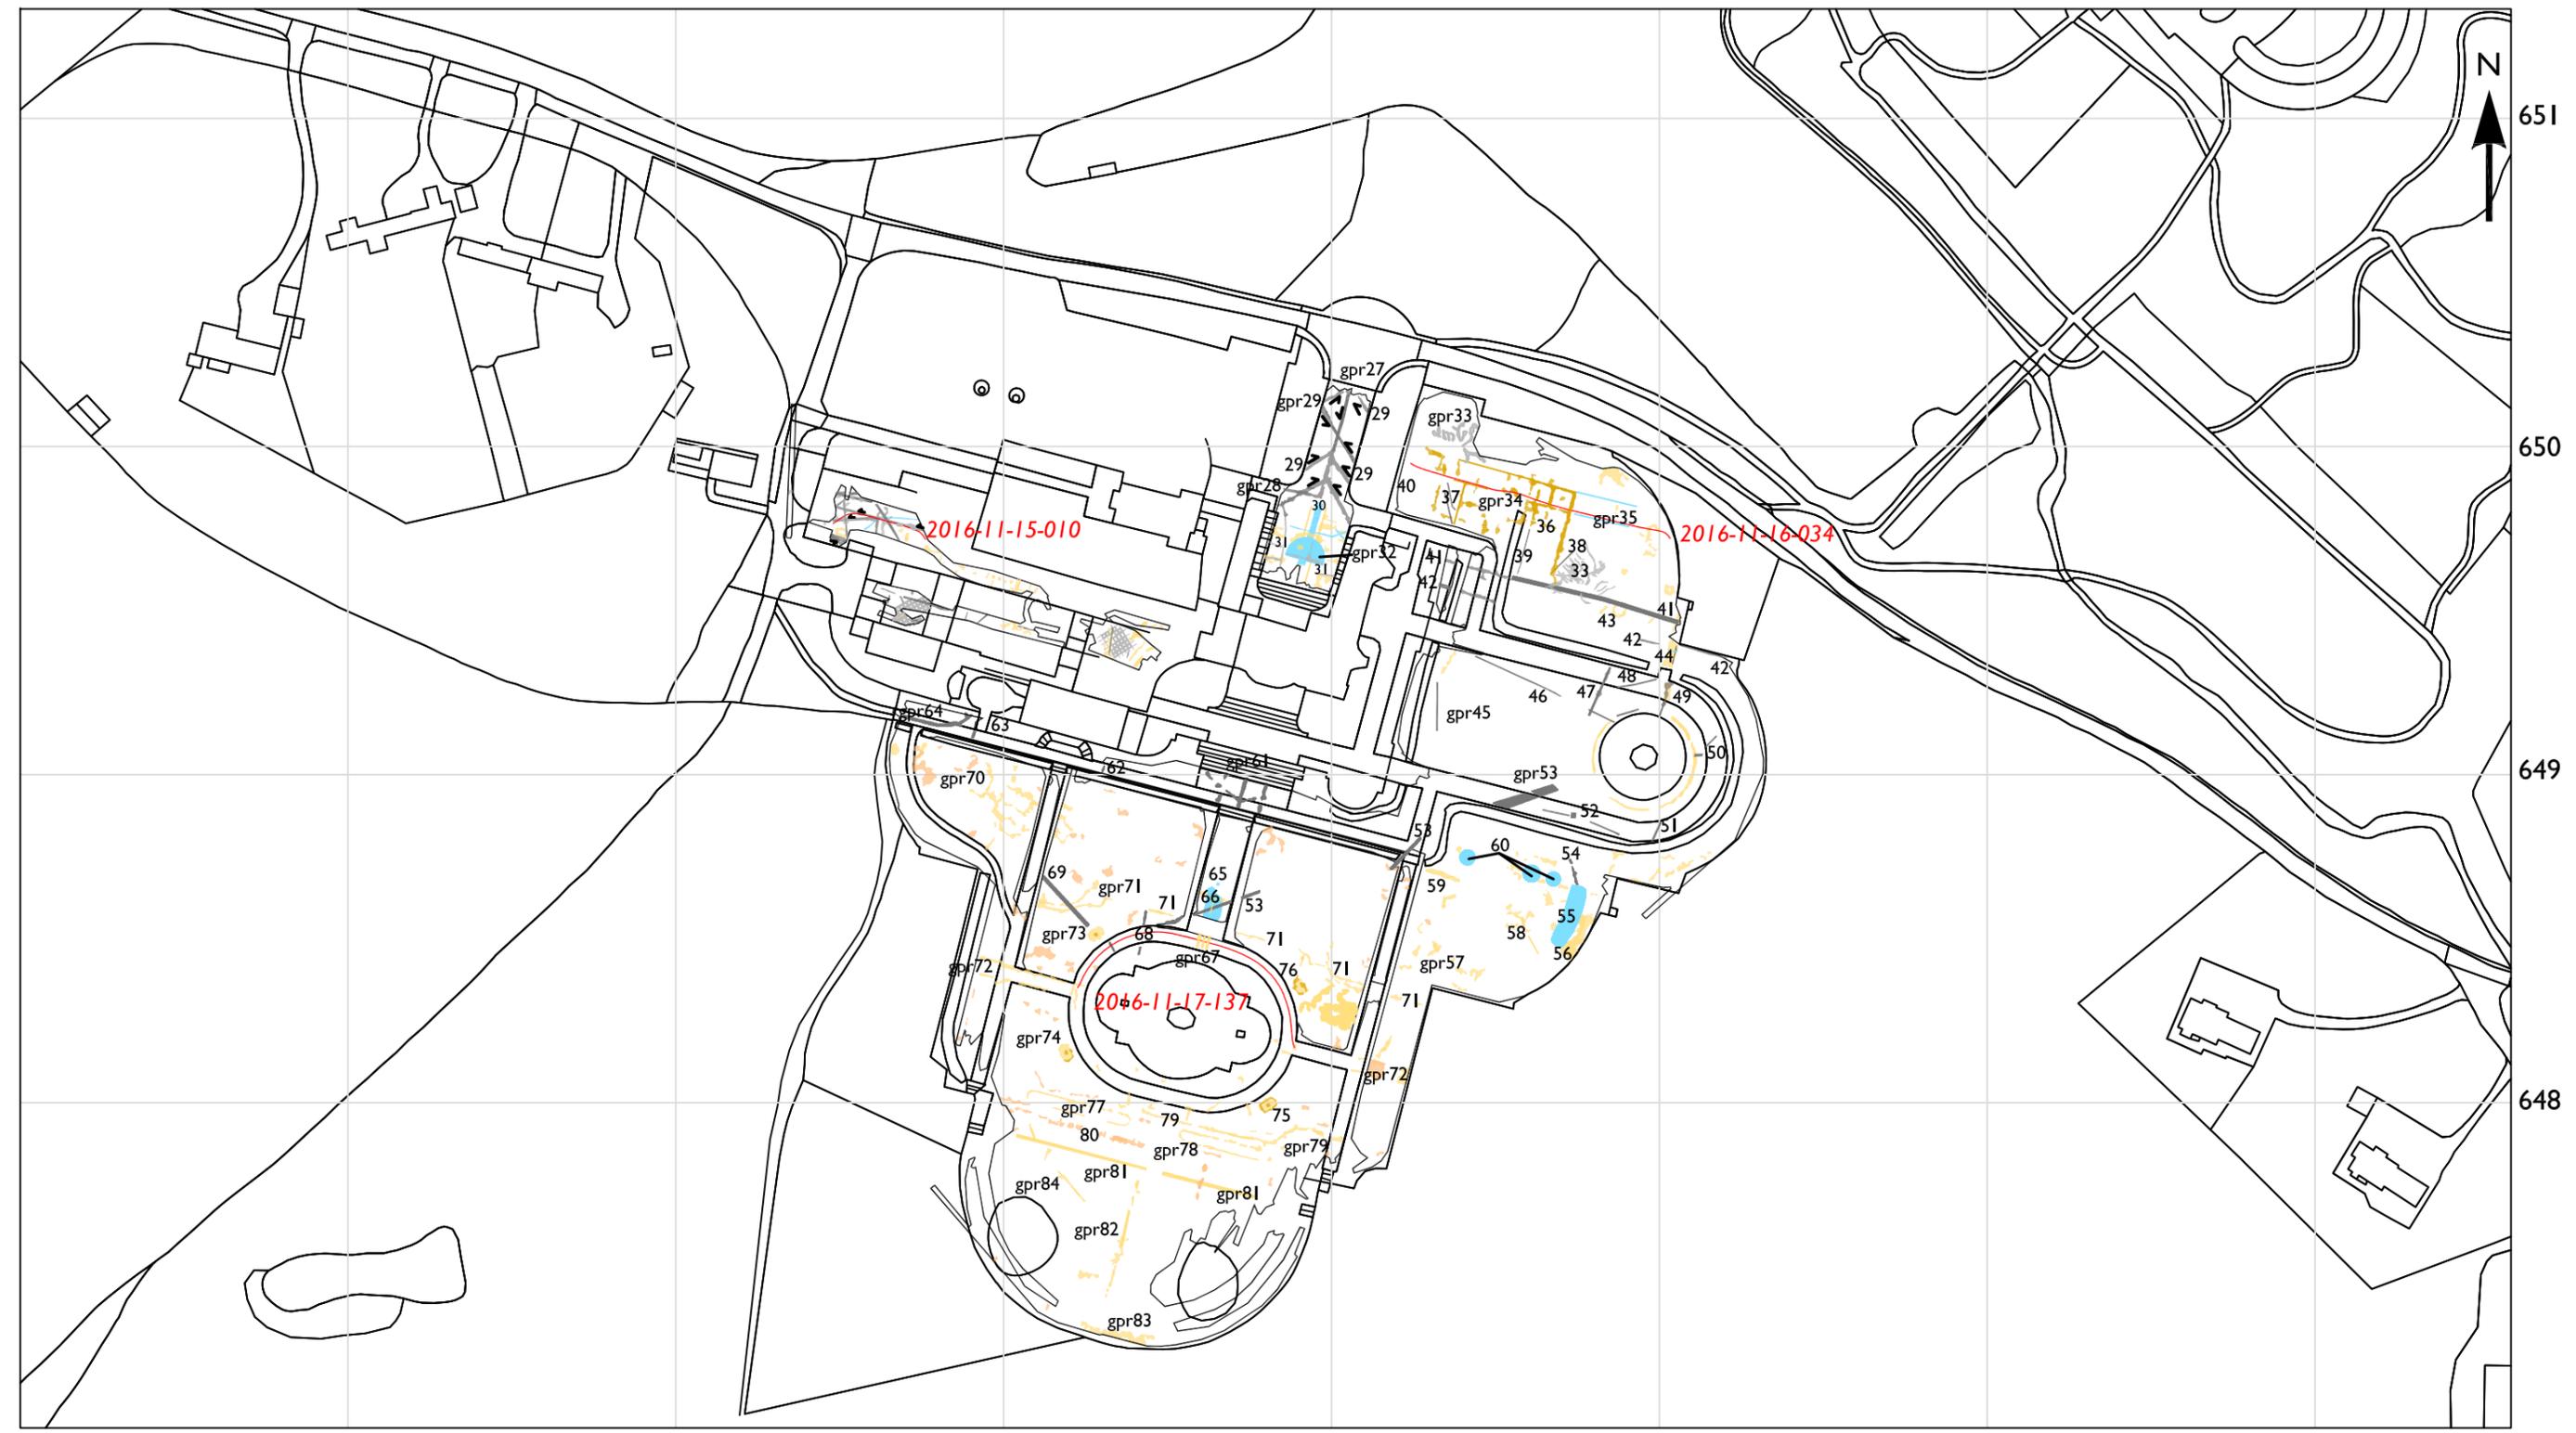
Summary of significant GPR anomalies, November 2016

The North Courtyard contains a central drain [**gpr27**] on Figure 8 which falls towards the house from 10ns (0.54m), where it meets a spur at [**gpr28**] and turns abruptly to the W, and is met along its length by a herring bone pattern of feeders [**gpr29**], falling from the edges of the metalled drive way in to [**gpr27**]. A linear low amplitude anomaly [**gpr30**] extends from the junction of [**gpr27**] and [**gpr28**] between the wings of the house, but is apparently of different construction to the main drain and is partially obscured by a network of shallow linear services [**gpr31**]. Most of the drainage system here would appear to be constructed from stone-lined conduits, rather than ferrous or ceramic pipes, as there is little correlation between the GPR responses and the previous magnetic survey (cf Bartlett *et al.* 1997, Plan 2, anomaly c).

Other potentially structural anomalies are found in between the two wings of the house, but are difficult to interpret due to their fragmentary nature and the extensive drainage system. An apparently semi-circular, low amplitude anomaly [**gpr32**] is evident from between 5.0 and 32.5ns (0.27 to 1.74m) and seems likely to represent the centre of the former gravel carriage turning circle, the outer elements of which appear to survive in aerial photographs of the derelict house taken in 1969. An alternative interpretation for [**gpr32**] may be sub-surface structural remains or a cistern associated with either surface drainage or rain water collection.

The East Parterre is mainly laid to lawn interrupted by planting and paths surrounding the Flora fountain, and some mature specimen trees whose root systems are visible [**gpr33**] in the near surface data between 2.5 and 10ns (0.13 to 0.54m). As expected from the previous geophysical survey the wall footings [**gpr34**] of the service wings demolished in 1804 have been detected between 7.5 and 37.5ns (0.4 to 2.01m) with the radar data, perhaps, suggesting a little more detail than the original earth resistance and magnetic results. This includes two parallel low amplitude anomalies [**gpr35**], apparently an extension of the building or related structures further to the E, perhaps the stable block added by the 1st Lord and Lady Foley in 1733. There are a number of elements within the building footprint that are more difficult to interpret, including three discrete reflectors at [**gpr36**] that do not extend as deep as the surrounding walls, and possible services at [**gpr37-39**].

Other services detected by the radar survey include the pipe [**gpr40**] recorded by the previous magnetic survey (cf Bartlett *et al.* 1997, Plan 2, anomaly a), and what appear to be two more substantial services [**gpr41**] and [**gpr42**] heading

E from the house. The previous GPR results show a pipe following the approximate course of [gpr41], assuming this is linear between the recorded GPR profiles and across the new parterre where the current survey could not gain access. However, the precise course of [gpr41] is less distinct as it continues E suggesting it either terminates at the foot of the slight scarp onto the level garden, continues as a pipe rather than a more substantial brick feature, or is buried at more considerable depth here. Between 2.5 and 7.5ns (0.13 to 0.4m) [gpr41] passes beneath a circular anomaly [gpr43] of diameter 4m which seems most likely to represent a former planting feature. There is also some evidence at a similar depth for a service, possibly [gpr42], cutting through the buried metalled surfacing of the path heading N from the steps onto the lawn at [gpr44]. Other, more fragmented responses are found in the vicinity of the demolished service range, but are difficult to interpret.

Further services are found in the accessible areas surrounding the East Parterre and Flora fountain, possibly related to water supplies and drainage [gpr45-53], and could well correspond with pipe type responses identified to the S of Lines 2 and 3 in the original GPR survey (cf Bartlett *et al.* 1997, Plan 2). Anomaly [gpr53] follows a course SW from the Flora fountain and appears to correlate with the two large pipes identified in the previous magnetic survey conducted to the S of the house.

This area is partially interrupted by modern metalled paths, the replanted south parterres and other planting together with the Perseus and Andromeda fountain. The water supply [gpr53] continues across the parterres but is only partially visible due to the interrupted area available for the survey, and does not correlate directly with the ferrous pipes interpreted from the magnetic data. A further short drain [gpr54] appears to run from a replanted parterre into a broader, low amplitude rectilinear anomaly [gpr55], possibly a soak-away or former area of planting. The near surface data between 5.0 and 12.5ns (0.27 to 0.67m) shows a high amplitude anomaly [gpr56] adjacent to [gpr55], which may represent a gravel or paved platform adjacent to the E balustrade wall of the garden. Other more fragmented responses in this area [gpr57-59] are difficult to interpret and may relate to partially surviving elements of the garden design, mature tree roots and some low amplitude anomalies likely to represent former planting beds [gpr60].

Evidence for drainage or other services beneath the modern paths is found at [gpr61-64], with further anomalies found towards the Perseus and Andromeda fountain including a surface inspection cover [gpr65], possible drains or pipes [gpr66] and three parallel linear responses [gpr67] associated with the water feature. An area of low amplitude response in the vicinity of [gpr53] and [gpr66] may be due to water leaking from these pipes and presents a possible

explanation for the local deformation of the path that has occurred here. Two other pipe runs are evident at [gpr68] and [gpr69] that are also partially represented in the previous magnetic survey (cf Bartlett *et al.* 1997, Plan 2, anomaly n). The outrun from the N of the fountain [gpr67] is intriguing as it would appear to comprise three large diameter (~0.5m) drain pipes, a parallel pair at a depth of ~0.7m from the surface matching the two openings currently visible inside the drained bowl, and central, slightly deeper response at ~1.0m. Further comparison with the promotional film made by the rock band Procul Harum in 1967 also depicts the drained fountain bowl but with four parallel drainage apertures visible (Fly Records 2012, visible at 0:33/4:00).

The fragmented anomalies at [gpr70] are similar to the magnetic and earth resistance responses and seem likely to represent elements of a previous formal garden design, although this would appear to be highly degraded. To the S of the restored central parterres some evidence for elements of Nesfield's original garden design appears to survive, including terrace walls [gpr71] which are partially visible on the surface, but may have been recut and more extensive than the current topography of the site might immediately suggest. Elements of the E-W path [gpr72] centred on the Perseus and Andromeda fountain also appear to extend beyond the modern settings, perhaps suggesting a connection with the perimeter of the garden taking in more circular walks and vistas. The location of four, ornate planters positioned around the fountain have been revealed by the current survey, at [gpr73-76], together with the central plinths supporting raised pedestals. It would appear that only part of the original design for eight such planters shown in a watercolour by Nesfield were actually realised, confirmed by historic photographs of the site c1870 (Gray 1997, p31 and p32). The area in the vicinity of [gpr76] seems quite disturbed and it is unclear whether this may be due, in part, to the course of the large vaulted conduits running from the service entrance immediately beyond the garden boundary to the fountain.

Further elements of the original garden design, only partially represented in the surviving topography, are found to the S of the Perseus and Andromeda fountain. These appear to represent former planting beds [gpr77] and [gpr78] together with other linear terracing or garden walls [gpr79-81] which partially reflect the design immediately N of the fountain (cf [gpr71]). A central linear anomaly [gpr82] could represent a former water supply to the fountain, believed to have been removed during the second world war, running down the hill from an area of possible hard standing [gpr83] associated with the location of the Golden Gates that once terminated the south parterre. Other responses within the south parterre are too fragmented to suggest a definitive interpretation, although a short linear anomaly [gpr84] seems likely to represent a drain run.

- Figure 8* Graphical summary of significant GPR anomalies from the gardens superimposed over the base OS mapping (1:2000).

The wider survey of the North Forecourt, East and South Parterre gardens has, despite the slightly interrupted nature of the areas available, complemented the previous magnetic, earth resistance and limited GPR coverage conducted in advance of reinstating the formal gardens. Some known deeper lying structures have not been detected due, perhaps, to the soil conditions at the site which appear to have limited the maximum depth of penetration to approximately 1.5m in parts, although the majority of GPR anomalies identified by the original survey have been confirmed. In addition, the current survey has provided new information regarding the location and survival of Nesfield's garden design, particularly in the south parterre. Whilst elements of this garden are known from historic photographs and Nesfield's own design drawings and water colours, it is evident from the geophysical survey that not all of the original plans were actually realised.
