PROCEEDINGS  
OF THE  
CAMBRIDGE ANTIQUARIAN  
SOCIETY

VOLUME LXXVIII

# ELY CATHEDRAL PRECINCTS: THE NORTH RANGE

ANNE HOLTON-KRAYENBUHL, THOMAS COCKE & TIM MALIM

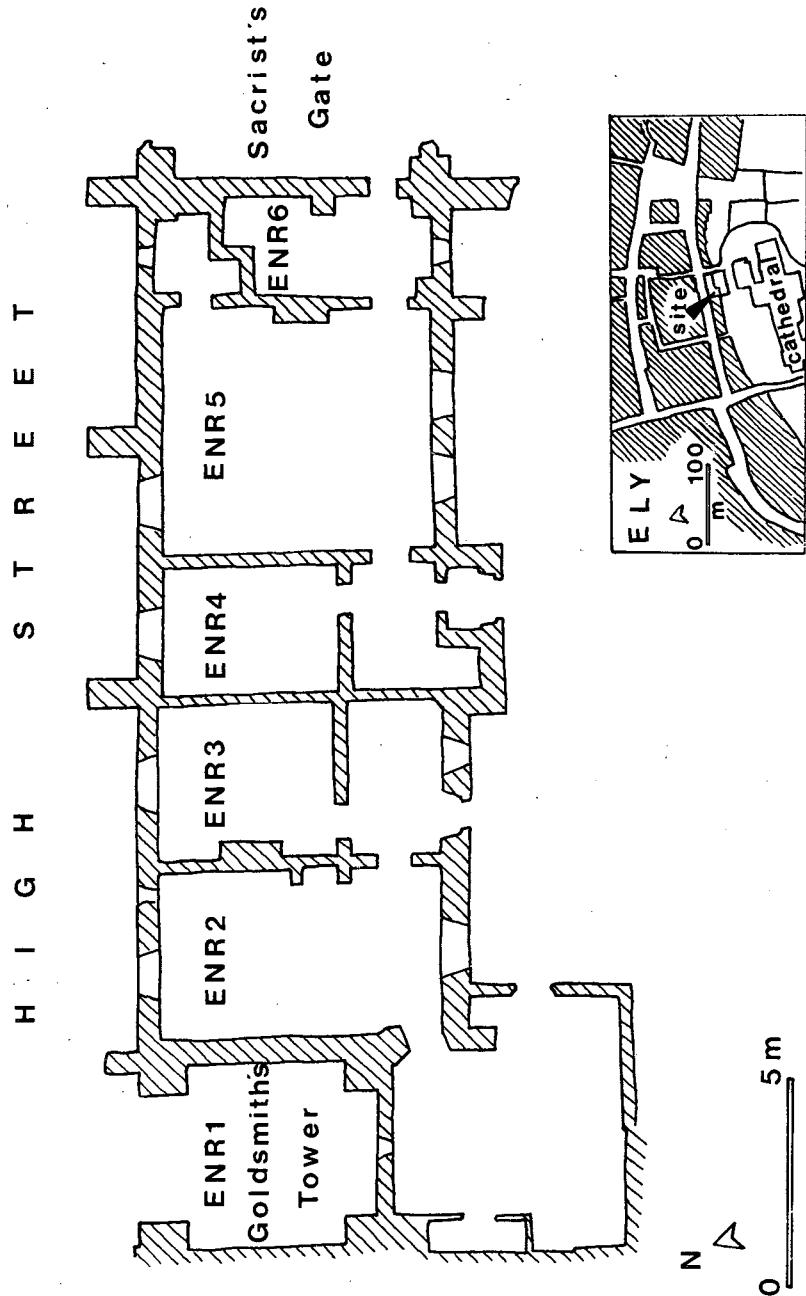
Figure 1b. Ely North Range site plan

Trial trenches were dug along the length of the range and earlier features were found to have survived. Further excavation took place inside the Museum (ENR5: Figure 1b) and Choir House (ENR2 and ENR3: Figure 1b).

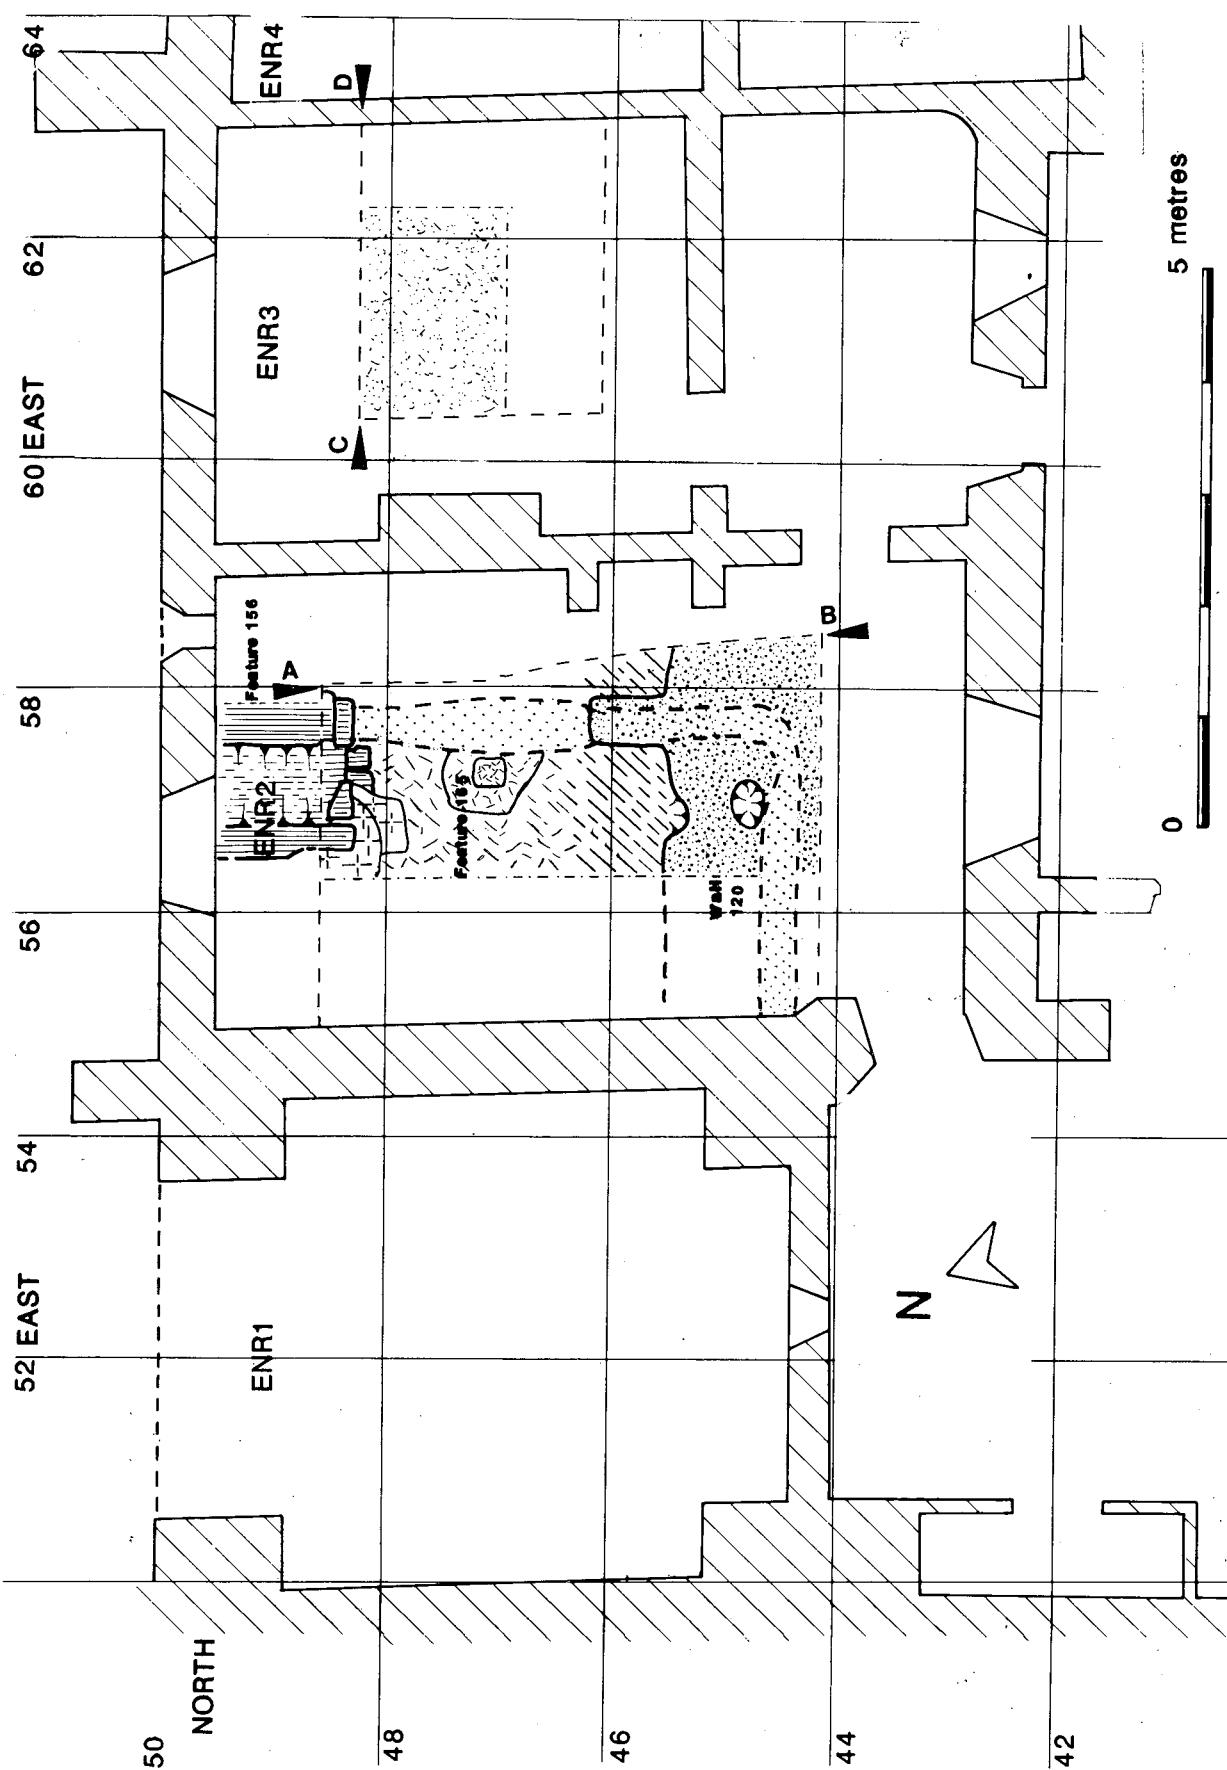
Figure 2a. Ely North Range, west half. Plan of ENR2 and ENR3, features in phases 2 to 4. ENR1 is the Goldsmith's Tower. Key: see figure 2b.

Foundations for a west–east wall existed in ENR5 and ENR2 (Figures 2a and 2b). The relationship between these foundations and other features in ENR5, ENR2 and ENR3 was not established.

In the south part of the trench, a two-metre stretch of wall foundations was located (Figure 2a: feature 120). The foundations were more than 1.2 m wide: the south edge lay beyond the limit of the excavation. The top of the surviving wall foundations lay at 20.50 m O.D.

A bowl-shaped pit had been cut into the foundations of the dismantled south wall (Figure 2a). A shallow trench had cut away part of the north edge of the foundations and the adjacent occupation levels. This trench had been infilled with compacted soil containing much chalk and clay, and the same compacted material sealed the surface immediately to the north of the wall foundations.

Brown soil containing chalk pebbles had been deposited over the foundations of the dismantled wall, infilling the shallow pit. The base of a stone wall on the same alignment as the earlier one was embedded in this dumped soil (Figure 2a). A 2.7 m stretch of wall was defined. It was 0.4 m wide and survived to a height of 0.2 m.

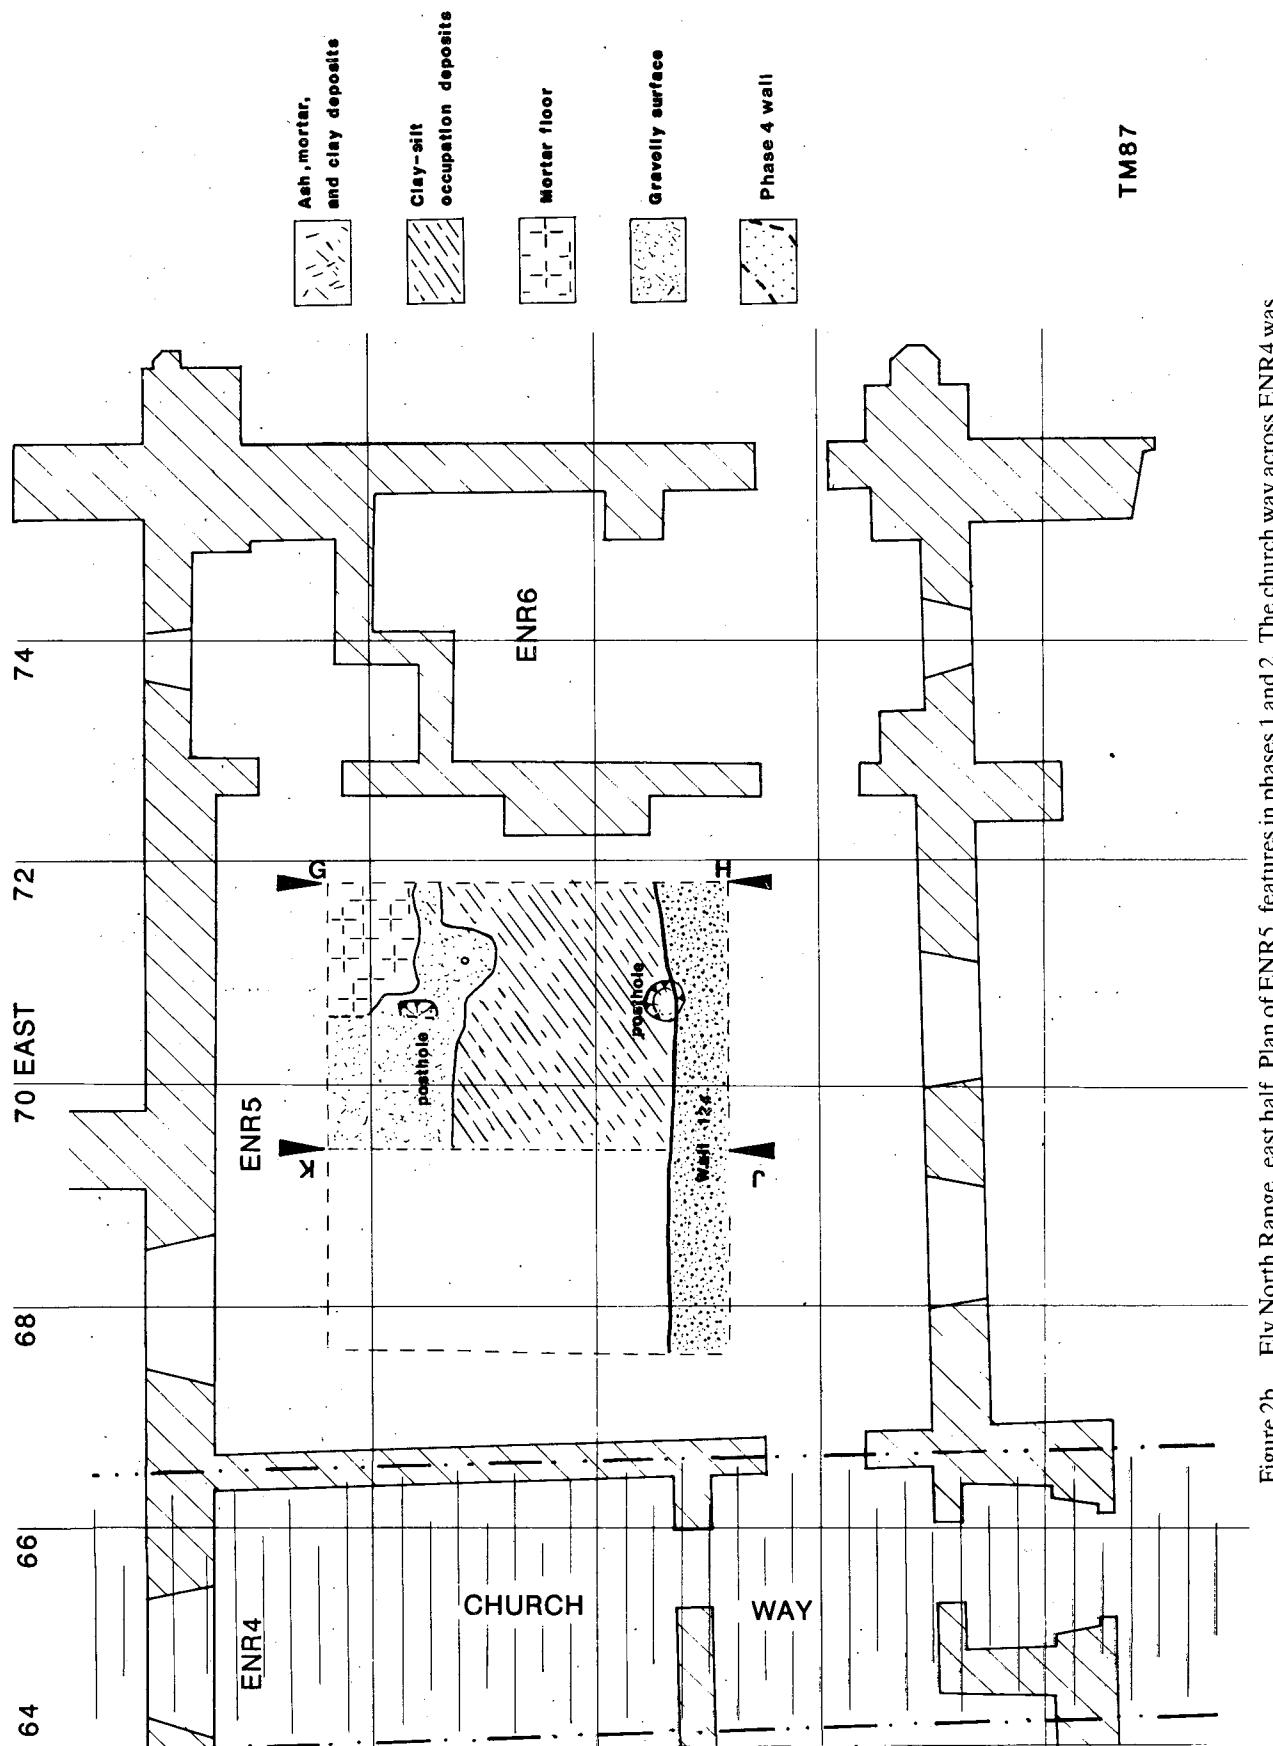
Figure 2b. Ely North Range, east half. Plan of ENR5, features in phases 1 and 2. The church way across ENR4 was of probable medieval origin.

A post-hole abutted on the north side of the wall foundations (Figure 2b). Another possible post-hole lined with flat pieces of limestone lay at about two metres to the north of it. A 20–30 mm thick surface of sandy mortar survived in the north-east corner of the trench. Its upper surface lay at c. 20.35 m O.D.

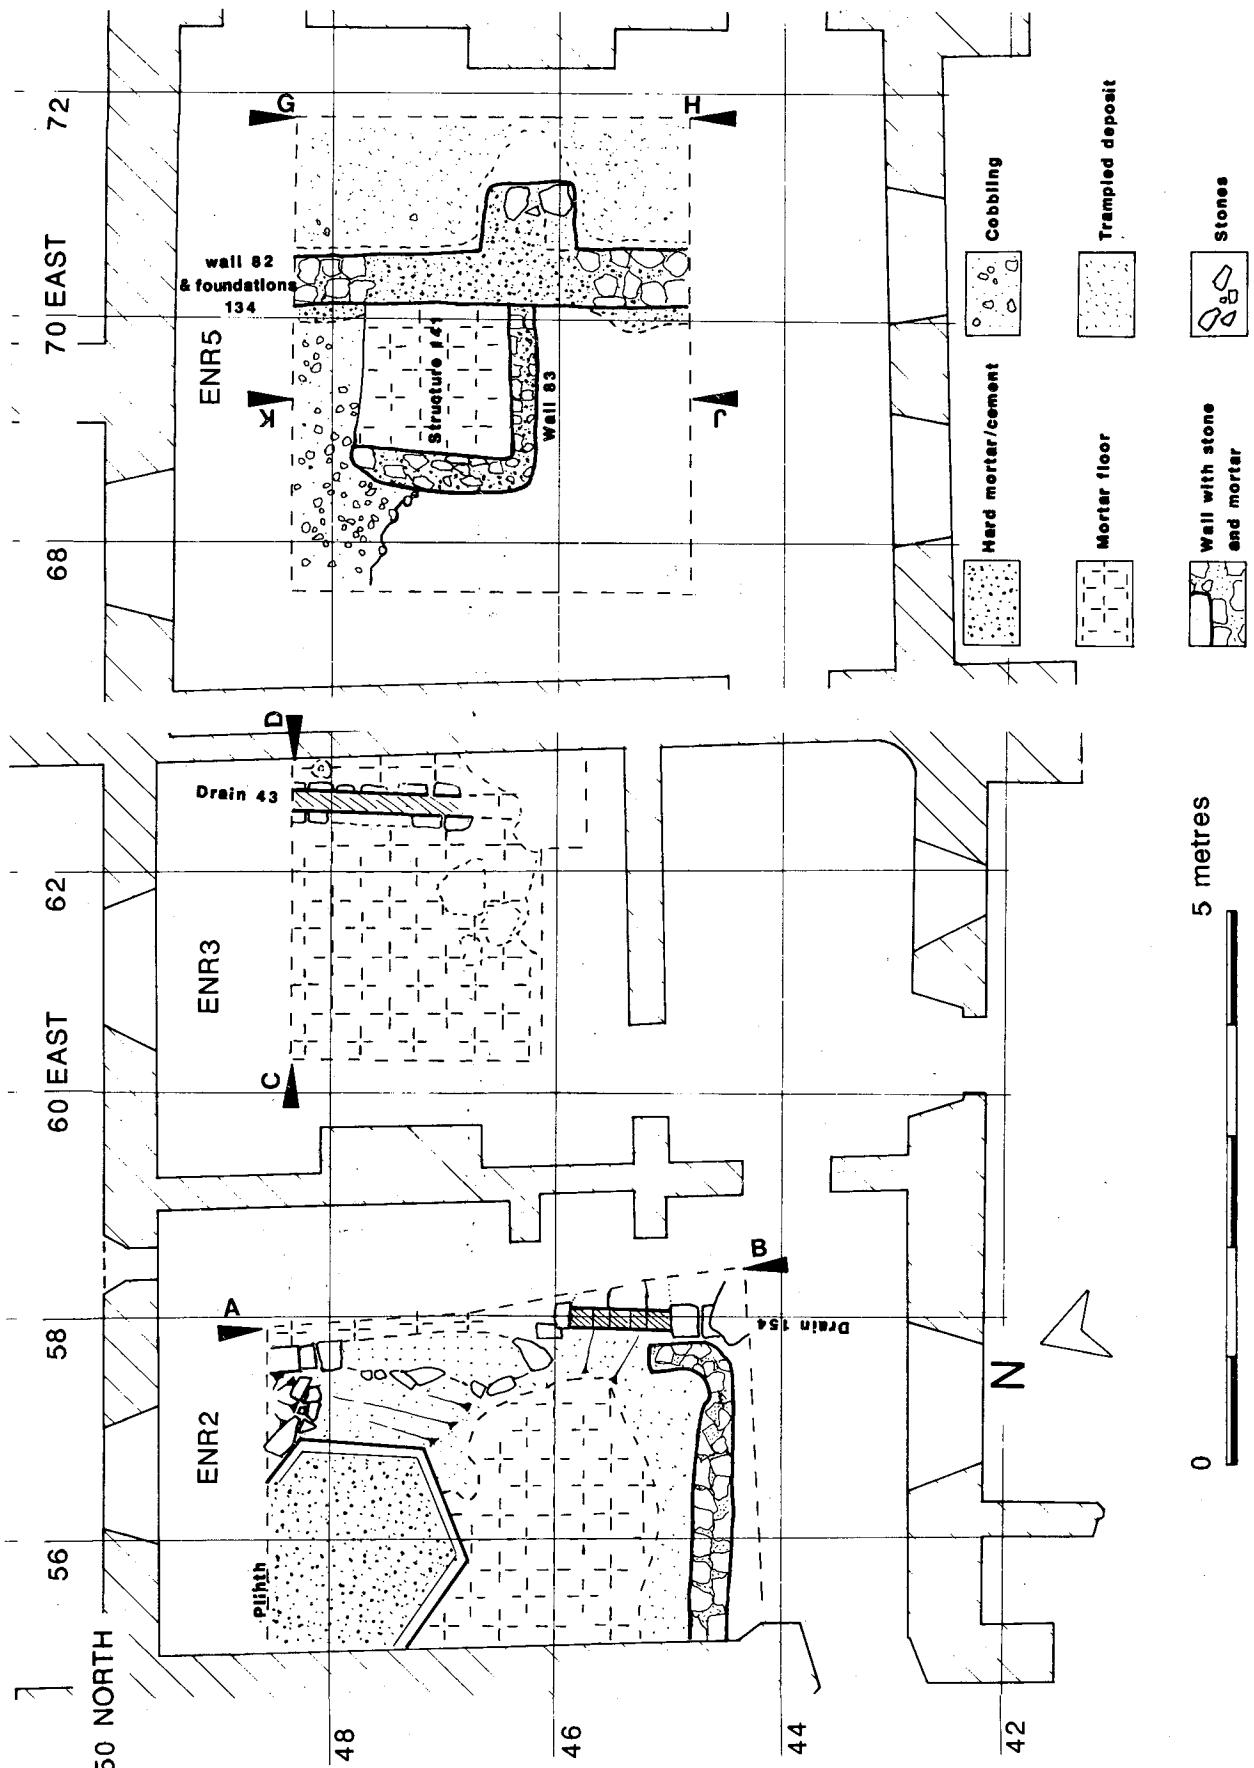
Figure 3. Ely North Range. Plan of phase 5 features in ENR2, ENR3 and ENR5.

Foundations for a north-south wall had cut through the mortar floor (Figure 3: foundations 134 for wall 82). A

straight-sided trench, 0.45 m wide, had been dug, and rubble and mortar had been poured into it, in three stages. The two lowest stages, of clunch and lime mortar, were c. 0.75 m high and existed in the central part of the trench, extending south as far as wall foundations 124 of phase 2. The uppermost stage, of a soil and lime mortar mix with clunch, was c. 0.3 m high and ran across the entire excavated area. At its north end, it butted and went over the hard gravelly surface that overlay the ditch filling described in phase 1. At its south end, it butted and went over the foundations of wall 124. Bonded on to its east side, foundations for a buttress-like protrusion were found which had been widened in the uppermost stage.

Above the north and south end of the wall foundations, the lower courses of wall 82 survived, consisting of regular blocks of limestone adhering to each other with hard cement. The base of this stone wall was at approximately the same level as the earlier mortar floor.

After the foundations for wall 82 had been laid, a square structure (feature 141) had been erected, butting on to their west edge. The construction of feature 141 had involved the removal of many of the earlier deposits in the centre of the trench (Figure 5b). The existing sides of this feature were vertical and survived to a height of 1.1 m. The sides were 1.4 m long internally. The north side had been cut through the hard ditch fill described in phase 1 and was not lined. An L-shaped wall formed its west and south sides. It was of stone with some tile and

The structure to the west of wall 82 (Figure 3: feature 141) lay on the site of the lean-to scullery mentioned by Bacon. This supports the suggestion that this structure may have been a soakaway. The removal and subsequent replacement of soil around it (phase 6) may have taken place after the cholera epidemic of 1832 when measures were taken to improve the general sanitation of Ely.

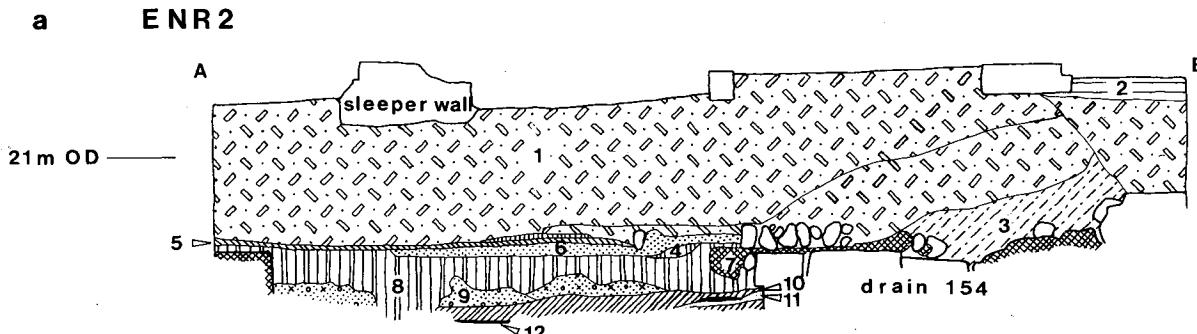
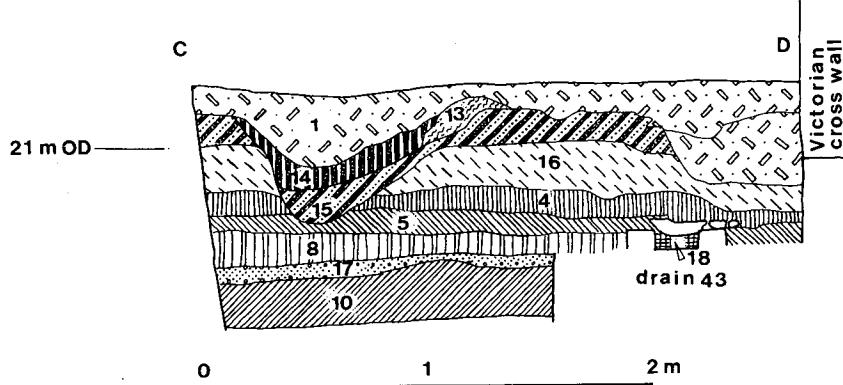
Figure 4. Sections. a. Section along the east edge of trench in ENR2. b. Section along north edge of trench in ENR3. Key: 1. Rubble. 2. Loose grey deposit. 3. Soil with tile and stone chips. 4. Clay. 5. Mortar floor. 6. Sand. 7. Mortar. 8. Brown clay with limestone and charcoal flecks. 9. Pebbles and mortar. 10. Brown silty soil with charcoal flecks. 11. Clay with chalk flecks. 12. Burnt surface. 13. Decayed wood. 14. Clay with ash. 15. Ash and burnt sand. 16. Ashy silt with grit. 17. Sand and gravel. 18. Drain fill.

An almost square feature with a charred black and red outer zone may belong to this phase (feature 165). It possibly represents the traces of a standing structure, such as a brazier, whose outer zone had burnt the underlying soil. There were other patches of burnt soil in the north half of the trench which may also be attributed to this phase (Figure 4a).

Demolition deposits were then dumped over the whole site (Figure 4a). They consisted mainly of stone

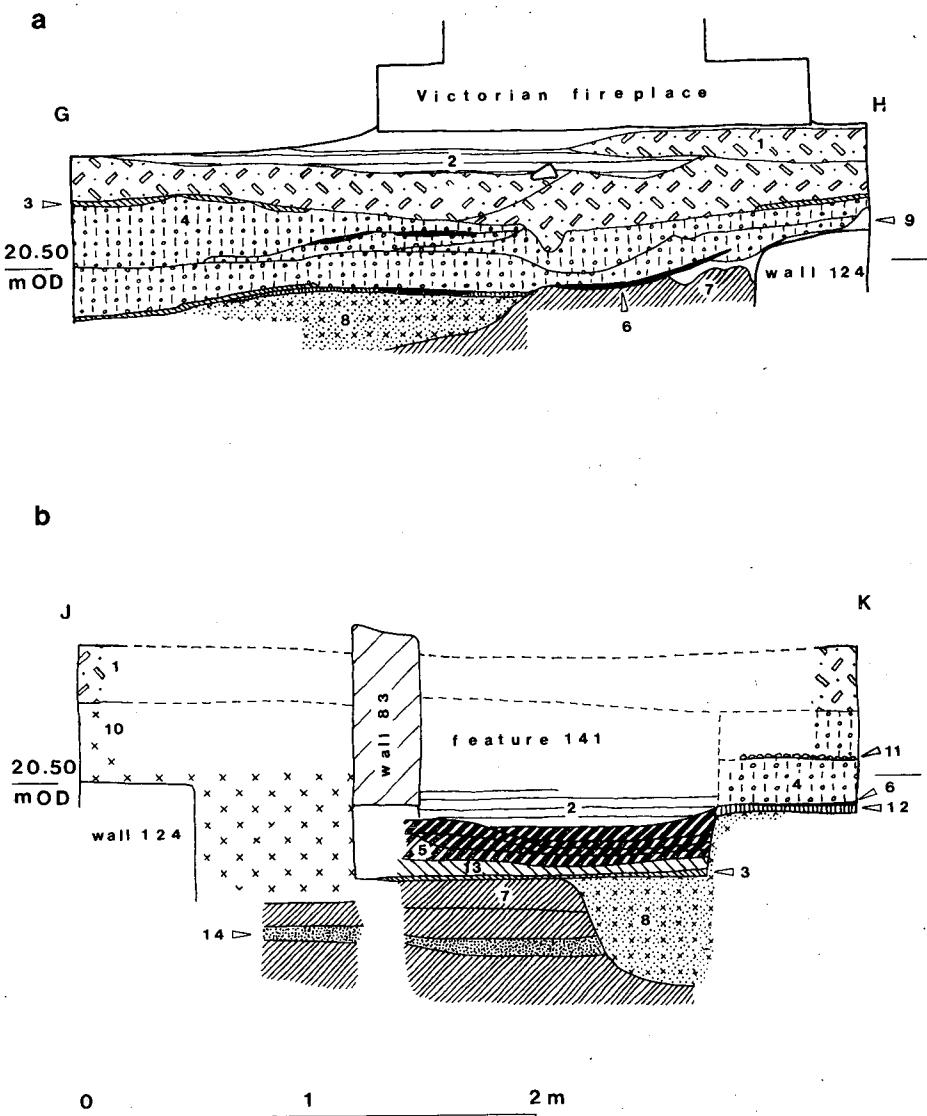
Figure 5. Sections in ENR5. a. Along east edge of trench. b. North-south section across feature 141.  
 Key: 1. Rubble. 2. Loose grey deposit. 3. Sandy mortar. 4. Compacted brown silty sand containing mortar. 5. Ash. 6. Burnt surface. 7. Grey and brown clayey silt with charcoal flecks. 8. Sandy silt with gravels. 9. Orange-brown silty sand with mortar flecks. 10. Brown sandy silt. 11. Cobbled surface. 12. Compacted grey silty clay. 13. Mortar rubble. 14. As 7, with patches of sand.

burnt patches and charcoal flecks (Figures 5a and 5b). There were patches of sand and small lumps of mortar in two of these layers; the total depth was about 0.8 m. In the centre of the trench only the lower deposits existed, the remainder having been removed by the later building of structure 141 (Figure 3).

The post-holes were infilled and the ground surface covered with compacted brown silty sand deposits containing mortar which also overlay wall foundations 124 (Figures 5a and 5b).

The level surface created in phase 3 was covered by silty sand deposits to a depth of 0.1–0.3 m (Figure 5a). These deposits were compacted and contained pieces of mortar, limestone and flint, and there were patches of ash. An amount of animal bone was found, some of it had traces of butchery and there was also bird bone and sherds of thirteenth- and fourteenth-century pottery, many of which were glazed. These included sherds of Lyveden ware, several fragments from a baluster jug as well as sherds from pitchers and cooking pots.

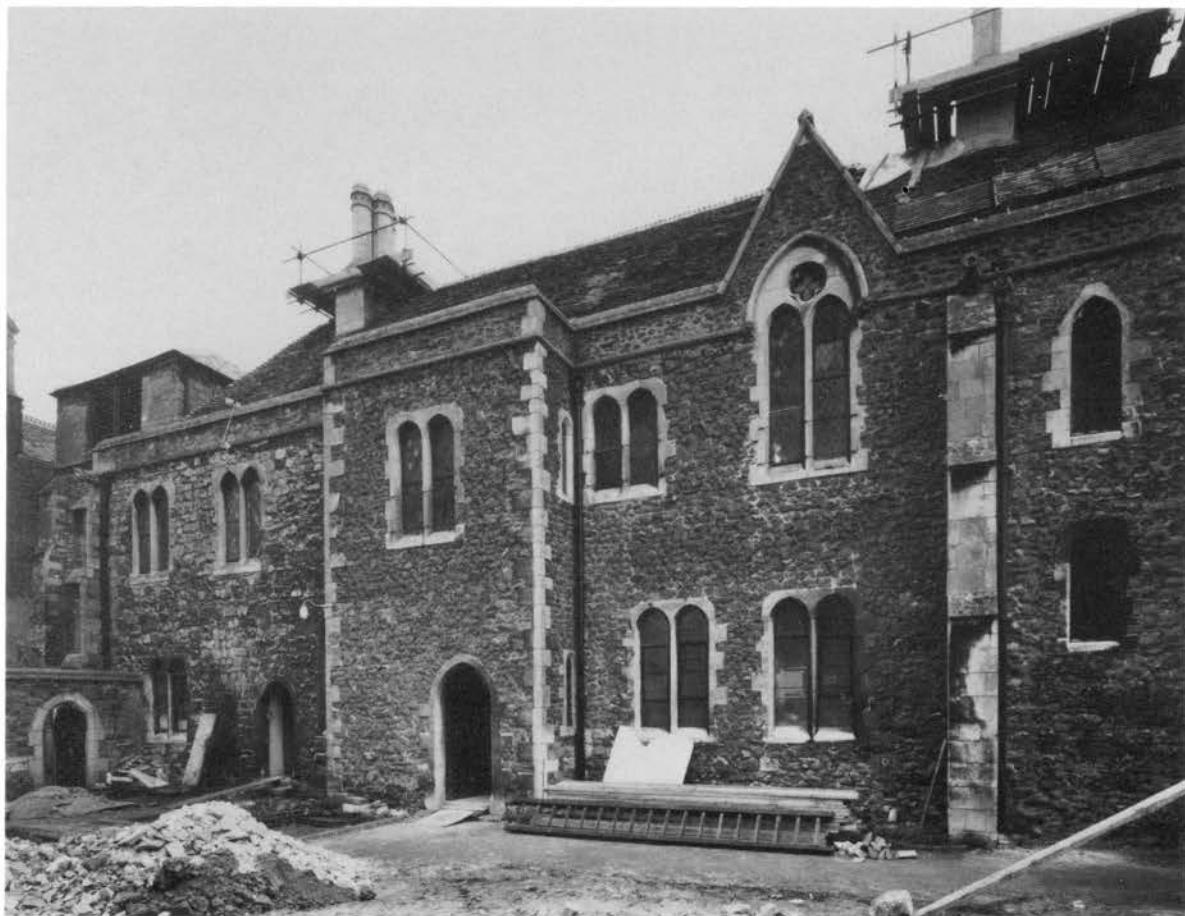
Plate 1. North Range, south elevation.  
(Crown copyright)

The complex of buildings studied comprises, from west to east, the so-called Goldsmith's Tower, then a two-storey range in two parts, the first of two bays, the second of three, which are continuous but not intercommunicating (the former Choir School), and finally the Sacrist's Gate (Plates 1 and 2). Although they are of medieval origin, they were extensively rebuilt in 1860–64. The exterior of the buildings is all of stone, mostly rubble but incorporating some ashlar. Much of it appears reused medieval material. The stone is Carstone except for some limestone, perhaps Clipsham, on the south side of the former Choir School range. The worked stone

in the quoins, buttresses and door and window openings appears to belong to the nineteenth-century rebuilding except in the Sacrist's Gate and the Goldsmith's Tower. The roofs both of the former Choir School range and of the Goldsmith's Tower also appear to be of the mid nineteenth century. The roof of the Sacrist's Gate was not inspected.

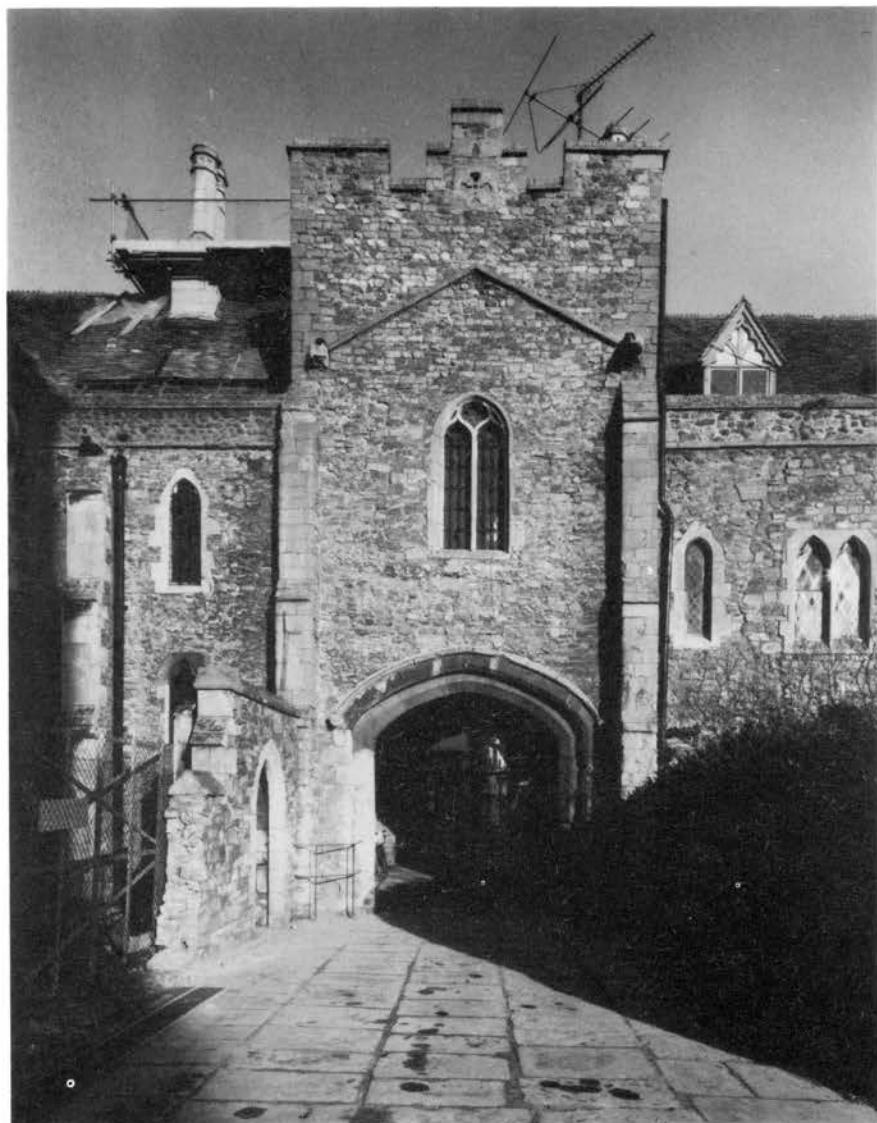
Plate 2. North Range, Sacrist's Gate, south elevation.  
(Crown Copyright)

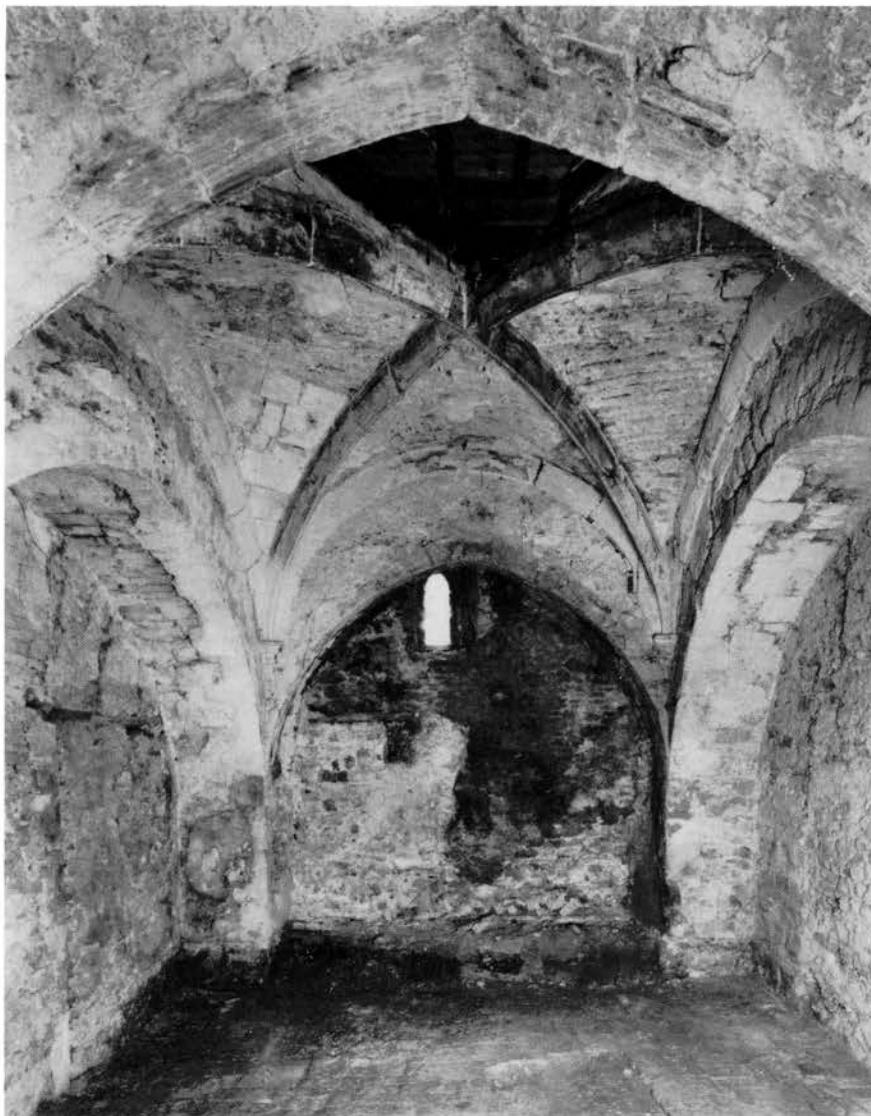
Plate 3. North Range, Goldsmith's Tower, interior of vaulted ground floor, looking south.  
(Crown Copyright)

On the ground floor (room ENR1) there is a large arch articulating each wall. Those on the east and west appear always to have been

blind. The vault is quadripartite with sharply chamfered ribs springing from polygonal moulded corbels. The fill of the vault is a mixture of stone and brick, in part destroyed. The floor has been excavated to reveal a brick floor about 0.2 m below the modern street level.

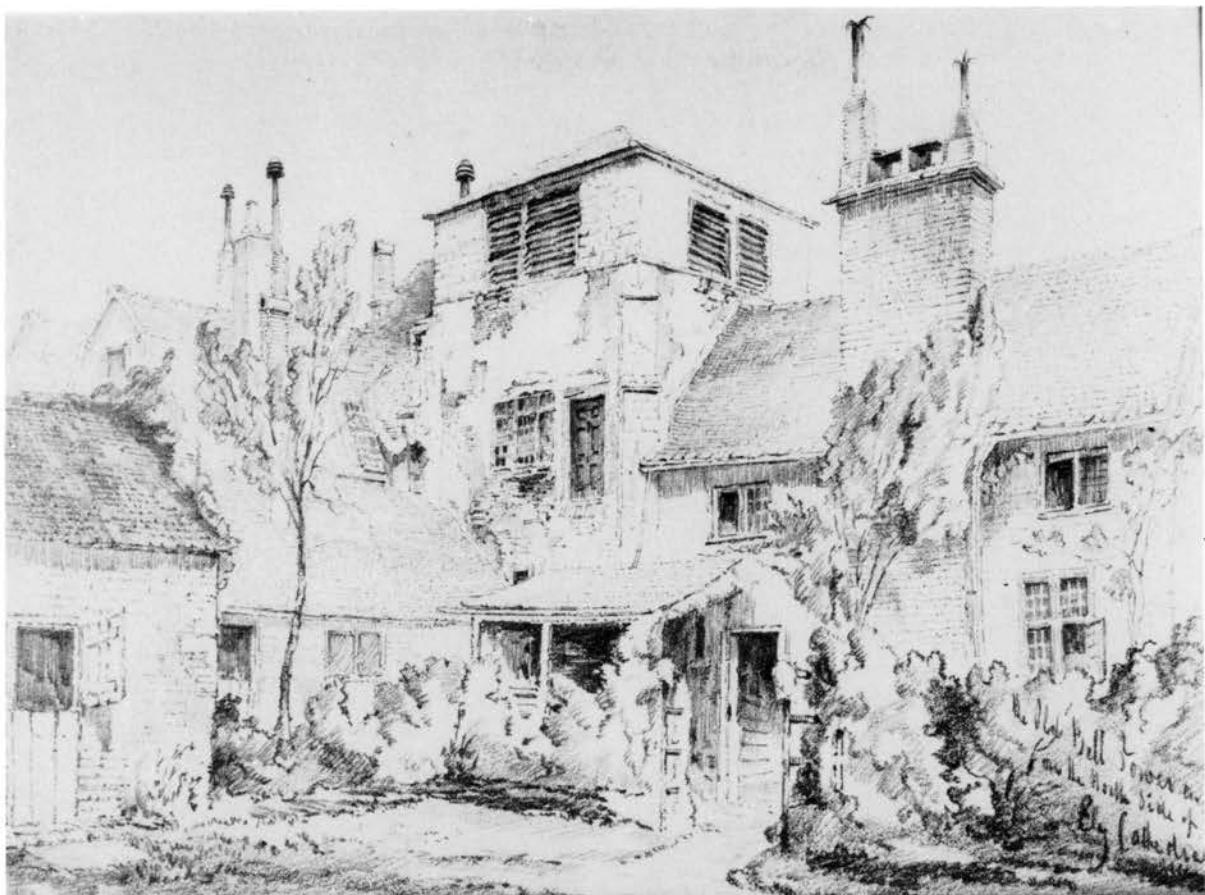
Plate 4. The Goldsmith's or Old Bell Tower from the south-east, 1857. Pencil drawing by Henry Baines.  
(Photograph: Crown Copyright)

depicted in the two drawings by Henry Baines showing them from the south-east (Plates 4 and 5). In a plan of the monastic remains in Ely, D.J. Stewart identified, from west to east, the bell tower, an open space, and the Sextry Hall.<sup>14</sup> Detailed measurements of this hall may be found in a drawing among Stewart's papers<sup>15</sup> which shows the west gable end wall of the hall in the same position as the wall excavated in ENR5 (Figure 3: wall 82). Stewart considered that the buildings between this wall and the Goldsmith's Tower were of post-medieval origin but it is possible that they had been altered in such a way as to conceal medieval fabric. In an article in the *Cambridge Chronicle* of 7 April 1860 it was reported that the buildings on the College side of the High Street were in poor condition and that all the windows on that side had been blocked up.

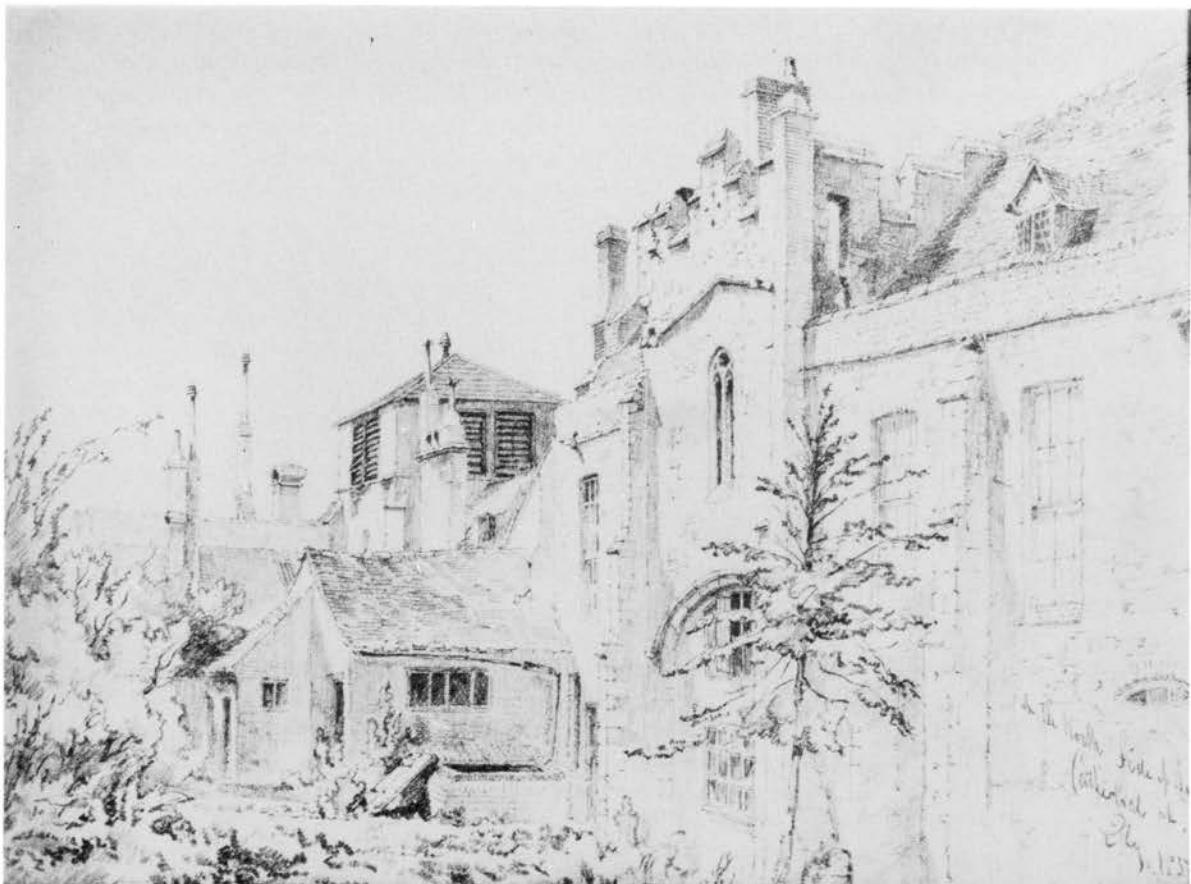
Plate 5. The North Range from the south-east, 1857. The Sacrist's Gate, then blocked, is shown in the foreground.  
Pencil drawing by Henry Baines.  
(Photograph: Crown Copyright)

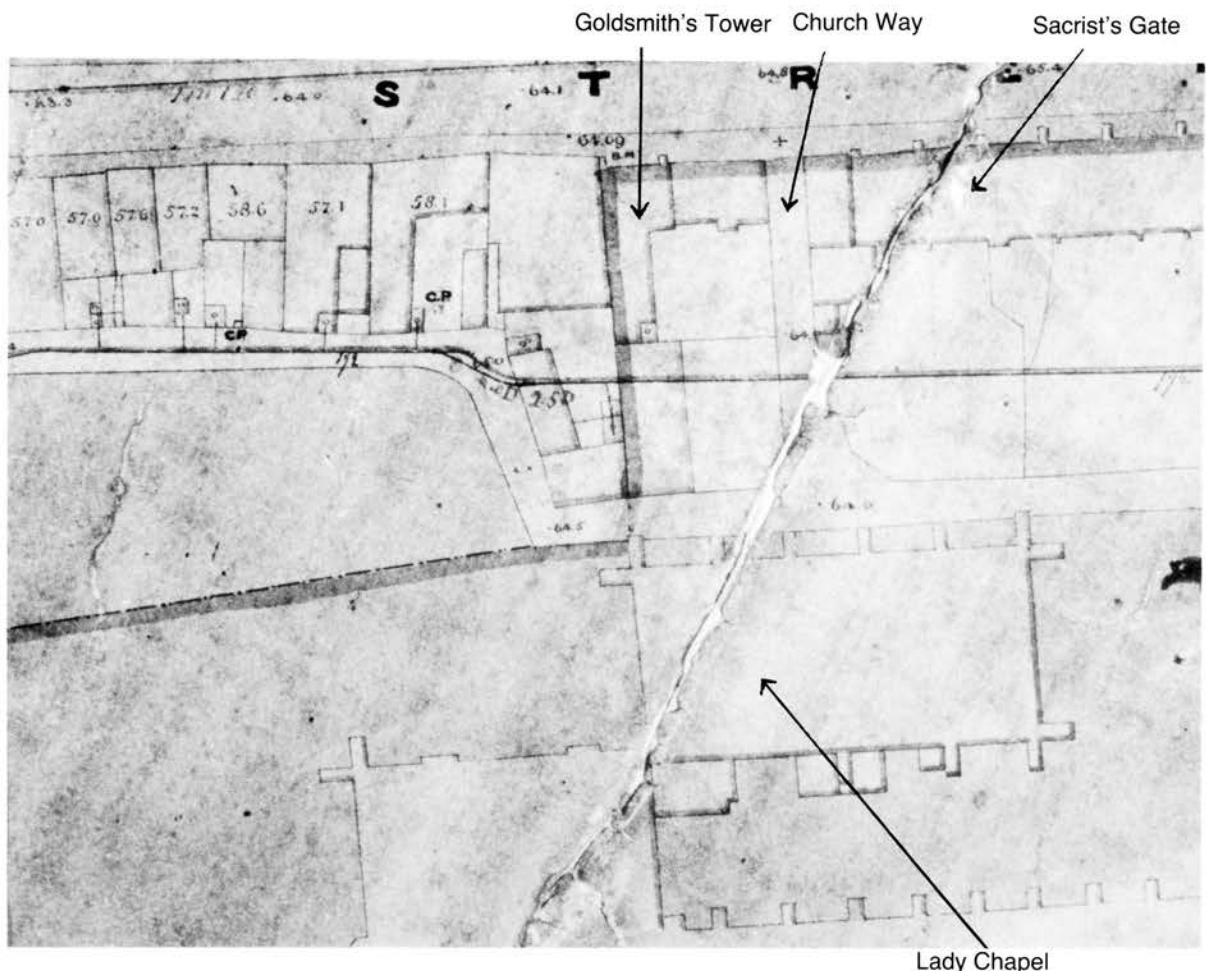
Plate 6. Part of the map of Ely by C.M. Bidwell showing the North Range and church way, 1851. The shaded line marks the parish boundary.

Goldsmith's Tower, to serve as a belfry. In this document, no reference is made to the church way that provided access for the parishioners from the street to their church. It is shown on Bidwell's map of Ely of 1851 (Plate 6). The trenches dug in the courtyard of the North Range in connection with the recent restoration provided some evidence to suggest a medieval origin for the church way. No burials were found in the part of the trench to the south of ENR4, ENR5 and ENR6, while a number of burials were located in the trenches in the west part of the yard. The church way may, therefore, possibly have run along the east boundary of the churchyard prior to Alan of Walsingham's building activity, and continued as a way of access.
