# Proceedings of the Cambridge Antiquarian Society

**Volume XCV  
for 2006**

# Conservation of early 17th Century allegorical wall paintings in St John's College, Cambridge

Tobit Curteis

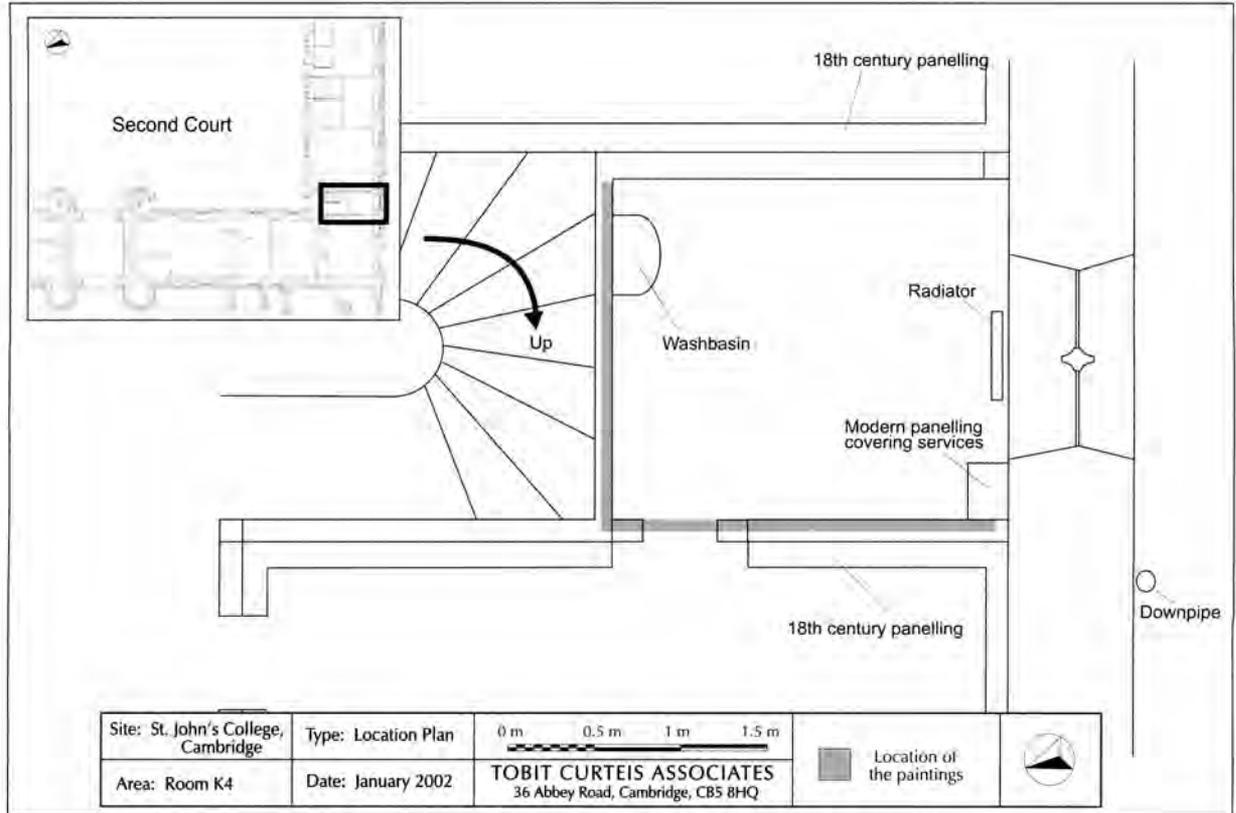
Figure 1. Plan of the room (Tobit Curteis Associates 2006)

The paintings are situated in a small room, entered through a moulded timber doorway, on the east side of room K4, in the south west corner of Second Court (Fig. 1). The walls of the small study or closet have the structural timbers exposed and are rendered, with the paintings occupying the upper part of the north and west walls above the central horizontal rail. On the west wall is a large landscape scene with animals and birds and a small townscape on the north end (Plate 2). In the centre of the painting is a stag sitting with a group of musical instruments including a drum, a trumpet and a viol. To the left is a large standing bird, now very disfigured, which appears to be an eagle or other large raptor. Below are a standing grey dog, and a seated animal with a large hump, believed to be a tortoise, while in the top left corner is a sun complete with radiating rays and a face. The left hand edge of the painting is hidden behind modern panelling. The whole scene is surrounded by a green frame with a black border, which extends onto the timbers above and below the painting.

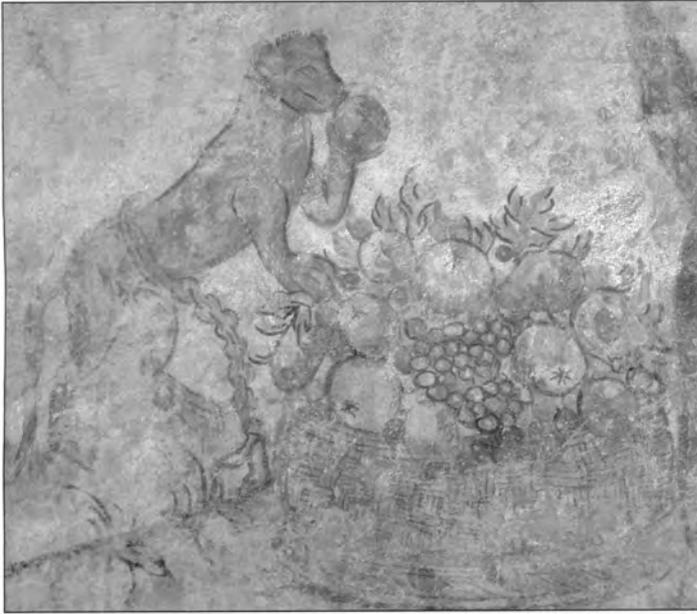
*Fig. 2. Detail of the ape on the north wall (Tobit Curteis Associates 2006).*

The painting on the smaller north wall is also framed in green, but unlike the west wall, it is split into two pictorial panels with a green frame between them. On the left side is a chained ape with a basket of fruit set within a landscape of foliage and trees, while on the right side is a curious green church with black outlines and details, also set in a landscape (Plate 3). Due to damage on the north side it is not possible to tell if other significant details were present.

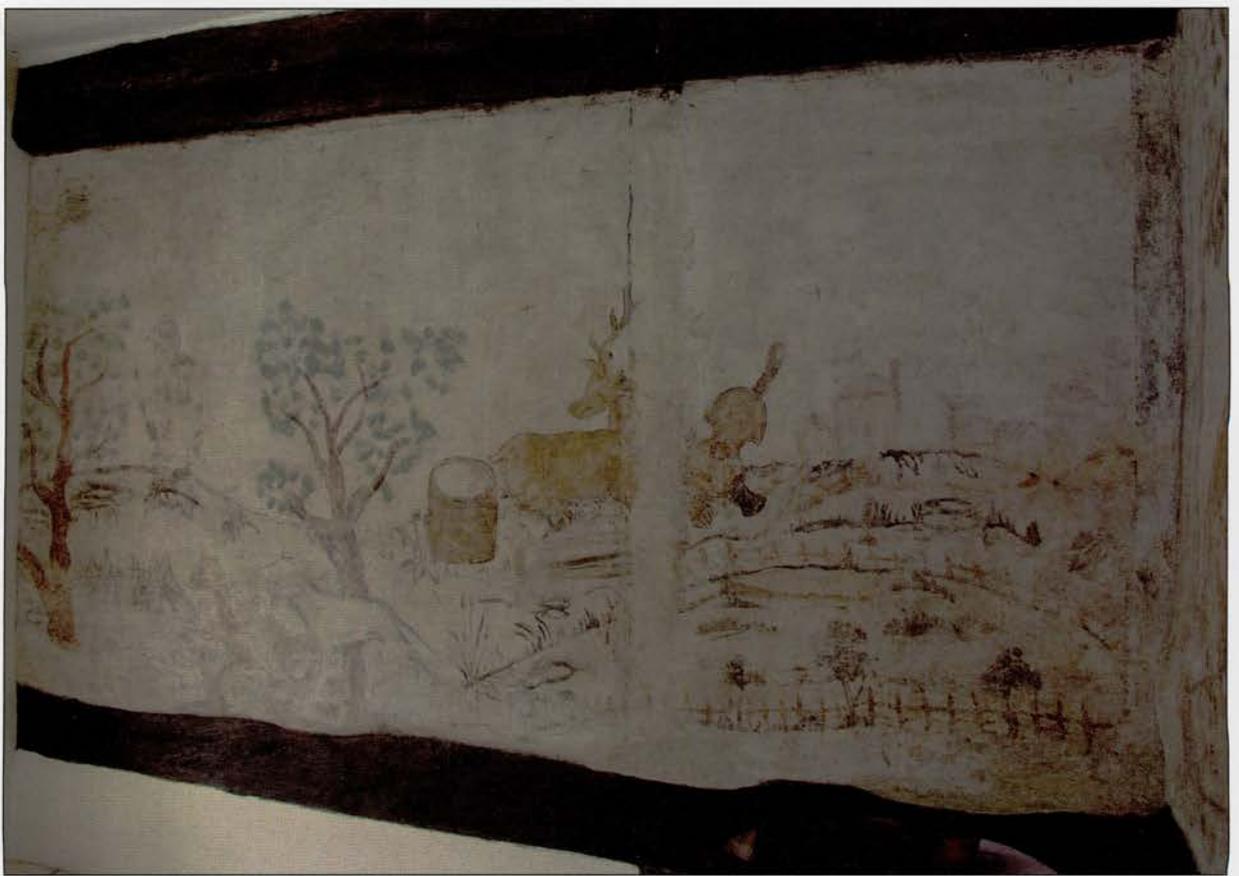
*Plate 2. The wall painting on the west wall, after conservation (Tobit Curteis Associates 2006).*

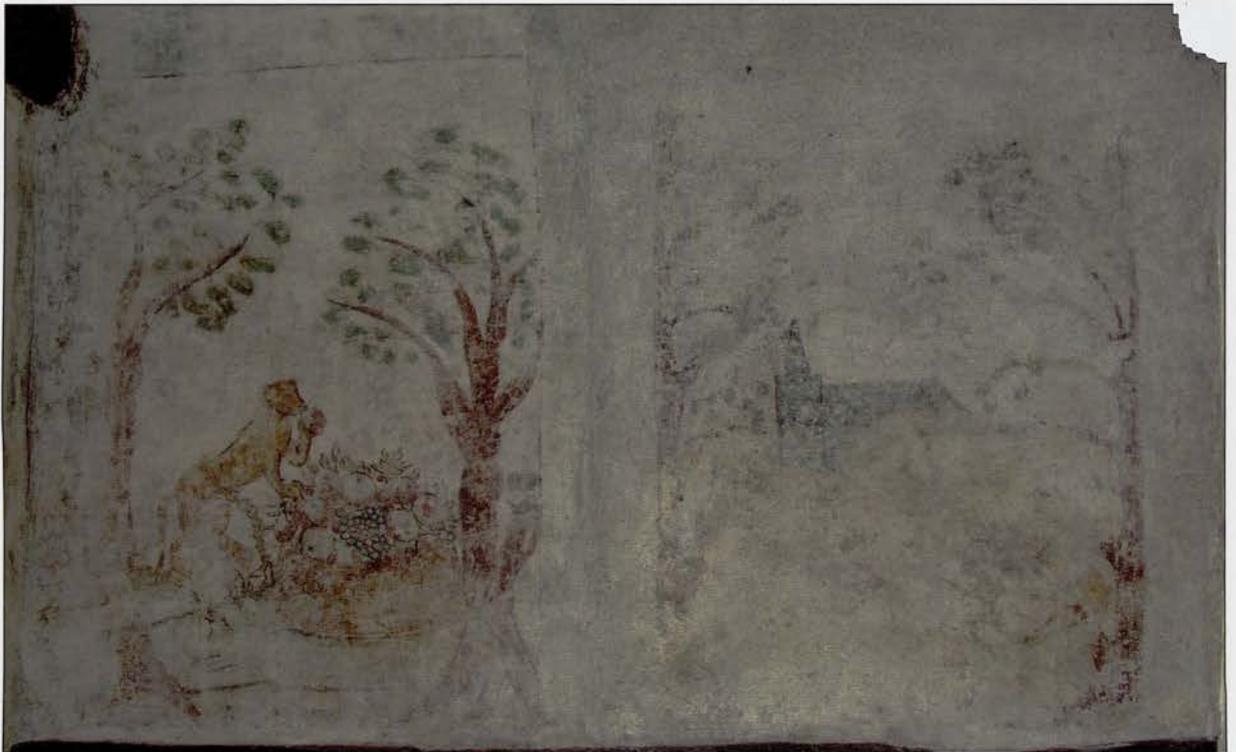
*Plate 3. The wall painting on the north wall, after conservation (Tobit Curteis Associates 2006).*

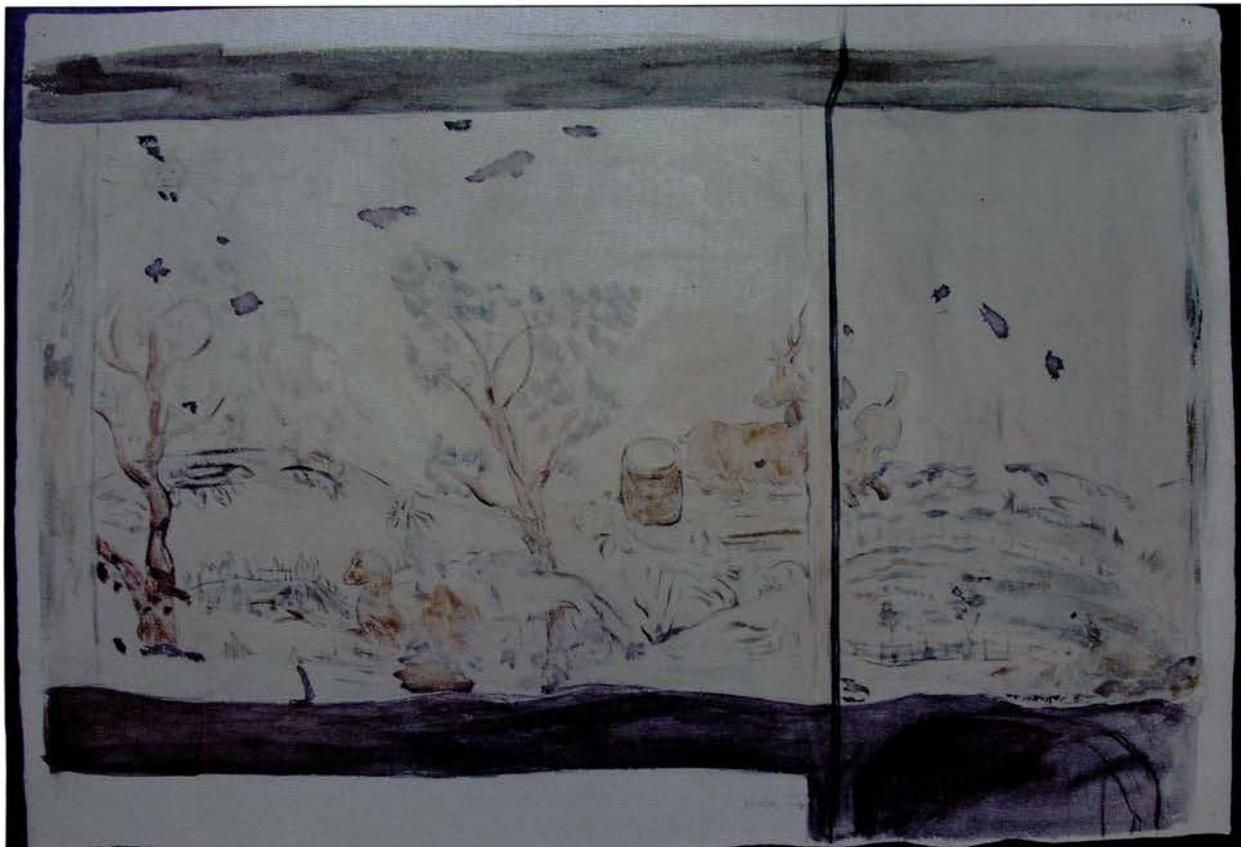
*Plate 4. Watercolour of the painting on the west wall by Agatha Hall Shore (©V&A Images/Victoria and Albert Museum).*

The paintings were discovered in 1924 during the removal of old wallpaper (Anon, 1925), at which time considerable mechanical damage appears to have occurred. EW Tristram, the leading authority on wall paintings at the time, was consulted as to their treatment and it appears likely that he recommended the use of a beeswax 'preservative' treatment in common with most other wall paintings which he examined at this period (Curteis, 1991). Watercolour copies of the paintings were made by Mrs Agatha Hall Shore, the wife of the junior bursar, and were deposited at the Victoria and Albert Museum.<sup>4</sup> (Plate 4)

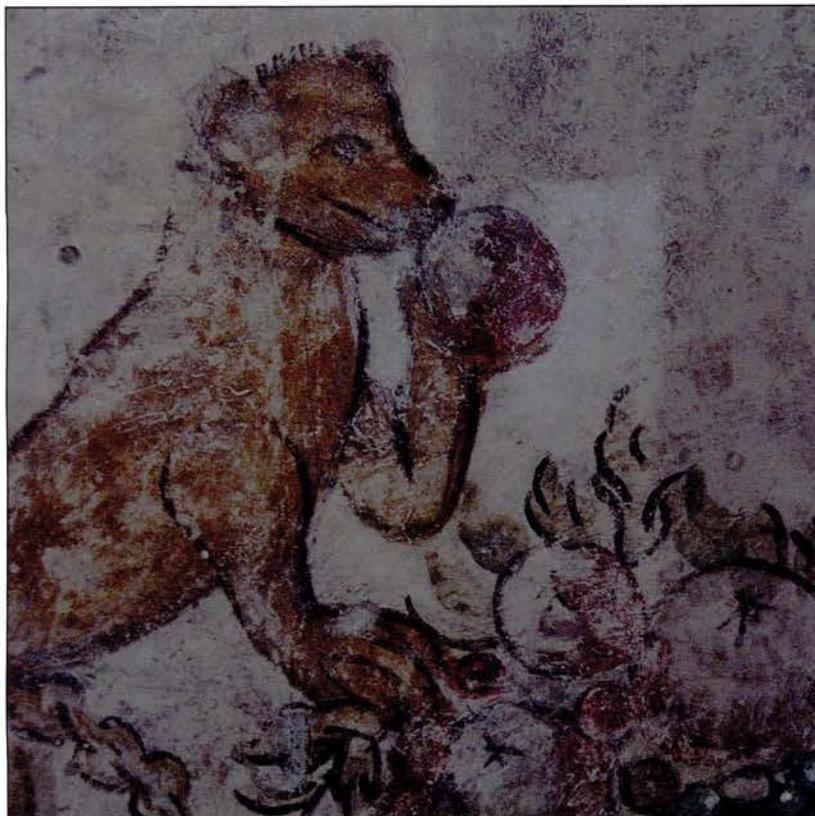
*Plate 5. Detail of the ape during the treatment of the wax layer. The area on the left has had the wax layer removed. (Tobit Curteis Associates 2006).*

The aims of the treatment programme were to repair and stabilise the painting (both the paint layer and the substrate), and to remove and replace unstable or potentially damaging historic repairs. Damaged plaster was repaired using a lime and sand mortar and unstable areas were re-adhered with a lime based grout. The wax coating was reduced using a gelled solvent mixture, in order to increase the visibility of the painting and to reduce subsequent accumulation of dirt particles (Plate 5). New repairs were reintegrated, but no retouching or reconstruction of lost areas of the original painting was undertaken. Wherever possible, materials were compatible with the original, and new materials were only added when absolutely essential (Tobit Curteis Associates, 2003).

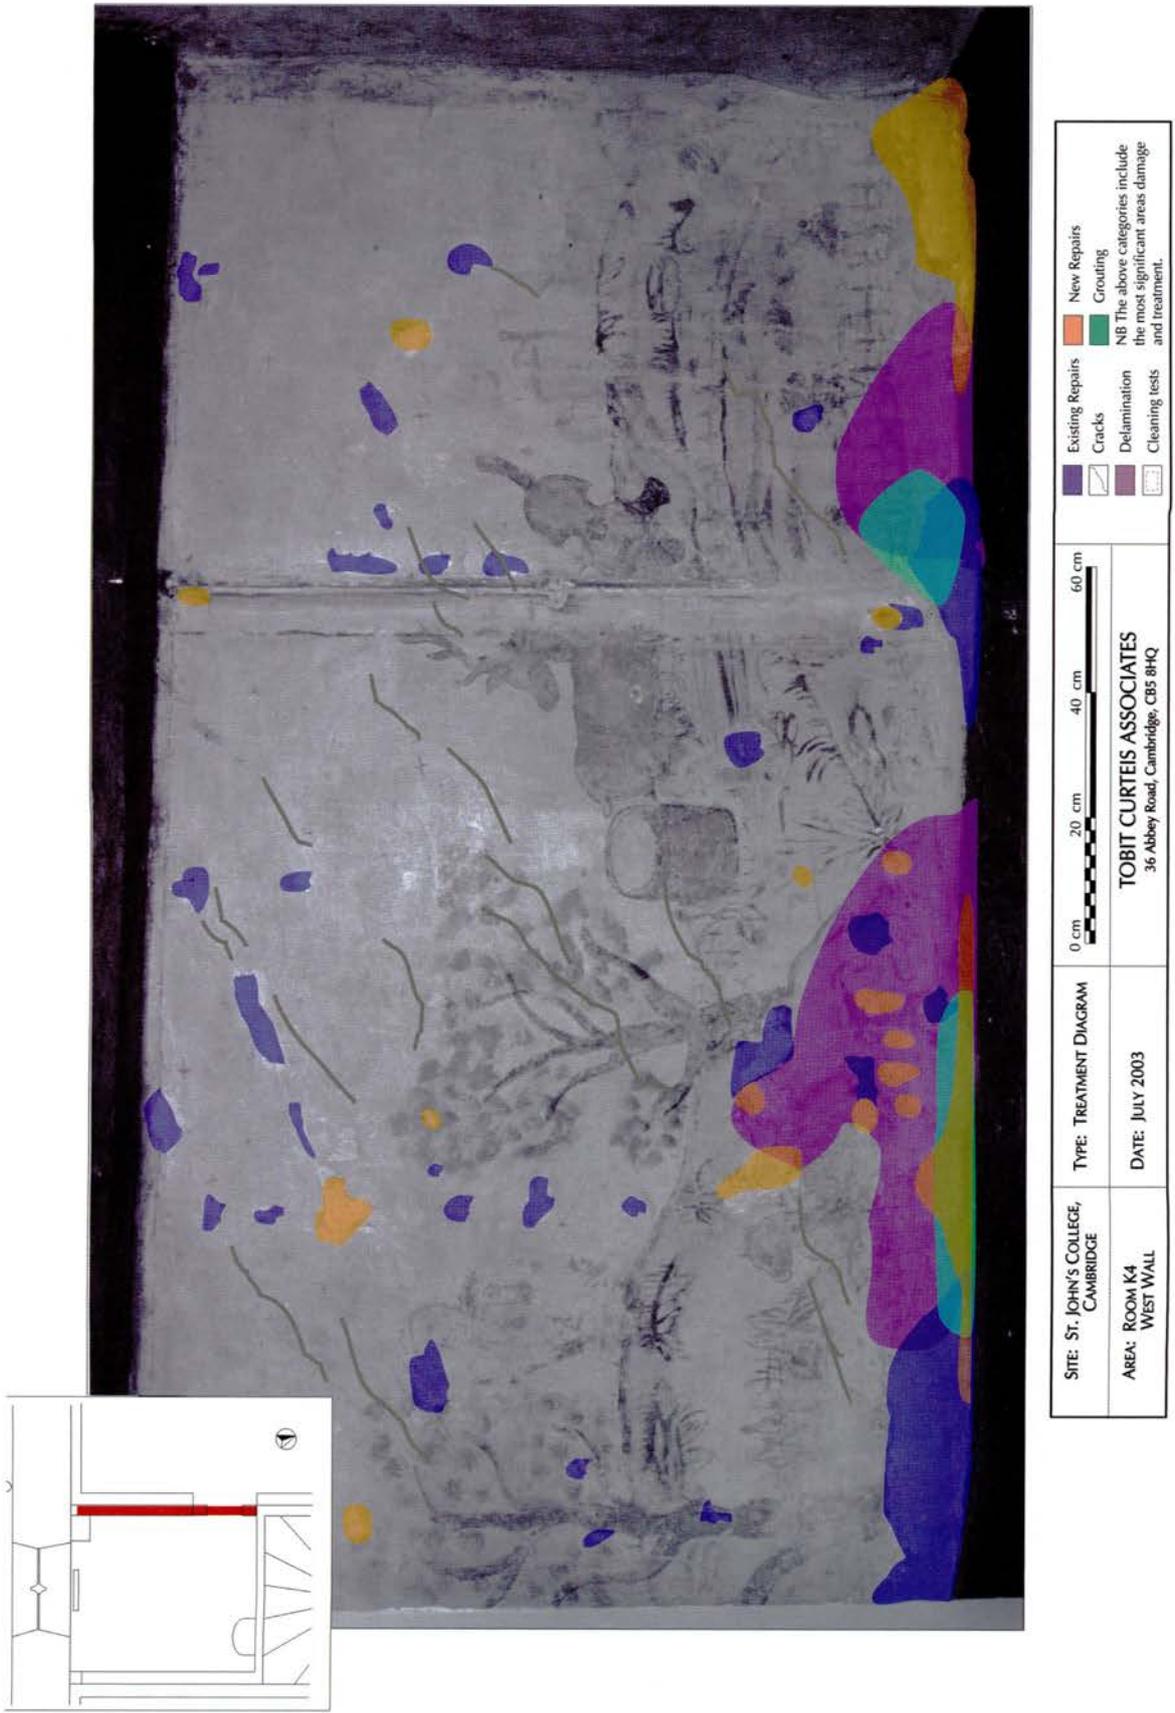
Plate 6. Part of the graphic documentation for the conservation treatment (Tobit Curteis Associates 2006).

Throughout the programme a detailed graphic and photographic record was kept in order to record the condition of all areas before treatment and the specific treatments applied to the different sections of the paintings (Plate 6).
