Upware and Bottisham sluices

K S G Hinde

Dredging of the River Cam at Upware in September 1989 unearthed a quantity of stakes and planks. This study seeks to explain their significance in the context of structures erected in the early nineteenth century to control the flow of water in the river below Clayhithe. No published information about these has been traced, save for partially misleading indications on some maps of the period.

Proceedings of the Cambridge Antiquarian Society XCVIII pp121-126

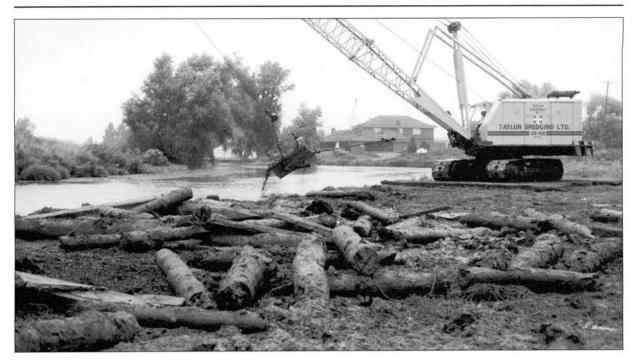
Figure 1. Remains excavated in 1989 with the River Cam on the left and the 'Five Miles' public house in the background.

The writer inspected the remains on 24 September 1989, and noted that they had been deposited on the washland just south of the junction of the outfall of Reach Lode and the Cam. He found the stakes to be rough tree branches, about 9 to 12in (23–30cm) thick, and some tapered to a centre point. The boards varied in width up to 18in (45cm). This wood was removed shortly afterwards. The only other remaining evidence of these is a series of photographs taken by Michael Petty, deposited in the Cambridgeshire Collection, Cambridge Central Library. Fig. 1 is one of these, and clearly shows the remains excavated, with

the River Cam on the left, and the 'Five Miles' public house in the background.

An exact identification of the 1989 remains will probably never be possible, not least because their early removal prevented detailed examination. Their nature suggests that they were not part of the lock itself. The possibility that they were parts of a coffer dam constructed when the lock was removed is unlikely. The stakes would form no tight dam. Dam boards were customarily shaped boards, about 9in. (23cm) wide and 2in (5cm) thick tapered to a point at one end (Clarke 1987). It is most likely that they formed parts of the side of the lock. McKnight (1975, 35) states 'on river navigations well supplied with water the sides of the chamber were sometimes partly or completely made of sloping grass banks, normally with a row of timber posts to prevent descending craft being stranded on the side'. The present paper may be useful if any further remains are found in the future, although it reveals that parts of the lock, staunch and overfall were to be re-used as far as possible for repairs to the other sluices. In addition, any remains of the staunch and overfall will have been left in the old course of the Cam, long since infilled and situated in the washland, which is unlikely to be disturbed.
