Archaeological Excavations at Whitemoor Marshalling Yard, March

Martin Railton and Fiona Wooler

Project Background

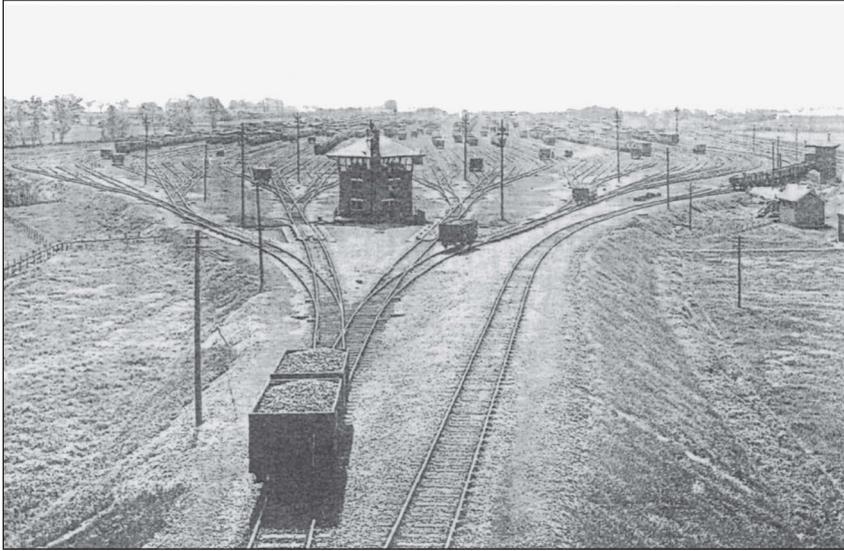
Figure 4. General view of Whitemoor Marshalling Yard c. 1929, looking south, with wagons passing from the hump through the retarders to the sorting sidings. Image courtesy of Railway Gazette 1929.

Whitemoor was consequently the site of Britain's first 'mechanised hump' marshalling yard, a system which used gravity to allow wagons to enter the sidings where they were sorted automatically into sets for onward transfer to their destination. The site had two humps, northbound and southbound, which fed wagons into the two yards (the Up yard and Down yard). The site was also the first to employ the Frölich retarders which used compressed air brakes to control the speed of the wagons as they descended from the hump. Two position signals were used by the shunting staff at Whitemoor Hump to indicate to the shunt engine driver the required speed to propel the wagons over the hump. As such, Whitemoor Marshalling Yard was the site of technical innovation. Once the Up and Down yards were operational in 1933, it was believed to have been the largest marshalling yard in Europe (Jacobs 2008).

ons were pushed over the summit of the hump and their own momentum and a steeper gradient would take them down into a fan of reception sidings. In 1907 Great Central Railway opened a hump yard at Wath, south Yorkshire, in which wagons were slowed down by mechanical retarders. Further complex yards were constructed by companies such as the North Eastern Railway at sites such as Newport, Teesside, and during the inter-war years, extensive yards were built at Feltham, Middlesex (LSWR 1921–23); Mottram near Manchester (1935); Hull (LNER 1935); Banbury by the GWR (1931), and of course Whitmoor (1929 and 1933) (Stratton and Trinder 2000, 167). An article in *The Railway Gazette* of September 20th 1929 declared of Whitmoor Marshalling Yard: 'This new hump yard, near March, is the first in Great Britain equipped with Frölich Retarders. Accommodation is provided for 4000 wagons, serving 350 destinations. At this yard the whole of the coal and goods traffic for the Eastern Section of the LNER from places north, east and west of Doncaster, and also from collieries and yards on the Great Central Section, Nottinghamshire and Derbyshire lines via Lincoln, is received and marshaled for forward transit' (Great Eastern Railway Society Sheet M298). Figure 4 provides a general view of the Whitmoor 'Up' Yard looking south; with the loaded wagons passing from the Hump to the sorting sidings, and Figure 5 is a view of wagons on the gravity hump itself.

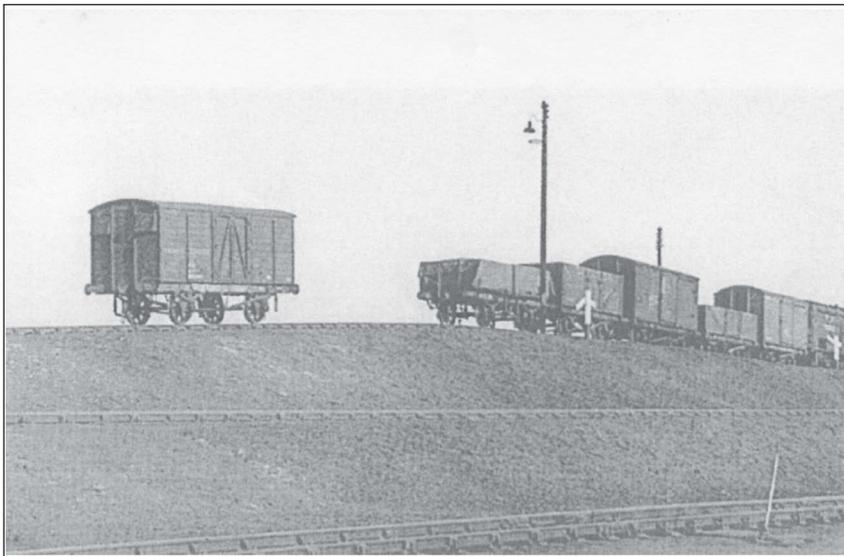
Figure 5. Wagons on the Gravity Hump at Whitemoor Marshalling Yard c. 1929. Image courtesy of Railway Gazette 1929.

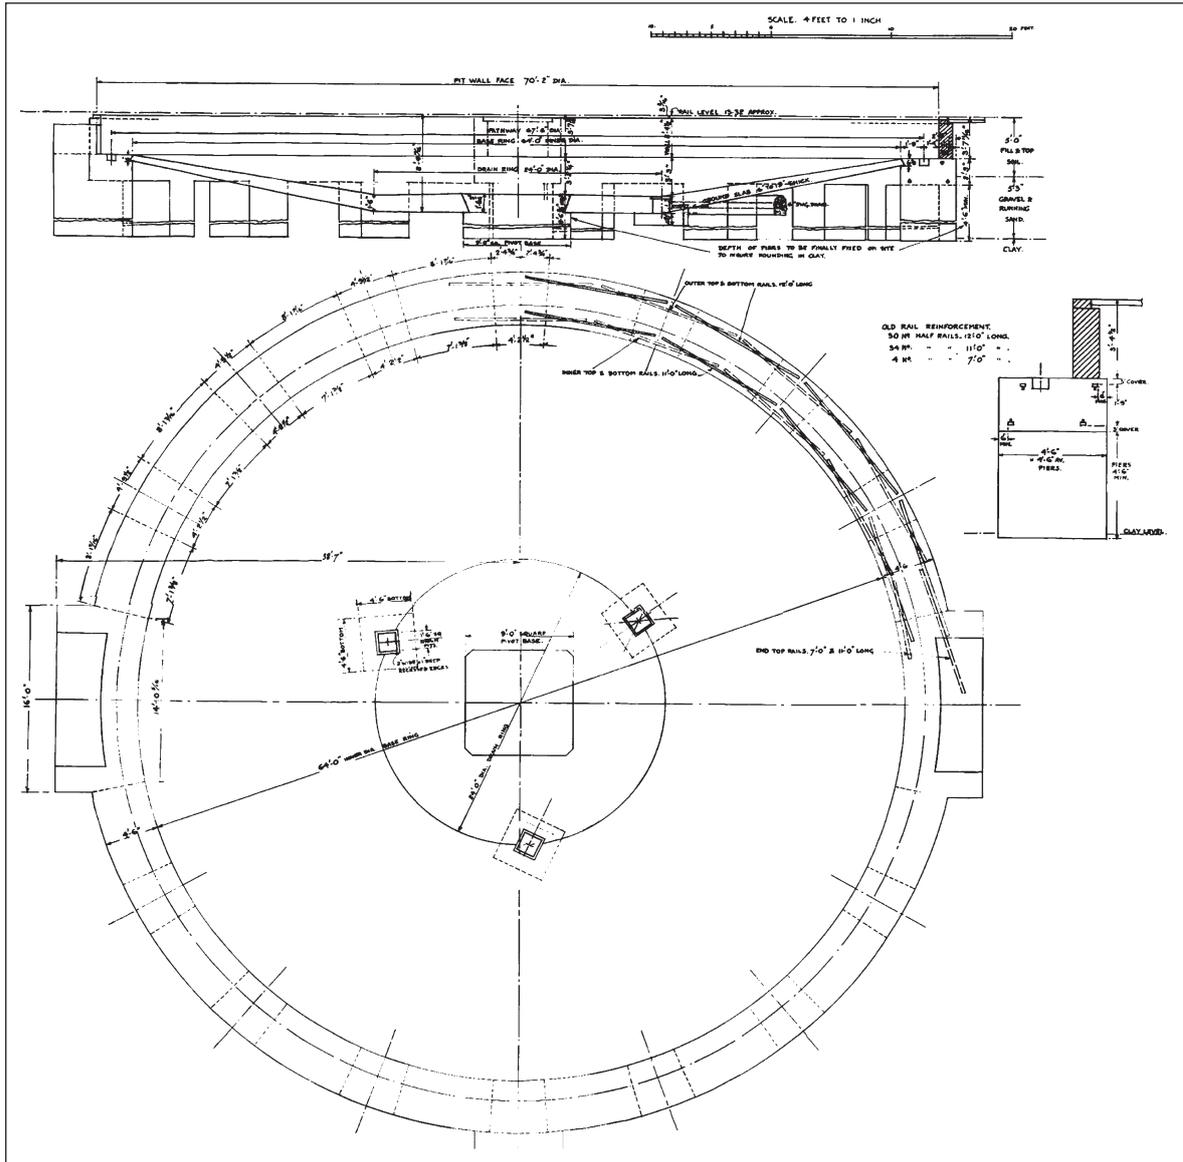
Figure 6. Plan of the new turntable, 1944. (Courtesy of Network Rail).

Turntable 2 was situated in the northern part of the site (Figure 2). A construction blueprint dated 1944 exists for this structure (Figure 6), which appears to have superseded Turntable 1.

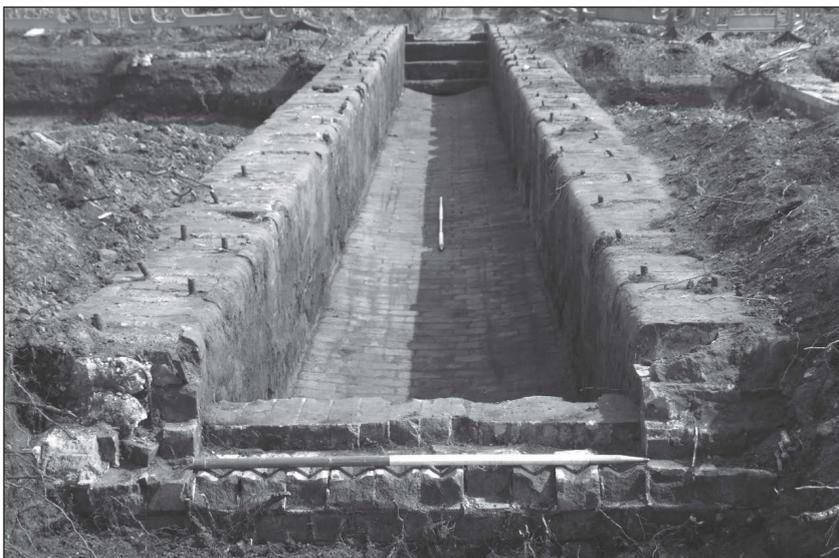
Figure 8. Inspection pit in Trench 25, looking south-east.

It was clear that the inspection pits were identical in construction method and materials, each set in a vertical-sided, flat-bottomed foundation cut, with concrete rafts forming the bedding layers for the walls. Brick floors were laid between the side walls, so that the inspection pits were entirely brick-lined. One of the inspection pits was fully exposed and excavated in Trench 25. This pit had an overall length of 17.25m and width of 2.20m, with an internal width of 1.14m. The side walls were constructed of machine-moulded, dark red-black bricks, laid in a bond that alternated two courses of stretchers (the long edge of the brick) with one course of headers (the short end of the brick). The walls were 0.58m wide and were constructed to a height of 0.76m above the floor level of the pit. The upper courses of bricks facing the in-

terior of the pit were bull-nosed, whilst those facing outwards were flat faced. A series of evenly-spaced rectangular impressions ran along the entire length of the side walls; these impressions incorporated the remains of iron fixing bolts, and from several *in situ* examples observed in Trench 24 it was clear that the impressions represented the fixing points for track shoes which had supported the rails running along the length of the walls.

The floor of the pit was constructed of bricks identical to those used for the walls. The floor level had a gradual fall from northwest to southeast, whilst the brickwork itself had been laid with a concave camber. At the southeastern end of the pit, the floor drained into a northeast to southwest aligned drain that probably also served the other inspection pits in this area. The drain was covered by an iron inspection hatch that also formed the lowest of three access steps into

the pit, the remaining two being brick-built and incorporated into the south-eastern wall. A similar flight of steps formed the north-western wall of the pit (Figures 8 and 9).

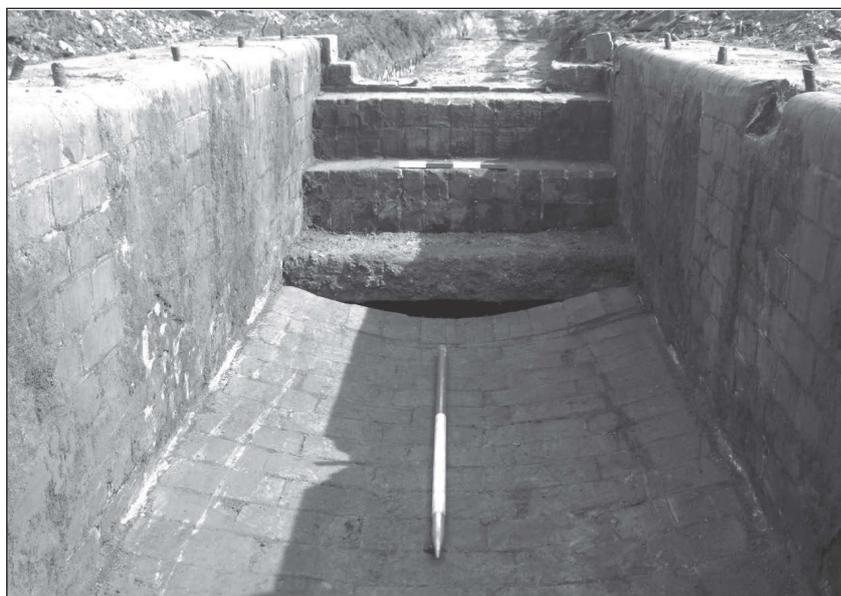
Figure 9. The concave base of the inspection pit in Trench 25.

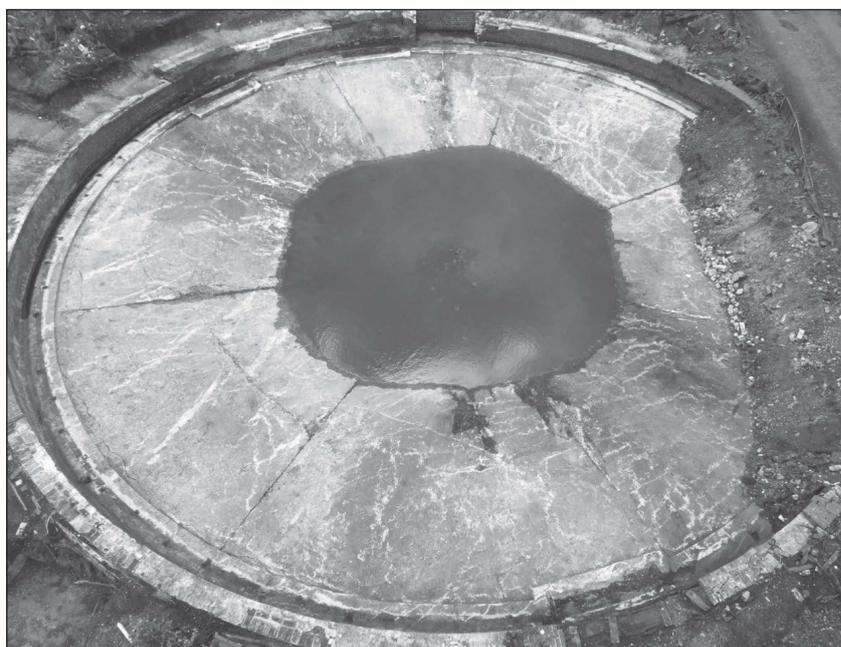
Figure 10. Aerial view of Turntable 1, looking south.

The Turntable 1 structure survived substantially intact, set within a 23m diameter circular construction cut. The turntable consisted of a 20.70m diameter concrete floor with a conical profile, which sloped steeply towards the centre. The floor had been laid in sections with the joints between each segment clearly visible (Figure 10). The enclosure wall of Turntable 1 was constructed of machine-moulded brick which was 11 courses in height, and was laid in stretcher bond. The wall had been constructed on a concrete platform which ran around the circumference of the floor of the turntable.

The centre of the floor almost certainly originally contained a substantial concrete stanchion supporting the central pivot or bearing for the rotating turntable arm, however this could not be identified as the centre of the turntable could not be completely drained of water. It would seem likely that the central pivot was destroyed or removed during the salvage of the turntable arm for scrap and that this process had also destroyed a sub-floor drain in the centre leading to the flooding.

Whilst the turntable arm and central pivot were missing, a number of interesting constructional details were observed. A 0.10m wide, 0.05m deep open drain ran around the circumference of the concrete platform on which the brick wall was constructed, close to the inner face of this wall (Figure 11). Set within the concrete platform which ran around the inner edge of the turntable were a series of rectangular machine-cut timber uprights, arranged in a radial pattern, which had been sawn off at the level of the concrete surface. The timbers originally supported a radial track or rail that ran around the inner circumference of the wall, which supported the ends of the turntable arm as it rotated.

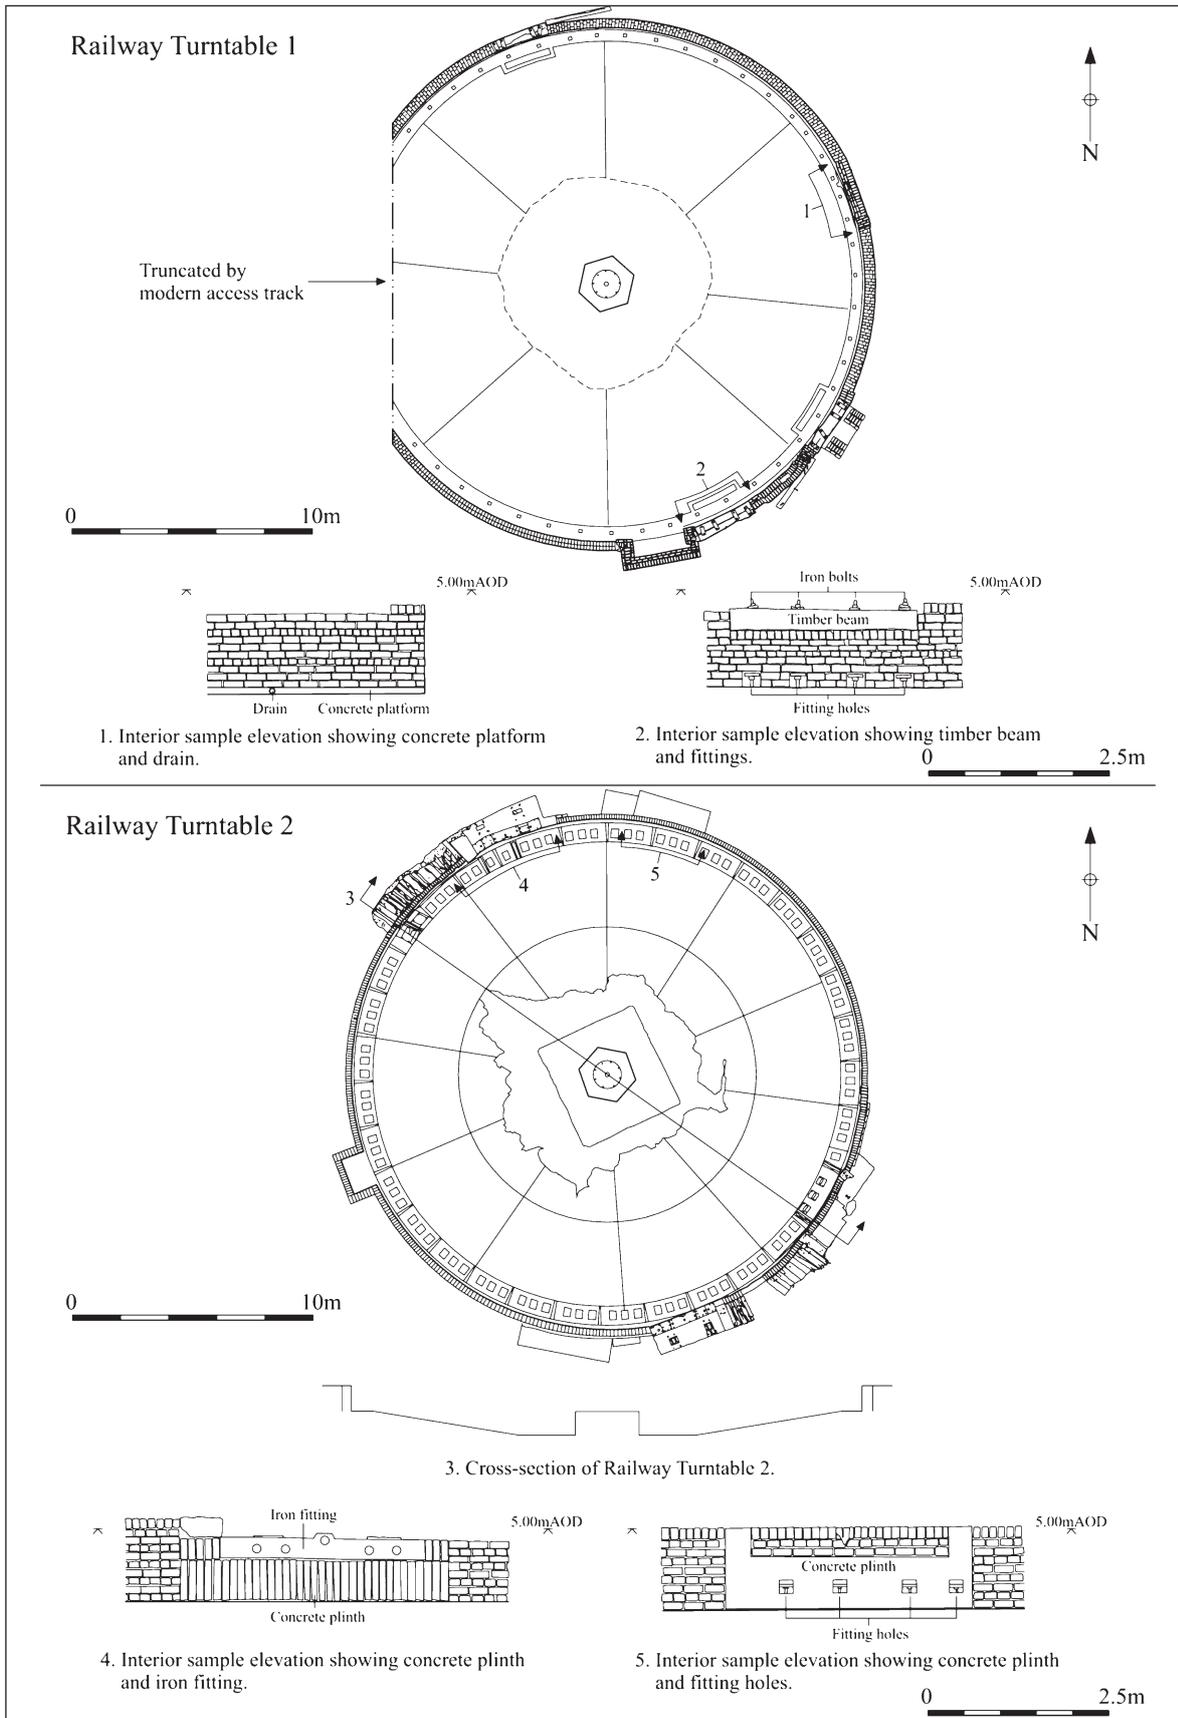
Figure 11. Railway turntables plans, cross-section and sample elevations.

Turntable 2 consisted of a large circular construction cut that truncated the natural sandy clays, and the overlying silty clay subsoil. Set within this cut was a conical concrete floor, with an internal diameter of 21.34m (slightly larger than Turntable 1), which dipped slightly towards the centre of the structure

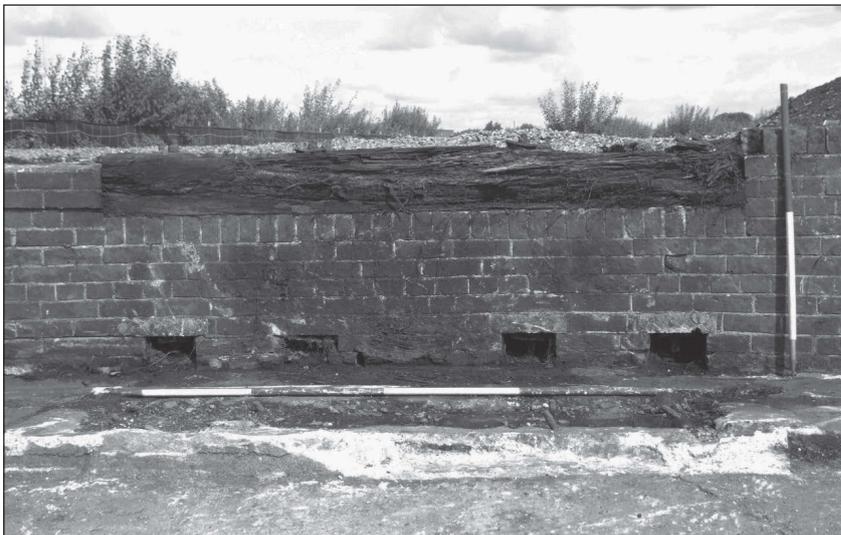
Figure 12. Turntable 1 detail, showing timber beam, openings and concrete platform.

At three points around the circumference of the wall of Turntable 1, the upper course of brick was interrupted by the insertion of 0.50m wide, 2.50m long timber beams, each of which still contained the re-

mains of metal fixings. Situated immediately below each of these beams were a series of four rectangular openings in the inner face of the turntable wall (Figure 12). Iron fittings could be observed within these holes and it is likely that these represented the other ends of the fixings visible in the upper surfaces of the timbers. Rectangular concrete pads were incorporated into the platform surface immediately in front of these openings, and each of these also contained the remains of iron fixing bolts. To the exterior of the turntable, three 1m wide, 0.20m long concrete and brick-built plinths were located immediately behind the timbers set within the turntable wall (Figure 11). It was therefore clear that the timbers and associated plinths represented the three points at which tracks entered the turntable, whilst the concrete and iron fixings in the interior of the structure probably represented the remains of the locking mechanism by which the turntable arm was correctly aligned with the tracks.

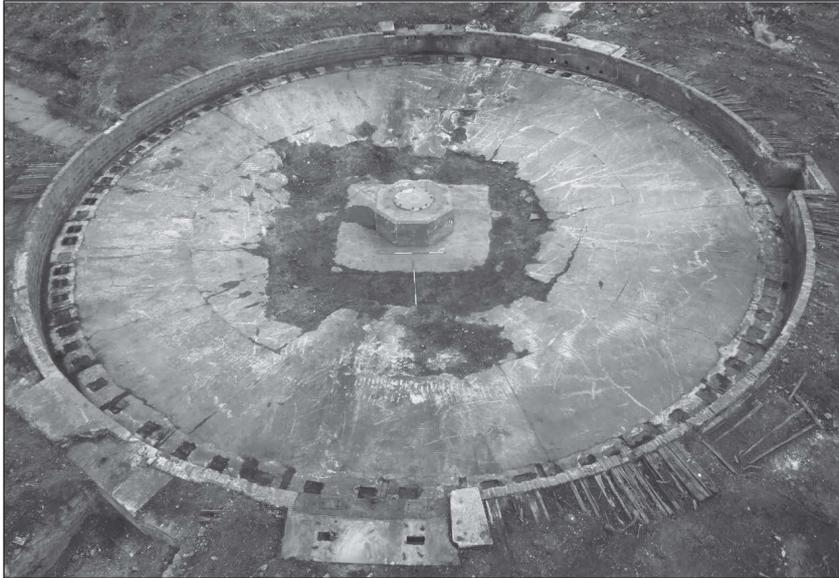
Figure 13. Aerial view of Turntable 2, looking south-east.

(Figure 13). The floor acted as a foundation for the circular turntable wall, which was constructed of brick. This enclosing brick wall survived to its full height of nine courses (1.10m) and was constructed of frogged, machine-moulded red bricks laid in alternate header and stretcher bond, capped with a top course of edge-laid headers. It was noted that some of the bricks were stamped 'ACCRINGTON NORI', these were hard, smooth, deep-red pressed bricks made of shale from the Coal Measures near Accrington, East Lancashire. They were widely used for engineering and industrial purposes and also for other building types in the late 19th and early 20th centuries. One of the trade names, 'Nori', is 'iron' spelt backwards and indicates the character of the brick (Brunskill 1990, 86). It was noticeable that the wall of Turntable 2 was markedly less substantial than that of Turntable 1, which may have reflected the shortage of suitable building materials in the immediate post-war period.

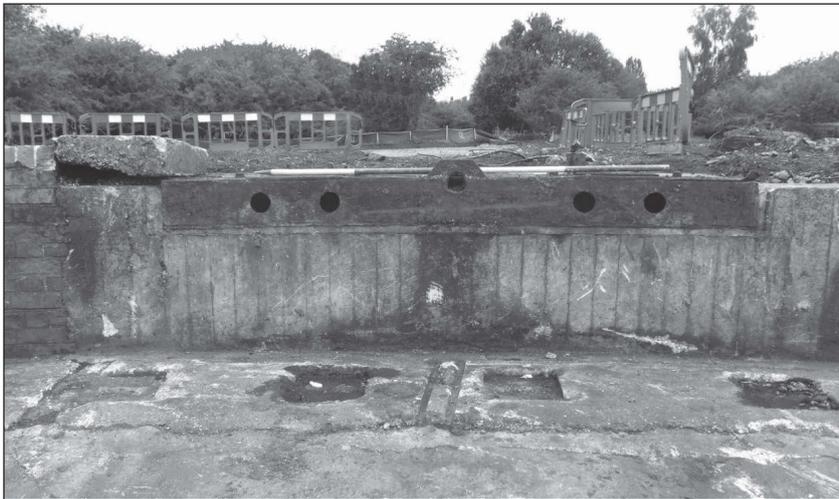
Figure 14. Detail of wall of Turntable 2, showing imprint of shuttering.

The internal sides of Turntable 2 contained two sections where the imprints of vertical timber plank shuttering for poured concrete could be observed between the brickwork (Figure 14). These sections related to the locations where the track entered the turntable, possibly after the remodelling, and each was constructed of a 3.30m long, 1.20m wide concrete plinth into which was set a rectangular iron fitting. These iron fittings were visible in the elevations of the turntable wall, and each incorporated four circular holes together with a centrally-placed raised fixing loop that faced the interior of the turntable.

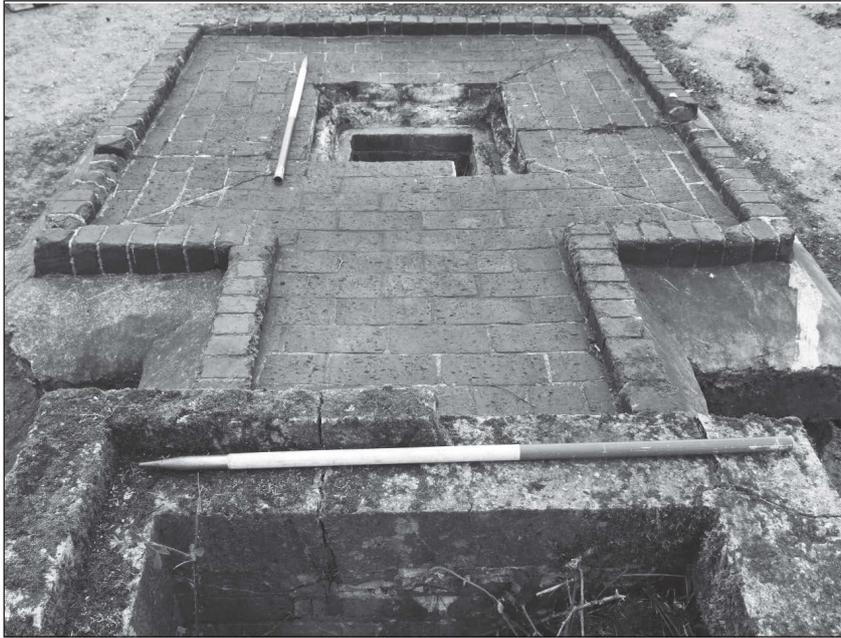
Figure 15. View of the Gravity Hump structure, looking south.

A 20m by 20m area at the extreme northern end of the Gravity Hump was excavated as part of the agreed mitigation strategy (Figure 2). The excavation revealed the remains of a brick and concrete structure measuring 6.5m by 3.0m. The structure appeared to have been built in two phases and consisted of a southern concrete foundation raft that supported a rectangular grey brick structure that contained a drain or manhole (Figure 15). A rectangular concrete beam, which possibly protected a buried drain or pipe, extended from the eastern side of the foundation.

The northern part of the structure consisted of an open-ended rectangular enclosure that was made of red, moulded bricks. Four large iron bolts were set into the brickwork, suggesting that the structure probably acted as a machinery base. No machinery remained *in situ* and the purpose of the structure has therefore remained unclear. Its location, however, on the gravity hump suggests that it was part of the railway control and switching apparatus.

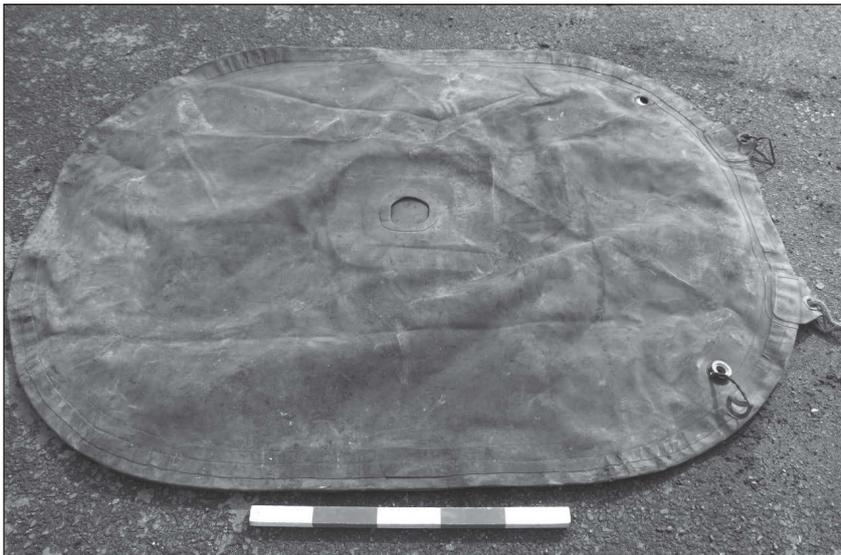
Figure 16. An inflatable rubber dunnage.

Figure 16 shows a large inflatable rubber dunnage manufactured by RFD Company Ltd, which would have been used for protecting fragile cargo. Of particular interest amongst the metalwork assemblage were several corkscrew-shaped iron hooks that were evidently designed to fit a long wooden handle. These were identified by Mr Howlett as shunters' poles, the hooks being used to snag wagon couplings as a means of directing and controlling the wagons as

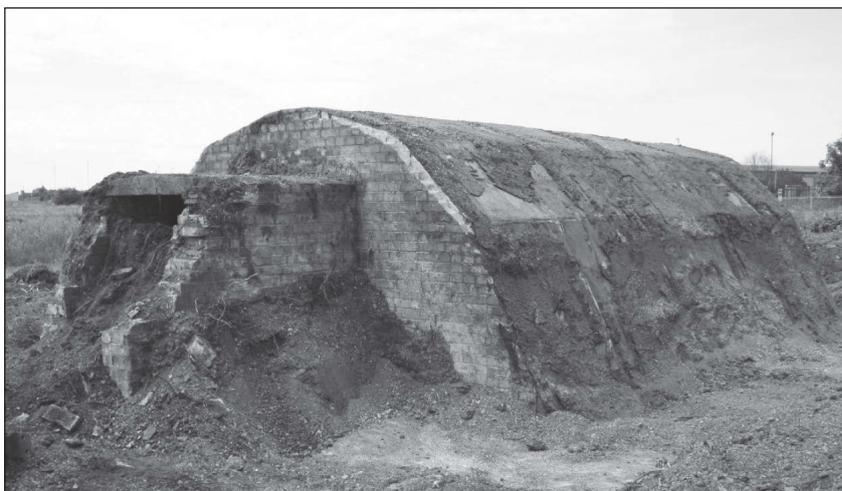
Figure 17. Air Raid Shelter No. 1, after the removal of its earth covering.

Air Raid Shelter No. 1 was completely uncovered in 2009 to enable a condition survey to be undertaken, prior to being recovered. It measured 20m in length, 13m wide and 3m high. This semi-circular structure comprised a brick-built entrance, with earth and concrete floor, bitumen covered concrete roof slab and pre-cast concrete arched beams with brick end walls and a large ventilation pipe to the rear (Figure 17). Concrete foundations were observed surrounding the outer walls of the structure. The building had been completely covered by medium brown sandy soil of around 0.4m in thickness, with soils sealing the front and rear access consisting of ballast, brick waste, metal and concrete (Railton 2010; Lilley and Lowman 2009).
