Report on Luminescence testing of mortar samples at St. Peter's Church, Wearmouth and St. Paul's Church, Jarrow, Co Durham.

By Ian Bailiff

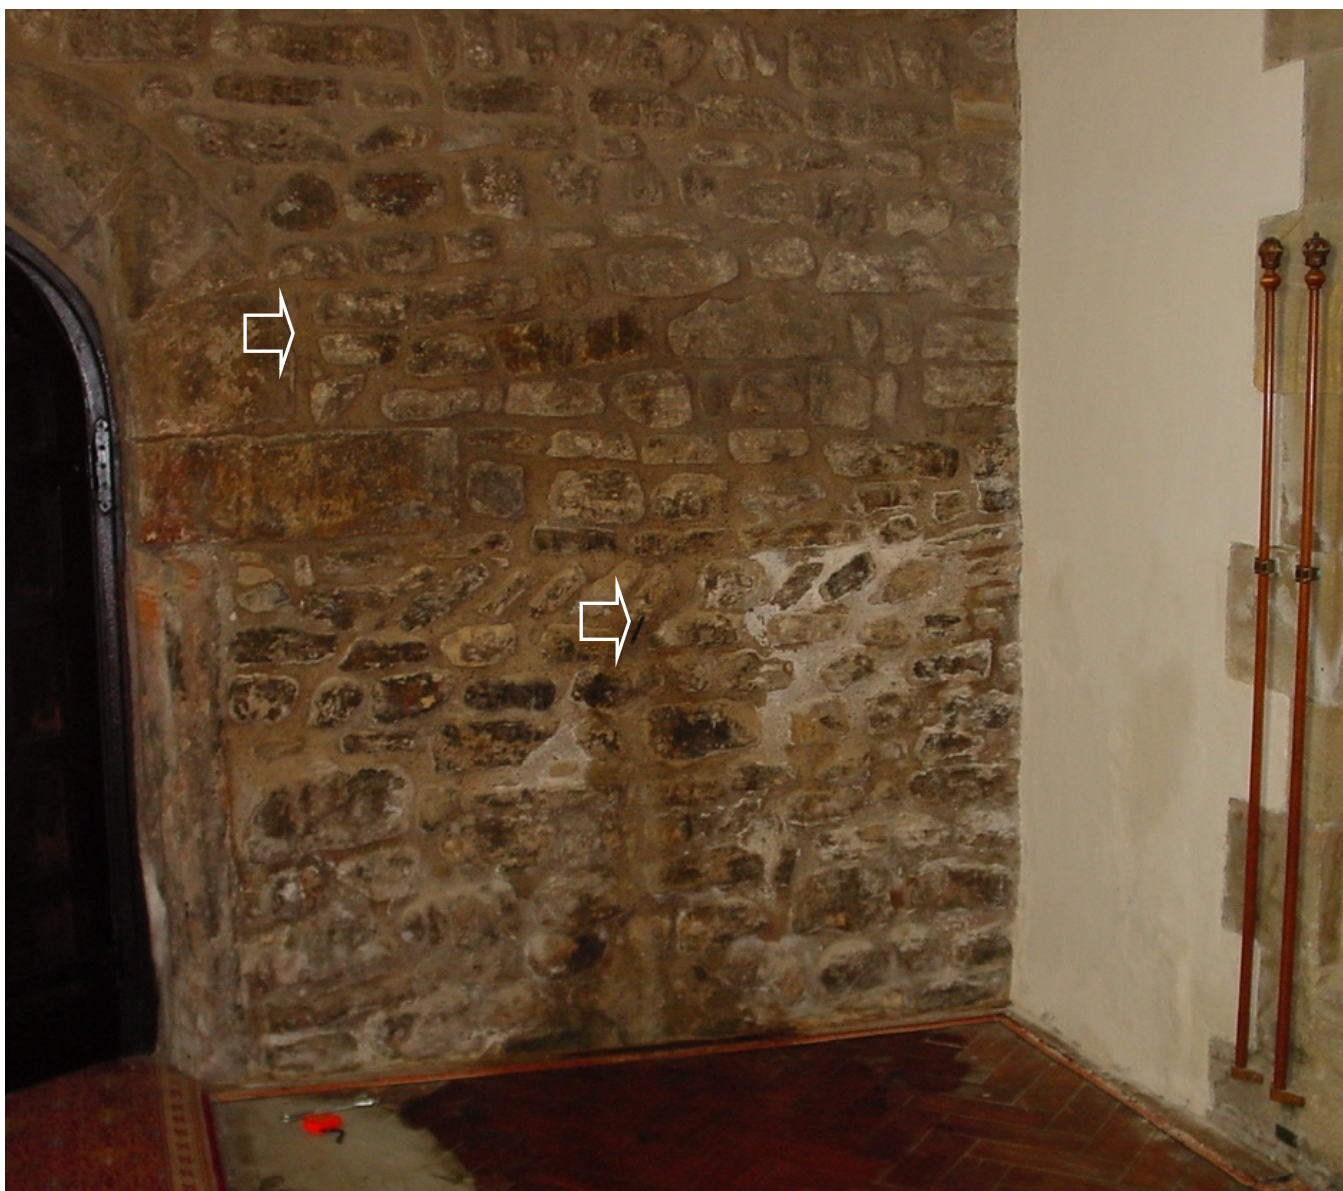
Figure 2

St Peter's, Wearmouth: Internal elevation of west wall of nave, showing the locations of the two drilled cores. These areas of coring are now backfilled.

At St Peter's church, Wearmouth, cores were obtained from a) the interior wall of the west elevation (Fig 2) at positions corresponding to locations 1.1 and 2.1 in the project design and b) the exterior wall of the west elevation of the tower at positions corresponding to location 2.2 and, due to health and safety considerations in terms of accessing location 2.3, an equivalent position on the north elevation was selected. Each core cavity was backfilled with lime mortar (Fig 3b). Once cut, the cores were promptly stored under dark conditions in black plastic bags.

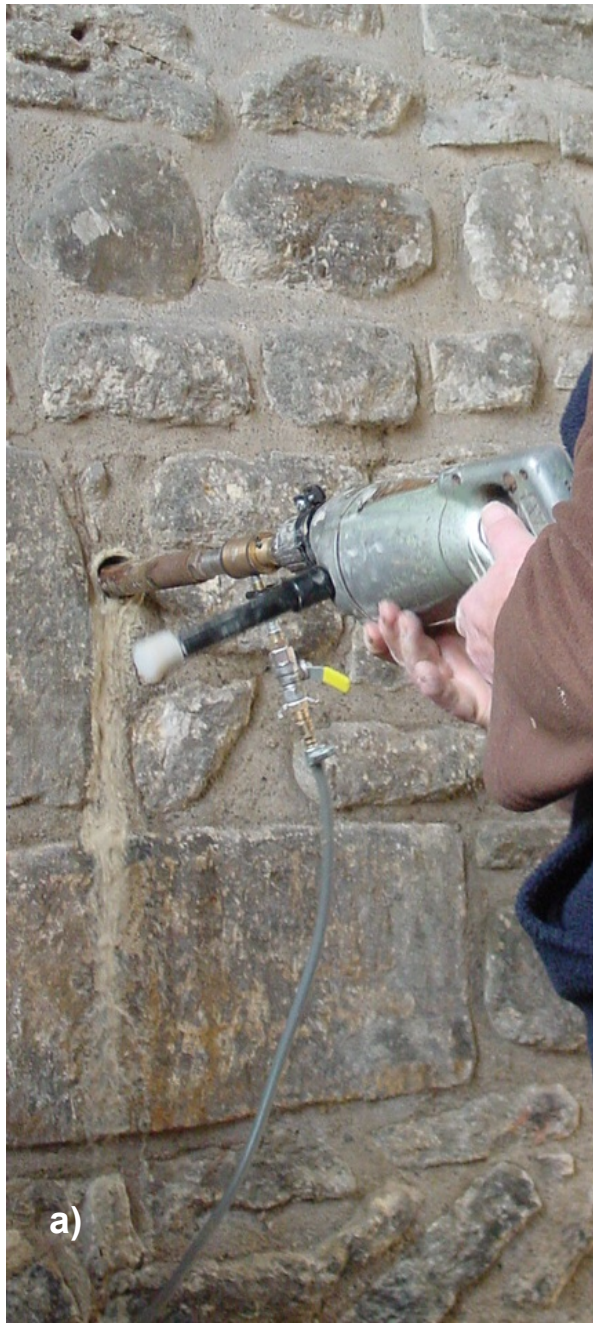
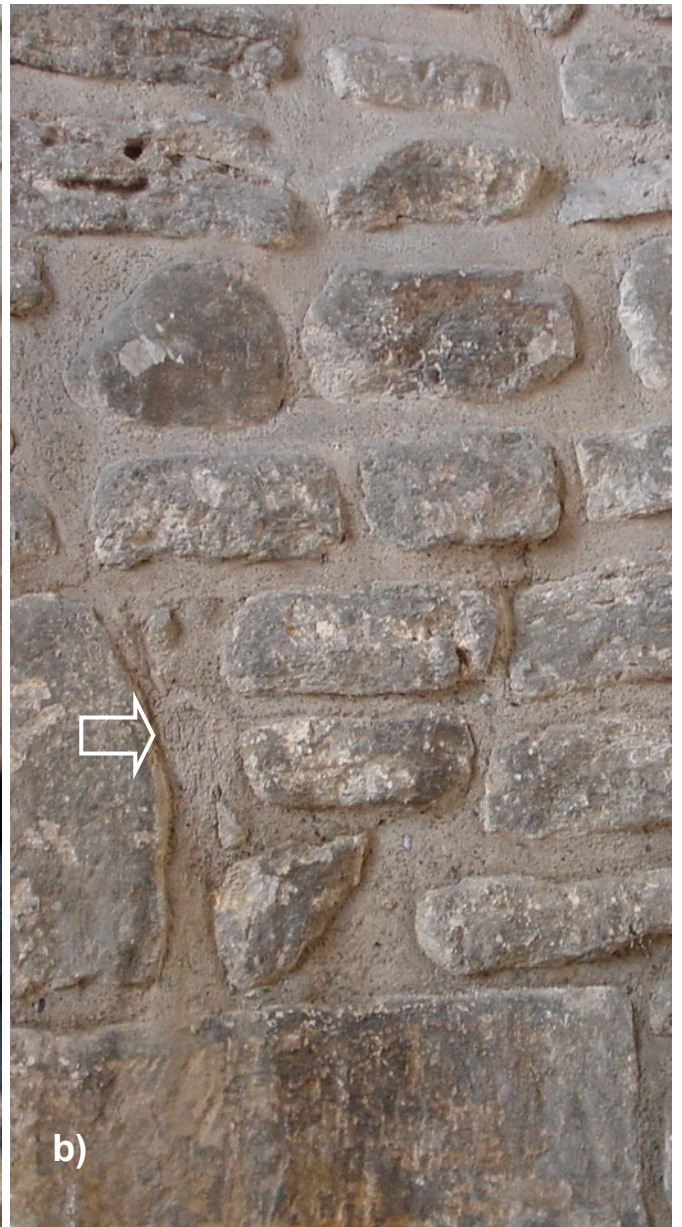
Figure 3

(a) Core drilling in progress; (b) the core hole backfilled with lime mortar.

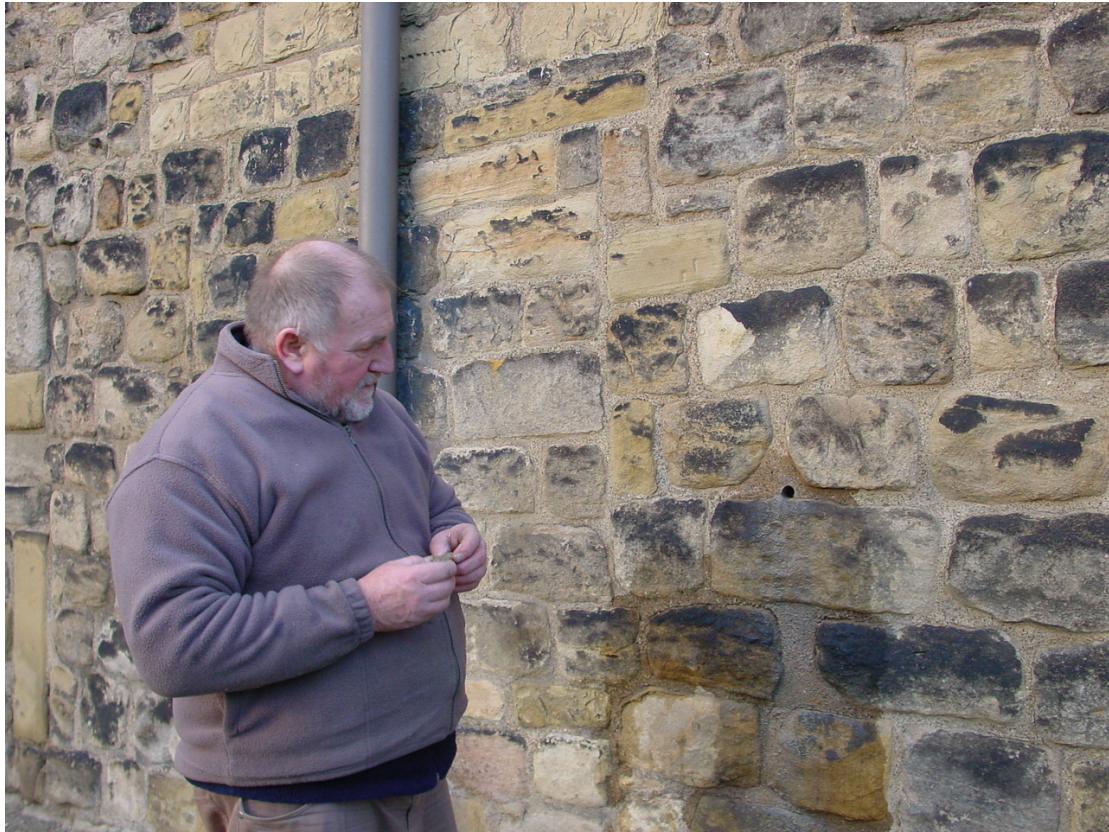
Figure 4

St Paul's Jarrow, Coring location 1:2: Dr John Senior holding a core comprising the outer modern mortar, the drilling of which revealed the presence of disaggregated material at greater depth, as found at the two other locations shown in Figs 3 and 4.

At St Paul's, Jarrow, three locations were drilled for mortar cores (Figs 4 and 5). However intact mortar was only found to be present in the outer layers (to c. 2 cm depth) comprising modern mortar and at greater depths the core drill entered a void containing disaggregated mortar (Fig 6). Hence no mortar associated with the construction phase was recovered from these locations.

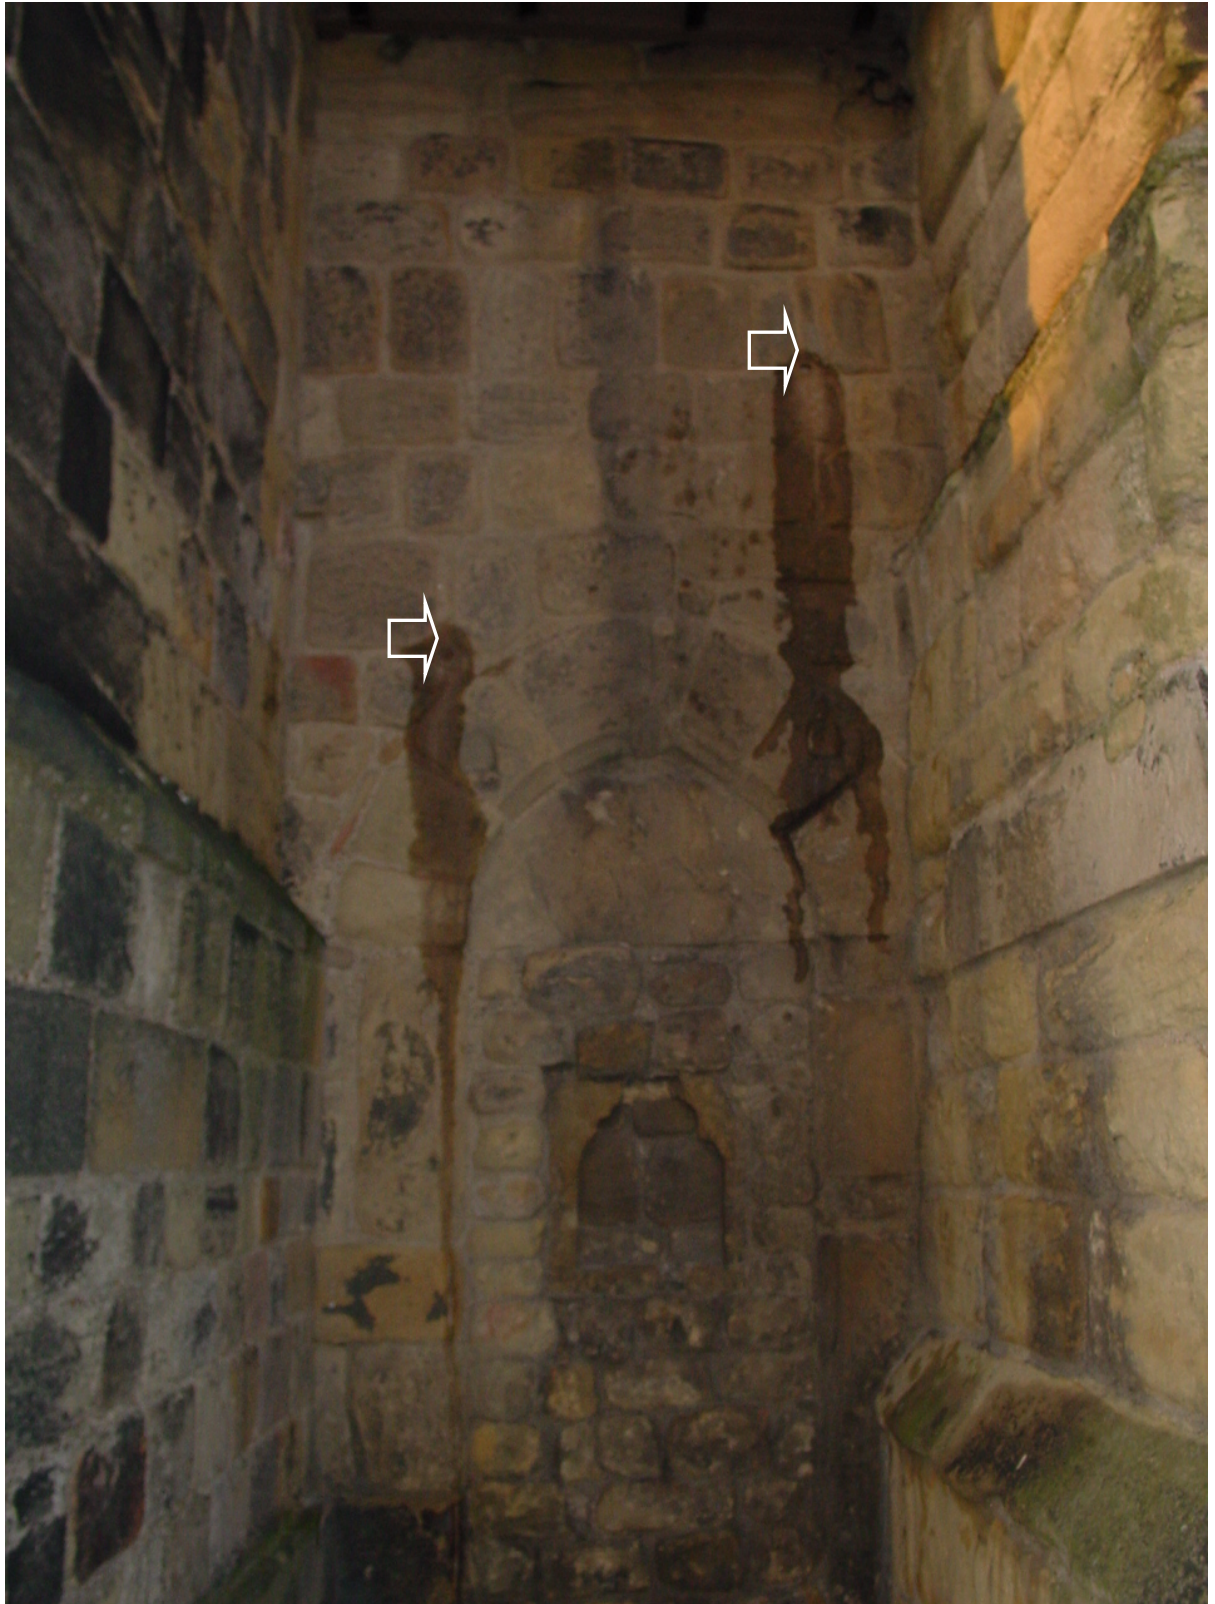
Figure 5

St Paul's Jarrow: positions of core drilling on South wall corresponding to location 2.5 in the project design.

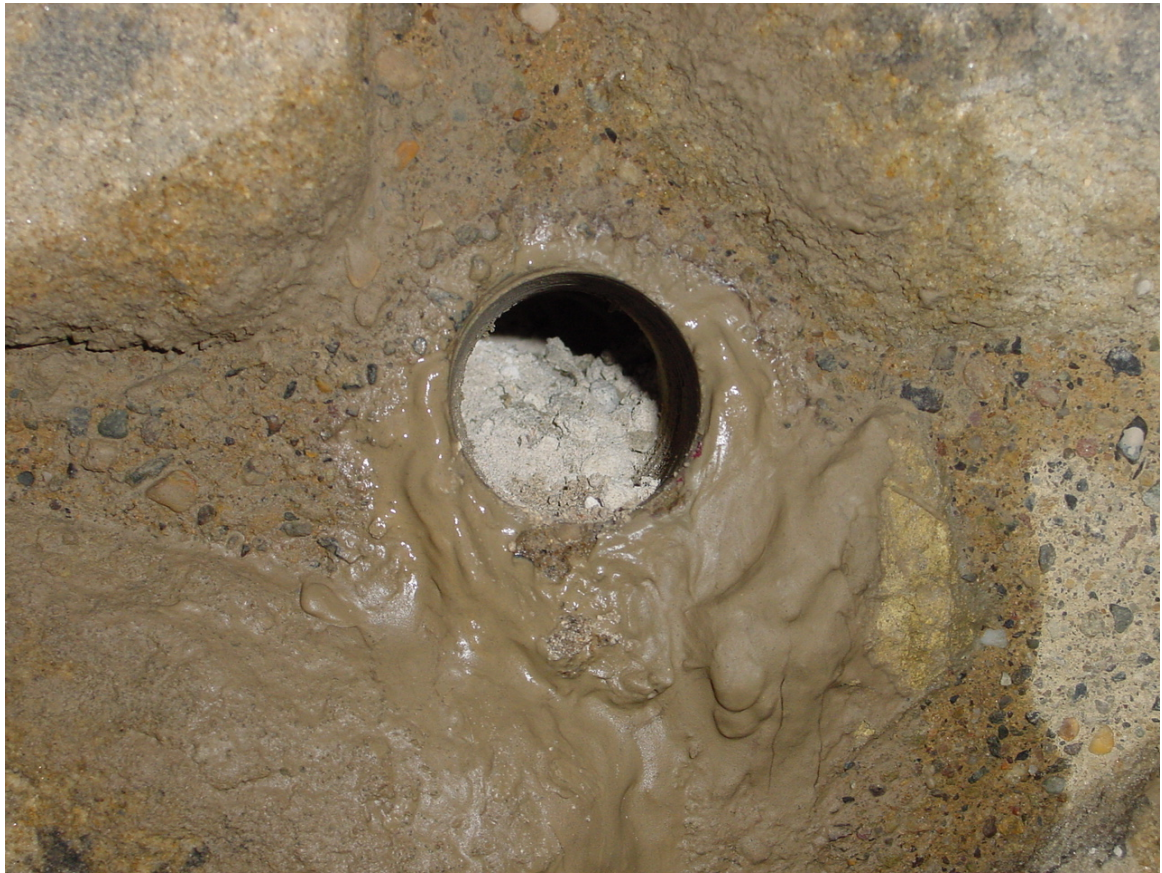
Figure 6

St Paul's Jarrow: close-up of drilled cavity revealing the presence of disaggregated material at greater depth.
