A Survey by
Birmingham University Field Archaeology Unit
December 1987

A SURVEY OF LLWYD MANSION, OSWESTRY, SHROPSHIRE

Birmingham University Field Archaeology Unit

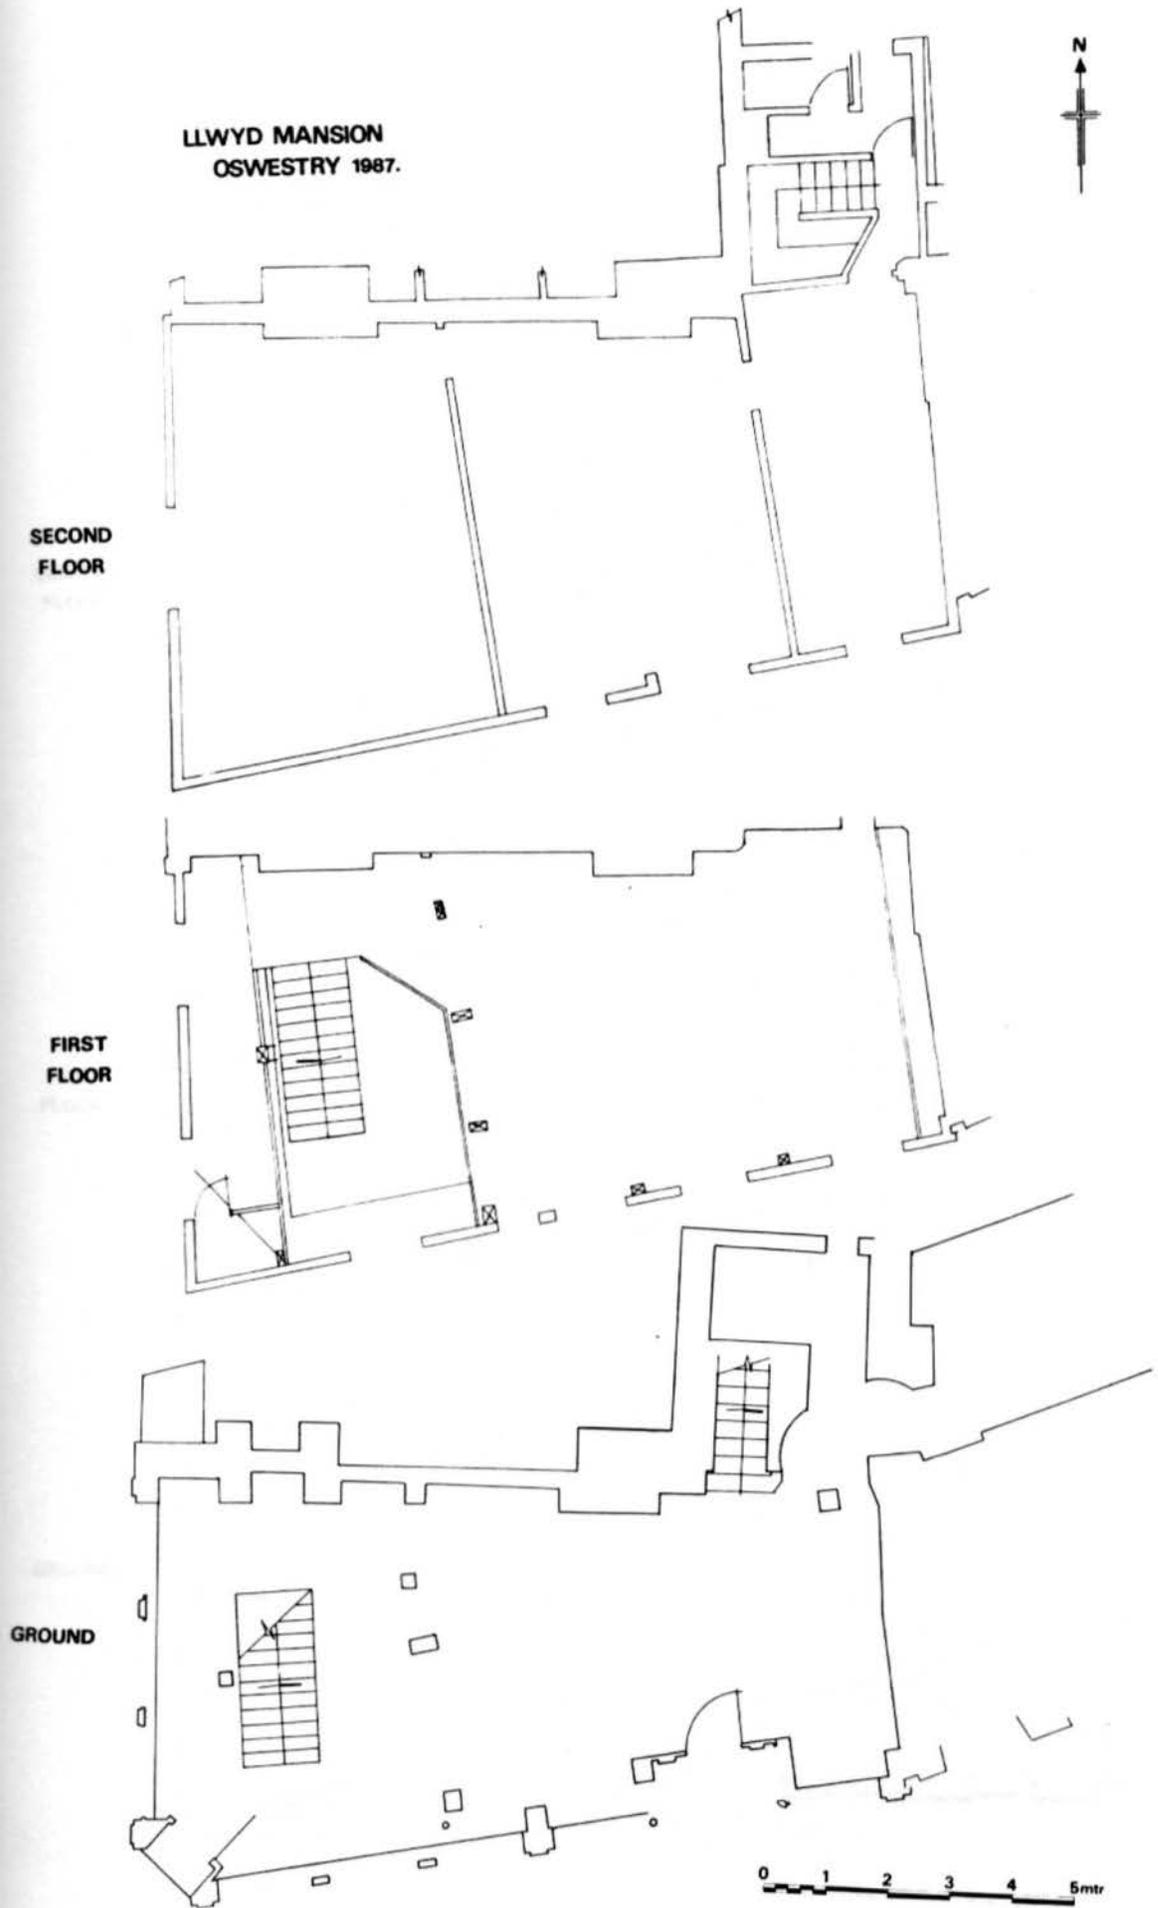
Figure 2 Floor Plans. Internal arrangements - A. Mirza

The cellar is irregular in plan (Figure 2), and of some depth; it lies under the western part of the building, only its southern wall bearing any direct relation to the ground floor plan above, this being parallel to the Cross Street frontage. It would appear originally to have been rectangular in plan, measuring 4.40 metres (east-west) by 3.50 metres (north-south). It is reached by a set of wooden steps, concealed by a trapdoor in the floor of the ground-floor room.

The ground floor is open-plan (Figure 2) and consists of a long room, c. 6.50 metres deep (north-south) in the west and tapering, due to the angled back wall, to 5.50 metres in the east. An arcade post in timber (Figure 5) is jointed into a tie-beam at head height which acts as a support for a wooden staircase at the western end of the room, giving access to the second floor. Access into the building at ground level is by two doorways, one in the angle of the south and west walls, the other, larger, door at the eastern end of the south wall. Both the street frontages are pierced by a series of almost continuous windows. The back, north, wall is built almost entirely of rendered brick while a projection at the north-east corner carries a stair up to the second floor, with a toilet built on the first landing and is quite obviously the most recent addition to the building. The timber framing of the east wall is now exposed (Figure 9), the panels between the timbers being infilled with brick. A number of modern brick trusses have been inserted at this level (see architect's plans).

The first floor is once again undivided and somewhat characterless (Figure 2). It is lit by two windows in the west wall and five in the long south wall; the timber framing is exposed along both of these faces whereas at ground floor level it had been largely destroyed. There is no access from first to second floor.

The second floor is divided into three rooms. Access into the first room in the east is gained via a staircase from the ground floor at the north-east corner, and from there the other two rooms are reached (Figure 2). The first room is lit by a single window in the south wall, the larger second room by two in the same wall face and the third room by two windows, one in each of the south and west wall faces. The third room is noteworthy for the fact that heavy braces extend out from the wall frame into the room, though they do not block the passage into the eastern end of the room. A chipboard ceiling has recently been inserted across the two eastern rooms and part of the westernmost room.

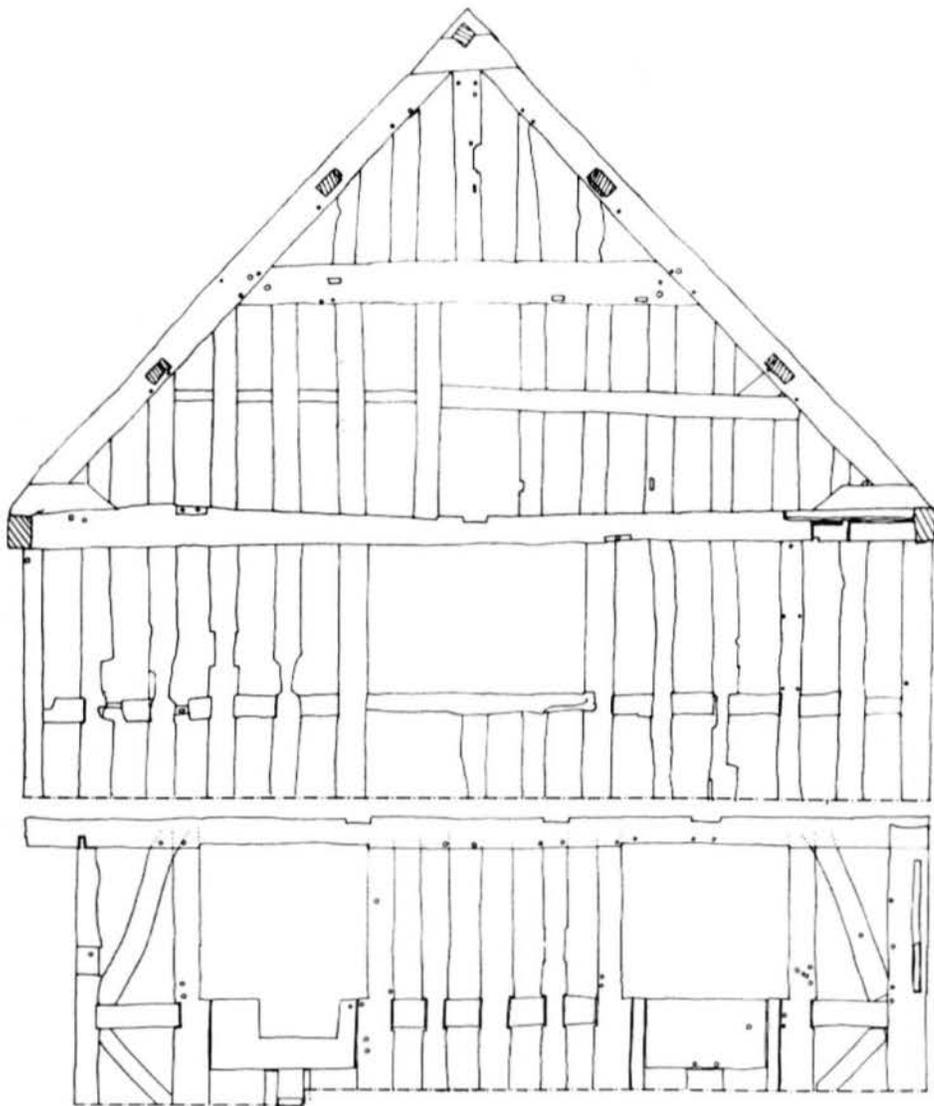
Figure 4 Roof. Truss No.1 [Archive] - J. Sterenberg et al.

For the purposes of description the beam sets have been numbered 1-6, No.1 being the western gable end and No.6 the eastern end. The terminology employed is that recommended by Cordingley. The roof, as it now exists, is of the Butt-Purlin Tie-Beam Truss type, Cordingley Type V (Cordingley 1961, Figs. 11,12), and is an elaborate version of his sub-type V4b. In this construction the main, frame posts support a substantial, arched tie-beam into which are jointed the principal rafters which form the truss, these being further strengthened by a collar-beam and a pair of queen struts. Two sets of pairs of angled braces, one above the tie-beam and another above the collar, give further support. The truss acts as both a principal and common rafter, the butt-side purlins being in pairs to support the common rafter couples which vary in their thickness. The ridge purlin sits in the angle formed by the principal rafters. Short, cusped braces in pairs link the upper side purlins to the collar-beams and the lower to the tie-beams. The roof construction is consistent for beam sets Nos.2-6, indeed the carpenters' marks recorded for these beams indicate contemporaneity; No.2 [//, variant //, ✱ in centre of tie-beam]; No.3 [///, no variant, X in centre of tie-beam]; No.4 [////, variant ////]; No.5 [/, variant /]. There are no marks on the eastern end set (No.6) nor on No.1 to the west. While No.6 is structurally identical to Nos.2-5, No.1 is strikingly different. While the trusses of No.1 are at the same 40 degree angle as the others they are not connected by the side purlin sets to No.2; indeed, these purlins end with a chamfer stop on the east side of No.2, with a Jones Type 1A die-out stop (Jones 1971, 12). Two stout, square-sectioned beams, running east-west and attached to the underside of the tie-beam by iron collars, link beam-sets No.1 and No.2 and side purlins of a different type carry the common rafter-couples westwards beyond beam-set No.2.

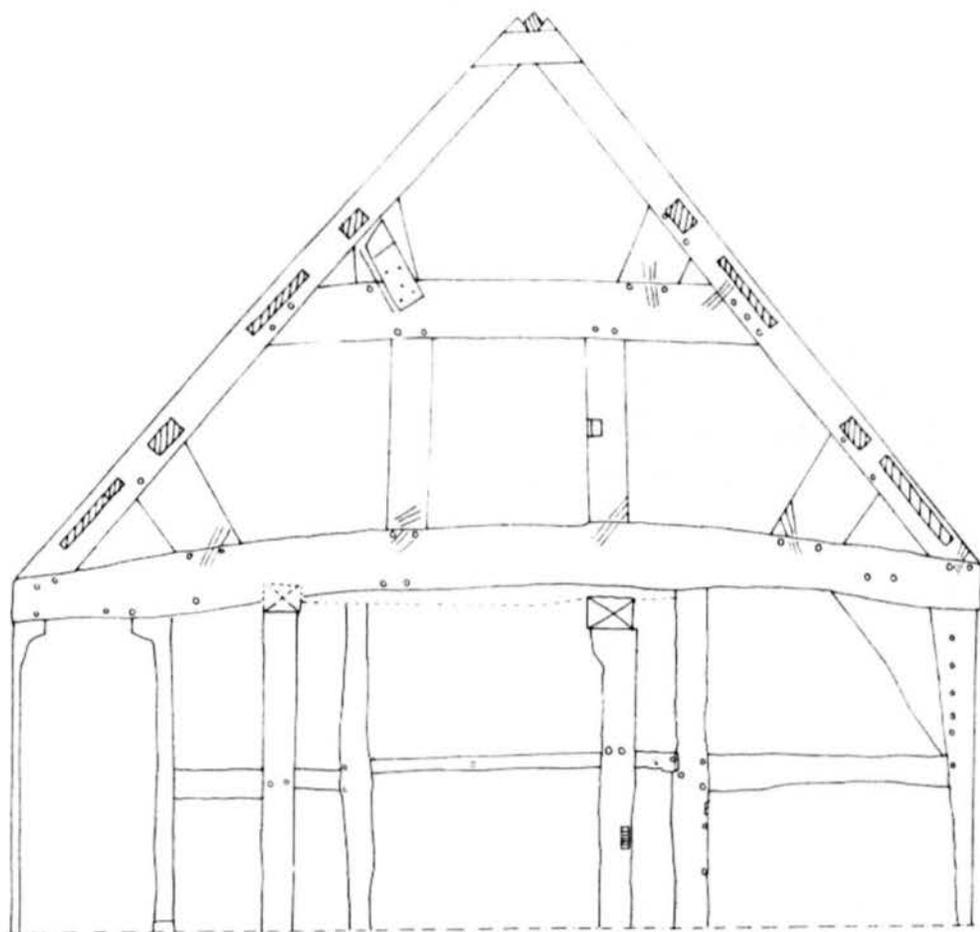
Figure 6 Roof. Truss No.3 [Archive] - J. Sterenberg et al.

The timber framing and door arrangements that form the screens at second-floor level, extending down from the tie-beams of sets Nos.3 and 5, appear much altered - as especially evinced by the numerous empty dowel holes in No.3 and inserted repair timbers - but there is no reason to suppose that these screens are not contemporary with the main part of the roof structure.

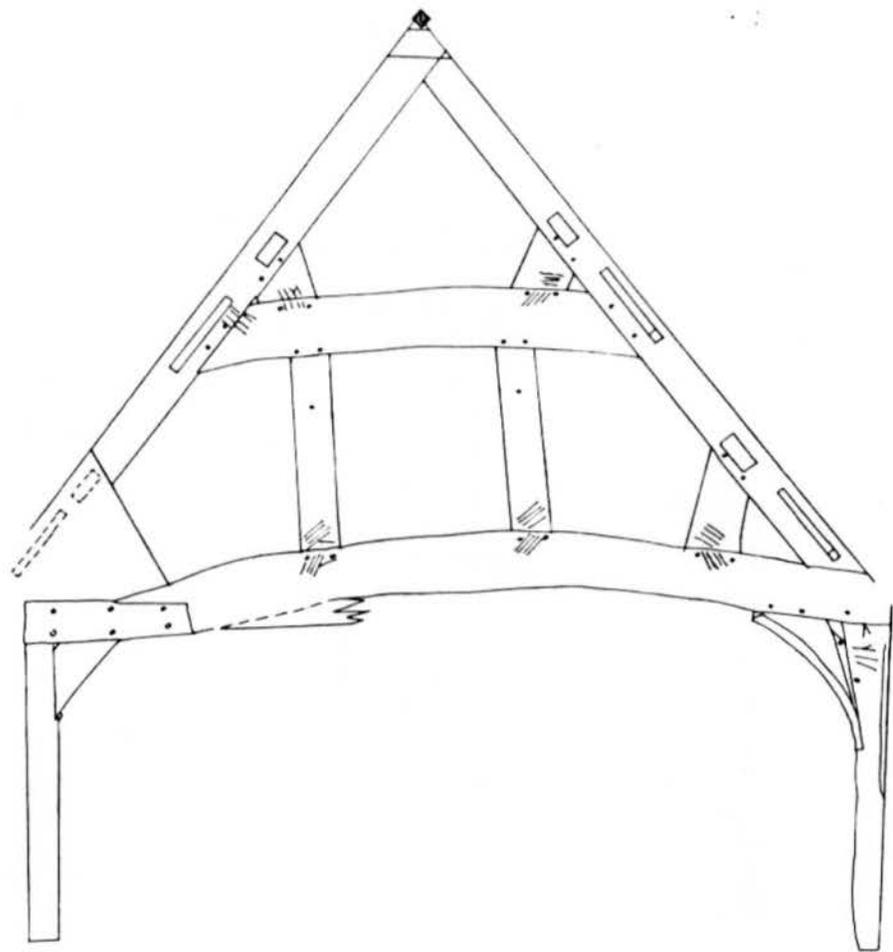
Figure 7 Roof. Truss No.4 [Archive] - J. Sterenberg et al.

This leaves for discussion the timbers exposed at ground- and first-floor level. Those belonging to the framing of sets Nos. 3,4,5 have either been removed or are obscured by the extensive alterations that have taken place along the north wall of the building. However, much of the lower framing associated with No.2 has survived and it is immediately apparent from the style of the carpentry that this lower timberwork bears no resemblance to that visible on the first floor and in the roof. So little remains that it is difficult to understand in isolation. A plain, vertical post rising from ground-floor level is jointed into a horizontal tie-beam and the joint strengthened by two arch braces. A matching brace survives on the north wall at the same height and an empty dowel betrays the position of another on the south wall. Rising from the tie-beam is a much more elaborate vertical member, with chamfered sides and a moulded capital. This capital has another post jointed into its top but this is cut off and obscured by the floor separating the first and second storeys. A brace is again present against the north wall but none is visible in a matching position on the south wall. These arcade posts are intriguing but any arched timbers would have been expected to spring from a timber carrying up the line of the chamfered arcade post to a roof tie-beam and, of course, such a timber is now not present and the argument is entering the realms of speculation. Empty dowel-holes along the lower tie-beam suggests the fixing of a wooden staircase here, more or less in the position of the present stair. The timbers that form the ground and first floors of Set No.6 (the eastern end of the building) are again noticeably different from the upper timberwork and are remarkably rough-hewn and unfinished; there is no doubt that such timbers were never intended to be so stripped bare. Their seemingly ramshackle alignment, contrasted with the well-coursed, horizontal infilling of the panels between the beams, produces an effect akin to that produced by op-art and to certain works of Bridget Riley -

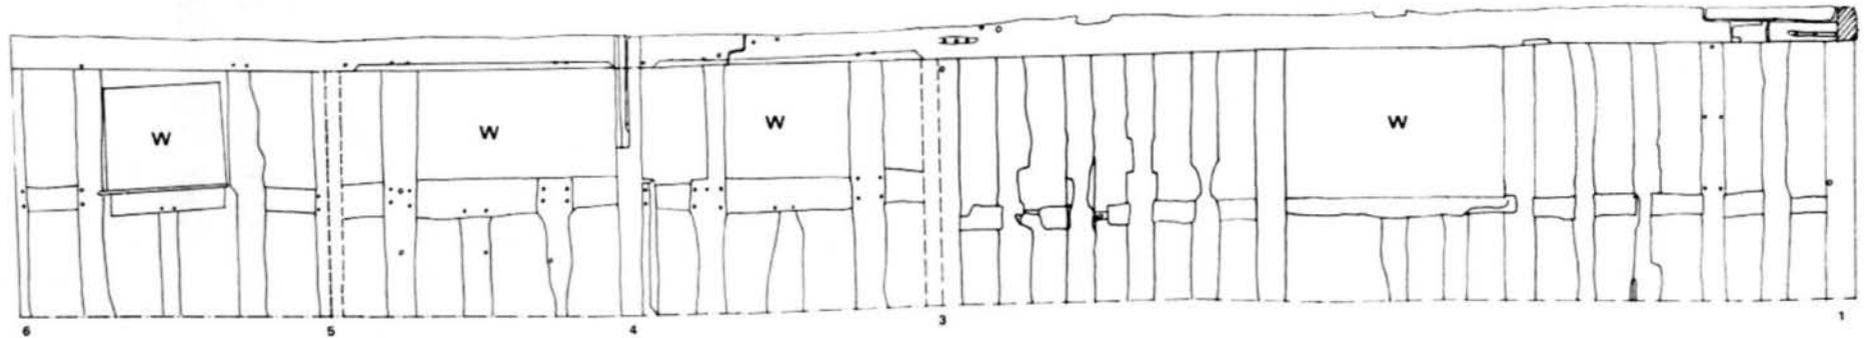
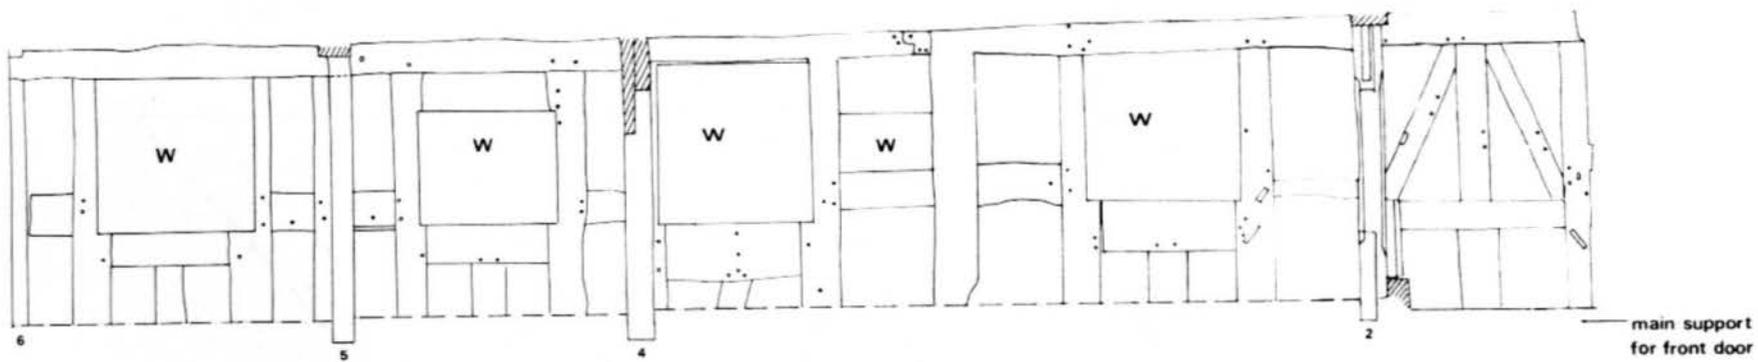
Figure 10 Framing. Southern elevation [Archive] - J. Sterenberg et al.

contrasting horizontals and verticals jockeying for attention. A recent brick truss hides activity at the side of the south wall, and the only noteworthy feature is on the first floor where timbers suggest there has been a window opening in the bottom half of the third panel to the north. At the western gable-end, as will be demonstrated below, the whole facade must be treated with the greatest suspicion. Though much of the timberwork at first-floor level, especially that of the windows, resembles that in the eastern gable, the timberwork above, with its numerous empty dowels, sockets and joints, with obvious repairs, replacements and inconsistencies, sows doubts, creates suspicions and questions the antiquity of the present arrangement.

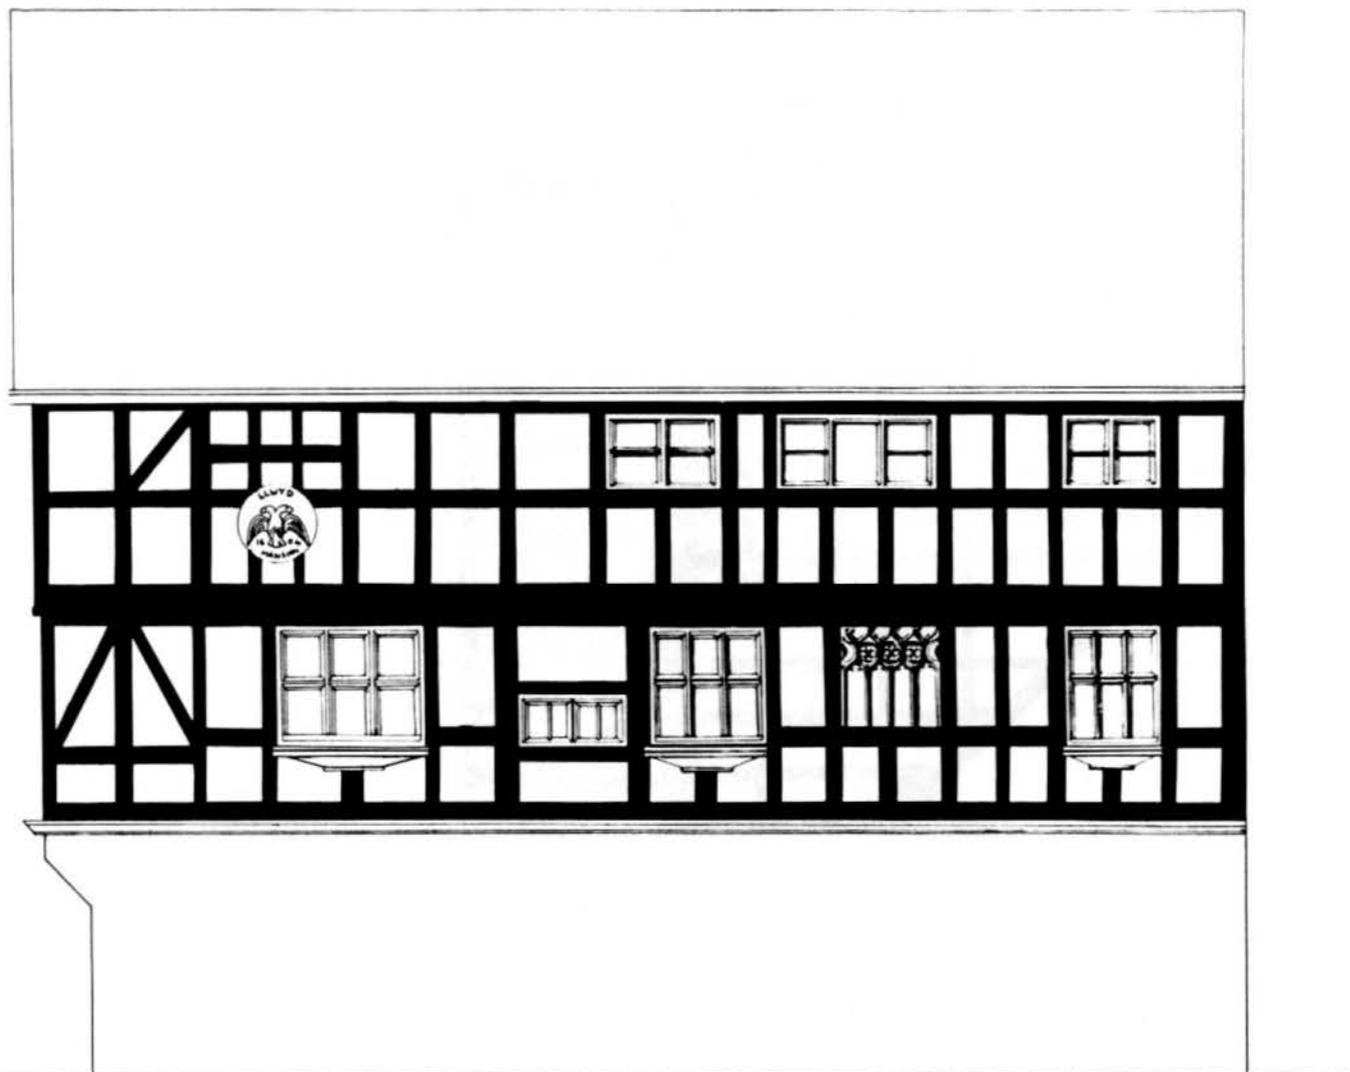
Figure 15 Southern elevation onto Cross Street - A. Mirza

The long, Cross Street, elevation (Figure 15) again is timber framed with studding and rails but the stressing of the horizontal with bressumers is here much more pronounced. On the ground floor, vertical oak pillars break up the monotony of the shop front, and above, at first-floor level, are three, large windows with pronounced projecting sills, (these had also been noted at first-floor level on the west elevation) and, most notably, a fine, elaborate and intricate window divided up into four lancet shaped lights; in the spandrel between each light are more cut-out panels forming

the head of the window frame. The windows on the upper face are largely characterless. Towards the western end of the building is a circular plaque displaying a two-headed eagle and the inscription LLWYD MANSION 1604.

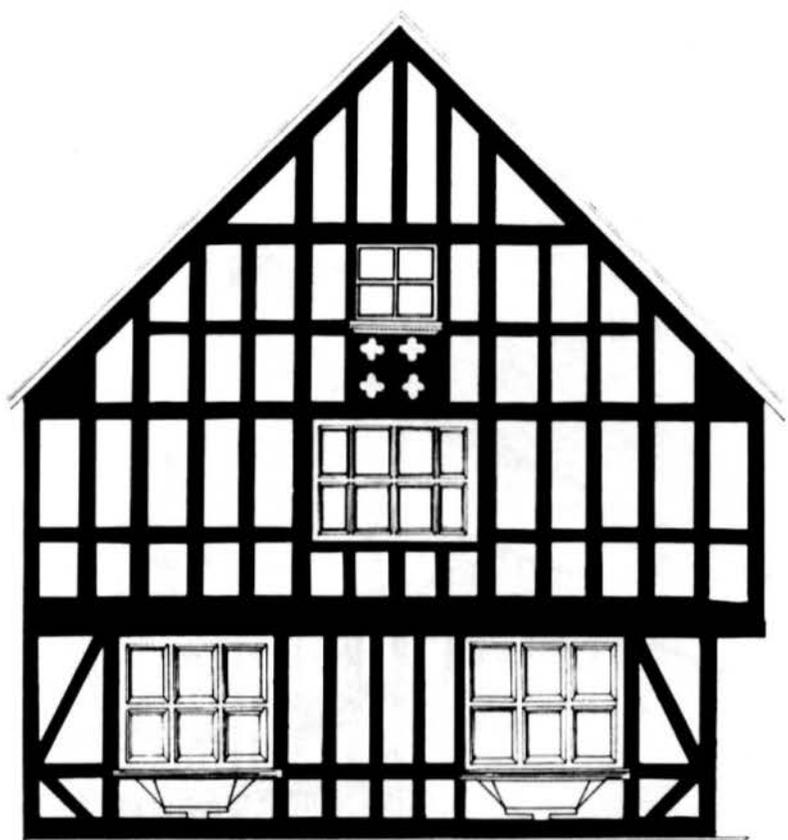
Bailey Street Elevation

Only two elevations are now presented to view. The Bailey Street, west elevation, (Figure 16) displays the gable-end of the structure, the whole, with the exception of the ground floor with its more-or-less continuous shop window, being timber framed with close studding and a number of angled braces. This elevation is divided at first-floor level by a substantial bressumer that carries out a jettied second floor. In the central lower part, under the gable, is a small wooden panel with four, cut-out, quatrefoil panels.

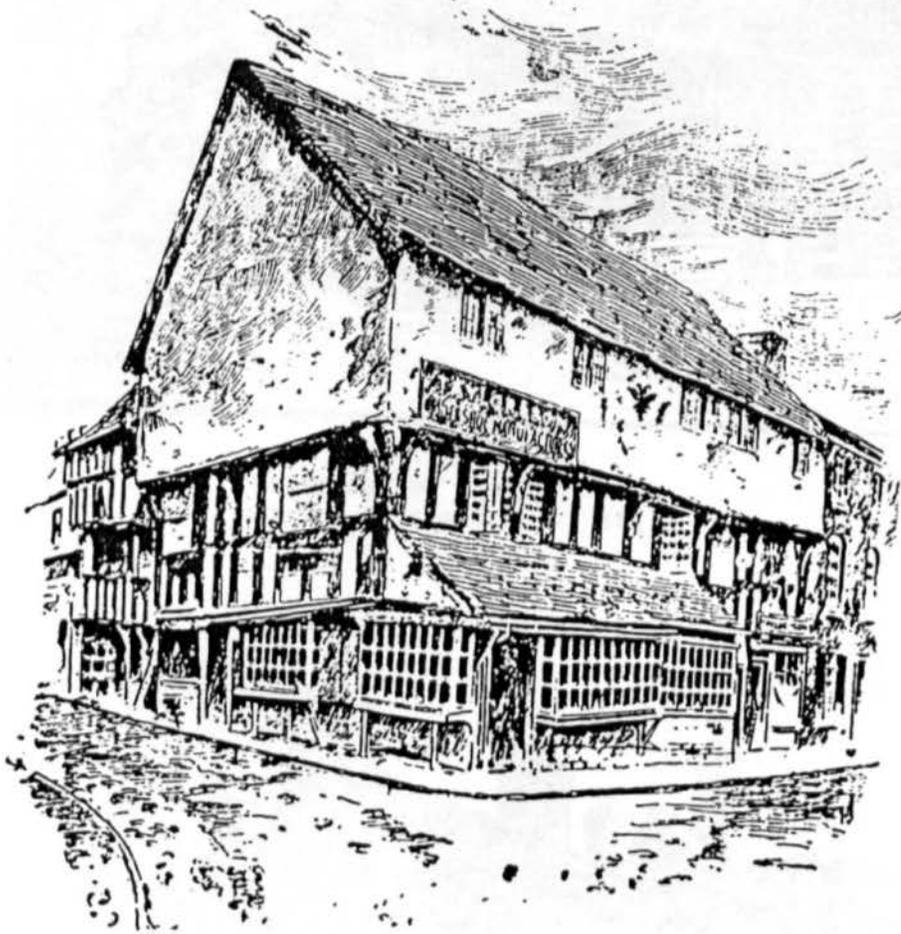
Figure 17 Drawing of Llwyd Mansion before 1875 renovation.
[Source Watkin 1920, 212]

Unusually for a town of its size with so many buildings of interest, Oswestry has largely escaped the attention of the early draughtsman and illustrator and it is only from the later nineteenth century onwards that Llywd Mansion receives attention and then principally from the photographer. An illustration from some time in the period 1860-1875 (Figure 17 - full reference to source given in list of illustrations) shows a splendid view of the building looking somewhat sprawling and dilapidated. The whole of the Cross Street frontage at second-floor level and the equivalent and upper part of the Bailey Street gable is windowless and rendered. This probably took place in the eighteenth century to avoid the paying of window tax, a ruse employed by many householders at the time. A shop sign and a decorative eagle, different to the eagle sign today and positioned in a different place, are the only other noteworthy features on the drawing above first-floor level. There are no windows on the gable above the second bressumer and four windows on the Cross Street second floor, differently spaced to the ones today, though that at the eastern end may be in the same position. The lower floors are almost unrecognisable; the shop front windows jut out onto the narrow pavement and there are four doorways visible, one doubtless for private rather than commercial use. The gable timberwork at first-floor level is similar to of that today, though of the two boarded-up or shuttered windows here, the northern one appears to be in a more northerly position. A very pronounced post-and-rib support stands between the bressumers at the south-west corner of the building. Much of the first-floor timber, at the west and central end of the building, is obscured by a lean-to roof that covers the bowed shop-fronts along Cross Street but it can be seen that the arrangement and style of the windows is very different to that of today; unfortunately the vantage point of the artist is such that no conclusion on the most elaborate window now present can be made as it is partly boarded-up. A photograph (Figure 18) taken at roughly the same time shows a view concentrated more on the Cross Street frontage. Worth noting is the timber-framed and jettied three-storeyed building just visible at right angles to (and joined to?) Llywd Mansion in Bailey Street and very similar

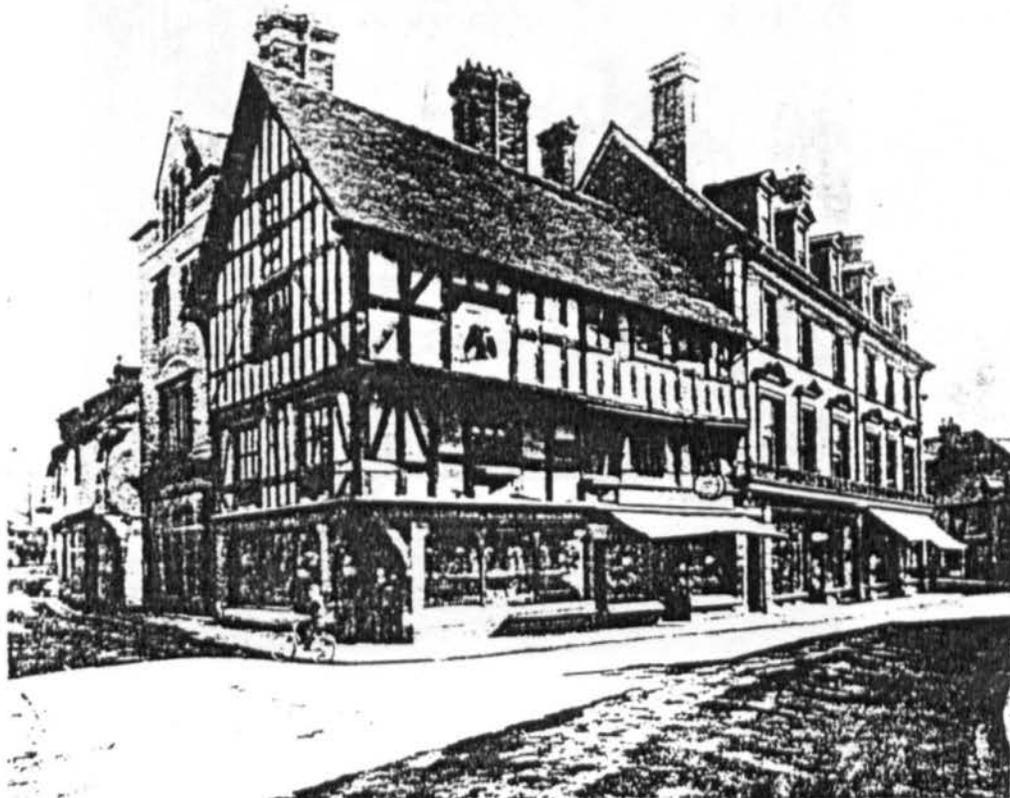
Figure 19 Photograph of Llwyd Mansion after 1875 renovation.
[Source Mitchell n.d., 63]

The next photograph of 1875, (Figure 19) shows Llwyd Mansion, again from the south-west, and the transformation is startling; the building has been completely renovated, as have the buildings and shops next to it in Cross Street. Indeed the timber-framed building in Cross Street has been completely demolished and a sober brick and stone building built in its stead. The shop fronts have been completely refitted and have retreated inwards from the pavement to be flush with the main wall faces. Three doors are visible, only one, at the east end of the Cross Street frontage, being as formerly. The rendering has been completely stripped off the upper storeys and gable and the timberwork looks much as it does today. The arrangement of windows on the first floor is as today, with all boards removed and the intricate window on Cross Street now clearly visible. The windows in the gable are now present while only three to the east are present on the first floor along Cross Street. There appear to be two separate shop fronts, one with a canvas awning, and so the downstairs space may well have been partitioned at this time. It can be noted now how the roof line of the building next to Llwyd Mansion in Cross Street has been substantially altered and raised to usurp the previously dominating status of the timber-framed building next door.

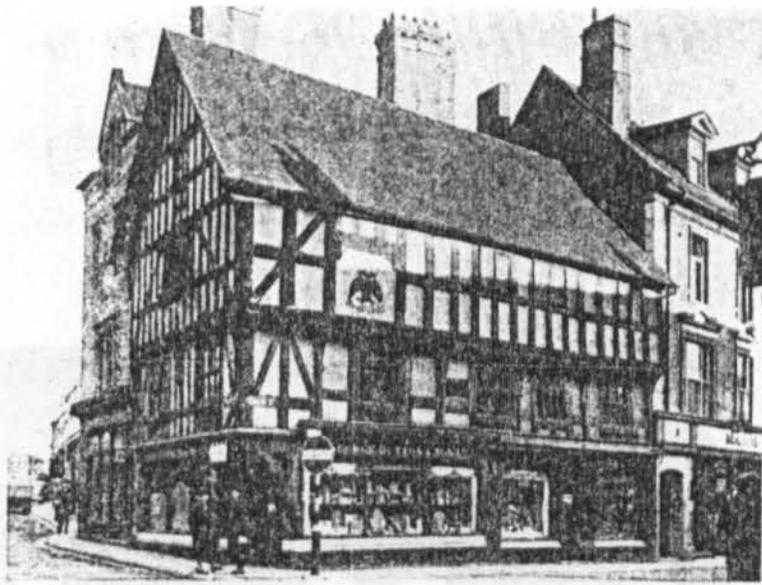
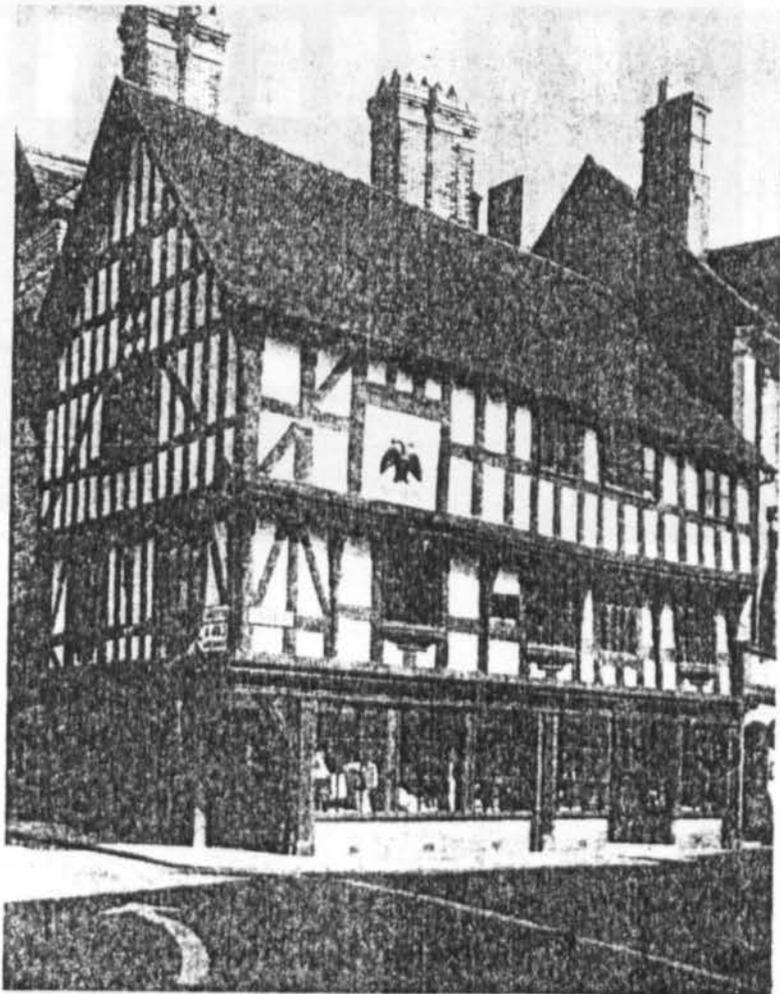
Figure 20 Photographs of Llywd Mansion before and after 1951 renovation.
[Source The Architect and Building News, 6.9.51]

The next three photographs in the series, all undated (Pryce Jones n.d.), show that up to the present time little or nothing has been altered externally save the arrangement of the shop frontages onto Cross Street and Bailey Street. The final, drastic alterations to the shop fronts, before the present campaign of refitting, can be seen in the 'before-and-after' shots of the building (Figures 20) taken in 1950-1951. It will be seen on these pictures that an inscription has now been added to the eagle plaque, and, indeed, with the exception of the replacement of this large square plaque with a less ostentatious circular example (with an extended inscription), little else on the facades above shop level has been changed.

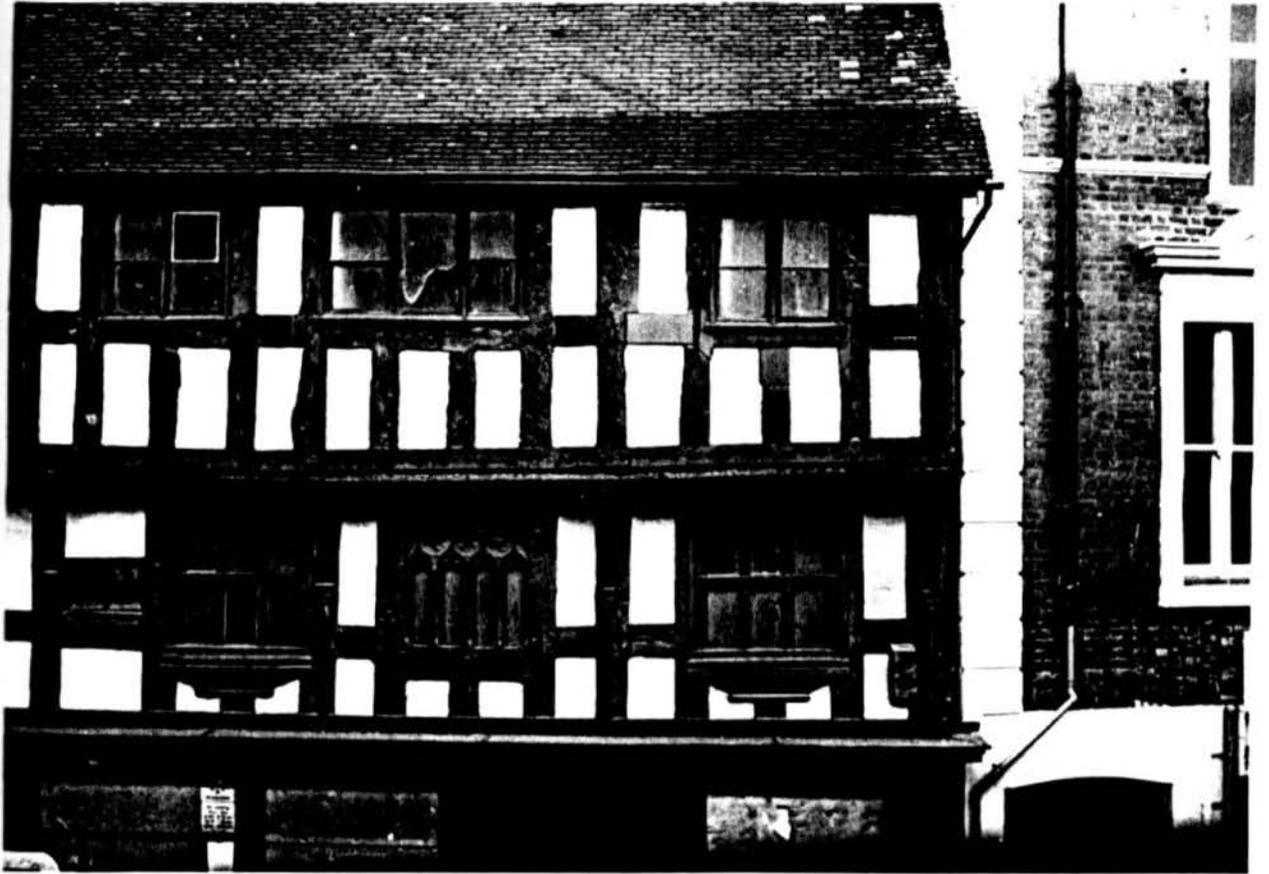
Figure 21 Photograph, 1987, of elaborate window in south elevation.

The windows in the upper part of the gable-end and those at first-floor level are also worthy of discussion. The pre-restoration photograph shows boards or shutters over two first-floor windows under the gable and over the position now occupied by the traceried four-light window. This latter window, from an examination of the surround, would appear from all the evidence to be in situ though there is a modern frame arrangement behind it. Such fine, intricate, wooden windows are rare survivals indeed and a local parallel can be found at the so-called Henry Tudor House on Wyle Cop, Shrewsbury, again with four lights and tracery in the head, original to the house according to one authority (Smith 1953, 280-281), a later insertion according to another (Forrest 1911, 79). One other four-light example with tracery head is known to the writers, from Floris House, Oakham, Rutland, assigned by one authority to the late fourteenth century (Barley 1986, 42 Fig. 15B). Therefore this Oswestry window is likely to be late fifteenth century, if not actually earlier, and will help to phase the part of the building in which it occurs but this will be discussed further below. The next windows to be considered are the five at first-floor level with elaborate projecting, moulded, bases to the frame. Similar windows can be seen at Gibbons Mansion, Wyle cop, Shrewsbury (Smith 1953, pl.130), and Butcher's Row, Shrewsbury (Wood 1965, 221, Fig.68) and they could date from the later sixteenth or early seventeenth century though the suspicion that one or two of them were remodelled during the Leighton renovation still remains. The windows on the second story are all relatively characterless and modern, probably including the large one under the quatrefoil panel. The final window is the small single-light window with two mullion rods on the Cross Street frontage at first floor level; this may have been plastered over at the same time as the upper parts of the house for its style is more likely to be seventeenth century.
