Archaeological Investigation at No.39 High Street, Olney Buckinghamshire, MK46 5QN (NGR SP 888 515)

Planning Application Ref. 12/01359/FUL

December 2012

Souterrain Archaeological Services Ltd

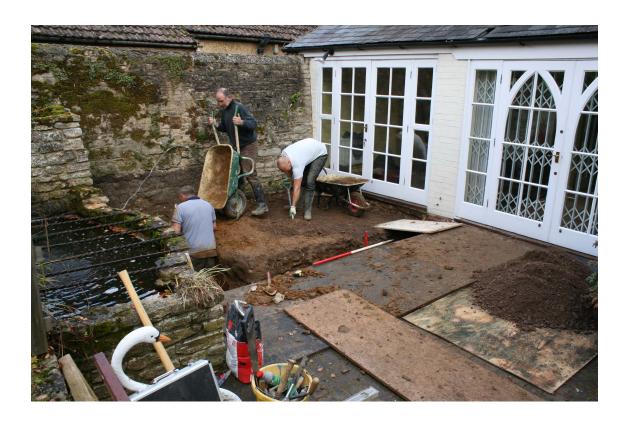
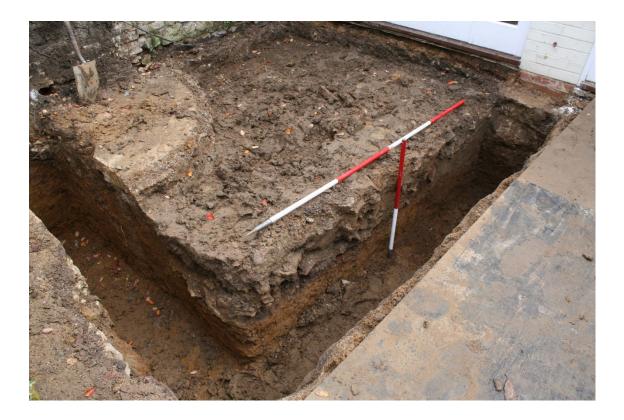
Figure 2. Overviews of the area of investigation. Facing northeast

- The areas of investigation measured approximately 2.4m x 3m (Figs. 2 and 3). A modern patio/yard (001) had been removed in advance, exposing a layer of modern sand and hardcore (002). Excavation of the wall foundation trench for the new extension first exposed a layer of limestone rubble in sandy clayey soil matrix (011), between 0.06m and 0.2m in thickness. There were no finds present. Beneath layer (011) were three pits of medieval date: [004], [007] and [009]. The first significant archaeological horizon was encountered at approximately 50.22m AOD (c.0.29m below the present day ground level of the back yard).

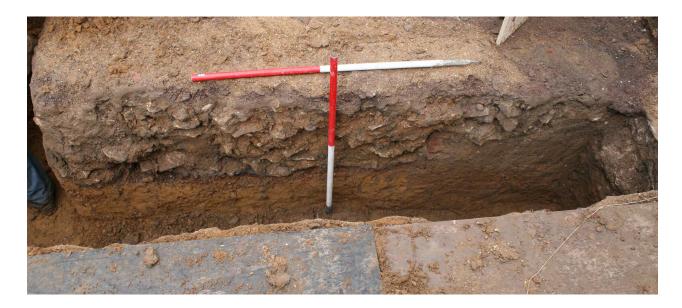
Figure 6. Section 3, facing north

016	DEPOSIT/ ?STRUCTURE	Four stacked fragments of limestone visible in the section only, on the east side of pit [004]. These were deliberately placed, although their function is unknown. They could not be clearly defined in plan due to limited depth of ground reduction.	wi.[004]; ?a.(016); b.(011)	ht. c.0.16m; wid.c.0.1m	Section 3	13 th century	15/16:10:2012

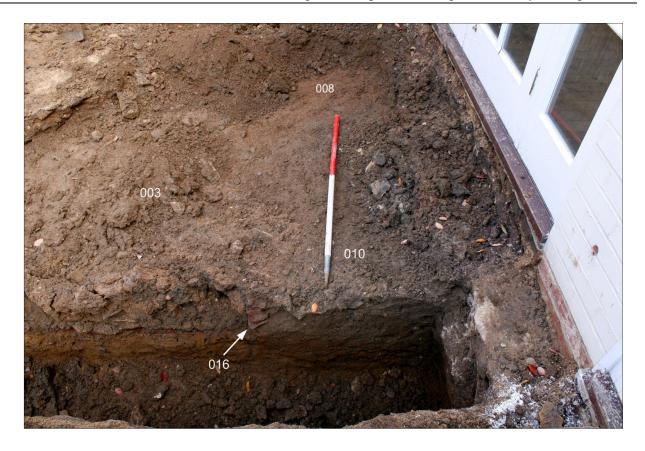
Figure 7. Reduced ground level, revealing medieval pits [004] and [009]. Facing north

- 6.3 The earliest features were **pit [009]** and **pit [007]** which may have been contemporary. These had been cut into the geology (008), the latter which was comprised of dark yellowish-brown sandy clay. **Pit [009]** was partially exposed in plan (Figs. 3 and 7). It continued to the east beneath the existing house extension (Fig. 4, Section 3) and to the south beneath the patio (Fig. 4, Section 1, contexts [005]/(015)). It was at least 2m in length and 0.4m in width and more than 0.6m in depth. Only its west side was visible in section, which was inclined at c.50°. Its fill comprised mid to dark brown sandy soil (010). Two sherds of locally-produced coarse pottery were recovered (Table 1), suggesting a date of 12th / 13th century for the pit. The function of the pit is uncertain. **Pit [007]** was visible only in the north-facing section (Fig.4 Section 1 and Fig.5). Its east side was stepped down at 60° and 15° whilst its west side was steeply inclined at c.70°. It had a flattish base and an overall depth of 0.38m. The fill (006) consisted of mid to dark brown gritty sandy soil with occasional charcoal flecks. It merged with the fill of pit [009]. There were no artefacts present.

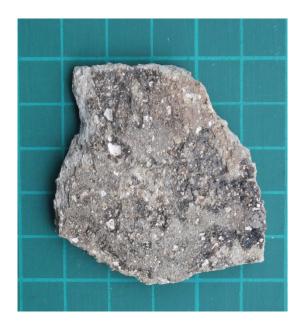
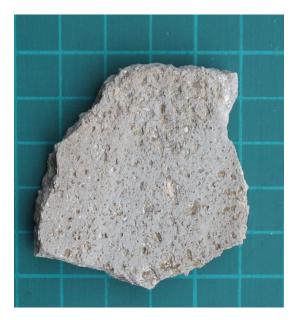
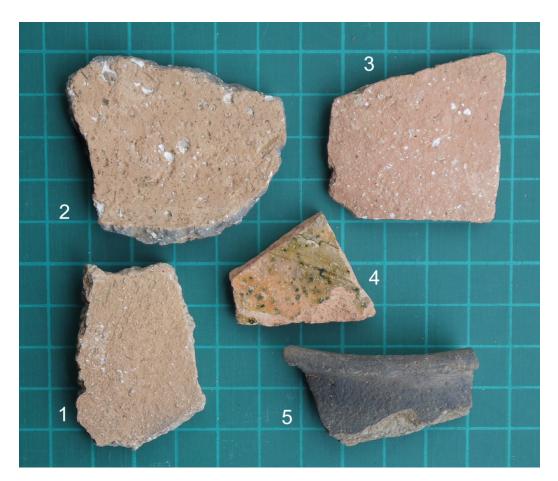
Figure 9. Pottery.

Top. Context (010). Sherd of $12^{th}/13^{th}$ century cooking ware with very degraded surfaces context (left: exterior, right: interior). This is a locally-produced ware from at Olney Hyde, Bucks (Beds B05; OH 'A'; / MK MC 3).

Bottom. Context (003). Nos. 1 to 3: 12th/13th century cooking ware in Olney Hyde 'A' fabric (Beds B05; MK MC 3). No.4:, piece of 13th century lead-glazed, jug or baluster from Brill, Bucks (Beds C09 / MK MS9). No. 5: rim of 13th century sandy ware cooking pot.

- 7.1 The medieval pottery identification and dating was done by Martin Wilson with confirmation by Jackie Wells MA. The sherds in the catalogue (Table 1) are arranged by Context Number. A total of seven medieval pottery sherds (80 grams) were recovered during the investigations from stratified contexts (Table 1). The pottery broadly dates to the 13th century. There is an overall minimum vessel count (MNV) of four (Table 2).
- 7.2 The assemblage consists of fragments of coarse ware cooking pots and dishes, a sandy medium grained ware which was produced locally at Olney Hyde²², Buckinghamshire and a single sherd from a jug or baluster from Brill in Buckinghamshire. The vessels represent household waste deposits. Specific sherds are shown at Figure 9.

- 8.2 Three intercutting pits were partially revealed. The earliest of these were pits [007] and [009]. Two sherds of locally-produced (Olney Hyde) cooking ware provide a 12th / 13th century date for pit [009]. One of the sherds had very degraded surfaces, most likely as a result of being in contact with a caustic substance (Fig.9, top). The sandy clay fills of these pits suggest that they were not dug for the disposal of rubbish.
