Archaeological Investigation:  
Sewage Treatment Plant  
& Foul Drainage Pipeline  
Heckfield Place  
Heckfield, Hook, Hampshire  
(NGR SU 737 616)

Planning Application 12/01367/FUL

**ARCHAEOLOGICAL INVESTIGATION:  
SEWAGE TREATMENT PLANT AND FOUL DRAINAGE PIPELINE  
HECKFIELD PLACE  
HECKFIELD, HOOK, HAMPSHIRE  
(NGR SU 737 616)**

Souterrain Archaeological Services Ltd  
Project code: SOU10/13-144

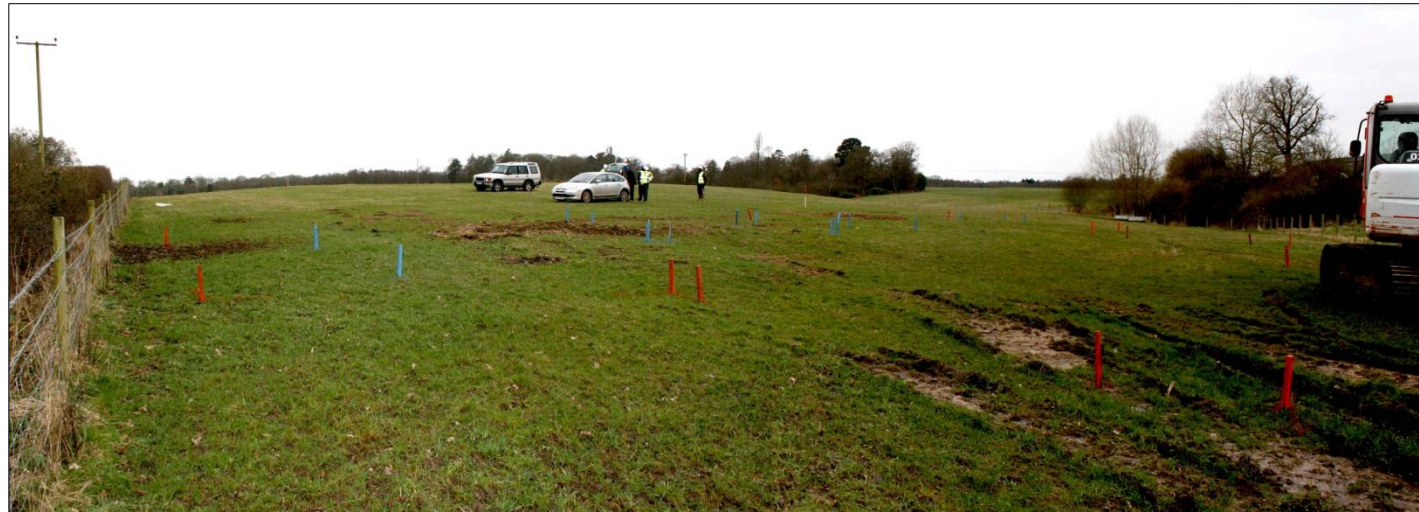
**Figure 8.**

**Pre-excavation view of  
Area A, March 2013,  
Facing S**

- 3.2 Prior to construction groundwork the site of the plant was open land under grass and used for grazing livestock (Figs 8 and 9). Similarly the pipeline was constructed throughout open grazing land of The Park.

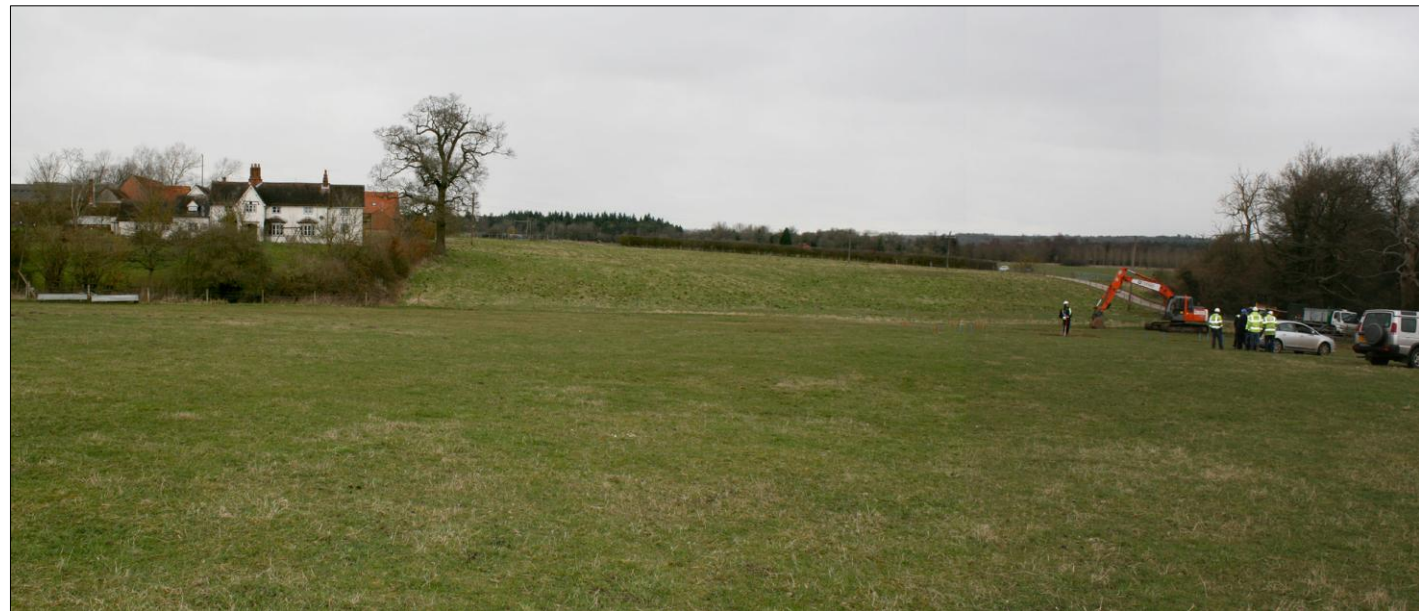
**Figure 9.**

**Pre-excavation view of  
Area A, March 2013,  
Facing N; Park Farm to left**

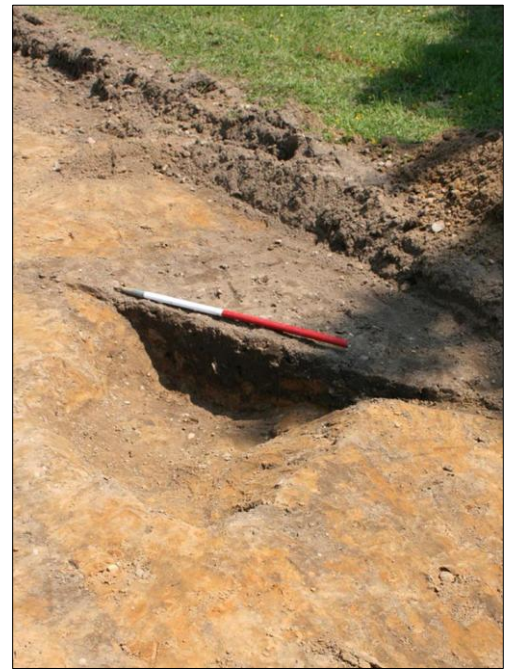
Figure. 18. Feature [030], Section 9

- 7.11 **Feature [030].** (NGR 473287, 161296). Figure 18, Section 9. This feature was irregular in plan (c.1.7m wide by over 1.5m) with steep irregular sides and a concave base with extrusions. It was partly exposed, the remainder continuing beyond the baulk. It was between 0.1m and 0.5m in depth. It contained a single fill (031) of dark greyish brown silty sand from which small fragments of ceramic building material (probably roof tile) were recovered. It was interpreted as a possible pit of unknown date.

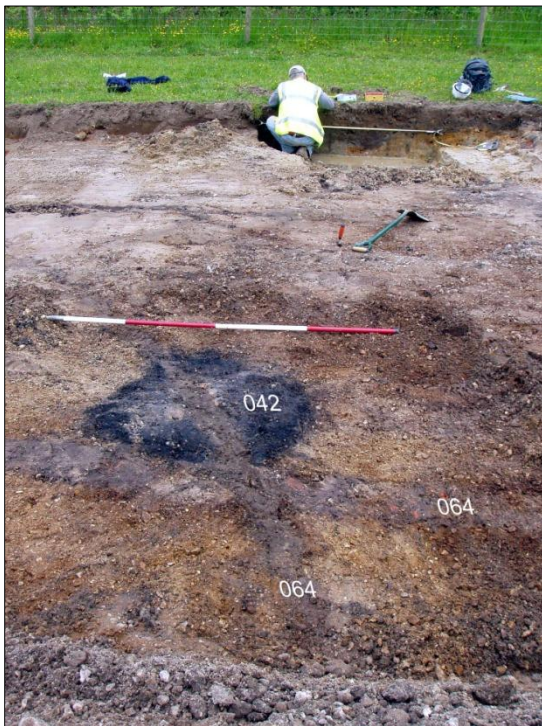
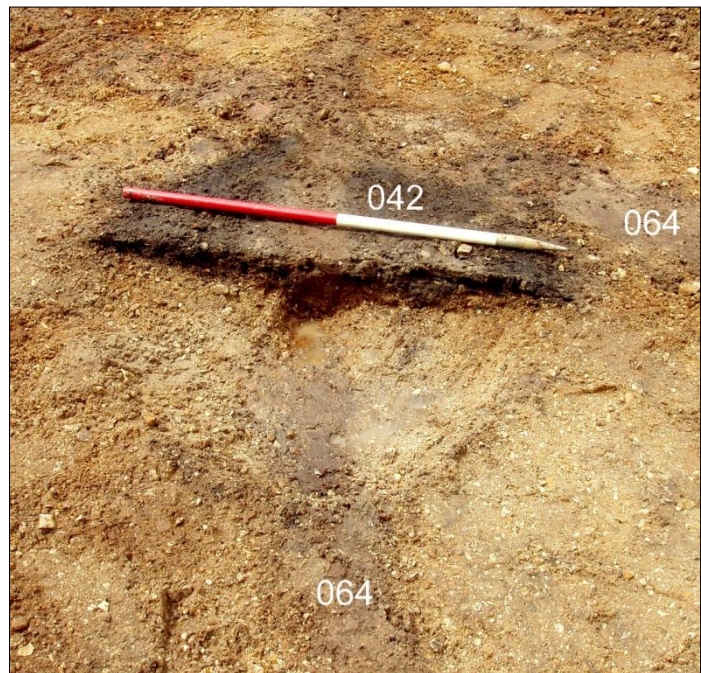
**Figure. 20. Area B. Top: Post medieval drainage [038], showing location of Ditch [039] (Section 11) and pit [034]. Bottom left: overview. Bottom right: Pit [041], Section 12**

- 7.17 **Post-medieval drainage system [038].** (NGR 473387, 161380 to 473402, 161395). Figures 16 and 20, Sections 11 and 12. Exposed over an area of c.165sq.m, this was a remnant of herringbone underdrainage system. It was concealed beneath a layer of soil (036) which was presumably deposited in the turning area a horse-drawn plough team at the end of each subsoiling plough-run. The remains were evidently part of a much more extensive drainage system which has not survived. They comprised two parallel drains, each 0.2m in width, aligned NE-SW, which were fed from a series of lateral drains.

- 7.18 Each drain contained un-mortared red brick rubble in a matrix of dark brown silty soil (064). Some of the bricks had vitrified /glazed faces, not dissimilar to those used the original part of the stable block at Heckfield Place, and of a type found elsewhere in the estate<sup>11</sup>. Despite the great quantity

of brick rubble exposed, only two dimensions could be determined (all were broken): 105mm (4¼") x 58mm (2¼"), these measurements were fairly consistent. Notably, the dimensions of bricks used in the stable block are comparable: 215mm (8½") to 220mm (8¾") x 100mm/ 105mm (c.4"/ 4¼") x c.58mm (2¼"). The bricks used in Heckfield Place mansion house, however, generally measure 220mm (8¾") to 224mm (9½") x c.105mm (4¼") x c.68mm (2⅝"), none of which are vitrified. It is therefore quite likely that the bricks used for in-filling underdrainage (i.e. context [038]) represent material left over from the construction of farm buildings. The land drainage rubble also contained occasional fragments of red ceramic roof tile. The drainage system is likely to have been created sometime between 1819 and 1840 since it does not appear in the detailed drainage plan of the earlier date, at which time this area appears as open shrubland. The original depth of each drain is likely to have been 30 inches (0.762m) (*post*.9.7). Where sectioned (Figs.20 and 21), they survived to depths between c.0.14 and c.0.25m, thus demonstrating the severity of impact of agricultural land improvement processes in this part of The Park.

- 7.20 **Pit [041].** (NGR 473394, 1613910). Figure 20, Section 12. This was a truncated a pit, c.0.1m in depth which was presumably originally cut from a much higher level. It was cut by the mid-19<sup>th</sup> century drainage system. A single fill (042) was discernible comprised of dark brown to black sandy silty soil. There were no finds present and its date could not be determined.

- 9.7 The structure of each drain recorded during the archaeological investigation belonged to a type known as 'Rubble Drain', in this case, filled with unused broken bricks. Such drains of the period were constructed to standard measurements: 30 inches (c.0.762m) deep and 5 inches (0.127m) wide at the bottom<sup>21</sup>. The rubble layer was laid 1 foot (c.0.3m) thick, following which 1 to 2 inches (0.025-0.05m) were allowed "*for sods to be placed on the surface to prevent earth from filling the drains and 16 inches [0.4m] for clearing the drain for tillage*"<sup>22</sup>.

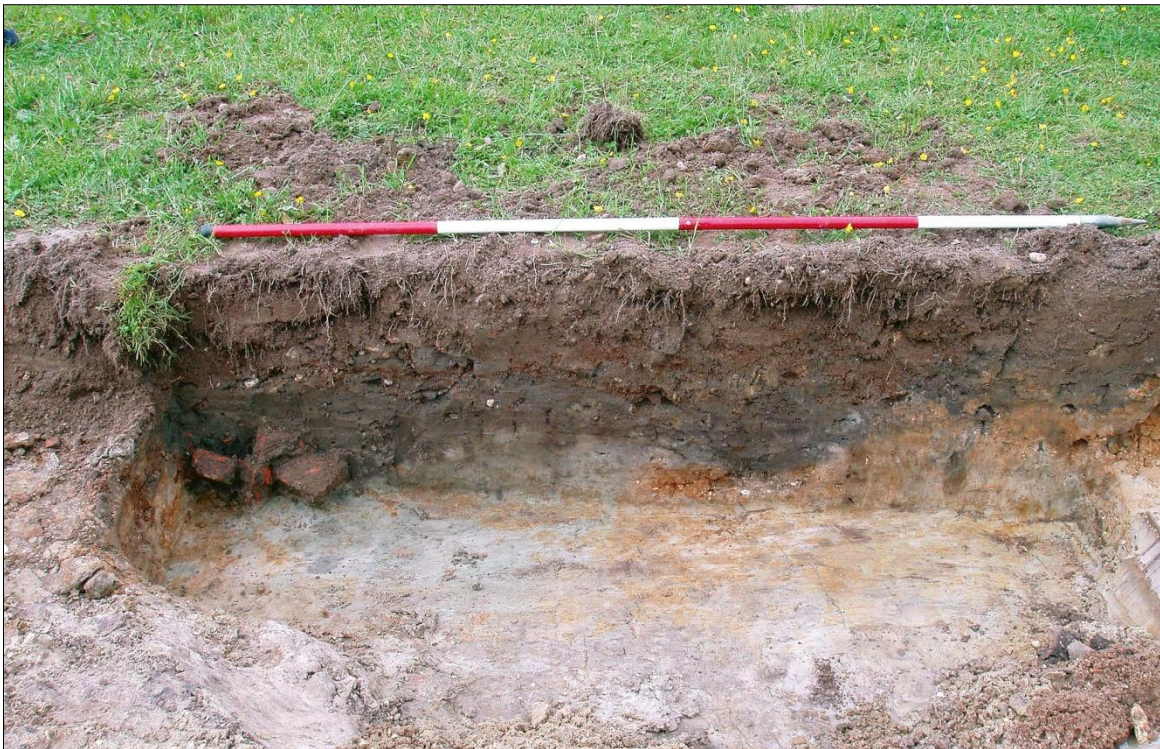
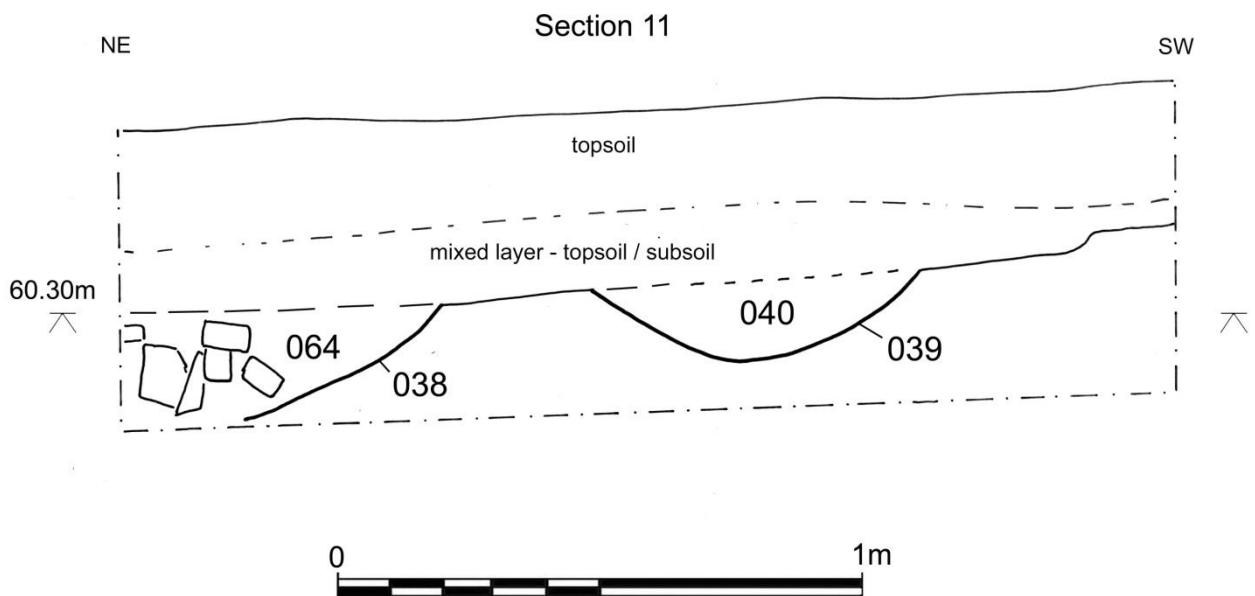
Figure. 21. Section (11) through ditch [039] and post-medieval drainage [038]

- 7.19 **Ditch [039].** (NGR 473388, 161390 to 473396, 161386). Figures 20 and 21, Section 11. The lower remains of a ditch, aligned NW-SE was cut by the mid-19<sup>th</sup> century drainage system [039]. Where sectioned, it was c.0.6m wide, with a concave profile, and survived to a depth of c.0.2m; the ditch was presumably dug from a much higher level. Its date could not be determined. There were no finds present. It does not appear on the 1819 estate map which is understood to preserve an earlier field system (*post*. 9). It was presumably either a field boundary or a drainage ditch.

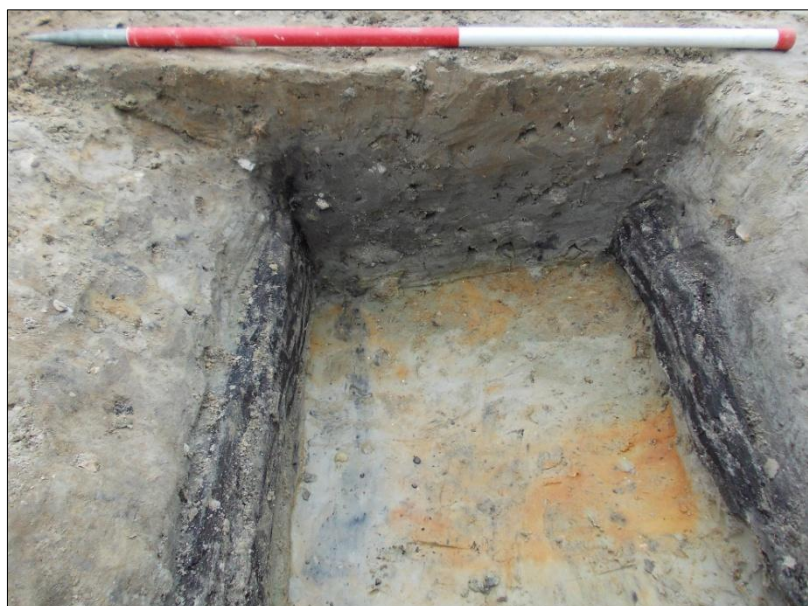
**Figure. 25. Area C.**  
**Wood-lined water channel**  
**[045], Section 14.**  
**Right: Section 14, facing NE**

- 7.23 **Wood-lined Channel [045].** (NGR 473553, 161447 to 473564, 161456). Figures 23 and 25. Located approximately 30m northeast of the perimeter fence of Little Binfield Coppice<sup>13</sup>, this was a steep-sided linear cut, c.1.1m in width and 0.43m in depth, which ran across the width of the stripped easement on a NE-SW alignment. The lower sides of the feature were lined with wooden planks. It contained two fills. The primary fill (046) was very compact dark blue-grey silty sand, up to 0.33m in thickness. The upper fill (047) was c.0.19m in thickness and generally about 1.1m in width, spreading outwards beyond the north side of the cut of the channel. It comprised mid-greyish-brown silty sand with abundant sub-angular stones, (<0.01m), which was probably a
