**An Archaeological Watching Brief  
At The Church of St James,  
Liverpool.  
(NGR SJ 3527 8904)  
Site Code 143**

*M. Adams*

*Produced for William Anelay Ltd*

*June 2012*

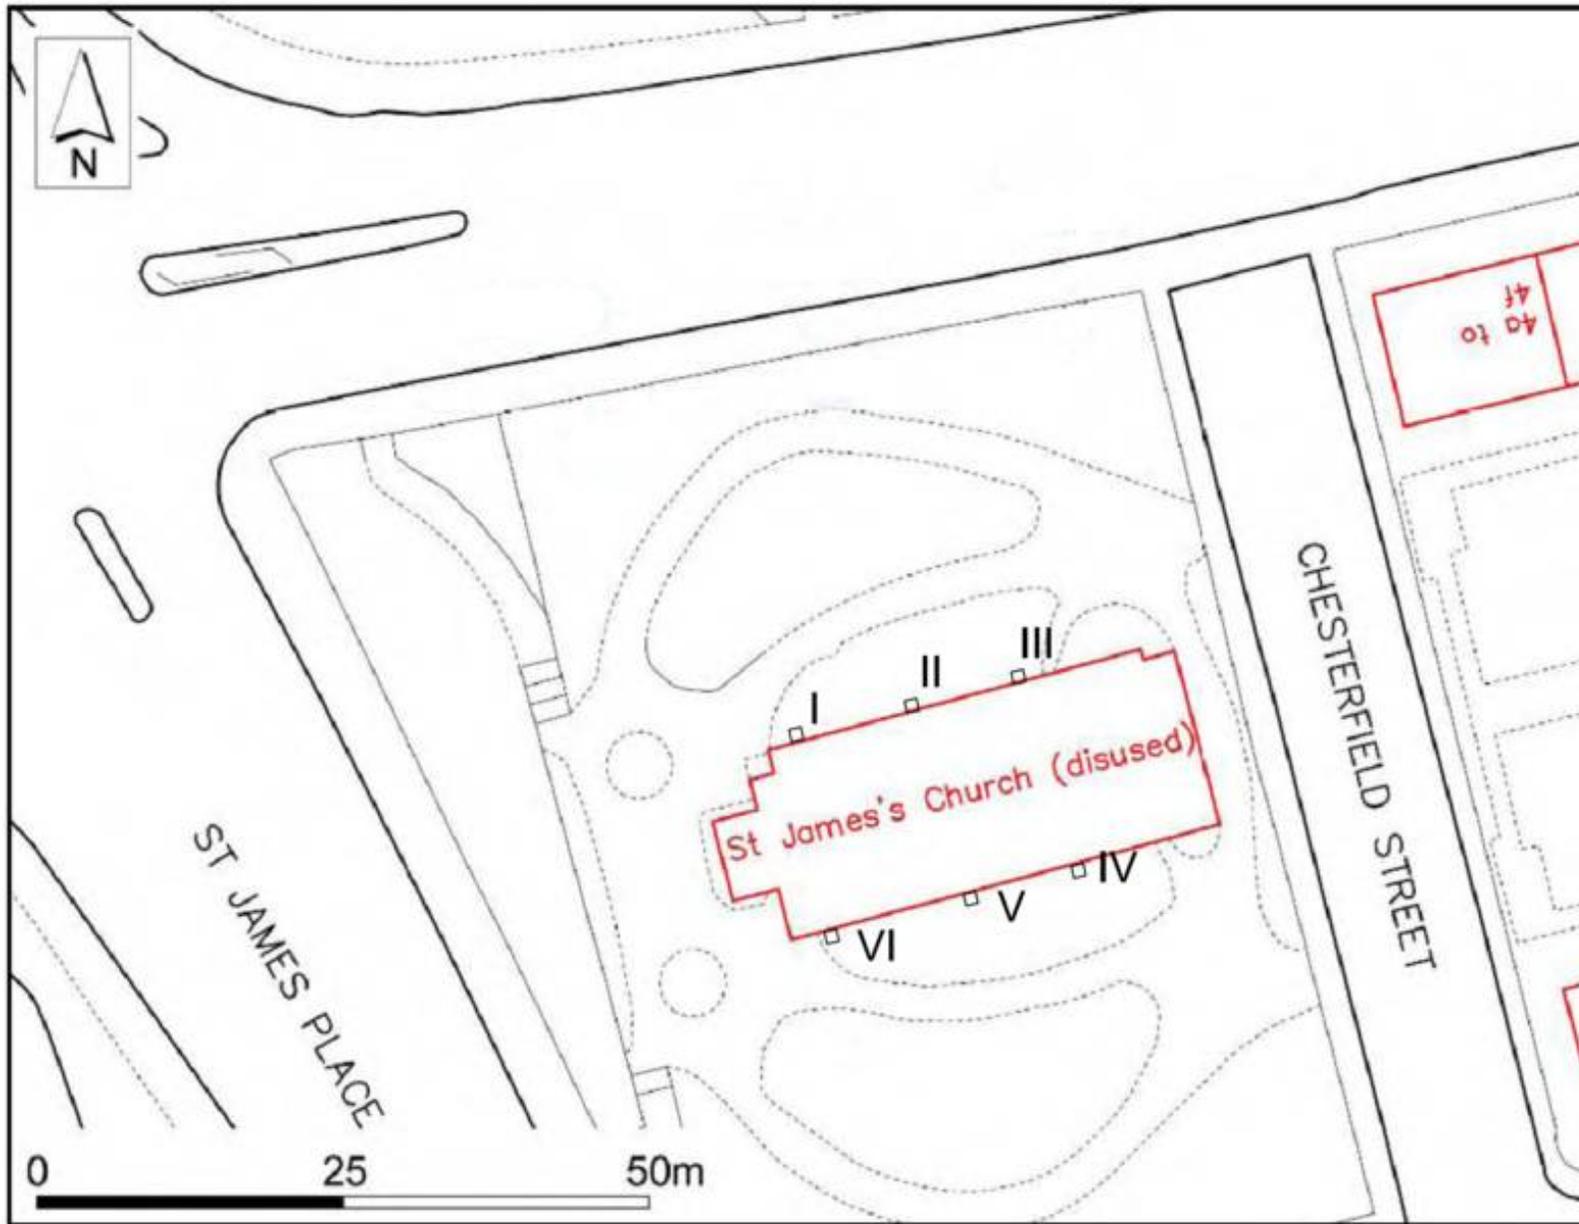
Fig. 1. Trench locations.

The project consisted of monitoring the excavation initially by hand of six test pits all measuring c. 1 x 1 m. Trenches I to III were located against the northern wall of the church, Trenches IV to VI against the southern wall (Fig. 1).

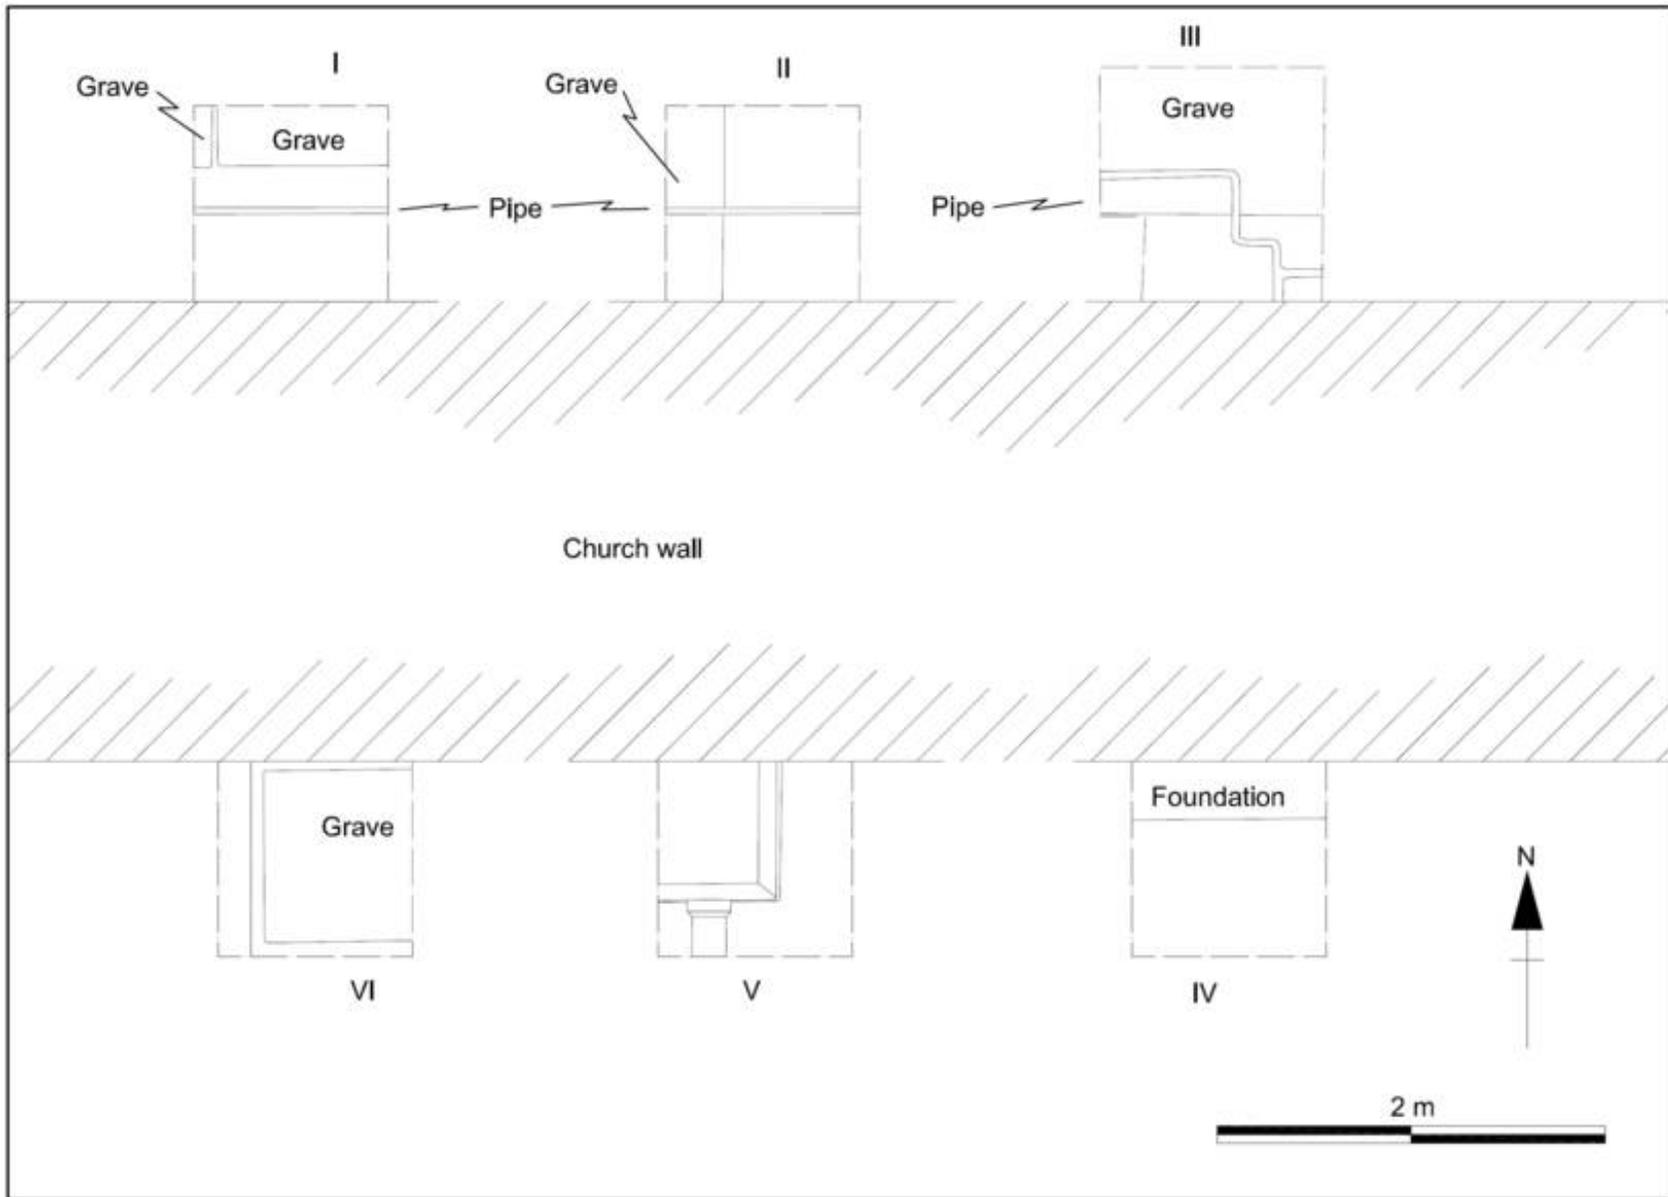
Fig. 2. Trench plans

The works consisted of hand dug test pits adjacent to the northern and southern church walls (Fig 2).

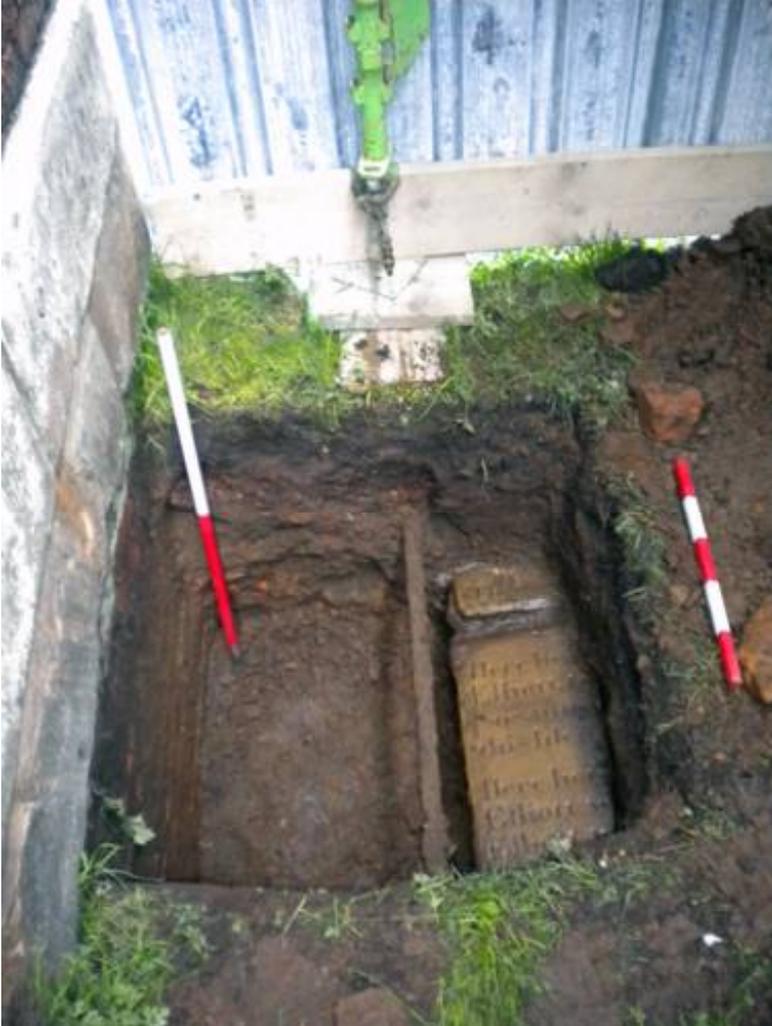
After the initial removal of turf and topsoil(context 1) to a depth of 0.20 m, a compacted, reddish brown layer of clay (context 2) which including frequents fragments of brick rubble was observed. This layer sealed an in situ grave slab which lay partly within the trench at 0.47 m below the present ground surface (Plate ???). This slab continued under the northern edge of the trench and only part of the inscription was visible. This read:

Although partial the inscription suggests that at least 4, possibly 5 or more, members of the Elliot family were buried below this slab.

The style of the lettering suggests a mid-19<sup>th</sup> century date.

A cast iron pipe ran east-west across the trench at a depth of 0.33 m.

Plate 1. Trench I showing excavated deposits. From the east

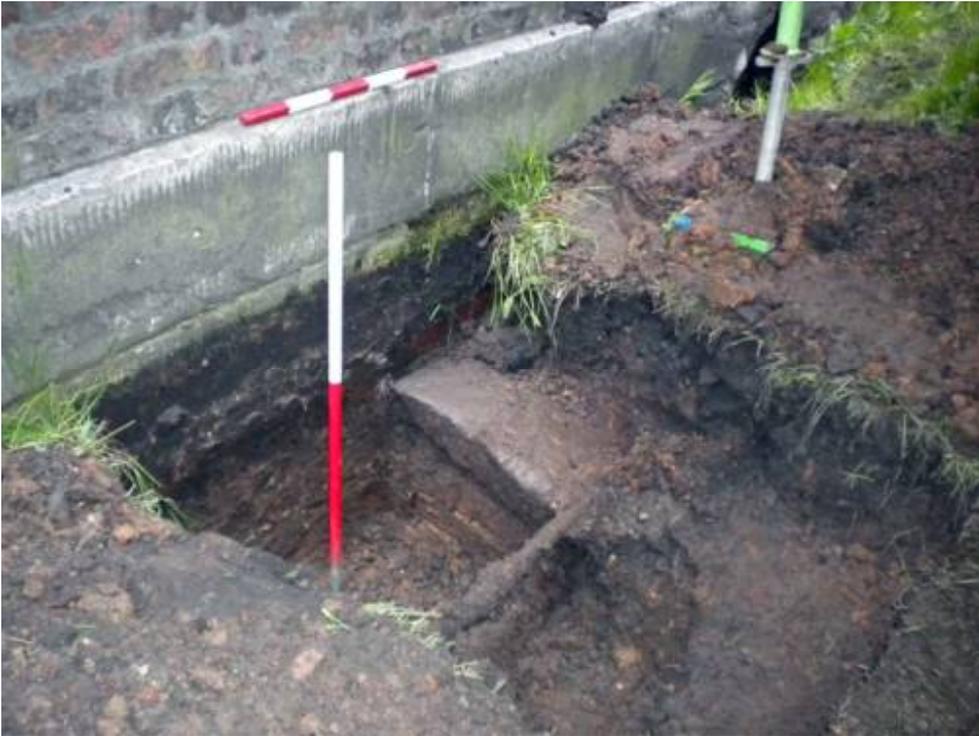
Top soil and turf (context 1) were excavated to a depth of 0.23 m and sealed Context 3 which was very similar in make-up to context 2 in Trench but contained more sandstone and brick rubble including smashed grave slabs. At the western side of the trench this sealed an *in situ* grave slab which had been cut through to insert an east-west aligned pipe obliterating the inscription. This slab was over a brick lining to a grave.

Context 3 was excavated to a depth of 0.5 m below the present ground surface and sealed a further layer of compacted, reddish brown clay with brick fragments (Context 4).

Plate 2. Trench II showing excavated deposits. From the north-east.

However, the biggest concern is the potential for burials within brick lined vaults present as voids along the route, such as that in Trench II. Although of limited archaeological interest (any further work could be confined to recording inscriptions as they are exposed), approached incorrectly these burials present a number of potential health and safety risks. For example, breaking through the slab with a pneumatic breaker would cause fragments of masonry to collapse into the void shattering fragile wood and lead coffins. The 2010 work showed that some of these are badly cracked and there is a risk of collapse if carelessly disturbed. In addition to the risks from lead and/or other dust generated by this disturbance there is an unquantifiable risk from pathogens such as small pox. However, given the date at which the churchyard was closed it is very unlikely that remains covered by the Human Tissues Act (2004) will be present.

The author is not qualified to give advice on mitigating for the risks posed by the above and it is suggested that the Environmental Health Dept at Liverpool City Council is contacted for advice. One option might be to carefully cut a channel through any slabs along the route, checking for voids as work progresses. It might be necessary to make provision to fill any voids with concrete or similar, though the methodology for this would require some consideration.

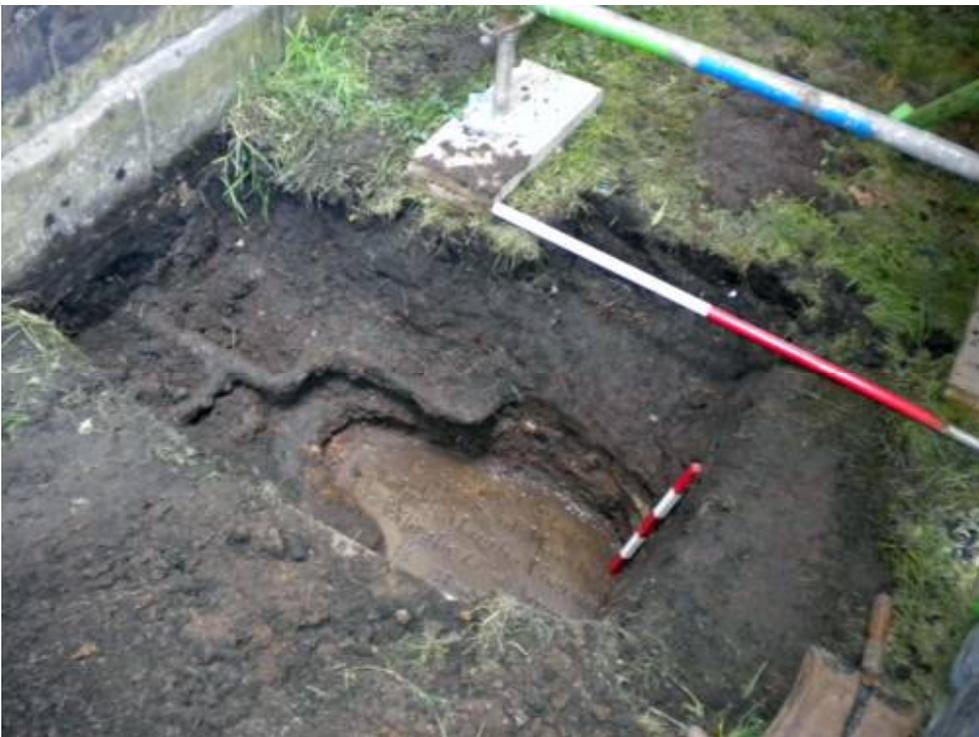
After the initial removal of turf and topsoil(context 1) to a depth of 0.15 m, a compacted, reddish brown layer of clay (context 5) which including frequents fragments of brick rubble was observed. Set within this layer was a network of cast iron pipes which hampered excavation. This layer sealed an in situ, east-west aligned grave slab which extended under the northern edge of the trench

This shows the presence of at least two early 19<sup>th</sup> century inhumations.

Plate 3. Trench III showing excavated deposits. From the north-east.

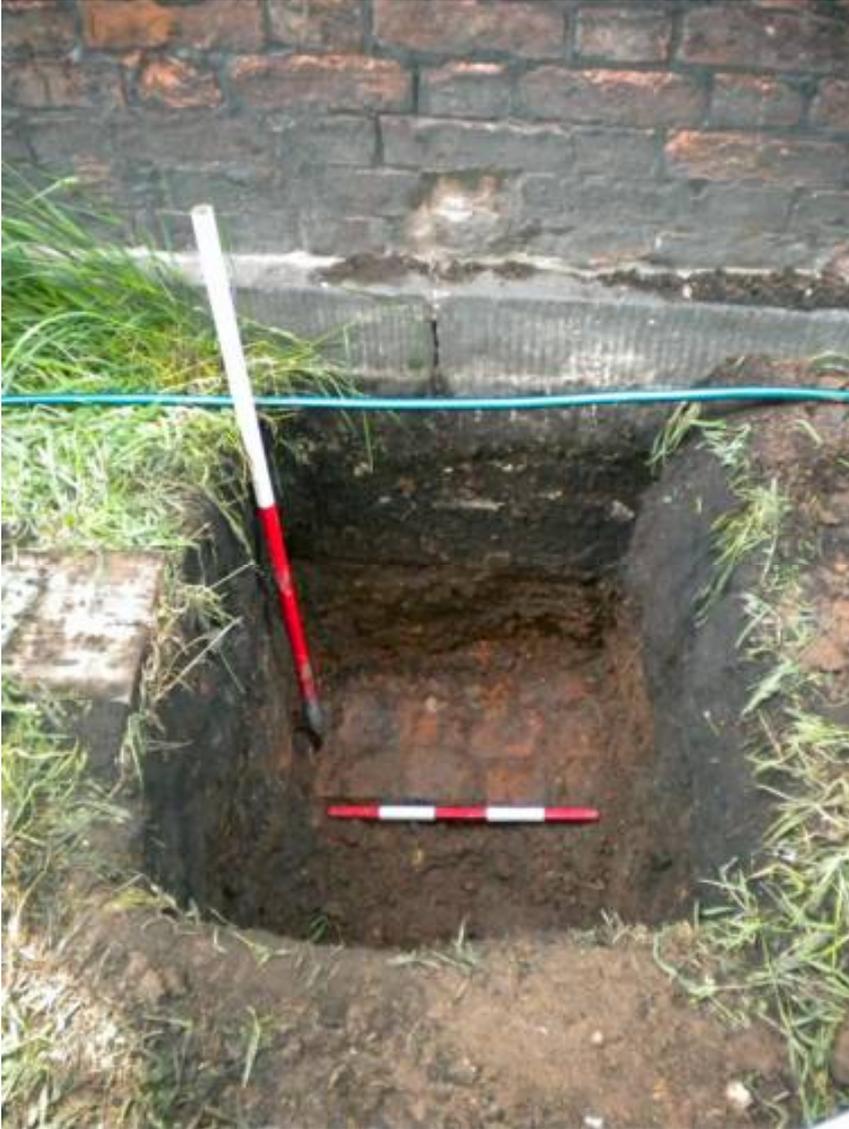
After the initial removal of turf and topsoil(context 1) to a depth of 0.20 m, a compacted, reddish brown layer of clay (context 6) which including frequents fragments of brick rubble was observed to a depth of c. 0.90 m. The only significant feature was the brick foundations to the church which were observed at a depth of 0.80 below present ground surface.

Plate 4. Trench IV showing excavated deposits. From the south

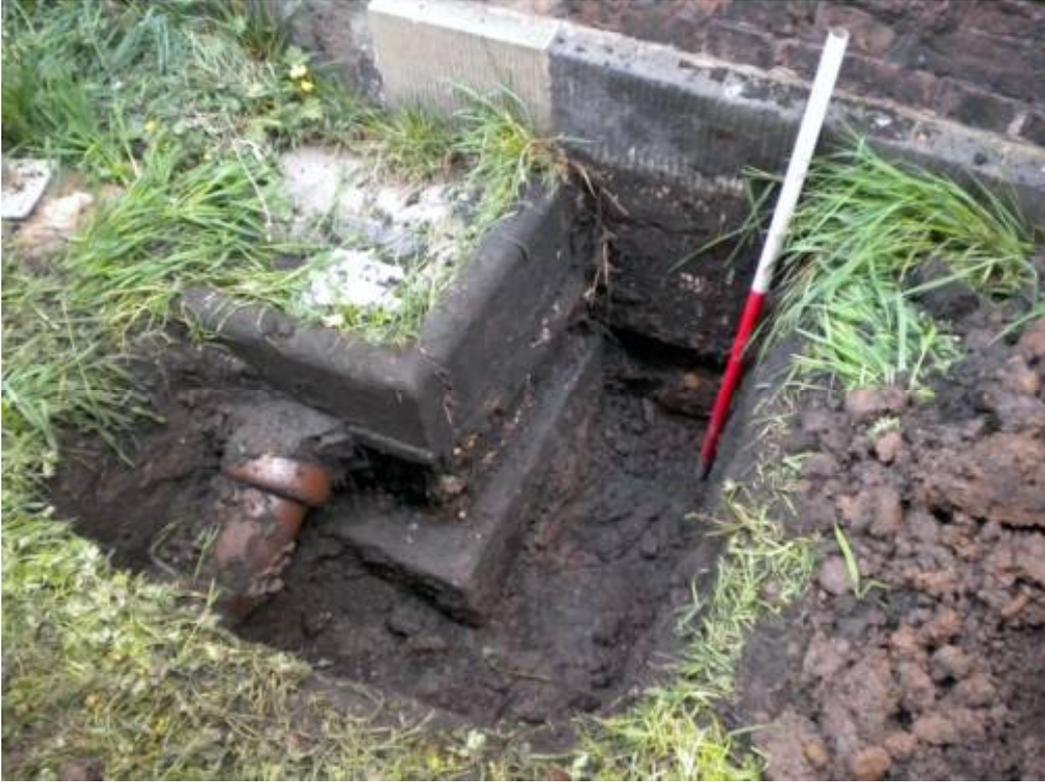
After the initial removal of turf and topsoil (context 1) to a depth of 0.18 m, a compacted, reddish brown layer of clay (context 6) which including frequents fragments of brick rubble was observed to a depth of c. 0.90 m.

Set within these deposits were two sandstone hoppers relating to drainage, one superimposed above the other.

Plate 5. Trench V showing superimposed drains. From the south-east.

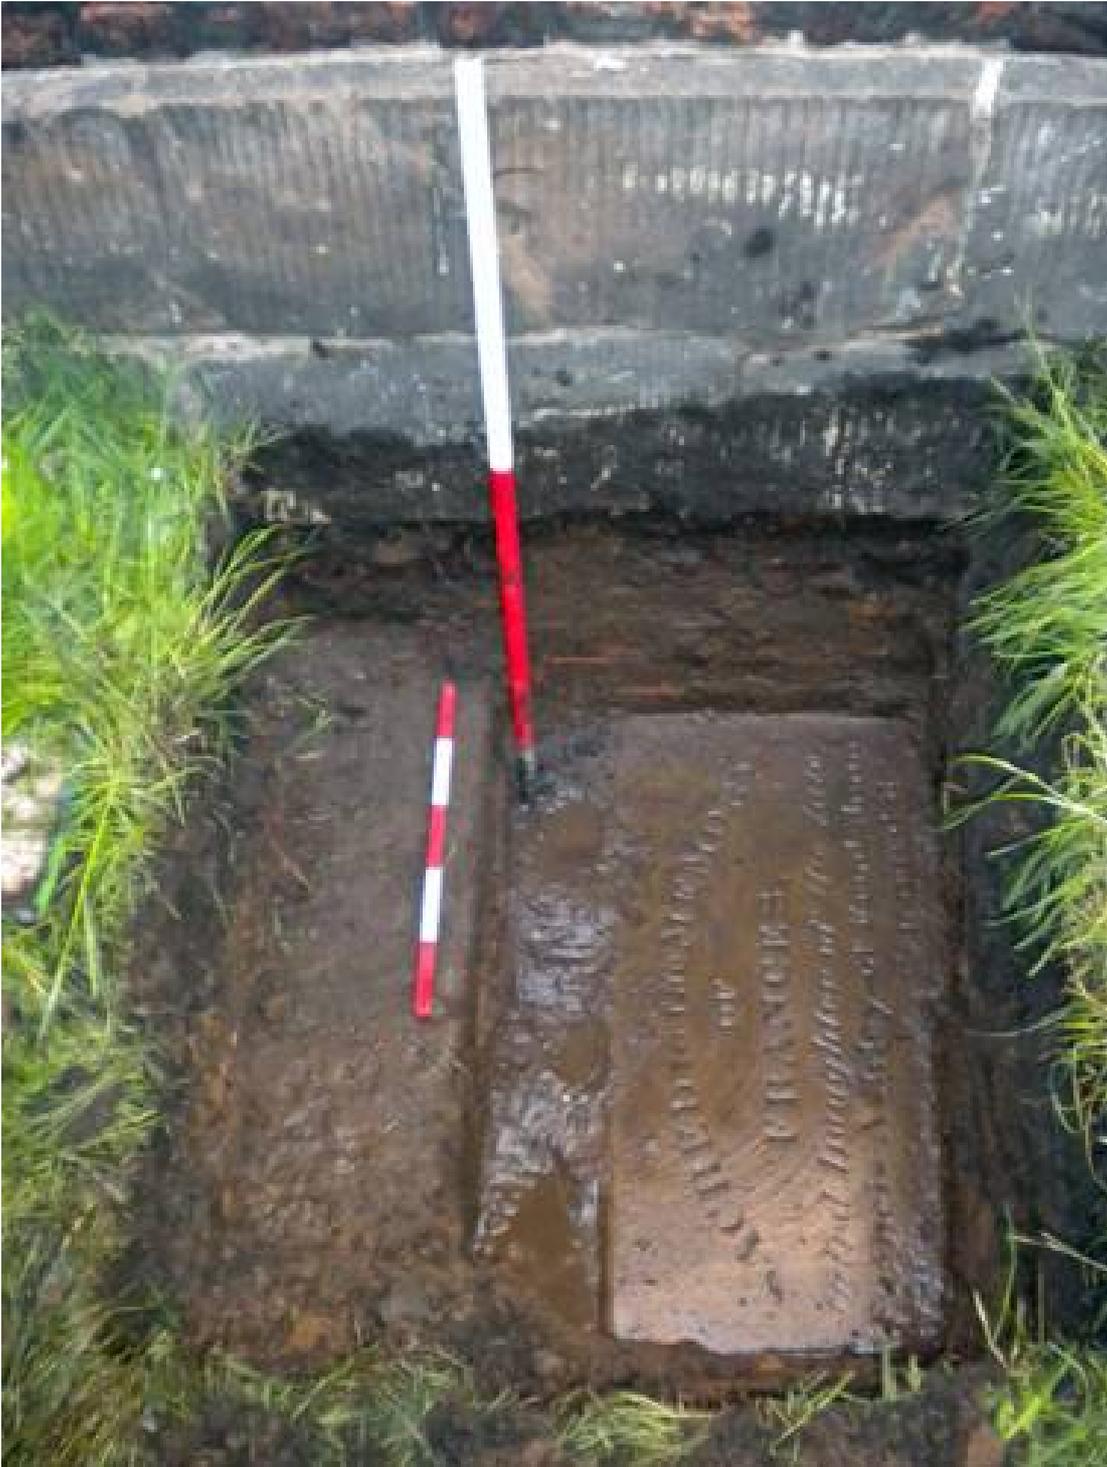
After the initial removal of turf and topsoil (context 1) to a depth of 0.18 m, a compacted, reddish brown layer of clay (context 7) which including frequents fragments of brick rubble was observed to a depth of c. 0.75 m.

This sealed the northern end of an apparently *in situ* grave slab, only part of the inscription was visible. This read:

The style of the lettering suggests a mid-19<sup>th</sup> century date.

Plate 6. Trench VI Plate 4. Trench IV showing excavated deposits. From the south
