ART. XI.—*Herring-bone Work, as seen at Egremont Castle.* By JOHN F. CURWEN, F.S.A.

Read at the site, Sept. 14th, 1927.

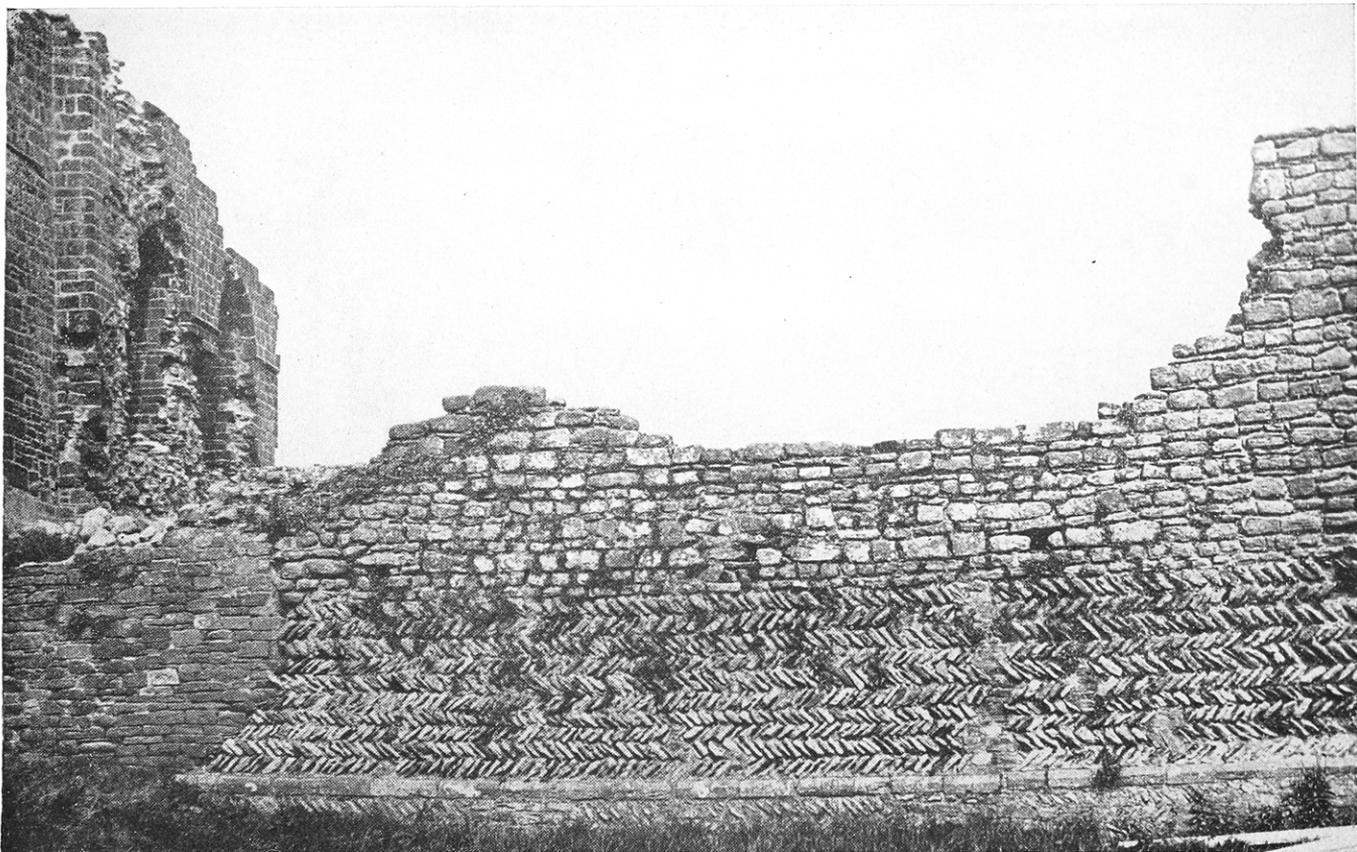
EGREMONT CASTLE: THE CURTAIN WALL,
tcwaas 002 1928 vol28 00013
Showing the herring-bone work.

EGREMONT CASTLE. Here we find an exceptionally large mass of it in the curtain wall, and in the lower portion of the Gate House, where there is no call for ornamentation, but just where it was thought necessary to widen out the bailey to the very edge of the steep escarpment, and where the builders naturally would have great anxiety as to the foundation slipping. And as a proof of their wisdom it is the one piece of original walling still existing.

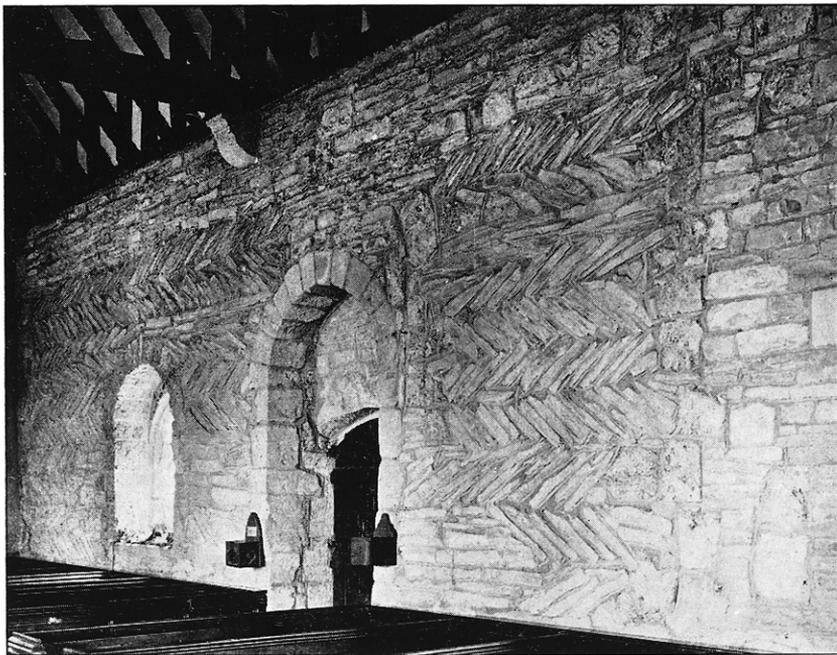
ASHLEWORTH CHURCH—HERRING-BONE WORK.

ASHLEWORTH CHURCH, Gloucestershire. On the inner face of the north wall of the nave, which is about 2ft 7 in. thick and dated to the first period of the twelfth century, there is a remarkable piece of the work which does not show on the outside. It is largely built with "Tufa" stone.*
