COCKPIT AREA, MOOR DIVOCK

ART. III.—*The Ford over Elder Beck.* By THOMAS HAY.

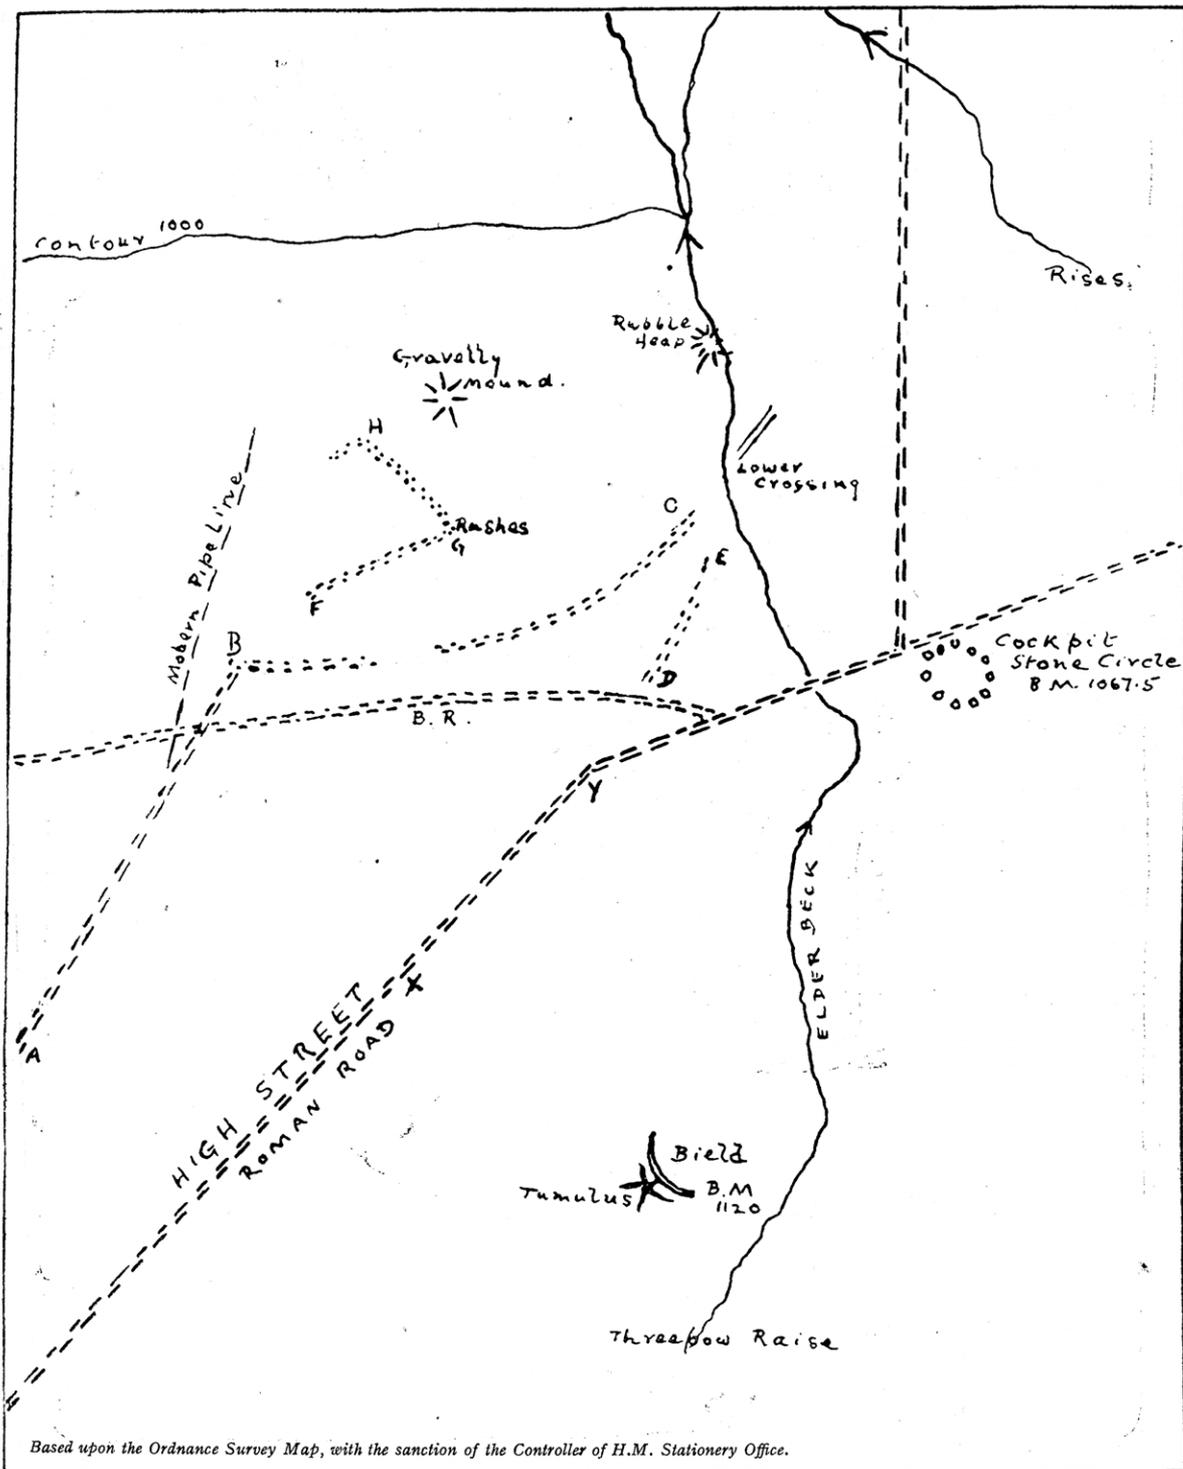
(6" Scale x 3) i.e. 18 inches to the mile.

Details from 6" Map in Black. Fresh details in Red.

THE Roman Road along High Street crosses Elder Beck close to the Cockpit on Moor Divock. In these *Transactions*, N.S., xxxviii, under the title of "Ullswater Notes," I gave some reasons for thinking that the Roman Road had not crossed the beck at the present ford but at a point 110 yards lower down in the direction of Pooley Bridge. At the same time it was mentioned that close to this lower crossing and on the left bank of the beck old foundations of roads and possibly of buildings or enclosures were to be found. It is now possible to give a map of these surface indications and what little has to be said will come best in a short description of the map. The details in black are all taken from the 6-inch map VII S.W. Westmorland but the scale has been enlarged threefold in order to give a bigger representation of the area. The details in red are the old foundations in question and some surface markings which will help to identify the place.

the last "t" in the words "High Street" on this map there is a good piece of foundation work and it is doubtless this piece that led the surveyors to their line on this particular place.

Now let us turn to the red markings. The Gravelly Mound is a wholly natural formation consisting of small materials and contrasting with the rest of the ground near it. It has rabbit burrows in it and is probably a late glacial feature. It is only put in for the purpose of a useful identification mark. The Rubble Heap by the beck side seems artificial and consists of small angular bits of rock much stained with red and there is a great deal of black earth in it. West of the accepted line of road there is another line of foundation work A. B. and the paving is particularly well exposed where a modern waterpipe has been cut obliquely across it. At B this line of road runs into a spread of foundation boulders. Here it seems to swerve right and be continued along B. C. to the lower crossing. At this lower crossing there is quite a number of the sunken tracks which become developed at any such crossing of a beck flowing through drift covered country. At D. E. there is a scattered linear spread of the foundation boulders which may represent the old approach to the lower crossing. The features at F. G. H. are in many ways like the road foundations but it is difficult to see what a road could be doing in such a position. It may be the foundation of some enclosure in which the blocks have spread out more than usual. At G. where the rushes are growing, some small mounds may be remnants of a building. One possible explanation is that the original line of the metalled road ran from X. to Y. to D. to E. to the lower crossing, then when this foundered at E. from natural causes, a new line of approach A. B. C. to the lower crossing was made. Then much later when the whole lower crossing became impossible, a new higher crossing
