ART. IV.—*Roman sites on the Cumberland coast, 1956.*

By R. L. BELLHOUSE, B.Sc.

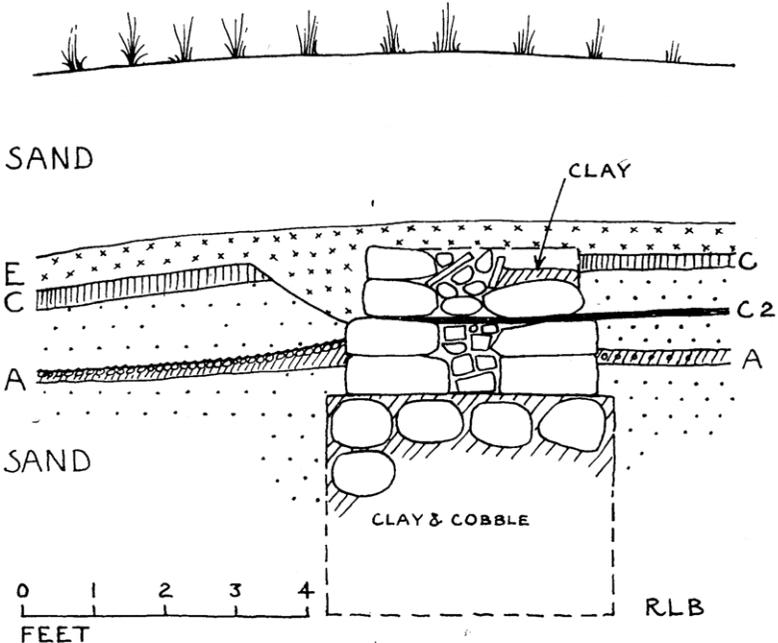
FIG. 2.—Town 15a. Section showing the levels in relation to the original and raised thresholds; interior of tower to right.

- A = Builders' débris, with gravel.
 C = Occupation level on wind-blown sand.
 C₂ = Trodden surface of original threshold extending inside the tower.
 E = Demolition level.

The raising of the threshold seems to have been needed because of the accumulation of about 9 in. of blown sand inside the tower as well as outside it; this must have begun soon after its construction, but the false step cannot have been made until shortly before its demolition. The evidence is shown in the section, fig. 2. The builders' level (A) has been lightly gravelled in front of the doorway, forming a path whose upper surface showed little evidence of wear; on this rested about 12 in. of blown sand, the top 3 in. of which merged into a black occupation-level containing potsherds; the demolition layer (E) rested directly upon this, without trace either of turf (denoting a period of abandonment) or of fresh sand. These levels, when studied in relation to the original and false thresholds, have a fascinating story to tell. When the time came for making the new step, the lowest courses of the left jamb's inner and outer corners were chipped away, in order to allow the keying in of fresh stones; since the two lowest courses were covered by accumulated sand and occupation-debris, this had first to be dug away: and the delve was clearly defined—but before fresh sand or occupation-debris could begin to fill it, the order must have been given to demolish the tower, for it was in fact filled by layer E. This seems conclusive proof of demolition by the Romans immediately after the short period of occupation attested by the pottery finds.

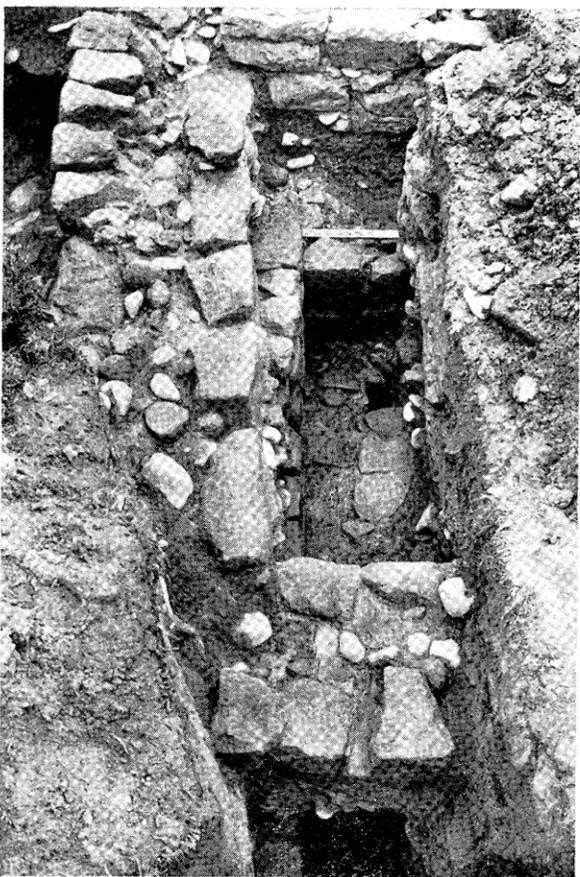
PL. II, FIG. 1.—Tower 126. North wall of Hadrianic tower and remains of later tower.

The doorway is just appearing at the right hand end of the scale.
Note the fire-rotted stones of the wall at the centre of the photograph.

We did indeed find the stump of a normal Hadrianic tower (Pl. II fig. 1), measuring 11 ft. 6 in. internally and with four courses of good masonry surviving, its doorway as anticipated in the north-east corner; standing upon it was the stump of a smaller structure. The contrast in build was striking, as Mr Blake's photograph shows. The floor of the Hadrianic tower showed more evidence of occupation than we had found at towers 15a and 13a, with as many as five hearths distinguishable against the north wall, just inside the door; the heat from the fire had burnt away and rounded the facing-stones of the north wall, as has been observed in turrets on the Wall. The pottery was all of one type, the dark latticed cooking-pot common to all the sites so far examined: pieces found just inside the doorway when put together formed an almost complete cooking-pot (see Appendix, p. 25 f. below), while other sherds came from two cooking-pots which had been cut down and used as bowls (cf. CW2 liv 49).

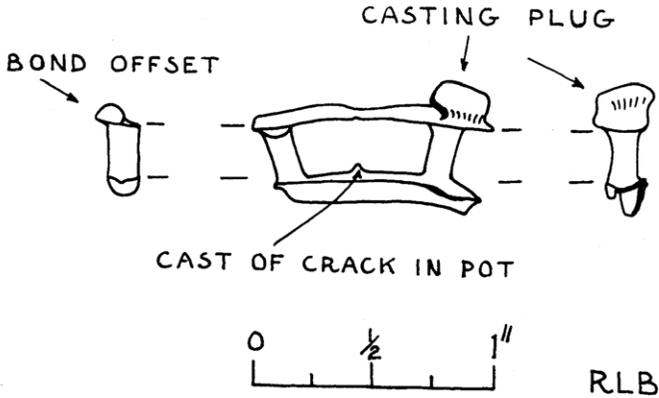
FIG. 1—The lead “rivet” found at Tower 12b.

The features of the rivet (fig. 1) made it clear that we are wrong in talking about the *rivetting* of Roman pottery; it has in fact been a *casting*, and there must have been a simple and satisfactory technique. The lead bond shows the following features, all indicating casting in a mould:

- (a) The mould-plug, a lump of excess metal remaining in the pouring-hole.
- (b) The ridge across the inner bar, where the molten lead has entered the crack in the pot.
- (c) The offset of the outer bar, due to faulty placing of the outer mould.
- (d) Faults in the metal, due to bubbles of air or steam.

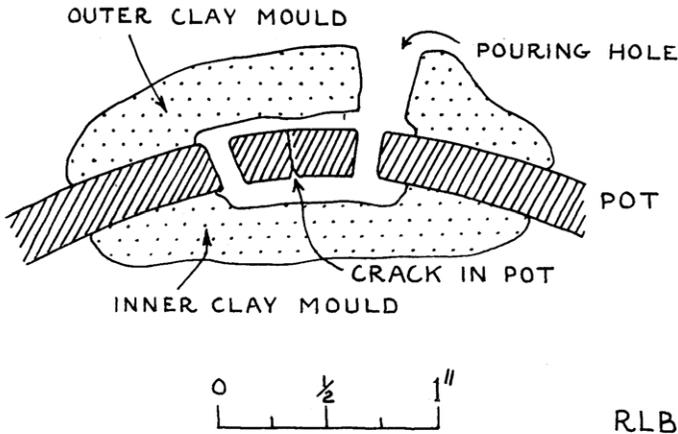
FIG. 2.—Section of a drilled pot, with moulds in position ready for pouring in the lead.

made by the holes on its surface enable a groove to be made joining them, thus completing the first mould. The outer mould is made in the same manner, but at one end of the groove on it a hole is pierced right through the clay, to form a pouring-hole. The inner mould can be placed accurately in position, because its groove can be seen through the holes in the pot, but the placing of the outer mould involves some guesswork: one of the holes may be seen through the pouring-hole, but the other can only be glimpsed under the raised edge of the mould, just before final positioning. This difficulty explains very nicely the offsetting of the outer bond in our example.

I resolved to experiment with the casting of lead bonds, using the simplest possible apparatus. The holes in the pottery were obviously drilled, and I made and used a simple bow-drill with a steel bit ground to a diamond point and a whorl fashioned from a piece of amphora. The actual drilling of the pot offered no problem, except that hard gritty fabrics quickly dulled the steel bit, although I had made it glass-hard. For moulds I used moist clay, two of them being required (fig. 2). After drilling holes on either side of the break to be repaired, the inner mould is made by pressing a lump of clay against the inside of the pot, covering the two holes; on removal of the clay, the marks
