ART. I.—*Excavations of Native (Iron Age) Sites in Cumberland, 1956-58.* By BRIAN BLAKE, M.A.

*Read at Penrith and Kendal, April 6th, 1957, September 12th, 1957, and 11th September, 1958.*

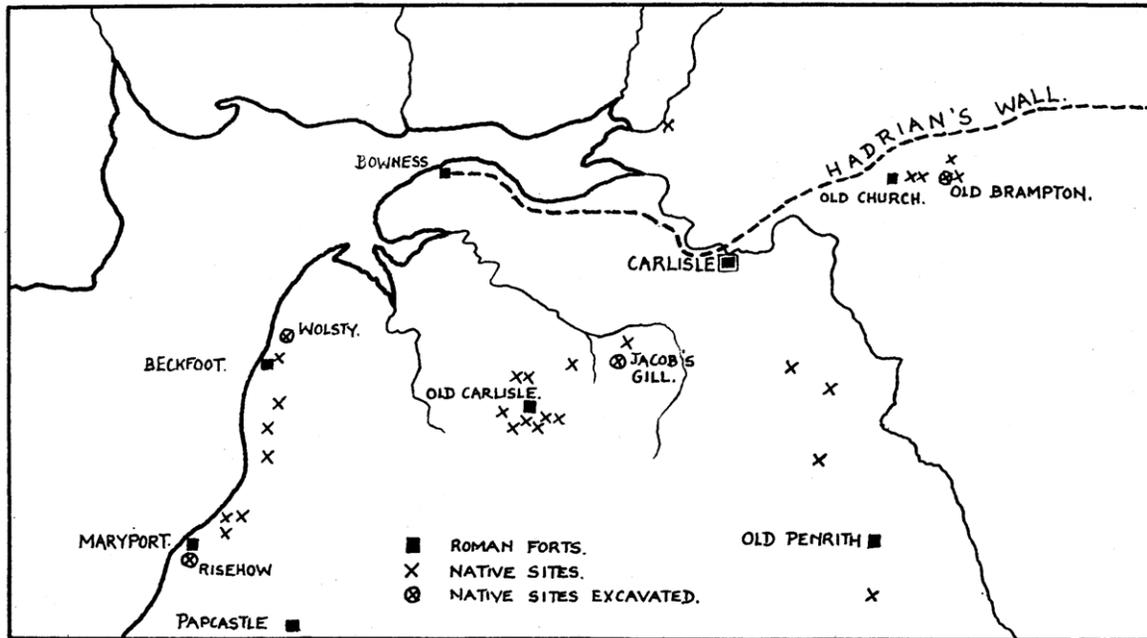
As a first stage, all these sites were indicated on a One Inch map of Cumberland, which is reproduced in the sketch diagram (fig. 1). This shows that no site which we assumed to be a native farm site is more than two miles from a Roman road, and that concentrations of farm

sites are marked in the neighbourhood of certain Roman forts. A first relationship is hereby strongly suggested unless the aerial survey was unduly selective, a point which cannot be immediately decided.

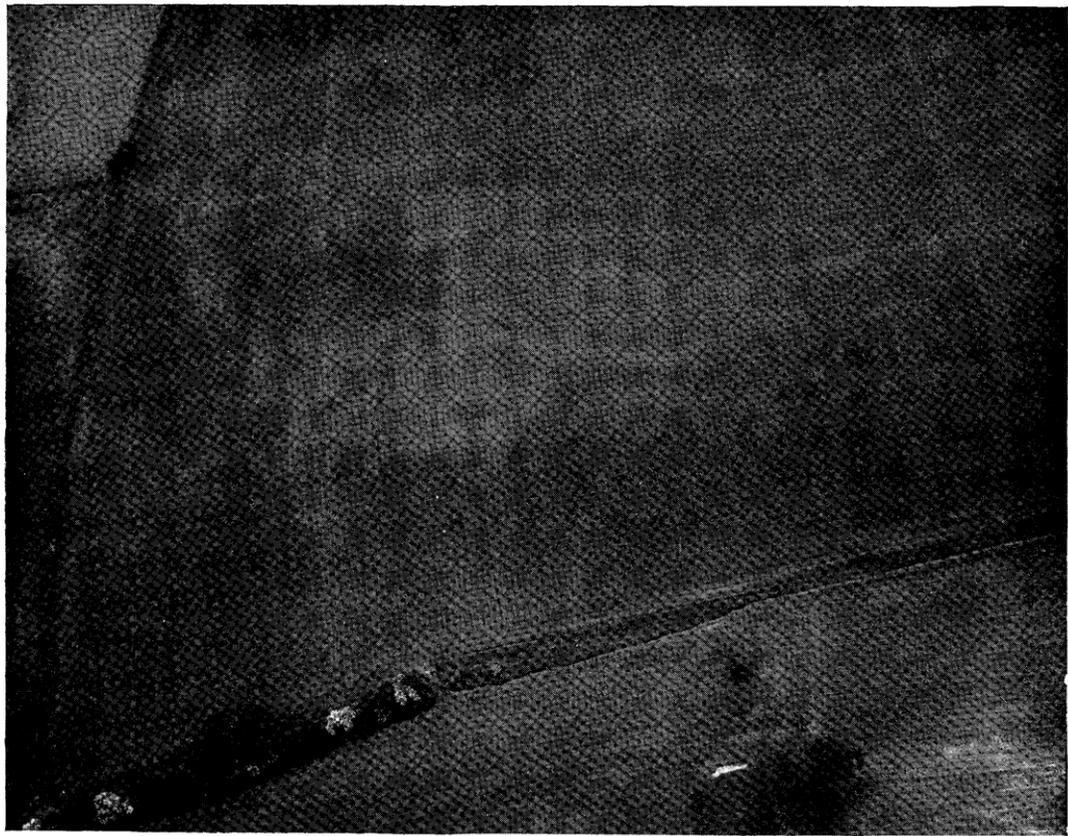
Pl. I.—Old Brampton: Aerial photograph.  
tcwaas\_002\_1959\_vol59\_0004

The excavation was based on Dr St. Joseph's photograph (Plate I) which clearly shows a single ditch. The position of the ditch was transferred to the map and a line drawn which was later excavated on the ground as a substantive interrupted trench to section the ditch and explore the interior (Plate II). The trench was 80 ft. long, 4 ft. wide and cut on a 10 ft. grid with 2 ft. balks so that it could form the basis of a gridded area excavation if required.

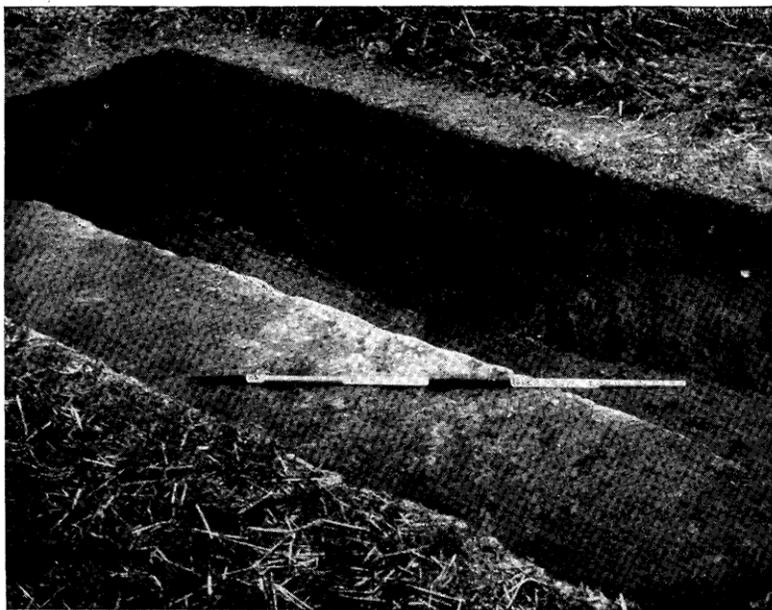
PL. III.—Old Brampton. Section showing profile of ditch.

*The Ditch* (Plate III) (fig. 3(a) and (b)). The ditch was 9 ft. wide and had a shallow curve to a depth of 4 ft. In one place it had not been completely dug out, a mound of natural clay having been left to provide a central support for a bridge of planks, the marks of which remained. Inside the ditch, a palisade trench averaged 1 ft. in depth and contained the clear imprint of a wooden palisade with a constant width of  $5\frac{1}{2}$  in. From the absence of additional supports it would seem that this palisade would not be stable if much more than 5 ft. high.

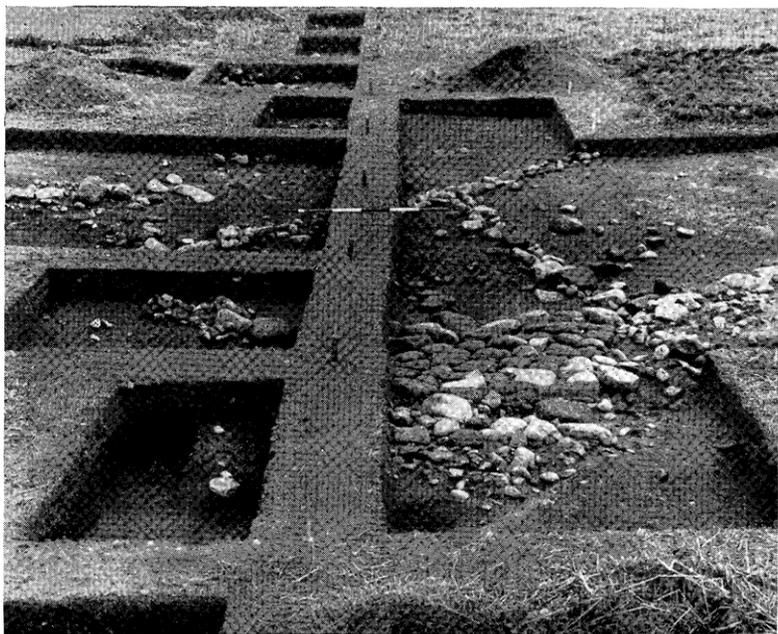
Pl. IV.—Old Brampton: House showing paved floor and drains.

*The Main Building* (Plate IV) (fig. 4(a)). The main building was (almost) a square of some 24 ft. Its walls were composed of untrimmed cobbles packed with smaller

stones and originally weather-proofed with turf. The decayed turf imparted a distinctive colouring to the external tumble. In several places the walls had been ploughed away, but their position could easily be distinguished by differences in the colour of the soil. The cobble walls could not have stood much more than 2 ft. high, and the upper structure would have been of timber, and, as far as the roof was concerned, was of branches and twigs, some of this having been burnt and the carbonized remains preserved. The interior of the building had been divided by crude walls of timber on a sparse foundation of stone into nine equal squares, each approximately 8 ft. square, of which we assumed that the eight against the walls formed the living area and the ninth or central one was a small courtyard, possibly open to the sky. The three squares on the northern side of the building were paved with small cobbles trodden rather than set, and here almost all the pottery was found. If humans and animals shared this building, we assumed that the humans lived on this side of the courtyard. The adjacent corner square was well paved with large blocks which had been well trodden. The purpose of this paved section was not apparent. It incorporated four pieces of Roman trimmed stone, presumably from Old Church Roman fort which may have been deserted when this farm was occupied, together with the broken segments of two querns. The interior of the building had been built in a shallow hollow of clay (presumably in dry weather), but at some secondary stage a main stone drain and a subsidiary one had been introduced. The drains were well built and supplied in places with cover slabs, but both were inadequately levelled.

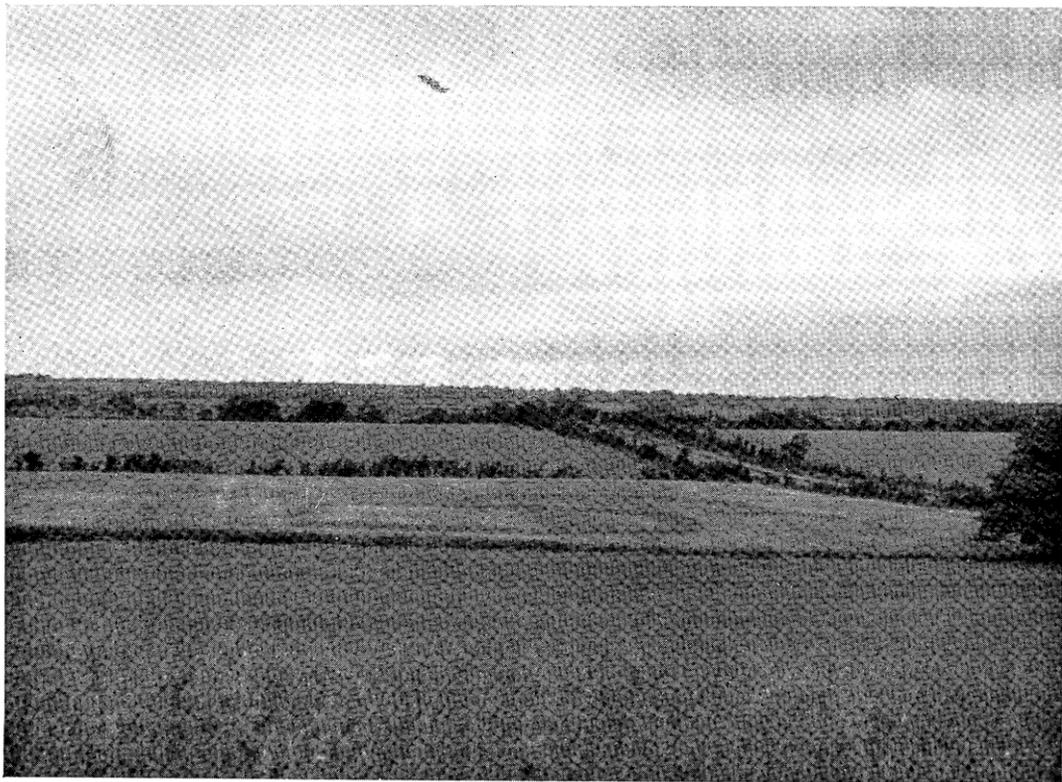
PL. V.—Jacob's Gill: Crop marks showing ditch.

The trial excavation at Jacob's Gill occupied five days, and Miss Hodgson and I were joined by Mr Salway. The extent and the form of the ditch were determined, and these are given in the plan (fig. 2(b)) and section (fig. 3(c)). No trace of a palisade was found, and it seems possible that the tumble of untrimmed stones on the inner lip of the ditch represented a rough dry stone wall instead of a palisade. The interior of the enclosure revealed only one aspect of occupation, a floor of small cobbles more in the nature of trodden gravel than of hand-laid stones. There were also a few fragments of walls which had been built on this spread, without foundation trenches in the spread, but the whole excavation was complicated by a number of field drains, at least two sets of stone drains and a third, at right-angles, of horseshoe tiling.

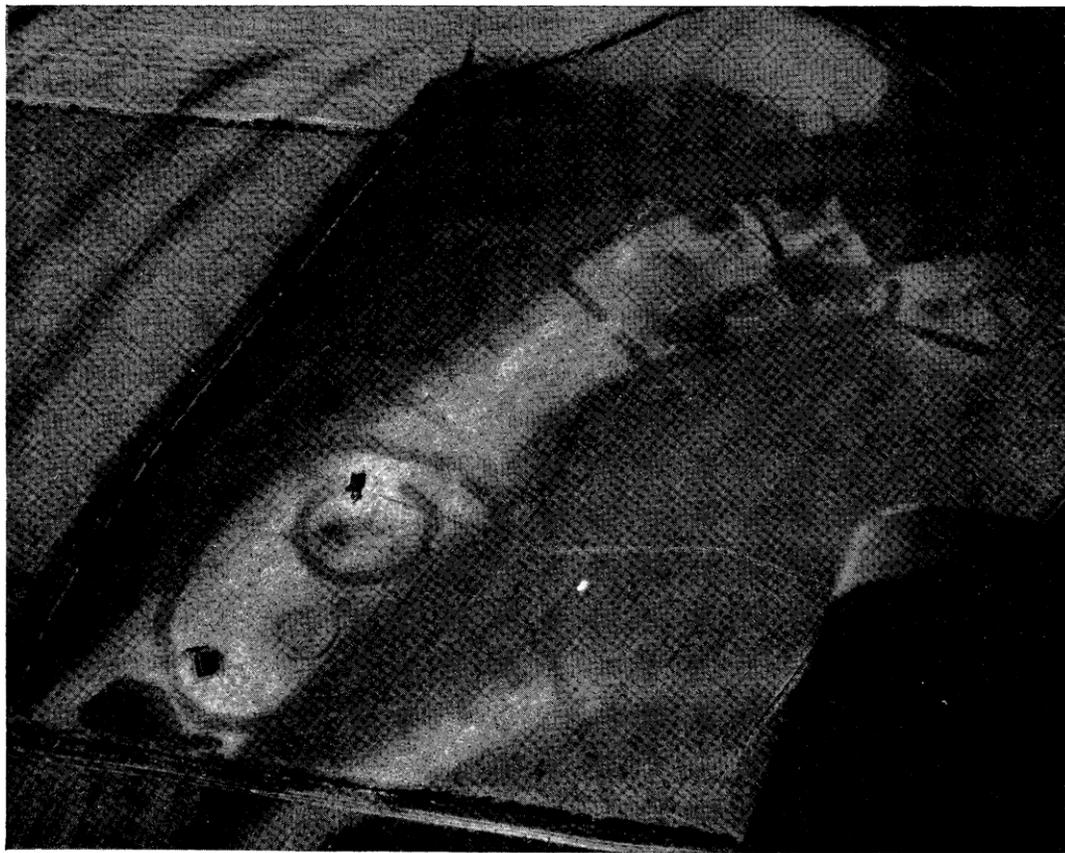
PL. VII. Wolsty Aerial photograph.  
tcwaas\_002\_1959\_Vol.5\_004

This excavation was based entirely on Dr St. Joseph's air photograph (Plate VII). For convenience, the three enclosing ditches are here called oval, circular and rectangular. All three were carefully established on a ridge of gravel which forms part of the main raised beach of the Solway, often known as "the twenty-five foot beach".

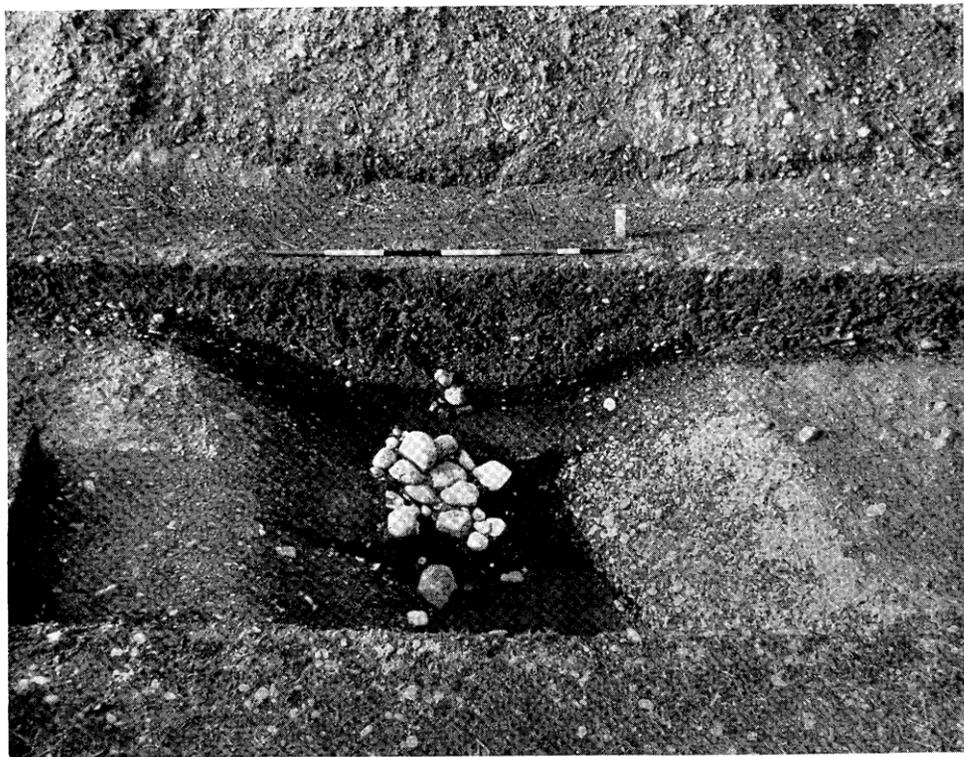
PL. VIII.—Walsbyre Dish, 1890, circular enclosure.

*The Circular Enclosure.* The occupation area within this circular ditch (fig. 3(d)) (Plate VIII) was well dated by pottery to the years immediately following the building of Hadrian's Wall and its Solway extension (of which there are two signal towers within half a mile). While no clearly defined buildings were found, a good assortment of pottery of typical northern Roman provincial groups, two knife blades and a quern were associated with the remains of stone floors as was a stone lined well, which held yet more pottery of the Hadrianic period including *mortaria*.

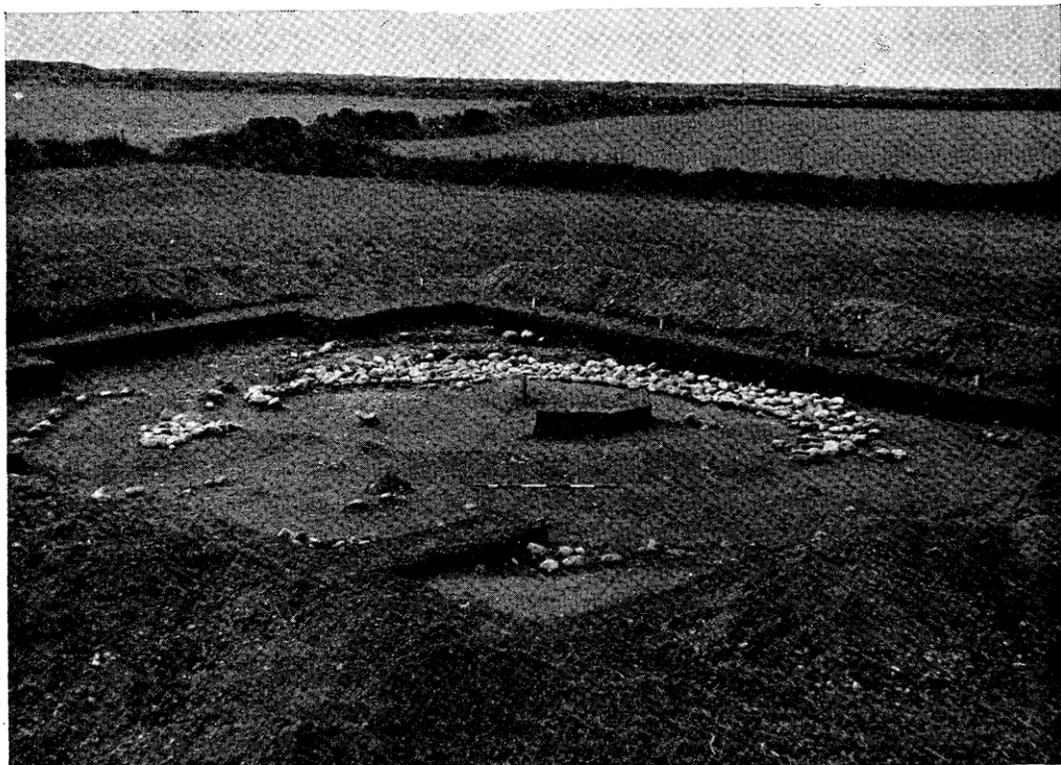
PL. IX.—Wolsty: Round House.

*The Building* (fig. 4(c)) (Plate IX). The building which we associated with this ditch was circular (a round house) and consisted of four parts: (a) a trench approximately 2 ft. wide and 2 ft. deep, from 43 to 45 ft. in diameter

and broken by entrances at opposite ends of one diameter;

(b) a packing of turf inside the trench, presumably to make wind-proof the wooden wall which we assume the trench to have held;

(c) a circular floor of cobbles 5 to 6 ft. wide quite carefully laid some 4 or 5 ft. inside the wall, i.e. isolated from the wall by the turf packing. At the outer edge of this cobbled floor opposite the position of the gaps in the wall were post-holes to take the supports of doors (Plate Xa), and the existence of a small stone threshold on a level with the floor plus the absence of turf remains in the entrance gap implied that the doors opened outwards forming a kind of "Celtic" porch.

(d) In the centre of the circle, four large deep post-holes packed solid with cobbles formed an 11 ft. square and had obviously held the main roof supports. In one case, this main roof support had finally fallen after breaking at ground level, and though its wood had completely disappeared, the semicircular hollow it had left in the gravel had acted as a receptacle for fine blown sand, which when sectioned gave the unmistakable impression of a round timber post 11 to 12 in. in diameter (Plate Xb).

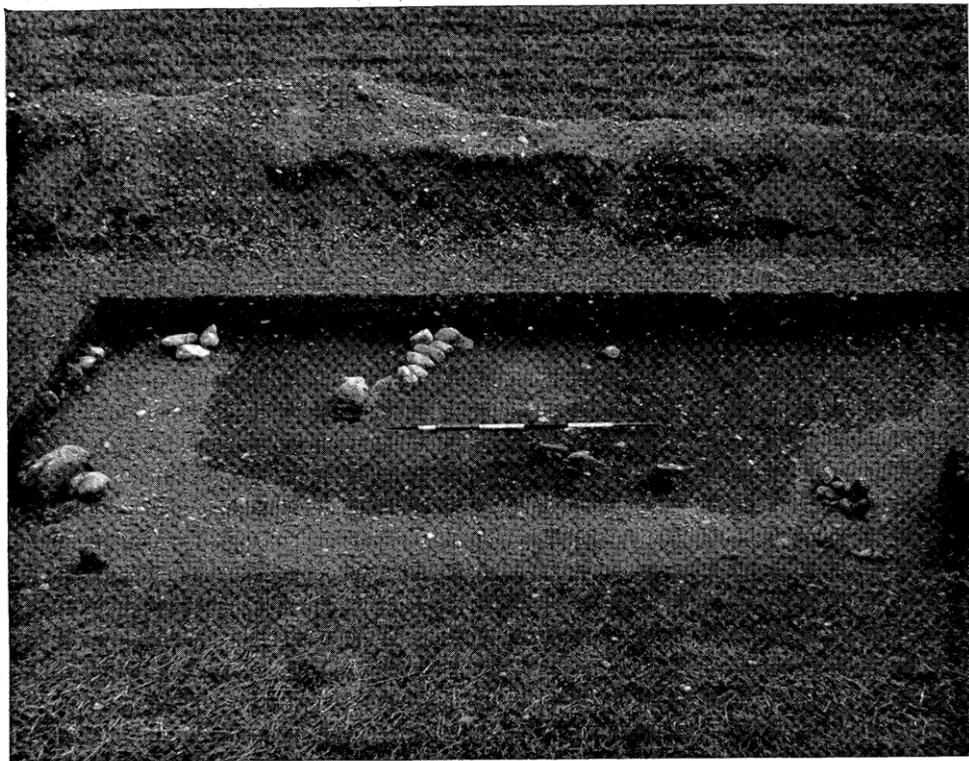
PL. XI.—Wolsty: Rectangular ditch at entrance (before sectioning).

consisted of a wide and deep ditch (fig. 3(f)) (Plate XI) 18 ft. wide by 8 ft. deep. An inner palisade of wood was founded on uprights sunk in deep stone-packed post-holes at intervals of 4 to 6 ft. The entrance had had a series of upright posts also stone-packed which appeared to have been burnt down.

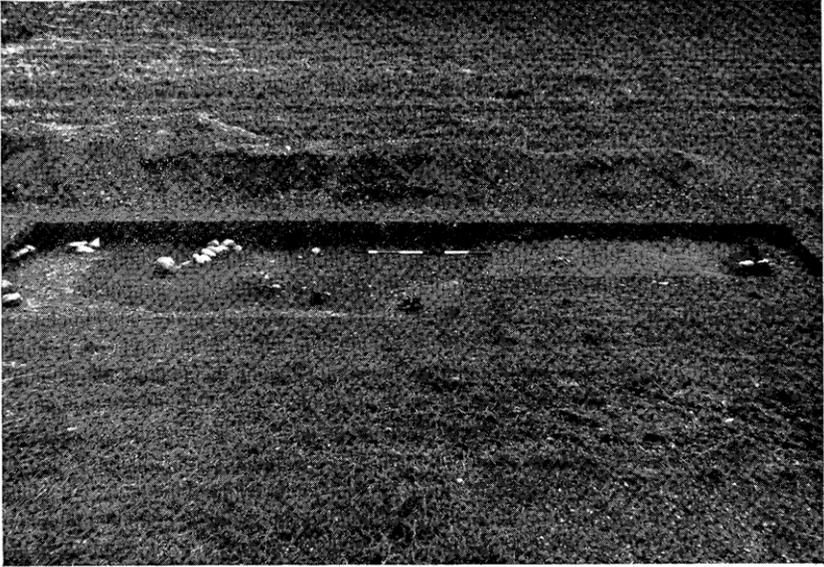
PL. XII, (a).—Wolsty: Exterior post-hole in relation to rectangular ditch.

The strangest feature associated with this ditch was a series of large post-holes almost without packing stones which were found *outside* the ditch (Plate XIIIa). These post-holes first appeared as specks on the air photograph, and we were able to pin-point them easily on the ground and excavate two of them. They were regularly spaced at intervals of 21 ft. and were 12 ft. outside the outer edge of the ditch. They were slightly pear-shaped as though designed to facilitate the raising of a heavy post, and had axes of 3 to 5 ft. and were 5 ft. deep. Their exact purpose remains a mystery although the distribution of small pebbles in one of the holes excavated suggests that a post of some 12 in. diameter might have occupied the hole.

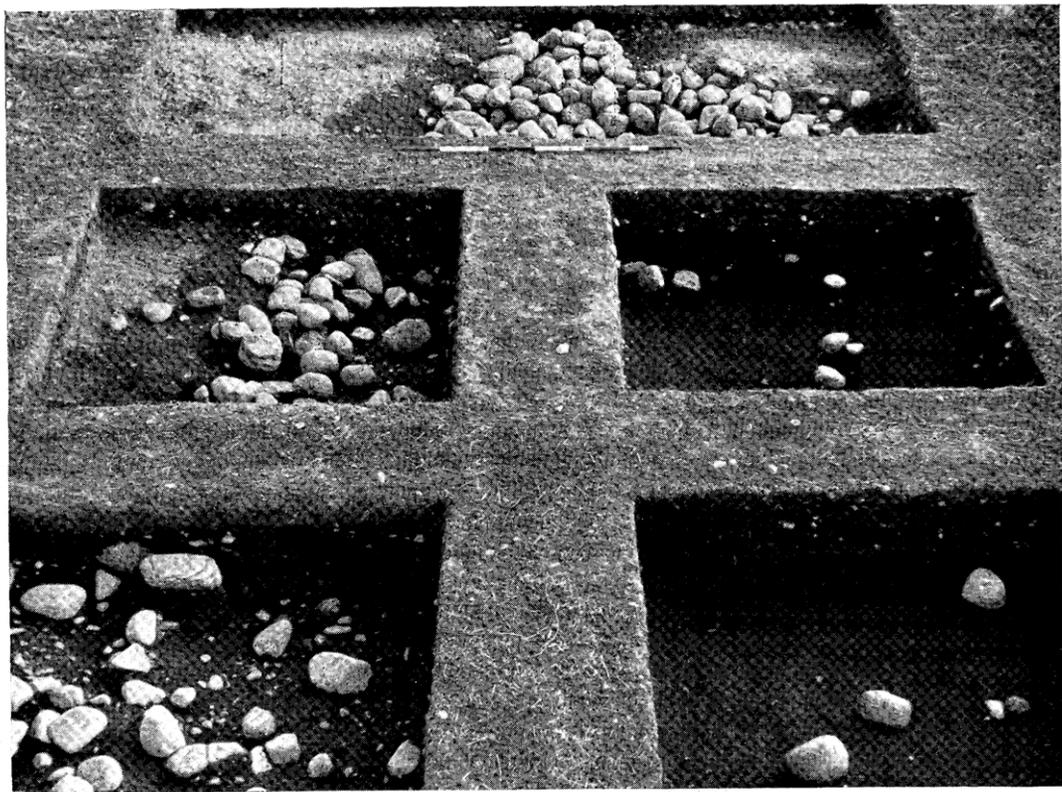
Pl. XIII.—Wolsty: Corner of rectangular building.  
tewaas\_002\_1959\_vol59\_0004

The interior of the rectangular enclosure contained not one but a complex of habitations. Each trial square opened produced Roman pottery of the 3rd-4th century, and in one corner of the enclosure a small area excavation revealed a squarish farm building (fig. 4(d)) (Plate XIII) which need not be described in detail as it is similar to the Old Brampton type although much cruder and lacking the stone drains and the paved corner.

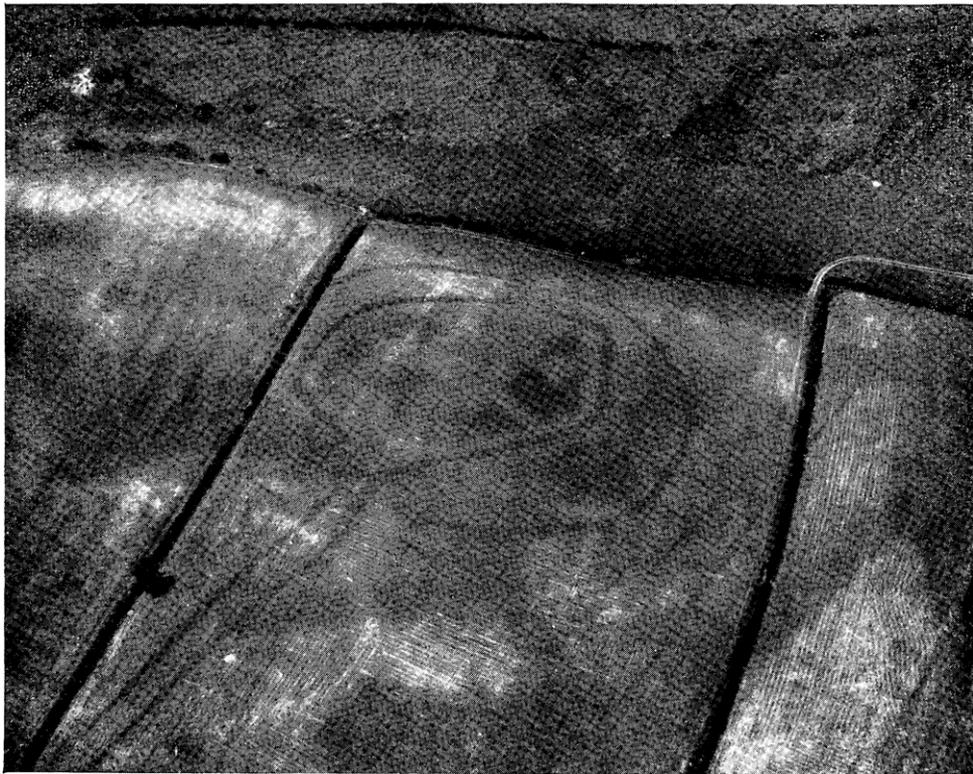
PL. XIV.—Risehow, Maryport: Aerial photograph.

This excavation was again based entirely on Dr St. Joseph's air photograph which showed two ditches,

generally spaced widely apart, but converging at what we assumed was an entrance from which two more parallel ditches led in the form of a protected road to the nearest water supply.

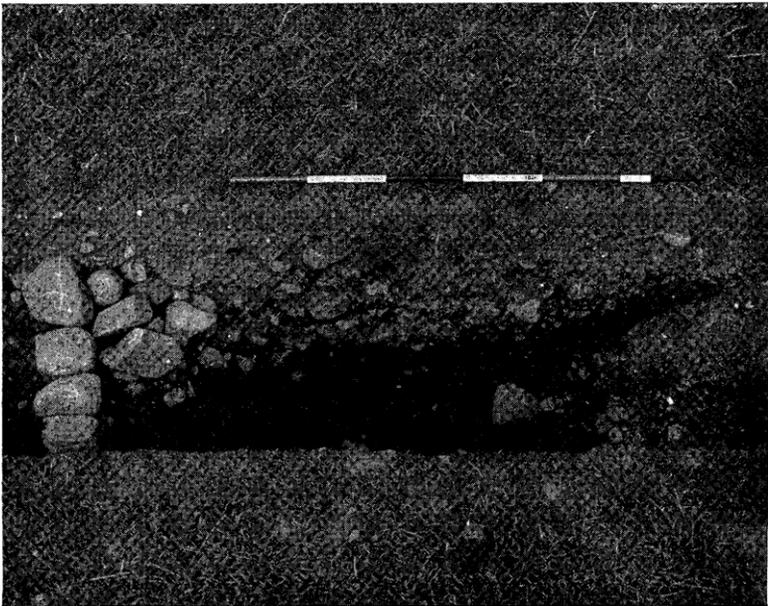
Pl. XVIb.—Risehow, Maryport, profile of inner ditch and wall.

*The Excavation.* The two enclosing ditches and a road ditch were sectioned (Fig. 3(g, h, i)), and an area excavation made in order to define the suspected outline of a building. The outer ditch was V-shaped and approximately 13 ft. across by 7 ft. deep. No trace of palisade was discovered although a tumble of stones in the bottom of the ditch implied the existence of a dry stone wall. The inner ditch was also V-shaped and slightly steeper on the inner slope, while on the very lip of the inner slope was a substantial and carefully built wall (Plate XVI(a) and (b)). These defences were impressive. The parallel ditches, 10 ft. across and some 4 ft. deep, were about 28 ft. apart, and as they led to a drinking place (still used for cattle), it was assumed that they were designed to stop cattle straying, perhaps in a time of danger.

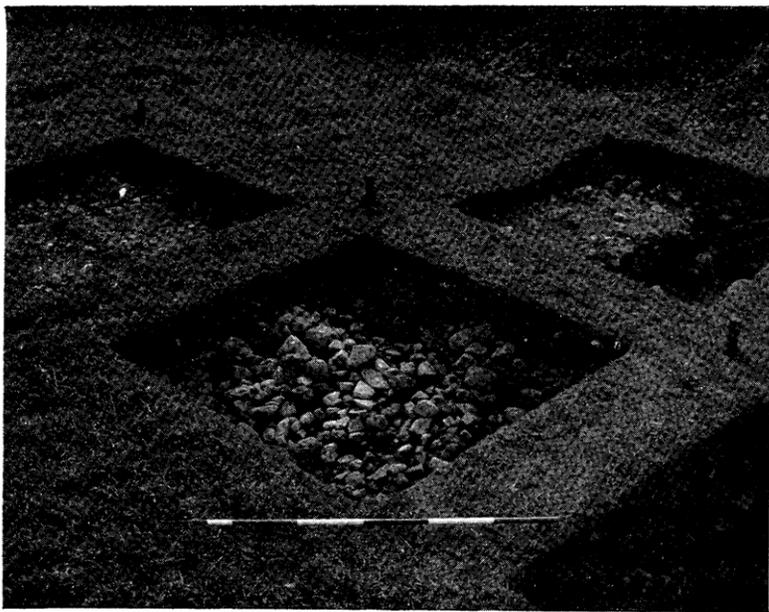
PL. XVIIa.—Risehow, Maryport, main foundations under tumbled wall.

*The Buildings* (fig. 4(e)) (Plates XVII a and b). In construction, the walls of the building were similar to the Old Brampton type, incorporating a row of very large cobbles as foundations for a wooden (?) superstructure, but the building was much larger than any of the others so far met, being approximately 70 ft. by 50. The size of the building plus the fact that there were few traces of occupation in its centre implied that it was more in the nature of a compound, and traces of cobbled floor and walling stretching only a few feet inside the main wall supported this view and implied the existence of lean-to shacks inside and against this compound wall.

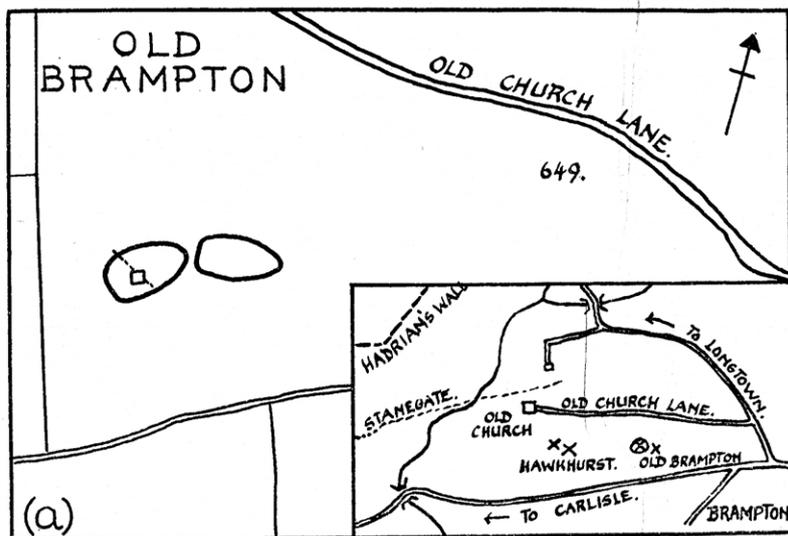
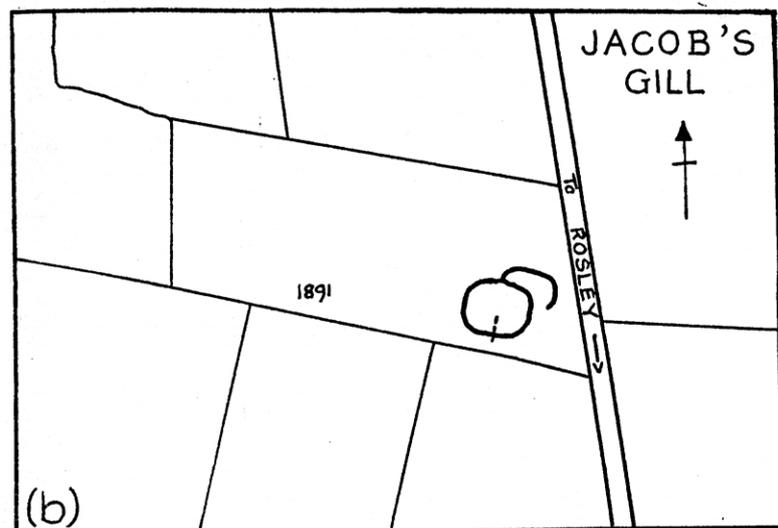
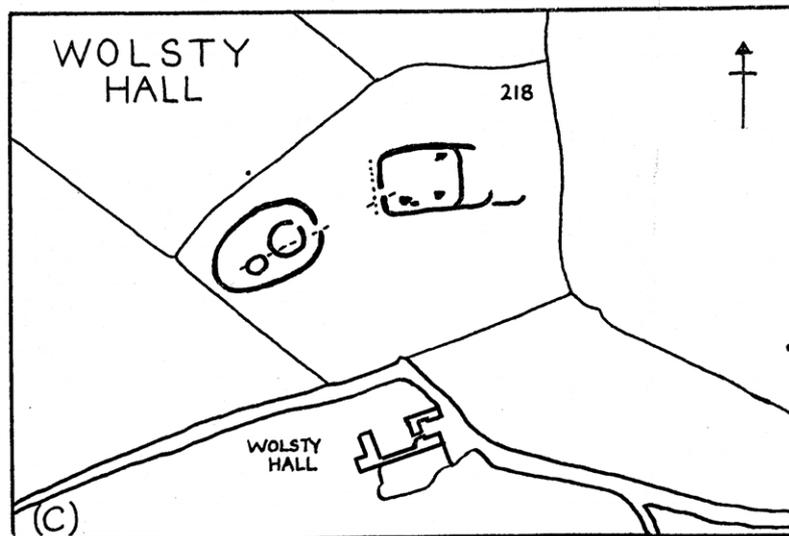
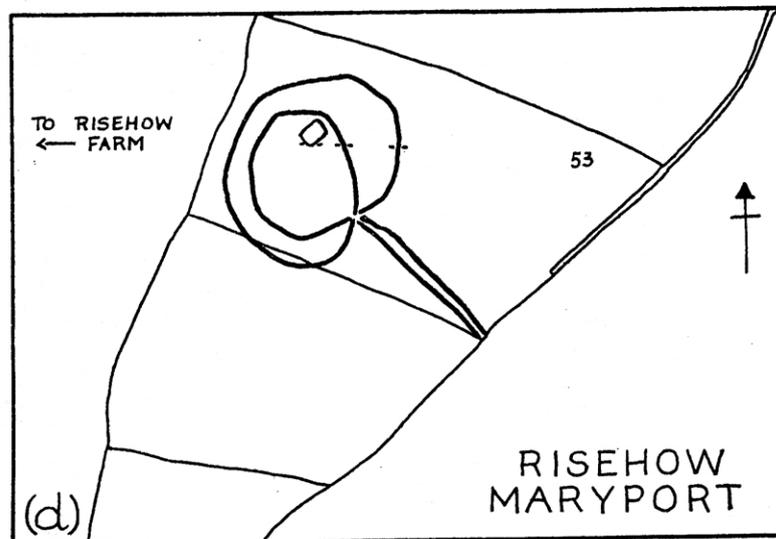
FIG. 2.

The relationship of this site to Old Church Roman fort and to Hawkhirst is shown in fig. 2(a). Of the two sites

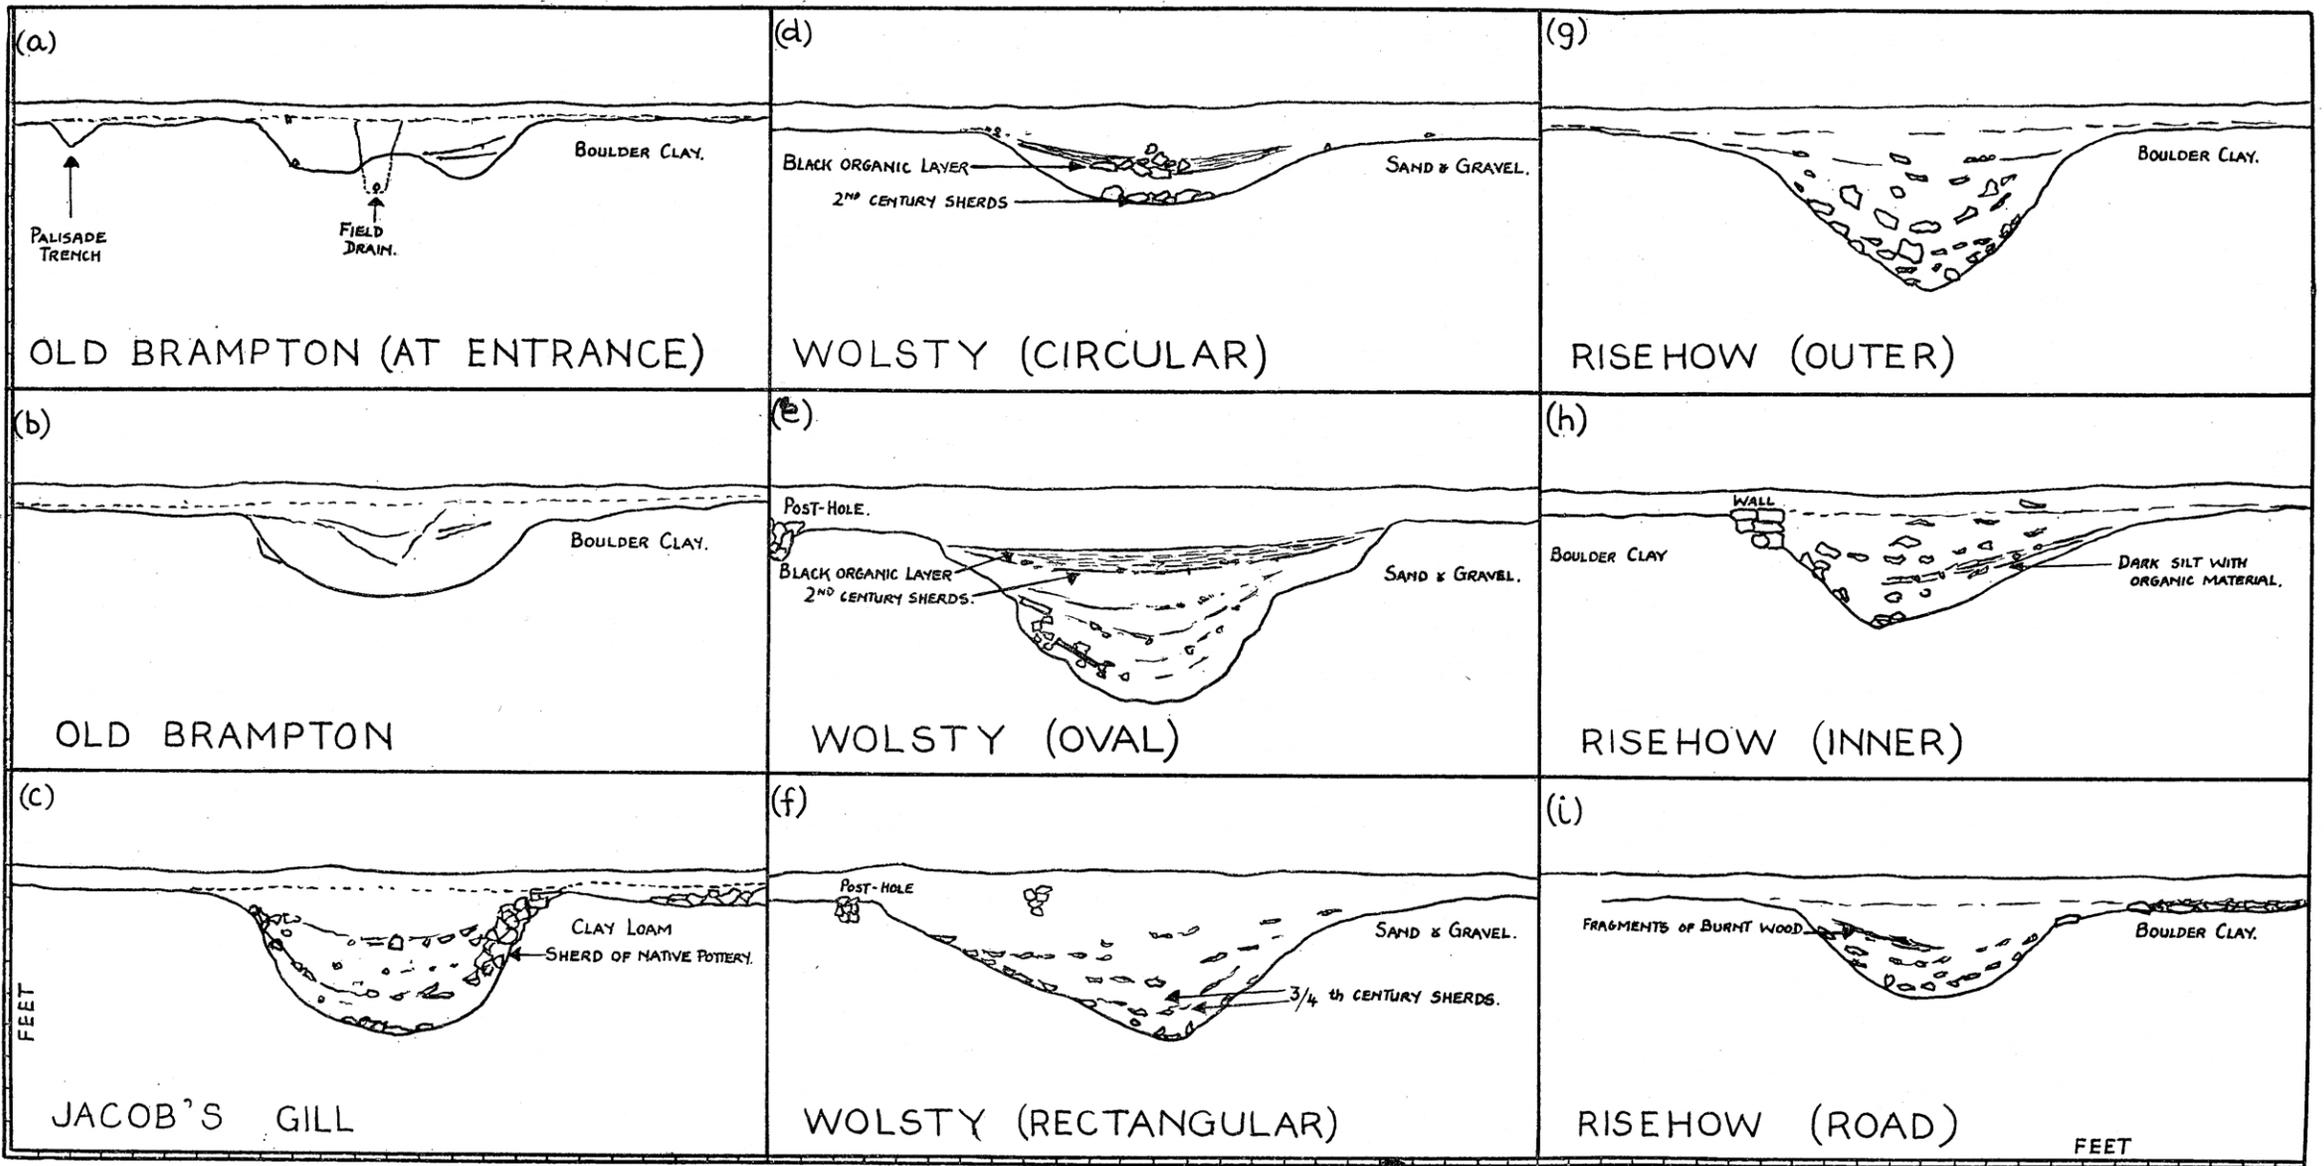
FIG. 3.

*The Oval Enclosure.* Hadrianic pottery was quickly found in the *upper* levels of this ditch (fig. 3(e)), and this, together with the fact that the habitation site associated with the ditch produced no pottery of any kind, suggested that this feature was pre-Roman. This suggestion was supported by comparison of the botanical evidence in the upper sections of this ditch and the bottom of the Hadrianic ditch, and also by the discovery of a saddle quern used as a packing stone for the strong wooden palisade which had been built 3 to 4 ft. within the ditch. The palisade had deep stone-packed holes for uprights every 3 or 4 ft. along the section excavated, and smaller holes must have supported uprights for gate-posts at the entrance.
