ART. I.—*Excavation in Eskdale, the Muncaster Roman kilns.* By R. L. BELLHOUSE, B.Sc.

Read at Kendal, April 21st, 1960.

THE ROMAN KILNS.
MUNCASTER. ESKDALE.

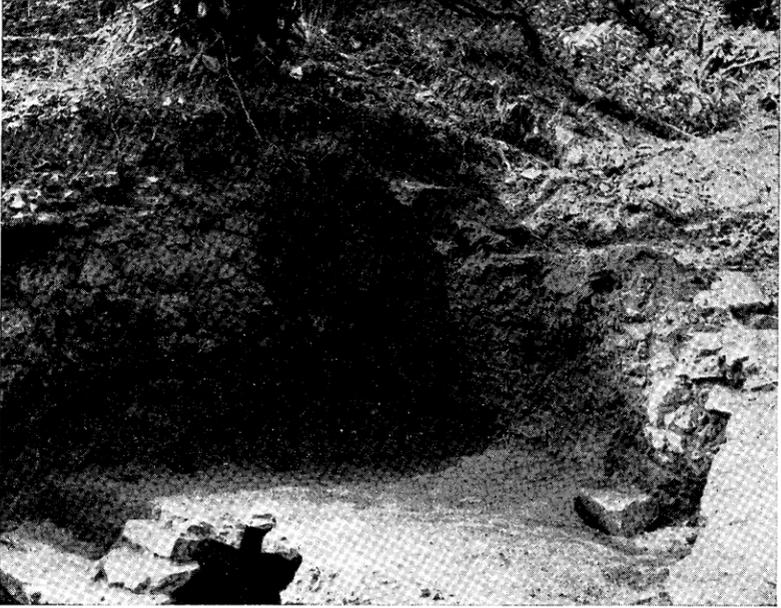
Photo: A. Whitehead.

General view of the kiln along the stokehole; fallen roof partly removed from firing floor.

The site was quickly cleared of overgrowth and soil was removed from the slope below the kiln. After four days' work under very trying weather conditions we had revealed the principal features of the structure; it had been built into the hillside and it may be conveniently described in two parts, first, a long tunnel-like stokehole built of rough granite blocks set in red clay, part of which had collapsed in antiquity, leading into a second structure, the furnace proper and the firing floor. It was by now clear that the preliminary examination in August, which was essentially the enlargement of Mr Fletcher's rabbit scrape, had led us through a hole in the firing floor at a point where the stokehole joined the kiln. This hole had no special significance at that time; through it we were able to see the granite pillars and brick corbelling supporting the firing floor. We could not determine how far the furnace penetrated the hillside, but the firing-floor was seen to be built between two parallel walls of granite blocks running into the hill, and the space between them over the floor was filled with a mass of broken brick and tile.

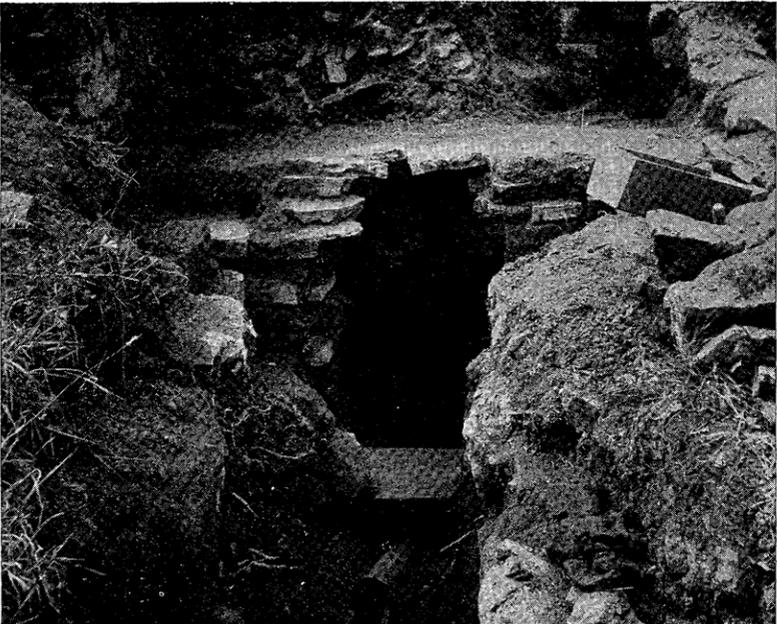
Photo: S. Buck.

The firing chamber; fallen roof removed revealing end wall of brick and remains of corbelling. A tegula waster in the corner is suspended by tree roots.

The axis of the kiln being roughly north to south, the west wall at the entrance survived to a height of 2 ft. 6 in. above the firing-floor where it showed the beginnings of courses of brick and tile. The east wall was ruinous, the greater part having long ago fallen outwards, while towards the back of the chamber its surviving part leaned inwards. The back wall above the level of the firing-floor was of coursed brick partly smeared with clay; below the floor, in the furnace, it was the same build as the granite side walls. Where the back wall joined the west wall we observed the beginnings of corbelling, obviously for the roof.

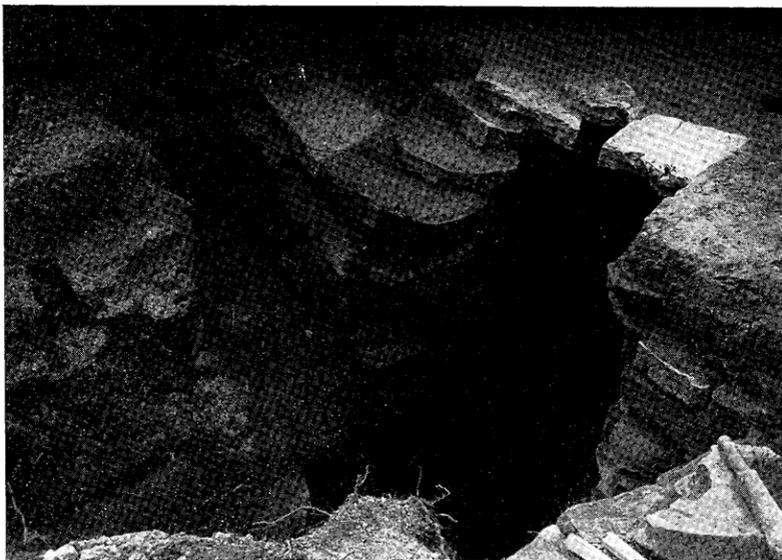
Photo: R. L. B.

The cross wall of tile and clay with central aperture; stokehole to left, firing floor top right. The left half of the photograph is approximately the full extent of Miss Fair's excavation.

The mode of construction of the kiln was now clear to us; the workmen had made a cut into the hillside and exposed, either by design or accident, a very convenient rock platform on which they had erected three sides of a square using granite blocks and clay. The open side of the square faced south and within it piers of granite and clay were made, from whose tops corbelling of heavy tile formed the base of the firing-floor. At the open side of the square a fourth wall of very substantial brickwork pierced by a single central entrance supported the firing-floor and completed the square. Mr Harry Stout's excellent plans make everything clear.

The stokehole must have been made last; it was a simply constructed tunnel of granite and clay in line with the hole in the brick fourth wall. A space about a foot wide between this wall and the tunnel end was bridged by tiles in order to extend the level of the firing-floor over the stokehole for access to the firing-chamber. A number of *tegulae* wasters lying on top of the stokehole arch at this point indicate that the last charge was probably in large part *tegulae* and that fired ware had been taken from the kiln before it fell into disuse. The greater part of the stokehole roof had long since collapsed and the remaining 4 ft. of arch was decidedly unsafe; this was carefully dismantled and removed together with the fallen masonry. On the floor of the stokehole along its length we found a line of *imbrices*; they started from a gap in the corner of a box-like arrangement of four heavy tiles enclosing a space 17 by 19 in.; the first four were inverted and covered by a mass of burnt clay and broken tile in which we found parts of several cooking-pots. The next three were the other way up and led right into the centre of the furnace where they rested in a trough cut into the solid rock floor, and were protected above by two heavy tiles 18 in. square.⁵ The purpose of this

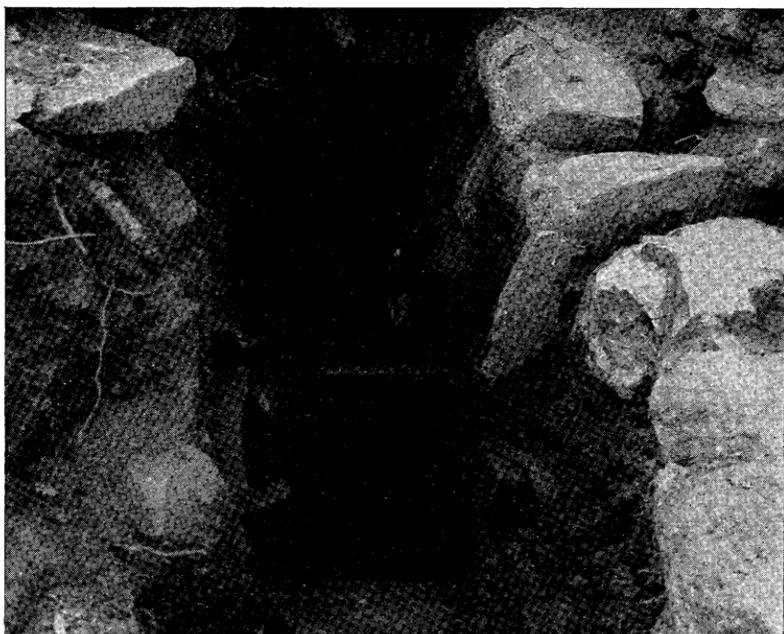
Photo: S. Buck

The tile "box" and the line of *imbrices* along the floor of the stokehole. The tile forming the fourth side, nearest camera, has been taken out. The protecting tile at the end of the stokehole can be seen at the top of the photograph.

arrangement must have been to regulate an extra air supply, not to the actual fire, but beyond it to the firing-chamber itself so that the ware would be fully oxidised and of an even colour during the final stage of firing. A similar box beyond the first and at a lower level was a surprise which must await further work at the threshold of the kiln for its full explanation.

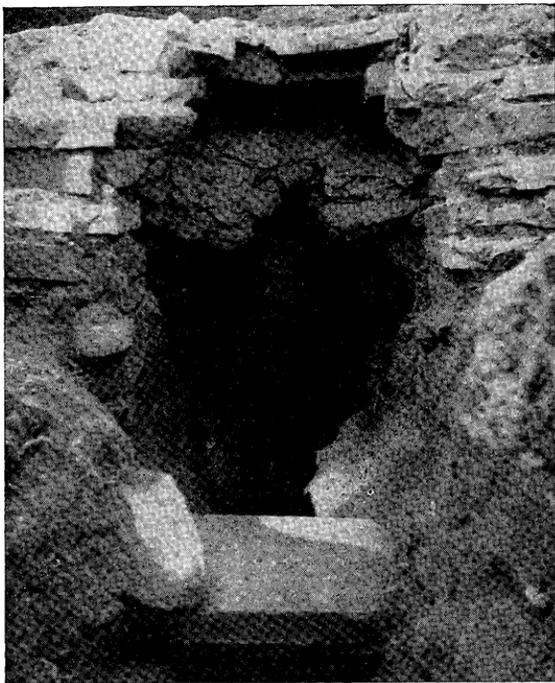
Photo: S. Buck

The entrance to the combustion chamber. The granite piers supporting the firing floor are seen in the centre; the tile in the foreground is one of two protecting the line of *imbrices* along the stokehole.
