ART. XI – *Excavations at Brougham Castle, 1987*

By JOHN H. WILLIAMS

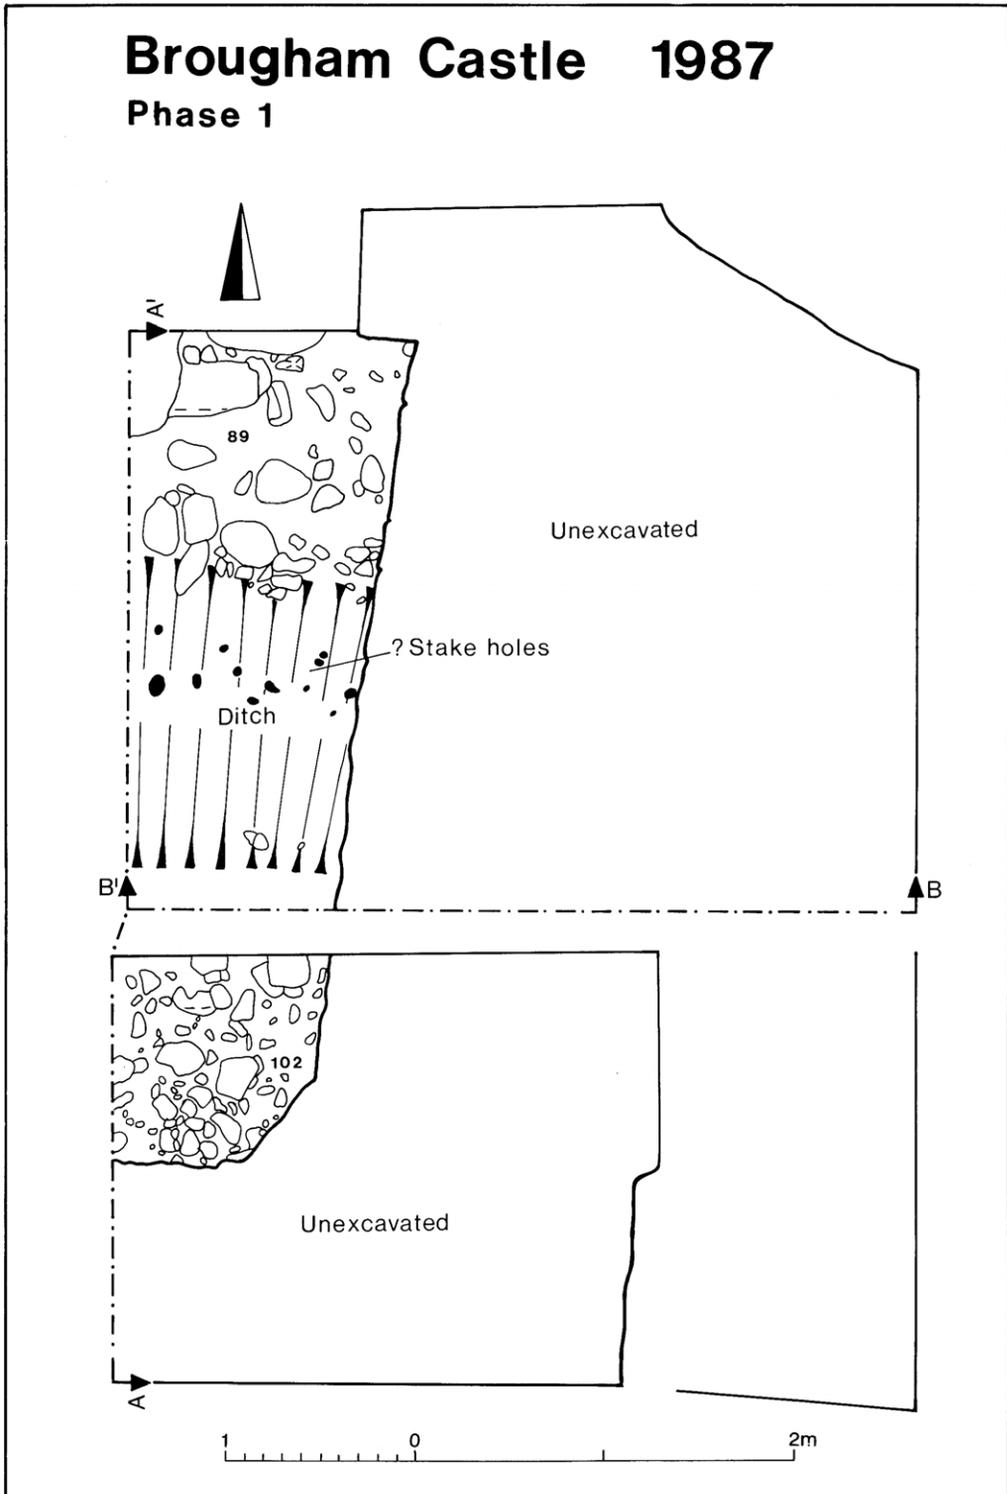
FIG. 3 The 1987 excavations, Phase 1.

A short length of a small ditch of U-shaped profile, which cut into the natural clay subsoil, could be seen running east to west. To the north and south of the ditch were compact metallated surfaces of water-worn cobbles and some sandstone (89, 102). In the north face of the ditch approximately twelve circular patches of dark soil between *c.* 0.07 and 0.10 m in diameter were thought to represent stake-holes or root holes but on excavation they were found to penetrate the natural clay to a maximum depth of 0.13 m. The lower fills of the ditch (103, 104) contained no pottery but the ditch is thought to be Roman. On the basis of the seven sherds of Samian found in other deposits a date in the second half of the second century may be suggested.

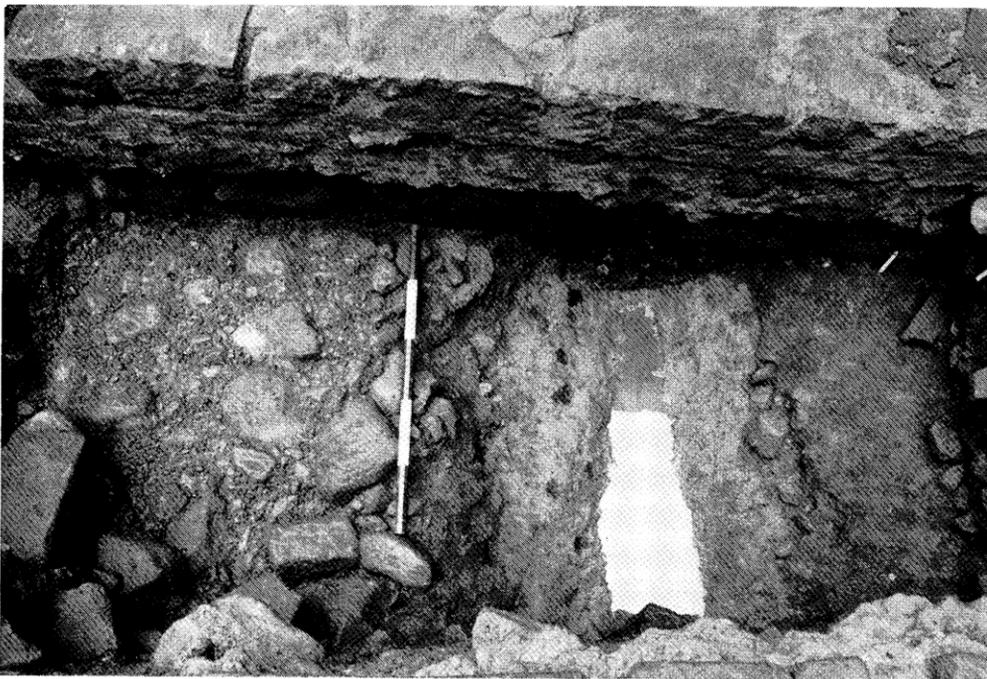
PLATE 1 The Roman ditch from the west with the possible stake-holes visible in its north face. To the north is cobbled surface 89. Two courses of the squared well-mortared masonry of wall 9 can be seen stepped out over rougher foundations.

Excluding modern work a six-phase sequence has been demonstrated by the excavation. The Phase 1 ditch is not specifically of military character but its alignment parallel to the northern rampart of the Roman fort and its proximity to it suggest that it may have formed an outer ditch in the defensive arrangements of the fort. The possible stake-holes or root holes in the north face of the ditch were possibly the remains of a further defensive obstacle comprising rows of sharpened stakes or a thorn hedge (*cf.* Johnson 1983, 53; Jones 1975, 113).

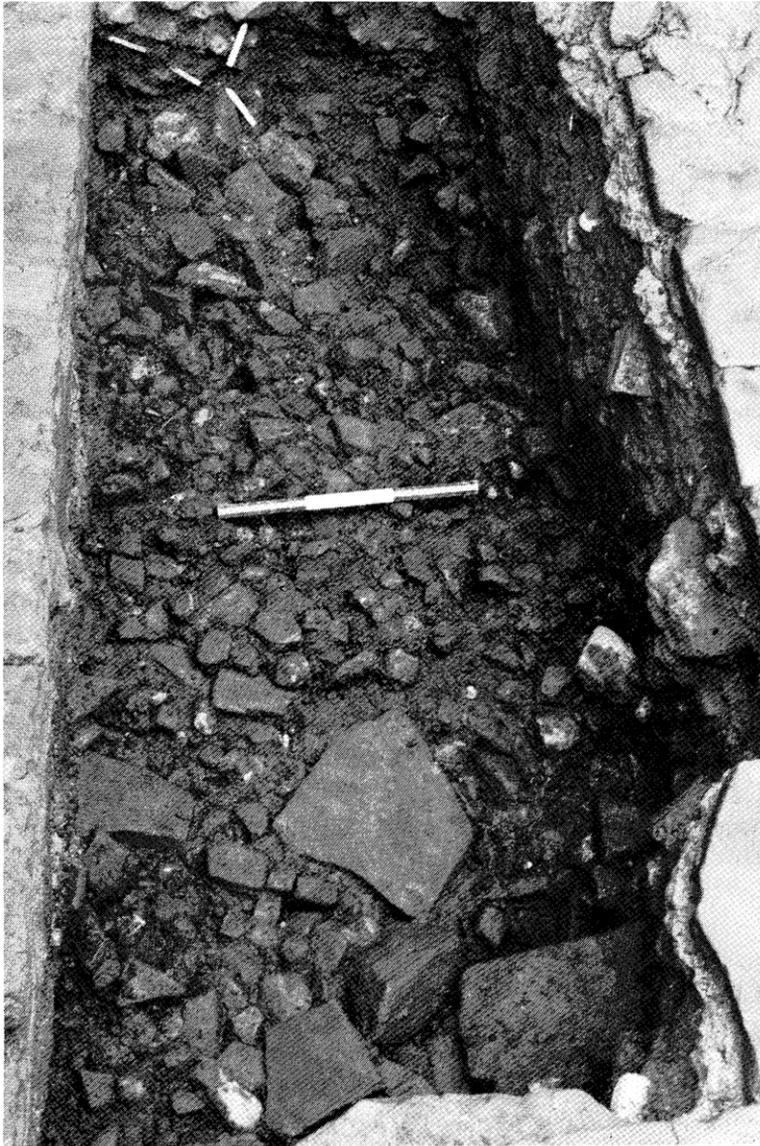
PLATE 2 The north section of metalled surface 75 from the north.

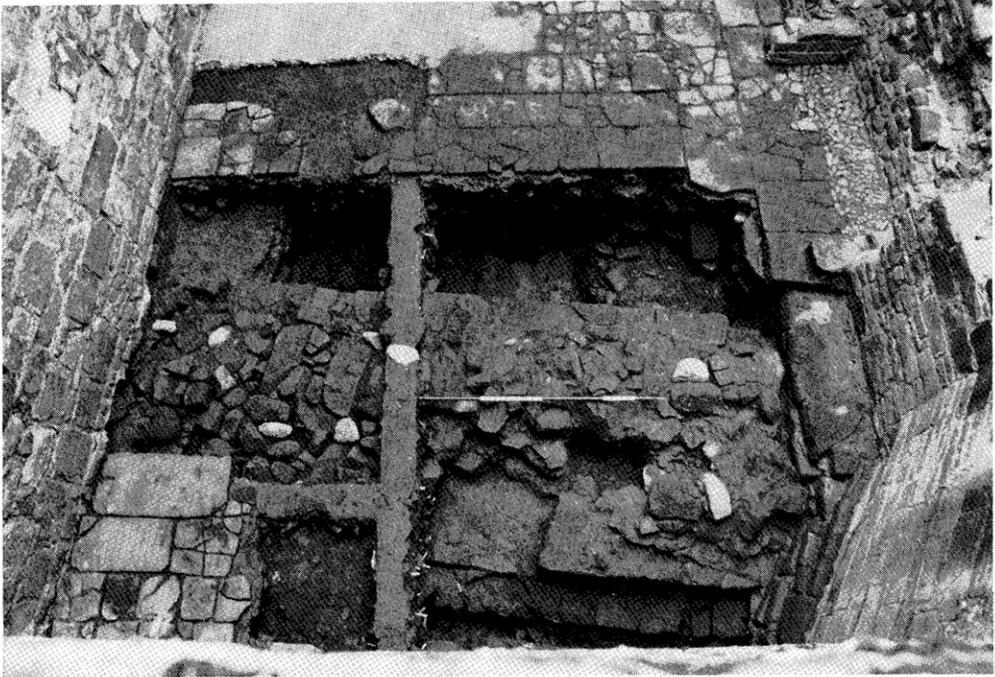
PLATE 3 The Phase 3 wall (9) from the east.

Phase 3 saw the construction of a substantial mortar-bonded wall (9), *c.* 2.6 m wide including an offset *c.* 0.40 m wide on its east face. At its south end, and well bonded with it, a buttress or another wall projected eastwards beyond the edge of the excavated area. Wall 9 was well faced and coursed and contained a rubble core. The construction trench for the foundations (71, 92) could be clearly seen to cut layers 65 and 75 but the relationship of the wall with layer 62 was not so clear (Fig. 5, Section B-B¹). Spreads of

south wall of the chapel, or at least its north face, seems to have been constructed over the top of wall 9. Two observations, however, can be made: firstly, if the line of the west edge of 9 (excluding the southern projection) is extended southwards, what appears to be a butt joint is encountered in the lower courses of the south chapel wall; secondly, to the east of this “butt joint”, rather small stones are to be found in the basal courses of the wall, suggesting some form of patching. It would appear that the south wall of the chapel was either refaced or partially rebuilt after the demolition of wall 9. Certainly on the evidence from the south side of the south chapel wall at least the eastern end of the chapel wall (the butt joint at B, Fig. 2) was originally erected at the same time as wall 9. The few fragments of medieval pottery from context 62 are consistent with a date sometime between the mid- to late thirteenth century and *c.* 1500.

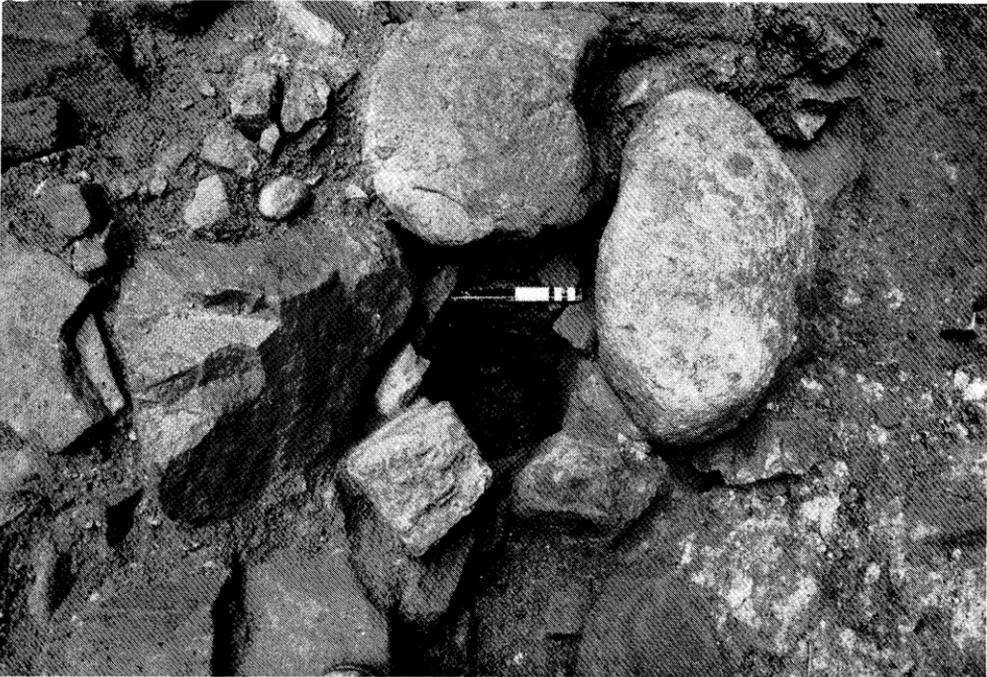
PLATE 4 Phase 3 post-hole 49 from the south.
