## Loandhu to Portmahomack Water Main Renewal

## Watching Brief

<b>Report No.</b>	HAS090606
<b>Site Code</b>	CWM08
<b>Client</b>	Scottish Water Solutions
<b>Planning Ref</b>	N/A
<b>Date / revision</b>	27/07/2010
<b>Authors</b>	Cait McCullagh and John Wood

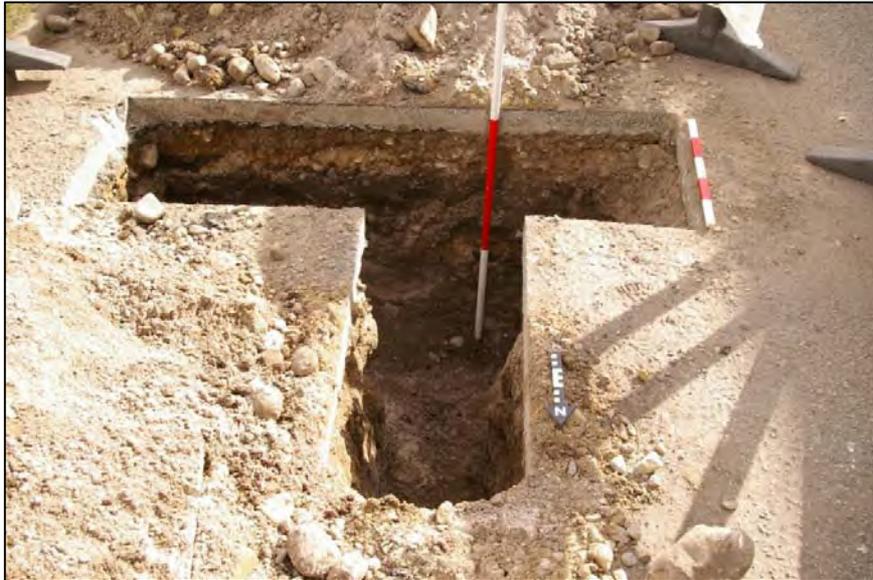
**Plate 2 Trench 4**

In the test pit excavated for Trench 4, Chapel Place, (centred at about NH 91716 84574), the present concrete roadway surface, 0.3m in depth, was observed to overlie 0.4m of dark grey silt/sand with intense washed pebble and occasional cobble; charcoal inclusions and deracinating sandstone spreads, which in turn overlay 0.3m (approx) of dark brown loam to the west of the E – W transept of the pit. As with the dark brown stratum observed in Trench 1, this too was interpreted as a possible archaeological horizon, overlain by re-deposited material; however, again no artefacts were evident here.

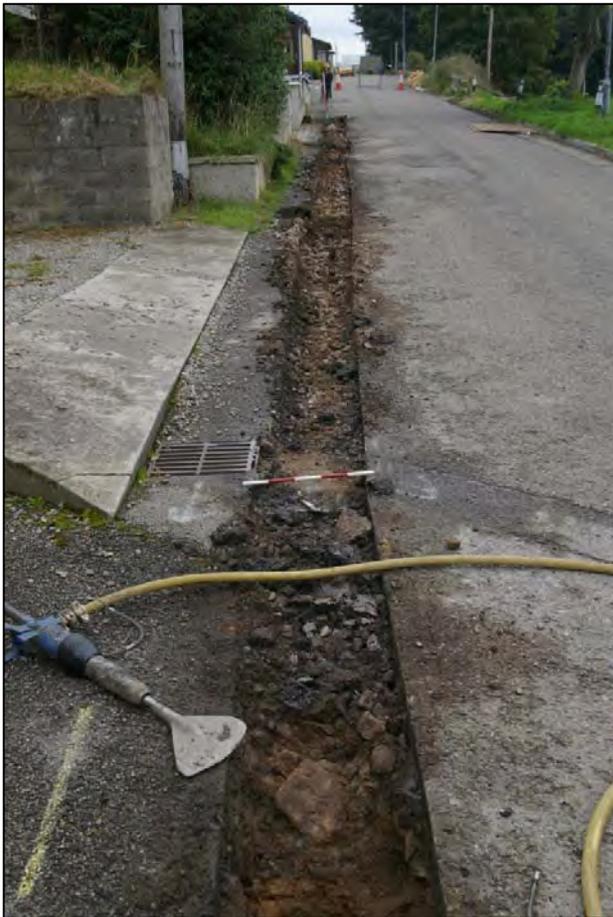
Plate 3 Trench 10

10.	IVO Features 18, 19, 22 Harbour Street intersection with Castle Street, then following the NNW – SSE trajectory along	D = 1.2m W = 0.5m L = 80m, observed through site visits.	This trench was excavated with a chain (suction) trencher. Test pits were checked and precautionary site visits were conducted during trenching.  Directly E of the Victorian Water Fountain, Feature 18, 0.12m depth of the present roadway surface; tarmac was seen to come down, as the trench progresses E, onto 0.03m of tarmac. Both surfaces came down onto 0.4m of a sandy silt re-deposited stratum, mixed with sharp stones, washed cobbles and pebbles and deracinating Old Red Sandstone. This in turn gave way to

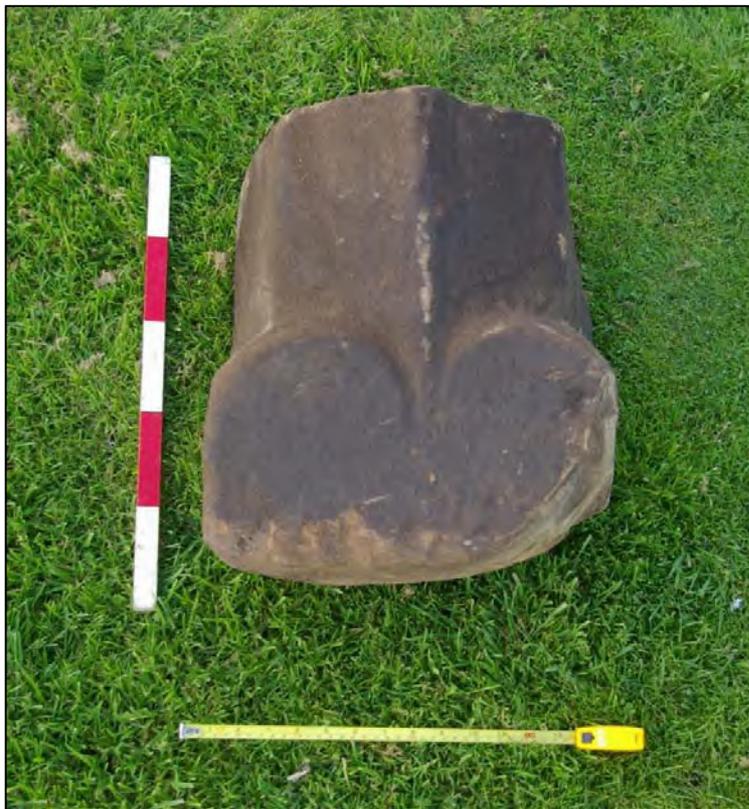
Plate 4 Carved stone capital (Find 4)

**Find 4** A possibly 13<sup>th</sup> Century carved sandstone capital column was found in Trench 11 at NH91442 84008, in the re-deposited layer of cobble and stone. (Dimensions: Length = 47.5cm, Width = 33cm, Thickness = 18cm ) The front faces show relief carved and incised gothic scrollwork – each scroll measuring 0.17m in diameter – over two panels of the four that survive of the possible hexagonal column shaft fragment. Looking at the reverse, the possible hexagonal column shaft fragment has been hollowed out, creating an 'hourglass' shaped void, indicating likely re-use. Pecked decoration is visible on the side face of the carved scroll that sits above one of the four surviving panels of the column shaft. A simple cruciform pictogram has been incised onto the pane. (See Plate 4 below)

During the water main renewal programme, a re-used, probably 13<sup>th</sup> c., carved stone capital (Find No. 4), decorated with gothic scrollwork, was found in Trench 11 on the Tarbatness Road.

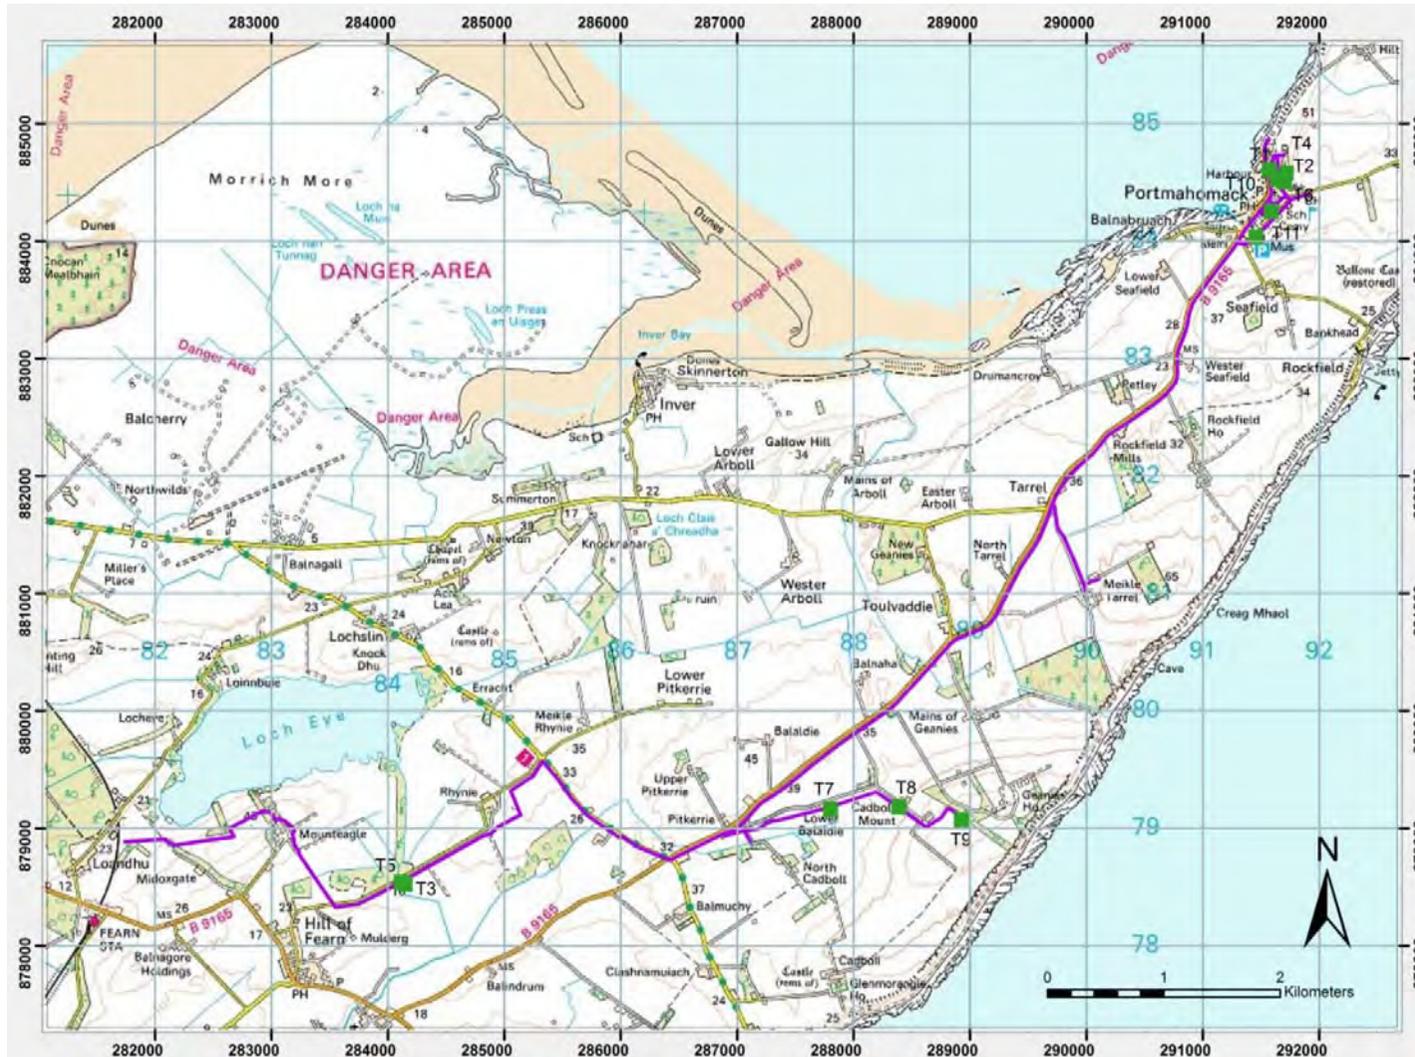
Figure 2 Water main line and WB trenches

Eleven trench sections were observed: details are given in Table 1 below. In Portmahomack Village, two of these were of substantial length: Trench 1, along Harbour Road, extended 739m from the NNW end of the village shore; and Trench 11 part of the Tarbatness Road; extended SSW 420m from close to Tarbat Old Parish Church. Also in the village, Trench 2, along part of Chapel Street (112m) and Trench 6, Gaza (30m) were observed, as was a test pit cut prior to directional drilling at Trench 4, Chapel Place.
