**ARCHAEOLOGICAL STRIP, MAP AND
RECORD REPORT:
GREEN LANE WORKS,
KELHAM ISLAND,
SHEFFIELD,**

Report prepared By Elmet Archaeological Services Ltd
Report Number 2014003
FEBRUARY 2014

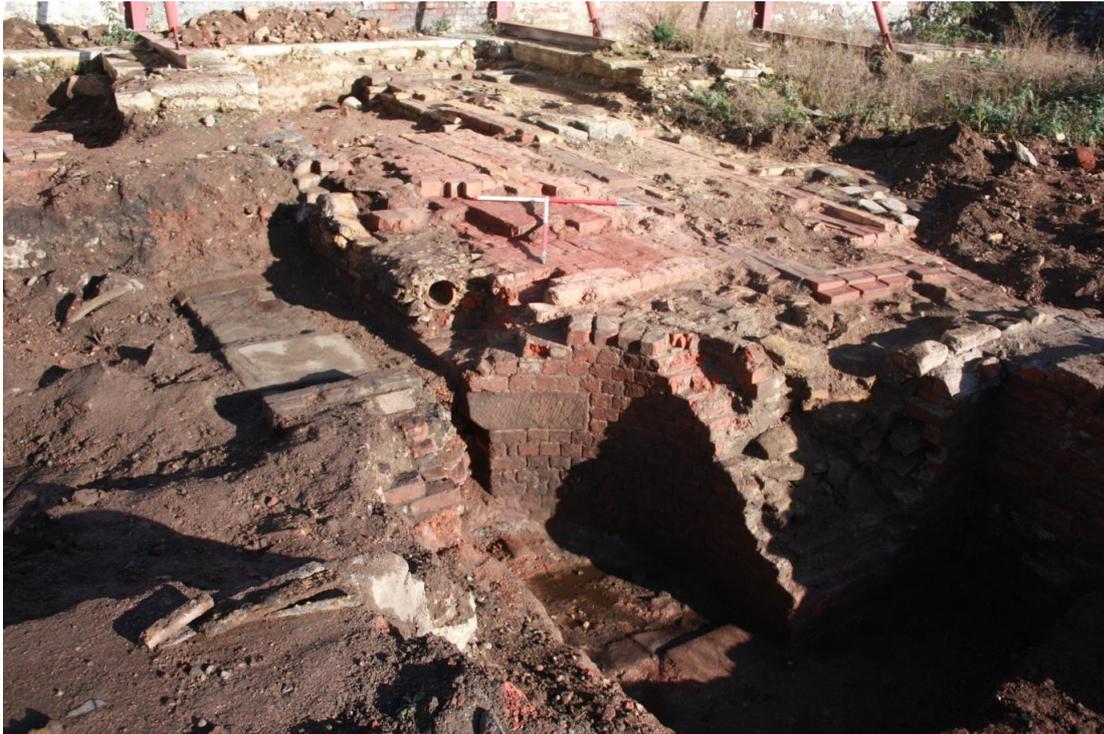
Plate 1: Eastern furnace showing extent of truncation and in situ remains. Facing north-east. Scales 2 x 1m.

The remains of the furnace flue opening consisted of the curvilinear wall **1032**, constructed with handmade red brick, bonded with white lime mortar and which resembled a D shape in plan (**Plate 1**). This wall had a height of 1.25m but the full length and width were not identifiable due to later construction and truncation. Keyed into the red brick wall **1032** was the sandstone plinth **1033**, which formed the arched shape of the lower part of the flue passage. This plinth also served as a foundation for the upper walls of the flue identified as **1034**. The sandstone blocks were dressed with a chamfered western edge whilst the southern extent was shaped to fit flush with the curve of the D of the furnace opening **1032**. The full length of the plinth was not recorded, but was assumed to be similar in construction to the sandstone plinths **1001/1003** in the western furnace (see below for details). The remains of the opposing red brick flue wall had been completely destroyed by truncation of the drains **1049** and **1051** so a full record of the furnace at this point was impossible.

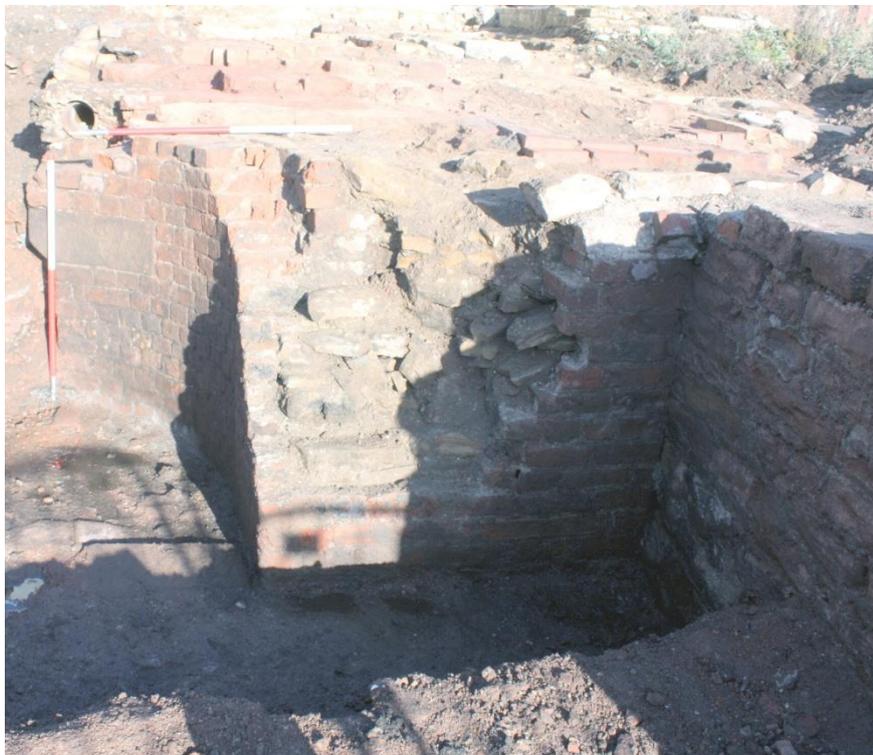
Plate 2: Southern frontage of eastern furnace showing D wall **1032**, floor surface **1047**, furnace front wall **1044**, sandstone packing **1043** and sandstone wall **1046**. Facing north. Scales 2 x 1m.

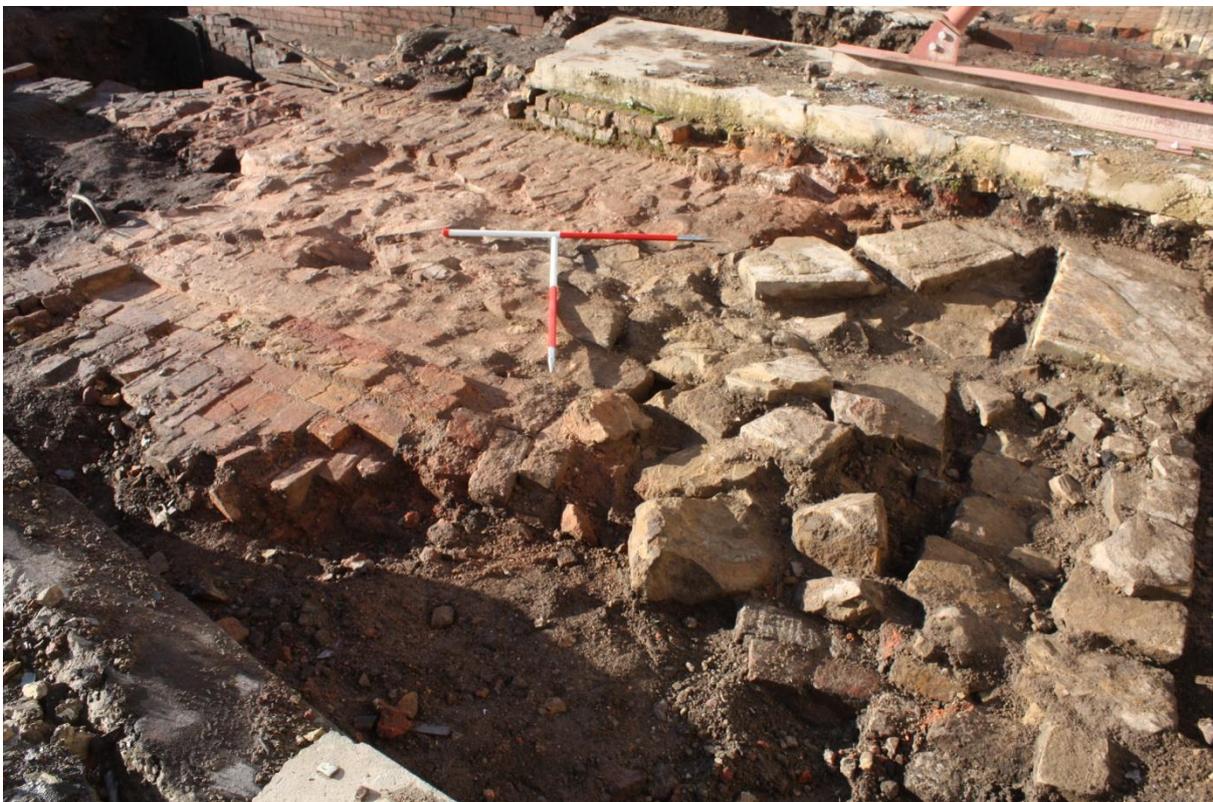
Plate 8: Northern extent of both furnaces, showing curvilinear sandstone foundation **1024** for the furnace cone and northern sandstone exterior wall **1025**, along with chest foundation remains. Facing south-west. Scales 2 x 1m.

The sandstone structure **1024** was 1.30m long, with a width of 0.42m and consisted of a single course of no less than three sandstone slabs (**Plate 8**). It was curved in plan and interpreted as the base structure of the western furnace cone, which was probably brick made above this foundation level. However, no evidence for these bricks was seen, but other cementation furnaces of a similar date may be used as a comparison. The remaining sandstone blocks lay directly below the modern concrete surface **1065**. Directly to the north of **1024** and butted against the foundation material **1028** was the massive sandstone wall **1025**. This structure measured 2.65m long and 0.60m wide and was orientated east to west and it is probable that these blocks represented the exterior northern wall foundation of the furnace. It consisted of no less than two sandstone slabs overlying smaller sandstone blocks with a rubble core. The full extents of this possible foundation were obscured by the modern concrete surface **1065** to the west.

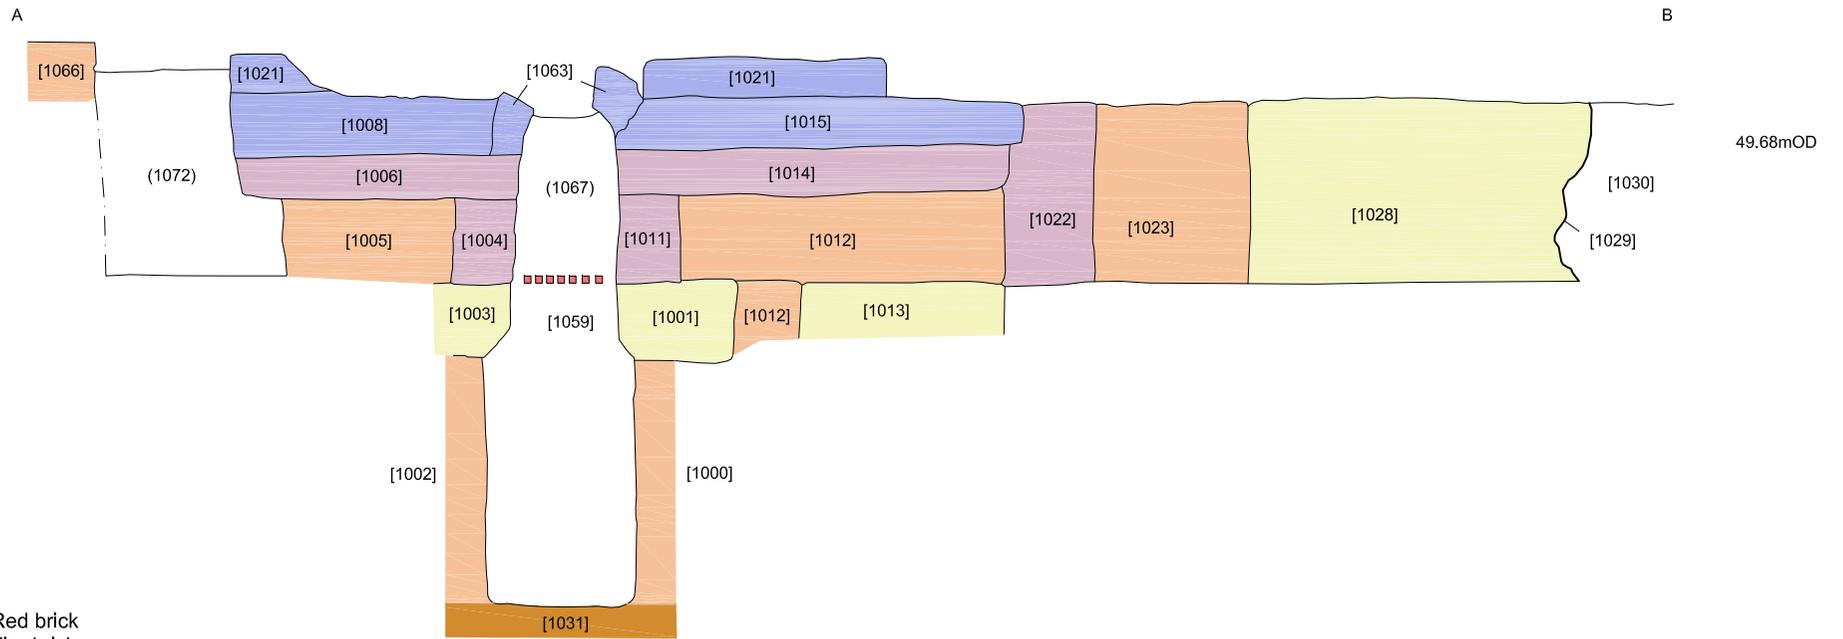
Green Lane, Sheffield
 South-west facing section
 through Cementation Furnace
 Excavation, Nov 2013
 Illustration No. 7
