**NEVILLE HALL MIFA
FREELANCE ARCHAEOLOGIST & CONSULTANT**

ARCHAEOLOGICAL MONITORING AT
CHURCH VIEW BUNGALOW,
NETTLETON ROAD, CAISTOR,
LINCOLNSHIRE.

National Grid Reference: TA 1165 0107
Site Code: : NRCA13
Accession No: LCNCC: 2013.206
Planning Reference: 130444

January 2014

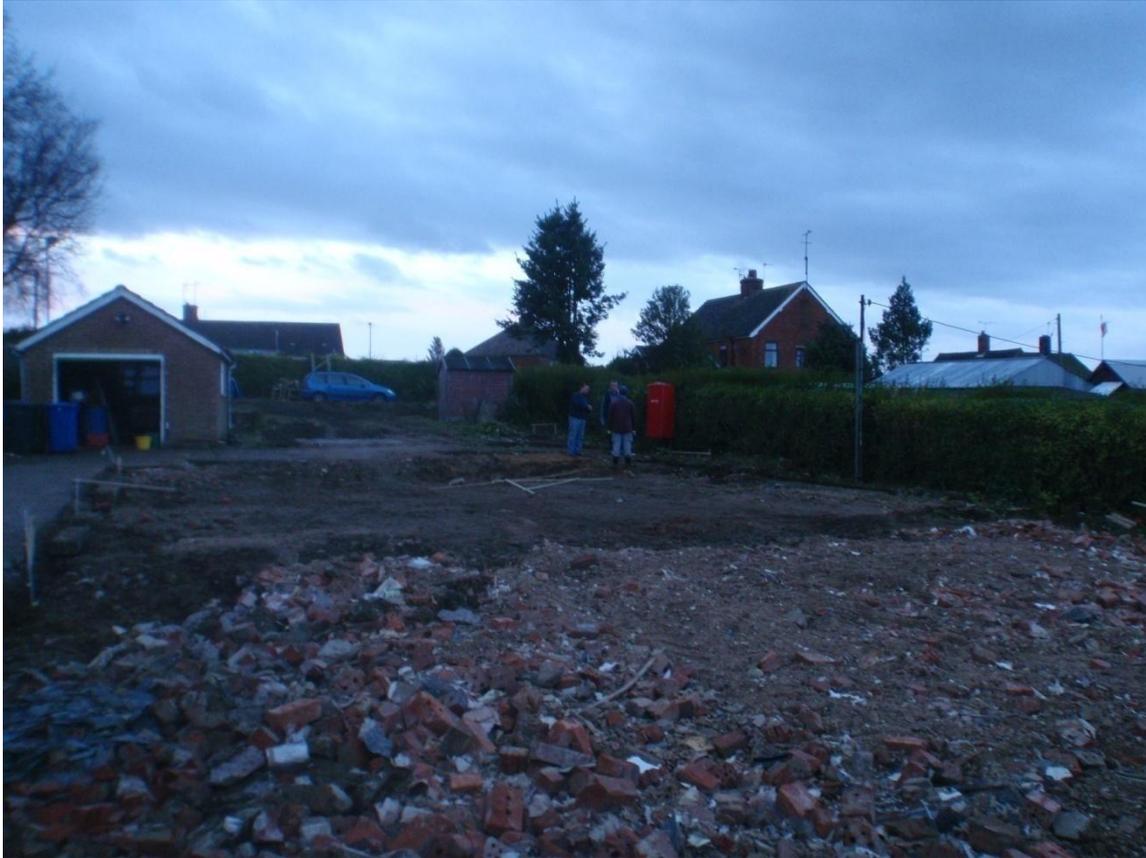
Plate 1: Pre-groundworks, from the north

- 7.1 All of the groundworks pertaining to this development were continually monitored and recorded. The former bungalow which had stood on this site had been demolished and the site cleared prior to arrival. The foundation trenches were excavated by a JCB3cx mechanical excavator that was fitted with 0.60m and 0.70m wide toothless buckets.

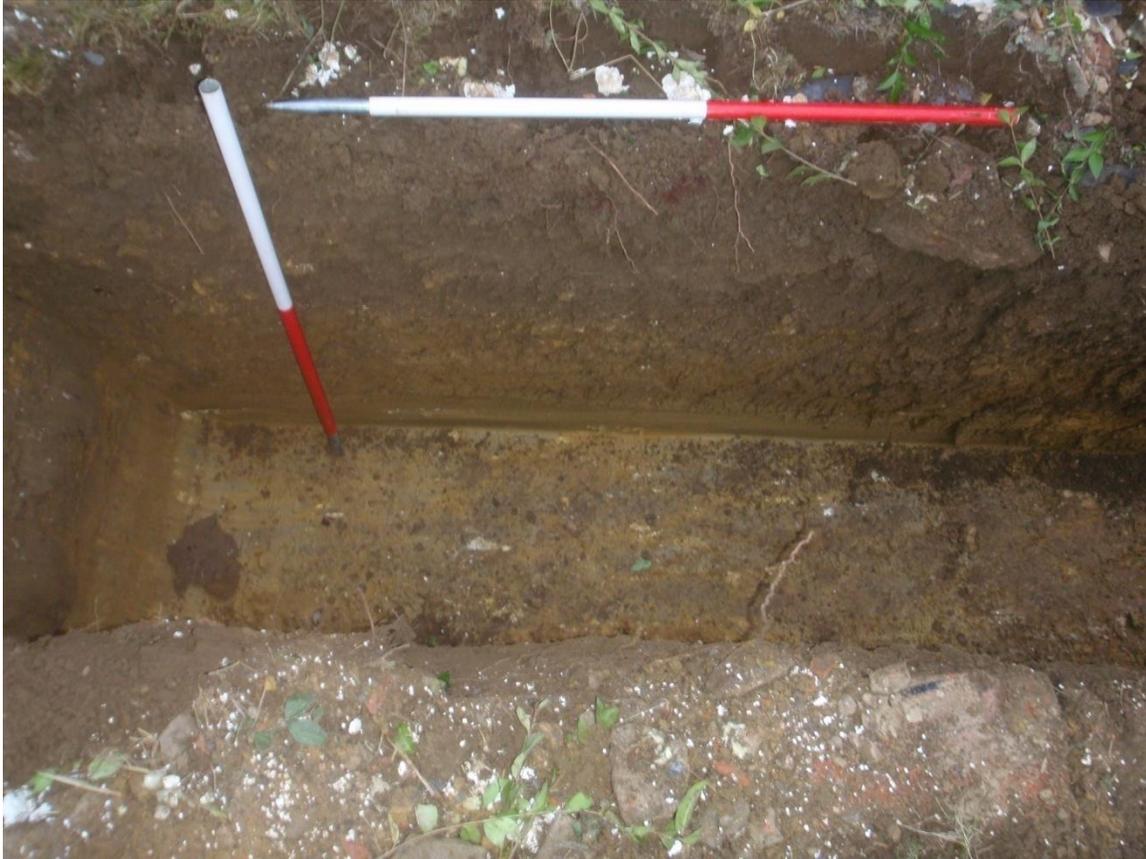
Plate 2: Representative Section 1, from the east

- 7.2 The monitored foundation trenches were excavated to varying lengths, to widths of between 0.60m and 0.70m and to depths of between 0.90m to 1.20m below ground levels. Over much of the area of the new build, the deposit sequence encountered comprised a modern topsoil horizon (**001**), an undated ploughsoil horizon (**002**) and an underlying natural horizon (**003**), which was encountered at the base of the trench excavations. This deposit sequence was recorded within **Representative Sections 1-3**.

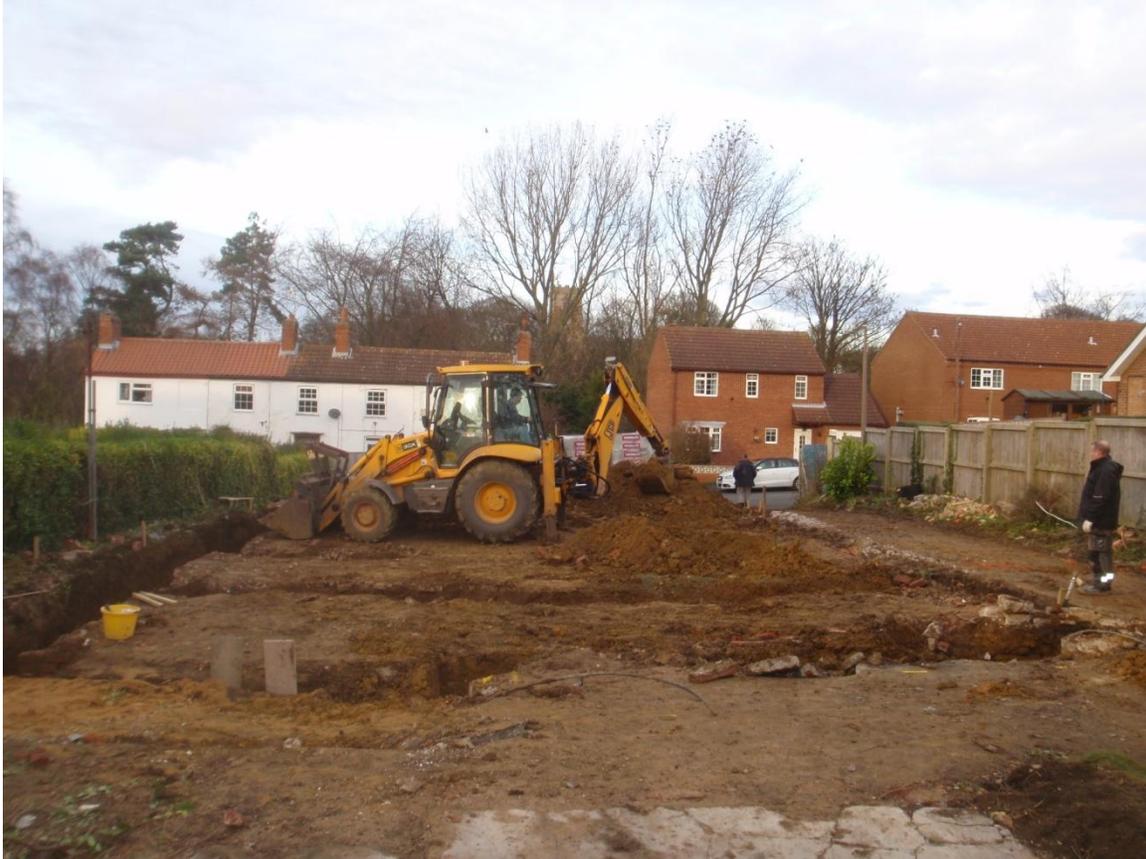
Plate 4: Excavation of the foundations, from the south

- 7.3 The outline of the build footprint of the former bungalow which had stood on this site was observed on the ground and at the trench edges of several of the foundation trenches. There was also some modern disturbance at the rear of the new build from existing and live services comprising a foul sewer. Within the southern and south-eastern portions of the new build area, a modern made ground deposit (**004**) was encountered within the area of the old build footprint of the former dwelling. This deposit was apparent on the surface and was substantial, extending almost to the base of the trench excavation, where it was observed to come down directly onto the natural horizon (**003**). This deposit was associated with the construction of the former dwelling on this site.

- 7.4 This situation was repeated along the eastern portion of the area of the new build. A second modern made ground deposit (**005**) was also encountered within the area of the old build footprint of the former dwelling. This deposit was also substantial extending from the ground surface to depth above the natural horizon (**003**), which was recorded at the base of the trench excavations. This deposit (**005**) was also undoubtedly associated with the construction of the former dwelling on this site. There was also some additional modern disturbance in the upper levels of the foundation trench along the eastern side of the new building from existing gas and water pipes.
