**Land to the rear of 6 Watergate
KIRKWALL
ORKNEY**

**DESK BASED ASSESSMENT AND
ARCHAEOLOGICAL EVALUATION**

**Land to the rear of 6
Watergate,
Kirkwall,
Orkney**

**Desk based assessment and
archaeological evaluation**

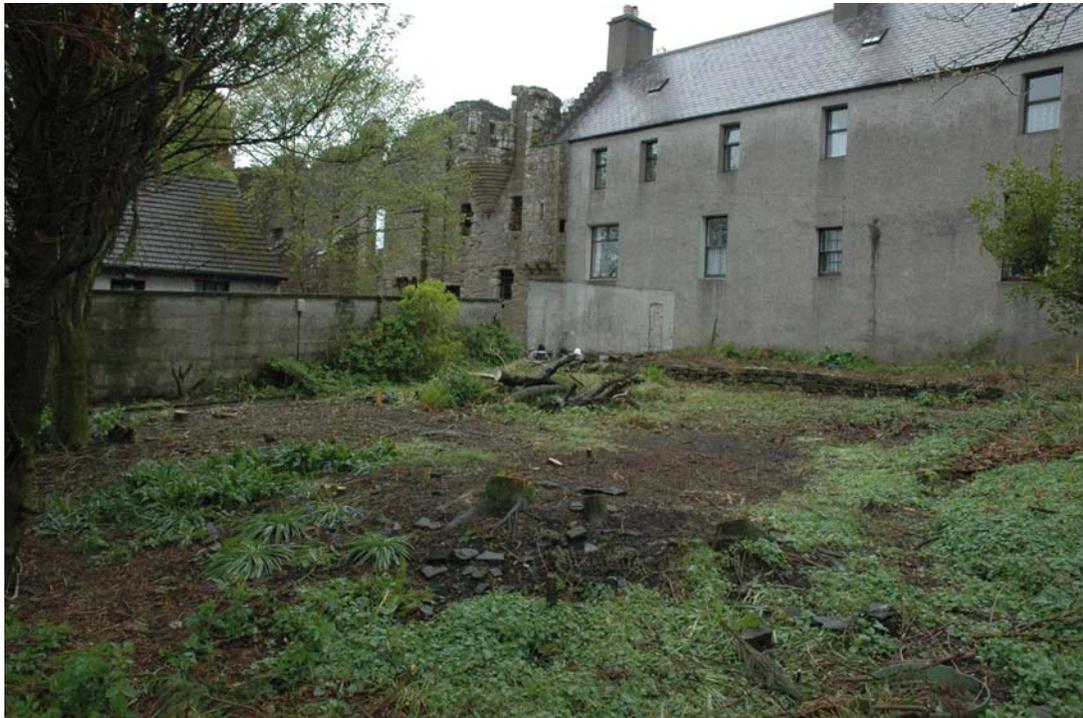
Plate 1: The north eastern part of the development area, with the Old Manse and the Bishops Palace in the background. Looking northeast.

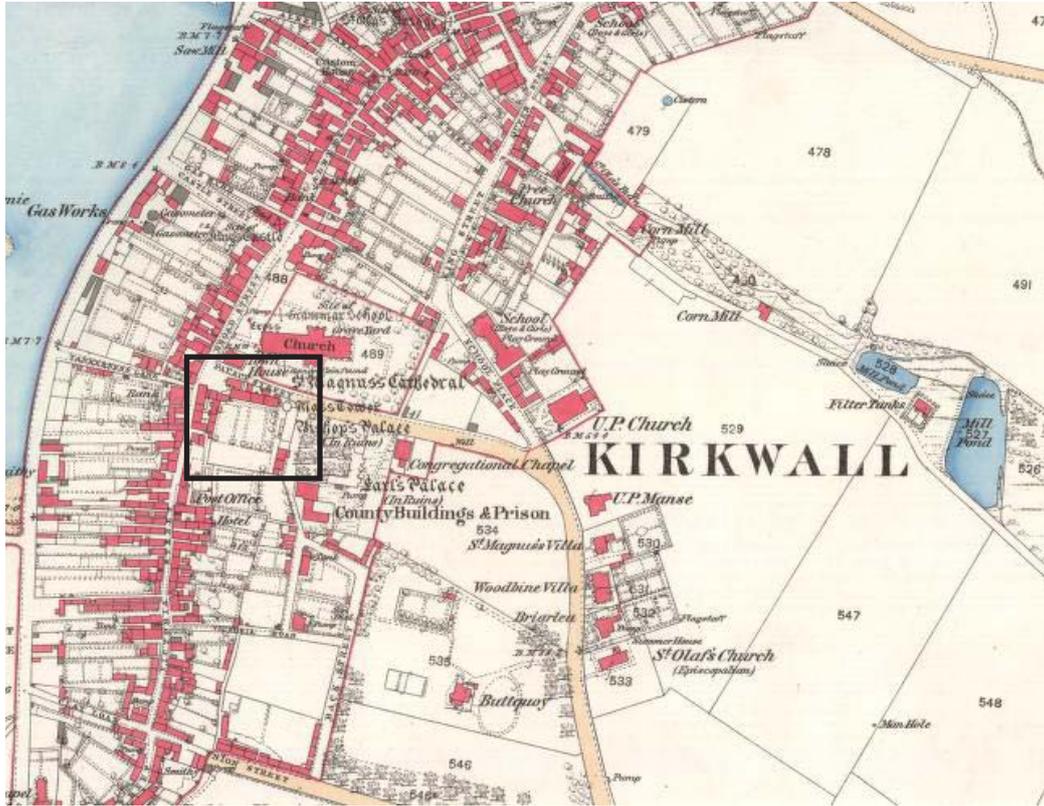
Figure 1 (above): The proposed development area shown on the Ordnance Survey town plan 25" to 1 mile 1st edition, 1880 (Sheet CVIII.3). Not to scale.

The first accurate mapping of Kirkwall is represented by the Ordnance Survey County Series of the early 1880s. The OS Town Plan of Kirkwall c1880 was viewed on-line at www.nls.uk/digitallibrary/map. This plan was the basis for the First Edition Ordnance Survey map and shows the same information. These maps show recently constructed Junction Road (although not yet joined to Scapa Harbour) forming the east shore of the Peerie Sea. The proposal area is blank and remains unoccupied by this time; there are no structures visible on the map. The Second Edition Ordnance Survey map of 1902 was viewed in the Orkney SMR and very little appears to have changed in relation to the assessment area.

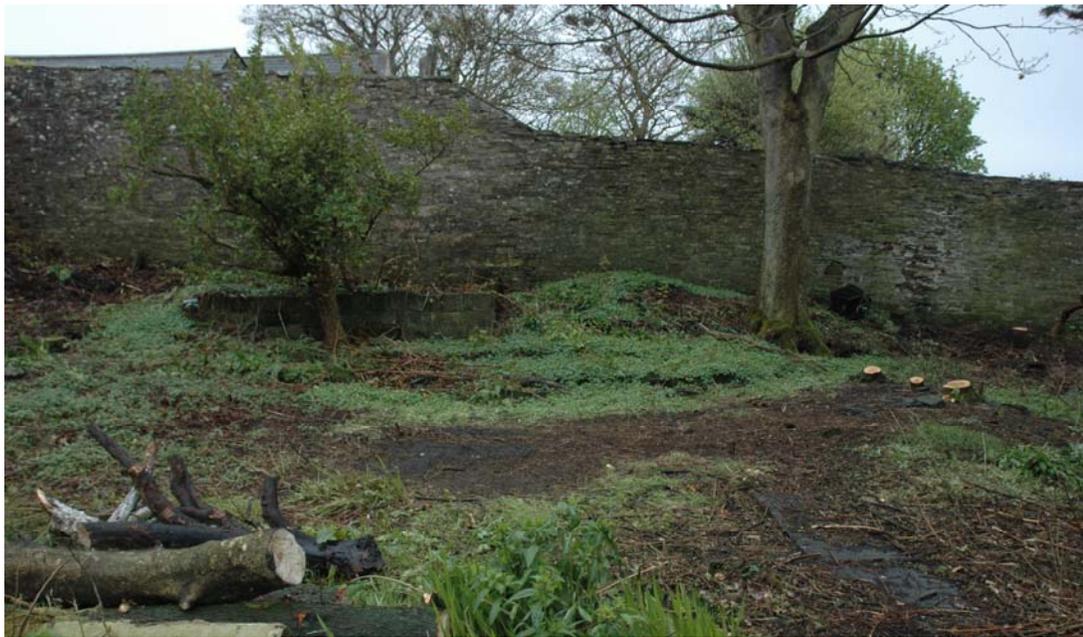
Plate 2: General view of the proposed development area, prior to excavation. Looking south.

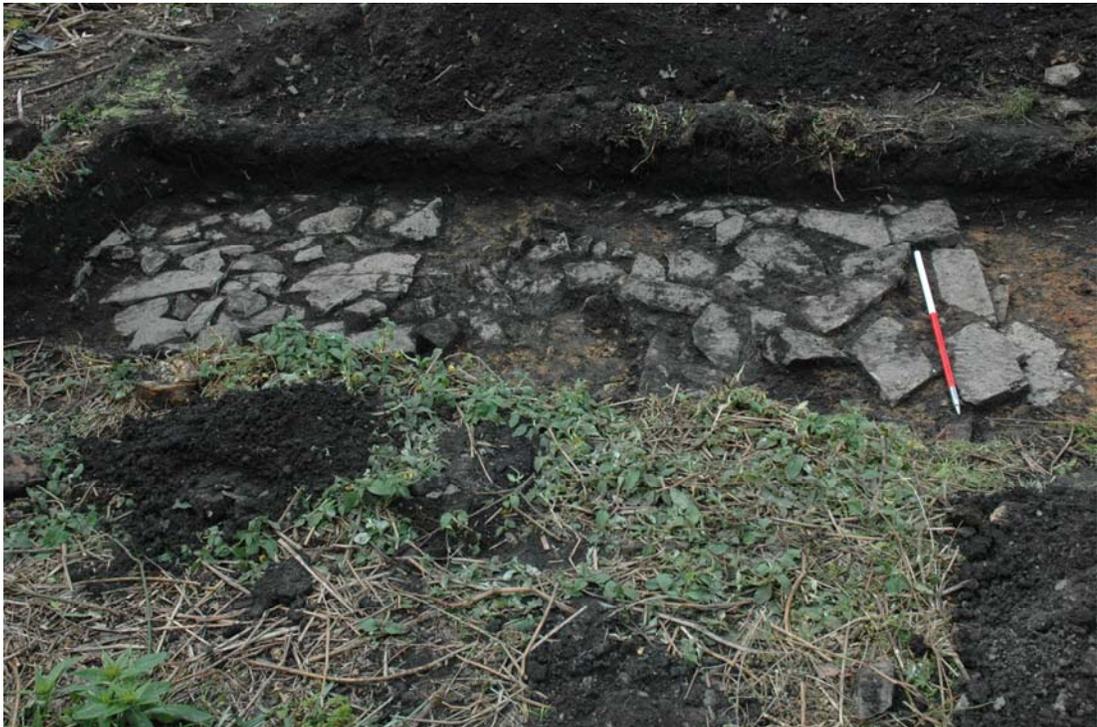
Plate 3: Stonework 103. Looking west.

Trench 1 was oriented north-south and located towards the east of the site, and measured 2.2m by 6.7m. It was excavated to an average 500mm depth. The topsoil **100** consisted of a rich, humic, dark blackish brown slightly clayey silt and measured an average of 250mm. This overlay the subsoil **101**, a dark greyish brown slightly clayey silt of up to 200mm in depth. Extensive stonework **103** was encountered at 350mm below ground level; at this point, the machine excavation ceased and the remaining overburden was removed by hand. Several sherds of post-medieval pottery, animal and fish bone, a human molar and a fragment of medieval painted vessel glass were recovered during cleaning and excavation of topsoil **100**. The stonework **103** formed a fairly regular and level surface extending more than 4.3m; whilst the northern edge was revealed, the southern, eastern and western limits of the structure were not exposed as they continued into the trench edge sections on these sides. The structure consisted of large, slabby, flagstone pieces, measuring an average of 380 x 280 x 60mm; these were not bonded and have been laid straight onto the bright reddish yellow clay glacial till **102**; no construction cut was visible.

The greater extent of structure **103** was north-south as it was revealed during the excavation, but the east-west direction of the face on the northern edge indicates that it is either the basal courses of a substantial wall or foundation layer of a structure running east-west across the site.

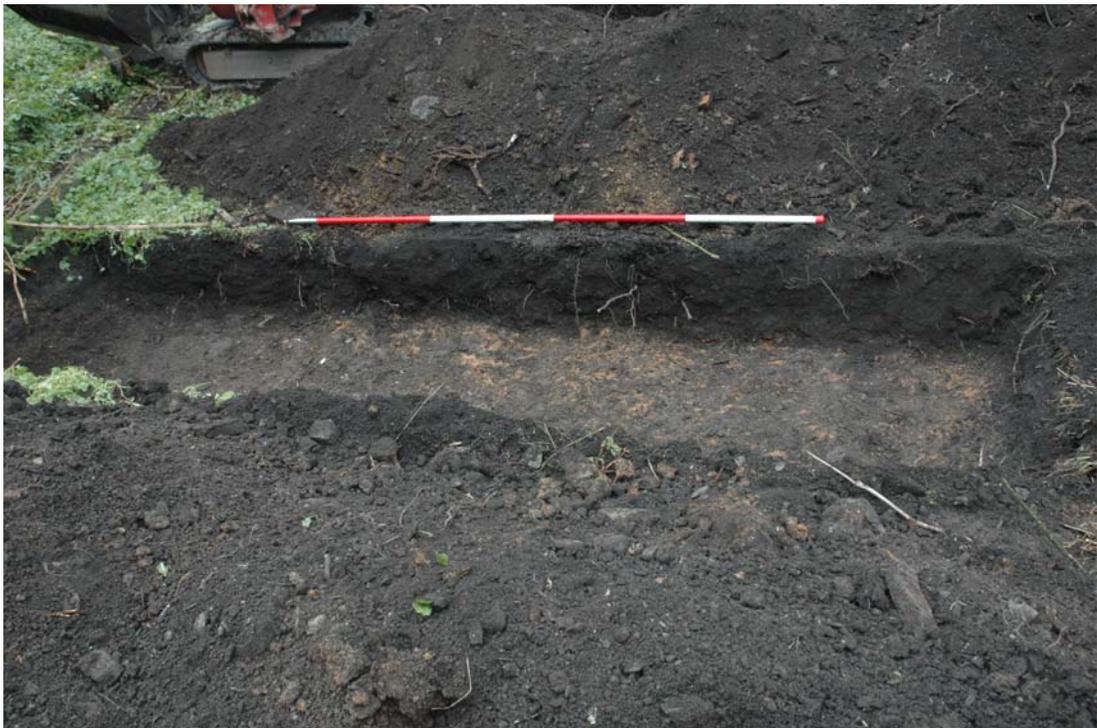
Plate 4: Trench 2, post-excavation to level of glacial till. Looking west.

Trench 2 was positioned parallel to Trench 1, 2.3m to the west, in order to attempt to uncover more of structure **103** that had been revealed in Trench 1. It measured 1m by 4m and was excavated to a depth of 380mm. In contrast to Trench 1, however, no archaeological deposits or structures were exposed; nor were any finds recovered from the upper layers. The well-sorted rich, humic, dark blackish brown slightly clayey silt topsoil measured an average depth of 310mm; this overlay the dark greyish brown slightly clayey silt subsoil, which was up to 70mm deep. Both of these layers were considerably disturbed by tree roots. Directly underlying the subsoil was the bright reddish yellow clay glacial till. No context numbers were assigned to this trench and it was recorded photographically prior to backfilling. Structure **103** in Trench 1 must either terminate just to the east of Trench 2, or be entirely removed on its western end.

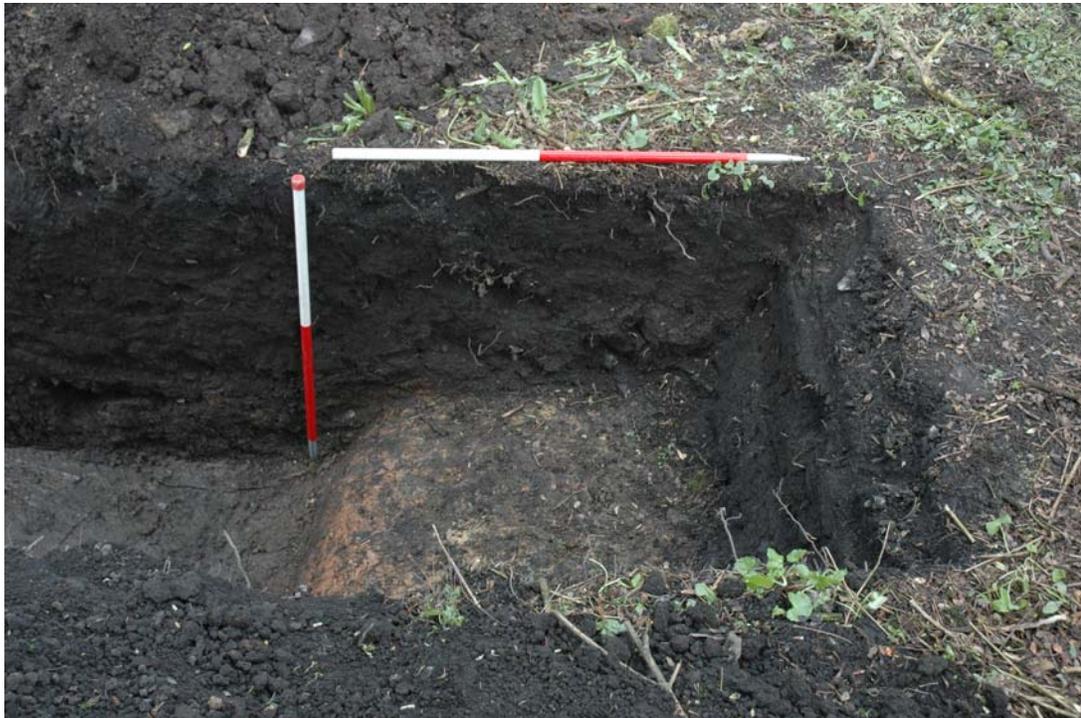
Plate 5: East facing section at the northern end of Trench 3, showing ditch cut 302 filled by silt 303. Looking west.

Trench 3, measuring 1m by 6.75 and oriented north-south, was positioned 8.6m to the west of Trench 5 at the western end of the site. The rich, humic, dark blackish brown slightly clayey silt topsoil **300** measured an average depth of 680mm; this overlay the dark greyish brown slightly clayey silt subsoil **301**, which was up to 370mm deep. Both of these layers were considerably disturbed by tree roots. At a depth of 800mm below ground level at the northern end of the trench, the bright reddish yellow clay glacial till of **304** was encountered. Glacial till **304** only extends for 1.2m to the south however, before it is sharply cut by a near vertically-sided linear cut **302**. Cut **302** is filled by **303**, a mid greyish brown sticky semi-waterlogged well-sorted clayey silt with occasional to moderate small rubbly inclusions. A body sherd of green-glazed medieval pottery was recovered from this fill, which is at least 150mm deep. Access difficulties and the presence of extensive tree roots prevented the excavation of the trench further to the south and the other (southern) side of the cut, if it exists, was not revealed. Excavation in Trench 3 ceased at 1.2m depth for Health and Safety reasons; the base of the cut **302** was not reached and it is not known if there are further fills below **303**. This feature appears to be a massive ditch cut (more than 5.5m wide), of unknown date, probably oriented east-west.

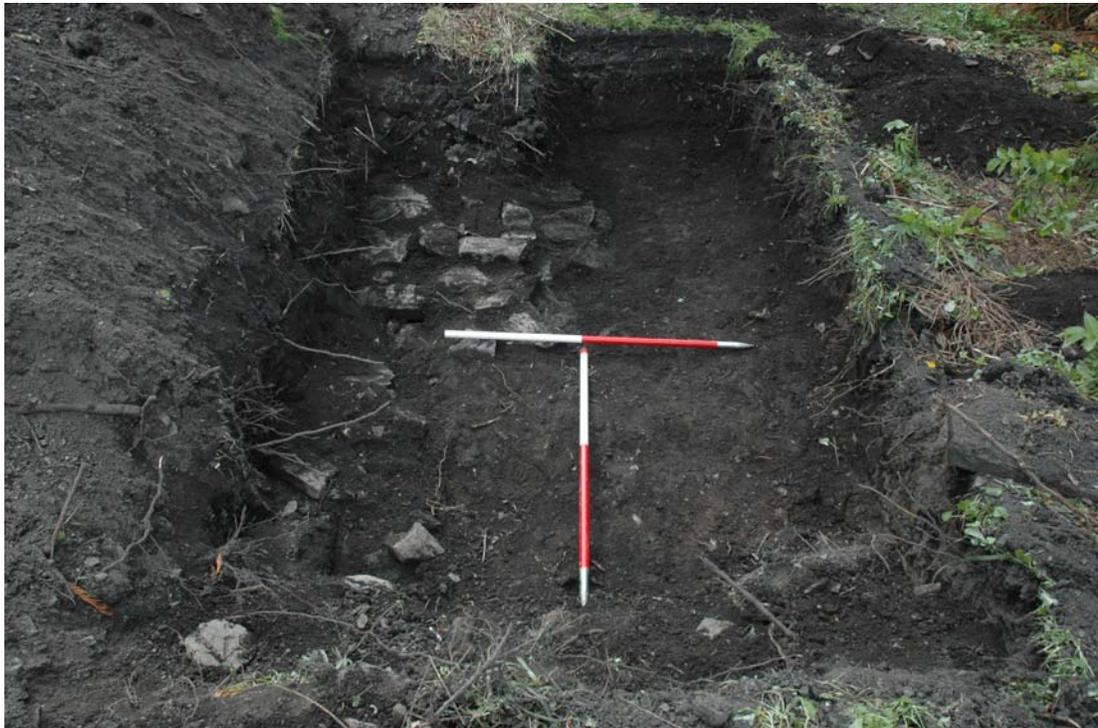
Plate 6: Extensive rubble layer in the southwest corner of Trench 4. Looking west.

Trench 4, measuring 3m by 1.85m and oriented east-west, was positioned at the southwest of the development area and machine excavated to a depth of 600mm. The rich, humic, dark blackish brown slightly clayey silt topsoil measured an average depth of 400mm; this overlay the dark greyish brown slightly clayey silt subsoil, which was at least 200mm deep, but not fully excavated. Both of these layers were considerably disturbed by tree roots. In the southwest corner of the trench, an extensive rubble deposit was encountered measuring 1.1m by 1.4m and oriented east-west; at this point, machine excavation ceased and the overburden was removed by hand with a shovel. The rubble deposit was very voidy and seemed to be from a demolition dump layer rather than relating to *in situ* remains. Several sherds of post-medieval pottery and animal bone were recovered from the topsoil. Trench 4 was recorded on a pro forma trench record sheet and by photograph; no context numbers were assigned to this trench and the rubble layer was not further investigated. Glacial till was not exposed and its depth is not known in this trench; it is possible that the rubble forms part of the extensive fill of the massive cut feature **302** encountered in the Trench 3 to the north. Time constraints prevented the removal of the remaining subsoil layer in this trench and the rubble deposit not further investigated.

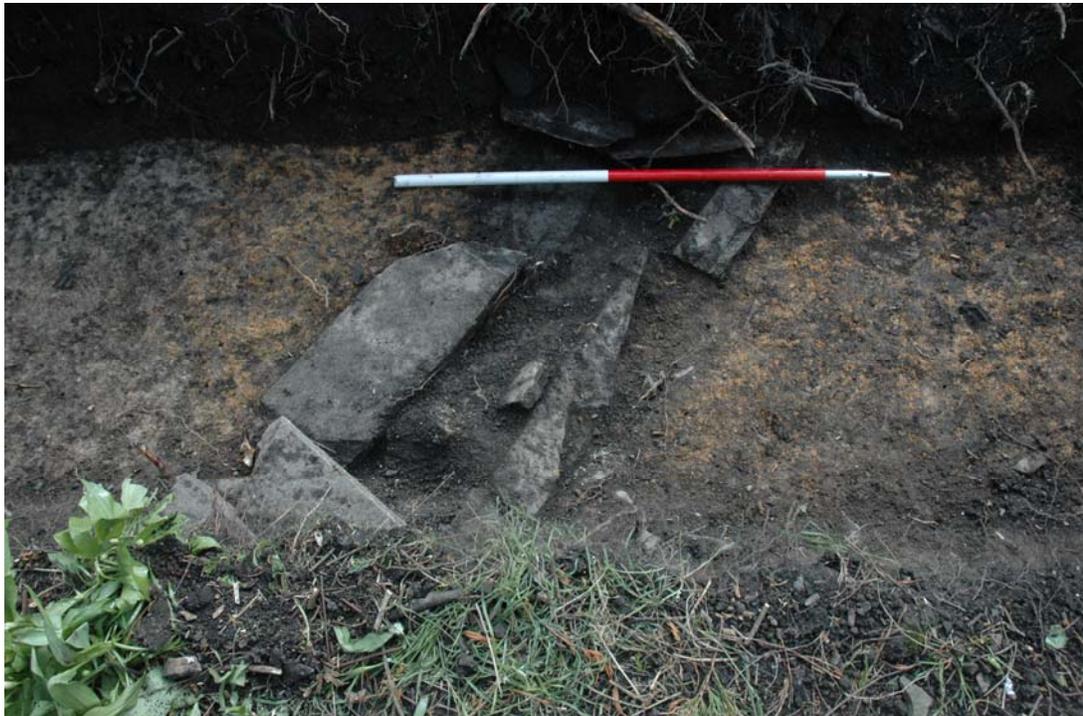
Plate 7: Stone-lined culvert or drain 503 in Trench 5. Looking west.

Trench 5 measured 1.1m by 6.4m and was located 5m west of Trench 1 and 8.6m east of Trench 3. The rich, humic, dark blackish brown slightly clayey silt topsoil **500** measured an average depth of 400mm; this overlay the dark greyish brown slightly clayey silt subsoil **501** which was 260mm deep. The trench was excavated to a depth of 660mm, at which point the bright reddish yellow clay glacial till of **502** and some stonework was encountered. Machine excavation ceased at this point and the remaining overburden was removed by hand. The stonework was cleaned by shovel and trowel and was revealed as the remains of a stone-lined culvert or drain. This feature is oriented northwest-southeast and consists of a linear, vertically-sided cut **503** into the glacial till **502**. This 660mm wide feature extended beyond the eastern and western limits of excavation and is wider than 1.5m. Medium sized slabby, unbonded and undressed flagstone pieces **504** line the cut. Capping stones from the culvert were visible in the section but not remaining *in situ* within the trench. In the middle of the drain **503**, bounded on either side by the stones of **504**, was a well-sorted, dark greyish brown soft clayey silt **505** with frequent small pea-grit inclusions. The drain and its fills were not excavated and were recorded as exposed by photograph and on pro forma context sheets.

To the north of **503**, a 1.5m long linear patch of well-sorted pale yellowy grey greasy silty clay **506** was exposed during cleaning. This was not excavated but is possibly the fill of a linear (oriented east-west) cut feature running across the trench, although interpretation is cautious given that this feature was not investigated.
