Shapinsay Potable Water Scheme Car Ness Battery Orkney

Watching Brief Data Structure Report

ARCHAEOLOGICAL WATCHING BRIEF: DATA STRUCTURE REPORT

PROJECT No: 317

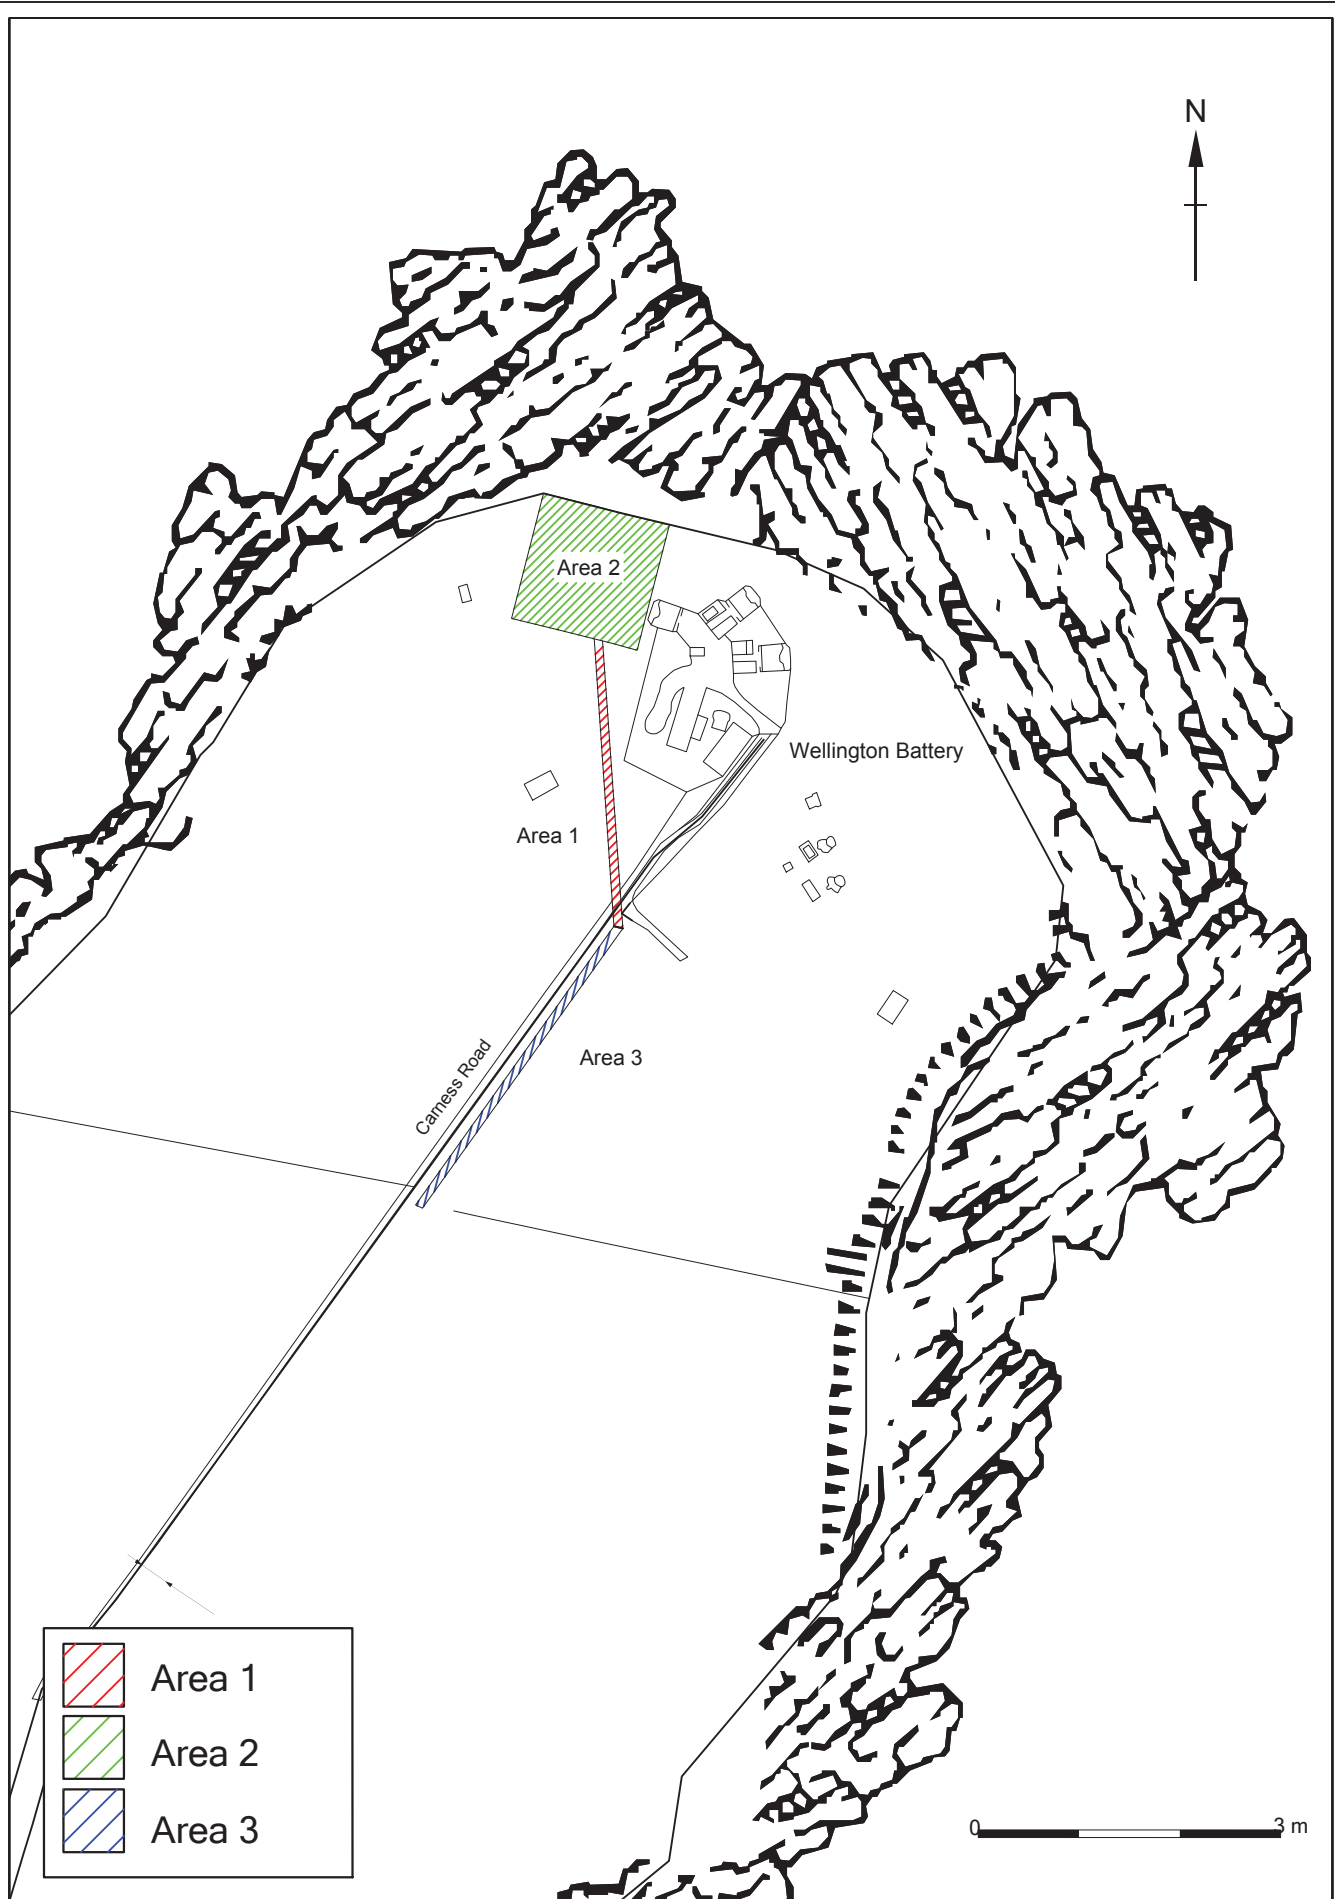
Figure.2. Area Locations

Area 1

Area 2

Area 3

The first area to be excavated was the access track running north from the existing tarmac road, to Area 2, the 50m x 50m area to be cleared for the drilling rig installation (see Figure 1).

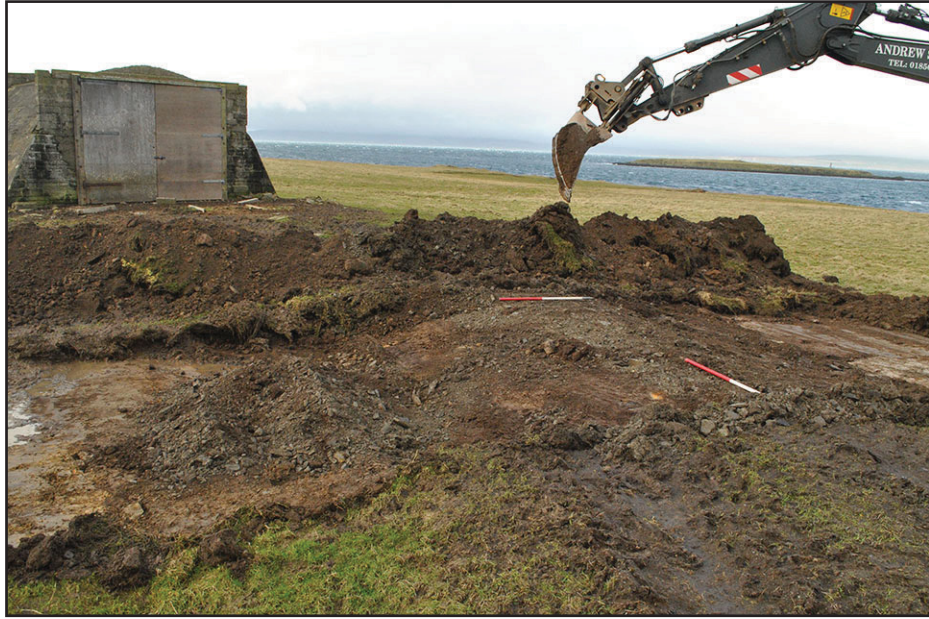
Plate 1: Area 2, showing track (103) after removal of topsoil, looking west.

About halfway between the tarmac road and Area 2 was a raised track running roughly east-west across the excavated corridor, with a maximum height of c. 250mm above the general ground surface level. The ground here was very wet and had apparently been churned up by recent vehicle traffic between a gate by the tarmac road to the east and the concrete structure believed to be a WWII engine room to the west, now in use as storage for farm vehicles. When what little remained of the topsoil (**101**), maximum depth 100mm, along this track was removed, a stone surface (**103**) was revealed. The track formed by this stone had a width of up to 5m. This layer of stone comprised angular fragments of quarried stone up to c. 50 x 100 x 150 mm but mostly much smaller stones and 'dust'. The depth of this material was up to 120 mm and it overlaid a second layer of coarser rubble (**104**), which contained more frequent larger stones but with approximately the same maximum size as those in (**103**). The lower layer of stone had a depth of about 120mm and did not appear to lay in a cut but seemed to be laid directly on to the clay till, although may originally have been laid directly on to topsoil – the water-logged nature of the deposits here made it difficult to discern. Both layers (**103**) and (**104**) had the appearance of being relatively recent additions and were not recorded in detail. Once photographed, the stone was cleared from the area and the clay till surface revealed.

The apparently modern access track (**103**) running from the tarmac road to the front of the former engine room may in some part follow the line of an original WWII access track, but its alignment does not match that depicted on WWII plans, and its installation will most likely have erased any visible traces (*ibid*).

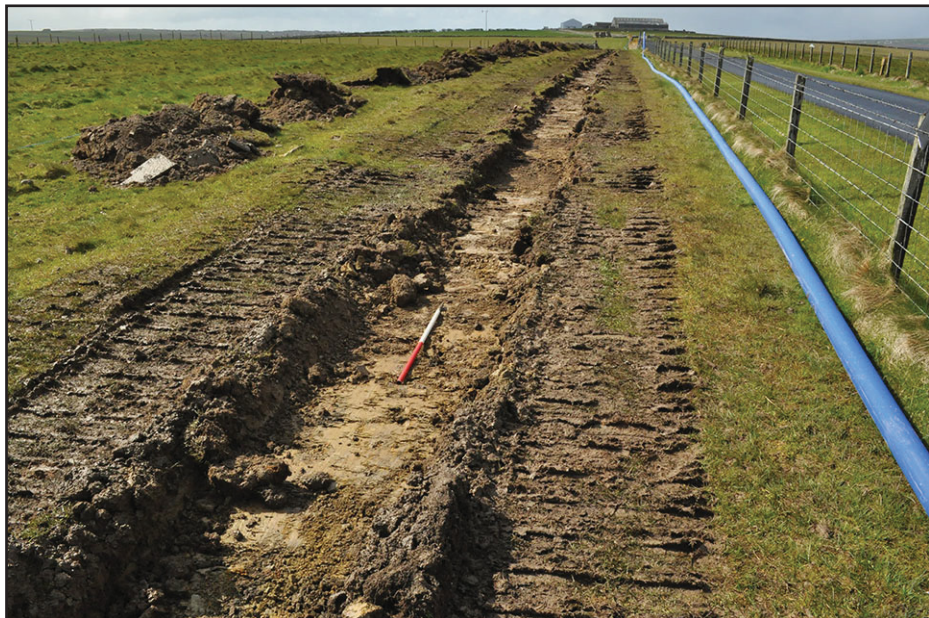
Plate 2: General view showing south end of Area 3 after excavation, looking south.

After topsoil was stripped from the southernmost end of the monitored area, near a modern gate at the northern end of a stone dyke, some superficial road surfacing was seen. Near the gate this comprised a shallow layer of beach stone. To the north of this, a thin spread of coal dust and/cinders up to extended for 8.0m from the north side of the gate, the east and west limits of which were not reached by the excavated area. In some places, tar appeared to have been laid but still only resulting in a very thin and rudimentary road surface.

Although the deposits seen at the far south end of Area 3 may represent some sort of access road running towards Car Ness Battery, it seems very unlikely, particularly when comparing its position with access tracks shown on versions of the WWII layout plan (Guy 1993, Dorman 1996). None of the tracks depicted on such plans show anything this far south of the batteries.
