## **Copland's Dock, Stromness, Orkney**

### **Onshore Desk-based Assessment and Walkover Survey**

## Baseline Onshore Desk-based and Walkover Survey:

**Project No: 286**

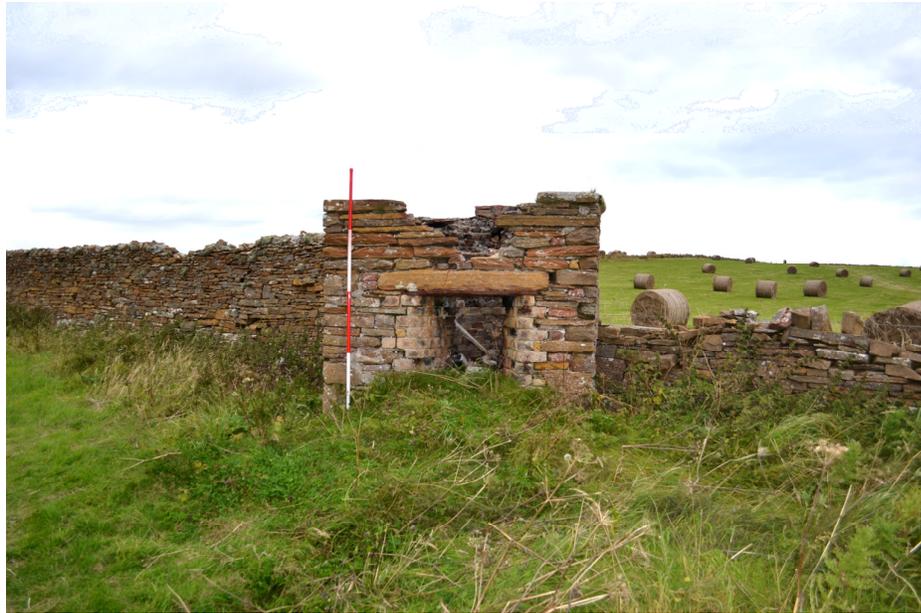
**Plate 1: Site 13, looking northeast.**

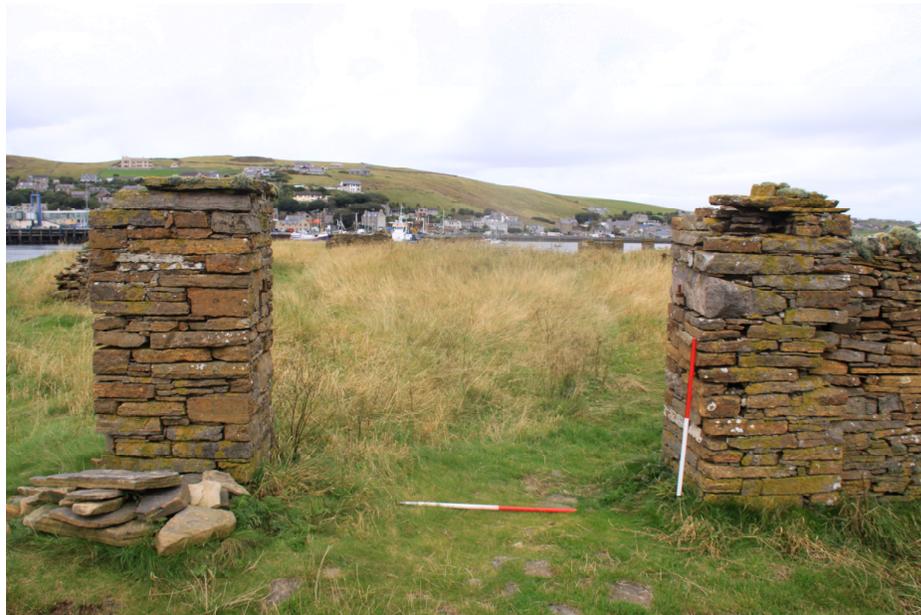
**Plate 2: Sites 15 & 16, gate piers, with mound, site 29 beyond, looking northwest.**

However, a few of the sites seen were assigned low rather than negligible significance since they were deemed to be part of the designed landscape associated with Garson House and the adjacent farm, which have Listed Building Category B status and are therefore of regional importance. Sites 1 & 2, the well-built, substantial and mostly well-preserved stone dykes either side of the track running west to east up from the shoreline are very likely part of the original 19<sup>th</sup>-century layout of that designed landscape and the earliest editions of the Ordnance Survey indicate that this track was the main

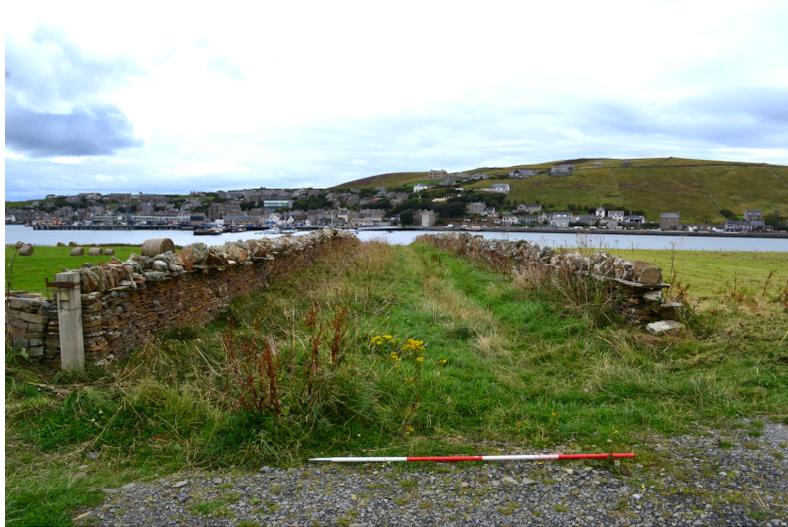
Outwith Copland's Dock (site 33), there is little of great interest in terms of sites of cultural heritage significance along the route of the proposed access track. The sites identified are mostly of negligible significance and in general are unremarkable and typical of the stone dyke field boundaries and gateways seen throughout Orkney. There are traces of a metalled track which was probably laid to provide access to Copland's Dock.

***Plate 3: Sites 1-4 inc., looking west.***

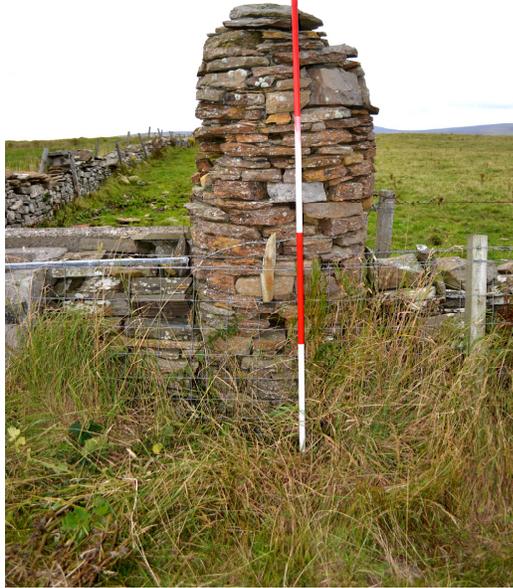
access route to Garson from Stromness. Site 9, most likely a former gate pier in the original alignment of the field boundaries and gateways of the same designed landscape, is a 2.0 m high, up to 1.0 m diameter circular pillar with a rounded top constructed mostly from flagstone with a few freestone and granite blocks. There are traces of lime mortar bonding, and possibly render, and there is the possibility that it served as a navigational marker or 'day beacon', although it is not immediately obvious what exact navigational purpose it would have had in such a position.

**Plate 4: Site 9, looking east.**

Some mitigation should be considered for site 9, the stone pillar, also probably associated with the designed landscape of Garson House. If avoidance is not possible, it would be recommended that a general survey of this feature be carried out, perhaps including no more than a more detailed photographic record and description to supplement the already recorded detail.

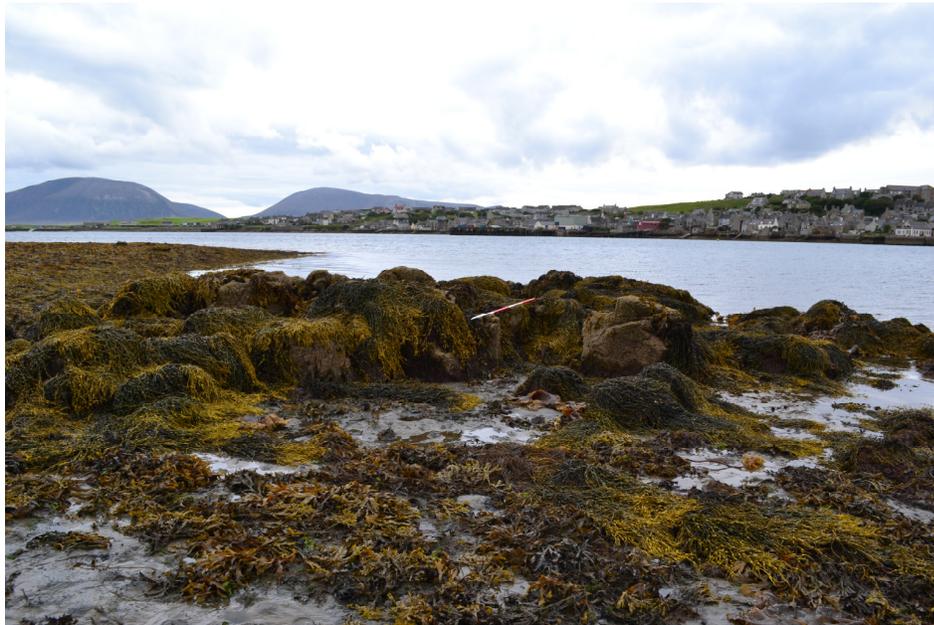
Site 22 is a possible slipway or channel cleared to approach the pier marked on the 2<sup>nd</sup> Edition Ordnance Survey (site 26). This may just be gap between natural bedrock outcrops, but this natural feature may have been cleared of stone, with the resulting pile of stone left on the south side of the gap. If a natural feature, this gap may have guided the location of site 26.

**Plate 5: South part of Site 22, looking southwest.**

However, the recommended survey at Copland's Dock outlined in 5.1 above should be extended to include the associated features in the inter-tidal zone, namely the pier and possible slipway (sites 22& 26) and slipway (site 27).

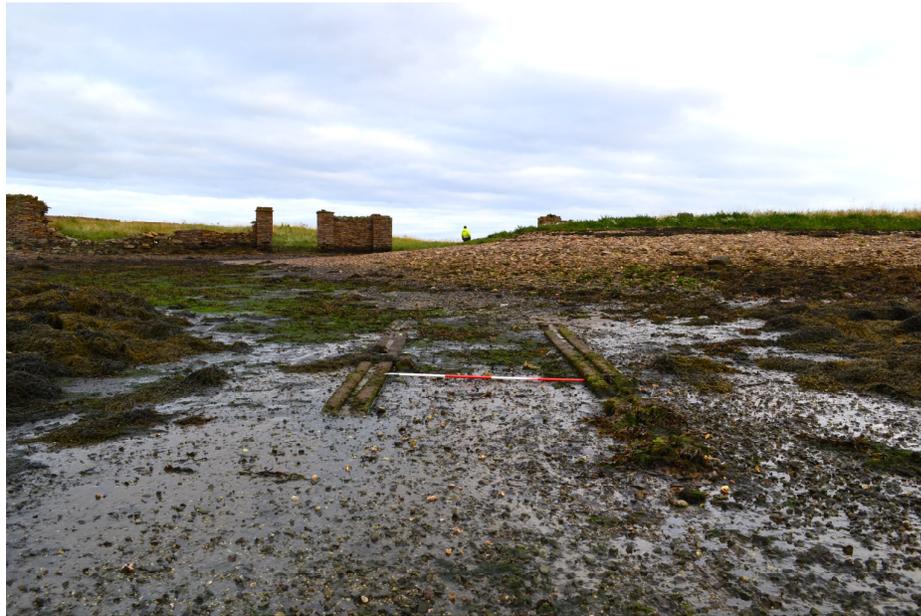
Site 27 is a continuation of site 20, the slipway comprising a pair of parallel

concrete channels seen inside the perimeter of Copland's Dock, running up to the winch. The nearby ayre to the south southwest has clearly grown and moved northwards since the dock's operational period, since the portion of the slipway nearest the dock's west side has been buried under rounded beach cobbles. A line of stones runs along each side to form a channel with an overall width of c 9.6 m. Only a few large blocks line the west side, but on the east is a more substantial remnant of a stone wall, up to c 1.5 m and 500 mm high, although this apparent width may have been increased by collapse.

***Plate 6: Site 27, foreground, with the west walls of site 33, Copland's Dock, background, looking east.***
