**The Granary,  
Milton of Ogilvie,  
Angus,  
Standing Building Record,  
Data Structure Report**

**January 2015**

Client: Mr Peter Ord  
Project: The Granary, Milton Mill, Milton of Ogilvie Job No: 201  
Document Title: Standing Building Recording

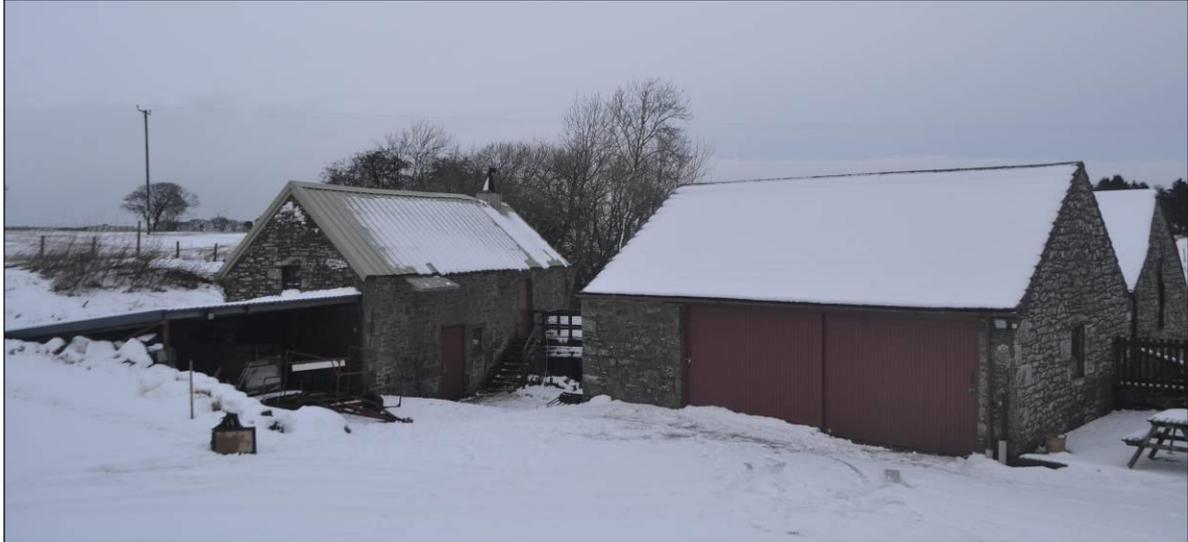
- 1.3.1 Milton Mill today comprises three separate buildings, of which the Granary is the most northerly of the three. Two of these buildings are historic structures, with the third (the southernmost) having been constructed within the last 25 years by the client, Mr Peter Ord.
- 1.3.2 The Mill complex sits on a neck of land sloping gently eastwards above the Glen Ogilvie Burn. This burn provided water for the mill, powering the wheel. The granary lies a short distance to the north of the mill building, built into the side of a steep southwards facing hill.

**Plate 1: The Granary building within the mill complex from the S (Photograph 143)**

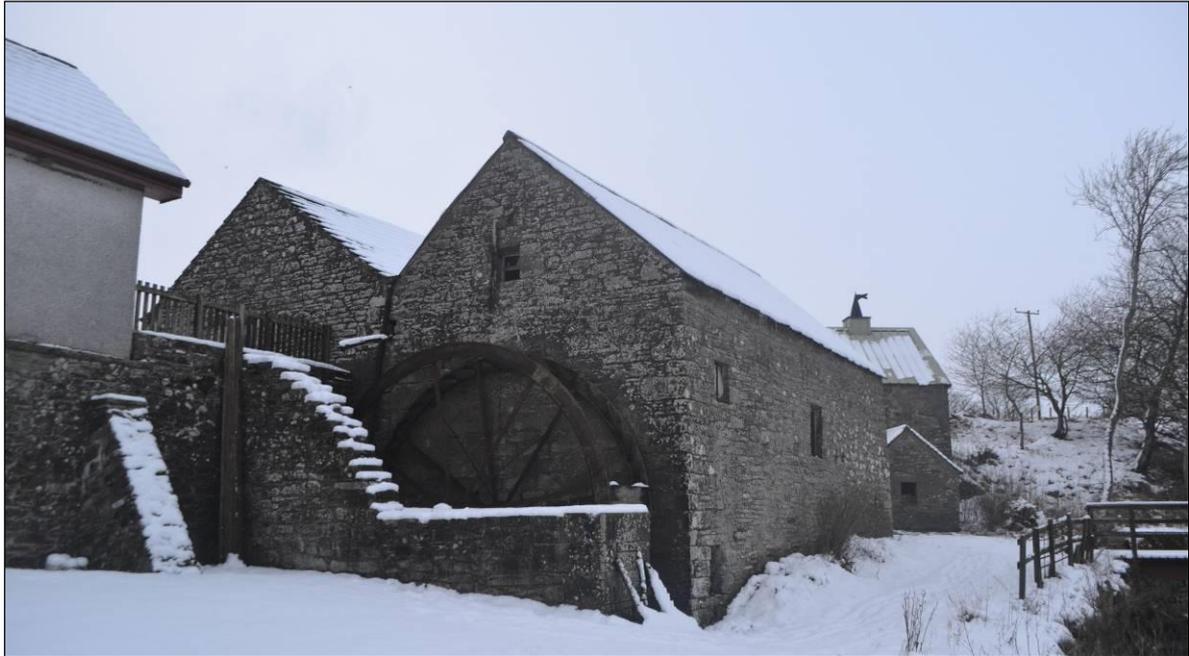
- 4.1.1 The construction date of the Granary Building is unknown. The Mill (Plate 2) was visited by J R Hume in 1974 during his collation of 'Industrial' sites in his series, "The Industrial Archaeology of Scotland". Hume briefly described the complex, dating it to the 18<sup>th</sup>-19<sup>th</sup> centuries. Other than the brief assessment by Hume, no real other work has been undertaken analysing the age and functions of Milton Mill. Hume's work is quoted in the NMRS, the Angus SMR and the Historic Scotland Listed Building database.

**Plate 2: The Mill building itself from the SE with The Granary just visible behind (Photograph 149)**

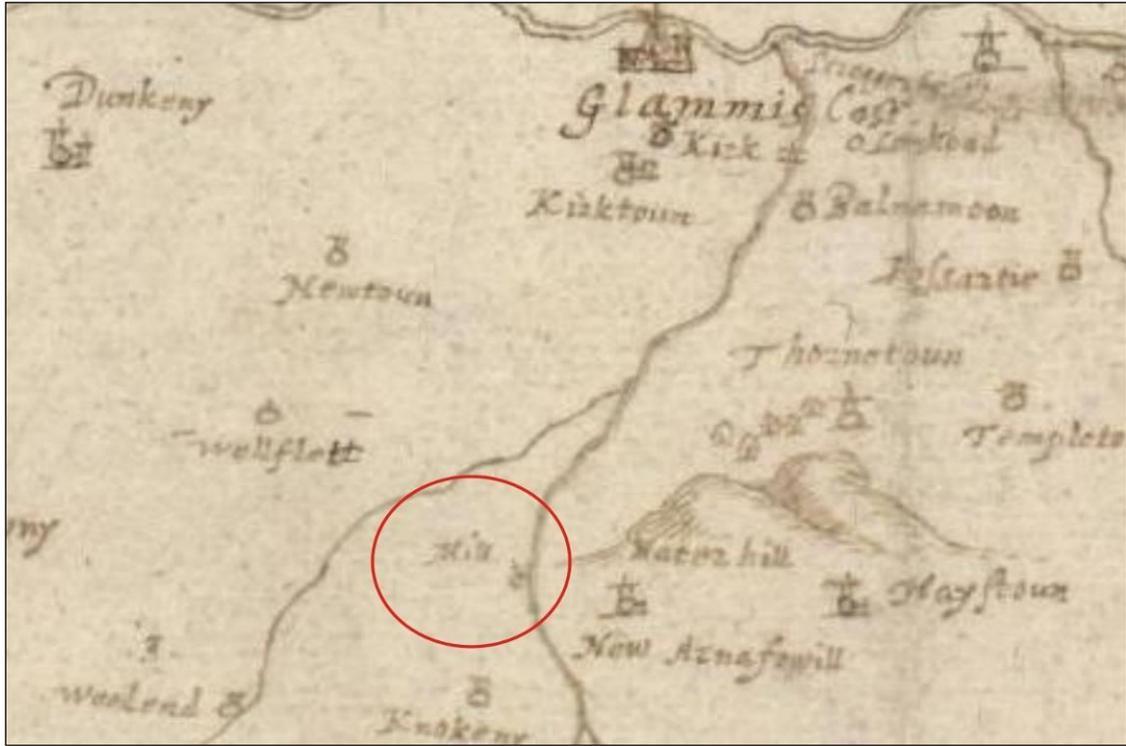
**Figure 3: Extract from Robert Gordon of Straloch's map of 'Brae of Anguss, The Height of Anguss', produced in the mid 17<sup>th</sup> century. This map clearly shows the 'Mill'. ARCHAS after NLS**

4.2.3 In the mid 17<sup>th</sup> century Robert Gordon of Straloch was engaged by a Dutchman named Joan Blaeu who was using earlier maps by Timothy Pont as the basis for his *Atlas Novus*. This was published in 1654. Gordon re-worked the existing 16<sup>th</sup> century Pont maps, and completed new maps for those areas not covered by Pont. Gordon of Straloch's map does not show a town, but clearly depicts the 'mill' (Figure 3). The presence of this shows it was an important feature in the landscape and economy of the area at this time.

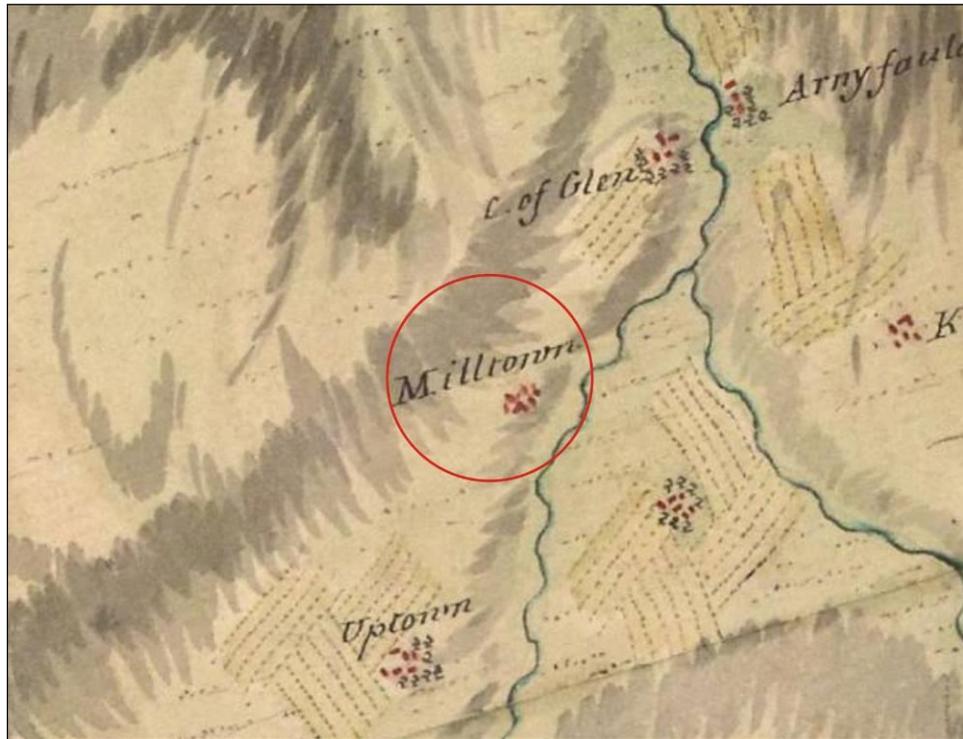
**Figure 4: Extract from William Roy's Military Survey of Scotland showing 'Milltown' indicated red. Note the lack of cultivation depicted in the immediate vicinity. © The British Library Board. All Rights Reserved (Roy Military Survey of Scotland)**

4.2.4 Pont and Gordon maps do not provide any detail as to the buildings on the site and the extent of the settlement. William Roy's 'Military Survey of Scotland' conducted between 1747 and 1756 provides a little more detail of the landscape (Figure 4). Roy's map revolutionised map making in Scotland, containing a lot more terrain detail than previously. Although the map was the result of 'rapid reconnaissance rather than a measured topographic survey'<sup>7</sup>, the various inaccuracies can be forgiven in providing us with the first cartographic view of Scotland with any level of detail – a snapshot of mid 18<sup>th</sup> century Scotland.

- 4.2.5 However, the level of detail often expected of Roy's map is not apparent here. 'Milltown' is shown, but where buildings are indicated ordinarily on Roys maps they are disaggregated however, on this occasion the spread of red buildings are noted as tightly clustered. The Glen Ogilvie Burn is also not noted. The wider surrounding landscape is shown as being free of rig and furrow or evidence of cultivation.
- 4.2.6 The Mill is clearly shown on John Ainslie's 'Map of the County of Forfar or Shire of Angus' from 1794.

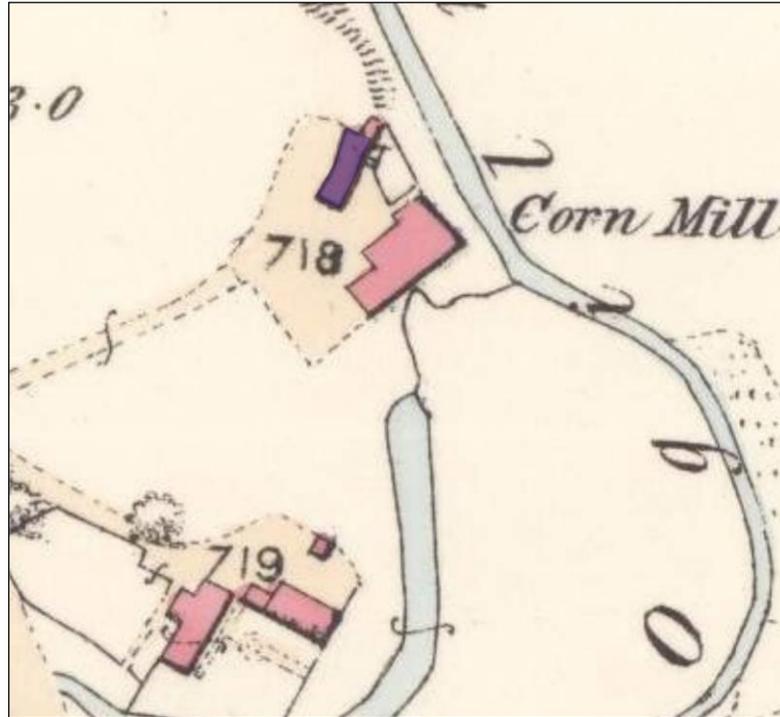
- 4.2.8 The Ordnance Survey 1<sup>st</sup> edition 25 inch to 1 mile Forfar, Sheet XLIII.8 (Glamis) (Figure 5) is the first map to show the buildings at Milton Mill in any detail. Both the Granary and Mill buildings are shown as upstanding and roofed, although in a different form to how they currently appear. The Granary plan is much the same as it is today, with the slight kink in the plan of the main west and east elevations apparent. The northern end of The Granary is noticeably different. It appears to have a small protruding extension running northwards off the north eastern corner. Overlaying the 1<sup>st</sup> edition map with the modern plan (Figure 5), this extension onto the north eastern corner seems to lie outwith the core of the building as it survives. A small, open air compound or enclosure is shown running southwards from the Granary towards the 'Corn Mill', but the two buildings are not joined by an elevated walkway at this time. It is presumed the upper doorway in the east elevation of the Granary existed at this time and that a small open box immediately in front of it constitutes a stairway. The Mill building itself is much larger, with an additional section protruding from the south west facing front of the building that survives today.

**Figure 5: Extract from the 1<sup>st</sup> edition 25 inch to 1 mile Forfar, Sheet XLIII.8 (Glamis) showing the modern Granary indicated blue. ARCHAS after NLS**

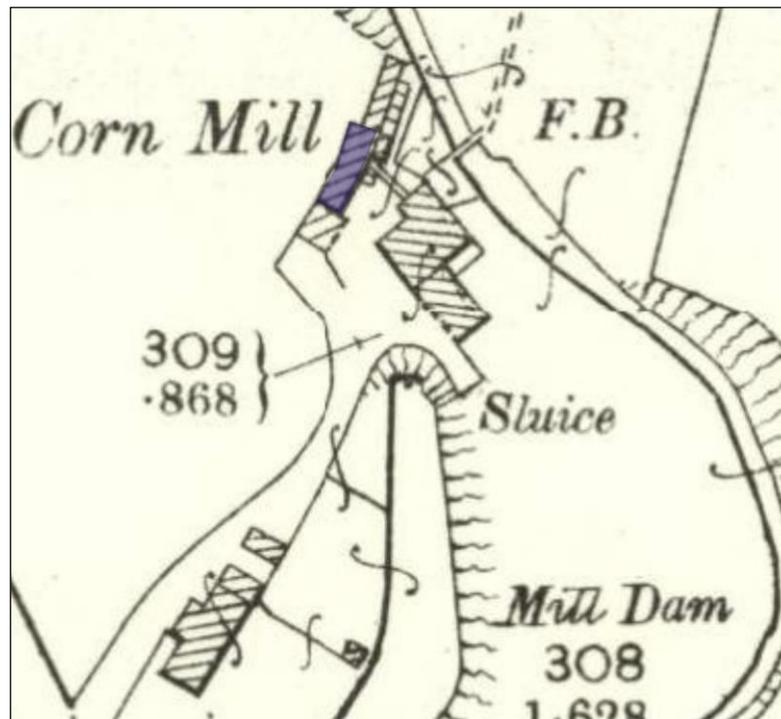
- 4.2.9 By 1900 when the 25 inch to 1 mile Forfarshire, Sheet 043.08 is surveyed (published 1902), Milton Mill is a much larger and more intricate complex of buildings (Figure 6). The core of the Granary building remains intact, clearly defined as separate, but with numerous additions, extensions and alterations. The small extension to the north east noted on the 1<sup>st</sup> edition Forfar, Sheet XLIII.8 (Glamis) (Figure 5) is gone, replaced by a much larger structure running NNE on the same alignment towards the Ogilvie Burn. A further structure with a number of delineated 'cells' has been appended onto the eastern side of this building, running parallel and abutting the Granary on the north east corner of the eastern facing external elevation. At the southern end a large square extension has been built. This likely corresponds with the storage area, open to the east currently used to store timber in this location. The bridge connecting the Granary with the Mill has been built with the core of the Mill taking on its current form. A large extension has been built onto the Mill's south east facing elevation.

**Figure 6: Extract from the 2<sup>nd</sup> edition 25 inch to 1 mile Forfarshire, Sheet 043.08 showing the modern Granary indicated blue. ARCHAS after NLS**

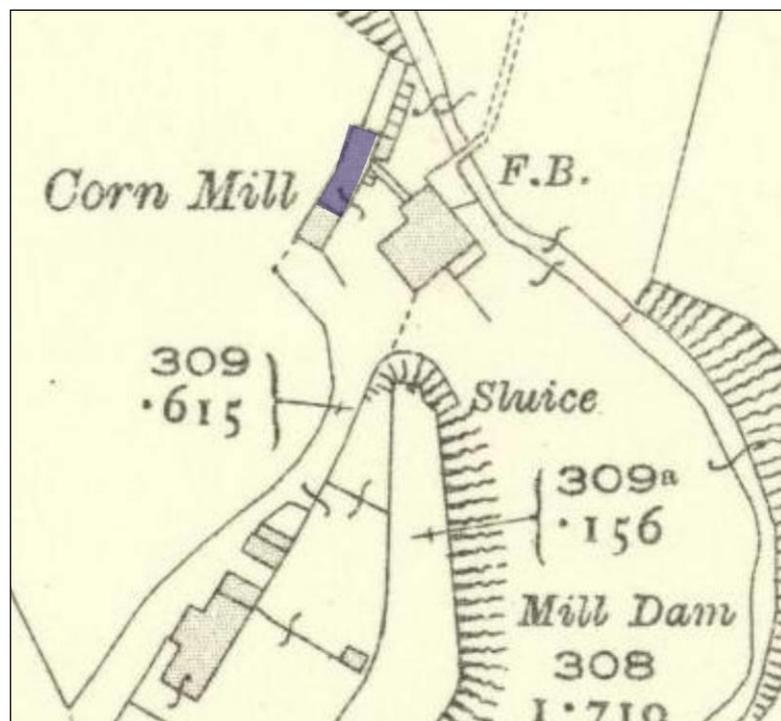
4.2.10 When the mill was surveyed by the Ordnance Survey in 1900 it appears to show the Milton Mill during what may have been its busiest time as by 1921 when the 25 inch to 1 mile Forfarshire, Sheet 043.08 was surveyed, the complex has decreased significantly in size (Figure 7). In 1923 the Granary is shown very close to its current state. Of the two extensions constructed to the north, one is shown as roofless and the other still retains the “cells”. The southernmost of these cells is depicted as roofed and seems to correspond with the small structure with the pitched roof which today gives access to the hearth. The extension on the south eastern side of the mill has been demolished and it has taken on its present form.

**Figure 7: Extract from the 1923 25 inch to 1 mile Forfarshire, Sheet 043.08 showing the modern Granary indicated blue. ARCHAS after NLS**

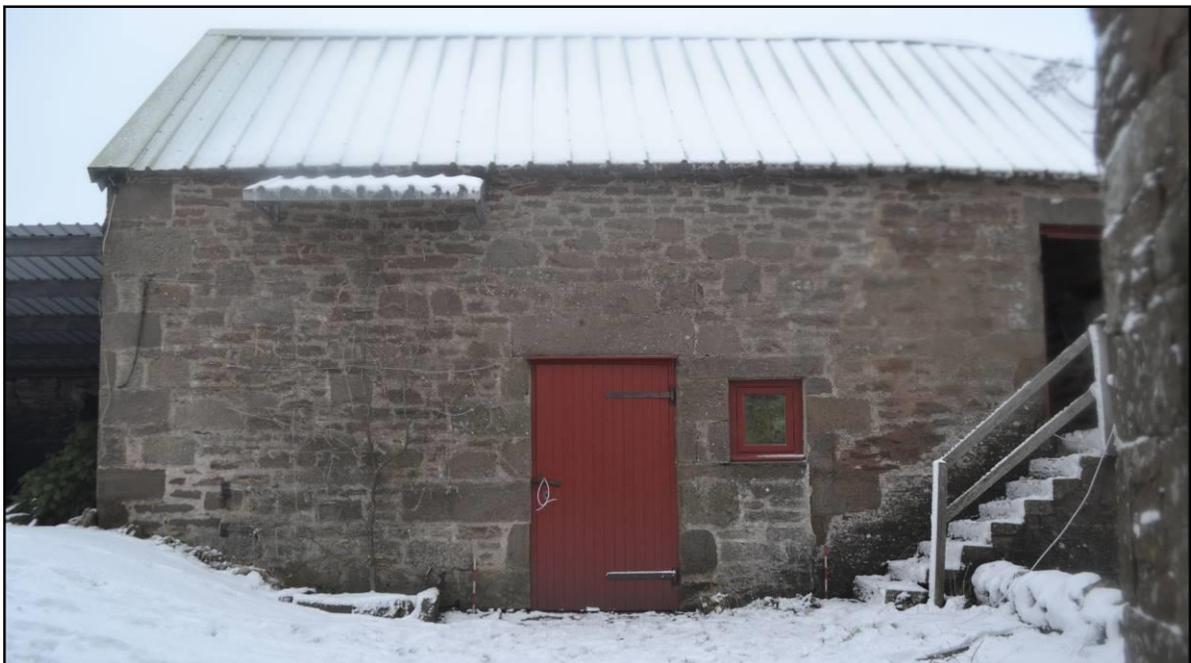
- 5.1.1 The main Granary building is roughly rectangular in shape, running NNE-SSW with a slight 'kink' in the longer elevation turning the building slightly further towards the north. It comprises three rooms built over two floors, with one on the ground and two on the first floor. The building is built into a steep south eastwards running slope, meaning to the north the upper floor is accessed at ground level. The ground floor room is accessed by a timber door set into the East Elevation (Plate 3). This room is self-contained and it is not possible to access the upper floor from within. The upper floor is either accessed at ground level from the west, or via an external flight of stairs from the east. A timber walkway connects this upper door with the Mill building to the east.

**Plate 3: View of the east elevation from the SW (Photograph 007)**

- 5.2.4 Slightly to the south of the main door a modern canopy (Plate 3) has been built just off roof level. There has clearly been a degree of pointing and re-working during the installation of this.
- 5.2.5 Unlike the neighbouring Mill building, there is only one obvious re-used stone, which may or may not have originated from Claverhouse Castle, although it is possible some of the rough ashlar quoins may have originated elsewhere. At the northern end of the elevation near the roof, an Fe pintle (door hanger) protrudes from a stone (Plate 8). It is hard to assess what function this may have served as there is no blocked opening or secondary pintle, while the stone is located high up on the wall above the roof of the small annex which gives access to the fire. Cracking in this area is likely as a result of heating from the fire below.

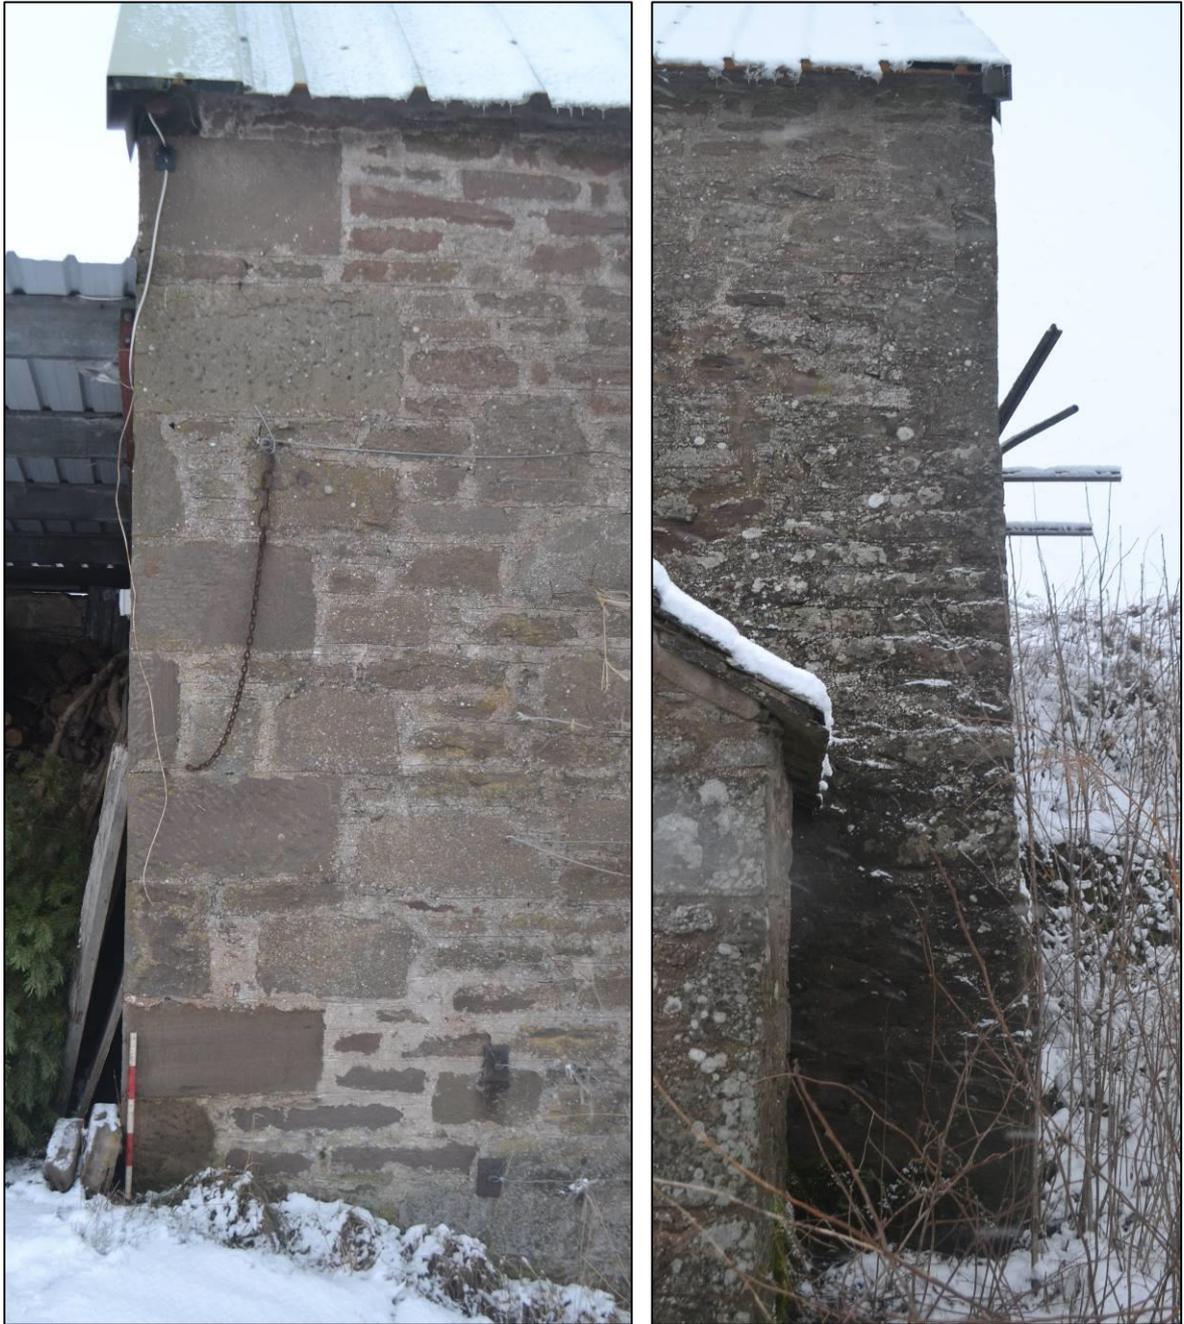
**Plate 4 & Plate 5: The rough ashlar quoins at the southern end (left) and absence of quoins at the northern end (right) of the east elevation. Note the larger quoins at the top of the southern end (left) (Photograph 020 (left) and 042 (right))**

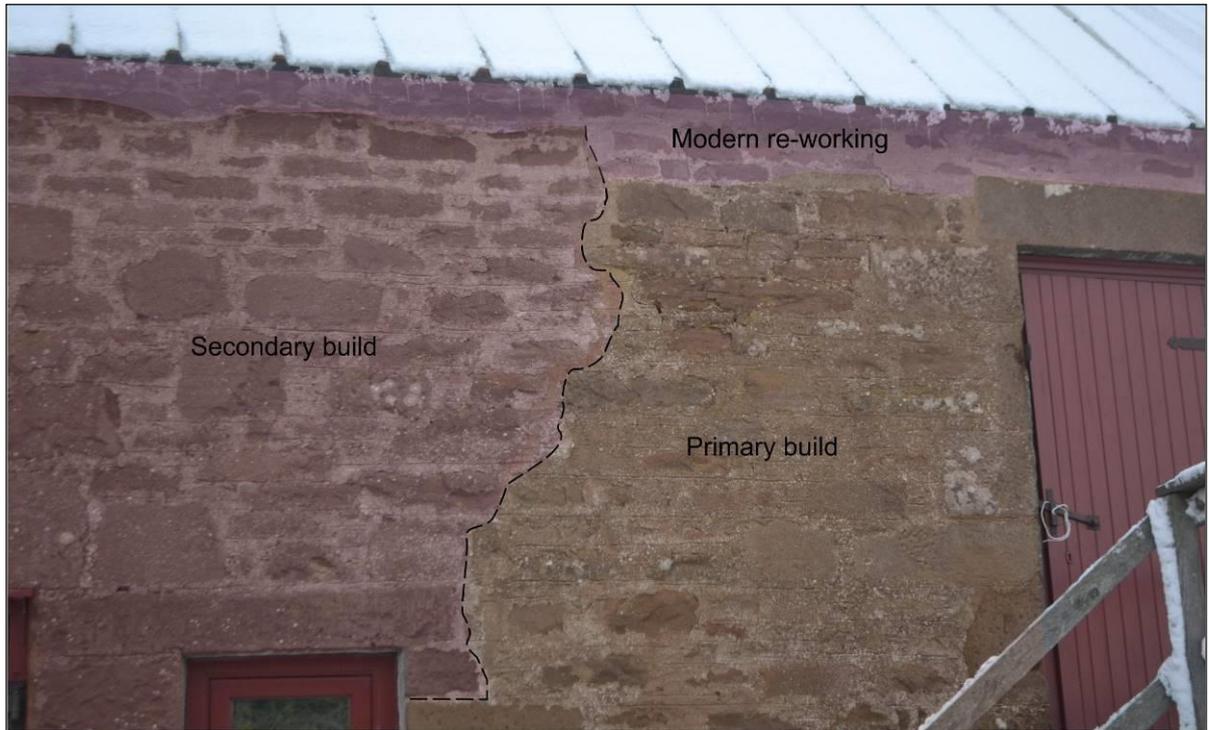
5.2.2 Although there is no obvious difference in the stonework, the build and pointing of the southern half of the building is noticeably different from the northern half. The pointing is the most obvious difference, being much lighter to the south (Plate 3 and Plate 6). A construction break can be discerned at this point, running upwards from the sole window set into the east façade.

**Plate 6: Cropped view of the eastern façade showing the changes in phasing. (Photograph 019)**

- 6.1.4 Overall, three major phases were noted in the fabric of the building, primarily on the east elevation (Plate 6). The construction break above the ground floor window and the redundant

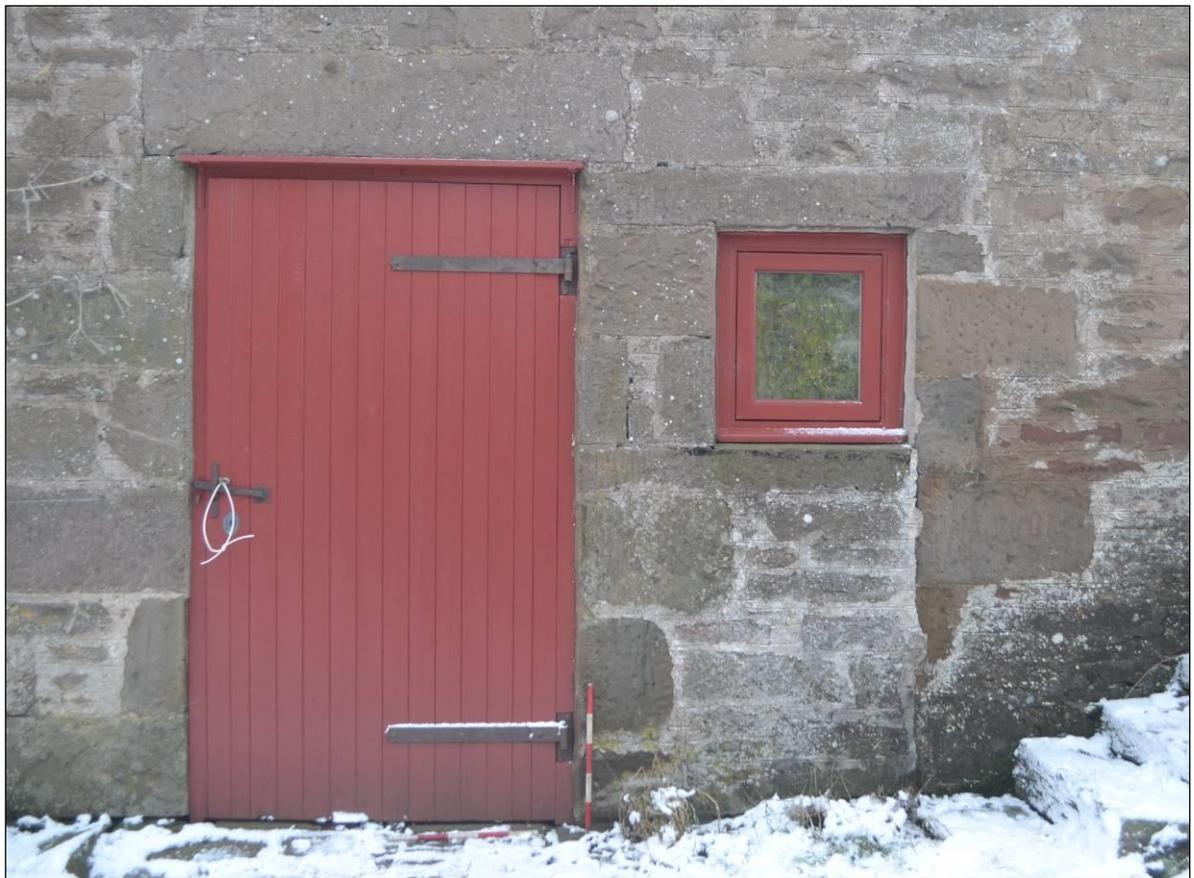
**Plate 7: Detail of the door opening and phasing in the east elevation (photograph 017)**

- 5.2.3 The small window is clearly a later insertion set against the jamb of an earlier doorway. The northern edge of the window is dressed by three rough ashlar quoin stones. These quoins continue below the window to ground level, and the window sill is not properly tied into these

(Plate 7). Initially it was thought that the window may have been inserted in place of what was initially a wider door opening, but assessment of the surrounding build and the lintel in place for both the window and the existing opening indicated that all of this was a secondary addition with the doorway being moved just over 1m southwards.

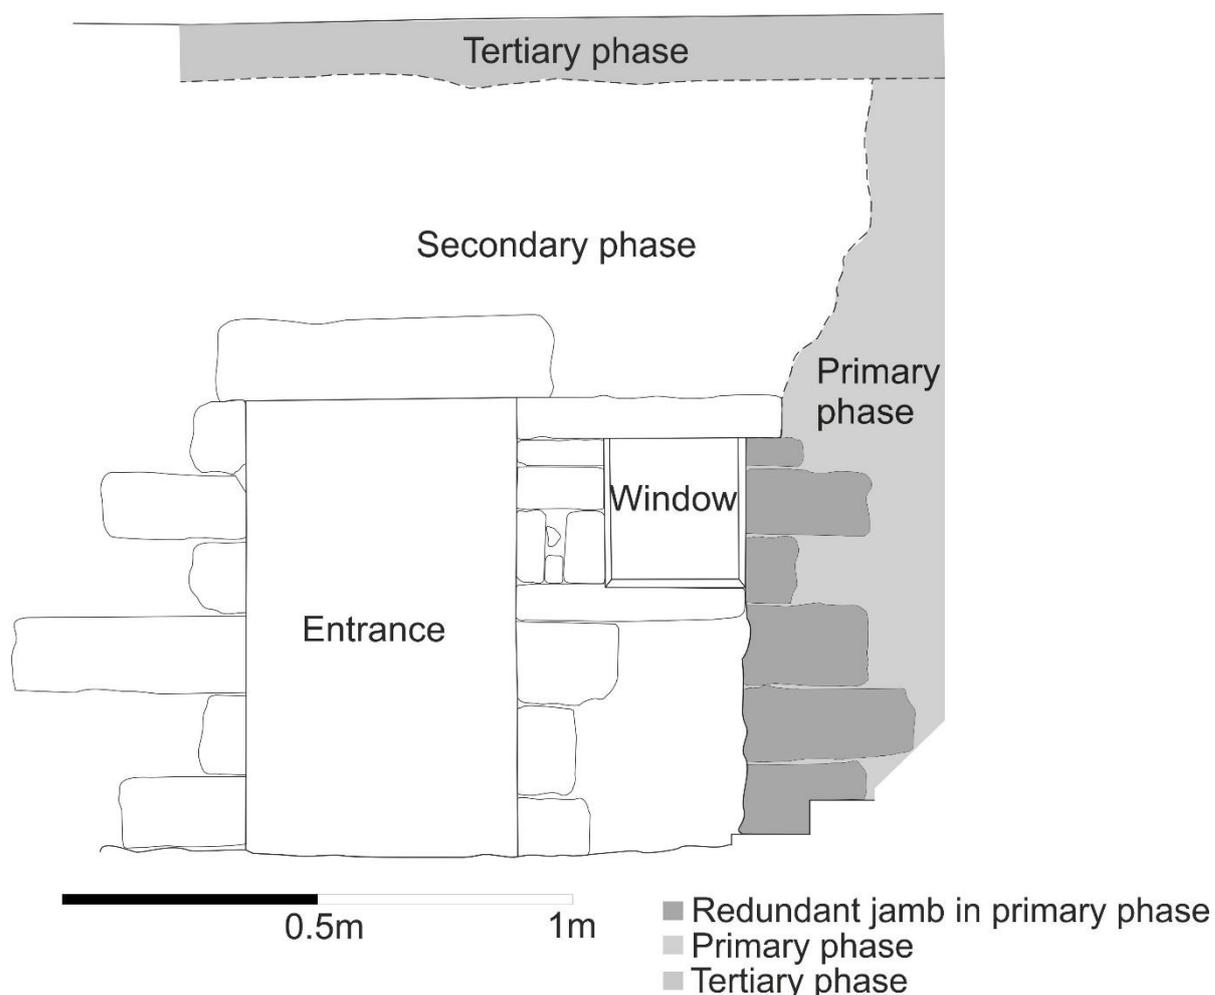
**Figure 8: Scaled phased drawing of the re-working of the East elevation (Drawing 001)**

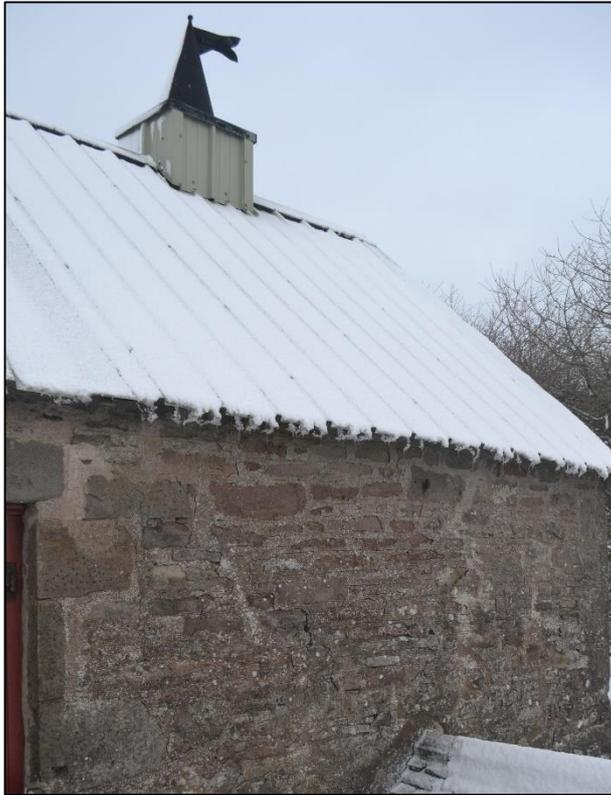
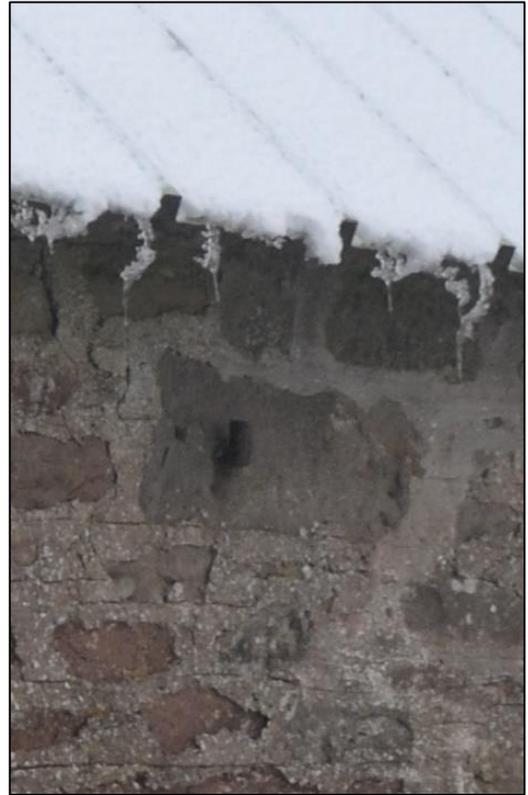
**Plate 8 and Plate 9: Location (left) and detail (right) of re-used stone with pintle in the east elevation (Photograph 013)**

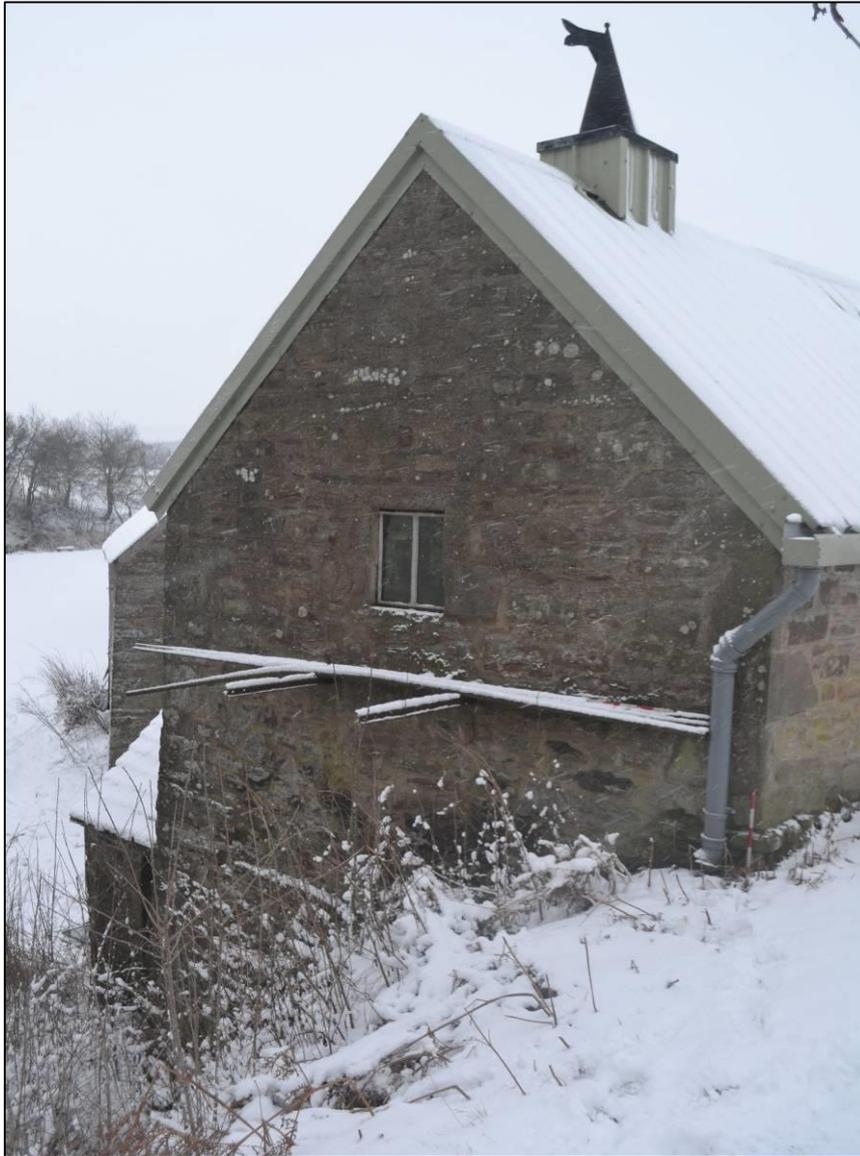
5.3.1 The north gable of the building straddles the south east running slope that creates the difference in levels for access to the first floor. It has one small, square window set in the centre of the upper level. Like the east elevation, the north has been heavily re-pointed, predominantly with portland cement. Although there is no clear coursing in the rubble, when this cement has been applied, attempts have been made to draw and create the effect of coursing in the cement.

**Plate 10: View of the N gable looking S (Photograph 048)**

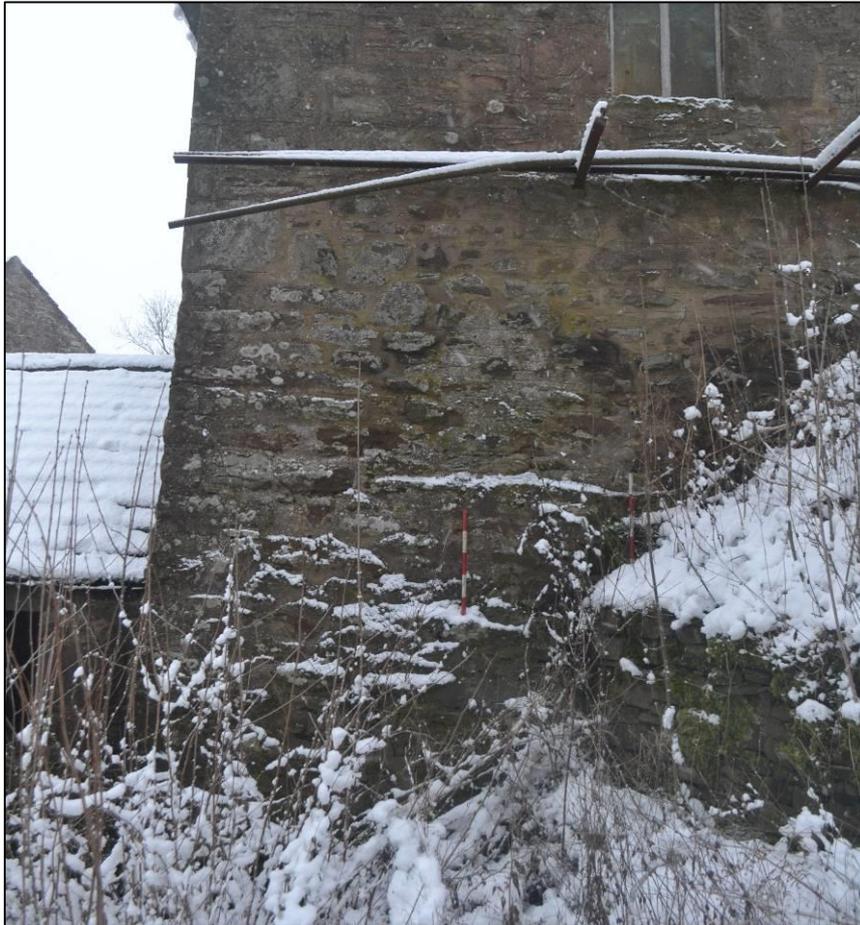
5.3.2 Map regression also revealed the presence of later additions to The Granary, built off the north eastern corner between 1860 and 1900. However, no direct evidence of this could be ascertained in the gable stonework. It is notable that there are no dressed quoin stones at the bottom of the north eastern corner (see Section 5.2.1) suggesting that they were not expected to be visible. However, it is difficult to see why this is the case as there is no obvious evidence that this area has been rebuilt. Indeed, the base of the wall in this area swells to the north, clearly as a support for the highest part of the walls and strengthening a weak point with the kiln located immediately behind (Plate 11).

**Plate 11: Detail of the stonework at the eastern end of the north elevation (Photograph 043)**

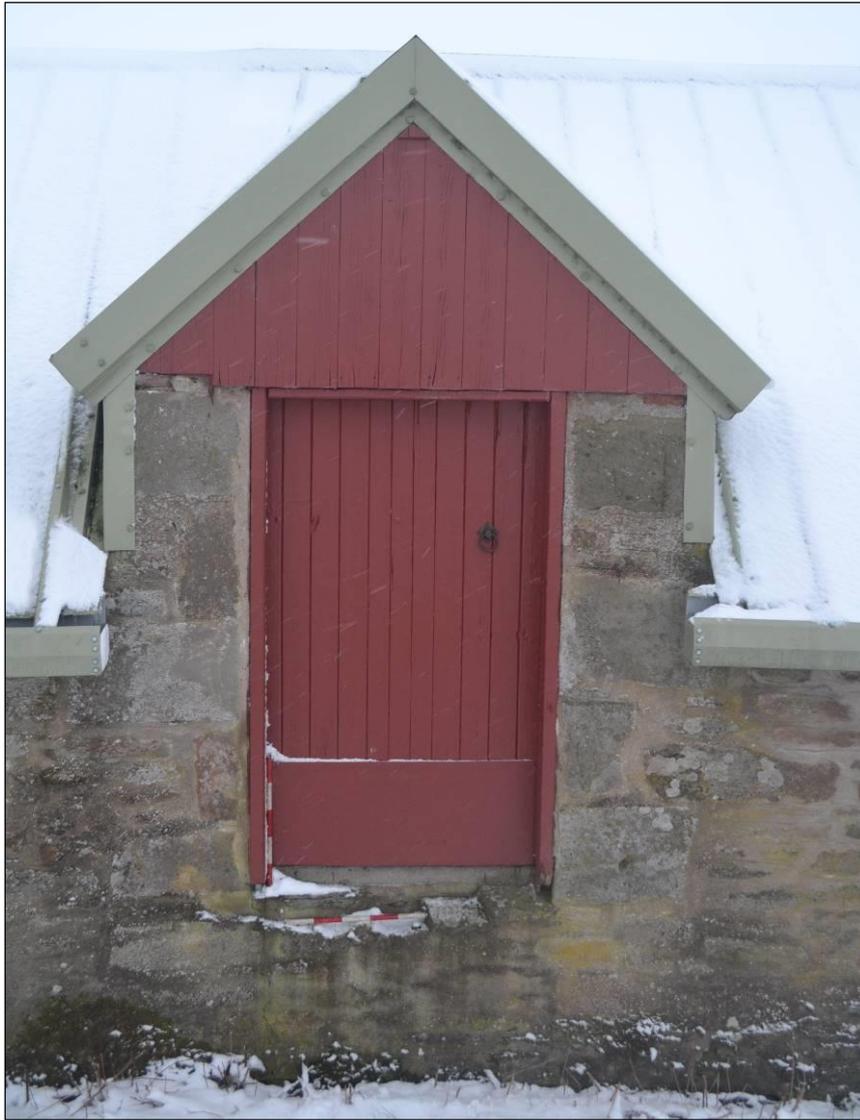
5.4.2 The main entrance to the 1<sup>st</sup> floor on this side of the building is through a wooden door under a pitched roof (Plate 12). This is raised off the ground, but there is no evidence for the removal of any stone steps. The entrance may be a later re-working.

**Plate 12: The entrance in the west elevation (Photograph 053)**

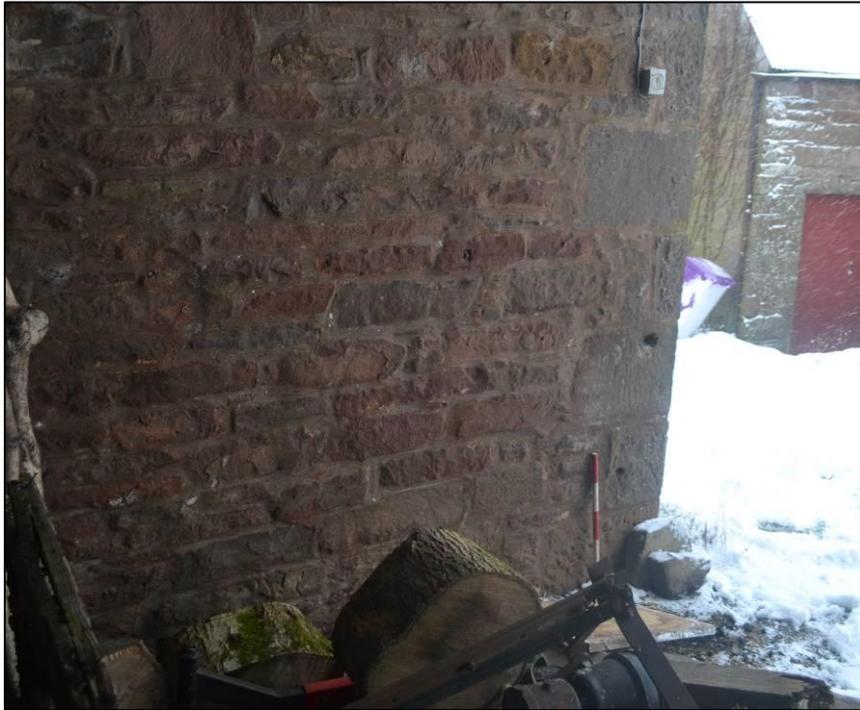
- 5.5.1 The map regression has shown that the southern elevation was abutted by a later addition between 1860 and 1900. This space is currently occupied by a storage area for timber.
- 5.2.2 Like the north gable, the southern gable is dominated by one square window in the centre of the upper floor.
- 5.2.3 The lower wall here has also undergone significant pointing in recent times, but seems to be much more regularly coursed with rectangular blocks of stone. There are two holes, or indentations set within the quoins of the south eastern corner just above ground level.

**Plate 13: Oblique view of the lower wall of the south elevation. Note the differences in the build of the lower and upper sections (Photograph 069)**

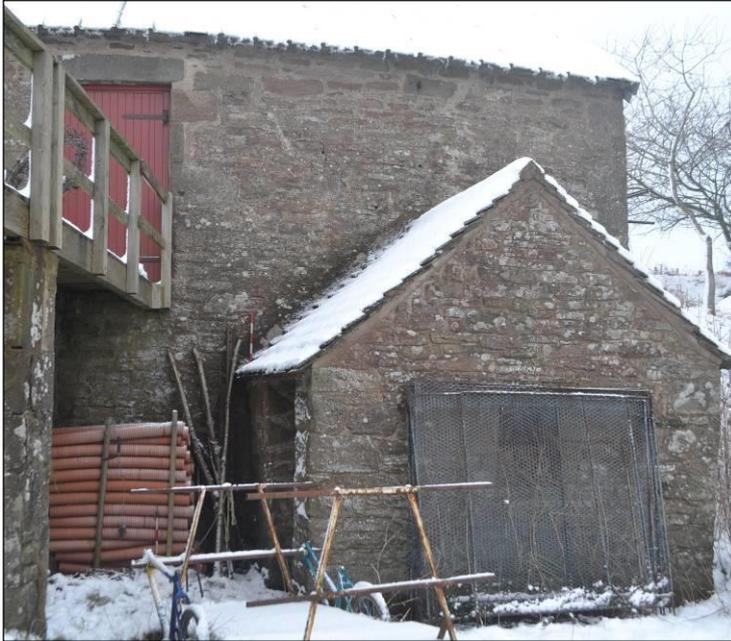
**Plate 14: View of the NE annex (Photograph 025)**

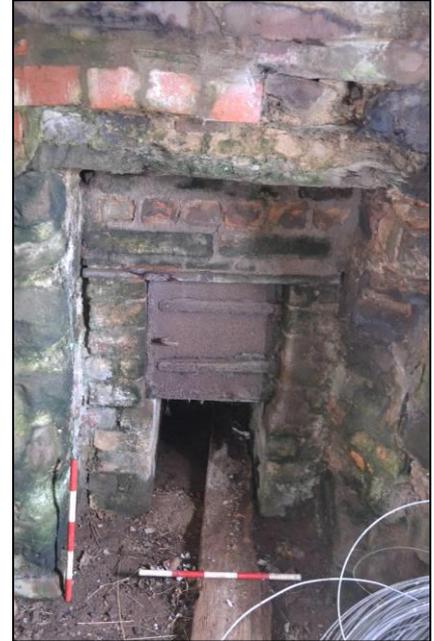
- 5.6.3 The fireplace inside the room (Plate 15) heats the kiln on the other side. The intense heating of the stones around the fireplace, as well as the heavy working in this area has caused the stones around the fire to crack and fracture. As a result this area has been re-worked and rebuilt a number of times utilising bricks.

**Plate 15: The fireplace providing access to the kiln – within the NE annex (Photograph 029)**

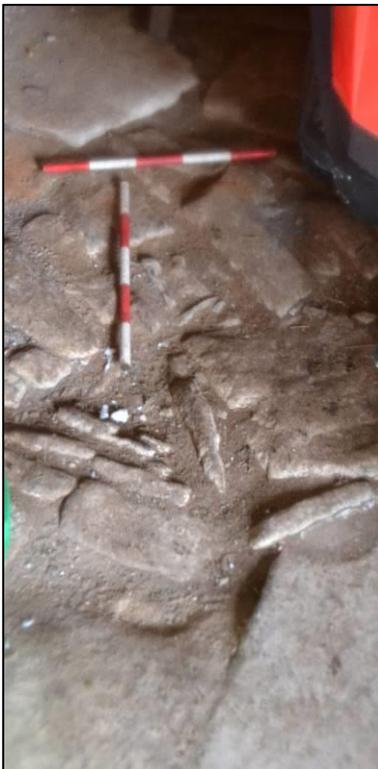
- 5.7.1 The ground floor of the Granary was used as a stable, with stalls at the southern end and gently sloping into a W-E aligned channel. Most of the floor surface in here is concrete, but the northern third is built from rough flagstones, presumably the original surface (Plate 16).

**Plate 16: Detail of floor surface (Photograph 127)**

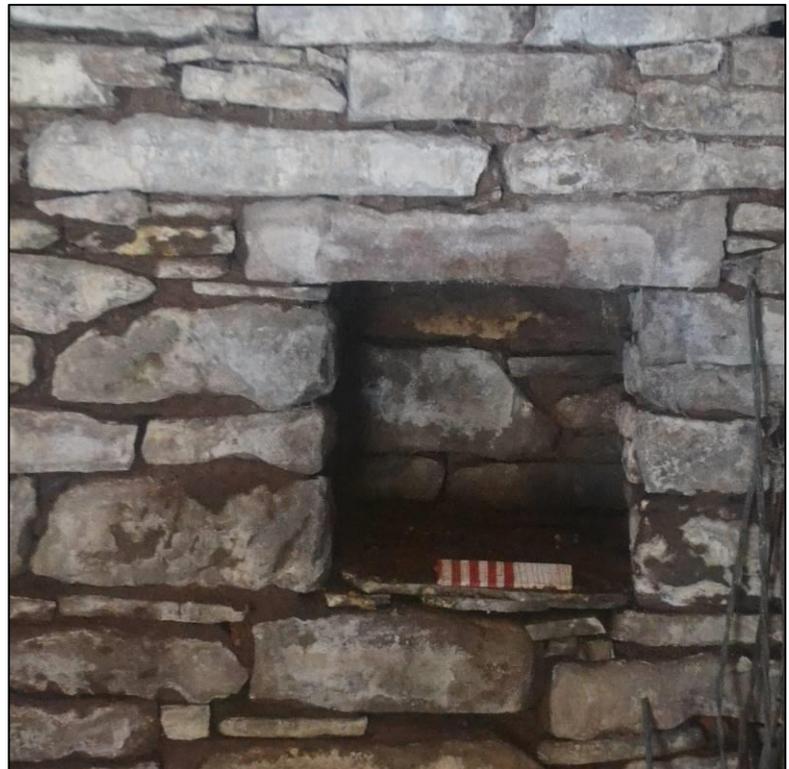
**Plate 17: Socket in east facing internal elevation (Photograph 139)**

5.7.2 Only one notable architectural feature was visible, a small opening in the centre of the east facing elevation (Plate 17). The function of this remains unclear.

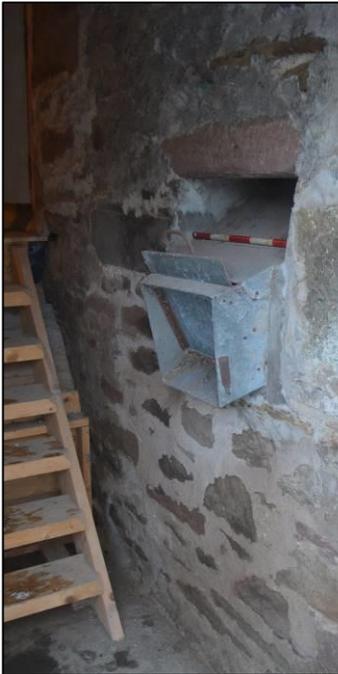
5.8.1 The access to the first floor on the eastern side does not open onto the main floor, but instead opens onto a small landing. This area is floored by large flagstones. An opening with a metal chute (Plate 18) leads through the internal wall to the drying room.

**Plate 18: The metal chute leading from the drying room in the granary (Photograph 073)**

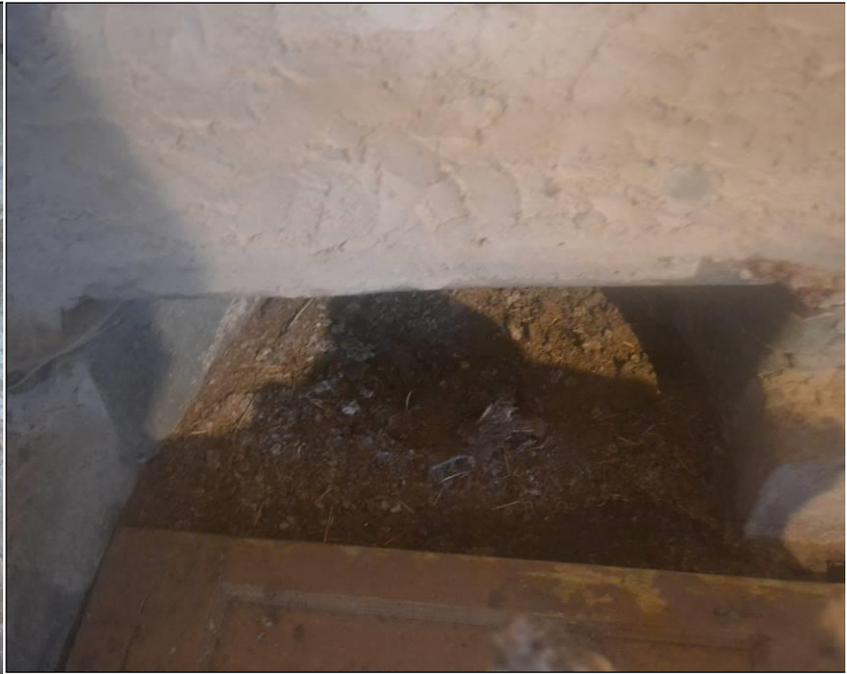
**Plate 19: The opening at floor level running from the drying room to the main granary (Photograph 117)**

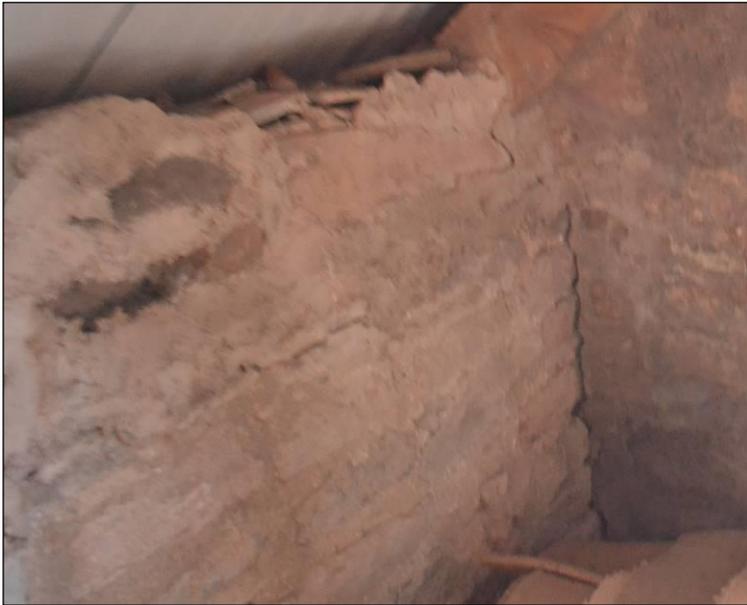
5.8.2 The internal walls of the granary are rough and seem in places to have been re-faced. This is especially true along the eastern wall where modern cement pointing indicates this was probably done when the roof was replaced in the 1950s. At the southern end of this wall, the eastern wall seems to abut the southern gable (Plate 20).

**Plate 20: The eastern wall (left) seeming to abut the southern wall (Photograph 099)**

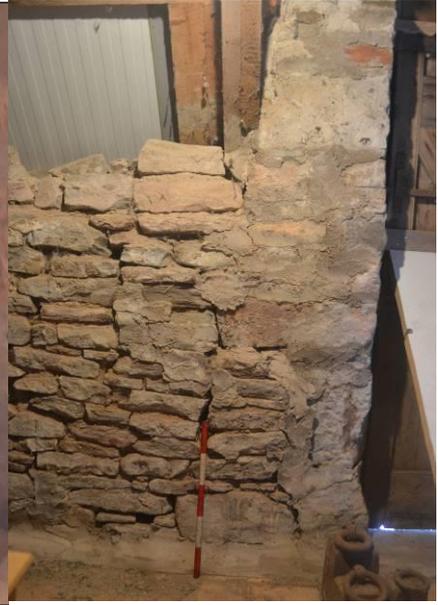
5.8.3 There is also clear evidence that the entrance through the western wall has either been inserted at a later date, or heavily re-worked.

**Plate 21: Evidence for rebuilding around the entrance through the western wall (Photograph 085)**

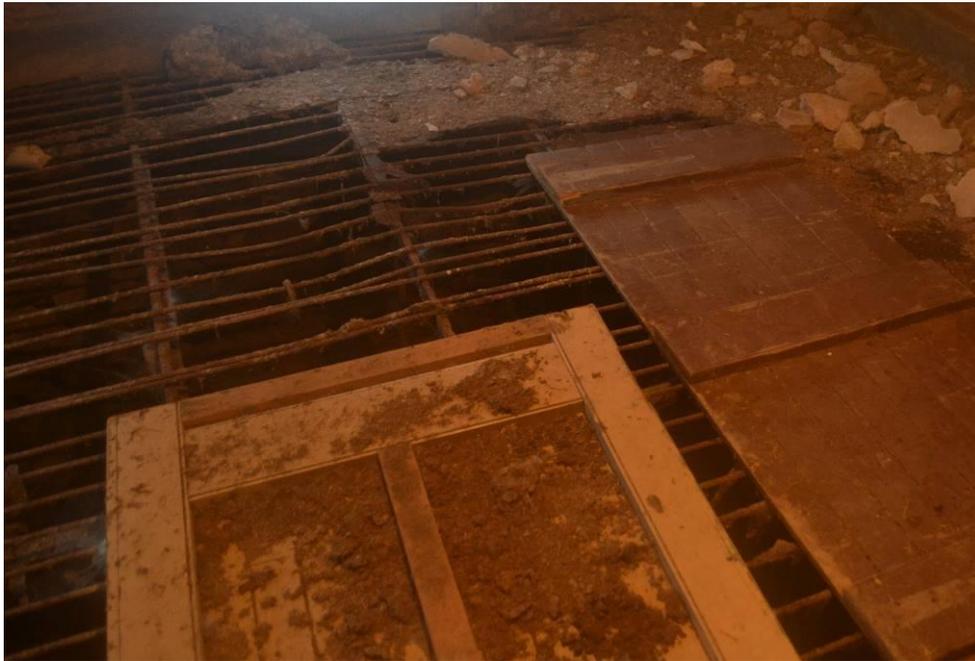
- 5.9.1 The kiln/drying room comprises a very degraded ventilated floor comprised of horizontal metal rods placed upon the metal girders noted protruding from the north elevation (Section 5.3.3). This floor was not considered safe (Plate 22).

**Plate 22: The Fe floor of the kiln/drying room (Photograph 106)**

- 6.1.8 Assessment of the Fe girders which hold the degraded ventilated floor in the drying room showed these to be re-used light railway tracks. The reason for their extension beyond the north gable is confusing.
