**The Granary,  
Milton of Ogilvie,  
Angus,  
Standing Building Record,  
Data Structure Report**

**January 2015**

Client: Mr Peter Ord  
Project: The Granary, Milton Mill, Milton of Ogilvie Job No: 201  
Document Title: Standing Building Recording

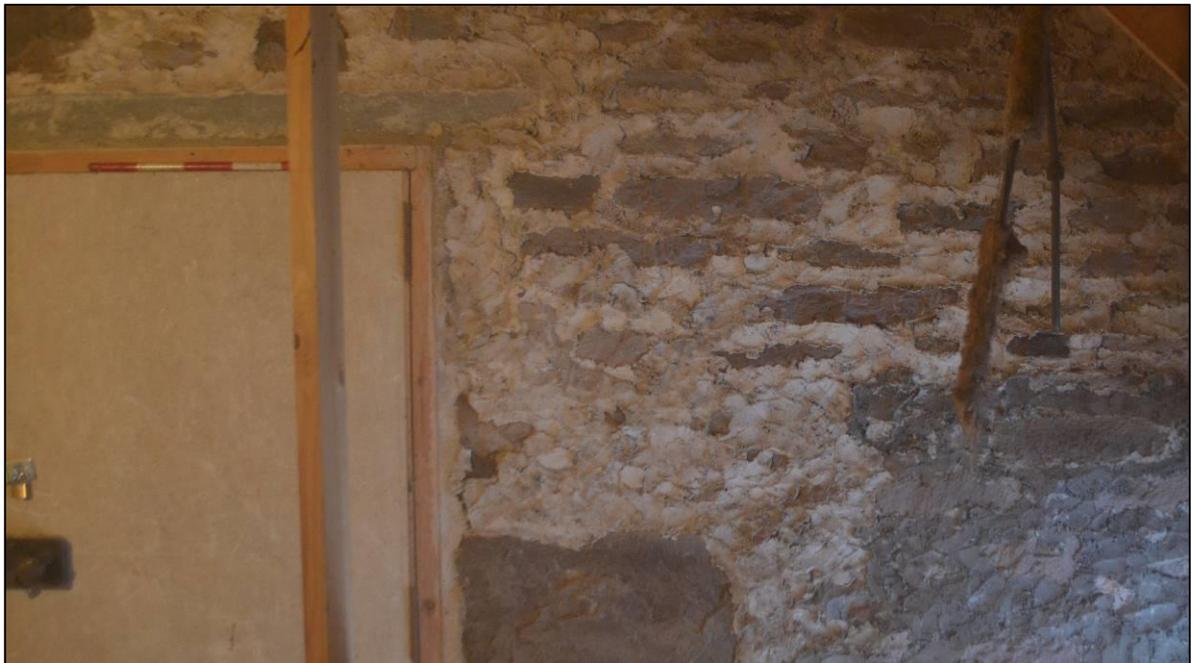
- 6.1.2 Assessment of the upstanding fabric of the Granary would agree with Hume's dating. The building has undergone significant alteration and repair which mask much of its development. There has been extensive re-pointing of the building which will have masked many of the tell-tale signs of its chronology and usage (for example see Plate 23). The work undertaken within the last 25 years by the owner has been sympathetic to the style and age of the building, but this was clearly not always the case.

**Plate 23: Evidence of pointing within the interior of the granary (Photograph 081)**

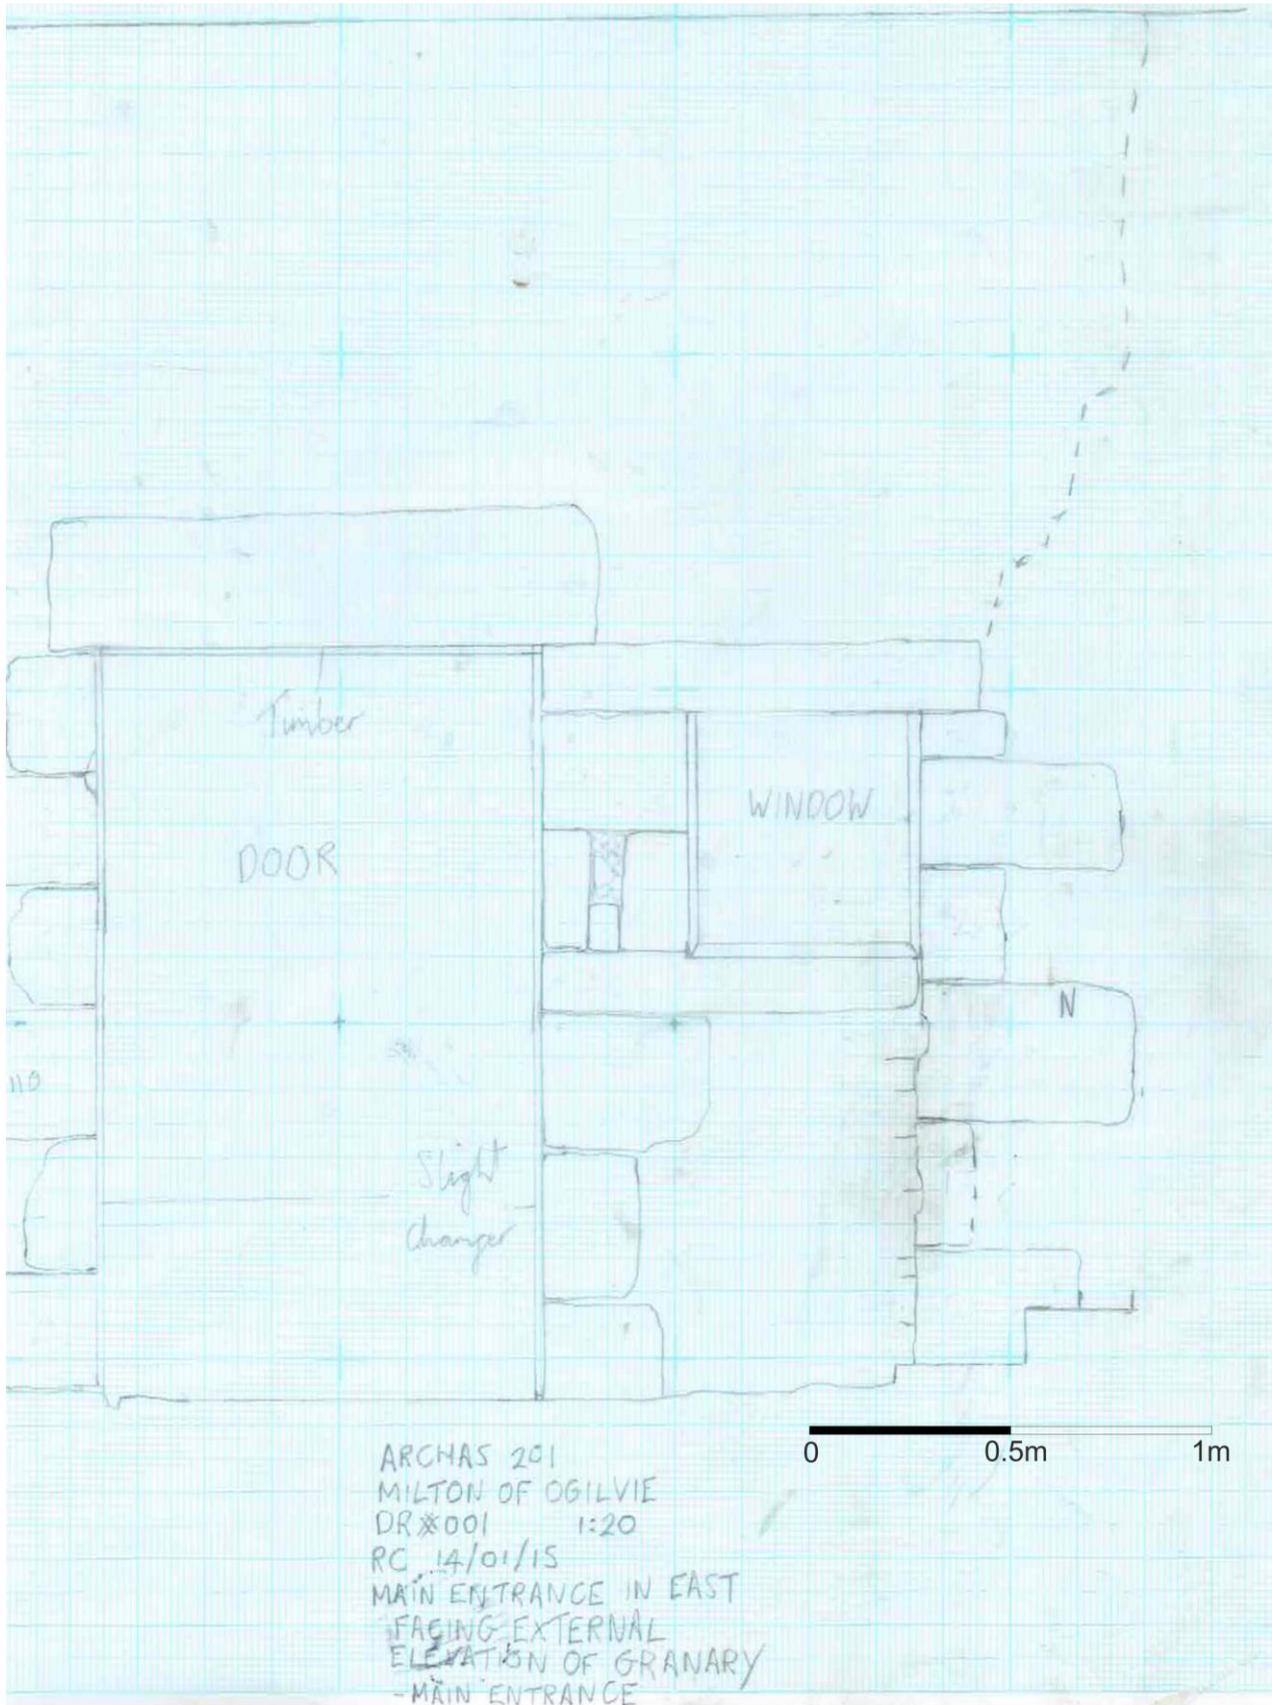
Figure 9: Field Drawing 001 – Main entrance in the East facing external elevation

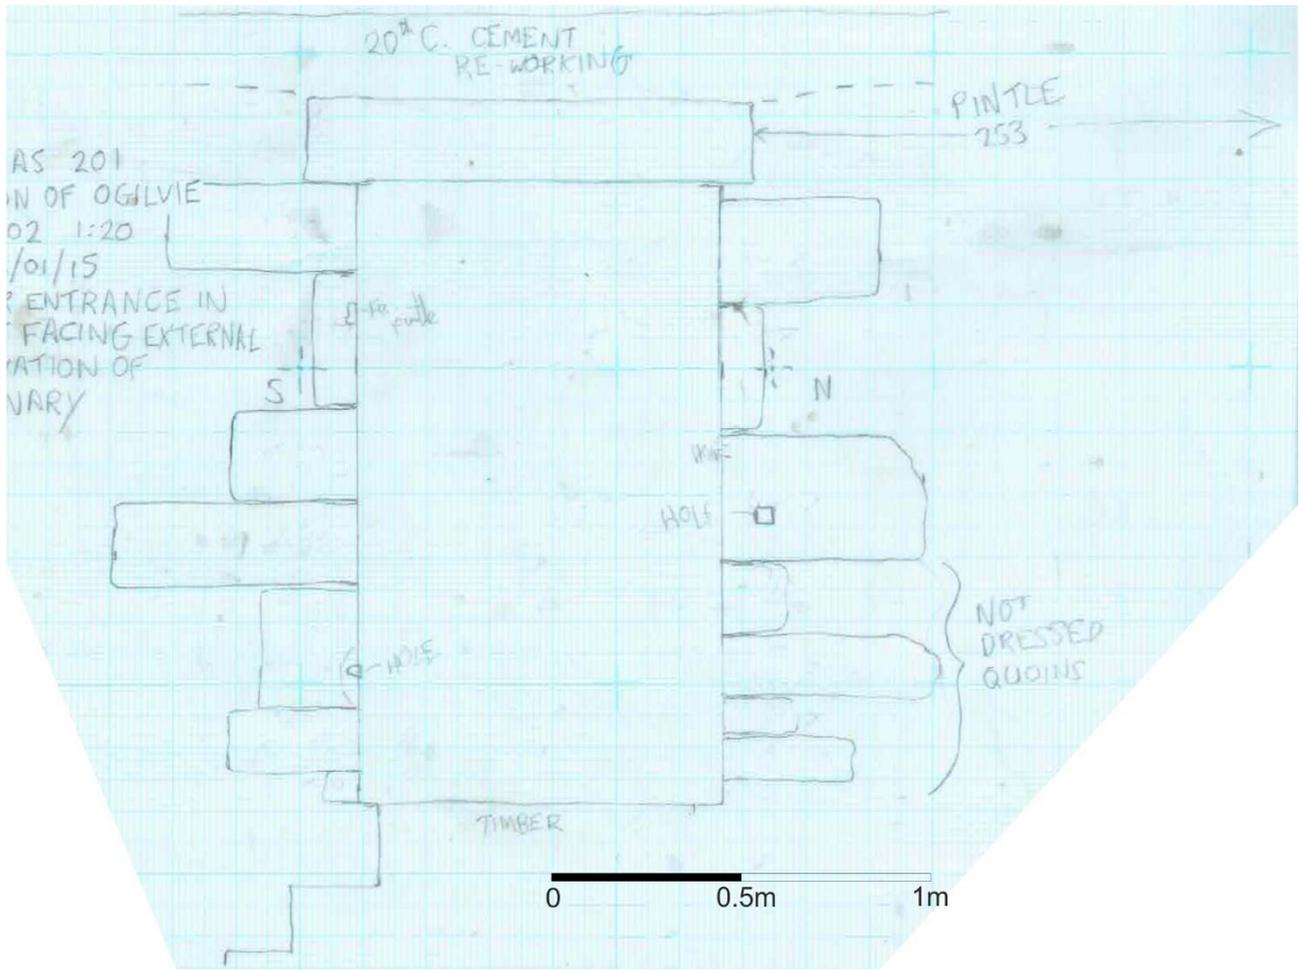
**Figure 10: Field Drawing 002 – Upper entrance in East facing external elevation of The Granary**

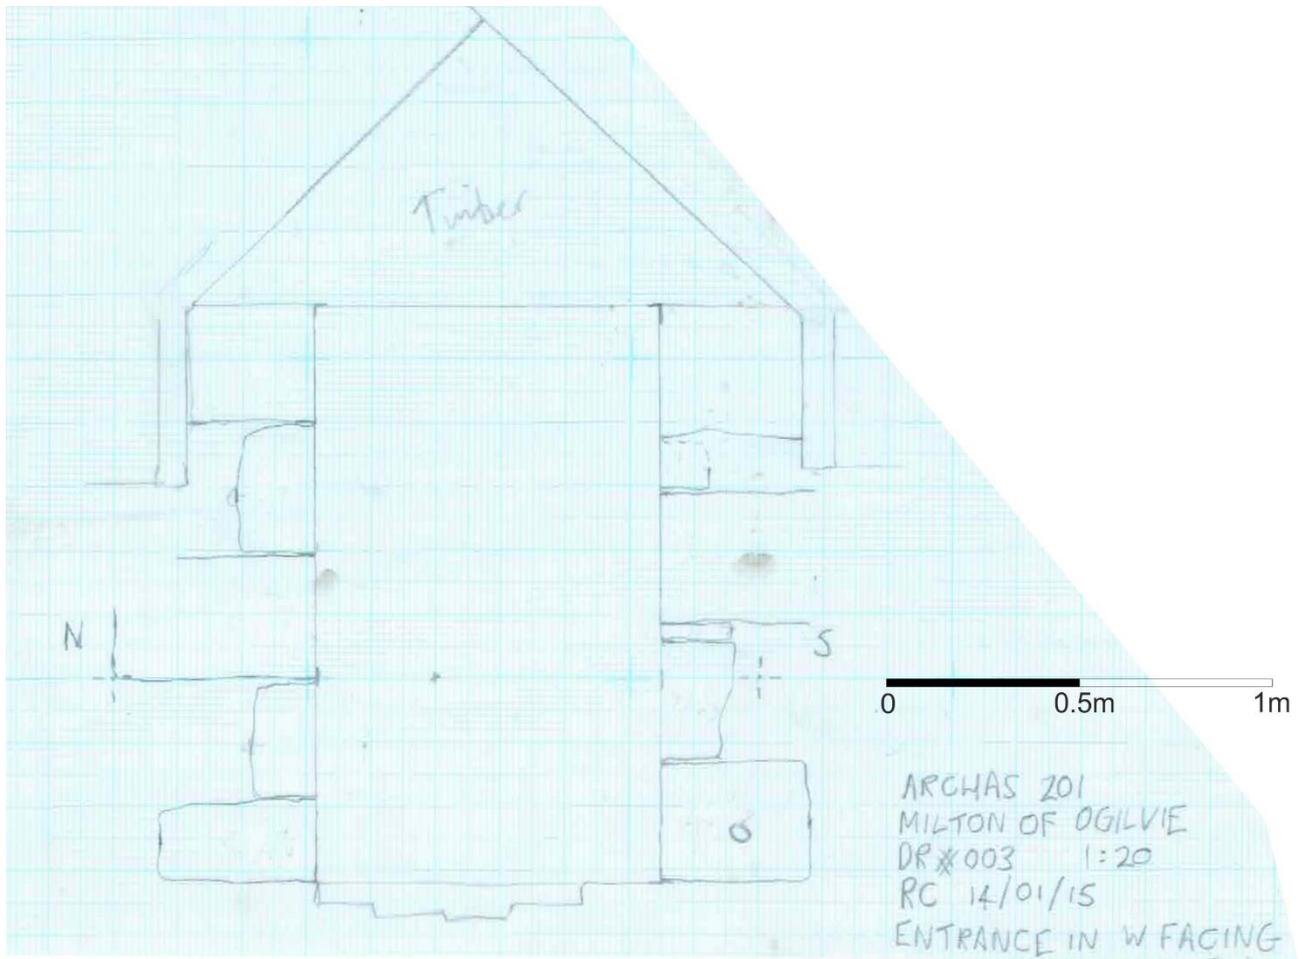
**Figure 11: Field Drawing 003 – Entrance in West facing external elevation**

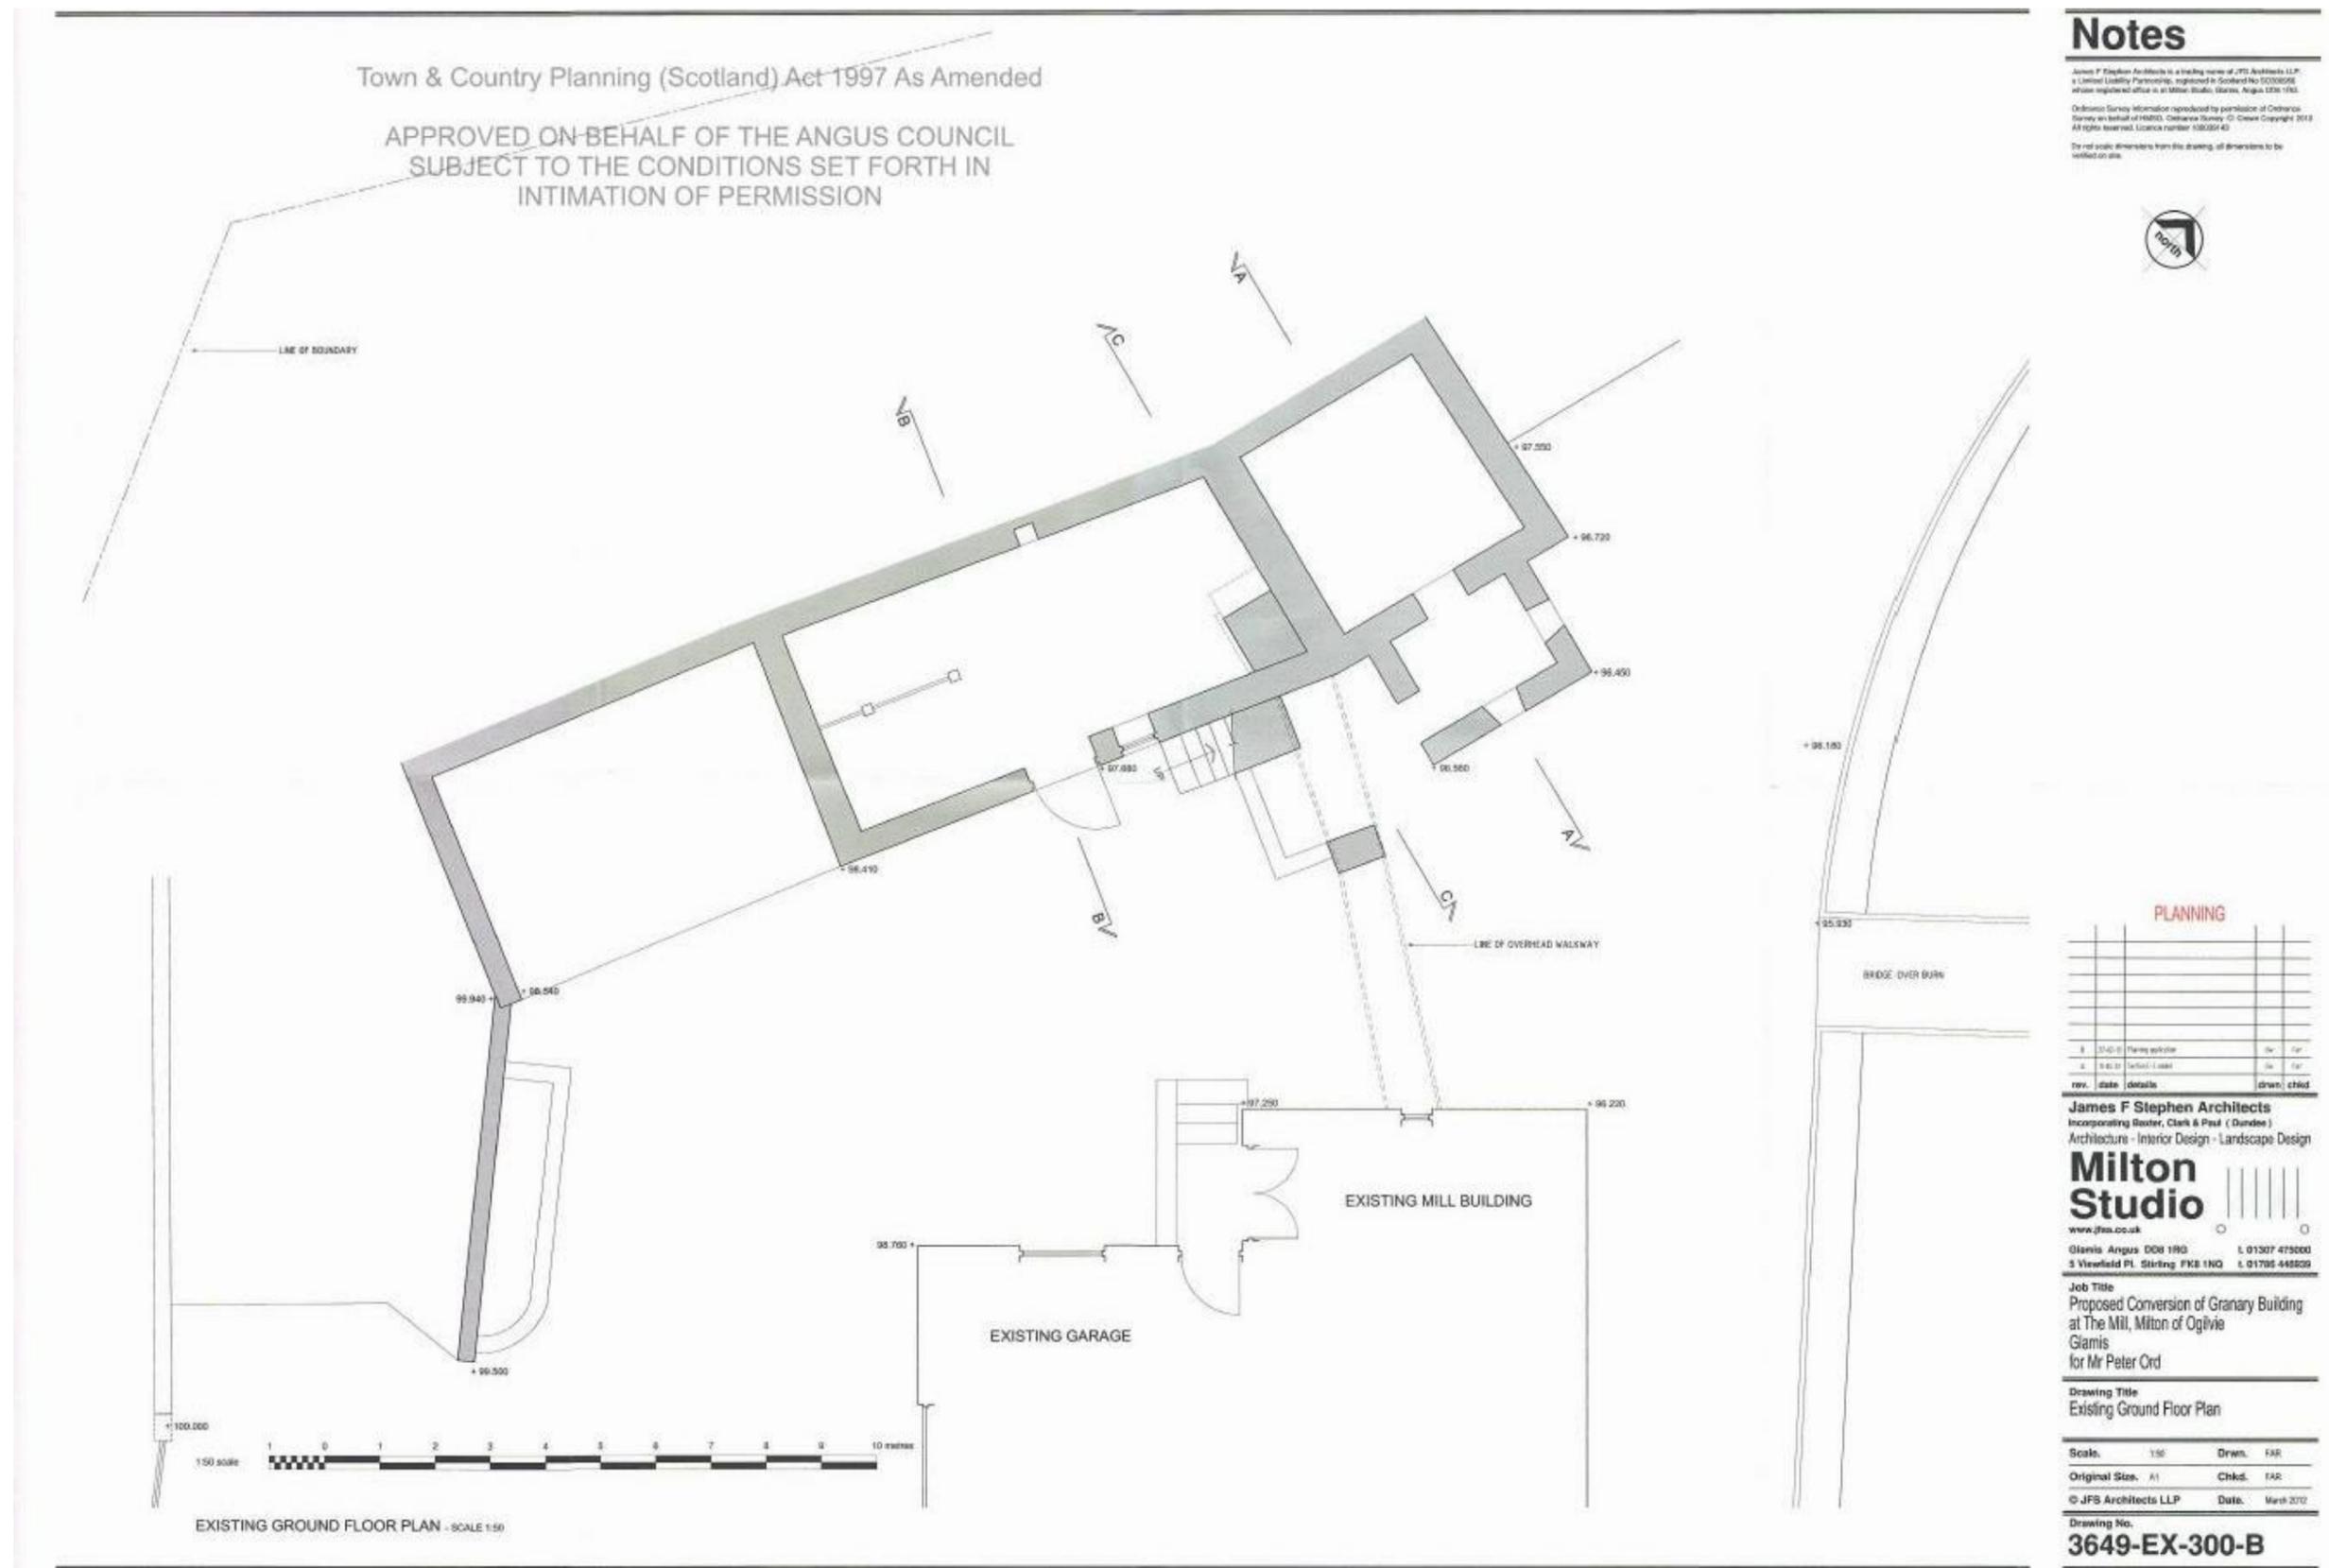
Figure 14: Existing Ground Floor Architectural plan as drawn by JFS Architects LLP
