**21 Marketgate North,  
Crail,  
Fife,  
Archaeological Evaluation  
Data Structure Report**

**July 2015**

Client: Fife Architects on behalf of Mr and Mrs Smith  
Project: 21 Marketgate North, Crail, Fife Job No: 214  
Document Title: Archaeological Evaluation DSR

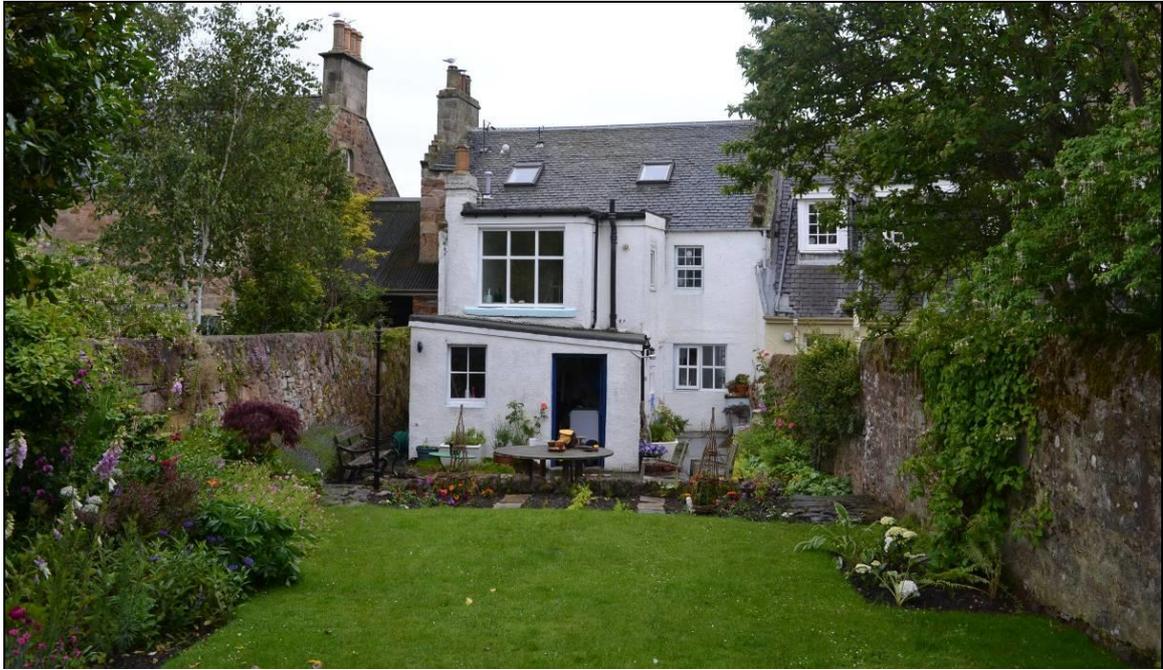
**Plate 1:** The back garden of 21 Marketgate looking south east (Photograph 005)

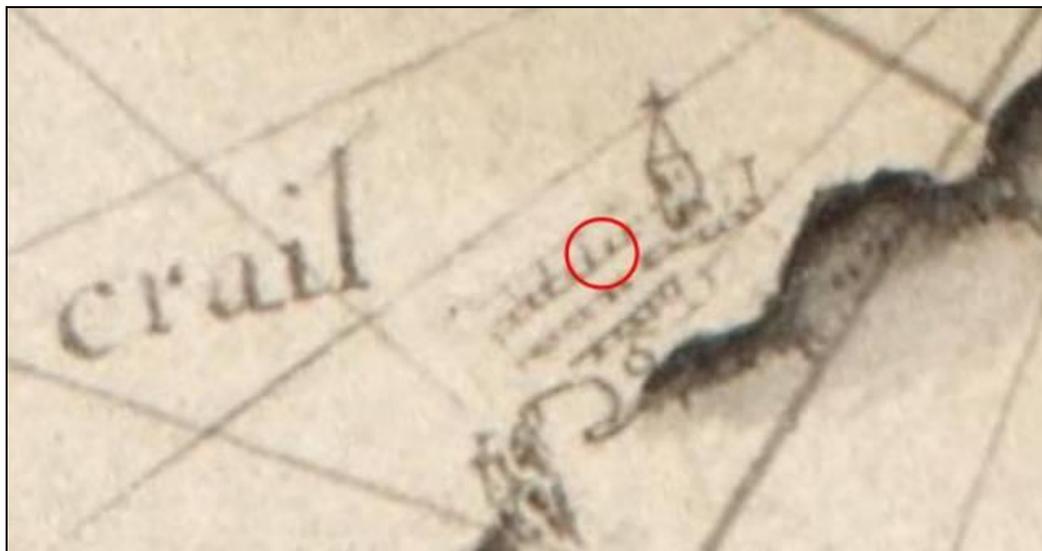
excellent detail (Figure 2). These are somewhat stylised, but clearly show the layout of the town with at least two parallel streets cut by a diagonally running street from the harbour. They also clearly show the Parish Church. It is the placement of this church that allows us to clearly see that 21 Marketgate would have been in the heart of the town at this time and likely densely occupied.

**Figure 2:** Extract from John Adair's map *The Hydrographicall mappe of Forth from the entry to ye Queens-ferry* from 1683. This clearly shows the layout of Crail in the 17<sup>th</sup> century. The rough location of 21 Marketgate is indicated in red. ARCHAS Ltd after NLS

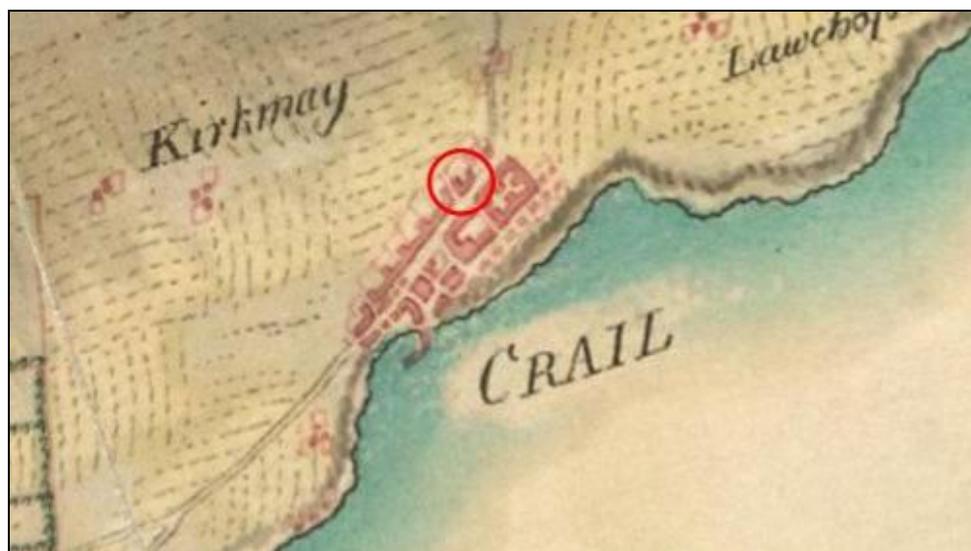
**Figure 3:** Extract from William Roy's *Military Survey of Scotland* with a general indication of 21 Marketgate as indicated red. © The British Library Board. All Rights Reserved (Roy Military Survey of Scotland)

2.2.6 William Roy's map clearly shows buildings on the site which predate the current structure at 21 Marketgate.

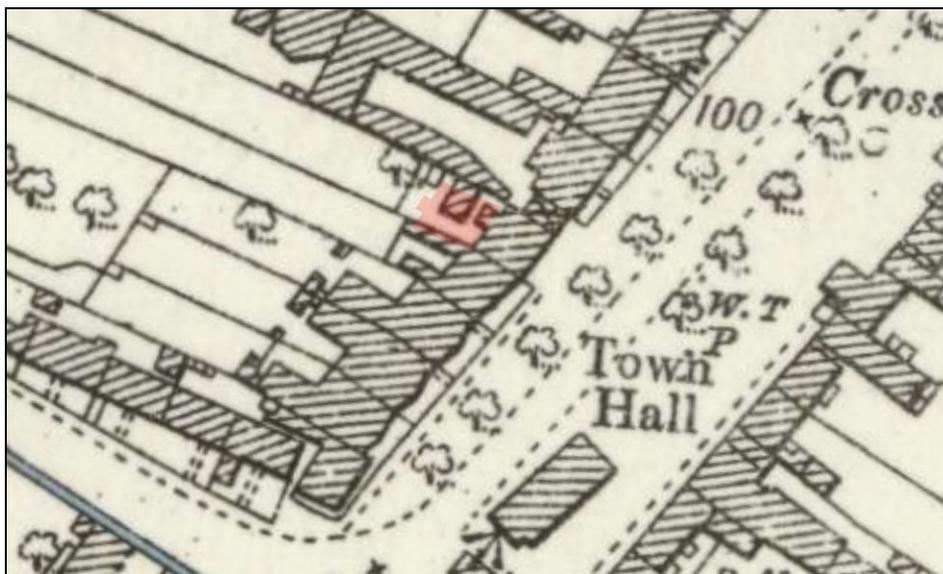
2.2.10 The 25 inch to 1 mile Fifeshire, 023.02 Ordnance Survey map, produced in 1894, shows the same layout of buildings as in 1854, but in greater detail (Figure 4). The extent of the additional structure built against 19 Marketgate is clear while a thick line across the back court indicates that this may have been raised and reached by a set of steps.

**Figure 4:** Extract from the OS 25 inch to 1 mile Fifeshire, 023.02 surveyed in 1893 and published in 1894. The proposed development area is indicated red. ARCHAS after NLS

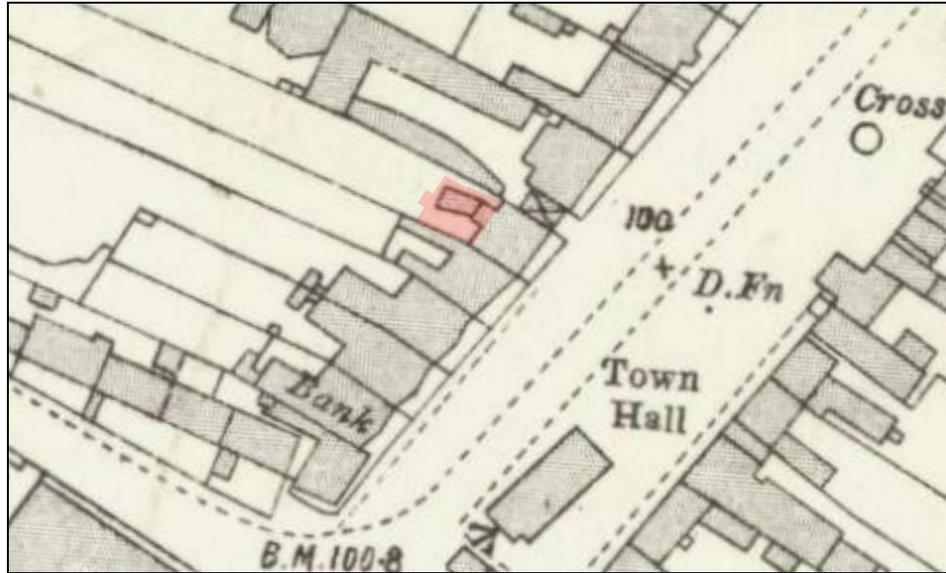
2.2.11 By 1912/14 when the revised version of the 25 inch to 1 mile Fifeshire, 023.02 was produced (Figure 5), the development area has changed. The north east to south west aligned building abutting 19 Marketgate has gone, replaced by a rectangular extension protruding from the rear of 21 Marketgate. There is also no indication of the possible terracing or raising of the back court as shown in 1893/94.

**Figure 5:** Extract from the OS 25 inch to 1 mile Fifehire, 023.02 surveyed in 1912 and published in 1914. The proposed development area is indicated red. ARCHAS after NLS

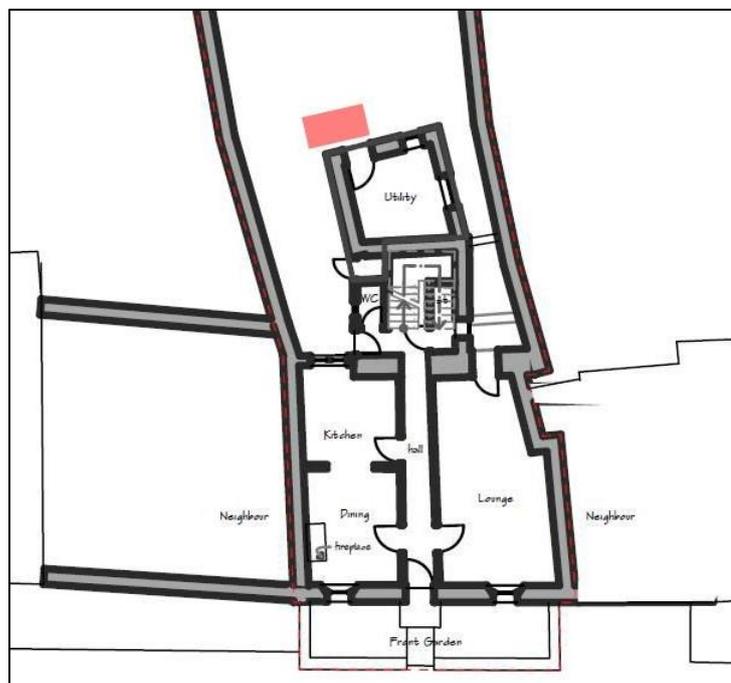
- 3.1.2 Through discussions with Fife Council Archaeology Unit, the evaluation trench measured 2m by 1m and was placed at the most accessible part of the development area (Figure 6).

**Figure 6:** Trench location as indicated red. ARCHAS Ltd after Fife Architects

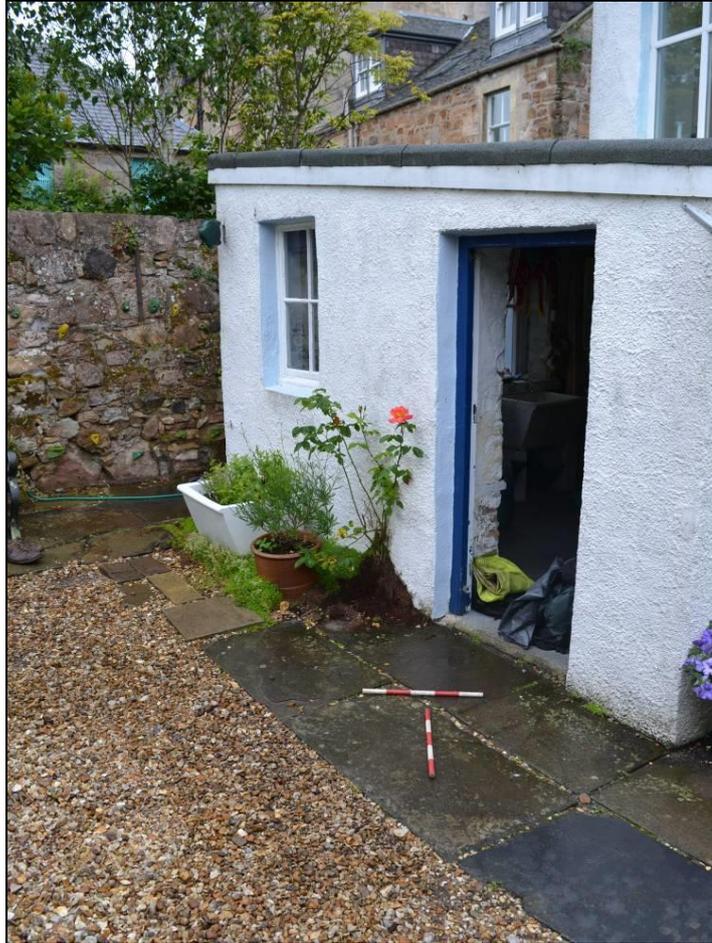
**Plate 2:** Pre-excitation view looking east (Photograph 002)

- 4.1.3 The area proposed for development is currently flagged with large slate slabs and covered with small stones (Plate 2). These were set within a bedding material of dark black brown silty gravel **(001)**. A levelling deposit **(002)** below this covered the whole of the trench.

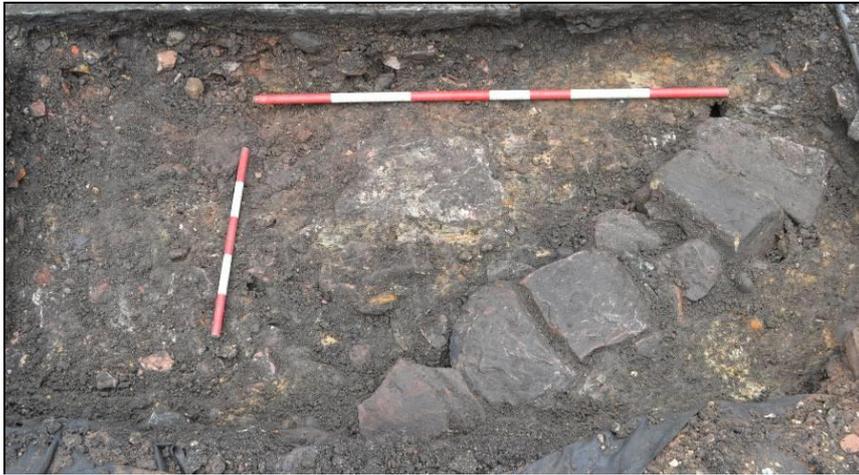
- 4.1.4 The deposits below **(002)** were very mixed. One large sandstone block in the centre of the trench (Plate 3) turned out to be the corner stone of the large wall **{013}**, running north east to south west before returning towards the south east. This wall ran on the same alignment as the existing outbuildings of 21 Marketgate which overlay the route of the wall. **{013}** extended beyond the limits of the trench, but there was no evidence of a wall having abutted, or been truncated from, the historic boundary wall with 19 Marketgate.

- 4.1.5 The dominant feature in the trench was a rough stone lined 'cundy' drain **{003}** (Plate 3). This drain curved around, but clearly respected the sandstone footings **{013}**. The capstones of the drain were rough slabs of no discernible pattern, while the sides were predominantly slabs set on their long sides to give a depth of c.0.27m. This drain was clogged with fine grain silt **(006)**.

**Plate 3:** {003} as exposed looking south east. Note the large sandstone block showing the location of {013} (Photograph 009)

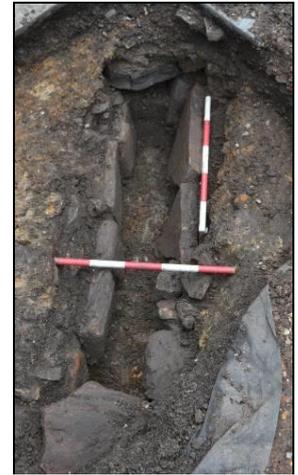
**Plate 4:** Mid-excitation view of {003} (Photograph 016)

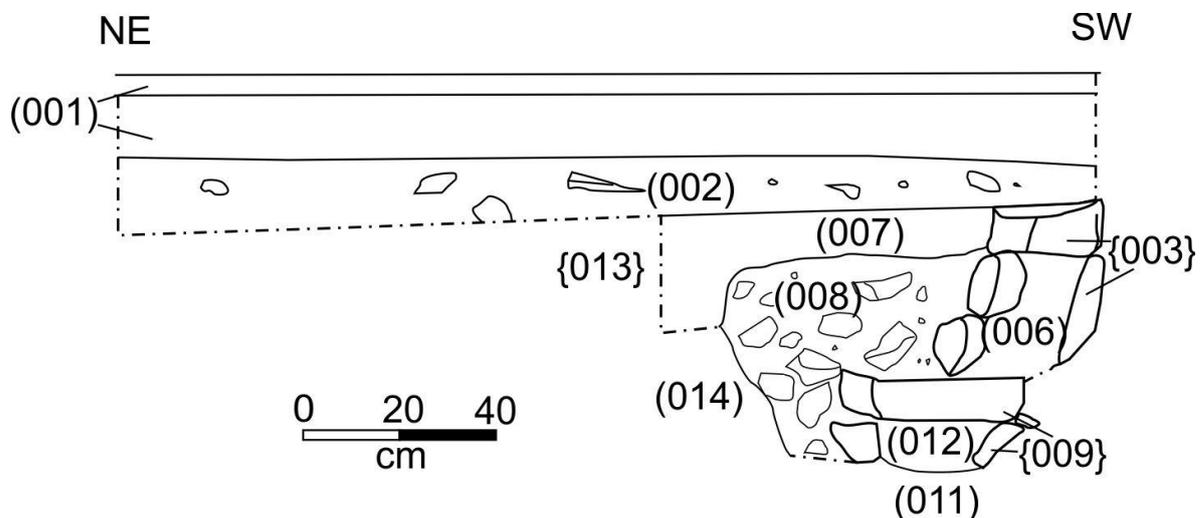
- 4.1.6 The stone lined drain {003} was cut through (005) and (008) (two synonymous deposits separated by the line of the drain). These are likely levelling or backfilled deposits associated with the construction of {013}.
- 4.1.7 Removal of {003} revealed a second drain beneath – {009} (Plate 5). This feature appeared much more substantial than {003}, with large, prominent cap stone slabs. This ran adjacent and parallel to the wall {013}, mirroring the right angle of the corner and indicating this was put in place contemporary with that building. Removal of the cap stones showed the edges of the channel to be rough boulders, giving the drain an internal depth of only c.0.10m. This too was clogged with silt (012). The levelling deposit (005/008) had been placed atop {009}, but a shallow cut [016] was visible into the natural subsoil (011) beneath.

**Figure 7:** NW facing section of evaluation trench (Drawing 004)

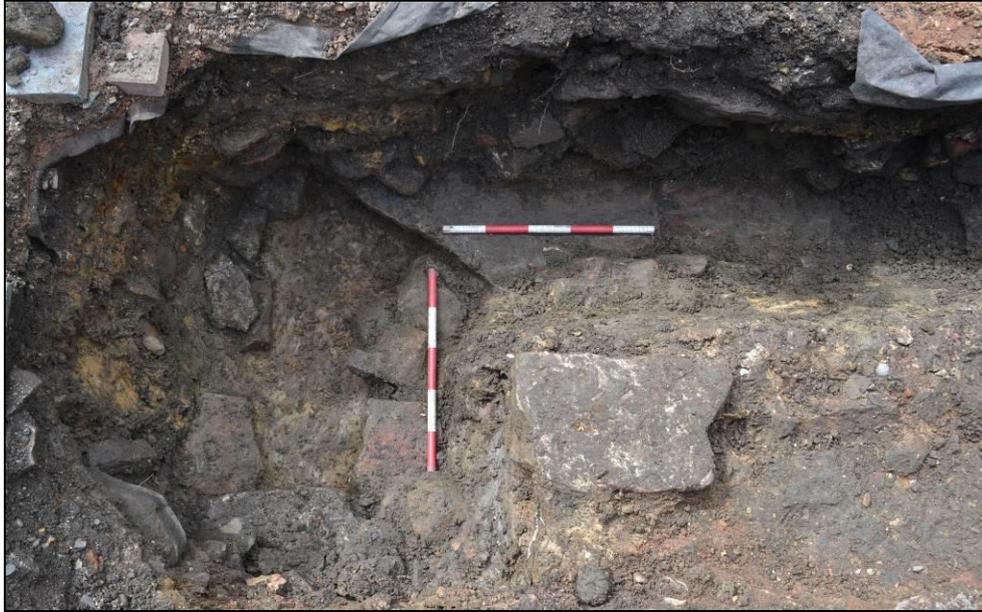
**Plate 5:** Post-excavation view facing north west. Note the wall {013} (bottom right) set within the thick clay (014) and the insubstantial nature of drain {009} (Photograph 029)

- 4.1.8 It was also noticeable that the wall {013} had been set within a matrix of thick, firmly compact heavy clay (014) along its outer edge.
- 4.1.9 The artefact assemblage was noticeable in that there were no finds which noticeably pre date the 19<sup>th</sup> century. Most of the faunal material is from small animals, with no real evidence for butchery. Ceramic recovered is all glazed fragments, seemingly dateable to the 19<sup>th</sup> century.

- 5.1.1 The structural remains {013} recorded at 21 Marketgate are almost certainly the remnants of the structure built against the south east facing elevation of the boundary with 19 Marketgate. This was first shown on the 1<sup>st</sup> edition 6 inch to 1 mile Fife, Sheet 20 from 1854. The origins of the building are unclear, but it is not depicted on less reliable maps of 1828 and 1832 and can be tentatively dated to the period between these maps and the 1<sup>st</sup> edition. The building was demolished between 1894 and 1912. Two fragmentary courses of roughly faced sandstone survive. These are foundation courses, bonded and encompassed within a thick set clay which would have acted as a damp proofing course.

- 5.1.2 A large stone lined drain {009} was constructed around the perimeter of the building, cut into the undisturbed natural subsoil. This had the appearance of a substantial drain, but in actual fact had a very shallow draft and became clogged with silt. This stone lined drain was replaced at some point by a more substantial drain {003} built at a higher level. This was more roughly constructed, but deeper and wider. {003} snakes around the remnants of {013} and was likely to have been constructed during the lifetime of the building.

- 6.1.4 ARCHAS Ltd recommend that no further archaeological involvement is required in advance of development and upon submission of this report that the planning condition can be discharged.
