**15 South Street
Milnathort,
Perth and Kinross,
Standing Building Recording,
Data Structure Report**

November 2015

Client: Scottish Water
Project: 15 South Street Milnathort, Perth and Kinross
Document Title: Standing Building Recording

Job No: 221

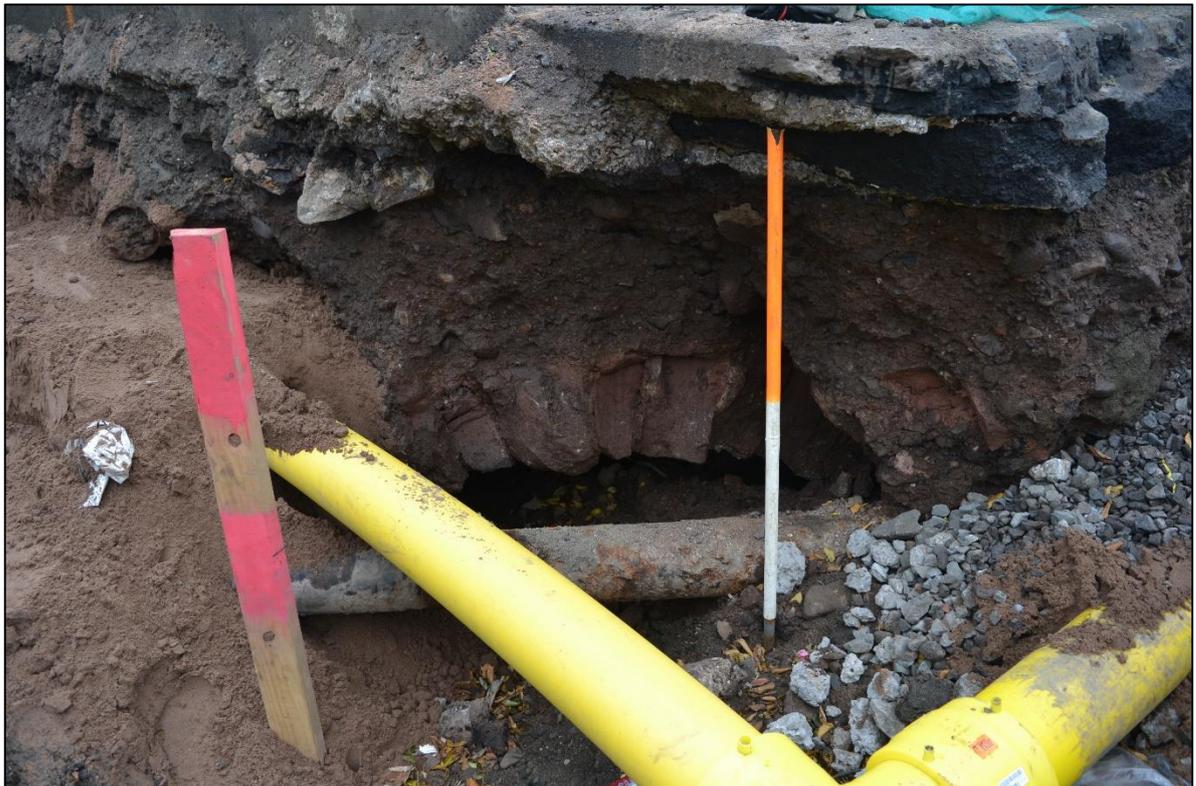
Figure 2: truncated remains of culvert in trench excavated by Scottish Water under The Cross, as viewed from the east

The mill lade culvert arch is situated beneath the boundary wall of a garden that fronts onto The Cross. Parts of the culvert are also visible to the northwest of the site beneath The Cross in a trench dug by Scottish Water (see Figure 2) and the mill lade then runs from the site area in a south-easterly direction where it feeds into the watercourse known as the Back Burn.

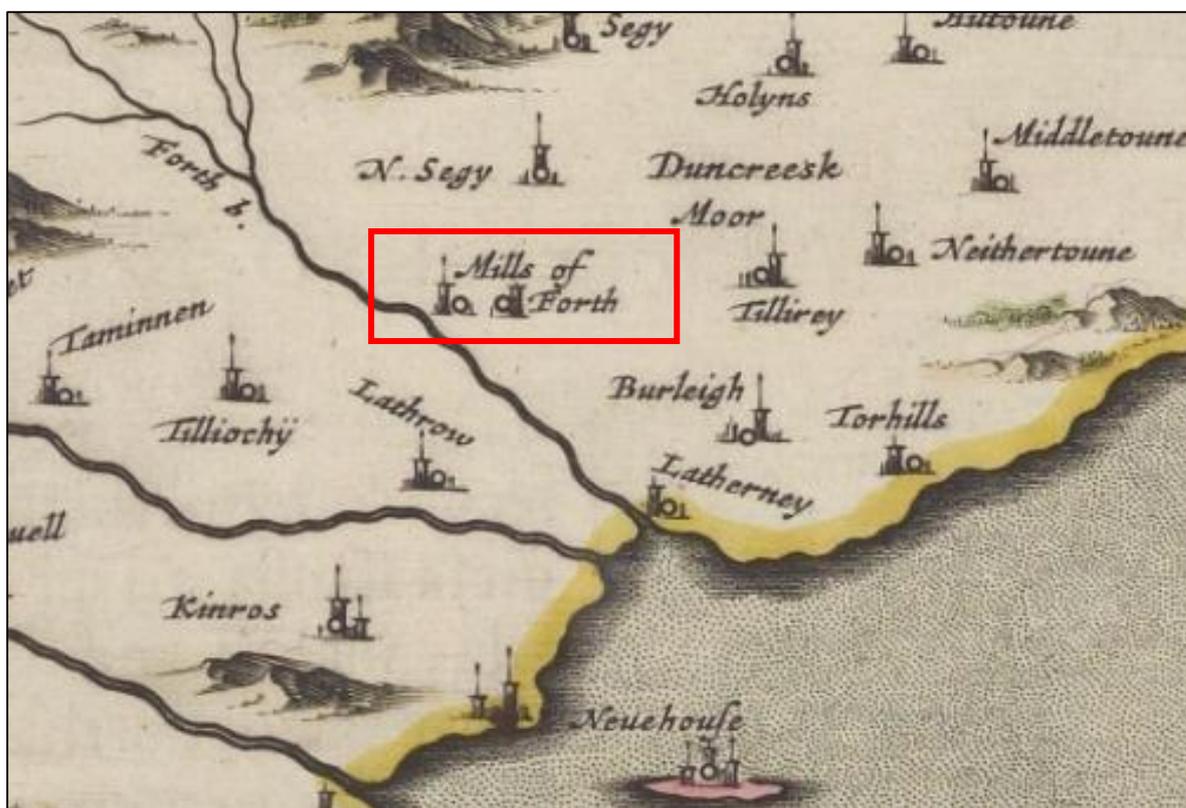
Figure 3: Extract from Joan Blaeu's 'Atlas of Scotland – Fifae pars occidentalis, [vulgo], The West Part of Fife' showing 'Mills of Forth' likely indicating Milnathort

3.2.2 The earliest maps of the Milnathort area that appear to refer to the village itself area were drawn by Joan Blaeu who lived from the 1596 until 1673 and produced his 'Atlas of Scotland' in 1654 based in part on earlier maps made by Timothy Pont. Blaeu's map (3) indicates a settlement he names as 'Mills of Forth' in approximately the correct location of modern Milnathort, suggesting it does indeed represent the town in question. The name of this village obviously implies the presence of mills.

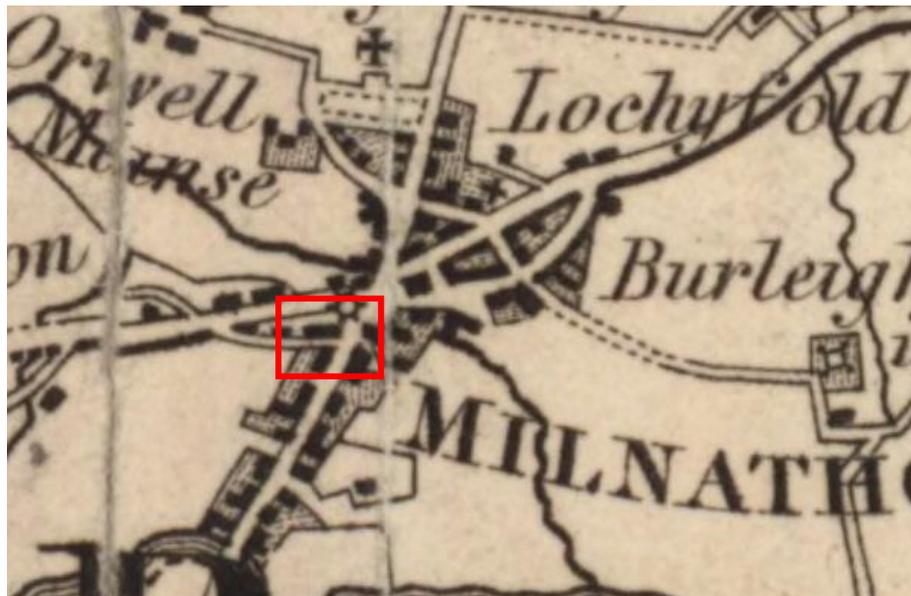
Figure 5: Extract from Sharp, Greenwood and Fowler's 1828 map showing a mill highlighted in red, to the WNW of the site.

- 3.2.4 Though Roy's map clearly indicates that 'Mills of Forth' clearly refers to Milnathort, given the relative location of Burleigh Castle (here 'Burley Castle'), it does not provide any great detail as to the types of buildings within the settlement. It is impossible to tell from this where map where the mills that gave Milnathort its name were actually located.
- 3.2.5 A mill is clearly shown on Sharp, Greenwood and Fowler's 1828 map of Milnathort (see Figure 5), which is the earliest map to show any great detail of the town. The mill is located just west of The Cross in approximately the position of the grain mill recorded by Hume, and it seems likely that the culvert is associated with this mill due to its location.

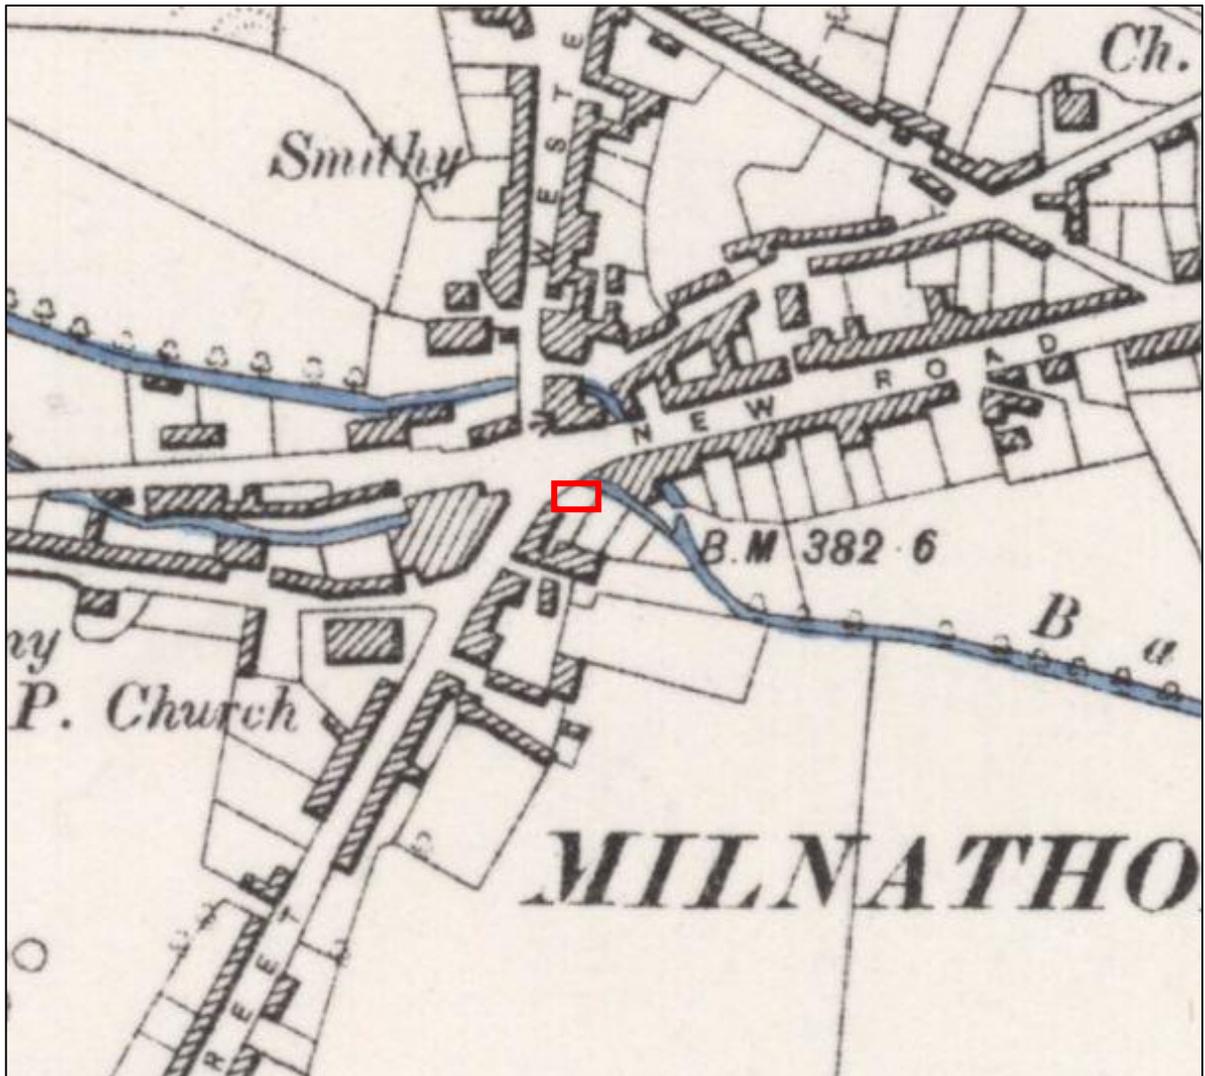
Figure 7: Extract from the 2nd edition Fife and Kinross Sheet XVIII.SW map, surveyed in 1895 with the site indicated in red. Archas after NLS.

3.2.8 By 1895 when the 6 inch to 1 mile Fife and Kinross Sheet XVIII.SW map is revised (published 1896, see Figure 7), the building to the north of the site is upstanding, but the rest of the area around the site appears very similar to that surveyed in 1854 with the addition of small boundaries on the ground to the south and west of the lade. The mill building to the west has had some structural additions and the map appears to indicate that the mill lade remained an open watercourse.

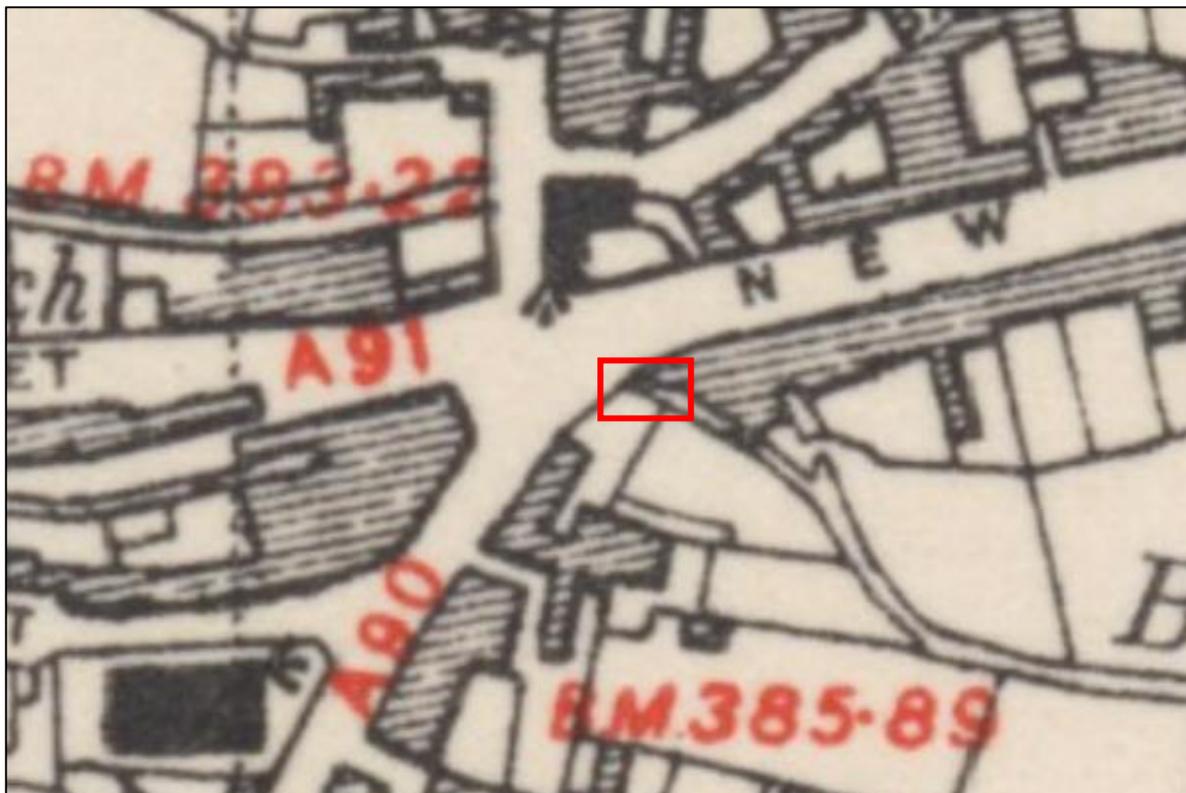
Figure 8: extract from the Ordnance Survey 1951 Fife and Kinross Sheet XVIII.SW map, showing few changes around the site since 1894 (site indicated in red). ARCHAS after NLS.

3.2.9 The 1951 Fife and Kinross Sheet XVIII.SW (includes: Kinross; Orwell), revised in 1950, indicates that the street plan largely remains the same, with some amendments to the garden boundaries to the south of the site. The map does not indicate whether or not the lade is still active at this point, although its presence is indicated.

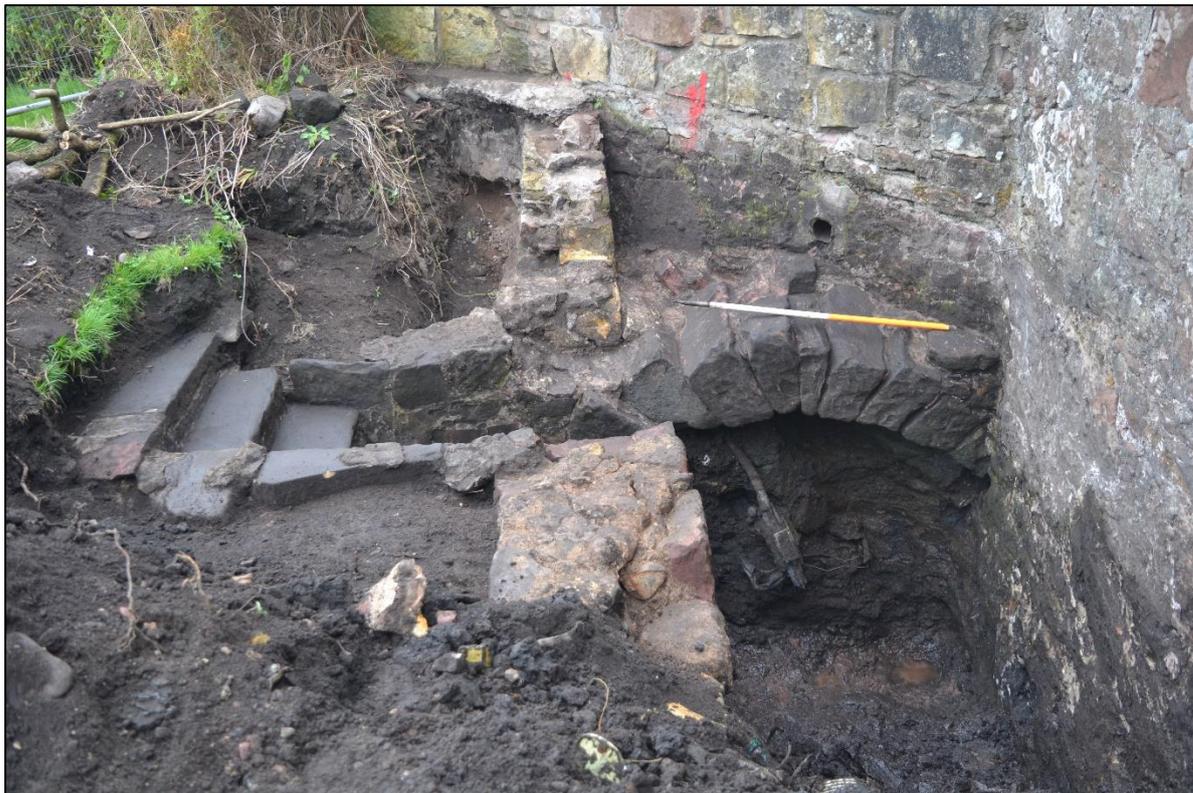
Figure 9: General view of site after cleaning

4.1.1 The mill lade runs approximately NW to SE, with the culvert lying to the NW. From the location of the culvert as seen under the road to the north in the trench dug by Scottish

Water, it would appear that the course of the lade veers to a more E-W orientation to the north and west of the site. A set of seven steps provide access to the lade arch from ground level at the SW, bounded by a rough wall on either side. The arch of the culvert begins at the point where the steps lead to the lade and continues to the WNW under the road.

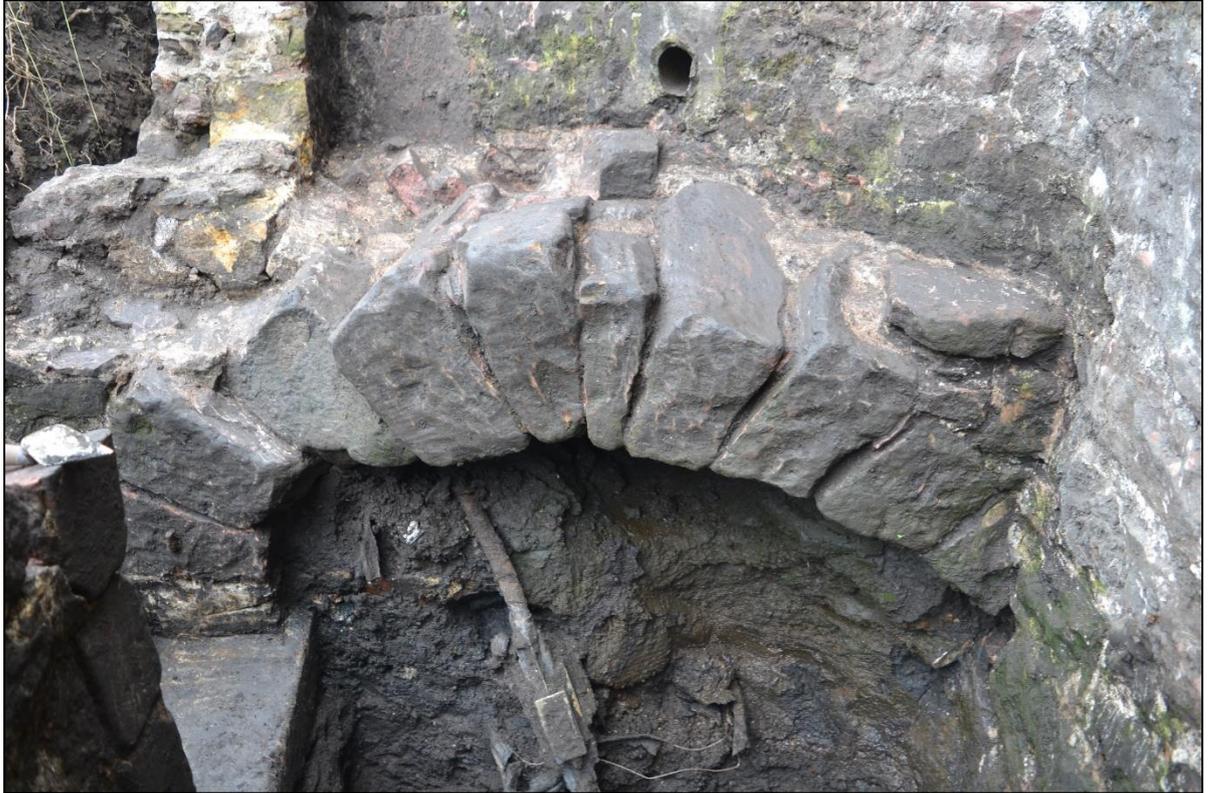
- 4.1.2 The arch [003] for the culvert is made of large roughly dressed sandstone blocks. They have been bonded above by a rough mixture of white limestone mortar and smaller blocks. Whilst the arch blocks do not have any great regularity in size, the keystone is noticeably smaller than the others (see Figure 10). The arch's SW side rests on top of the bottom step of the stairs, whilst its NE side is keyed into the NE wall of the mill lade. The highest point of the underside of the arch is 1.30m above the base of the mill lade, which was not lined with any building material but instead formed from the natural subsoil, a well compacted pink gravel and stone.

Figure 10: Detail of culvert arch [003]

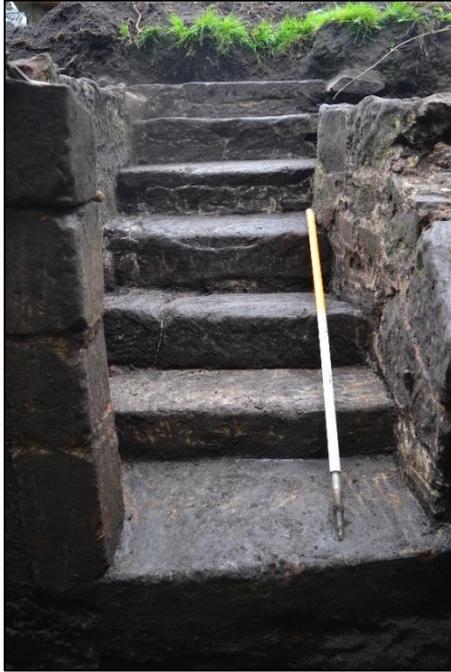
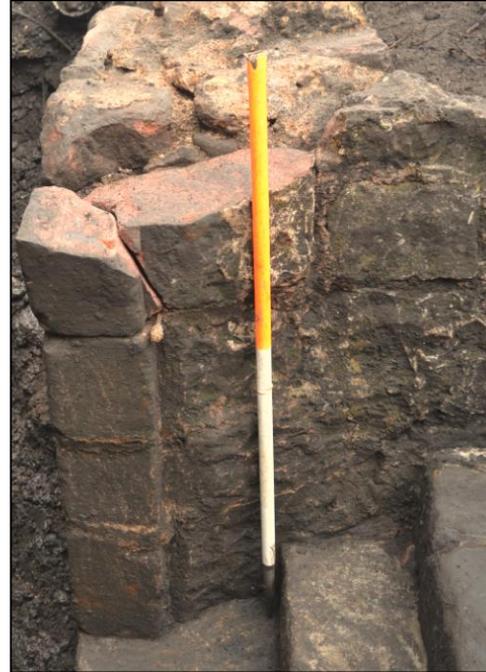
- 4.1.3 The steps [004] are generally uniform in size and shape though the bottom step protrudes further than the rest. The upper 5 steps are formed from large slate slabs mortared into sandstone blocks. The lower 2 are faced with mortar so it was impossible to determine the building material, but they all appear to be part of one phase of construction with the function of providing access to the lade and culvert.

Figure 11 & Figure 12: View of steps [004] from below (left) and the NW (right). Note finer dresswork on doorjamb above the bottom step and iron gate fitting in Plate 5

- 5.1.3 The function of the steps is uncertain: they may have been a means for the people living in properties to the west to retrieve water from the mill lade or they may have been used to provide access to the culvert arch, for cleaning and maintenance of the culvert and lade. The presence of a gate at the base of the steps suggests a safety consideration as the water flowing down the lade would have been swift and powerful at times.

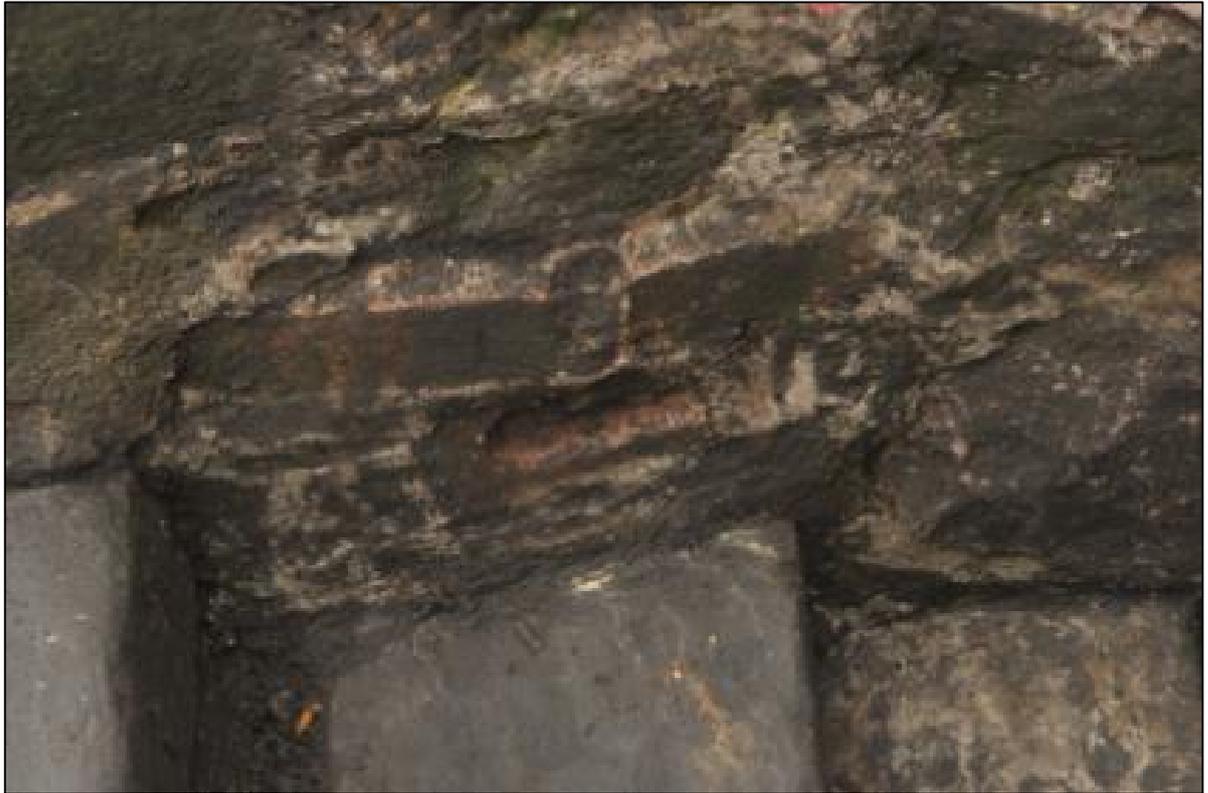
4.1.4 The steps are walled on either side, by [005] to the NW and [006] to the SE. Both walls are constructed from sandstone blocks and occasional bricks (including one with frogging in [005]) bonded with a lime mortar. The building material for [006] included a reused pediment (see Figure 14). Both walls exhibit a pronounced curve (see plan) and [005] has an iron pintle protruding above the bottom step (see Figure 13), with associated iron fittings protruding from [006] indicating that a gate would have been located here. Both walls form the return of the SW wall of the mill lade, [007] and appear to have been built at the same time as this larger wall. Wall [007] was also built using rough sandstone blocks bonded with lime mortar except for at its base where the very lowest course comprised undressed stones set directly above the natural subsoil. The dressed gate doorjambs [006] and [007] (see Figures 11 & 12) were much more finely dressed than any other parts of the walls. None of these walls extend above the current approximate level of the garden and it is likely that they were reduced to this level once the lade went out of use.

Figure 13: detail of wall [005] showing reused bricks, including frogged brick in centre of shot

- 5.1.2 Assessment of the structures on site suggest that the lade, culvert arch and steps are all part of a single phase of construction, with the small wall [008] being the only later phase prior to the building of the modern wall bounding the garden from the road to the northwest. If this is the case it would mean that the construction of the lade would have been roughly contemporary with the construction of the road system which converges at The Cross. Unfortunately there is no secure dating evidence for the construction of the roads, although they are present on Fowler, Greenwood and Sharp's map in 1828. Roy's mid-18th century survey shows the same roads although the detail is poor. We can therefore infer from this that the lade and culvert were built prior to 1828 and perhaps earlier than 1752. The presence of a frogged brick in wall [005] (see Figure13) indicates that the structures date from later than 1690, as this is when brick frogging started to spread across Britain from southern England according to RW Brunskill's 'Brick Building in Britain'.

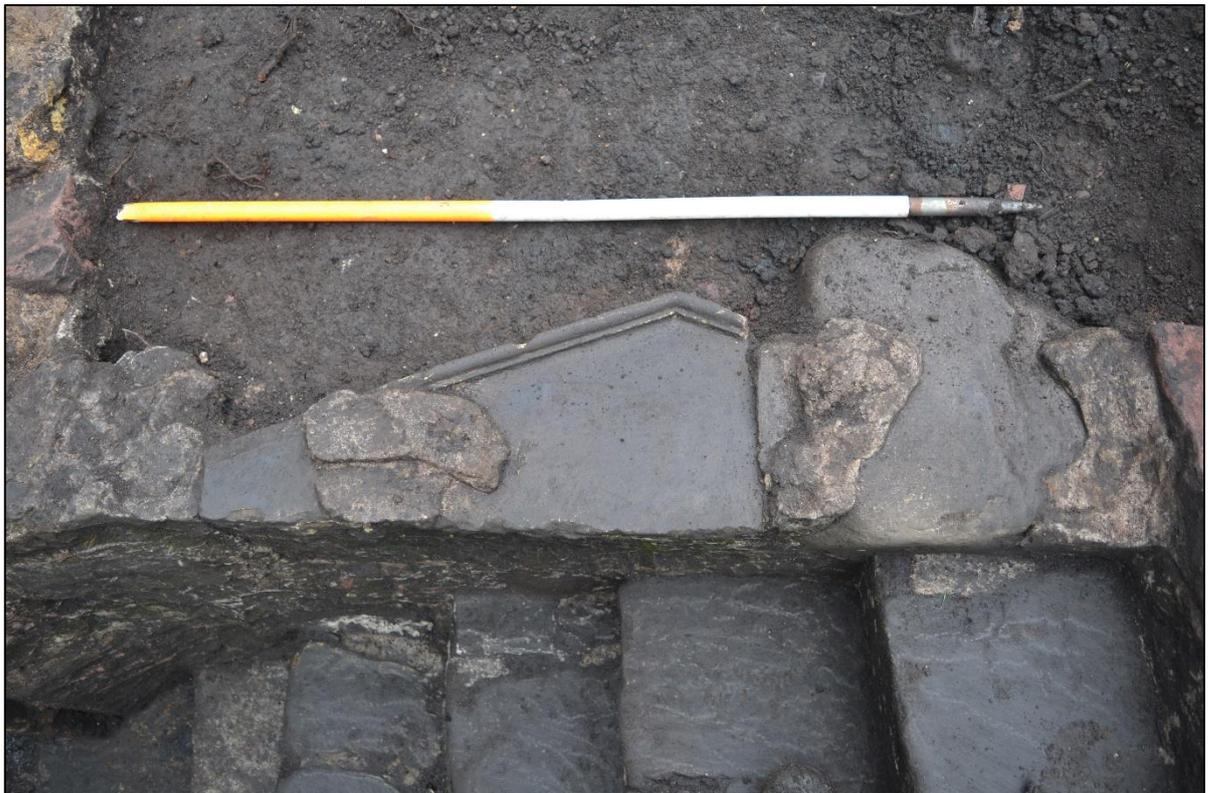
Figure 14: Detail of reused pediment forming part of the construction of wall [006]

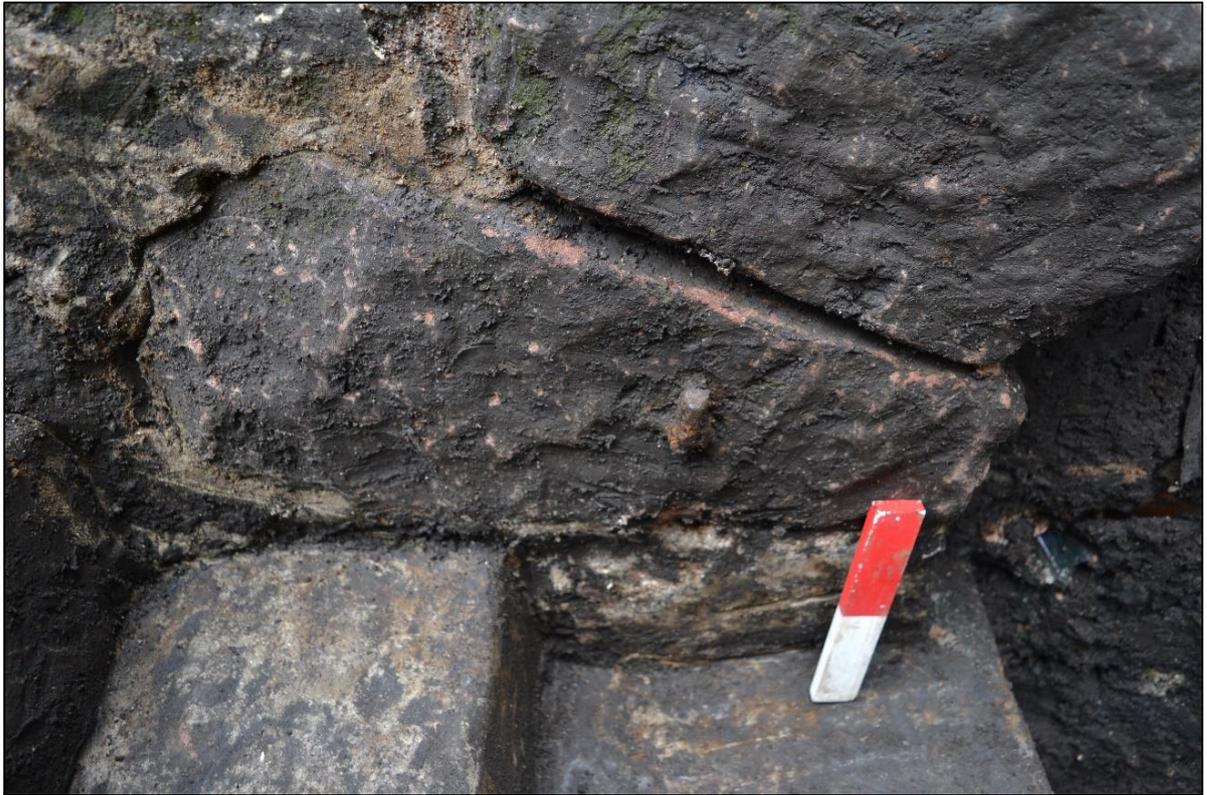
Figure 15: Detail of arch [003], steps [004] and wall [005]. Shows iron pindle mortar facing of lowest two steps and all three features as part of one phase of construction
