June 2016

**Troon Harbour: Archaeological Assessment
 Timber Yard, Biomass Boiler with CHP**

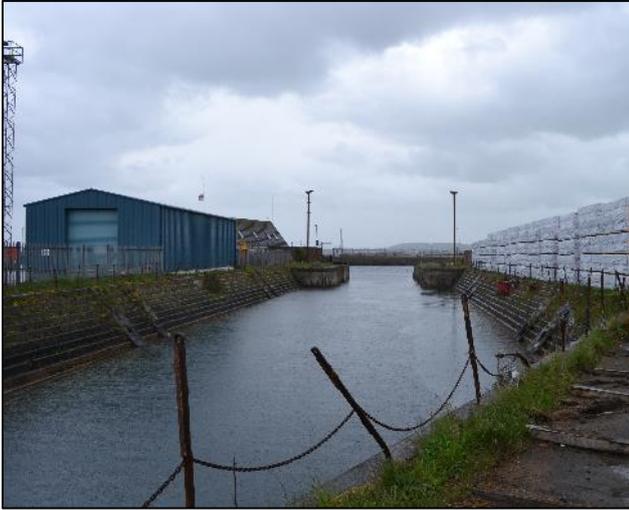
Plate 1: Graving Dock to north of proposed development area

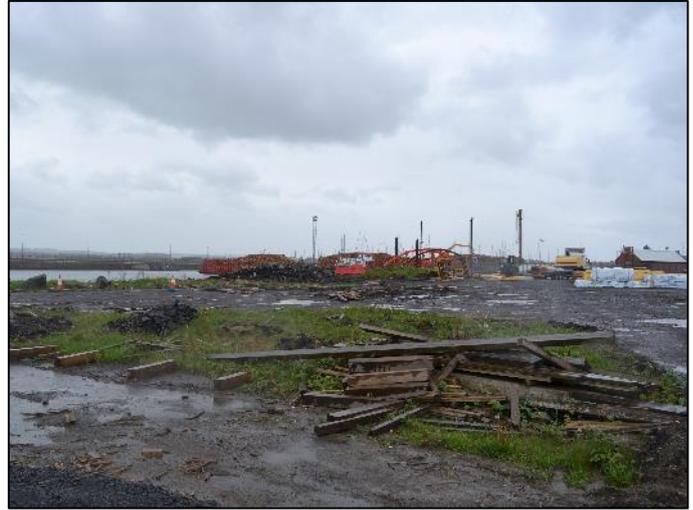
Plate 2: Looking south across the proposed development area

The site today is a work and storage yard for the Gannon Brothers timber facility which borders the site along its SW side. It is uneven underfoot, surfaced with a mixture of concrete, tarmac, hardcore and vegetation.

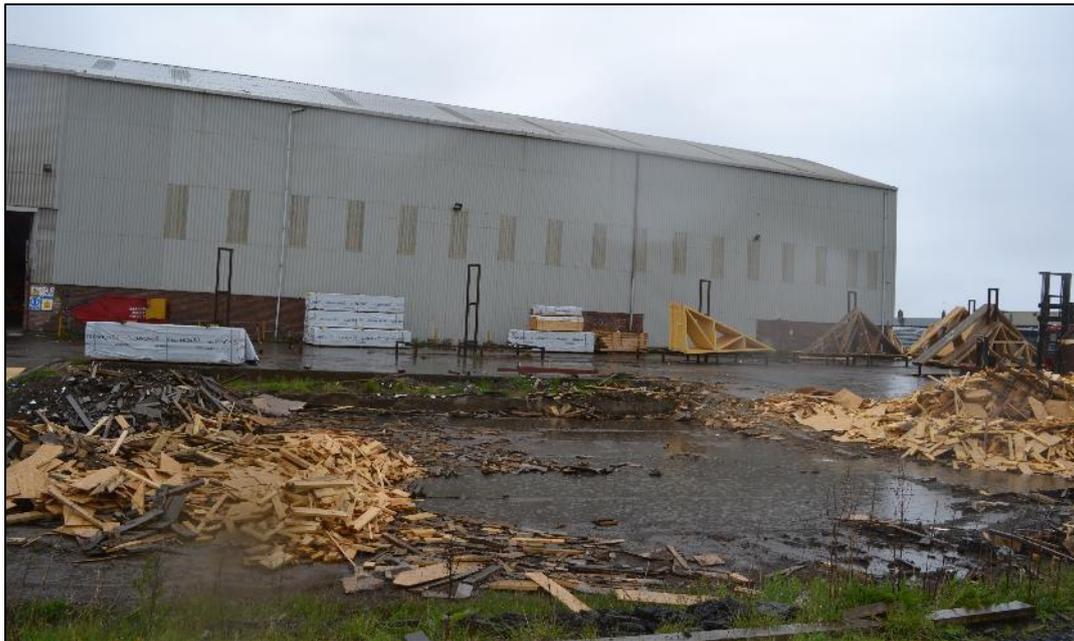
Plate 3: Looking west across the proposed development area

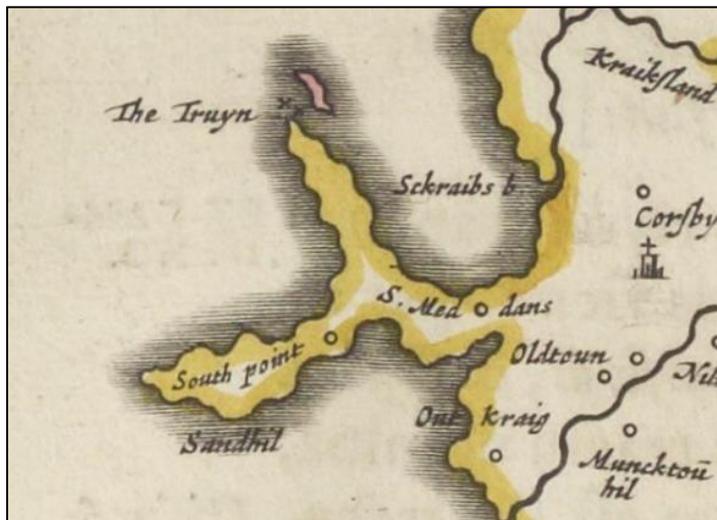
Figure 1: Extract from Joan Blaeu's 'The Province of Kyle' from 1654 showing the 'Truyn' peninsula. NLS

Joan Blaeu's 'The Province of Kyle' acknowledges the work of Timothy Pont and shows the same geography, with the large two-pronged headland. The northernmost prong is called 'The Truyn' (Figure 1).

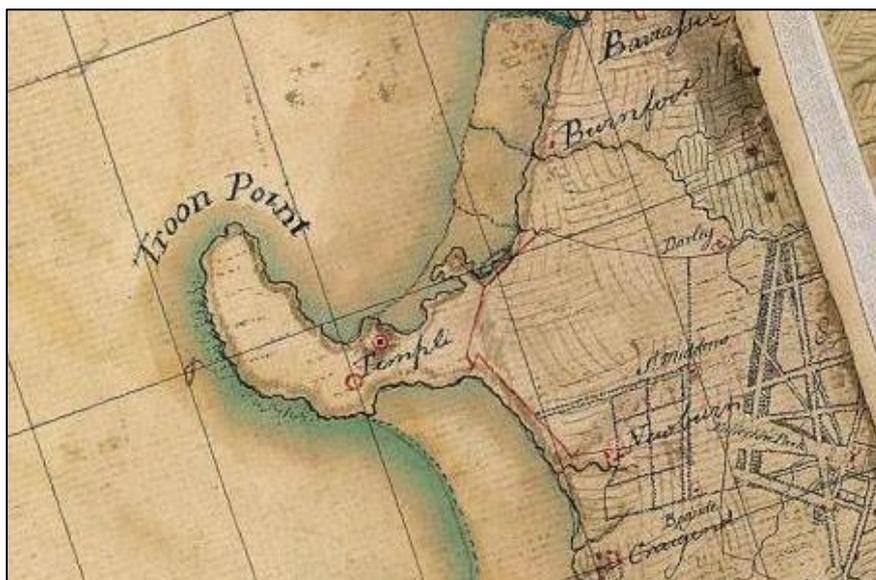
Figure 2: Extract from William Roy's Military Survey of Scotland showing 'Troon Point' with the site marked 'Temple'. © The British Library Board. All Rights Reserved (Roy Military Survey of Scotland)

William Roy's 'Military Survey of Scotland' conducted between 1747 and 1755 (Figure 2) provides much greater detail than shown on earlier maps. Roy's work revolutionised map making in Scotland, containing a lot more terrain detail than previously shown. Although the map was the result of 'rapid reconnaissance rather than a measured topographic survey', the various inaccuracies can be forgiven in providing us with the first cartographic view of Scotland with any level of detail – a snapshot of mid-18th century Scotland.

Roy's depiction of the proposed development site and the Troon area shows a site marked as 'Temple' midway along the peninsula. The area to the east comprises agricultural land marked by a series of field systems and small farming settlements. The western end of the peninsula is undeveloped with the mapping style giving an indication of marshland.

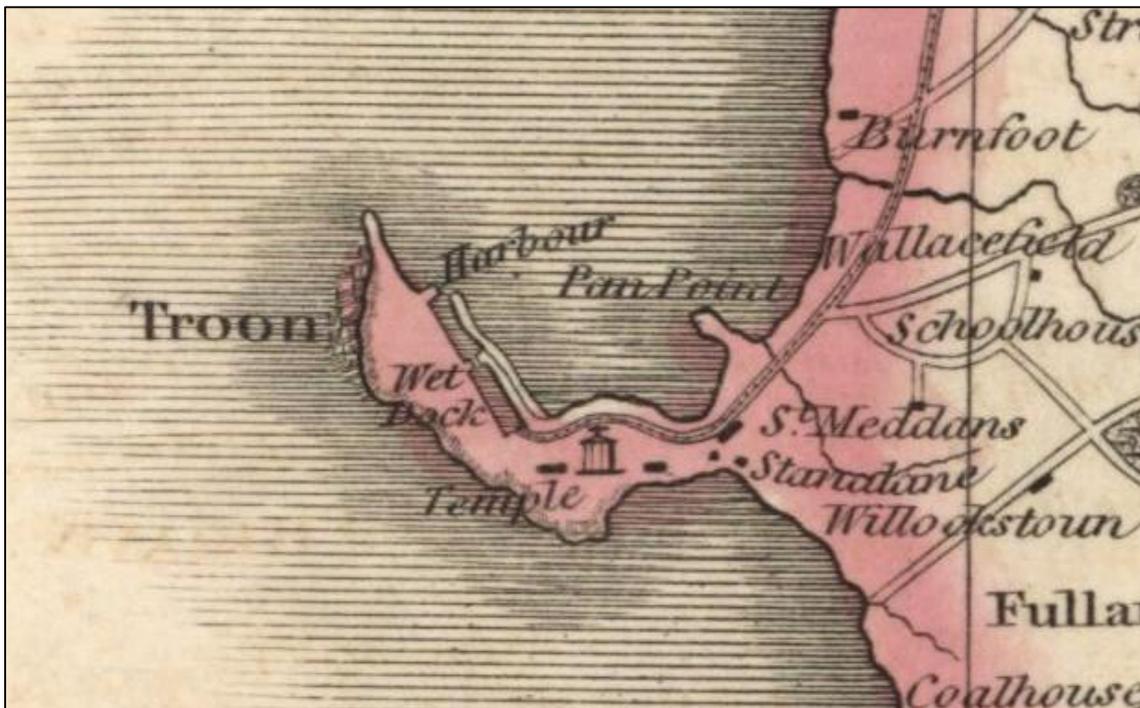
Figure 3: Detail of John Thomson's 'The Northern Part of Ayrshire, Southern Part' from 1828. Note the 'harbour' and 'wet dock' on the peninsula

By 1828, this harbour has either become more clearly developed, or the scale of John Thomson's 'The Northern Part of Ayrshire, Southern Part' is such that more detail is shown (Figure 3). The map shows substantial work has been done to the peninsula to create a long narrow harbour, with an inner area marked as 'Wet Dock'.

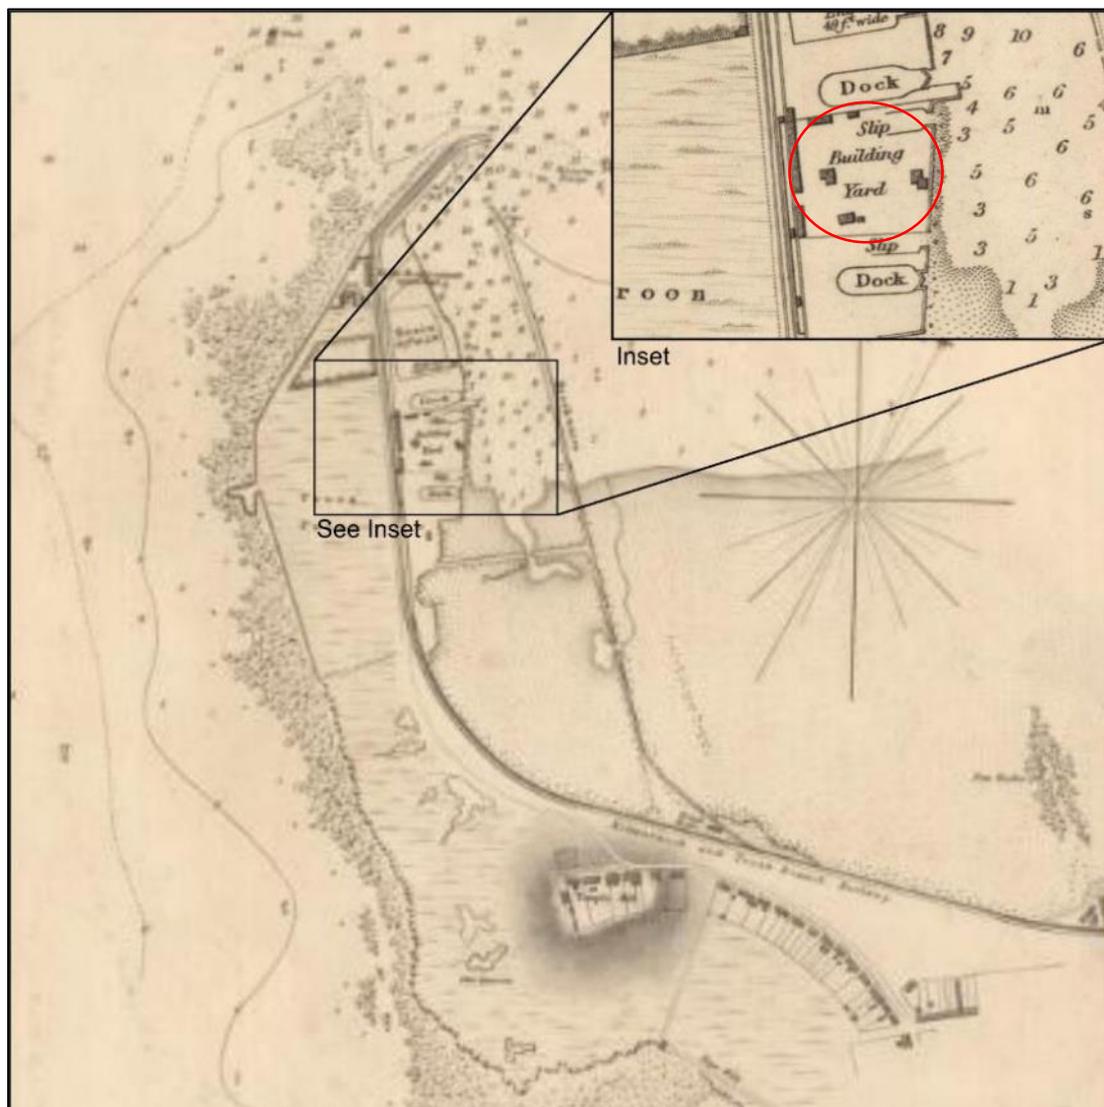
The Hydrographic Office of the Admiralty completed a detailed survey of Troon Harbour in 1847 (Figure 4). This shows the extensive development of Troon Harbour in excellent detail. While this was indicated to some degree in Ainslie's map of 1828, the Admiralty survey shows the extensive changes on the Troon headland in the roughly 100 years since William Roy's map was produced.

The structure of the harbour is essentially as it appears today, with an Inner and Outer Harbour separated by a cross wall with a 'drawbridge'. A 'basin' has also been constructed while the proposed development area is clearly depicted in some detail between the two dry docks, each with a 'slip' either side. This is marked as 'Ship Building Yard' and dotted with a series of small buildings serviced by the Kilmarnock and Troon Branch Railway.

The peninsula as a whole is largely undeveloped. The 'Temple' shown on previous maps is gone, replaced by a crescent of houses on what is now Templehill.

Figure 4: 'Troon Harbour' by the Admiralty Hydrographic Office from 1847 with the proposed development area shown in detail and indicated red. ARCHAS after NLS

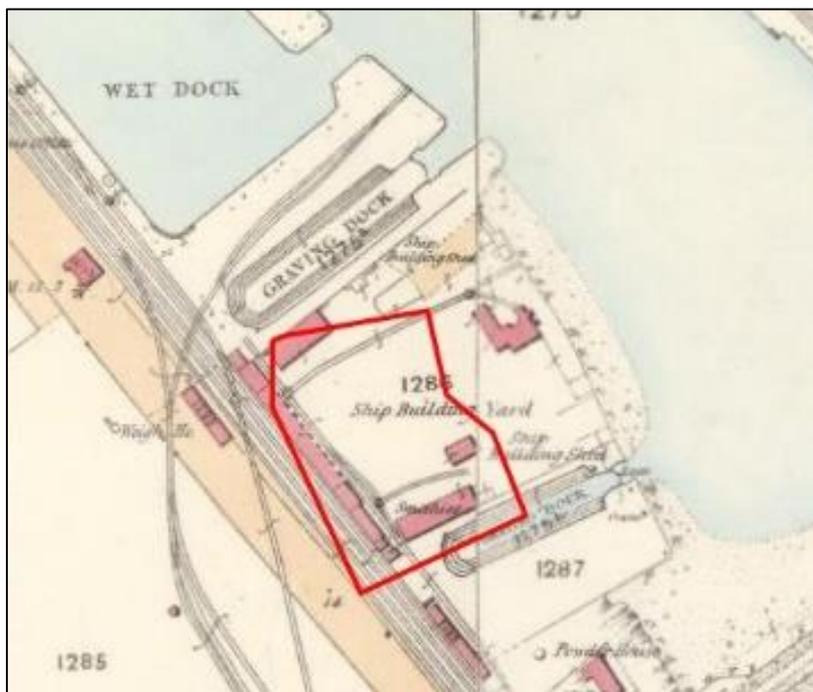
The 1st edition Ayr Sheet XXII.13 and XXI.16 from 1860 (Figure 5) shows little change from the survey of 1847 (Figure 4). The Ship Building Yard has changed little, with one length of buildings along the railway line and four further free standing structures of various sizes within the area defined by the two graving docks.

Figure 5: Detail of the 25 inch to 1 mile composite Ayr Sheet XXII.13 and XXI.16 from 1860 with the proposed development area superimposed in red. NLS

Superimposing the proposed development area onto the 1860 maps (Figure 4) shows the railway tracks running into the site along its west side as well as some possible branches off into the yard itself. In addition, many of the linear terrace of buildings bordering the railway is also shown within the development area, while three of the four buildings of the ship building yard will also be partly, or wholly covered by the development. The graving dock at the southern end of the site also has potential to be impacted by development.

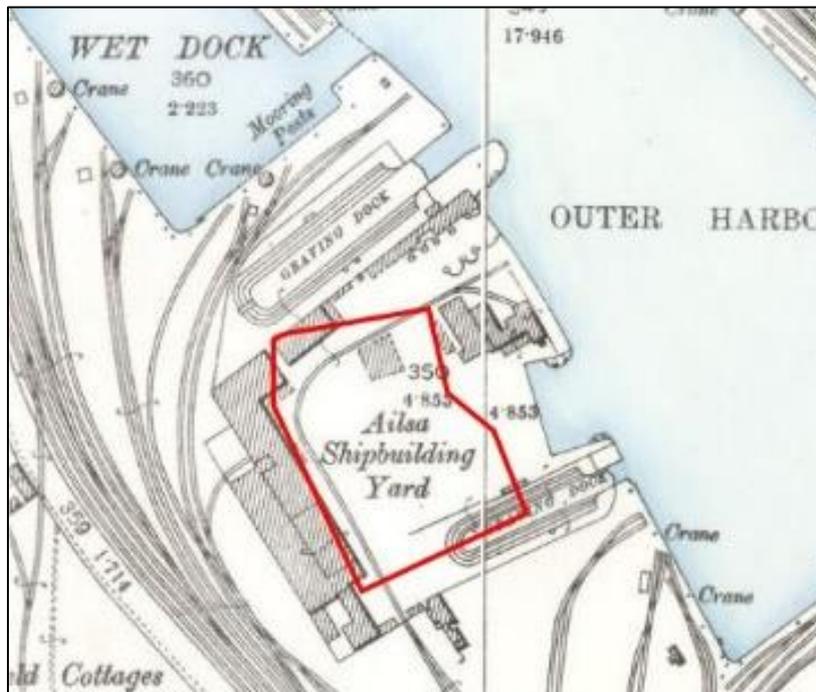
By 1896 the Shipbuilding Yard and the proposed development area have changed significantly, clearly becoming larger, more substantial and organised (Figure 6). There has been a notable re-alignment of the railway network serving the Harbour, which is now much more expansive and running to the west of the site, well outwith the development boundary. The harbour wall itself is also now clearly defined shown as a clear line delineating it from the sea where before a gradual shoreline was shown. The 'Slip' to the south of the 'Graving Dock' in 1860 has also gone. Only the building at the northern limits of the proposed development area, adjacent to the large 'Graving Dock' survives from 1860, with the proposed development area on the whole free from occupation.

Figure 6: Detail of the 25 inch to 1 mile composite Ayrshire Sheet 021.16 and 021.13 from 1896 with the proposed development area superimposed in red. NLS

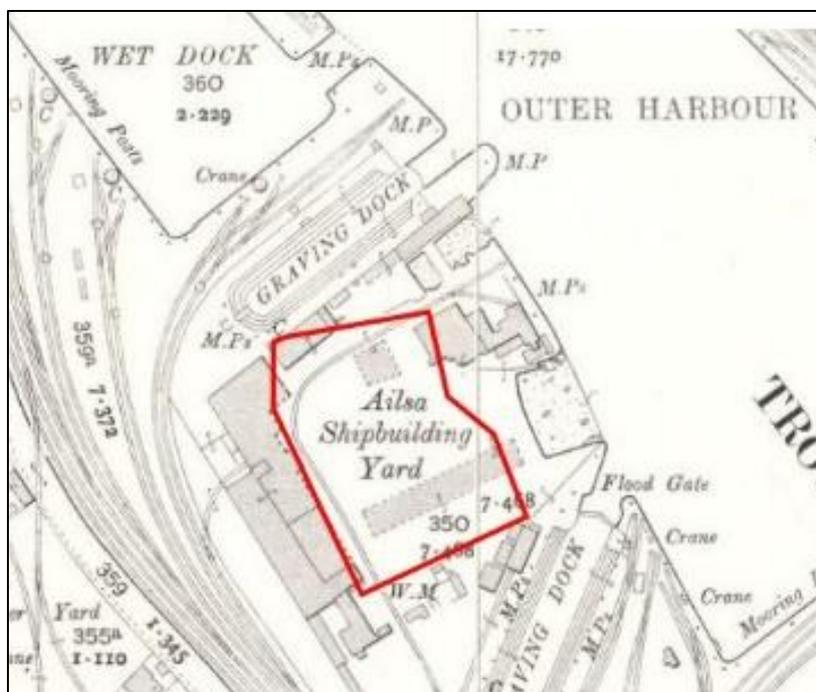
By the production of the 1909 maps, the ship building yard has undergone further substantial change, although alterations within the limits of the proposed development are confined to two possible structures represented dashed lines, but shown in the style of being roofed (Figure 7).

Figure 7: Detail of the 25 inch to 1 mile composite Ayrshire Sheet 021.16 and 021.13 from 1909 with the proposed development area superimposed in red. NLS

The most notable thing about the 1909 maps is outwith the development area. The southern of the two graving docks depicted on maps since 1847 has gone, with a larger dock constructed to the south and re-aligned from ENE-WSW to NNE-SSW. This is the graving dock in use to the south of the development area today.

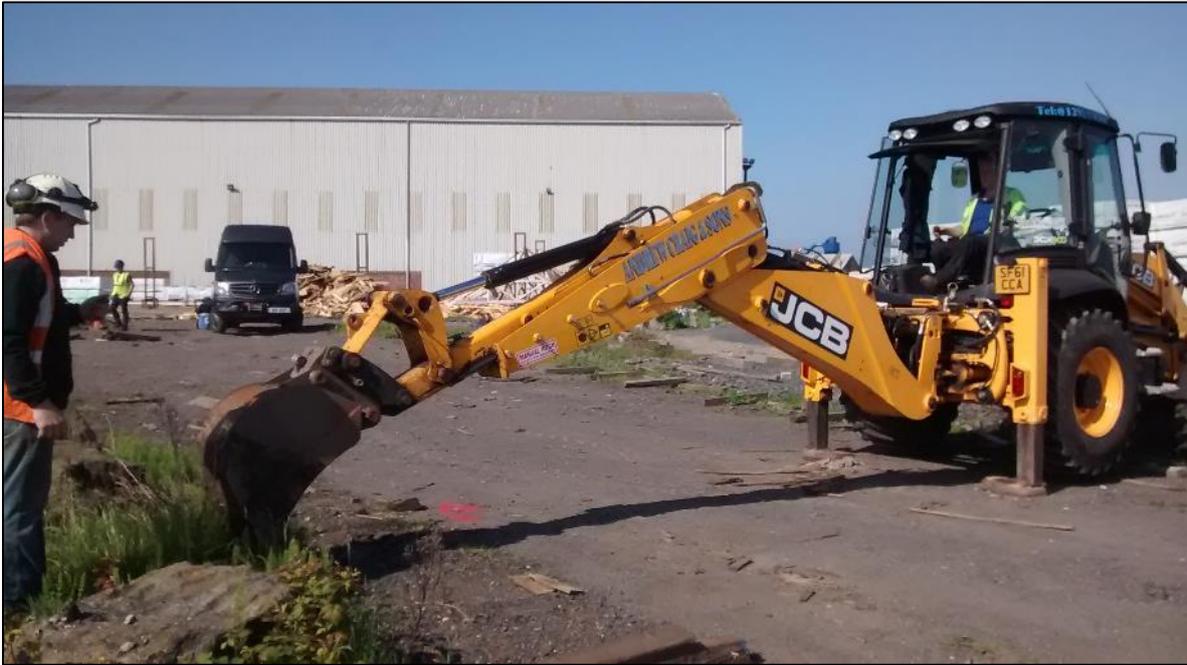
A watching brief was maintained over two days on Wednesday 25/05/16 and Monday 30/05/16 by Ross Cameron. Trenches were initially opened by a 360°, 3 tonne mechanical excavator fitted with a narrow toothed bucket. When this proved unsuitable to tackle the rubble deposits, excavation resumed with a JCB 3CX (Plate 4). Weather conditions throughout were bright and sunny, making photography challenging.

Plate 4: Working shot looking west. Opening Trial Pits

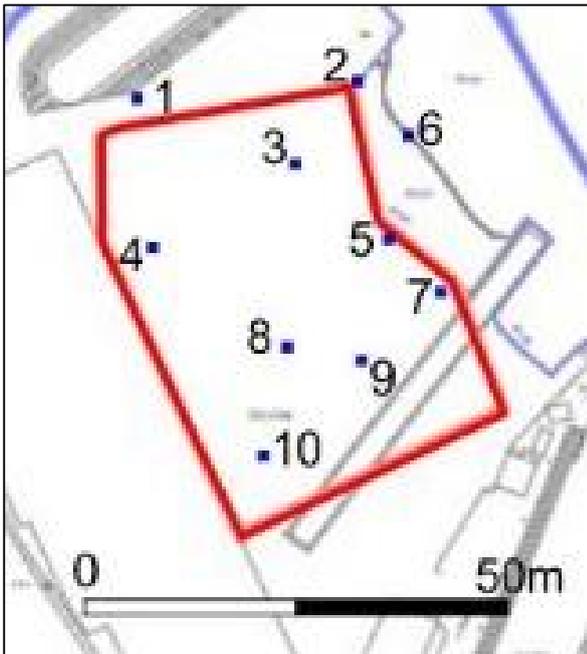
Figure 8: Locations of Trial Pits excavated at Troon Harbour shown against modern plans. ARCHAS after SKF Ltd

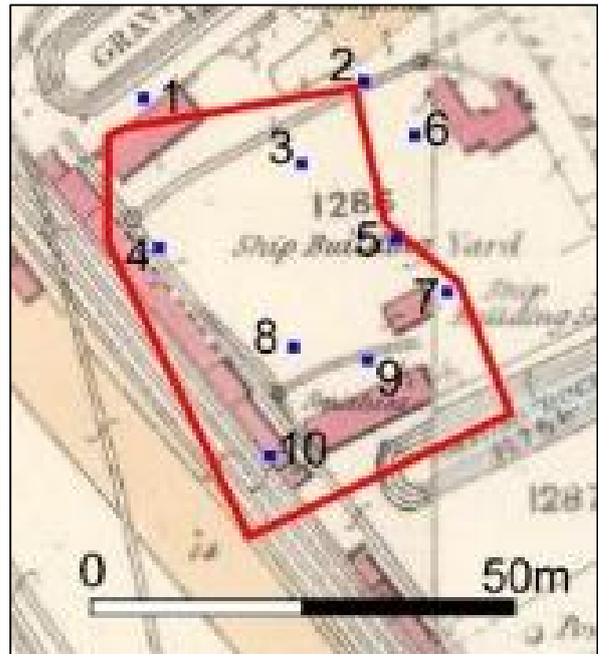
Figure 9: Locations of Trial Pits excavated as plotted against the OS maps of 1860. ARCHAS after NLS

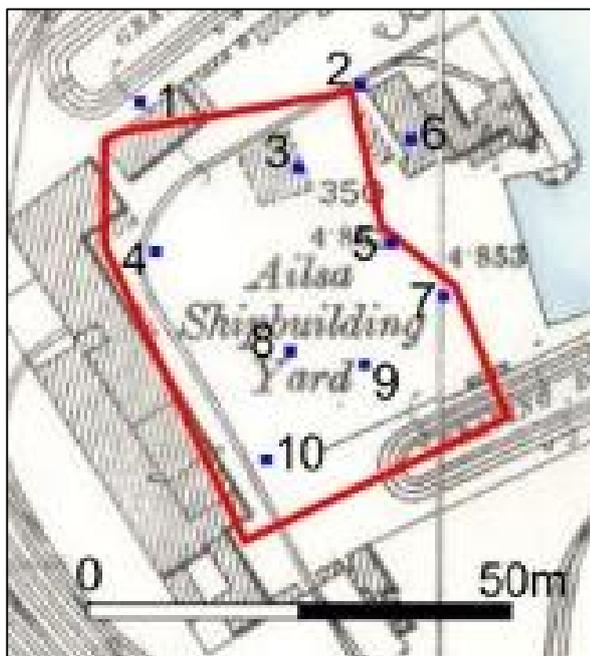
Figure 10: Locations of Trial Pits excavated as plotted against the OS maps of 1896. ARCHAS after NLS

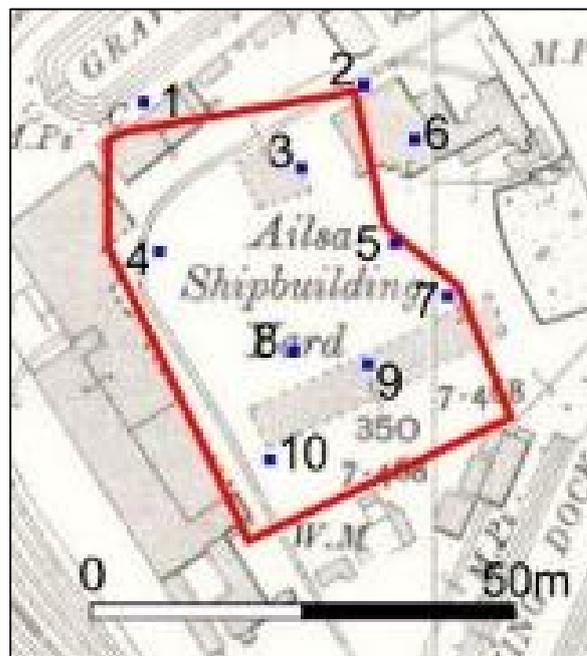
Figure 11: Locations of Trial Pits excavated as plotted against the OS maps of 1909. ARCHAS after NLS

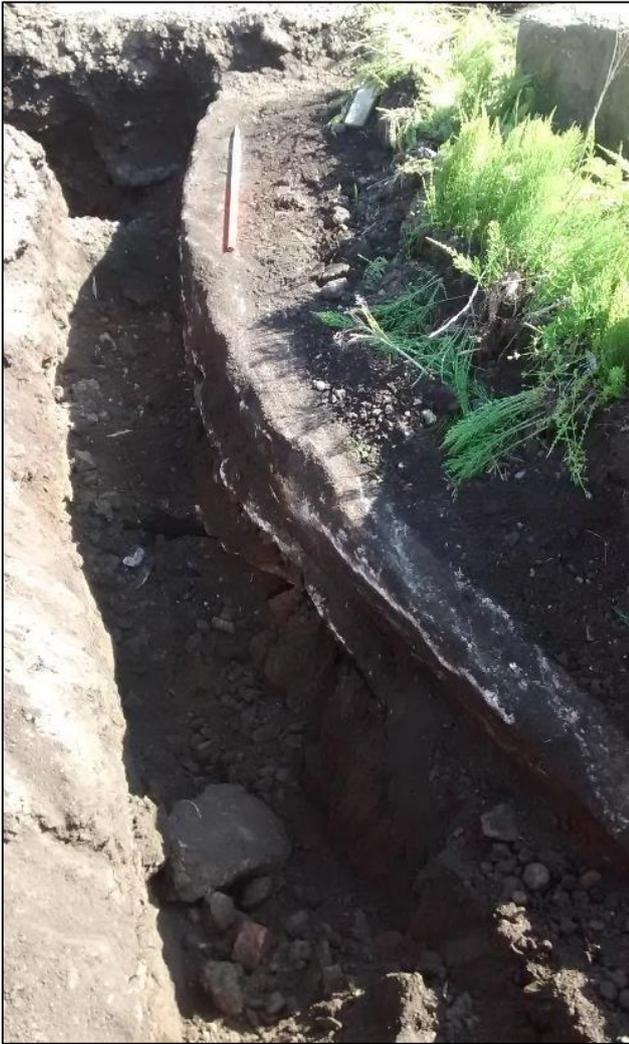
Upper levelling deposits (**201**) revealed a concrete strip foundation 0.40m deep and 0.70m wide **{203}**. Extension of the Trial Pit to the SW revealed this to be curved, returning towards the south (Plate 5 and Plate 6). This was clearly a 20th century structure, limited in scale due to the depth of the foundations, set upon modern made ground (**202**).

Plate 5: View of Trial Pit 2 looking NE. Note {203}

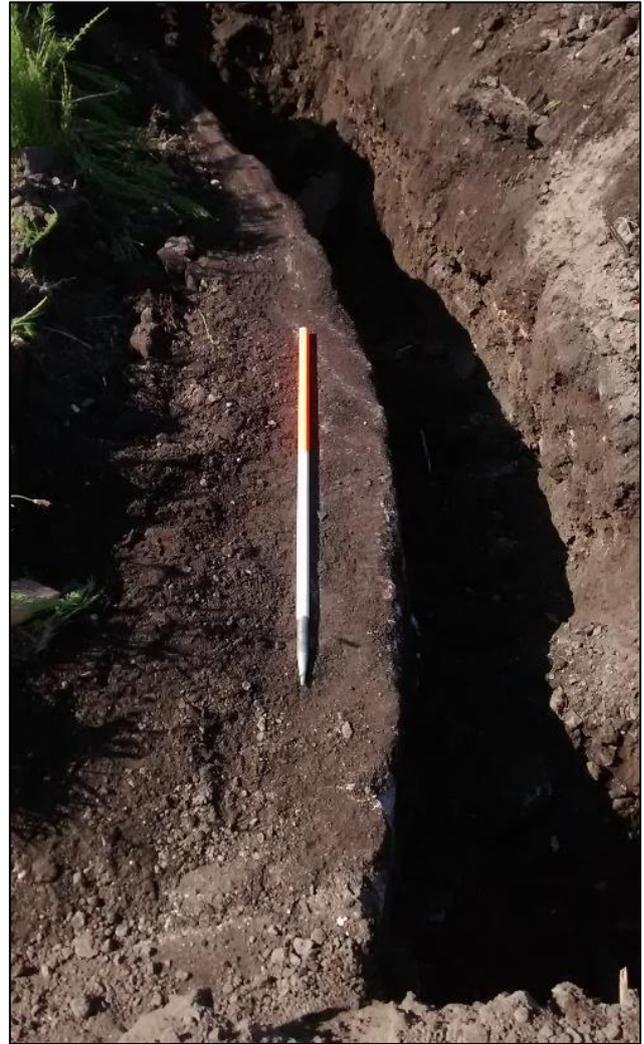
Plate 6: View of Trial Pit 2 looking SW. Note {203}

Trench 2 was terminated at 2.50m. No significant archaeological deposits were recorded with the material removed comprising made ground.

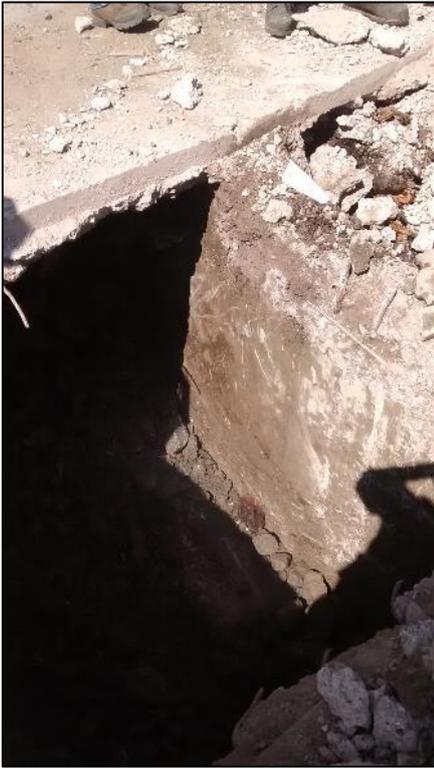
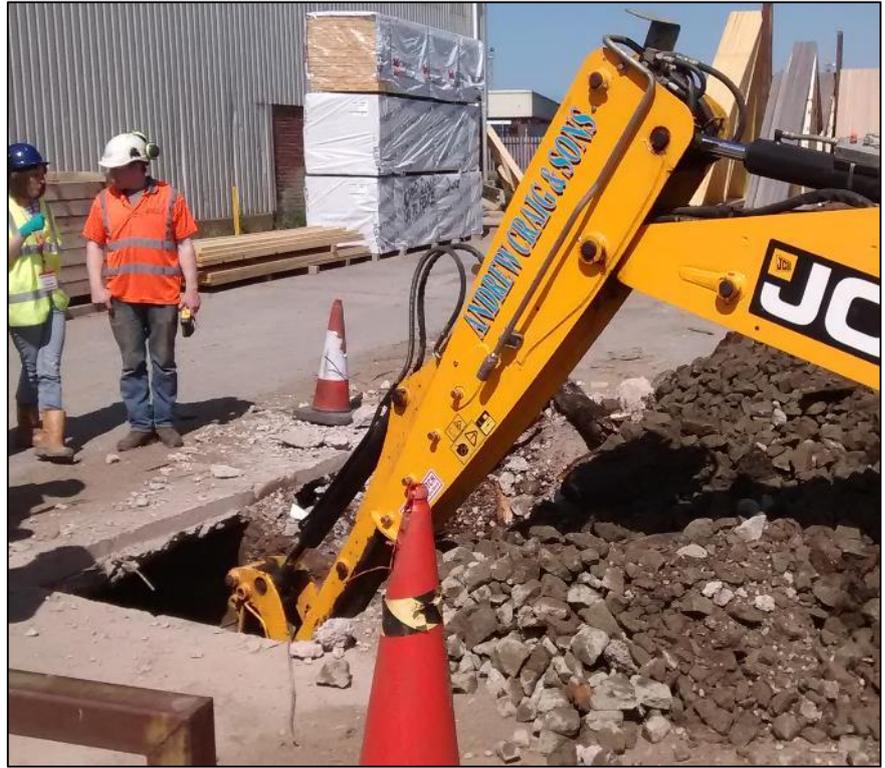
Plate 7: Post-excitation view of {402} terminating on {405} **Plate 8: Mid-excitation view of Trial pit 4 looking N**

Excavation of Trial Pit 4 required the removal of the concrete floor surface {401}. This revealed a reinforced concrete cross wall {402}, neatly dividing the trench into two equally sized compartments. The NE of these appeared to contain thick unworked logs of timber. The SW was excavated to a depth of 2m and hardcore of small to medium angular stones. Excavation was terminated on what appeared to be a concrete floor {405}.
