'Working with Historic Farm Buildings: Thoresby Estate Perspective'

Case study 1. Thoresby Home Farm (THF)

Case Study 2: Poplars barn

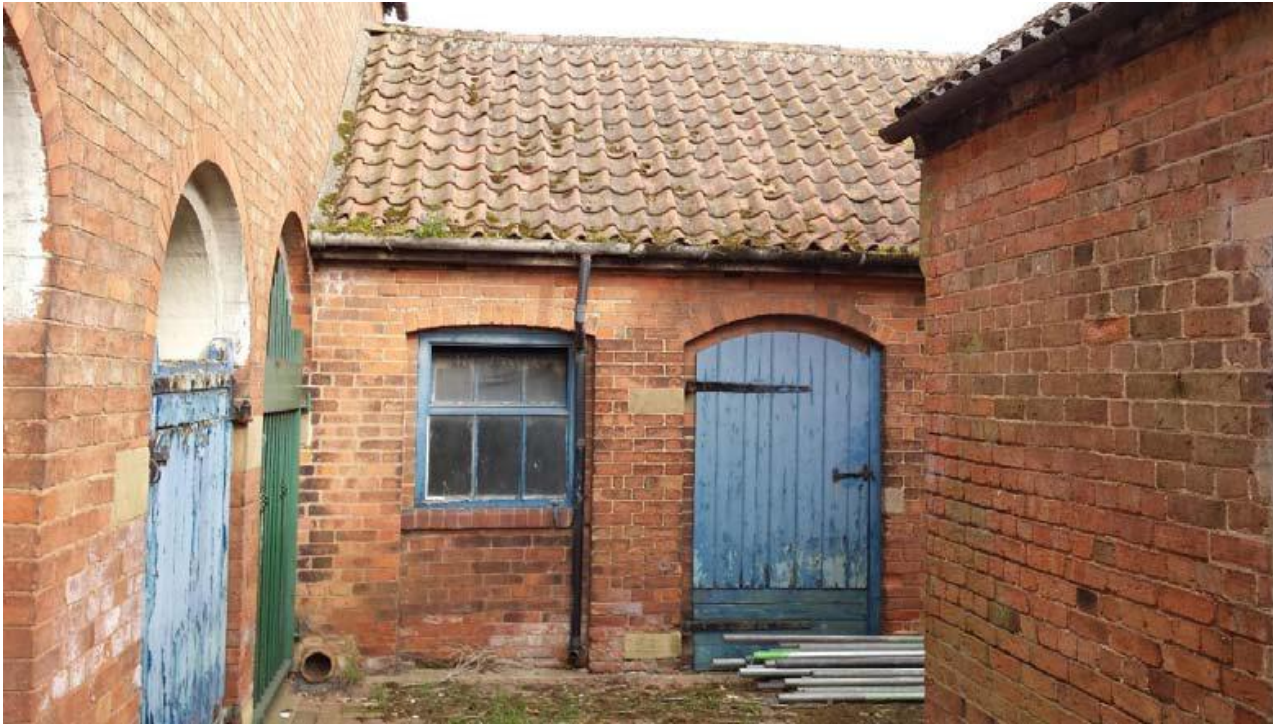
Physical space and limitations of the site

- Farms and their buildings by their nature were designed to accommodate the technology and methods of their day.
- Historic farmsteads are often very nuclear in layout in that all the buildings are close together limiting vehicle access and movement.
- Buildings were designed to store materials, crop, “plant” (in the form of carts) and livestock...and sometimes all of the above in one building!

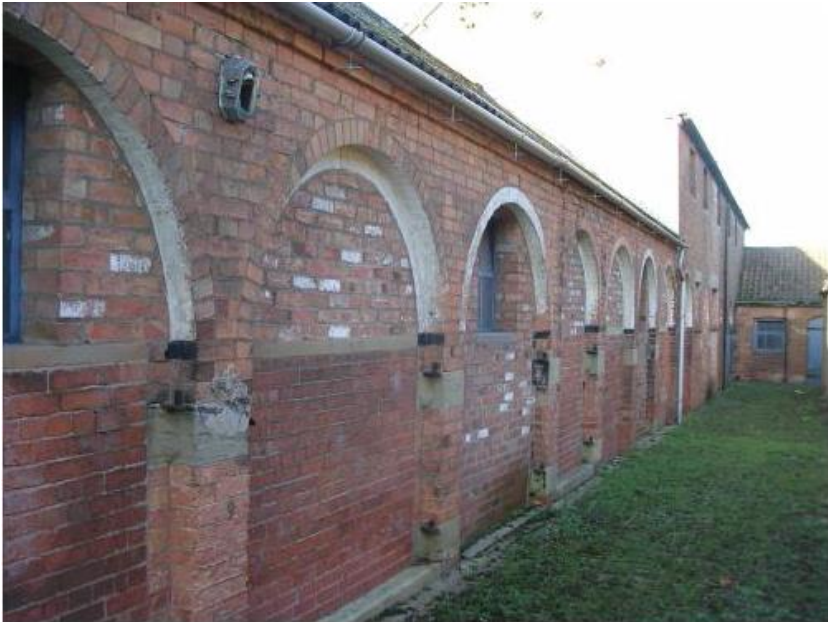
Structural

- Often foundations are very limited and walls quite thin making them difficult to apply additional loads to without losing valuable internal features.
- No matter the end use it is likely that some form of thermal performance upgrade will be required.
 - Farm buildings built right up to the 1920s are likely to be built of a vapour permeable construction using lime.
 - Any insulation applied needs to maintain that permeability and not alter the condensation variance of the wall which will cause interstitial condensation.
 - Full compliance with Part L is not required when retrofitting traditional buildings.

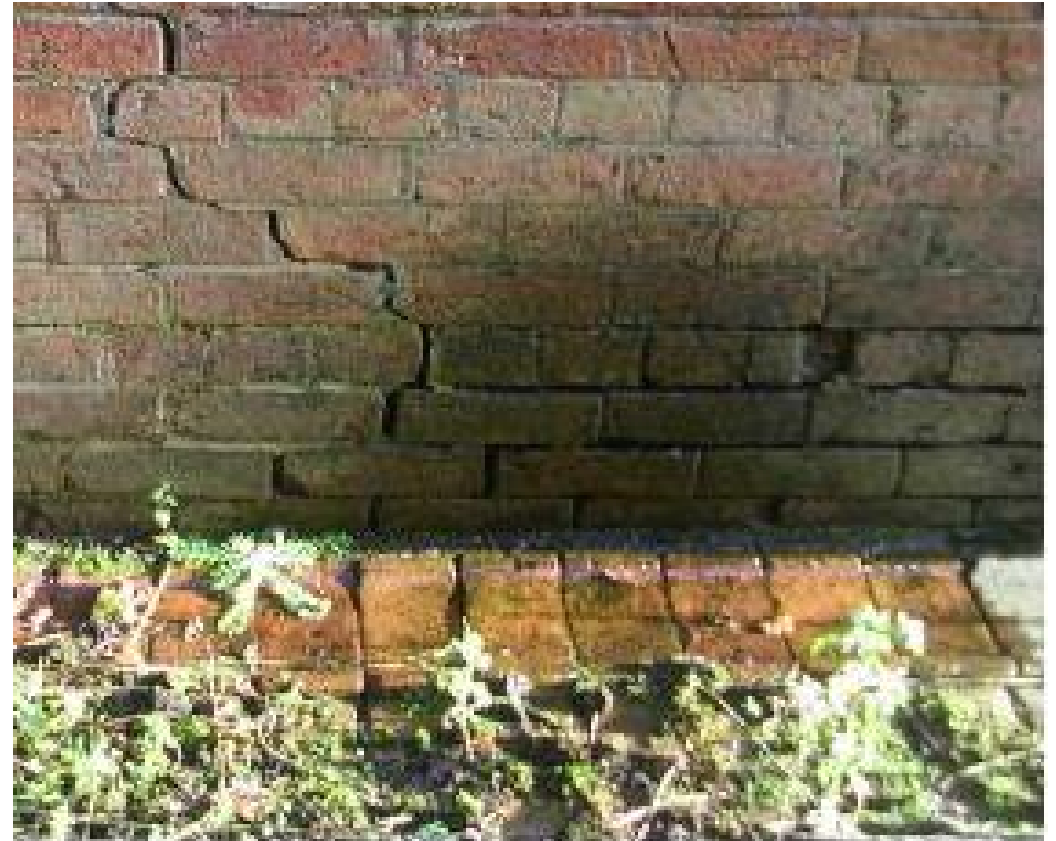
- Very often this will cause far more damage than it solves and may not be needed at all!
- Treat the disease not the symptom. Identifying the cause and rectifying is a lot better choice.
Some common causes

- Failed or incorrect material used for pointing/rendering/plastering (i.e. Portland cement)
- Ground levels. Ground has a habit of creeping up over the years, yards are relayed on top of old yards, muck is spread on grassed adjoining areas or piled up against walls
- Neglected rain water goods (above and below ground). A gutter might be fine but is it simply disappearing into the ground and water is being soaked up into the wall
- Let the building breathe!

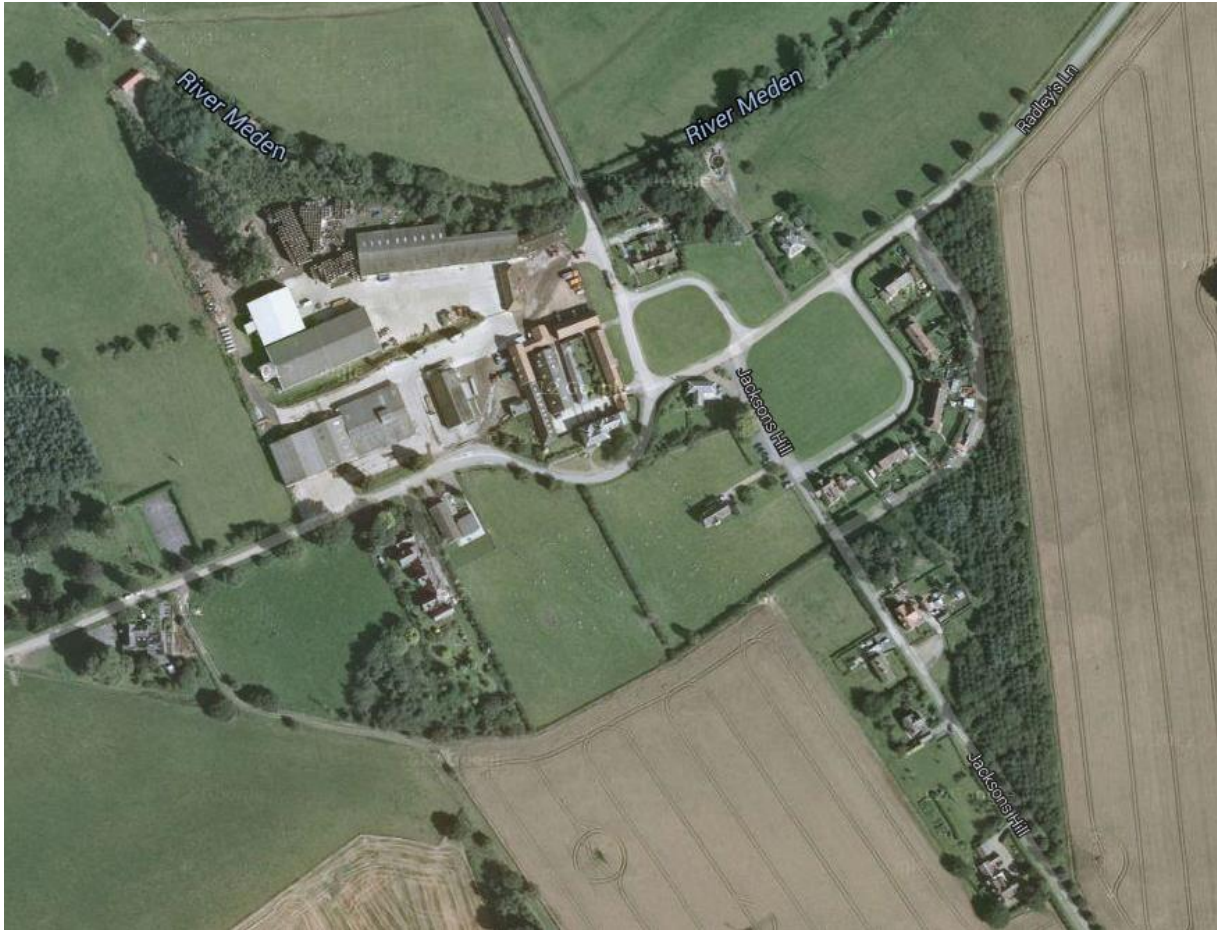
Access and parking

Many farmsteads have developed over time meaning new buildings have spread out from the original farm. In this case it is worth considering

- How will people access the development?
- Where will they park?
- How do we keep them away from what may still be a working farm?
- What is the access from the main road like?

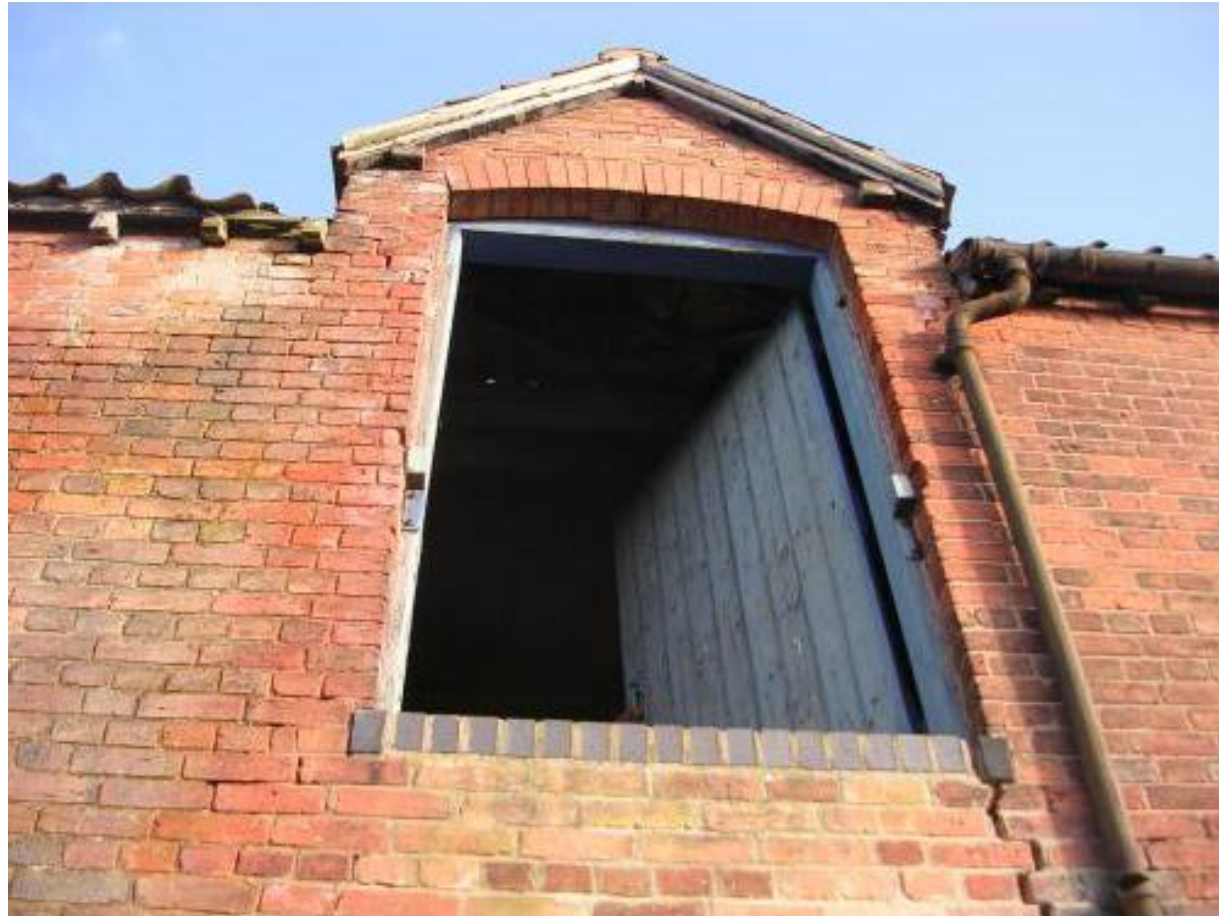
- THF is located in an area of active and historic mining subsidence.
- The extensive damage will require the installation of helifix type stainless steel ties within the fabric to stabilise and secure the areas of movement.

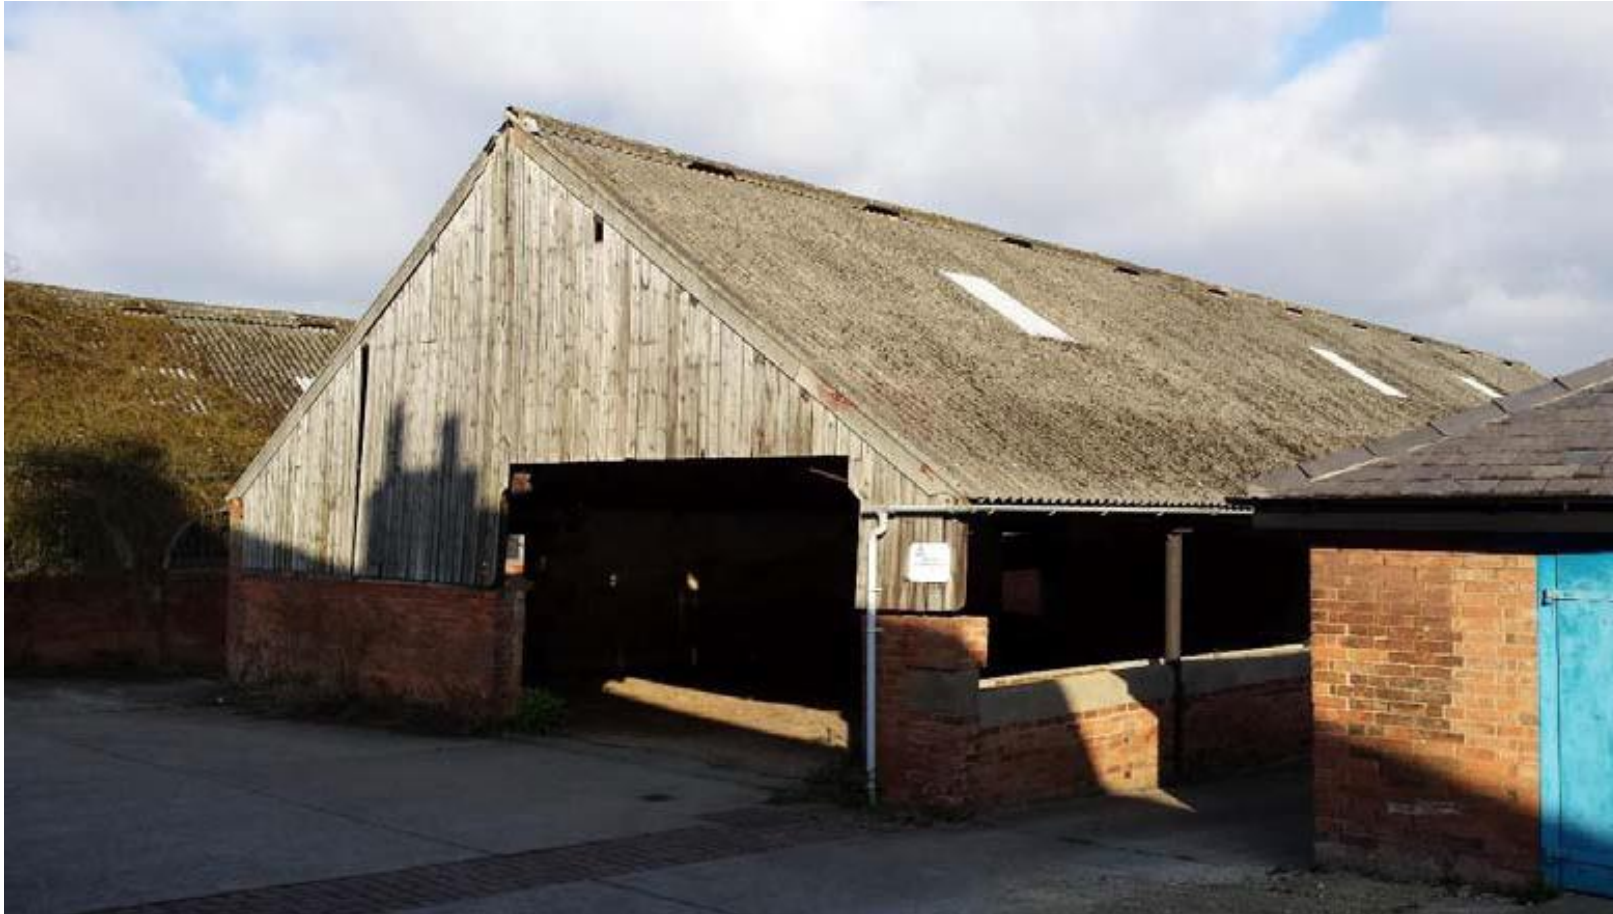
- Initially the covered yard was to be demolished and landscaped.
- On further review it was identified that the space could be developed to provide additional office space.
- While not listed the structure does contain some nice examples of architectural cast ironwork.
- Structural inspections revealed evidence of roof spread and failure of the cast iron columns. As such any inserted building will have to be largely self supporting on the eastern elevation and reinforced on all others.

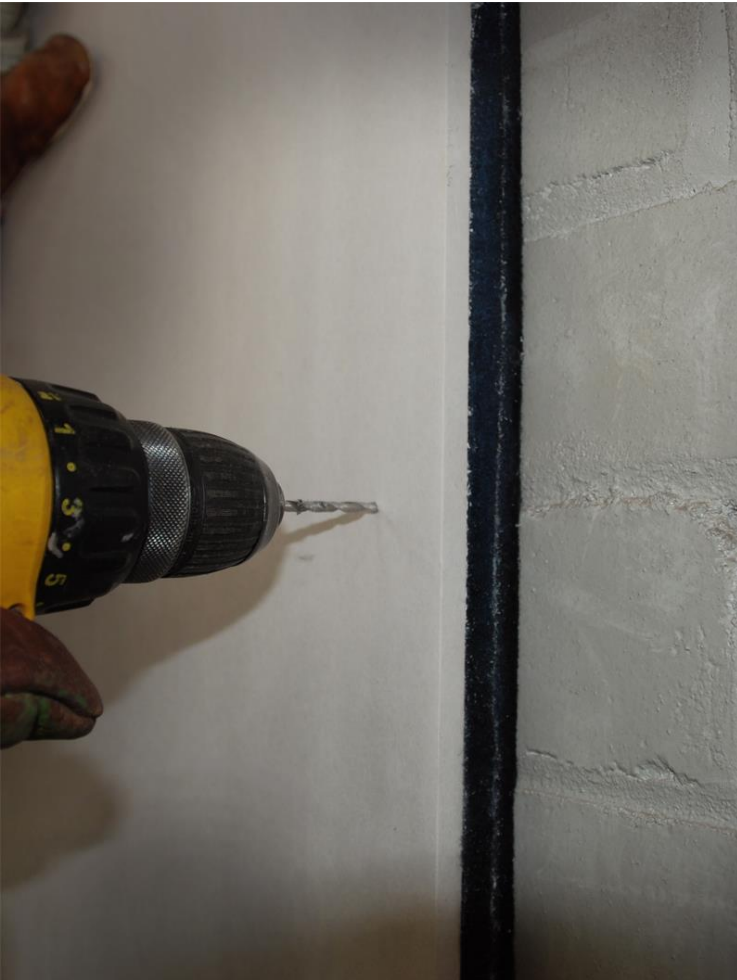
In order to maximise thermal performance without compromising breathability or moving the dew point of the external wall we elected to install Thermablok aerogel/magnesium silicate IWI to the building.

- A rigid and hydroscopic insulation board (9mm) laminated to Thermablok Aerogel hydrophobic insulation membrane (10mm) with an R-value of 0.82 (m²K/W).
- A fully breathable system that ensures a healthy, durable working building with a natural ability to absorb, control and release moisture.
- Thermablok Aerogel **does not** rely on a vacuum or heavy molecular gases to insulate.
- Thermablok Aerogel is hydrophobic and is therefore not affected by moisture or age and is a hostile environment, offering no bacterial platform for mould growth.
- Unlike paper faced/wood based products, Magnesium Board also provides a hostile environment, offering no bacterial platform for mould growth.
- Direct, mechanical fix to the existing masonry substrate without the need for any framing system or ventilation cavity, which means even further space saving.

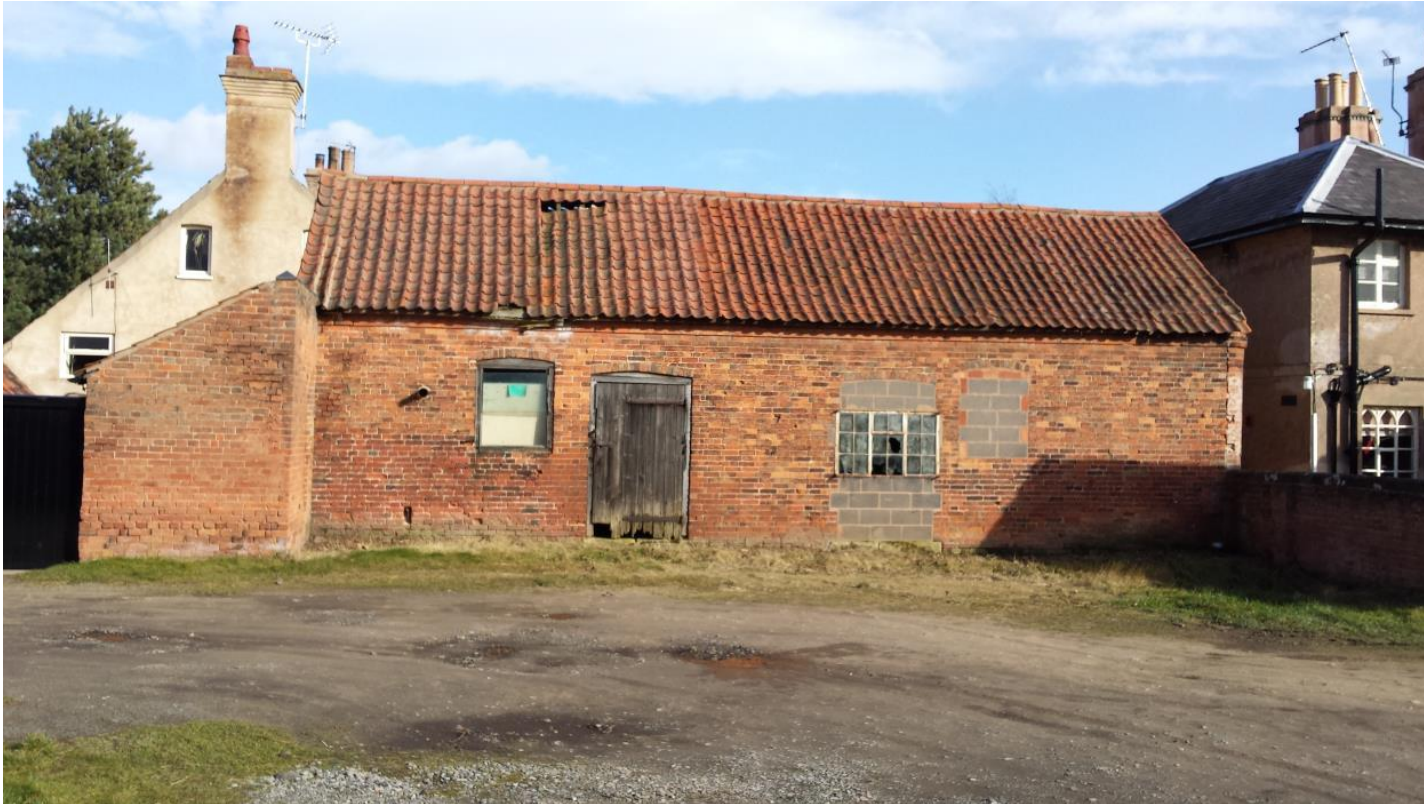
The Site

- Located in Budby village. Budby was laid out between 1803-1807 by Earl Manvers as an estate village.
- Every dwelling in the village is listed as well as a number of other features (post box, a number of boundary walls etc.).
- The “barn” is an undesignated heritage asset but falls within the curtilage of two listed houses.
- Access is by a narrow stone road which is unsuitable for tractors or lorries.
- The structure has fallen into a very poor state of repair as it provides no useful purpose at present.

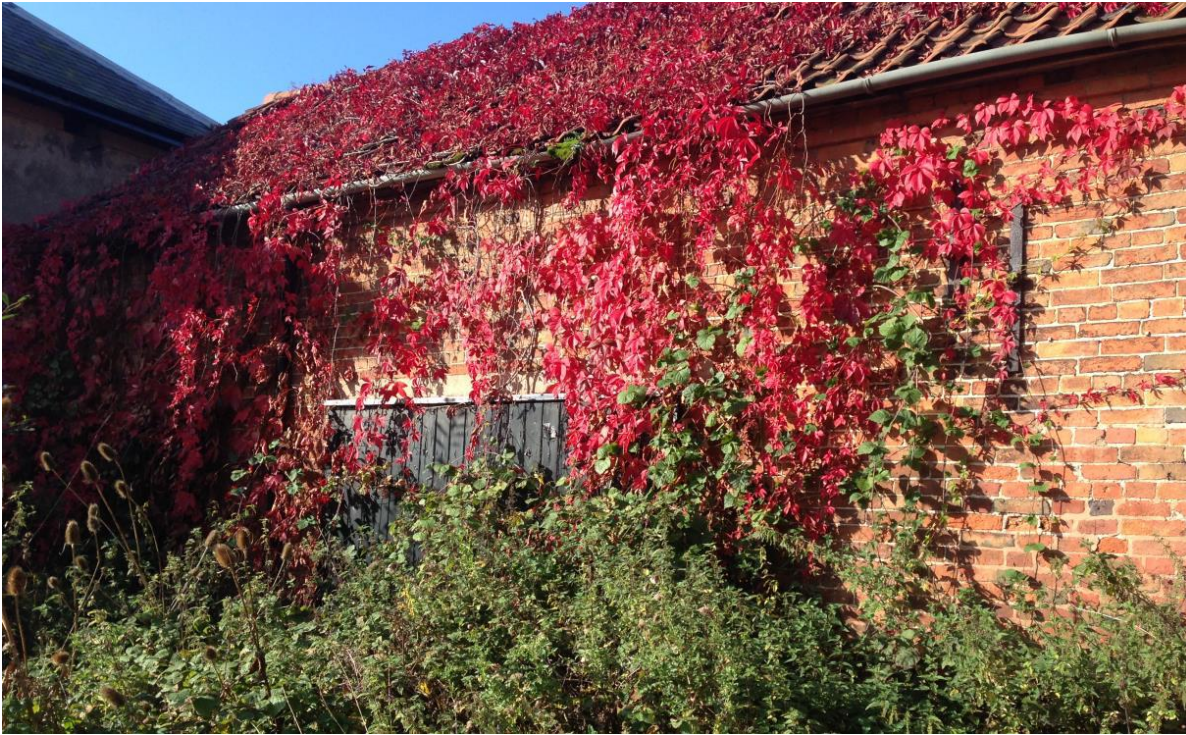
Specific Challenges

- Structural stability
- Heating the development
- Limiting external impact on the building aesthetics

- Historically the wall dividing the barn from the neighbouring property has been lowered. It is also suspected that an archway between the house and barn has been removed reducing structural support to the gable end.
- The building has, as is common, only very limited foundation.
- The walls of the building are only a single brick thickness (approx. 220mm).

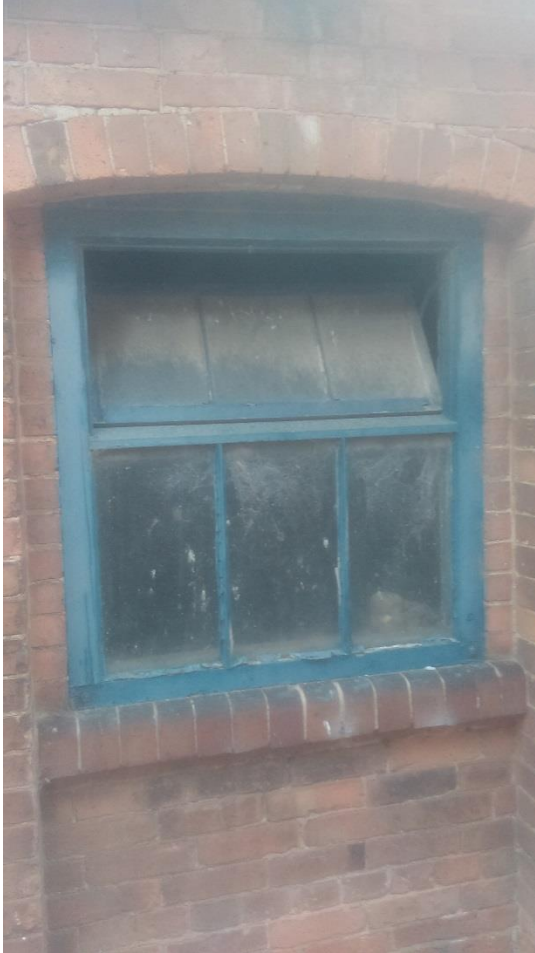
- Given the nature of the site we have sought to limit the external changes to the structure to those required to make the building structural sound and weather tight.
- Where we are installing new windows these will be hopper sash type in keeping with the agricultural nature of the building.
