## RYKNIELD STREET. EXCAVATIONS NEAR HIGHAM.

By MARGARET SAUNDERS.

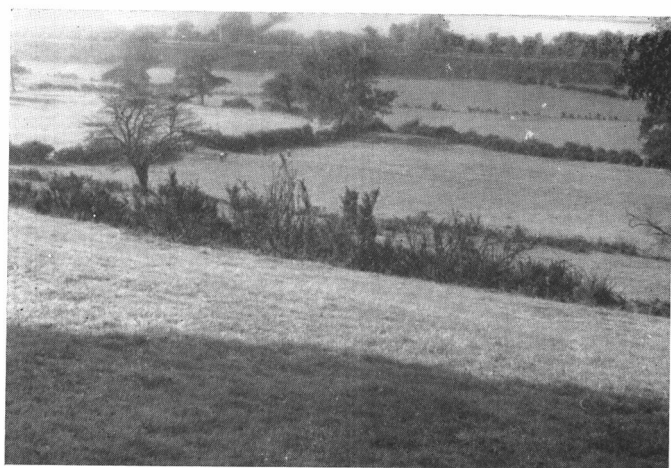
PLATE VIb. A view of Section B from the hill on the east.

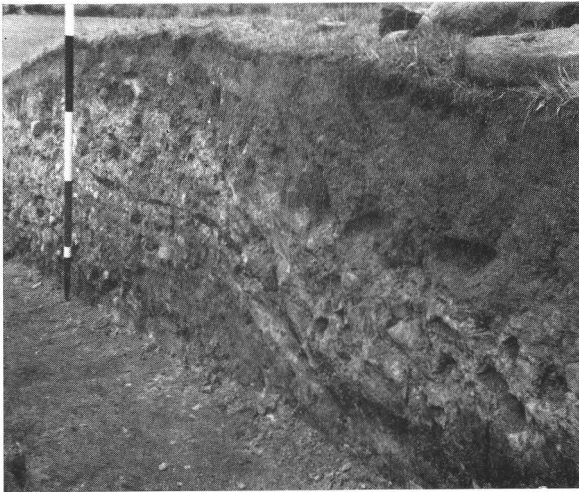
PLATE VIIb. Section A showing the coal road surface.

of wear on the coal surface, and a deposit of black washed into the ditch, may not indicate more than a few years, or even months, of use, but could have been the work of a century or more if the ditches were regularly cleaned out and the traffic not too heavy.
