# STAIRWAYS TO NOWHERE; COMMUNITY ARCHAEOLOGY AT STAVELEY, NORTH-EAST DERBYSHIRE, INTERIM REPORT 2005

By FRANK ROBINSON

ARCUS were commissioned by Staveley History Society to provide professional training and supervision during a community archaeology project, 'Stairways to Nowhere', at Staveley Hall, Derbyshire (centre SK 43387490). Documentary and map evidence suggested that the surviving hall building (now Staveley Town Council offices) represents the remnant of a much larger hall; the final phase built in 1604, probably on the site of an earlier medieval building. A successful application for Heritage Lottery funding was made, in order to investigate the site of the seventeenth-century hall through community archaeology, and seven evaluation trenches were consequently excavated during August and September 2005.

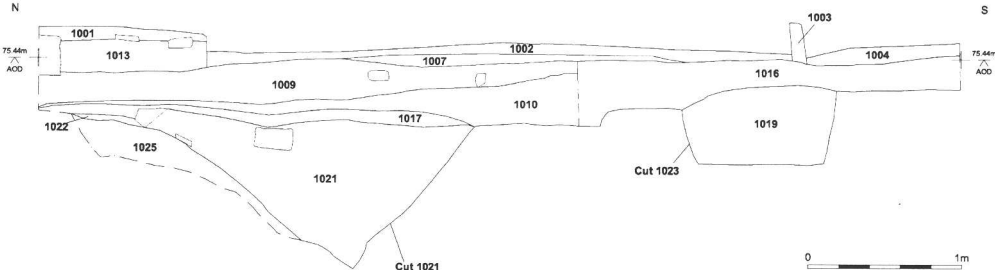
Fig. 4: Staveley Hall: trench 1, west facing section.

sloping in a regular 45° V-profile. At the centre of the base was a rough steep-sided gully 0.34m wide and 0.16m deep. The ditch was filled throughout by a uniform deposit (1018), a very dry and compacted sandy silt with sandstone rubble and charcoal throughout, clearly representing a single act of backfilling. Very little cultural material was present within the backfill, but a small group of twelfth- to fourteenth-century pottery suggests a time frame for the backfilling episode. Bloomery iron-working slag was also present within (1018), and this material was subject to further analysis (see below).

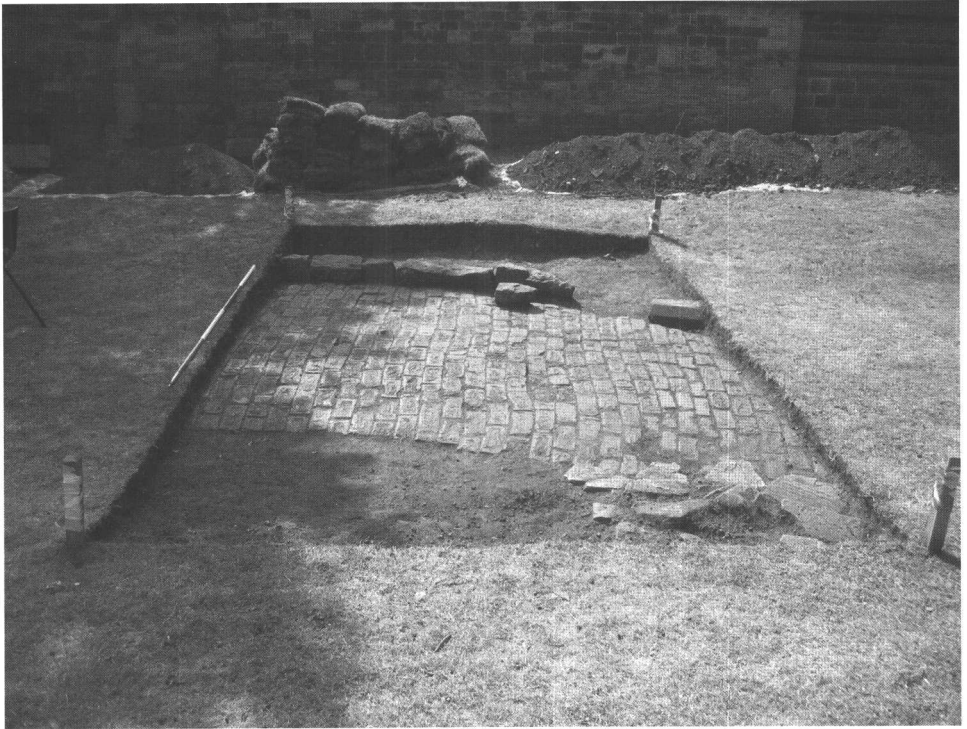
Plate 1: Staveley Hall: trench 1; showing nineteenth-century brick path [1002], looking south.

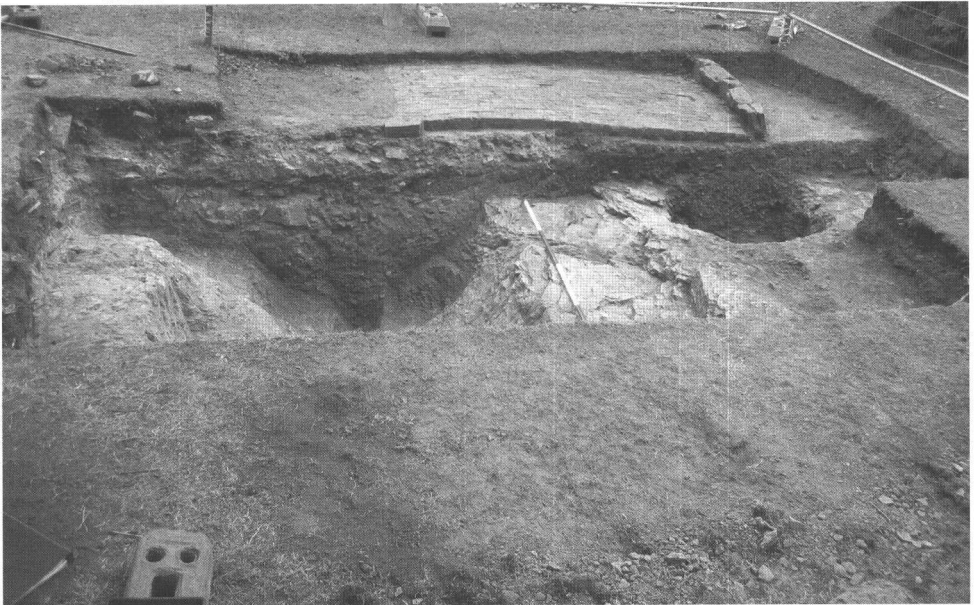
Plate 2: Staveley Hall: trench 1; showing early rock-cut ditch [1021] (left) and robbed-out foundation trench [1023] for the southern external wall of the seventeenth-century hall (right), looking east.

Trench 1 (Figs 3 and 4) was excavated south of the standing hall building, to intercept the anomaly located during resistivity survey, possibly corresponding to the projected southern external wall of the 1604 hall. Although this anomaly proved to be a brick path of recent date (Plate 1), the robbed-out foundation trench of the external wall was identified, along with a substantial V-shaped ditch probably of medieval date (Plate 2).

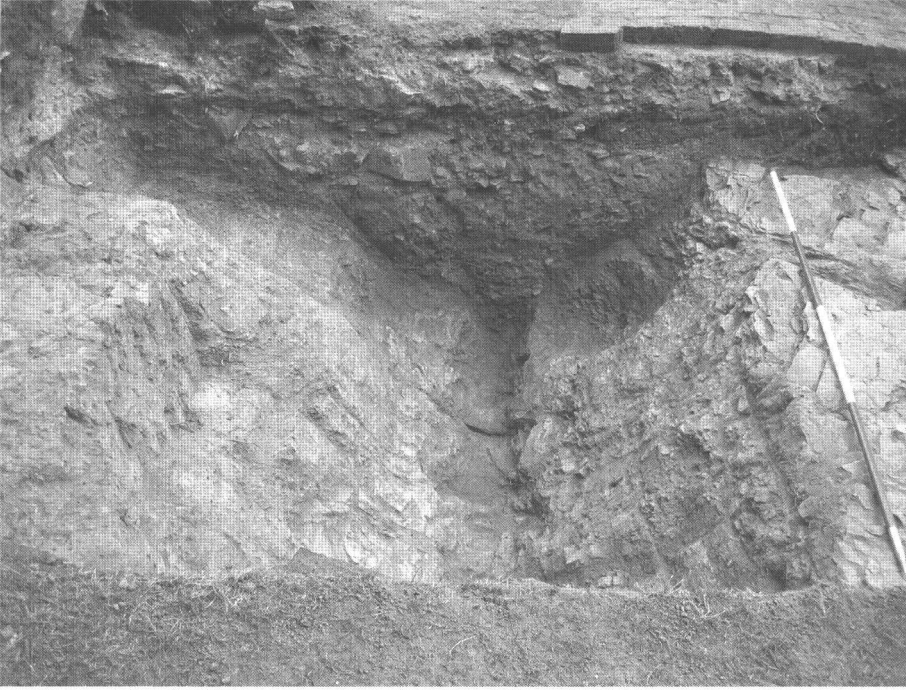
*Early V-shaped ditch* (Plate 3). The earliest feature identified was a substantial V-shaped ditch [1021] running east-west, and excavated into sandstone bedrock (1025), the surface of which was encountered 0.30–0.40m below the modern ground surface. The ditch was 0.90m deep from the bedrock surface, and 2.10m wide at its upper edge,

Plate 3: Staveley Hall: trench 1; early rock-cut ditch [1021], looking east.

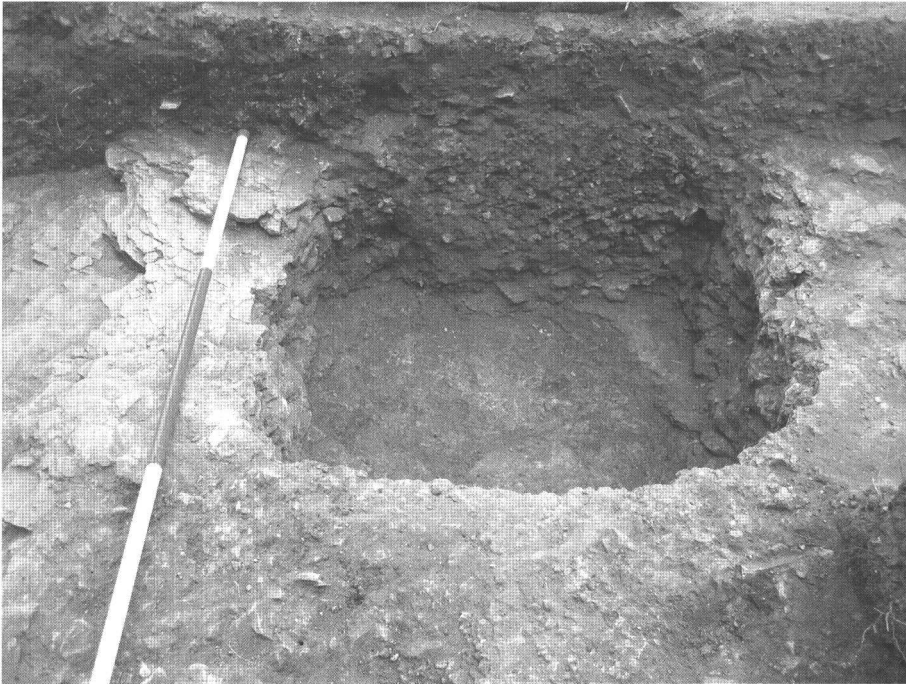
*Seventeenth century hall.* Towards the southern edge of the trench, to the south of [1021], a trench [1023] ran east-west, excavated into sandstone bedrock (1025). [1023] was 0.32m deep from the bedrock surface and 0.85m wide, with regular vertical sides and a flat base (Plate 4). The backfill (1019) of this feature was compacted rubble, with

Plate 4: Staveley Hall: trench 1; robbed out foundation trench [1023], looking east.

pale pink lime mortar, some apparently *in situ* at the base of the trench. [1023] was interpreted as the entirely robbed-out foundation trench for the southern external wall of the 1604 hall. Material culture within the backfill included sixteenth to nineteenth century pottery and seventeenth to eighteenth century clay pipe. This is consistent with the suggested demolition date during the 1840s for this part of the building.

External wall footings are likely to be represented by the robbed out foundation trench [1023] and possibly the substantial wall footings [7002], [7014] and [7017]. These structures are of similar dimensions, around 0.9m wide. [1023] confirms the southern extent of the building, while the structures in Trench 7 may form part of the eastern façade. The northern extent of the building is suggested by the marked change in deposits between Trench 2 and its northern extension, although no trace of this wall was identified, and the relevant archaeology may have been removed during insertion of a modern gas pipe. The external footings were mortared, with a pinkish lime mortar in [1023] and a yellowish lime mortar in [7002], and construction was of sandstone slab, roughly faced to each side, with a rubble core. Two fragments of millstone within [7002] had been re-faced to the outside of the wall, suggesting re-use of stone which may have been locally sourced. While [1023] had been excavated 0.32m into the sandstone bedrock, [7002] was only recessed 0.14m into the surface of the natural clay.

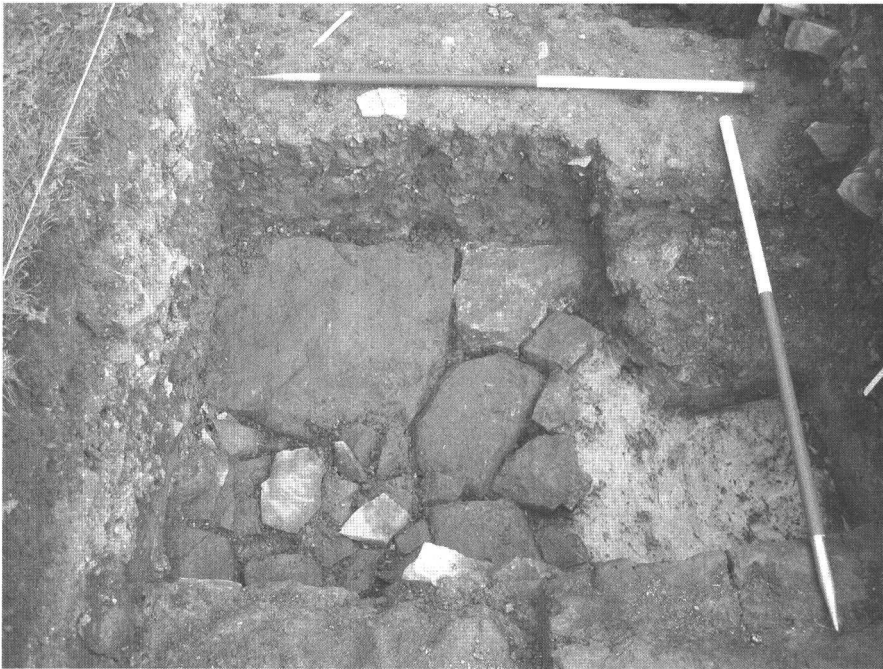
*Sunken feature [2027]* (Plate 5). A rectangular cut feature [2027], 1.35m wide, 0.36m deep, extending into the western baulk of the trench, was observed to cut part of the

upper fill (2016) of the early ditch [2041]. Cut into natural yellow clay (2015) on three sides, the northern side appeared to be consolidated with a dump of clean greyish clay (2005). The base of [2027] was a stone structure [2020] composed of two layers of sandstone slabs, the upper layer up to 0.13m thick, laid in a grey silty bedding material (2034) to form a flat upper surface, with edging slabs on the southern side. Above [2020], the feature had subsequently filled with a mortar-rich deposit (2022), with redeposited yellowish clay (2021) above. Fifteenth to sixteenth century pottery from the bedding layer (2034) suggested that this feature was contemporary with the seventeenth century hall, although it is clearly well below the floor level of this building. The large extent of the room identified as a 'kitchen' on the 1682 plan suggests that the roof may have required support columns, and this feature may represent a partially robbed-out pad foundation for one of these. Alternatively the flat base and edging slabs may suggest a stone-lined pit or perhaps a partially robbed-out foundation trench (although the lack of mortar around the base [2020] would argue against this).

Plate 5: Staveley Hall: trench 2; foundation pad or stone-lined pit [2027]/[2020], looking north.

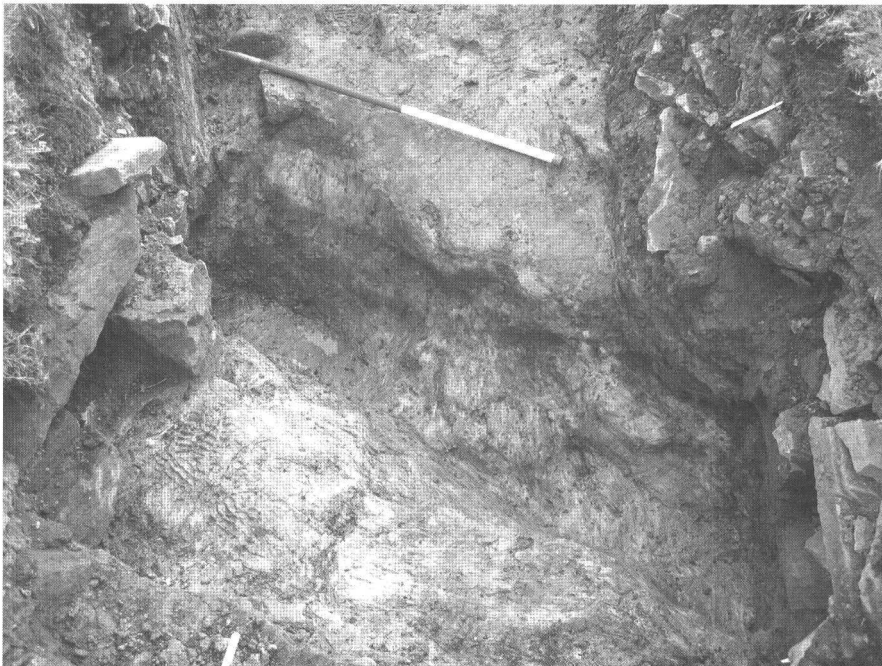
*Medieval ditches/gullies* (Plate 6). The earliest features in this area were associated with medieval shell tempered pottery and clearly relate to activity some time before the 1604 hall. [2041], a NW-SE ditch, was excavated 0.58m into natural sandstone clay, with an irregular U-shaped profile, 1.10m wide, and steep sides. The ditch was subject to silting, with a sequence of waterlogged clays and clay silts (2032), (2025), (2023) and (2016). The primary silt (2032) contained shell tempered pottery dating between the eleventh and thirteenth centuries, as well as bloomery smelting slag. (2023) contained twelfth to thirteenth century shell tempered pottery and twelfth to fourteenth century whiteware. The continuation of ditch [2041] was also excavated in Trench 7 to the south-east (feature [7003]/[7013]).

Plate 6: Staveley Hall: trench 2; medieval ditch [2041], below stone-lined drain [2013], looking south.

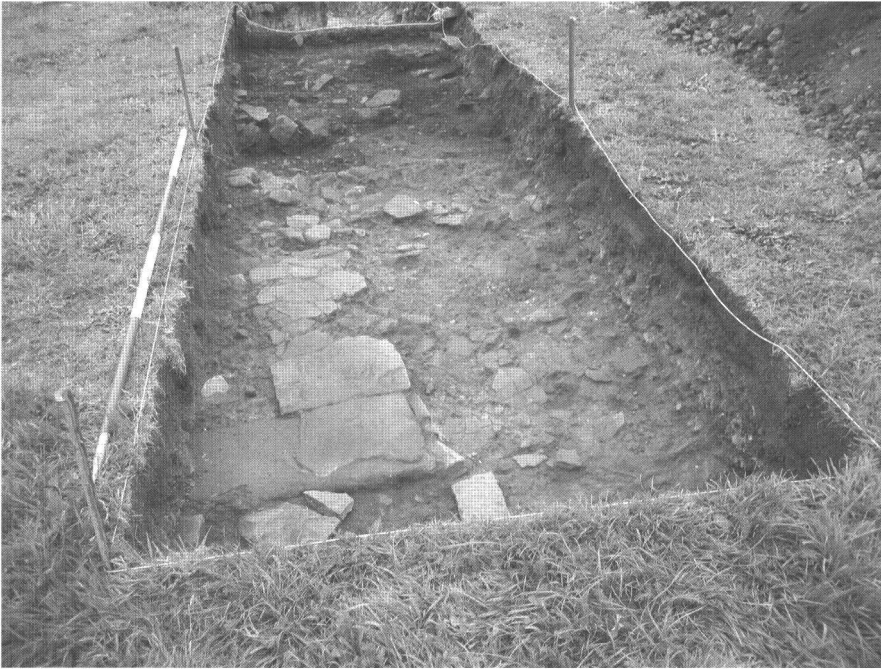
*Northern extension* (Plate 7). Beyond the modern service pipe at the original northern end of Trench 2, the trench was extended northward by a further five metres. The natural surface (2039) was considerably deeper in this area, and appeared to slope away northwards, from 0.80m below the modern ground level at the southern end of the extension, to 0.95m below ground level at the northern extent. This contrasts with the relatively shallow natural surface in the main trench, and may reflect a difference between areas internal and external to the 1604 hall. The stratigraphy in this area was also markedly different from the main trench, comprising a sequence of layers of compacted industrial waste with concentrations of ferrous slag in the lower layers (2042) and (2035), green vitreous slag in (2031), a coal-rich spread (2028) and a rubble layer (2030) at the upper horizon. A very worn sandstone slab surface [2029] survived above this sequence towards the northern end of the extension. The boundary between this dumping sequence and the very different stratigraphy within the main trench corresponds closely to the expected position of the northern external wall of the 1604 hall. The sequence in the extension seems likely therefore to represent landscaping during the lifetime of the hall building, possibly during the early eighteenth century. The slab surface [2029] may therefore represent a survival of part of an external yard surface.

Plate 7: Staveley Hall: trench 2; fragmentary sandstone flag surface [2029] in northern extension, looking south.

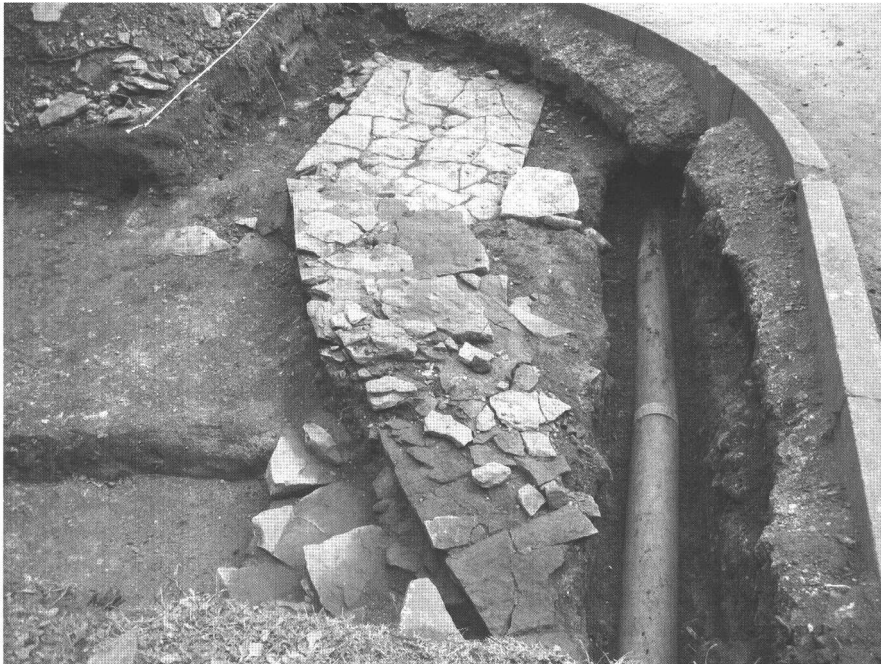
*Seventeenth century hall; entrance steps [3002]*. Trench 3 (Fig. 7) was excavated in a planting bed just east of the surviving hall building, corresponding with the expected position of a semicircular entrance stairway projecting to the north of the 1604 hall. The trench limits were tightly constrained within surrounding concrete kerbs; however, the lowest footings of steps [3002] survived within the trench (Plate 8), though with some disturbance from modern services. [3002] formed a curving edge, originally

Plate 8: Staveley Hall: trench 3; footings [3002] for an entrance stairway to the hall, looking east.

composed of five dressed slabs 0.05m thick, the largest measuring 1.30m × 0.80m, now heavily cracked and weathered. Moulded lead ties in the interstices between the masonry anchored the slabs; no mortar was evident. [3002] had been laid onto rough rubble footings [3009] and [3005], which in turn lay on the natural yellowish clay surface (3008), encountered only 0.38m below ground level. To the rear (south) of this front edge was a soil and rubble infill (3003), with a similar material (3004) to the north. Material culture from (3003) and (3004) included early material such as a sixteenth or seventeenth century sherd from a Frechen-Köln stoneware bottle, bearing the typical *Bartmann* facemask, and a group of early seventeenth century clay pipe. The deposits had clearly been subject to later disturbance and mixing, as nineteenth century material was also present.

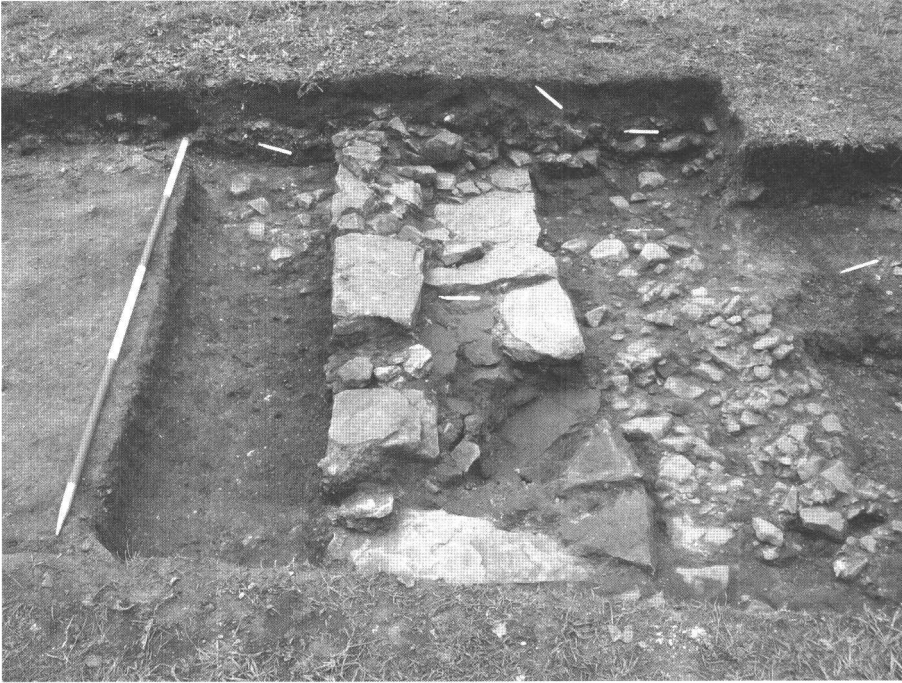
*Seventeenth century hall; east-west wall [4013].* Situated towards the southern end of Trench 4, the footings of a substantial wall (Plate 9) were located running east-west across the trench. Build was of sandstone slab, typically 0.13m thick, roughly finished to the exterior, with a rubble core including burnt sandstone creating a drystone structure 0.75m wide. Four courses survived, constructed directly onto the surface of the natural clay (4034), which was encountered 0.72m below the modern ground surface. This wall may correspond with the location of an outbuilding shown on the 1682 plan.

Plate 9: Staveley Hall: trench 4; wall footings [4013], looking west.

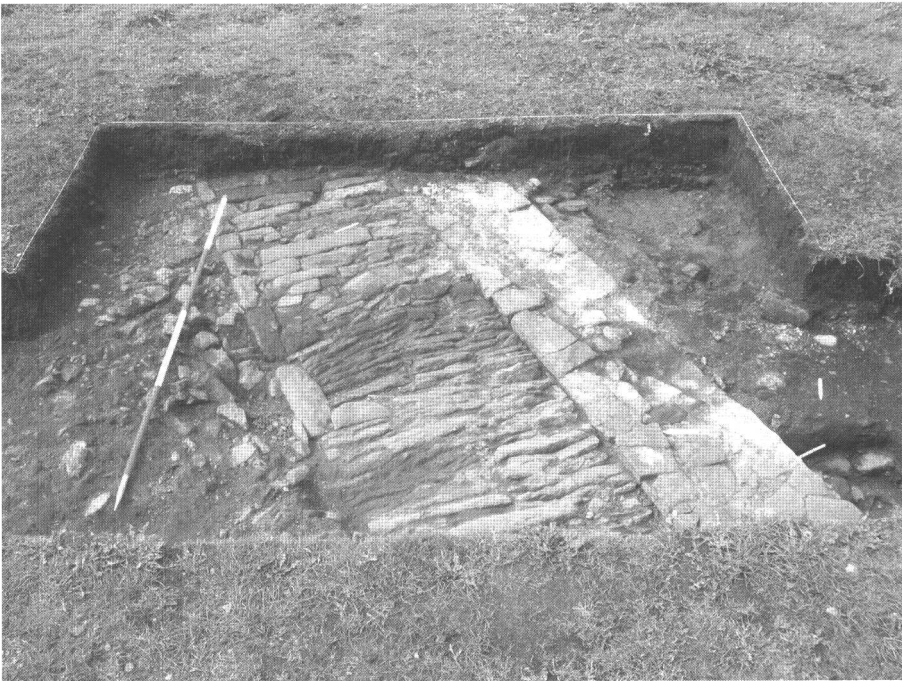
*Wall and cobbled path [4002]/[4004].* These structures (Plate 10), running SW-NE at the northern end of the trench, corresponded to the anomalies seen in the resistivity survey. Wall footing [4002], 0.60m wide, was built on a rough rubble foundation, with sandstone slabs typically 0.08m thick, roughly finished to the exterior, and a lime mortar bonded rubble core. Immediately to the south, and on the same alignment, was a cobbled pathway [4004], 1.05m wide, of flat sandstone cobbles inserted vertically to measure typically 0.35m x 0.09m at the surface, and 0.16m deep. The cobbles were laid perpendicular to the wall [4002] and were edged on the other side by a linear kerb of larger stones parallel with the wall, and inserted to a depth of 0.32m below the cobbled surface. [4002] and [4004] were constructed on a redeposited clay and rubble base (4031), 0.18m thick, laid above the underlying made ground (4019)/(4026) and a greyish silty packing material (4024) was used to bed the cobbles. Fragments of a metalled surface (4003) were present above the cobbles, suggesting that this path was in use for some time, and subject to at least one episode of re-surfacing.

Plate 10: Staveley Hall: trench 4; wall footings [4002] and cobbled path [4004], looking west.

These structures post-date the levelling episodes discussed above at the northern end of Trench 4. Although these structures are not shown on any plan of the hall, seventeenth century pottery was found in the surface of the path [4004], and material from the packing deposit (4024) below the path is entirely consistent with a seventeenth century date. It appears therefore that [4002] and [4004] are indeed contemporary with the seventeenth century hall.

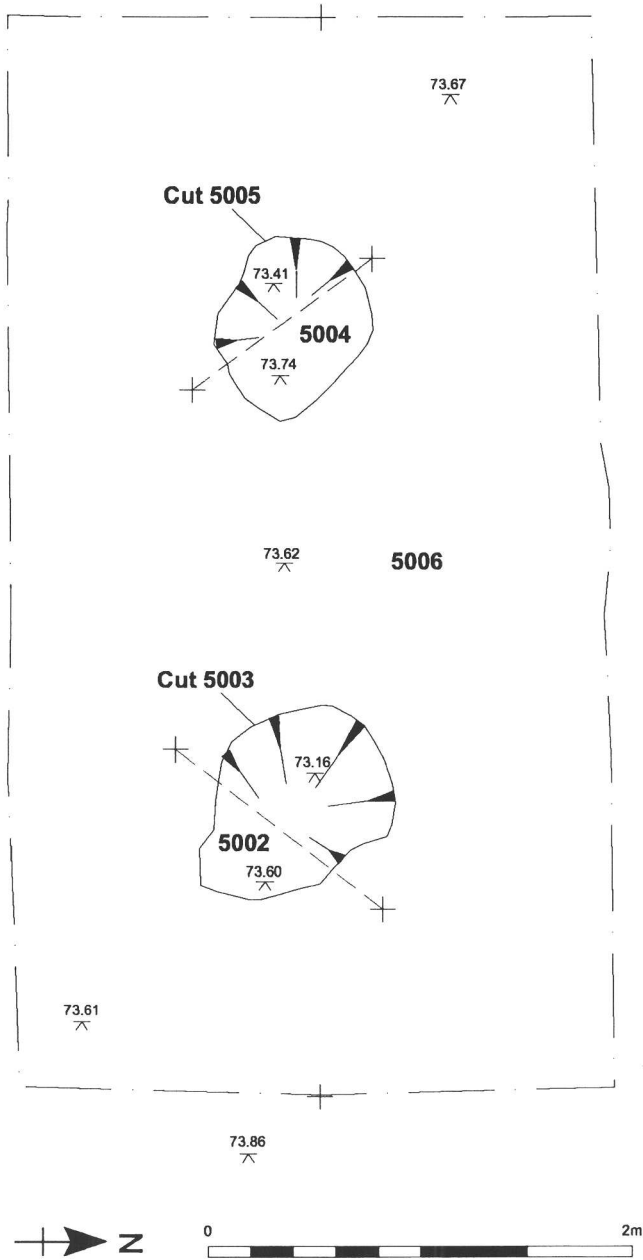
Fig. 10: Staveley Hall: trench 5 plan.

*Natural coal deposits.* The underlying topography was observed to slope eastward, with the natural surface reached at 1.00m below the modern ground level at the western end, and 1.20m below ground level at the eastern end of the trench. At the western end of the trench the natural was a yellow sandstone clay (5009), with an outcrop of coal (5008) at the eastern end.

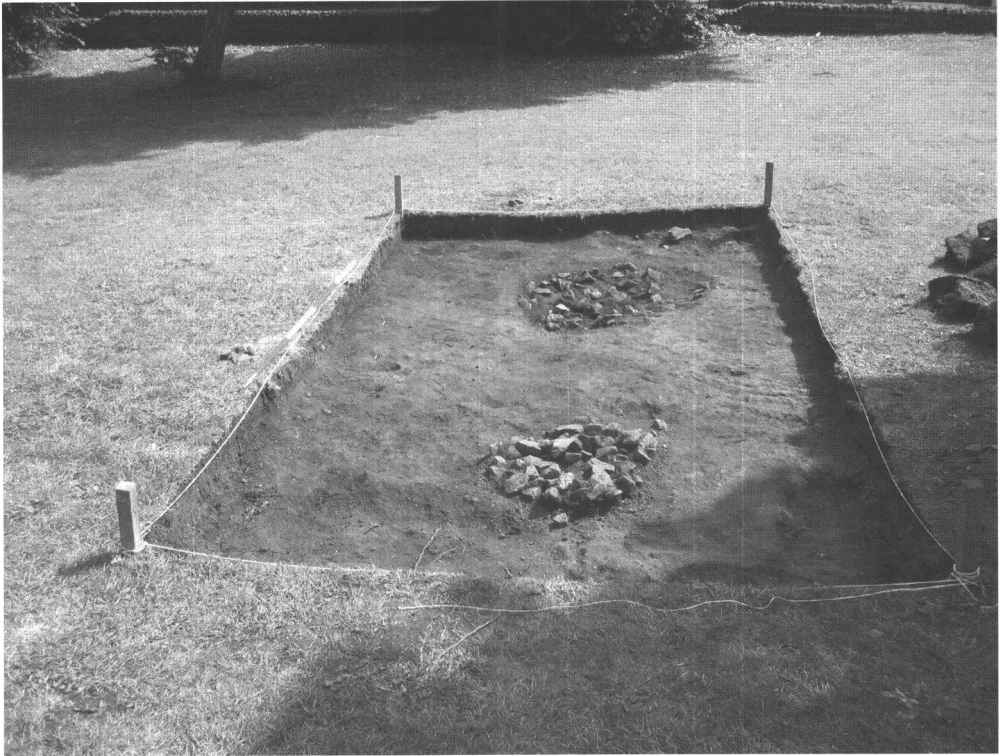
Plate 11: Staveley Hall: trench 5; landscaping deposit (5006) with eighteenth century pits [5003] and [5006], looking east.

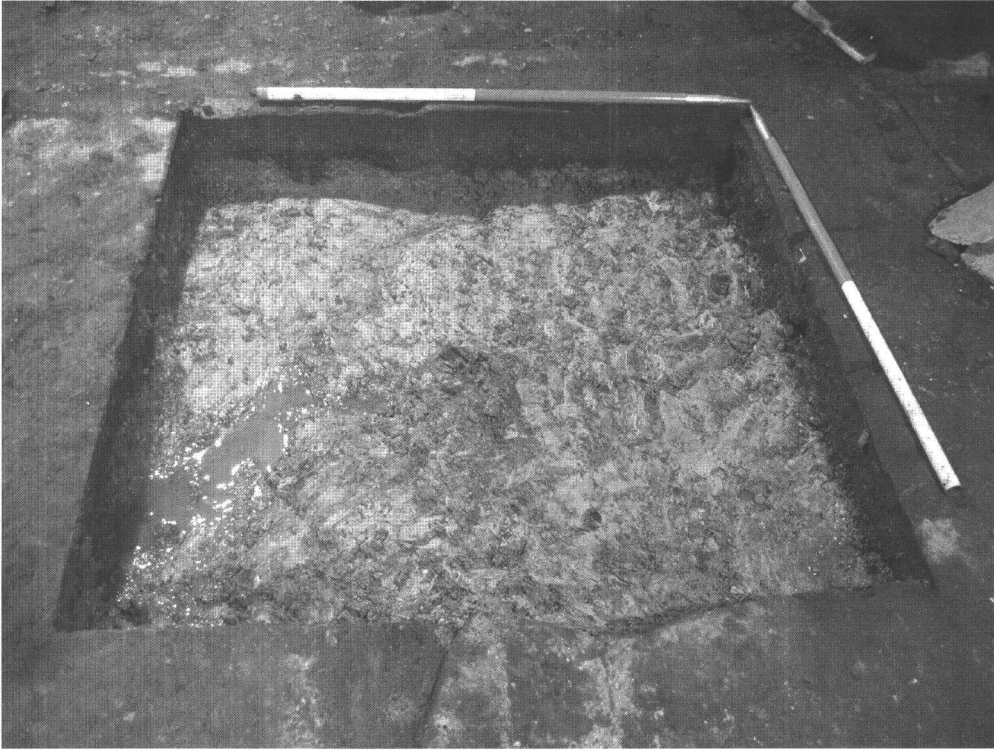
Trench 6 (Plate 12) was a small sondage excavated below the slab floor of one of the cellars beneath the surviving hall building. Two damaged slabs were raised, revealing a fine (0.05m) layer of reddish grit, presumably used as levelling for the slab floor. Below this was undisturbed natural, a pale grey shale clay. No evidence for an earlier floor was identified.

Plate 12: Staveley Hall: trench 6; sondage through cellar floor into natural shale clay, looking south.

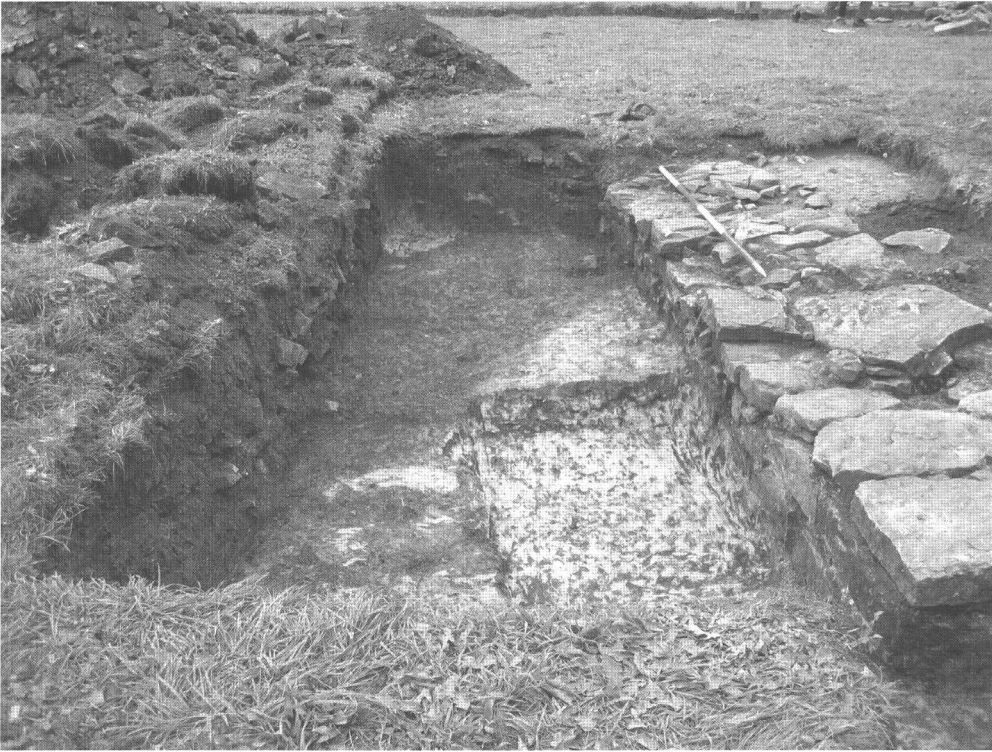
*Seventeenth century hall; wall footings and drainage.* Like wall [4013] in Trench 4, the structural features in Trench 7 were constructed directly onto the surface of the natural clay (7010), 0.58m below the modern ground level (Plate 13). In the southern part of the trench, three courses of a substantial wall footing [7002], 0.90m wide, ran 4.10m east from the western baulk of the trench, sitting on top of the fill of ditch [7003] at the western end. Construction was of large sandstone blocks up to 0.15m thick, roughly

finished to the exterior with a rubble core, in a pale yellowish lime mortar. One fragment of re-used millstone had been incorporated within the structure.

Plate 13: Staveley Hall: trench 7; wall footings [7002], overlying silts of medieval ditch [7003]/ [7013].

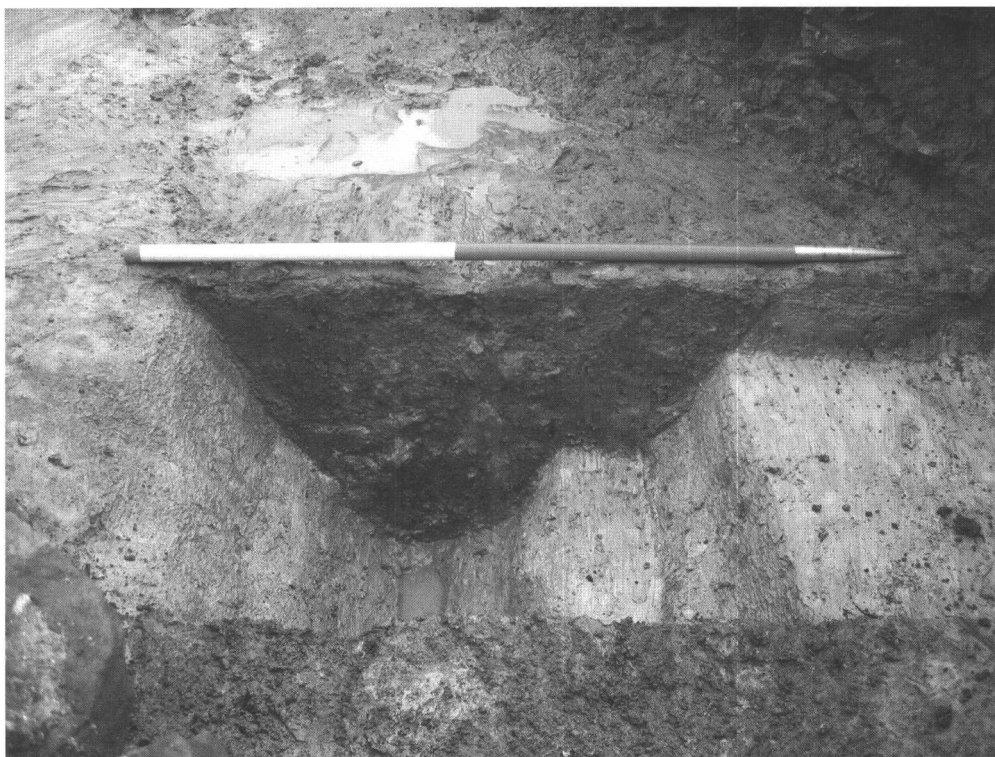
*Medieval ditch [7003]/[7013].* This feature, running SE-NW, was located in the south-western corner of Trench 7, and formed a continuation of ditch [2041] in Trench 2. [7003] was excavated 0.52m into natural sandstone clay, and formed a rough V-shaped profile, 0.8m wide, with steep sides (Plate 14). [7003] appeared to be a re-cut of an earlier ditch [7013], only visible to the south of [7003]. The grey clay fill (7005) associated with [7013], was considerably lighter in colour than (7004), the homogenous silty clay fill of [7003].

Plate 14: Staveley Hall: trench 7; section through medieval ditch [7003]/[7013], looking south-east.
