AN ARCHAEOLOGICAL WATCHING BRIEF AT THE OLD BARN DARLEY ABBEY, DERBY

SUMMARY

An archaeological watching brief was undertaken during 2006–2007 at the site of The Old Barn, Darley Abbey, Derby (centred on SK 3523238314) by Archaeological Research Services Ltd on behalf of Derby City Council in advance of restoration work to the 19th century barn.

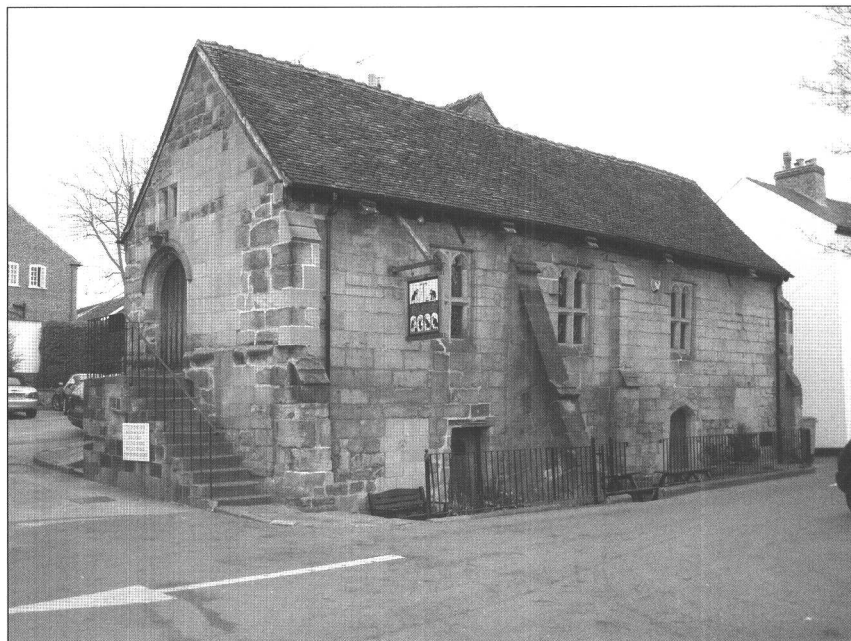
Plate 1: The Old Abbey Public House, Darley Abbey.

The only remaining upstanding building is an upper floor hall house, now a public house, built probably *c.* 1450 (SMR 32468) (Fig. 2; Plate 1). The date of this ‘Old Abbey’ building is based on architectural considerations and dendrochronological work undertaken on principle floor joists (Derbyshire SMR). Other archaeological finds from Darley Abbey have been scarce. Apart from 15th century structural remains uncovered at No’s 7, 8 and 9 Abbey Lane, no other medieval remains have come to light (Derbyshire SMR).

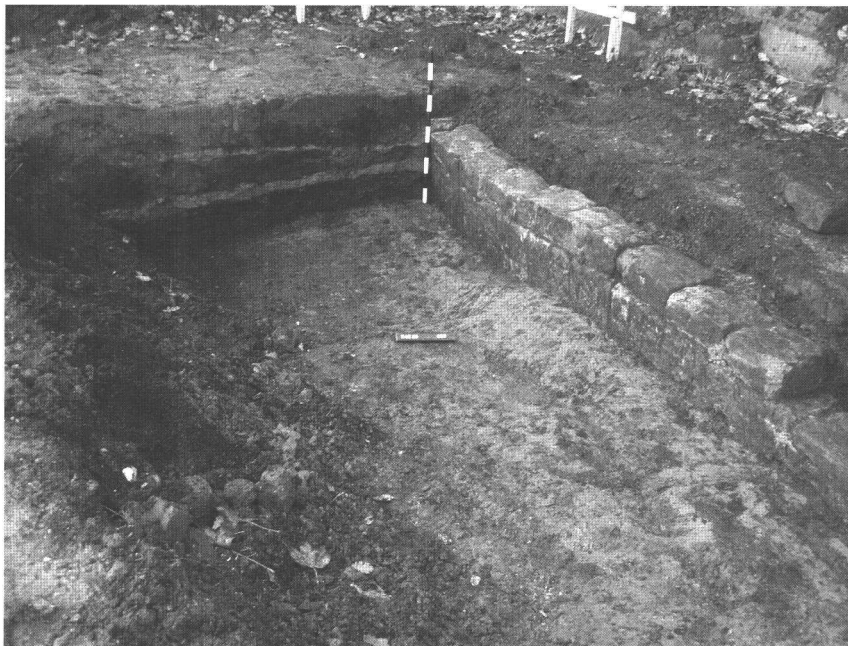
Plate 2: Darley Abbey: view of wall one (Scale: 1m).

During the excavation of the footings for the new barn building a wall was uncovered 1.1m below the modern ground level (Fig. 3 (006); Plate 2). The wall was found to be

on the same alignment as the footings and obstructed any further digging in that area. The exposed area of wall measured $4.54\text{m} \times 0.3\text{m}$ with a maximum surviving height of 0.5m . The wall was a single course in width and survived to two courses in height. It was constructed from sandstone ashlar blocks that were skilfully dressed. Mortar

was located between the stones but no finds were discovered in connection with this wall.

The deposits found banked up against the wall suggested a period of industrial use, after the wall's construction. The deposits consisted of layers of black, coal-rich material with a maximum thickness of 0.27m that appeared to have been sealed by thin layers of redeposited clay with a maximum thickness of 0.1m. The large pieces of coal within the layers had not been burnt which suggests they formed part of a waste deposit. The redeposited clay layers may be interpreted as floor levels although a lack of finds suggests this is unlikely. It is also possible they acted as levelling/sealing layers to stabilise the ground after the coal waste had been discarded.

Map evidence indicates that before the construction of the barn in the 19th century the site was an area of enclosed wooded parkland. There is no map evidence indicating medieval structures on the site, suggesting the wall is possibly of medieval date. Due to the walls' potential significance, the position of the barn was moved 3m to the east, enabling preservation of the wall *in situ*.

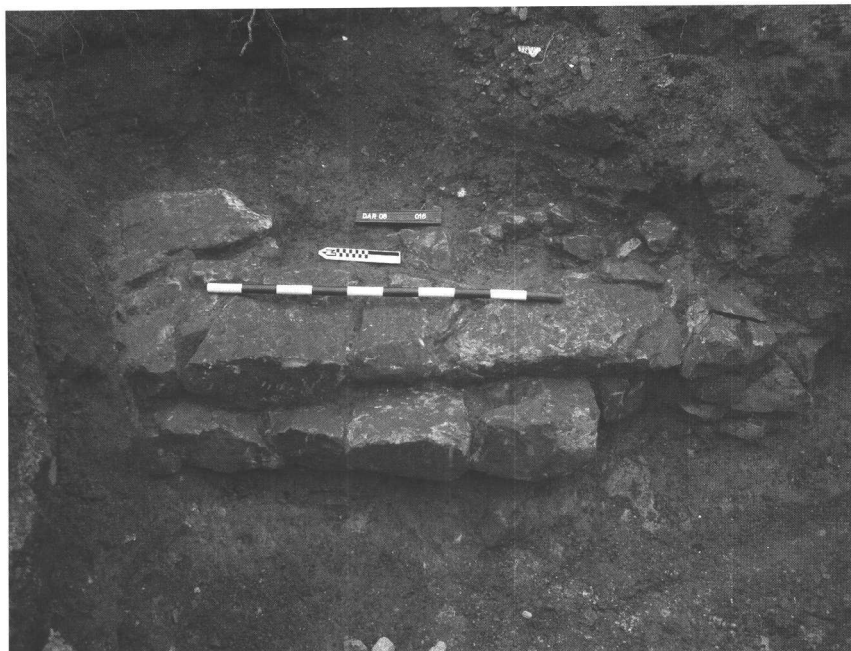
Plate 3: Darley Abbey: view of wall two (Scale: 1m).

During the excavation of the footings that ran north-south on the east side of the building a substantial sandstone wall was uncovered (Fig. 3 (016); Plate 3). A significant amount of the wall was exposed by hand and although the wall terminated to the south, it continued north into the baulk. The remains consisted of a wall two courses deep with two outer faces of larger, faced blocks with an inner core of smaller stones. The exposed wall was 2.1m long and 0.5m wide with a maximum depth of 0.29m. The stones had been faced but not to the high standard of the first wall uncovered.

The stones were larger and more roughly arranged suggesting this was the foundation layer of a substantial, structural wall. The bottom course was not only wider but had redeposited clay packed around it implying the bottom course may have been beneath ground level for added stability. The suggestion that these courses may have lain beneath ground level may explain why they are not as well constructed as wall one.

Whilst excavating the wall two pieces of medieval pottery were found beneath the lowest stones. After analysing the sherds, Cumberpatch noted that both sherds came from a jug, one being a handle piece from a rod handled jug. Both sherds appear to be of the Burley Hill type, manufactured at the site of Burley Hill near Duffield (Cumberpatch 2003). An accurate date for Burley Hill Ware has not yet been resolved but the use of suspension glaze on the fragments found suggests a date range between the mid 13th and the later 14th to 15th centuries (Cumberpatch 2004). The wall was abutted by a deposit of orange redeposited natural clay that appeared to have been packed around the wall to stabilise it within the foundation trench that had been cut for it. The sherds of pottery were located within this context suggesting that they were incorporated with the clay at the time of the wall's construction.

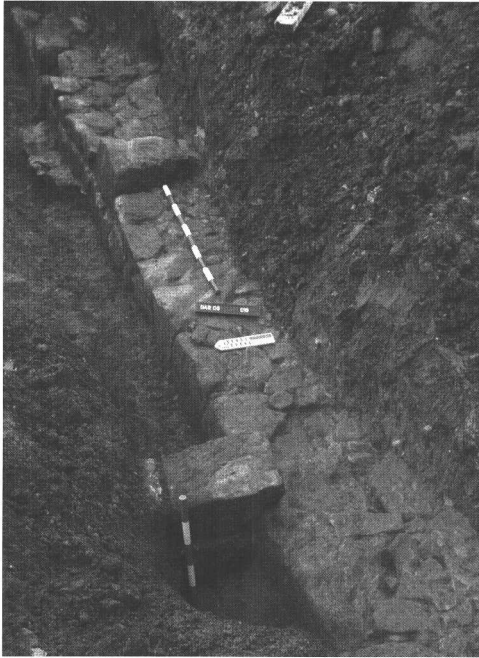
Plate 4: Darley Abbey: view of wall three (Scale: 1m).

During the excavation of a service trench on the south side of the barn a substantial sandstone wall was uncovered (Fig. 3 (018); Plates 4 and 5). It was exposed over a length of 6.72m before continuing under the baulk and averaged 0.64m wide. The wall survived to two courses deep and consisted of two outer faces with an inner core of smaller stones. The wall was well built using well-dressed ashlar sandstone blocks.

From the position of the key stone another wall may continue south into the baulk, indicating the remains of a structure extending further than the area already excavated. The west end of the wall continued into the west baulk but the wall stopped to the east where it had been disturbed (indicated by the prevalence of broken sandstone in that area). Further excavation revealed a junction between walls one and three. The smaller wall, which was partially excavated to the north, abutted the larger wall three and is therefore structurally later. The sandstone block that linked the two walls was carefully moulded on one corner so that it neatly rested on the other wall, an attention to detail that suggests a high level of workmanship. The wall had the same orange, redeposited clay packed against the base so as to fill the void of the foundation trench and the wall foundations themselves. The same deposits, consisting of the coal-rich material and the redeposited clay layers found when excavating wall one, were present on the excavated side of this wall. All these remains were preserved *in situ*.

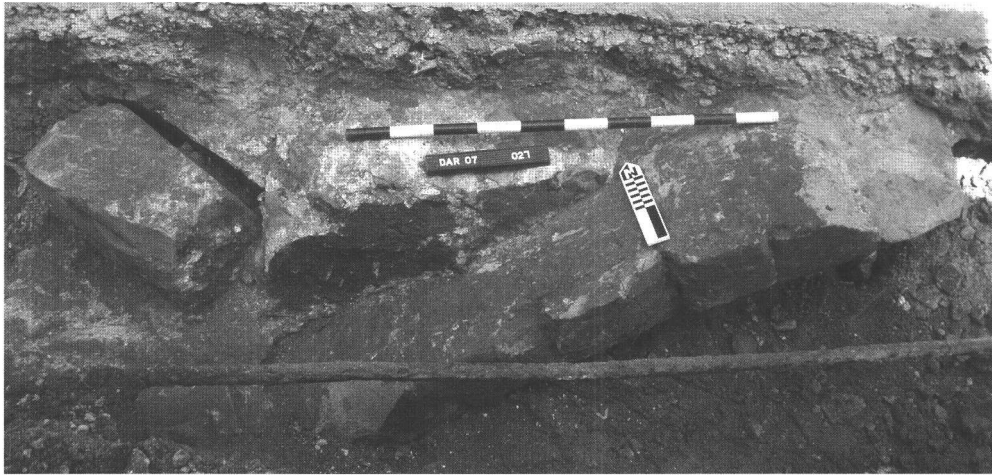
Plate 6: Darley Abbey: view of the arched sandstone structure (Scale: 1m).

The excavation of another service trench located in close proximity to The Old Abbey Public House revealed an arching sandstone structure (Plate 6). The structure was located 0.33m below the surface of the ground and 19.88m east of the south-east corner of The Old Abbey Public House. The structure was only partially revealed as it was located on the north side of the trench which could not be extended. The structure survived to three courses in places and was on an east-west alignment. Although the structure had collapsed slightly, it still retained its original curved shape. The stones were carefully worked and mortared in place with the exterior blocks having been chamfered on the underneath. The sandstone blocks used to construct the feature were fine grained and lighter in colour than the other sandstone blocks found elsewhere on the site.

The arched structure possibly appears on an early map of the area. The 1708 map of Darley Abbey completed by William Woolley illustrates the River Derwent having a man-made mill stream diverted from the main river channel in this area, creating an island. The smaller channel has since disappeared but is marked on the map as a mill fleam. Two bridges are shown to be located over the mill fleam, one of which corresponds to the location of the arched structure. The map also indicates The Old Abbey Public House and the Woolley Mansion which, apart from a few farm buildings, were the only standing buildings at the time. The 1708 map pre-dates the earliest Evan's Mill suggesting the channel marked 'mill fleam' may have been used to power earlier mills associated with the abbey. An inquisition taken on the death of Abbot Henry of Kedleston in 1287 revealed that Darley Abbey had two mills and a smith's forge (Robinson 2001, 10). Although their location has never been determined they would have been close to the river which suggests that the bridges could be medieval in date.
