## SCHANNOCHILL ARCHAEOLOGICAL SURVEY

Client: Forestry Commission Scotland  
Prepared by: Clare Ellis, Argyll Archaeology  
August 2015

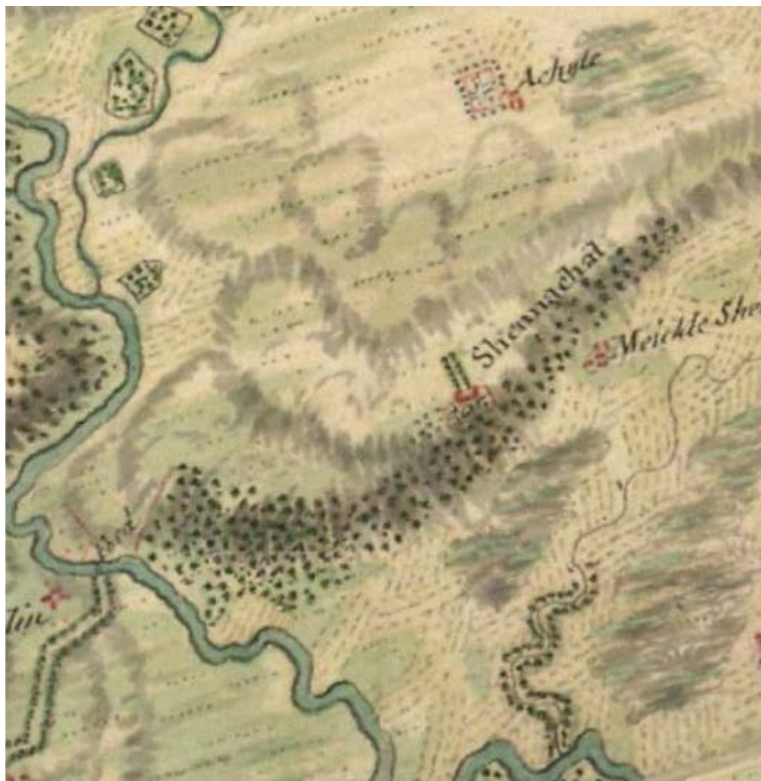
*Plate 1. Roy's Military Map 1747-55, showing Shennachal and the strip of native woodland. Stirlingshire.*

- 4.3.2 Schannochill is identified on Roy's Military Map 1747-55 as Shennachal and is shown as a C shaped structure with an avenue of trees leading from the house north-westward and a faint trace of an enclosure on the southern side (Plate 1). There is now no surface trace of this enclosure. Roy's map also shows a curvilinear stretch of woodland on the south side of the house, the remains of which is still visible today and is bounded on the north side by an earthen and stone bank (Site 6); this bank may have its origins in the later medieval period. The land to the north and west of the house does not appear to have been under cultivation at this time and the presence of a couple of ponds (1<sup>st</sup> Edition OS Perthshire Sheet CXXX 1866) indicates that it was probably grazed by cattle. However, there is a reference to an 'obligation by John Monteith of Arnbeg to [blank] regarding payment of tack duty on half rounge of Over Shenochyle and sowing of seed corn on said land 28/4/1674', (National Archives GD 22/3/53). This may refer to the clearly cultivated land located on the southern side of the linear strip of woodland.

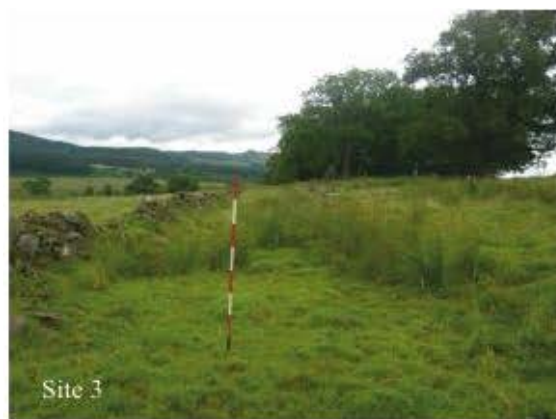
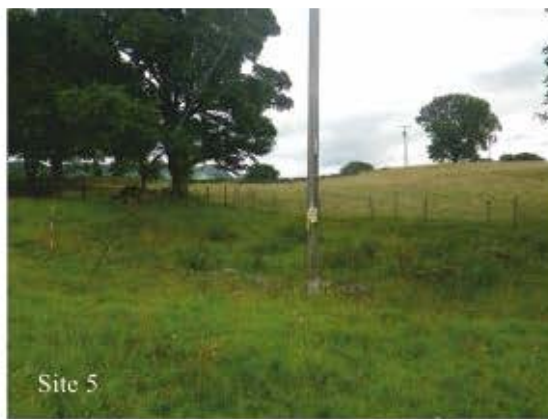
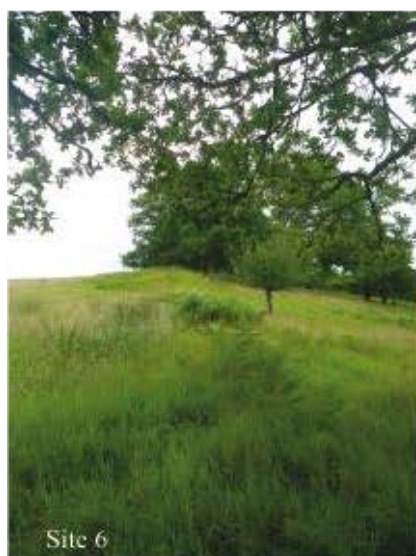
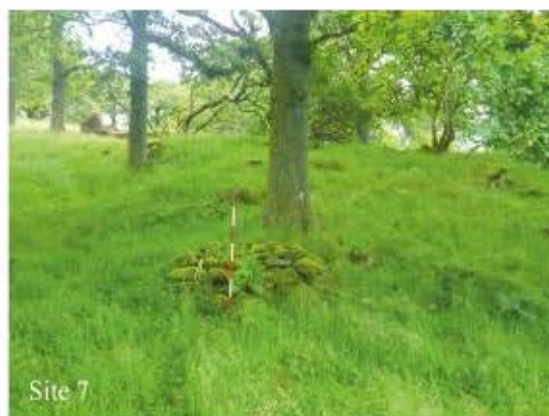
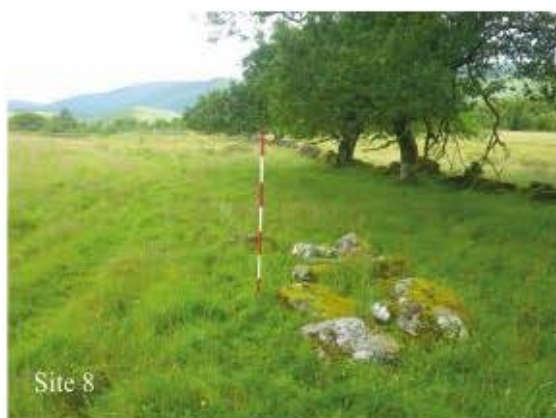
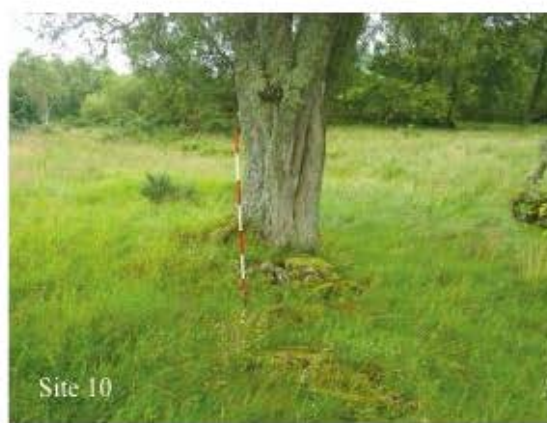
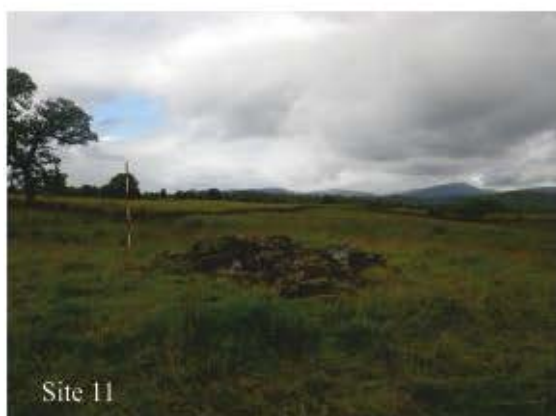
*Appendix 1: Photographic register*

No.	Site	Description	Taken from
1	6	Bank	SW
2	7	Pet burial ?	S
3	8	Clearance cairn	SE
4	8	Clearance cairn	SW
5	10	Clearance cairn	SE
6	4	Location of pond	W
7	5	Well/enclosure	S
8	3	Road	S
9	11	Clearance cairn	E
10	12	Clearance	E
11	13	Clearance	E
