THE ALLIANCE AND LION SALT WORKS, MARSTON, NORTHWICH

SCHEDULED MONUMENT NO 34985-002

VOLUME III: THE ARCHAEOLOGICAL EXCAVATIONS, 1992-2015

REPORT NO 2015-01

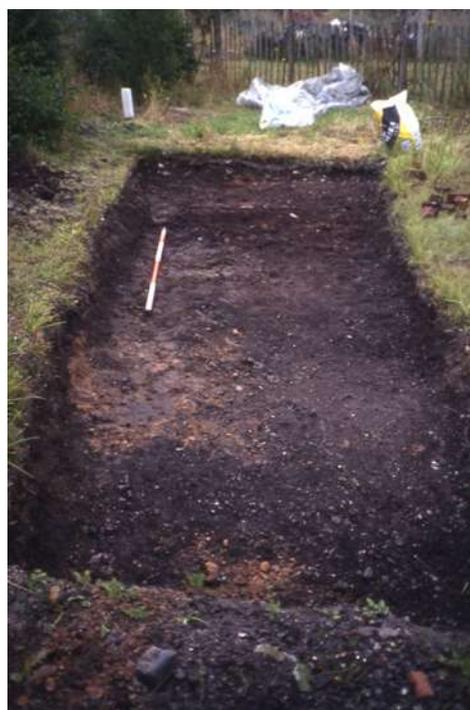
2.1: Trench 93-I, East facing

The earliest deposit was a grey-brown clay deposit (4300). At the western side of the excavation was a hand-made red brick wall foundation (4301), orientated north-south. On the eastern side was a brick drain (4302). These features were overlain by clinker-ash (4303), possibly derived from the stoves or boilers associated with the site.

At the eastern side of the trench a hand-made red brick path (4304) c. 0.35m below the ground had been built on top of this layer. The path and remainder of the trench were covered with a layer of brick-rubble, clinker-ash and pan-scale (4305).

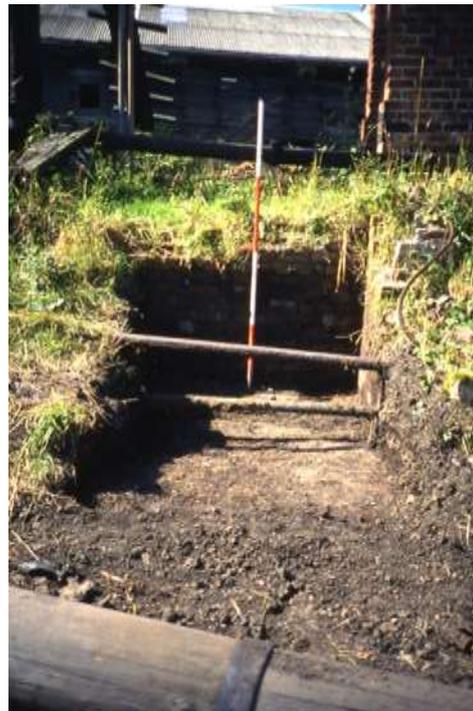
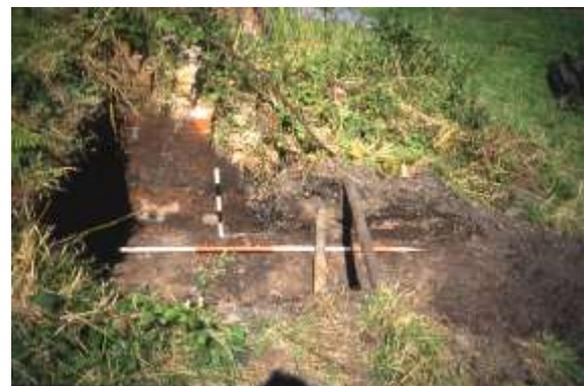
2.5: Trench 93-III, west facing

2.6: Trench 93-III, north facing

Trench 93-III was designed to investigate the remains of the south-eastern butter pans from Henry Ingram Thompson's Lion Salt Works that dated to c. 1910 (Phase 5). It was located on the eastern side of the fishery pan on the line of the Lion Salt Works property boundary. It was excavated in two parts, 93-IIIa and 93-IIIb,

separated by a single brick pier. The excavation was still visible in 2012 (2.5, 2.6).

The earliest deposit was clinker-ash material (4309). This was overlain by brown-grey clay surface (4310). The clay surface appears to have been up-cast from the excavation of trenches for the walls of the furnace of the fishery pan (4311).

Cut into this clay surface were the remains of the timber supports (4312) for the hurdles that ran along the eastern side of the fishery pan. The timber survived intact at the northern end of the trench. In the middle, the wood had decayed but still survived as a cast. Pan-scale was found between the hurdle supports and along the side of

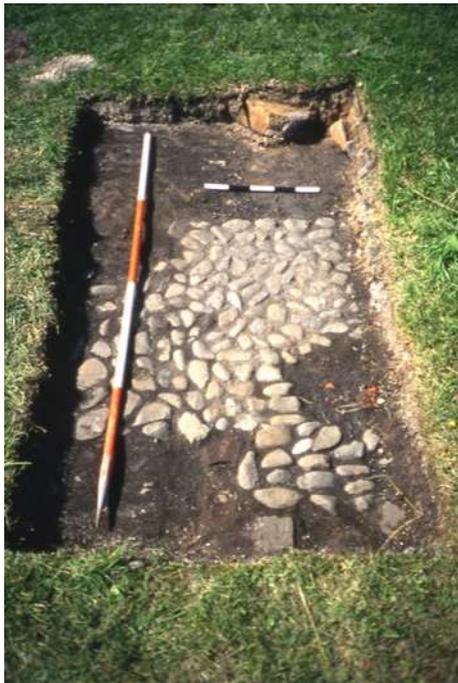
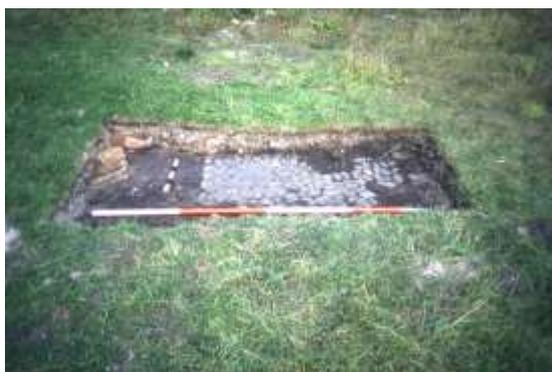
2.7: Trench 93-IV, south facing

2.8: Trench 93-IV, west facing

The small trench was laid out to discover the south-eastern corner of the stable building (Building 19, see above). It was 2.0m (east-west) x 0.5m (north-south) and excavated to a depth of 0.2m below current ground level (2.7, 2.8).

The earliest deposit was a cobbled surface of river pebbles (4314), possibly associated with the brick path (4304) located in Trench 93-I. This was overlain by clinker-silt and brick rubble (4315).

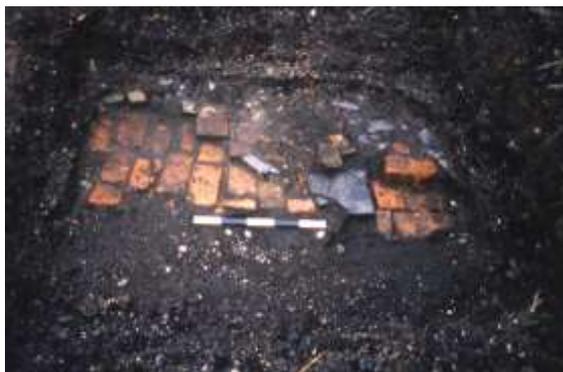
2.10: Trench 93-VII, detail of brickwork uncovered

below current ground level (2.10). It was later subsumed into excavation Trench 94/95-IV (see 2.3 below).

The earliest deposits encountered were a solid mass of hand-made, red brickwork (4322) that suggested the vaulted remains of a furnace or flue. The brick was degraded and the excavation was ceased. Excavation was continued in subsequent seasons (see below, Trench 94/95-IV). The brickwork was covered by a shallow layer of black clinker ash (4323).

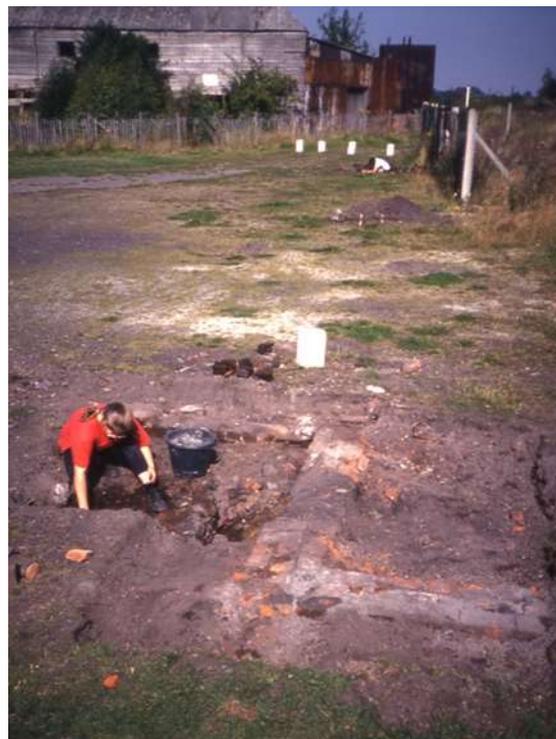
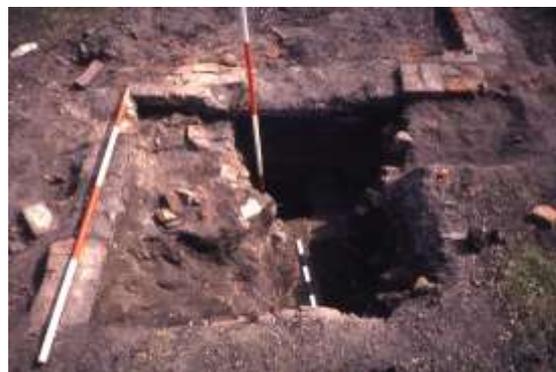
2.11: Trench 93-VIII, with Trenches 93-X and 93-XI to the north, north facing

2.12: Trench 93-VIII, east facing

Cut into this was the remains of a series of wall foundations equating to Building 12. The hand-made red brick wall ran north-south (4325). It was 0.4m (15 inches) wide, had a row of header bricks forming the foundation of the wall and was taken up for another nine surviving courses in English Garden Wall bond (2.11, 2.12).

It turned a corner at the south-west and then continued as a wall (4326) that ran east-west. This wall was slighter, being 0.23m wide (9 inches) but of similar construction, notably leaning to the south as it had become collapsed. It continued to the east as a red line of brick dust incorporated within the surface of the car park. Trench 93-VIII

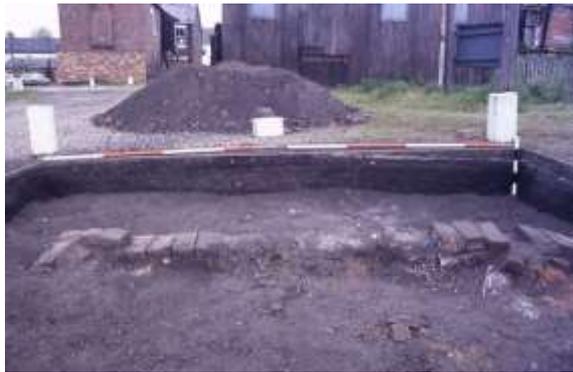
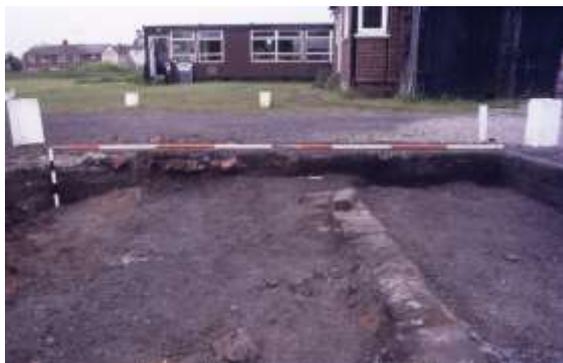
2.16: Trench 94/95-I, after initial layer of excavation, including wall 4104, south facing

2.17: Trench 94/95-I, after initial layer of excavation, including wall 4104, south facing

A narrow north-south, hand-made, red-brick wall (4104), two skins thick (0.22m), ran for c. 3.5m before discontinuing at the southern end (2.16, 2.17). This was again, overlain by a shallow layer of clinker silt material (4105). It was overlain by the

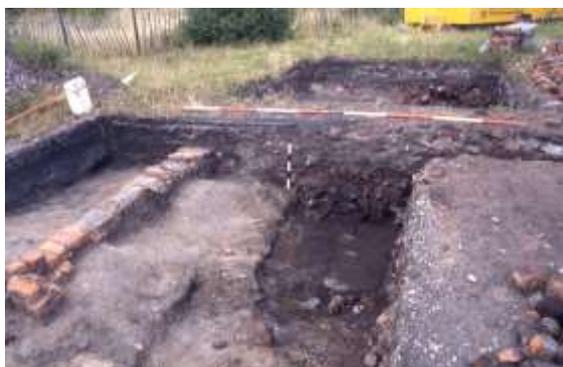
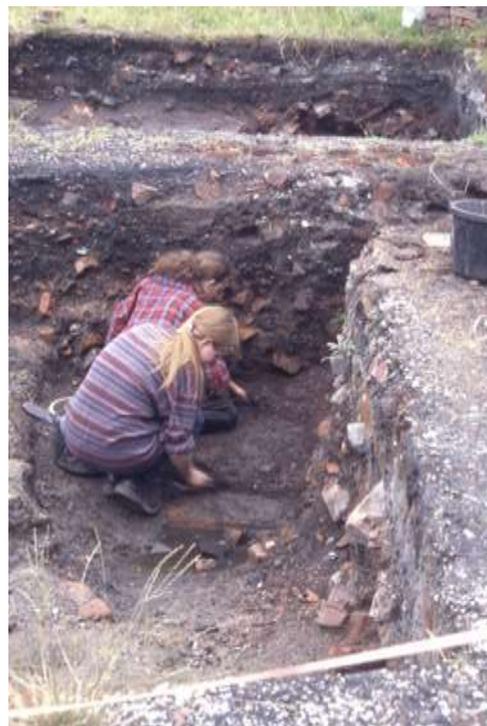
2.18: Trench 94/95-I, after excavation, north facing

2.19: Trench 94/95-I, Trench 94/95-III, during excavation 1995 season, north facing

A mixed layer of brick rubble and silt (4103) covered the trench for a depth of c. 0.4m. Within this deposit was a preserved plank of wood, c. 300mm x 150mm. This appeared to be the remains of an elm board from a salt tub (2.18, 2.19).

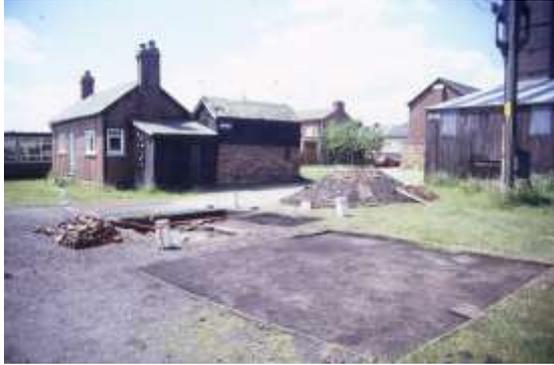
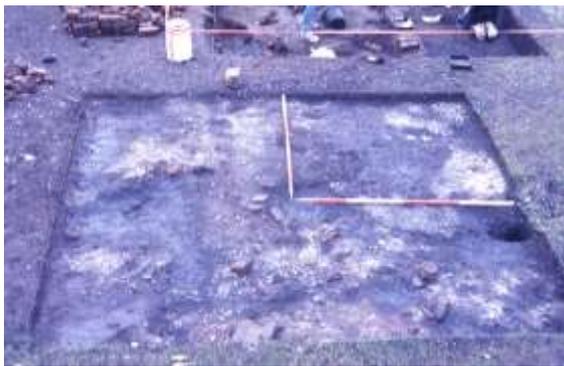
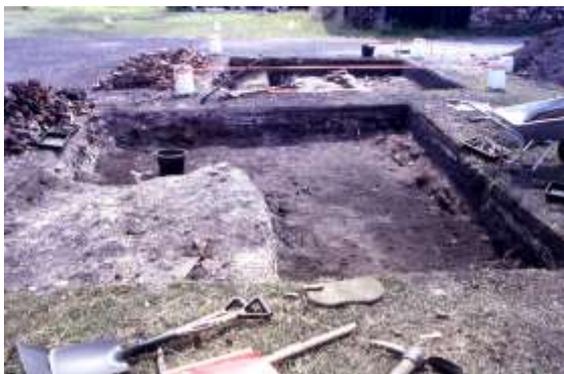
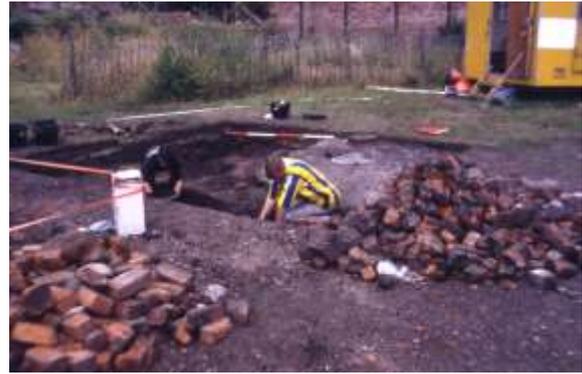
2.26: Trench 94/95-III, prior to excavation, south-west facing

2.27: Trench 94/95-III, initial layer, south facing

2.28: Trench 94/95-III, post excavation, south-west facing

2.29: Trench 94/95-III, during excavation, north-west facing

Trench 94/95-III was separated by a narrow baulk from Trench 94/95-I and located 0.3m to the north. It was on the same alignment on the western side of Building 13 on Thomas Ward's c. 1880 plan. It was also c. 4.0m by 4.0m in size. The trench was originally excavated in 1994 as an open area excavation taken down in spits across the excavation to a depth of c. 0.4m (2.26, 2.27, 2.28, 2.29; AS001; AS008).

The trench revealed layers of brick rubble and black clinker silt across the entire area (4111), c. 0.3m deep. Running along the edge of the north-west baulk was a north-south aligned near collapsed hand-made red brick wall foundation (4112). This was the continuation of wall 4101 to the south in Trench 94/95-I.

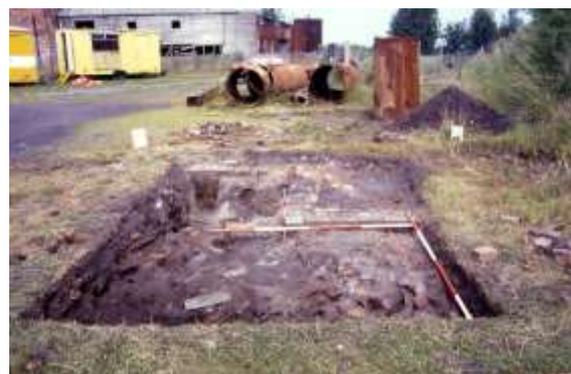
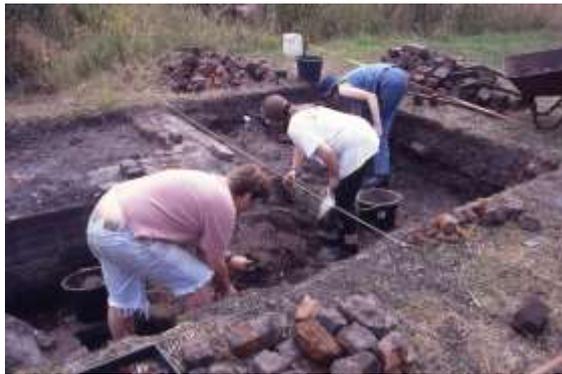
2.30: Trench 94/95-IV, initial strip, north facing

2.31: Trench 94/95-IV, during excavation, south-east facing

Trench 94/95-IV was located over the south-west corner of Building 12 on Thomas Ward's plan. The building was initially investigated in Area VIII of the 1992-1993 work. Its initial excavation was subsequently expanded in size. The trench was c. 3.0m (N-S) and 4.0m (E-W) (2.30, 2.31; AS001, AS008).

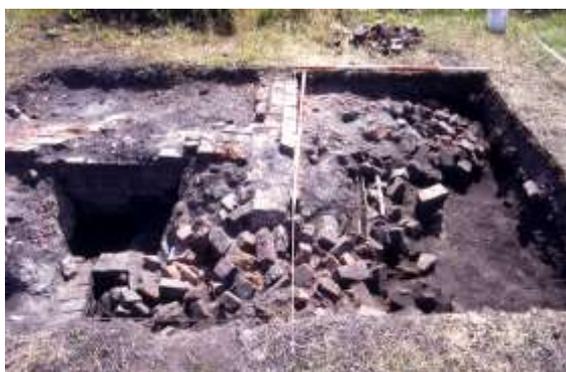
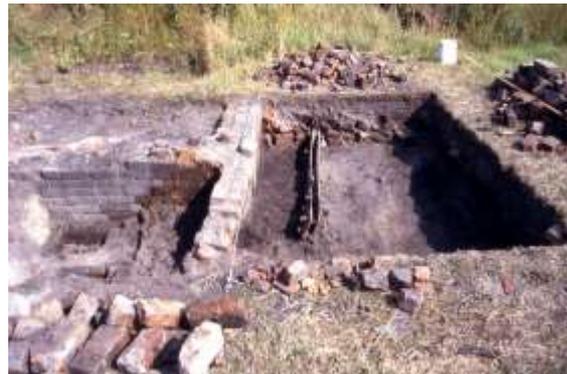
2.32: Trench 94/95-IV, initial strip, north facing

2.33: Trench 94/95-IV, post excavation, east facing

The earliest remains were described above in Trench 93-VIII as (4325), a north-south wall and in the south-west wall (4326). These were revealed to be the remains of an east-west (4115) and north-south (4116) walls. These were revealed to be three courses wide (c. 0.4m, 15 inches) and laid in English Garden Wall bond. Extending west of these walls were two hand-made, red-brick, wall foundations (4117, 4118), two skins (0.23m, 9 inches) thick, orientated north-south. Between was a square hand-made, red-brick, structure (4119), two skins (0.23m, 9 inches) thick, that represented an underground flue (2.32, 2.33).

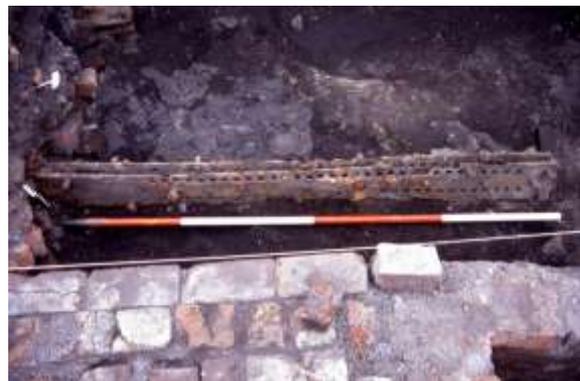
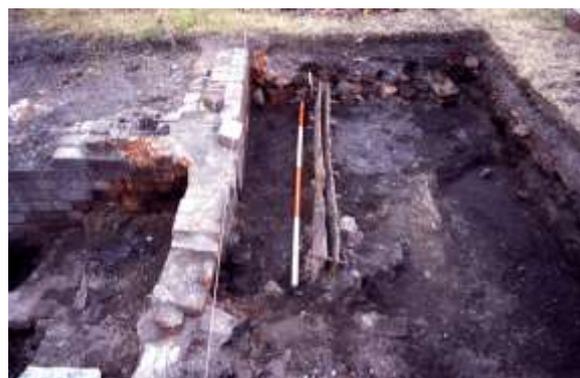
2.34: Trench 94/95-IV, jigger tool, SF117, south facing

2.35: Trench 94/95-IV, jigger tool, SF117, east facing

A jigger tool (SF117) was found south of east-west wall (4115), and a second one could be seen in the eastern baulk (4125), but was left in place. Small parts of the jigger tool survive but the remainder has corroded (2.34, 2.35).

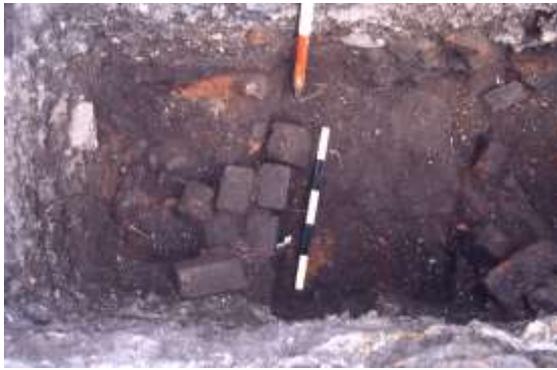
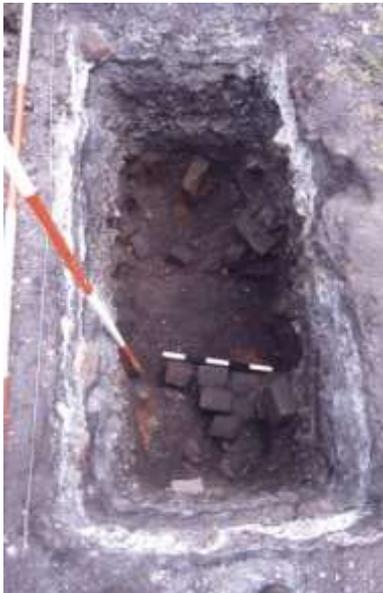
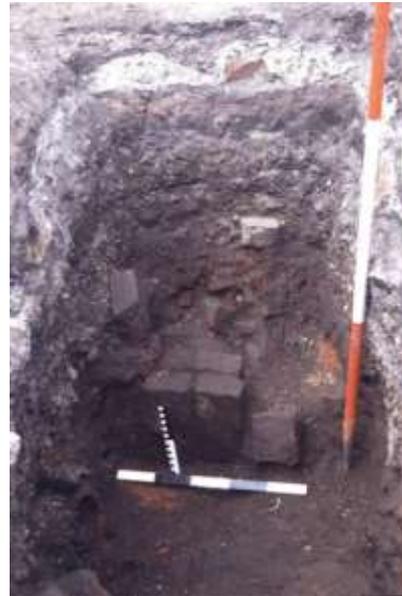
2.37: Trench V, overhead of wall 4101, 1995 season

2.38: Trench V, after excavation, 1995 season

2.39: Trench V, wall 4101, east facing, 1995 season

At a depth of about 1.2m, a brickwork floor (4100) was encountered, which would have been located to the front (west) of the open pan. The floor was made of hand-made, red brick, laid on side in

Stretcher bond. It extended for c. 1.2m from the western edge of the trench. A fragmentary, narrow brick wall overlay the floor surface, two courses wide, of hand-made red brick (4101). This appeared to correspond with the original western wall of the furnace (2.37, 2.38, 2.39).

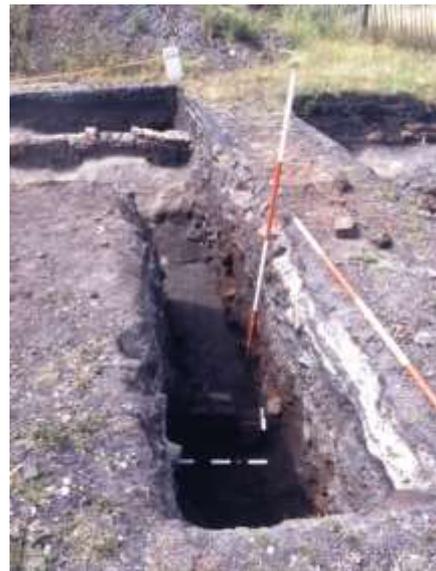
2.40: Trench V and Trench I, after they were joined, west facing, 1995 season

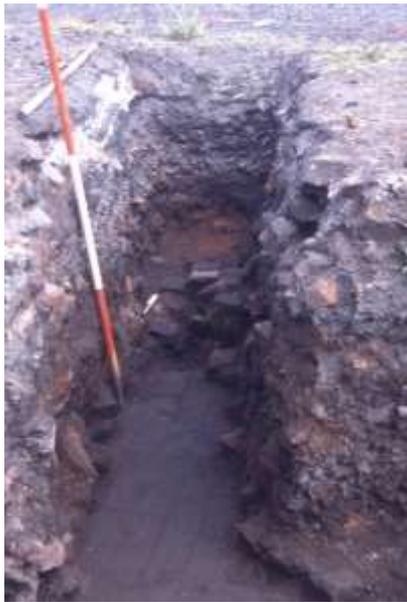
2.41: Trench V, after excavation, east facing, 1995 season

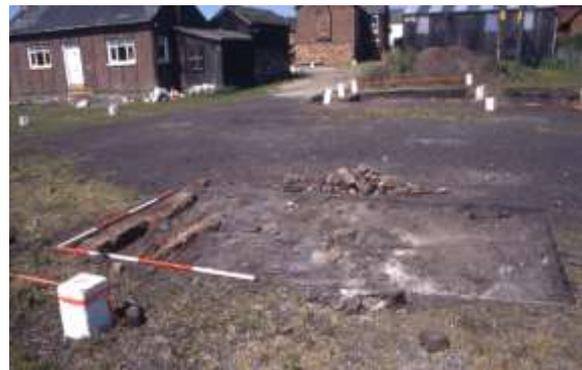
2.44: Trench 94/95-VI, initial excavation, south-west facing, 1995 season

Initially it was excavated in plan during the 1994 season. During the 1995 season a profile was excavated across the northern side of the trench (2,42, 2,43, 2,44).

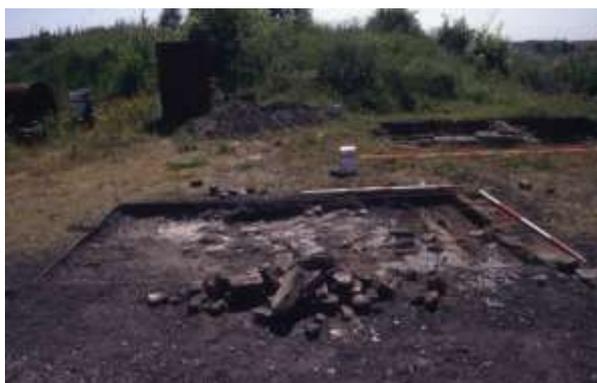
2.42: Trench 94/95-VI, with Trench 94/95-IV, initial excavation, east facing, 1995 season

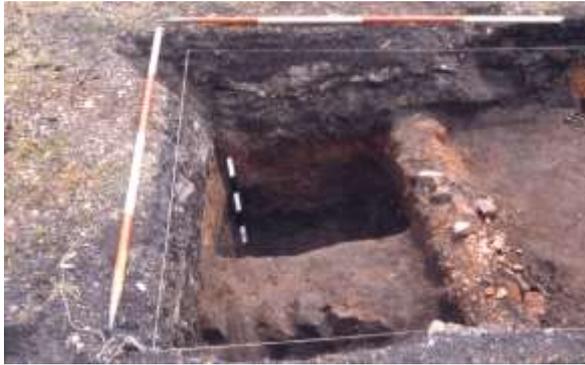
2.45: Trench 94/95-VI, sondage in north-east corner, east facing

The earliest deposit in the trench was grey-brown silt clay material (4126) associated with the subsoil of the original field. This was overlain by a layer of brown mixed silt, c. 0.15m deep (4127). This was overlain by a narrow deposit of black clinker ash, c. 0.2m deep. Over this was a layer of red silt-clay, 0.2m deep (4128) (2.45, 2.46).

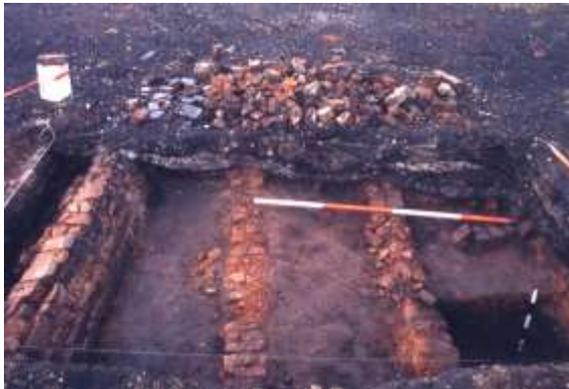
2.46: Trench 94/95-VI, excavated flues, west facing

The remains of the back-end of the furnace under the open pan were within Trench 94/95-VI. This consisted of a series of flues built on a layer of red silt-clay (4128). This layer acted as the 'caulk' for the furnace. The caulk was a loam material designed to allow the ground to expand and contract, during heating. The layer has become oxidised due to the temperature of the furnace above and created an even uniform red colour. This layer was also found under Pan House 4. It is commonly associated with glass and pottery kilns. Above this were four brickwork walls that acted as flues (4129, 4130, 4131, 4132), running east-west. They were originally interpreted as the remains of a brick vault (4322) in Trench 93-VII. The flues were typical of the excavated examples between Pan and Stove Houses 3, 4 and 5, recorded during restoration work. This suggests that these were flues that led from the furnace into the stove house where the heat was recycled to dry the block salt.

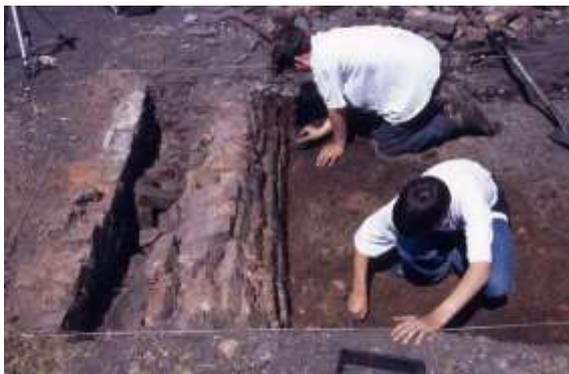
2.47: Trench 94/95-VI, southern wall of pan house and flue wall, west facing, 1995 season

Above this layer were the remains of a series of four east-west flues (4129, 4130, 4131, 4132) at a depth of c. 0.3m below the current ground level. They were coarsely built of hand-made red brick laid in English Garden wall bond, two skins thick. They were severely heat affected and had

laminated in places. The northernmost of these (4132) was visible in section only (2.47, 2.48).

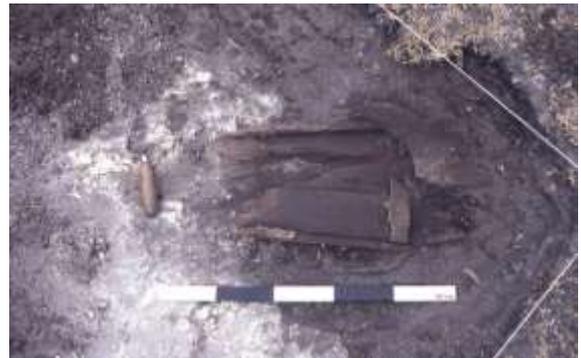
2.49: Trench 94/95-VI, salt tub, SF142, in north-west corner, 1995 season

was overlain by mixed brick rubble and black clinker-ash furnace waste deposit (4136) associated with the demolition of the salt pan and subsequent levelling of the site. Within this layer the remains of a preserved elm wood salt tub were discovered (SF142) (2.49, 2.50).

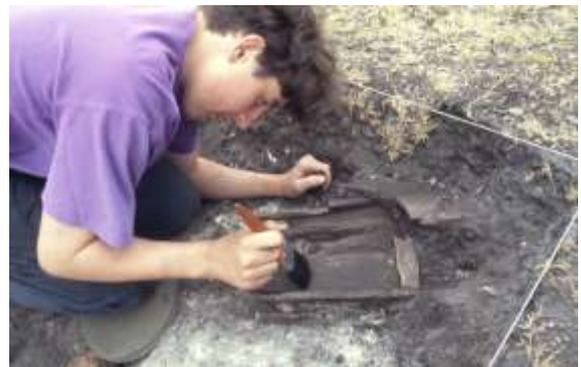
2.50: Trench 94/95-VI, salt tub, SF 142, during excavation in north-west corner, 1995 season

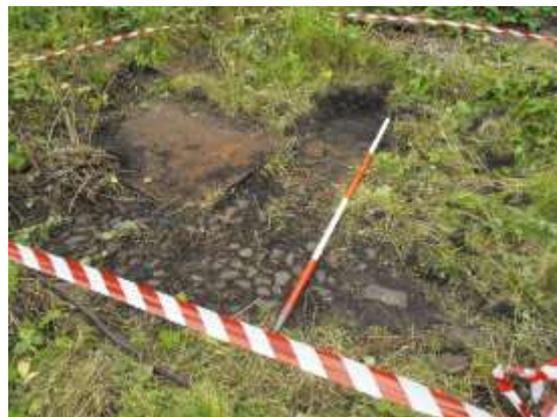
3.5: Cobble surface 438 north-east of pump house, west facing

The exception was an area of cobbles exposed just below ground level, to the south of Stove House 5 and to the north-east of the nodding donkey and pump house complex. The remains were revealed during clearing of this area prior to the enabling works. The exposed area of cobbles was 2.0m (N-S) by 1.0m (E-W) and comprised rounded river cobbles 50-100mm in diameter, set in a black-brown silt matrix (438, 3.5).

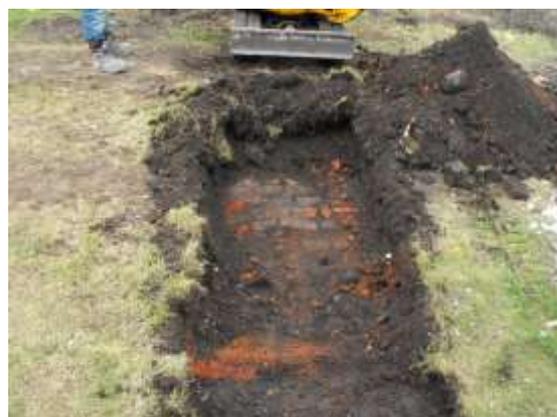
3.6: Brick-surface west of Manager's House (439), south facing

Remains of a brick surface were revealed in a trench cut for telephone cables and a water pipe. It ran south-west to north-east, south-east of the Manager's House. The surface was constructed of hand-made red brick, laid on-side in Stretcher bond (439). It extended for c. 3m north-south (3.6, 3.7, 3.8). The trench turned sharply and then ran south-east to north-west, as a very shallow trench across the area to the east of the Manager's House

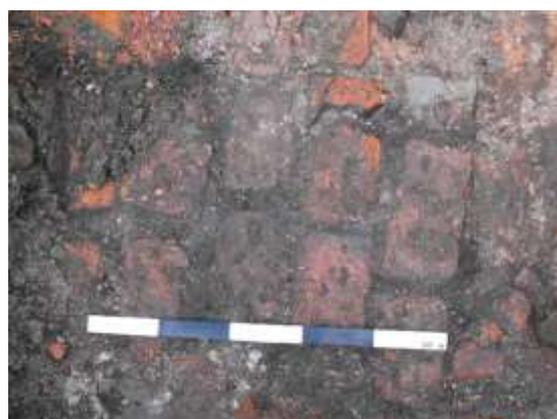
3.7: Detail of brick surface west of Manager's House (439)

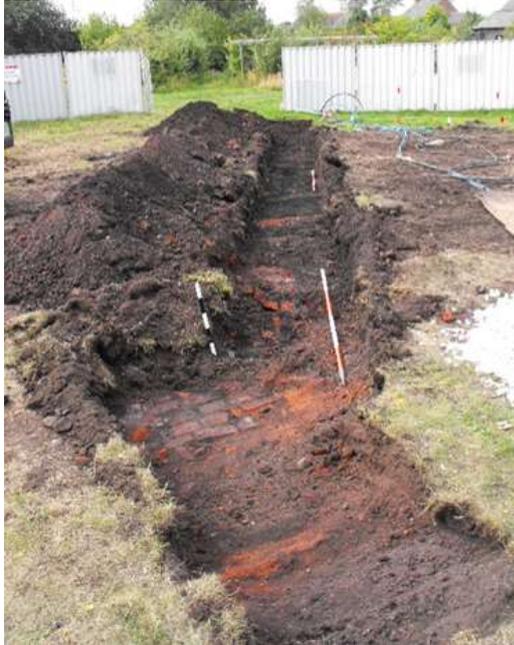
3.8: Brick surface west of Manager’s House (439), south-west facing

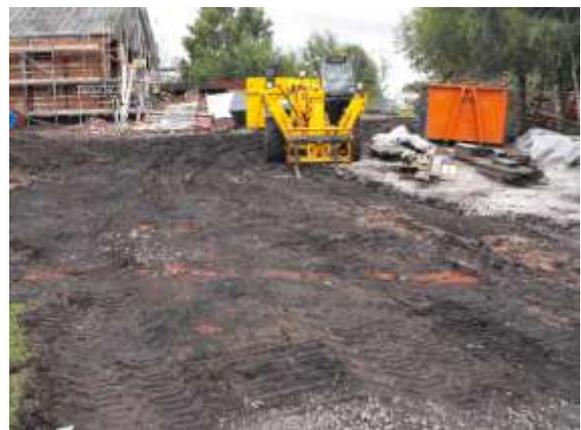
3.11: Southern edge of building Alliance Works, north facing

Just to the north was a hand-made red brick wall foundation, two courses wide (0.25m), which ran east-west (440). This was the line of the southern

edge of a large warehouse of the Alliance Works and was also during soft-stripping (3.11, 3.12). This corresponded with the edge of the building observed in Trench C during excavations in 1993 (see above). The area was covered by the same mixed black-brown rubble and humic topsoil (437) as previously described above.

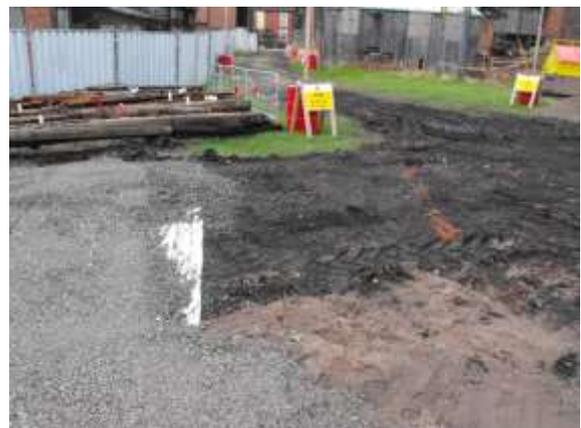
3.12: Southern edge of building Alliance Works, east facing

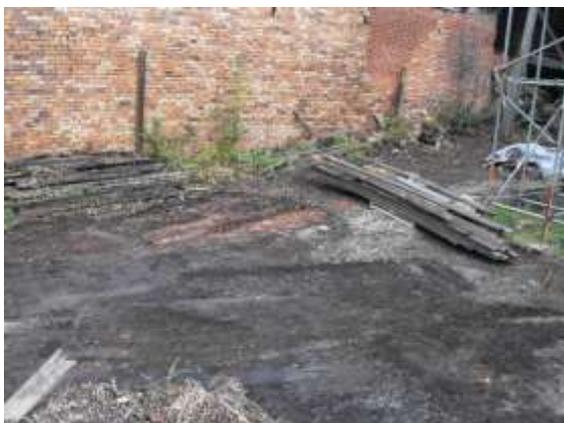
3.18: Remains of brick wall adjacent to Stove House 4, west facing

red brick wall (443) surface was uncovered adjacent to the eastern edge of Stove House 4, again about 1m from the wall and c. 3m in length (3.18). The area was covered with the same mixed black-brown rubble and humic topsoil (437) as previously described above.

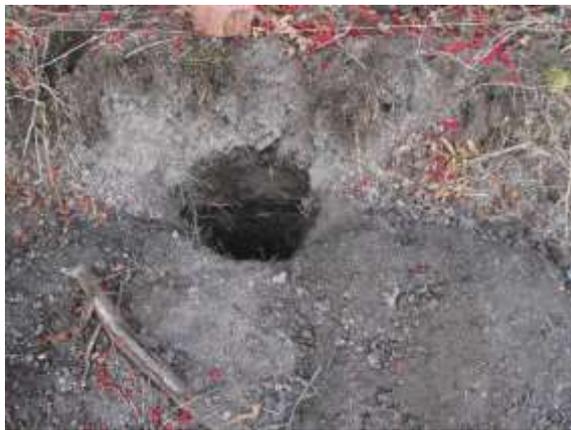
3.21: Fence post-excavation, cinder remains (444)

During the construction of this fence the metal posts were made fast by a series of concrete post bases. These were excavated in the ground, 300mm x 300mm and 600mm deep. The majority of these fence posts revealed no archaeological deposits. No significant archaeological deposits were revealed in the fence posts south of the Occupation Road. The majority of fence posts north of the Occupation Road revealed no significant archaeological deposits. The exception were a series of five fence post holes, c. 20m south of the canal. These revealed remains of ash-cinder deposits (444; 3.21) close to the surface. A single fence post revealed hand-made red brick remains (445; 3.22). It was excavated to shallow depth (<300mm) to preserve the archaeological remains.

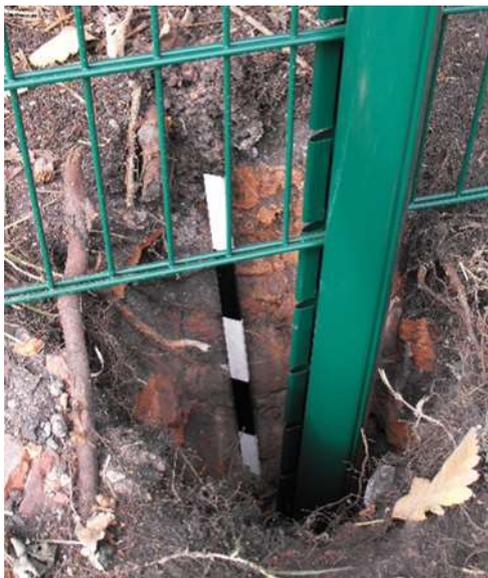
3.22: Fence post-excavation, brick remains (445)

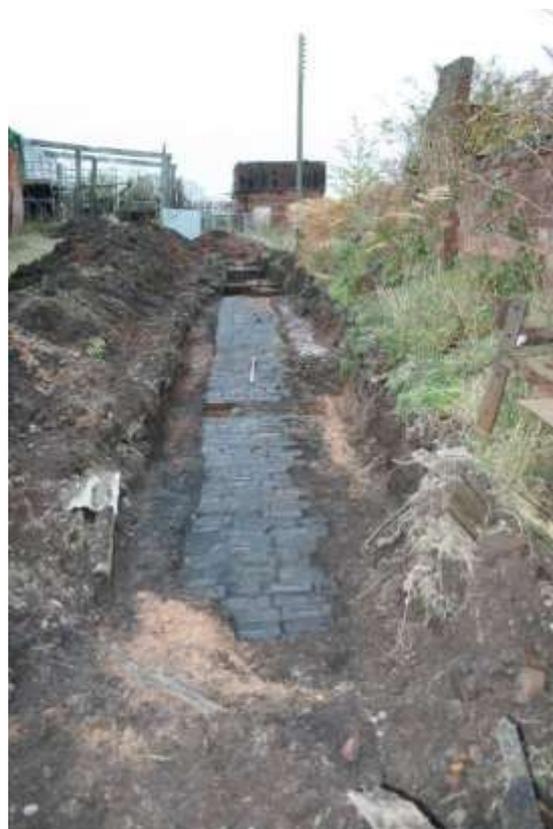
4.1: Looking north-east along surface 12, Trench 2

The structural elements exposed in the southern part of the trench were dominated largely by the well-preserved remains of a brick-built path (12), the upper surface of which lay at a depth of 0.20m below the modern ground level (4.1). Surface 12 was exposed for a length of 11.5m, and was up to 0.8m wide (AS011, AS012). It was composed of machine-pressed bricks, each measuring 230 x 120 x 80mm, some of which incorporated a frog, and a few were stamped 'Birchenwood', denoting the manufacturer. There was no surviving evidence for the use of mortar in the surface. A small slot excavated by hand through a damaged part of the surface revealed that it was a single course in depth, and had been laid onto a bedding of ash and cinders.

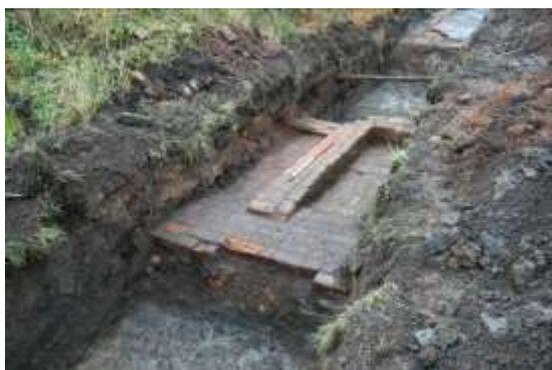
4.2: Surface 15, Trench 2

The remains of a further brick-built surface (15) was exposed at a depth of 0.4m in the central part of the trench, situated 4.4m to the north-east of surface 12. Surface 15 comprised machine-pressed bricks, each measuring 230 x 120 x 80mm, bonded with a lime-based mortar. The surface was slightly concave, sloping down gently to the centre from both ends. The south-western end of the surface abutted a 0.4m wide brick-built wall (13), which was aligned north-west/south-east across the trench (4.2). Wall 13 was three brick courses wide, and survived to a height of 0.7m.

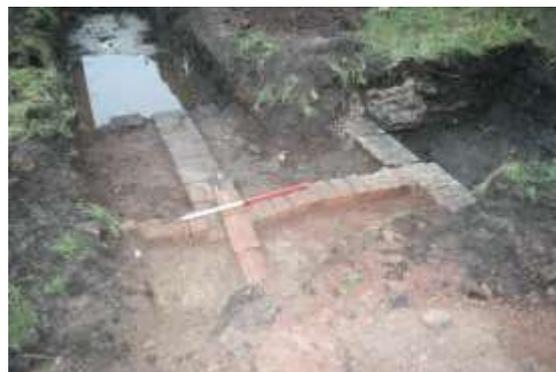
4.3: Looking south-west across walls 16, 18, 19, 20 and 21, wall 30 visible in section

had been largely destroyed. Wall 30 was five brick courses wide, indicative of having been a load-bearing structure, and comprised machine-pressed bricks bonded with a lime-based mortar. The position and alignment of the wall corresponded with the footprint of the eastern wall of the Red Line Inn, as depicted on the Sale Plan of 1868.²⁴

Immediately adjacent to wall 30 was north-east/south-west-aligned wall 21, which formed the western side of the group. Wall 21 was three-courses wide, and similarly comprised machine-pressed bricks bonded with a lime-based mortar, although appeared to be of a later date than wall 30. Wall 21 was abutted by north-west/south-east-aligned wall 19, which was only a single course of bricks wide, and continued beyond the eastern edge of the excavated trench (AS011). Wall 16 lay parallel to the south of wall 19, and survived to a height of 0.37m. The two walls were joined by north-east/south-west-aligned wall 18, which was one and a half bricks wide, and had a modern electricity cable with stamped tile capping (20) laid along its upper surface. Walls 16, 18, 19 and 21 all comprised machine-pressed bricks, each measuring 230 x 120 x 80mm, and bonded with a lime-based mortar. The walls appeared to be of a contemporary construction, whilst their position corresponds with the south-western corner of the north-east fishery salt pan depicted on historical mapping of 1898 and 1910.²⁵

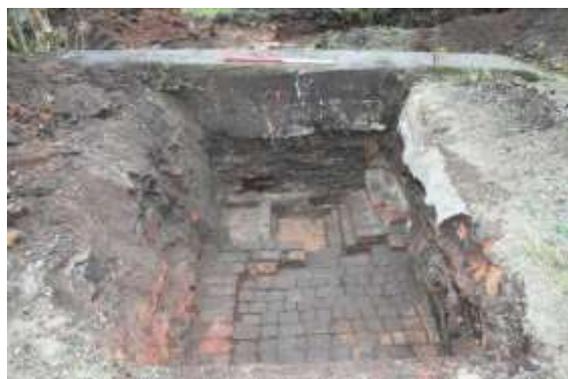
4.4: Looking east across wall 26 and surface 23/25, concrete beam 22

trench. The structure comprised north-east/south-west-aligned wall 29 at the western end of the trench, and the truncated remains of wall 26, which was exposed on a north-west/south-east alignment for 1.3m and then returned south-west as a wall three brick courses wide (AS011). Both walls comprised machine-pressed bricks, each measuring 230 x 120 x 80mm, bonded with a lime-based mortar. The two walls bounded a surface of broken machine-pressed bricks (27), which did not appear to have any bonding material, although the slightly burnt and sooted condition of the component bricks suggested that they had been subject to high temperatures (4.4), consistent with their suggested association with a fishery salt pan.

The remains of another brick-built surface (23/25) were revealed to the southeast of wall 26 (AS011). This was associated with a single brick wide wall (24), which was aligned east/west and continued beyond the northern edge of the excavated trench. These structures seemed to form the north-eastern end of a c. 2m wide brick-built structure that had been demolished, filled in with a dumped deposit of ash, cinders, crushed brick and burnt clay (33) and then covered with crushed brick (32) to create a resilient ground surface (Fig 9). The latter deposit had a fairly uniform thickness of 0.25m, and had formed a level surface that probably represented twentieth-century demolition and remodelling of the site. This may have been associated with the construction of concrete beam 22, which was aligned north-east/south-west across the trench, was 1m wide and survived to a height of 1.4m (4.4).

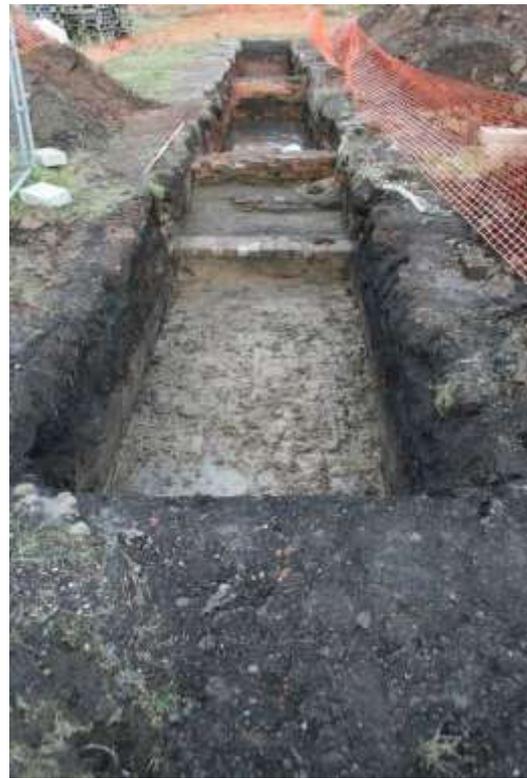
4.5: General view of Trench 4 (West), looking south-west

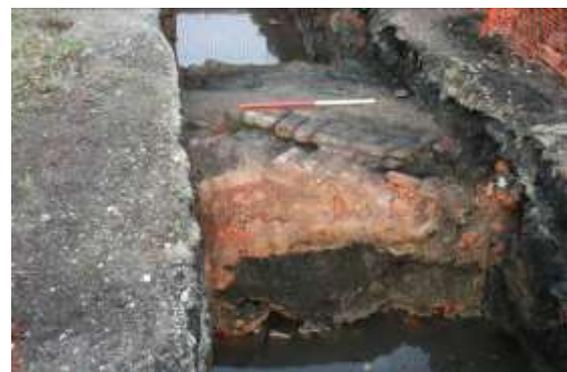
4.6: The exposed remains of structure 118

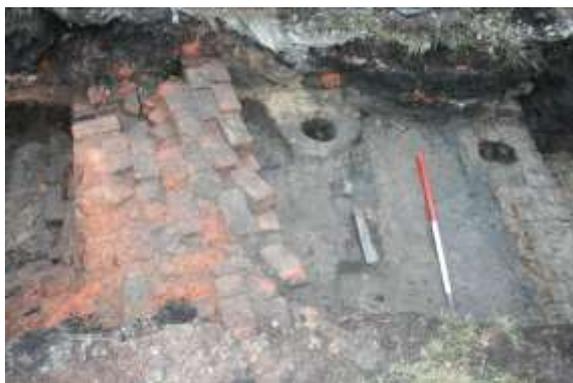
4.7: Structure 114, wall 115 and postholes 116 and 117

cut (4.7). Both contained the stumps of wooden posts. Posthole 116 was 0.23 x 0.18m, and survived to a depth of 0.07m deep, and was partially cut into wall 115. Posthole 117 was 0.32m in diameter and 0.3m deep, and lay closest to structure 114 (AS014). These probably formed elements of the timber framing for a structure associated with the pan/stove houses of the Alliance Salt Works. Wall 115 is likely to have formed part of the same structure, with 114 perhaps representing the remains of an internal feature.

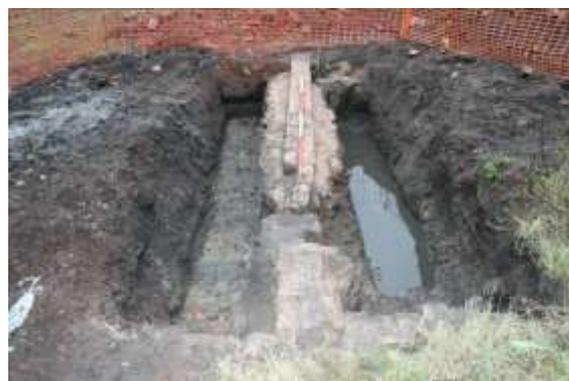
4.8: Wall 37 in Trench 5

The natural geology, comprising light grey sticky clay (40) was exposed at the base of the excavated trench (4.8). This was overlain by a 0.8m thick deposit of mixed dark grey clay, ash and crushed brick (35), which is likely to have derived from the demolition of the 19th-century structures.

The exposed remains included a north-west/south-east-aligned wall (37), which lay immediately beneath the modern ground surface (4.8). Wall 37 was exposed along the centre of the trench, was two brick courses wide, and had been built on a concrete foundation, indicative of a 20th-century construction date. The fabric of the wall comprised machine-pressed bricks. The north-western end of the wall appeared to have been cut through an earlier wall (36), which similarly comprised machine-pressed bricks. The remains a vertical I-

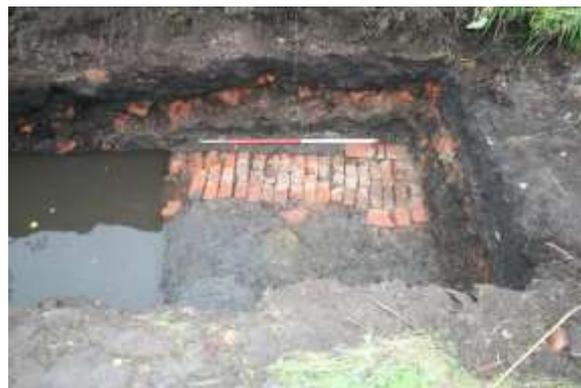
4.9: Structure 90 in Trench 12

Surface 85 was overlain by a deposit of crushed bricks in a sandy clay matrix (84), which may have derived from the demolition of the Building No 29. This deposit had been cut by structure 90, which comprised a 0.5m wide surface composed of hand-made bricks. This was aligned north-east/south-west, and had perhaps formed the base of a drain or a flue, although none of the component bricks retained any indication of having been subjected to high temperatures (4.9).

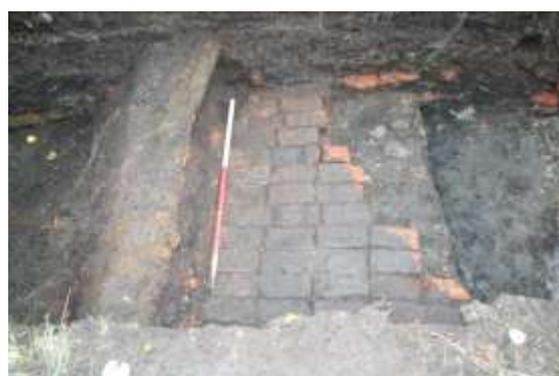
4.10: Surface 89 and cast-iron pipe 81 in Trench 12

Surface 89 lay at a depth of 0.6m below the modern ground surface, comprised machine-pressed bricks, and was a single brick course thick. The surface sloped downwards slightly to the north-east, although it remains uncertain whether this was a design feature or a result of slumping (4.10). The surface was laid on a bedding of coarse dark purple cinders (87) and a thin lens of compact black sandy clay (77).

A second cast-iron pipe (81) was exposed some 3m to the north-east of pipe 88, and was similarly aligned north-west/south-east (Fig. AS017). Pipe 81 had a diameter of 120mm, and incorporated a corroded high-pressure flange joint, suggesting that it may have been a steam pipe.

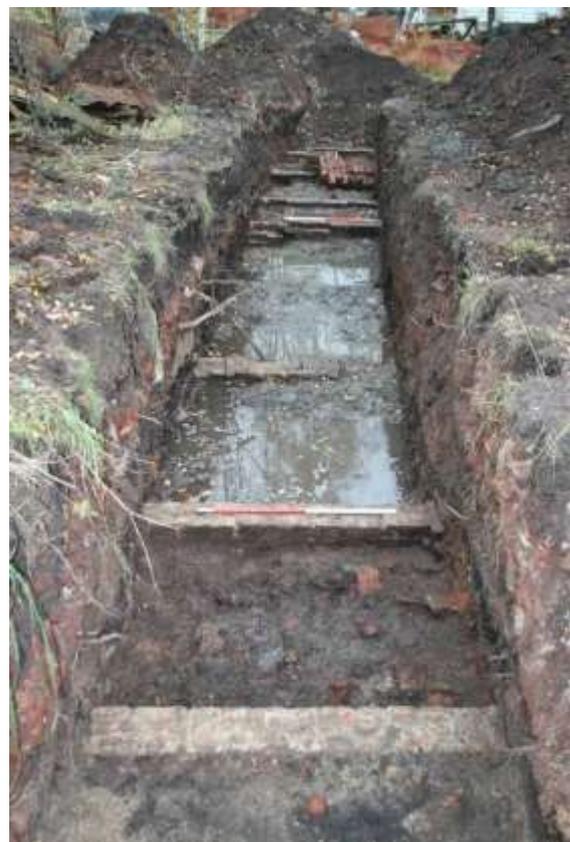
4.11: Looking south-west along Trench 13

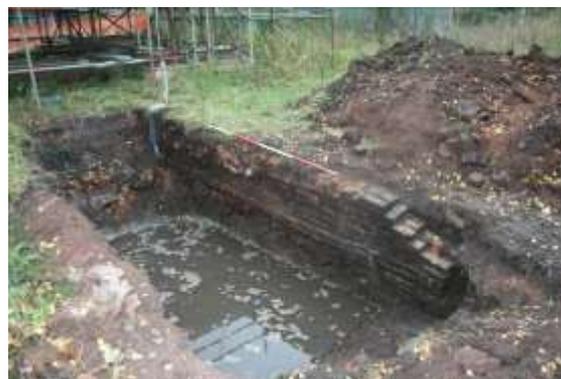
4.12: Wall 72, Trench 14

below the modern ground surface. The south-west-facing section of the trench comprised a wall (72) comprising machine-made bricks in 4:1 English Garden Wall bond, with slightly splayed header footings sat on crushed brick and cinder bedding (73 and 74). The top of the wall was exposed at a depth of only 0.01m below the current ground surface (4.12). Wall 72 was aligned north-west/south-east, and its position corresponded closely to the northern wall of a rectangular building forming part of the Alliance Salt Works depicted on the Ordnance Survey map of 1882.³⁵

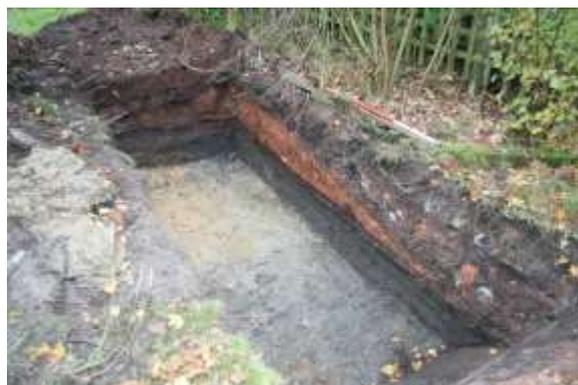
4.13: Trench 15 (West) fully excavated

of mixed, sticky grey clay (05), which potentially represented a buried ground surface. This was sealed by a level and compacted lens of purple cinders and black ash (04), which appeared to have been laid deliberately to create the foundation for a solid surface. This was overlain by a compacted band of crushed brick fragments and burnt clay (03), which had a maximum thickness of 0.5m at the north-eastern end of the trench (4.13).

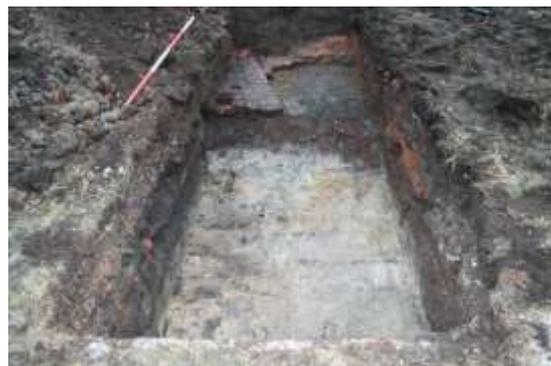
4.14: Trench 15 (East) fully excavated

Trench 15 (East) was placed to the north-east of Trench 15 (West), and was similarly beyond the boundary of the Scheduled Monument. The trench was targeted on a structure that housed the open salt pans in the Alliance Works (Open Pans A9-A12).³⁶ The trench was aligned north-east/south-west, and was excavated to a length of 5m and maximum depth of 1.1m (see AS003 above, AS020). The natural geology, comprising light grey sticky waterlogged clay (179), was exposed at the base of the excavated trench (4.14).

Natural geology 179 was overlain by a 0.08m thick layer of loose purple cinders (178), which may have derived from waste material from the boiler house for the Lion Salt Works. This was overlain by a 0.12m thick band of semi-compact black cinders (177) and a 0.1-0.2m thick deposit of compact fine black ash (176), which may have been deposited as a levelling for a brick surface (174). Brick surface 174 was two brick courses thick, and comprised machine-made bricks, each measuring 220 x 100 x 85mm. Some of the bricks incorporated a frog, and a few were stamped with 'Jabez Thompson Ornamental Brickworks Northwich', representing the manufacturer's mark. Surface 174 occupied the northern part of the trench, whilst to the south was a 0.1-0.2m thick layer of mixed loose black cinders, ash and brick fragments (175). Deposit 175 and surface 174 were overlain by a 0.1-0.2m thick layer of semi-compact dark grey brown clay loam and cinders (173). This was sealed by a 0.2m thick band of mixed loose dark grey cinders (172), and 0.08m of turf and topsoil (171), which formed the modern ground surface.

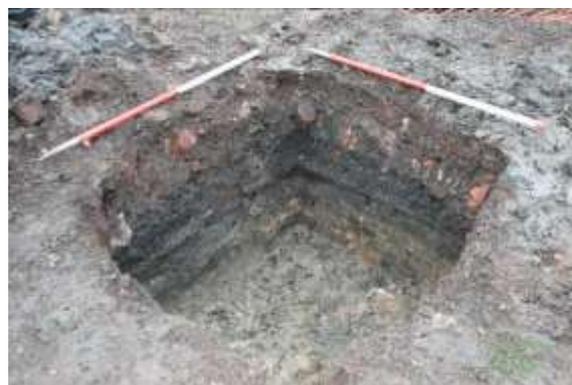
5.1: Test Pit BH 3, fully excavated

Test Pit BH3 (5.1) measured 1m square and was excavated to a maximum depth of 0.86m within the footprint of Stove House 5 (see AS003 above). This part of the site may also have been occupied previously by a cottage (Alliance Works, Building 19),³⁹ which is thought to have been demolished prior to the construction of Stove House 5.

The natural clay geology (159) was exposed at the base of the pit, and was overlain by a 0.12m thick deposit of dark grey brown plastic clay (158), which may similarly have been of natural origin. Deposit 158 was cut by an irregular-shaped feature (157), which contained mixed light brown mottled clay with brick fragments, mortar and late demolition rubble (156). This was sealed by a series of dumped horizons (155, 154, 153 and 152), which seemingly represented late 20th-century activity.

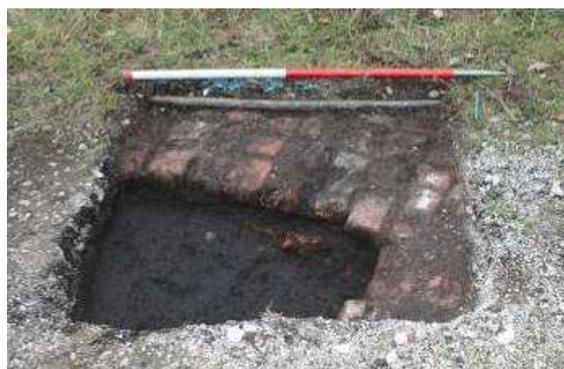
5.2: Test Pit BH 4, showing brick surface 138

Test Pit BH4 was placed a short distance to the north of the Manager's House in the southern part of the site (see AS003 above). It measured 1 x 1m, and was excavated to a maximum depth of 0.2m (5.2). It was re-excavated as Test Pit TP13, see below. A deposit of indurated black ash (139) was exposed at the base of the test pit, which formed a levelling horizon for a brick surface (138). Surface 138 comprised handmade bricks, and was a single brick course thick. This was overlain by a 0.05m thick layer of limestone hardcore (136), which formed the modern surface. Embedded within hardcore 136 was a live electricity cable (137), which was exposed along the south-western edge of the excavated test pit.

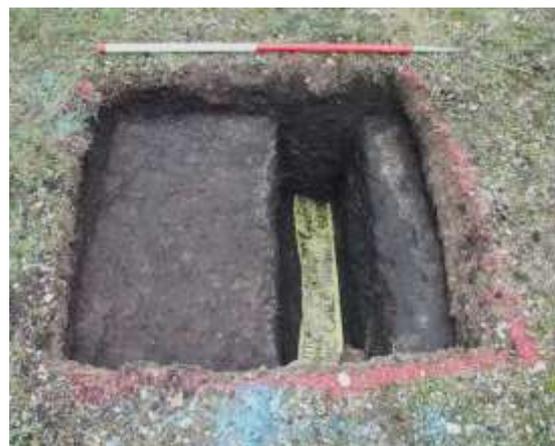
5.3: Test Pit BH 5, fully excavated

Test Pit BH 5 was placed to the north-east of the former Red Lion Inn (Building No 5), adjacent to the site's boundary with Ollershaw Lane (AS003). This area is shown on the sequence of historical mapping to have been an access route throughout the various stages in the development of the site. The test pit measured 1 x 1m, and was excavated to a maximum depth of 0.59m (5.3). No buried structural remains were encountered in the test pit. A rough concrete surface (103/105) of probable late 19th- or early 20th-century date was

exposed at a depth of 0.15m below the modern ground surface. The surface had been cut by a north-west/south-east-aligned linear trench, which was 0.34m wide. This contained a live electricity cable, and had been backfilled with a deposit of black silty sand (107). A 0.15m thick layer of limestone hardcore and crushed brick fragments (106) sealed the trench, and formed the modern ground surface.

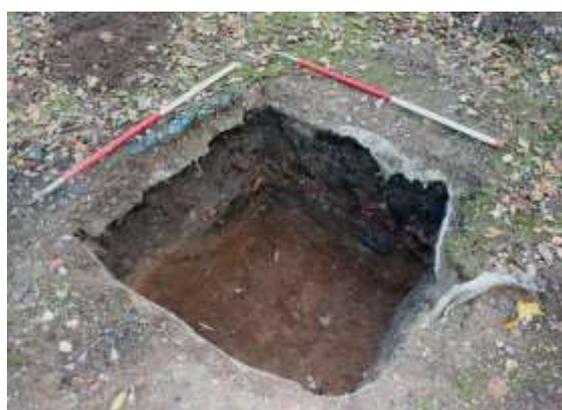
5.4: Test pit TP 1, fully excavated
