THE ALLIANCE AND LION SALT WORKS, MARSTON, NORTHWICH

SCHEDULED MONUMENT NO 34985-002

VOLUME III: THE ARCHAEOLOGICAL EXCAVATIONS, 1992-2015

REPORT NO 2015-01

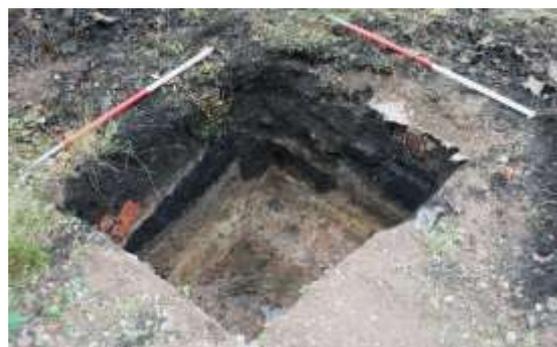
5.5: Test pit TP 2, fully excavated

Test Pit TP 2 was placed in a former yard area to the south of Stove House 5 (Building No 11), in the central part of the site. The test pit measured 1.1 x 1.1m, and was excavated to a maximum depth of 1.1m (5.5). The natural light grey clay geology (150) was exposed at the base of the test pit (Fig 18). This was overlain by a 0.22m thick deposit of sticky yellow clay (149), which contained occasional small fragments of brick, and probably represented a disturbed natural horizon. A thin deposit of sticky grey clay (148), identified in the south-eastern part of the test pit, was stratigraphically above clay 149, and was similarly likely to represent a disturbed natural horizon. This was overlain by a 0.10m lens of black cinders and ash (147), which appeared to represent a dumped

deposit, and was sealed by layer yellowish-brown mixed sticky clay (146). Layer 146 was cut by a square-shaped feature (144), the base of which lay at a depth of 0.76m below the modern ground surface (Fig. AS021). Feature 144 was filled with a deposit of compacted black cinders and ash (143), which also contained modern crisp packets and fragments of steel wire. This was overlain by a 0.05m thick band of compacted light pinkish-yellow clay (142) and a deposit of brown clay and cinders (141). The modern ground surface comprised mixed loam and cinders (140).

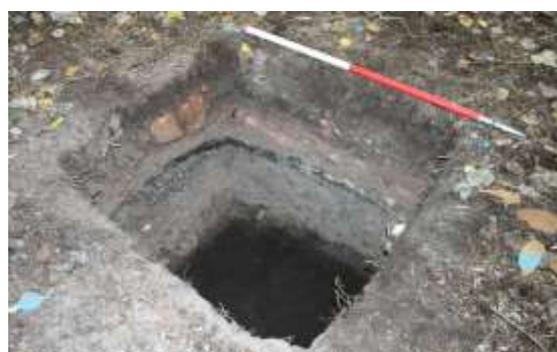
5.6: Test pit TP4, fully excavated

Test Pit TP 4 was placed in the southern part of the site, beyond the boundary of the Scheduled Monument (see AS003 above). It measured 1 x 1m, and was excavated to a maximum depth of 1m (5.6).

The lowest deposit encountered (170) comprised a layer of compacted clay loam containing abundant black cinders, which may have derived from the

smithy. This was sealed by a 0.65m thick deposit of banded light grey to pinkish-grey cinders and nodules of iron slag (169), which were similarly likely to have derived from the smithy. The overlying layers (168 and 167) also contained abundant cinders and fuel ash, and were sealed by a 0.1m thick deposit of burnt limestone (166). The uppermost layer comprised a 0.1m thick deposit of loam topsoil (165).

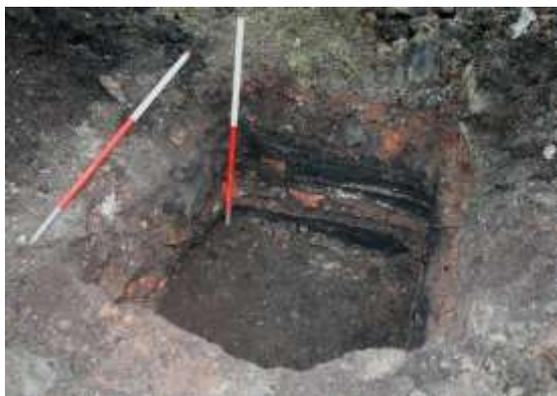
5.7: Test pit TP5, fully excavated

Test Pit TP 5 was placed to the west of Trench 2 adjacent to Stove House 4. It measured 1.1 x 1m, and was excavated to a maximum depth of 1m. Test Pit TP 5 was placed to the west of Trench 2 (see AS003 above). It measured 1.1 x 1m, and was excavated to a maximum depth of 1m (5.7). A layer of dark grey cinders with occasional brick fragments (135) was exposed at the base of the excavated test pit. This was overlain by a series of thin layers and lenses (134, 133, 132, 131, 130, 129, 128, 127 and 126), which all contained cinders, ash and small fragments of fired clay or brick, presumably representing waste products from the industrial processes associated with the salt works. The uppermost of these deposits (126) was sealed by a 0.15-0.25m thick layer of mixed dark brown clay and crushed brick (125), which was overlain by the modern hardcore surfacing (124).

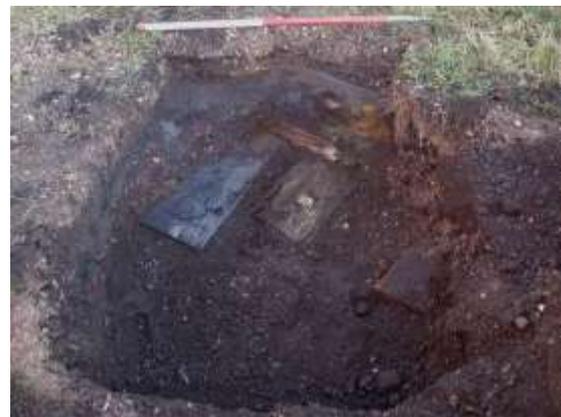
5.8: Test pit TP 6, fully excavated

Test Pit TP 6 was placed close to the eastern corner of the former Red Lion Inn (see AS003 above), measured 1 x 1m, and was excavated to a maximum depth of 0.4m (5.8).

The remains of four worked timbers of differing sizes were exposed at the base of the excavated trench. These were all 0.08m thick, and were embedded in a layer of clinker (208). The timbers were overlain by a steel rail (203), which was exposed in the north-eastern corner of the excavated test pit (Fig. AS021). These features were almost certainly associated with the railway lines that are depicted in this part of the site on the Ordnance Survey map of 1910.⁴¹ Clinker 208 and steel rail 203 were sealed beneath a 0.35m thick deposit of indurated black ash, similar to deposit 139 in Test Pit BH4. A 0.05m thick layer of hardcore (201) formed the modern ground surface.

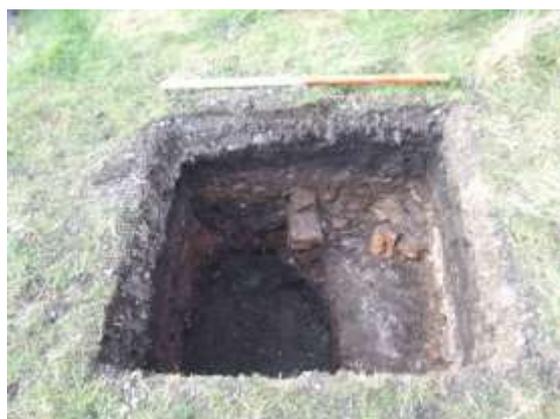
5.9: Test pit TP7, west facing

The earliest deposit in Test Pit TP7 consisted of a brown black layer of silt clinker material (306), 0.2m deep. It contained both pottery and glass, with printed transfer wares of 19th-century date (author inspection). This was overlain by a layer of loose coarse rubble in dark brown sand silt (305), 0.10m deep. A discontinuous layer of white-grey lime mortar (< 0.03m deep) appeared to be a formation layer for a boundary wall that survived as only two hand-made red bricks in situ, although further bricks may have represented loose material. The trench was subsequently filled with mid grey-brown silt-rubble (303) that contained pottery, glass and ferrous slag, 0.15m deep and a gritty layer of brown-black clinker-silt (302), 0.20m deep. The test pit was sealed by a layer of gravel bedding material (301) and a thin layer of humic topsoil (300) both of which date or post-date the 2009 enabling works. Test pit TP7 revealed the remains of a possible short section of wall. This may relate to the remains of a former boundary wall first visible on the 1910 Ordnance Survey Map.⁴² The pottery associated with the earliest

Phase 5: The pottery associated with the earliest layer (306) was on initial assessment from the 19th century. This would date to the earliest period of occupation of the site by the Lion Salt Works and possibly associated with the conversion of the cottages along Ollershaw Lane into the Red Lion Inn. A short section of wall foundation (304) may relate to the remains of a former boundary wall first visible on the 1910 Ordnance Survey Map.⁴³

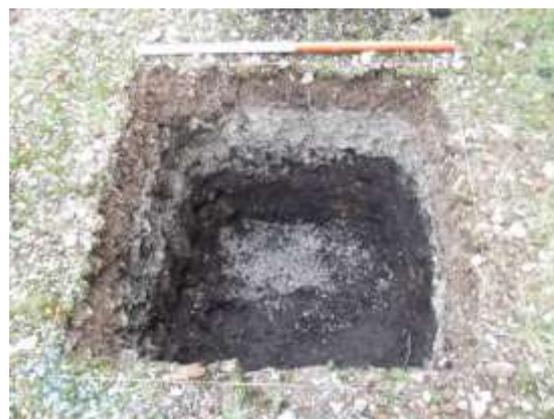
5.10: Test pit TP8, east facing

Test Pit TP8 was located between the Red Lion Inn and Stove House 4 (AS003 above, AS023). It was 1m x 1m and excavated to a depth of 0.8m. It was designed to replace BH5. The earliest deposit in TP8 was light grey pea gravel (310) associated with a sewerage run. This was overlain by dark black-brown gravel silt-clinker containing large river pebbles and brick rubble (309). Above this was imported grey gravel road stone (308), 0.25m deep and a layer of imported rubble (307), 0.15m deep. The test pit revealed remains of a sewerage service run to the toilet block of the Red Lion Inn, probably put in place in the refurbishment of the 1980-1990s. The 0.40m depth of road stone and rubble related to work undertaken during the 2009 enabling works.

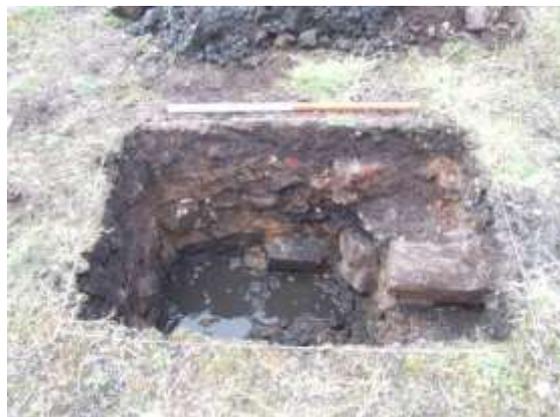
5.11: Test pit TP9, south facing

The earliest deposit in the test pit was a yellow-brown clay-silt that became sandier with depth (318). This may have represented the natural material but could equally be re-deposited. Over this was a mixed light grey ash and clinker layer (314) that was cut by a vertically sided feature that appeared to be a foundation trench 317. The foundation trench was filled by dark brown waterlogged clinker-silt material containing rubble and salt pan scale residues (316) that was at least 0.30m deep but was not fully excavated. Above this was a thin layer of salt pan scale residues (315) that probably constituted a dump of material associated with the demolition of the Alliance Works. The uppermost fill was a black clinker silt layer (313) that contained some salt pan scale, pottery, glass and ferrous metal. This included a single vertical iron pin that may have been in situ and part of the construction for the foundation. Above this were layers of dark brown sand-silt-

Phase 3: The earliest deposit in the test pit was a yellow-brown clay-silt (318) that represented re-deposited natural material. The remains of a foundation trench (317) within the test pit appear to relate to a large building located within the Alliance Works visible on the 1882 Ordnance Survey map. Elements of this may have been excavated in Trench 12 of the evaluation (see above).

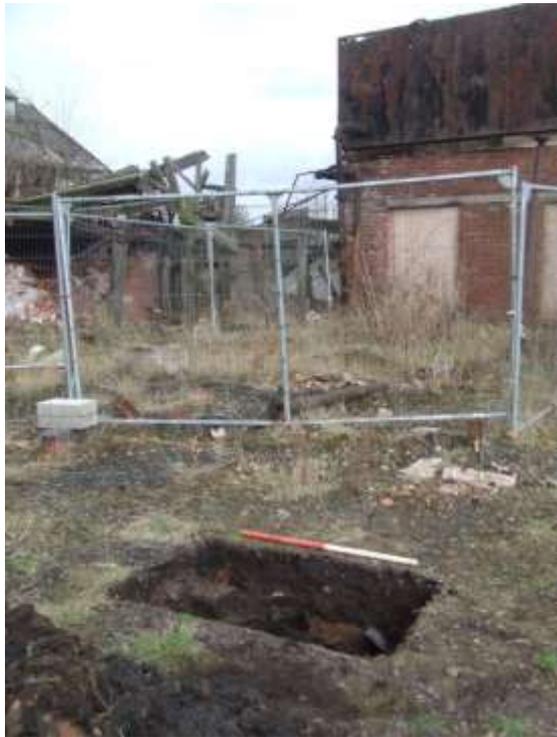
5.12: Test pit TP10, north-west facing

Test pit TP10 was located c. 10m south of the Brine Tank and immediately north of Stove House 5 (AS003 above, AS023; 5.12). It was 1.4m (E-W; expanded during excavation) by 1m (N-S) and excavated to a depth of 0.8m before it was discontinued due to water inundation. It replaced a test pit that was due to be excavated adjacent to the Brine Tank that could not be excavated due to health and safety concerns over the presence of a deep brine shaft which has still not been located. The earliest deposit was a very mixed dirty clinker layer that was heavily waterlogged (323). This lay beneath a band of mixed yellow-brown sand-silt-clay and black-brown silt (322), 0.10m thick. Another thick layer of mixed black-brown sand-silt with brick and panscale rubble (321) 0.40m deep, contained a wooden sleeper. This was overlain by another narrow band of yellow sand-clay (320), and mixed brown sand-silt-rubble topsoil layer (319), 0.10m deep.

layers (319, 320, 321, 322, 323) and related to demolition of Stove House 5 and associated excavation.

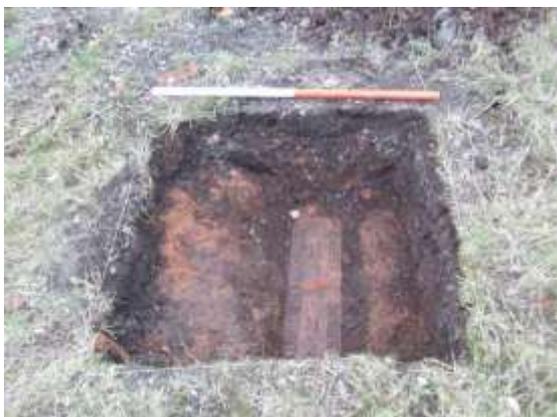
5.13: Test pit TP11, south facing

The earliest deposit was a mixed red-orange sand and clay deposit (325). Within this was the cut for an electricity service run (325) with the associated cover of ceramic tile marked 'ELECTRIC' suggesting that the service run was between 20-40 years old. Above this the trench was filled with a mixed compact brown sand-silt fill with some brick and panscale rubble (324), to a depth of 0.25m.

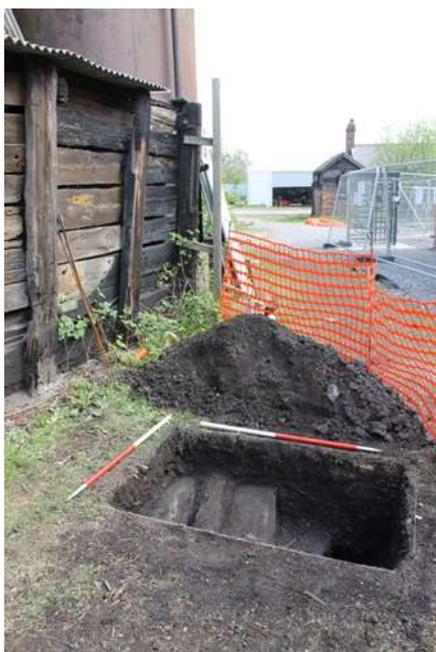
5.14: Test Pit 12, east facing

The earliest deposit located within the test pit was a grey-brown silt-clay layer (361), +0.15m deep. Over this was a coarse brown-black clay-rubble clinker layer (360) of heavily waterlogged material. A compact brown clinker-silt (359), 0.25m thick overlay this in turn to form the construction base for a series of rail lines. The remains of a rail line were represented by a wooden cross sleeper (365) 0.25m wide by 0.12m thick. Laid over this and perpendicular to it was a degraded ferrous metal rail (363) 0.20m wide and 0.10m thick, orientated east-west. Adjacent and parallel to it either side were two wooden sleepers. Sleeper 364 to the south was 0.28m wide and 0.05m deep, whilst sleeper 362 to the north was 0.27m wide and 0.05m deep.

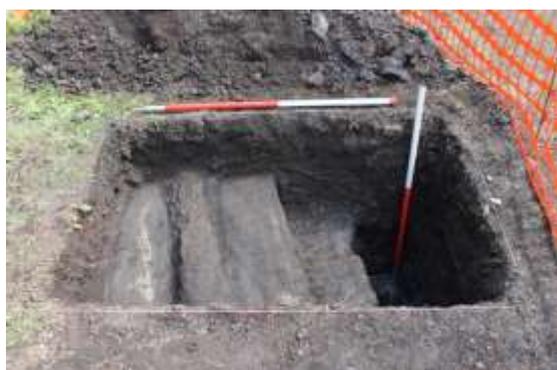
5.15: Test Pit 12, east facing

It was covered by mixed brown sand-silt clinker, 0.10m thick (358), black-grey silt-gravel, 0.15m thick (357) and sealed by a black-brown clinker silt layer (356), 0.10m thick.

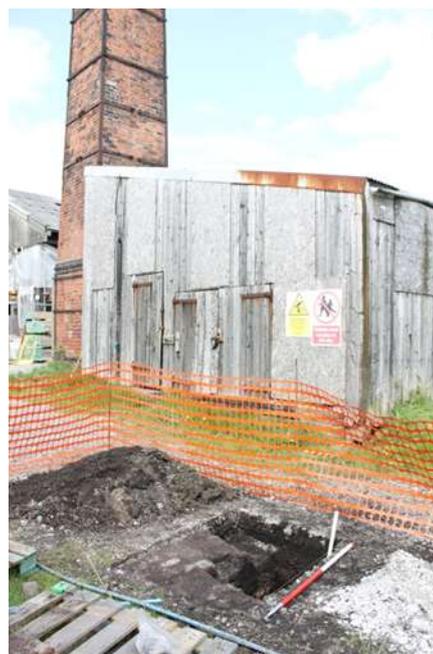
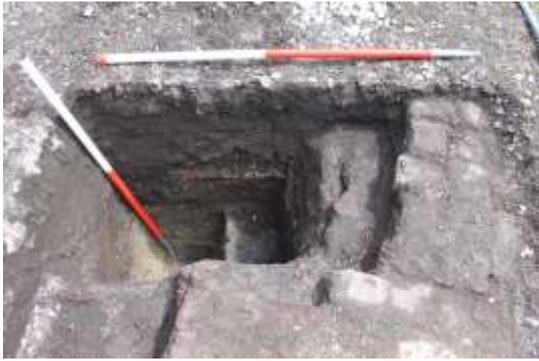
Test Pit TP13 was located between the pump house and the boiler house adjacent to the manager's office (Fig. AS003 above, AS024, 5.16, 5.17) (23.66m AOD at top). It was originally excavated as Bore Hole 4 (BH4) during evaluation work in November/ December 2011 (see BH4 above). It was subsequently excavated to allow the area to be drilled for a bore-hole. The trench was 1.0m (E-W) x 1.4m (N-S) in size. It was excavated to a depth of 1.0m.

The earliest deposit was yellow-grey silt clay with some river pebbles (369). It was overlain by a layer of grey-brown silt-clay (368), 0.35-0.40m deep and orange black mixed clinker silt (367), 0.20m deep. This was overlain by a narrow band of black-grey silt containing brick rubble (366), 0.10m deep that appeared to from a compact surface. It contained considerable quantities of 19th-century pottery and clay tobacco pipe. This layer was sealed by a layer of indurated black ash (139), in which was a hand-made red brick surface (138). This was sealed by imported grey gravel (136). These last three contexts have previously been reported on during the evaluation (OAN 2011).

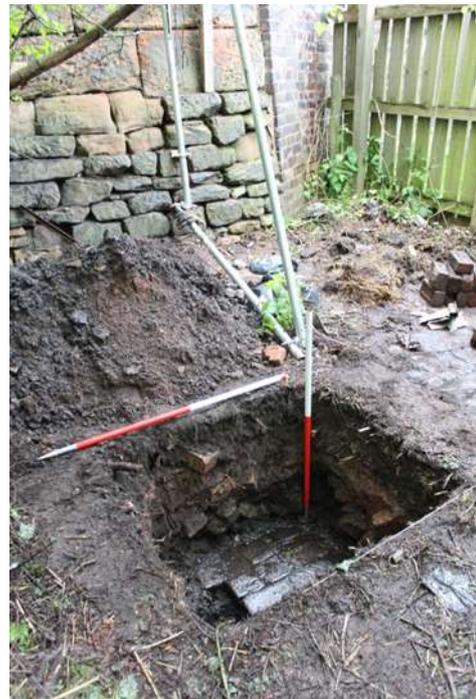
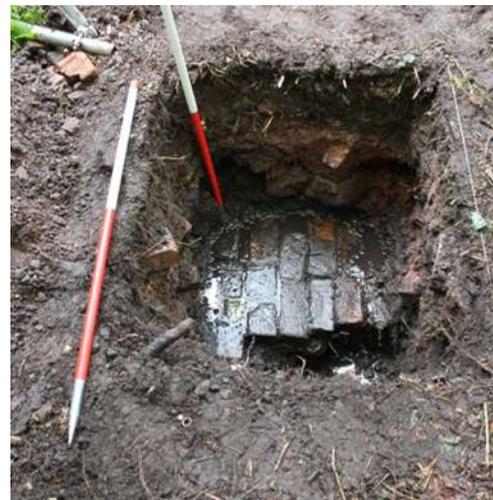
The earliest deposit excavated was waterlogged black loose silt brick rubble (377), 0.15m deep. This was overlain by a hand-made red brick surface (376), laid on-edge in Stretcher bond. It extended for 0.75m before it discontinued. The bricks were 8 3/4" x 4" x 3" in size but vary slightly and would appear to have been seconds.

The brick surface was overlain by loose black silt rubble (375), 0.20m deep, loose black brown silt

rubble (374), 0.50m deep and black humic-silt topsoil with root infiltration (373), 0.12m deep.

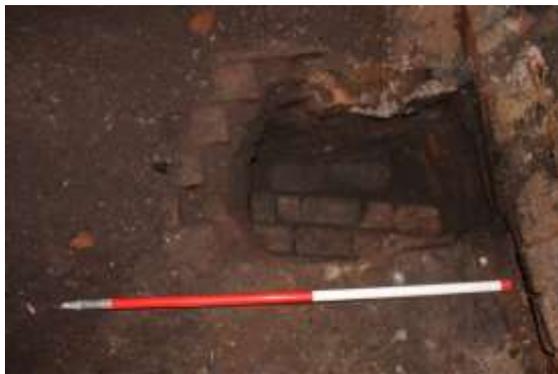
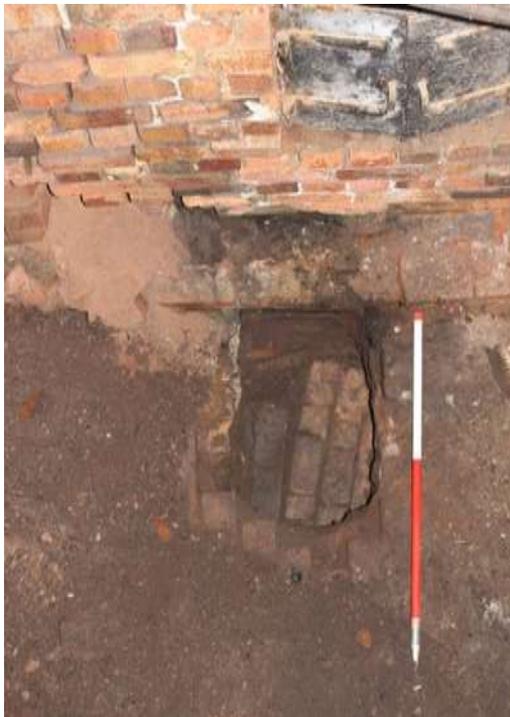
Test Pit TP15 was located within Pan House 3 adjacent to the southern elevation and the eastern jamb of doorway 6053 (AS003 above, AS025, 5.20, 5.21) (24.47m AOD at top). It was 0.5m (E-W) x 1.0m (N-S) and 1.2m deep.

The lowest layer encountered was a mixed black-grey clay-silt (383). It was overlain by mixed black-

brown compact silt that contained some rubble, pottery and clay tobacco pipe (382), 0.55m deep. Above this was loose mixed black-grey ash-clinker (381), 0.15m deep. This was the formation layer for a slate pad-stone (380) for the post of PH3 southern doorway (6053) and machine-cut red brick floor surface (379), laid on-side in Stretcher bond.

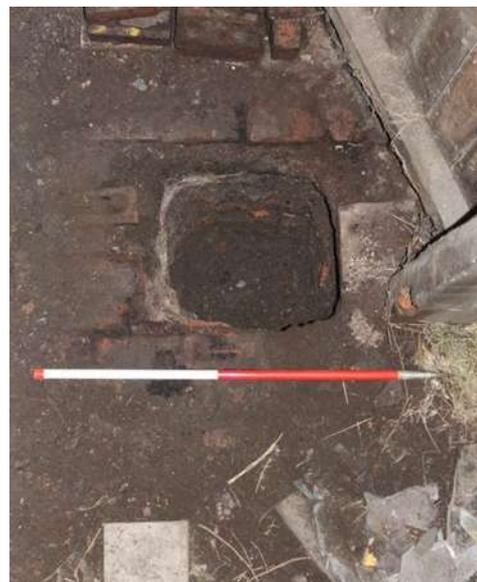
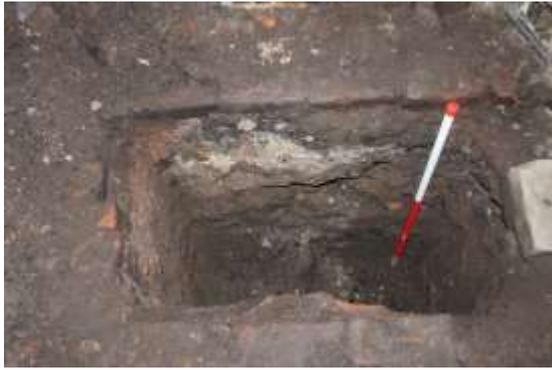
Test Pit TP16 was located immediately south of the southern stove wall (6060) of Pan 3 (AS003 above, AS025; 5.22, 5.23) (24.67m AOD at top). It was 0.65m (N-S) x 0.70m (E-W) in size and excavated to a depth of 0.70m.

The earliest deposit encountered was a hand-made red brick wall foundation (386), laid on-side and roughly bonded. The bricks were 8¾" x 4¼" x 3" in size. This covered the entirety of the base of the test pit. This was overlain by black-grey clinker-silt (385), 0.40m deep and black-grey mixed clinker-silt and rubble (384), 0.15m deep. Over the top the floor of PH3 was laid (379; see TP15 above).

Phase 4: The brick wall foundation (386) appears to pre-date the establishment of Pan House 3 and almost certainly relates to the laying out of the Rhomboid-Shaped Building and the south-western of three Butter Pans.

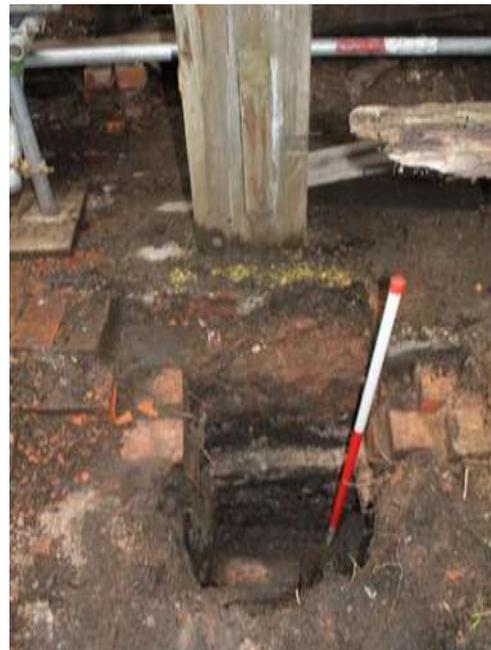
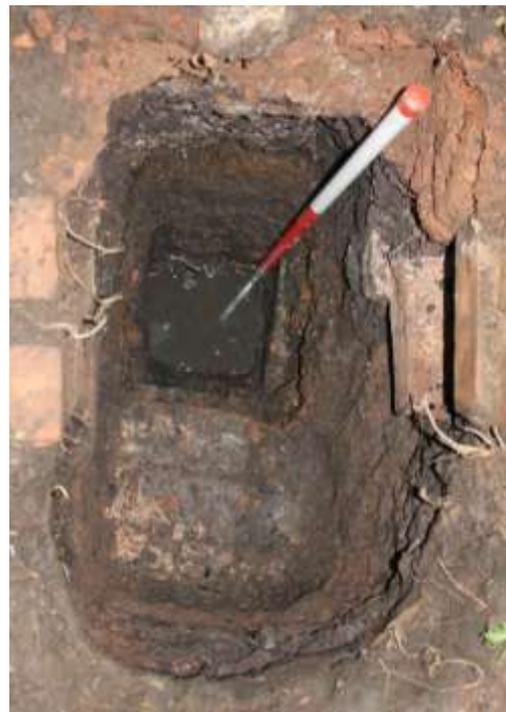
The earliest deposit encountered was grey-black silt-clay containing fine ash and rubble (393), 0.15m in depth. This was overlain by black-brown sand-silt-ash (392), 0.28m deep, which formed the formation layer for wall foundation (391). This hand-made red brick wall foundation (391) in English bond, was corbelled at the base. The bricks were 8 ¼" x 4 ½" x 3" in size. It was aligned at an

angle to PH4, SSW-NNE, with a cross-wall perpendicular aligned WNW-ESE.

Overlying the wall foundation 391 was mixed black-brown sand-silt (390), 0.70m deep. Set into this layer was wall foundation 387 of hand-made red brick in English bond. The bricks were 8 ½" x 4 ¼" x 3" in size. The wall was corbelled at the base. It was the same as wall 6219 recorded above-

Phase 4: The earliest deposits of wall foundation 391 has an alignment contrary to the buildings above and relates closely to the walls of Brick Sump 6254 located c. 3m to the south-east suggesting they are part of a contemporary phase that pre-dates the building of Pan House 4. This appears to relate to a series of butter pans laid out in 1896-1900 and would have formed the western wall of one of these butter pans.

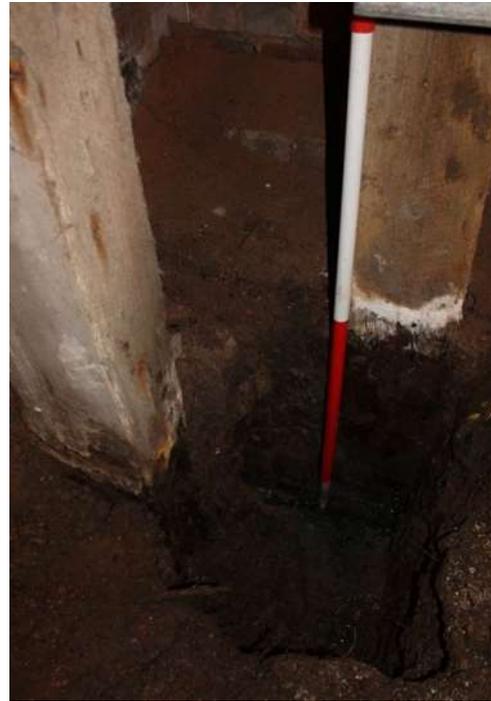
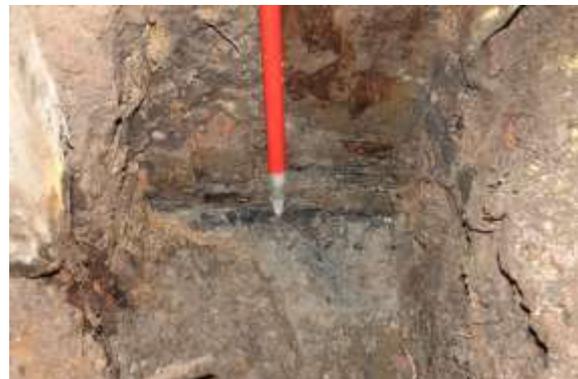
The earliest deposit excavated in Test Pit 18 was waterlogged black-brown silt-clay with rubble inclusions (396). This was overlain by wooden sill beam (397), 0.08m in depth and at least 0.40m in length (width not excavated). It was bonded to, and formed the base of Post 6041 above. Two loose hand-made red bricks were set against the end of the sill beam. In contrast Post 6040 was set on a grey concrete pad (395). The area around the base of these posts was filled with loose red-grey brown, sand-silt rubble layer (394), 0.50m deep. Within this material were the broken remains of two yellow-brown ceramic drainage pipes, 0.22m in diameter and 20mm thick. The first ceramic drain (398) ran east-west from under Wall 6009 and Ollershaw Lane into the ditch of the western

hurdles 6057. It was broken adjacent to post 6041. The second ceramic drain (399) ran north-south from Ditch 6057 and is presumed to have continued south towards brick sump (6422).

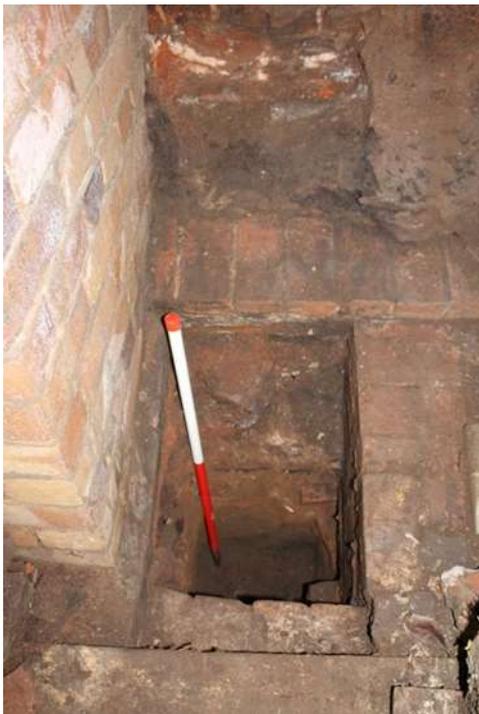
5.28: Test Pit 19, west facing

Test Pit 19 was located on the eastern side of Pan House 4 adjacent to the northernmost brick pier (6281) of Stove Wall 6279/ 6283 (AS003 above, AS026; 5.28, 5.29) (24.86m AOD at top). It was 0.45m (N-S) x 0.55m (E-W) and 0.75m deep. The earliest deposit excavated was mixed firm mid-grey silt-sand (403), +0.1m deep (not fully excavated). This was overlain by firm red sand-silt layer (402), 0.35m deep. This layer was typical of heat oxidised sand layers and the formation for the ditch of the eastern hurdles.

Phase 7: The earliest layers are almost certainly associated with construction layers for the furnace of Pan House 4. The use of sterile sand layers may suggest that a 'caulk' layer was put in place prior to constructing the stove. A caulk was a mixed loam layer designed to withstand the heat of furnaces/ stoves during firing and enable the contraction and expansion of the soil under cooling and heating. Typically clay would crack and cause collapse of foundations. The use of a loam layer allowed for expansion and contraction. The brick walls are part of the original Phase 7a construction of Pan House 4.

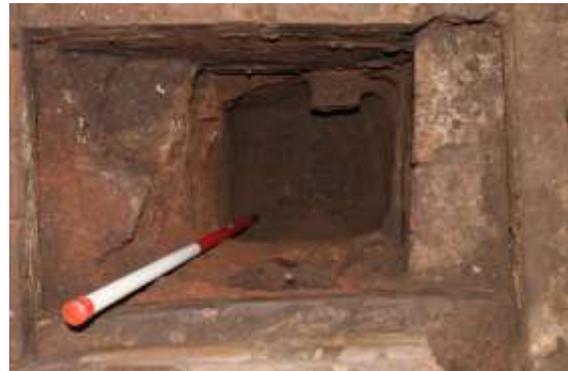
5.29: Test Pit 19, north facing

Two walls (400, 401) were built through this layer. Wall 400 was of hand-made red brick in the English bond and orientated north-south. The bricks were 9" x 4 1/2" x 3" in size. Wall 401 abutted Wall 400 as a perpendicular cross-wall running east-west. It was made of hand-made red brick in the English bond (brick size 9" x 4 1/2" x 3"). These walls supported the brick floor surface of the eastern

hurdle drain (6260, see below), the earliest phase of the Stove Wall (6279, see below) and the inserted brick pier above (6281).

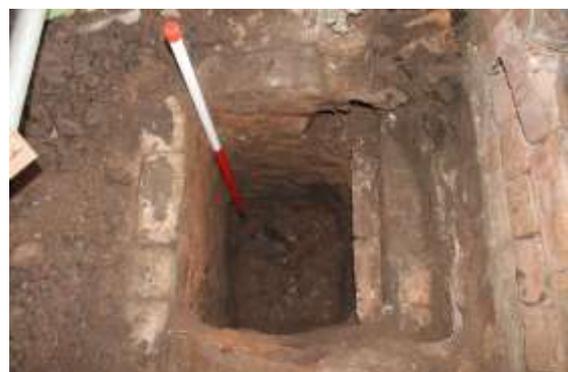
5.30: Test Pit 20, north facing

Test Pit TP20 was located in the eastern part of Pan House 4 adjacent to Sill Wall 6245 (AS003 above, AS026; 5.30) (24.67m AOD at top). It was c. 2m north-east of Test Pit TP19. It was 0.6m (N-S) x 0.5m (E-W) and excavated to a depth of 0.90m.

The earliest excavated deposit was a dark-grey layer of mixed silt and mortar with small quantities of brick rubble (408, not fully excavated). Overlying this was a compact grey-brown silt-sand with very occasional brick rubble (407), 0.45m deep. Sill Wall 6245 had been rebuilt on hand-made red brick wall foundations (405) in English bond. This consisted of five courses of corbelled brickwork (0.35m deep, brick size 8 ½" x 4 ¼" x 3"). This in turn was overlain by compact red silt-sand (406), 0.35m deep. On this the floor surface (409, same as 6260) of the eastern ditch was built. This was built in machine-cut red brick, laid on-side in Stretcher bond (brick size 9" x 4 ½" x 3"). It sloped east to west to the centre of the drain.

Phase 7: The layer above (407) this is very similar to those located in Test Pit TP19 (403) and is probably equivalent. It can be assumed to be part of an episode of construction of Pan House 4 in the 1950s (Phase 7a) that included the construction of wall foundation 405, red silt-sand layer 406 and the floor of the ditch (409/ 6260). The Sill Wall (6245) has clearly been re-built after collapse probably in Phase 7b or 8.

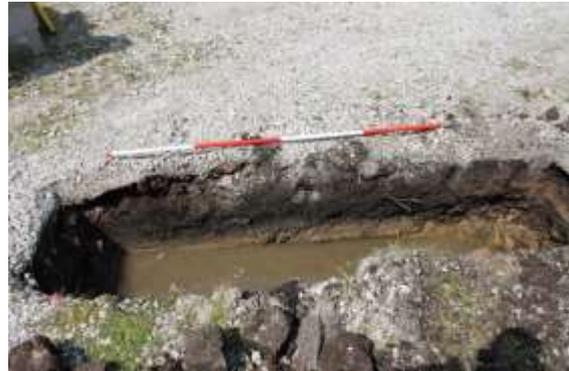
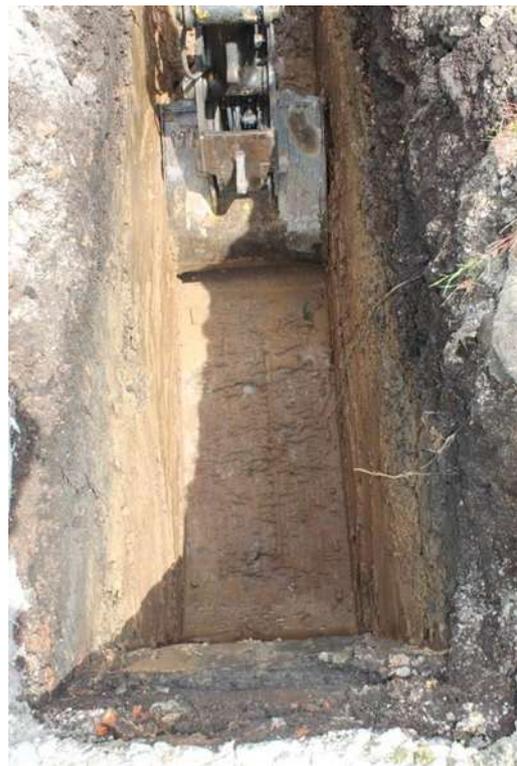
Test Pit TP21 was excavated outside the area of the Scheduled Monument as part of an infiltration test, designed to establish the permeability of the ground in advance of the excavation of Soakaways 3 and 4. It was located at the south-eastern edge of the site, on the edge of what is now the car park (AS003 above, AS027; 5.31, 5.32). It was machine excavated with a toothless ditching bucket. It was orientated NW-SE and 2.2m (NW-SE) x 0.6m (SW-NE) and 2.05m deep (22.78m AOD at top).

The earliest deposit was natural yellow-brown clay, with grey clay inclusions (414), excavated to a depth of +0.50m. It was overlain by a further natural layer of yellow-brown silt clay that appeared to be the upper natural substrate (413), 0.90m deep. This resulted in an impermeable layer

over which was a discontinuous granular gravel layer that had iron-panning (412), 0.10m deep. This was located at the north-east end of the test pit. It was rapidly inundated with water. It was overlain by mixed black-brown silt rubble (411), 0.35m deep. The former car park surface was a grey gravel layer (410), 0.10m deep.

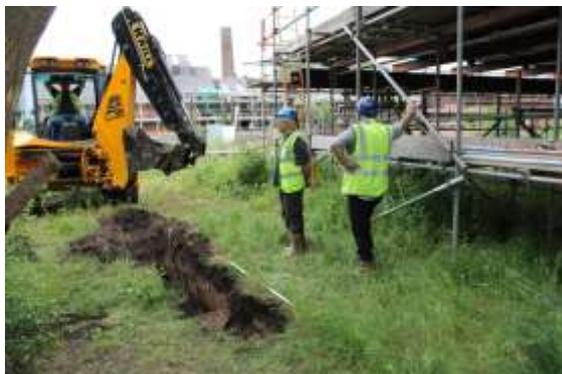
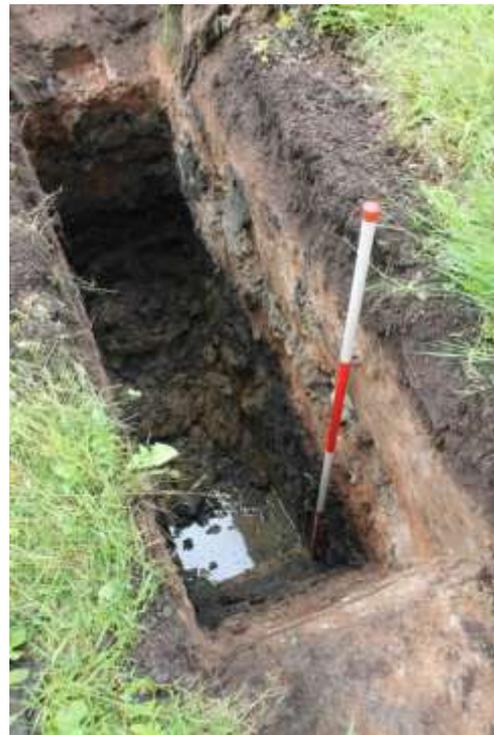
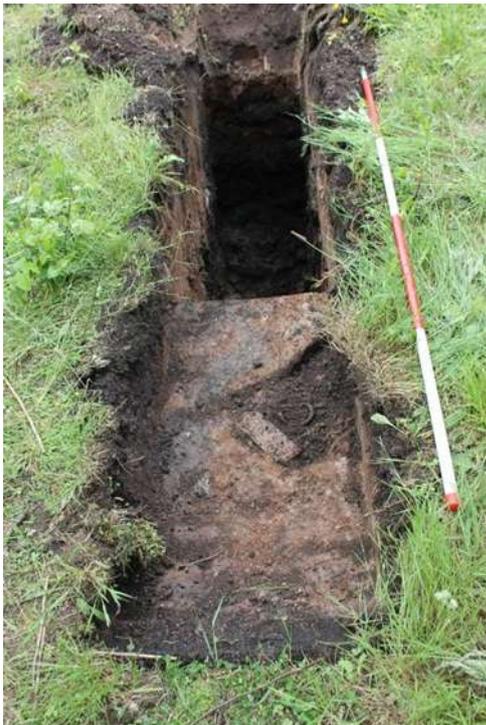
Test Pit TP22 was located to the south-east of Pan House 5 adjacent to the oil tank bases (now the temporary location of Pan 5). It was excavated as part of an infiltration test, designed to establish the permeability of the ground in advance of the excavation of Soakaway 2. It was located c. 2m south of the oil tank bases, orientated WSW-ENE and was machine excavated with a toothless ditching bucket (AS003 above, AS027; 5.33, 5.34, 5.35).

It was 3.5m (WSW-ENE) x 0.6m (NNW-SSE) and 2.05m deep (23.97m AOD at top). The earliest deposit located within the test pit was yellow-grey clay with streaky grey clay inclusions (420), at least 0.5m deep. Above this was a friable, organic, black-grey peaty clay layer (419), 0.50m deep. It was sealed by compact hard red clay and grey mudstone (418), 0.55m deep. Over this layer was yellow-red silt clay with grey clay inclusions (416), 0.45m deep. Excavated into this layer was a rectangular wall foundation cut, orientated NW-SE, filled with loose brown rubble (417), 0.28m wide and 0.45m long. The test pit was covered in

humic black-brown topsoil material mixed with rubble (415), 0.20m deep.

Phase 3: It is unclear whether the layers above this of friable organic black-grey peaty clay (419) and red clay and grey mudstone (418) are re-deposited or part of the natural material. Layer 418 corresponds directly with layer 164 of Test Pit 1 (see above) interpreted as re-deposited natural. The location of the test pit corresponds with a series of three open pans of the Alliance Works. These were excavated in Trench 13 and 14 and contained a series of east-west walls of the stove houses at a depth of c. 1.4m. It therefore seems probable that these deposits correspond to the Alliance Works (Phase 3).

Phase 7: The wall foundation 417 does not correspond to any features shown on maps and may relate to part of Pan House 5.

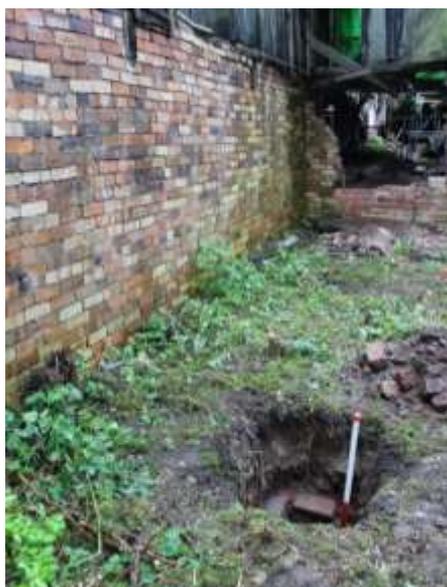
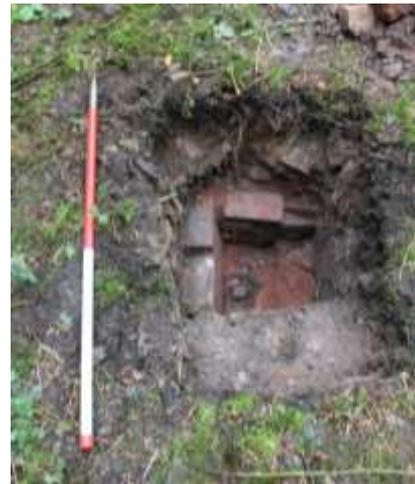
Test Pit TP23 was located in the Pan House Garden, adjacent and to the east of Stove House 2. It was designed to investigate the remains within Pan House 1 and to assess the impact of proposed Soakaway 1 and the survival of the tunnel beside Stove House 2 (AS003 above, AS026; 5.36, 5.37) (24.93m AOD at top). It was 0.9m (N-S) x 0.7m (E-W) and excavated to a depth of 1.0m.

The earliest deposit excavated was loose dark-brown sand-silt layer (426). Wall foundation 422, orientated north-south, and bonded perpendicular to this was wall foundation 423, orientated east-west were built over this layer. They were made in hand-made red brick in English bond and survived to a height of three courses. This was overlain by a layer of red silt-sand (425), 0.15m deep. This was overlain by firm grey-brown clay silt (424), 0.30m deep and loose and mixed sand-silt and hand-made brick rubble, demolition layer (421), 0.55m deep.

Phase 4: The wall foundations (422, 423) are almost certainly associated with Pan House 1. Similar wall foundations have been found under the eastern hurdle ditches of Pan House 4 and it is suggested that this was part of the original eastern ditch structure. The layer above of red silt-sand (425) was similar to material associated with Pan House 4 ditches.

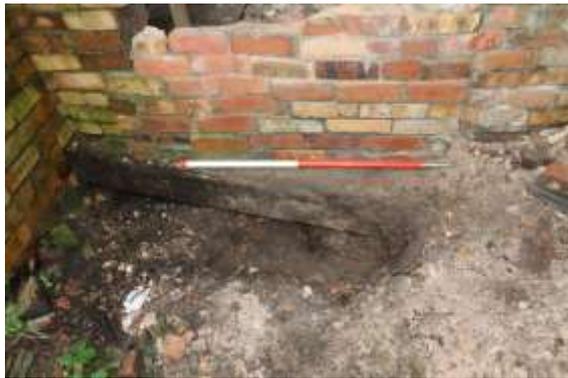
5.38: Test Pit 24, south facing

Test Pit TP24 was located in the Pan House Garden and excavated again to assess the extent of the tunnel adjacent to Stove House 2 (AS003 above, AS026; 5.38) (25.05m AOD at top). It was located in the corner between Stove House 2 and the Link Block. It was 0.9m (E-W) x 0.5m (N-S) and 0.5m deep.

The tunnel was visible south of the northern Link Block wall running north-south from the area adjacent to Chimney 2. It appeared to have originally continued to the north into the area of the Pan Garden. Within the test pit on the southern side and beneath the northern wall of the Link Block was a void. A large ferrous metal beam (429), 0.25m wide supported the link block wall above the void. The link block wall was made in two parts a hand-made red brick wall in rough bond (427) that appeared to be the jamb of a blocked doorway that had been subsequently infilled with hand-made red brick in a rough bond (428). The area north of the wall had been back-filled with loose black mixed sand-silt rubble (430) to a depth of at least 0.50m.

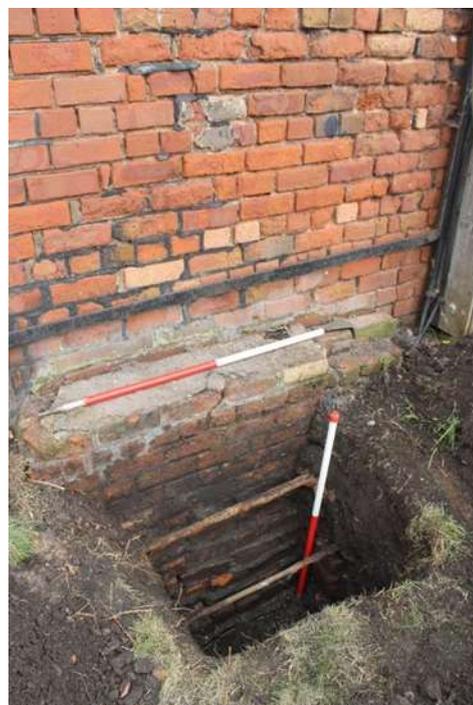
5.39: Test Pit 25, adjacent to Chimney 3, north-east facing

Test Pit TP25 was excavated in investigate the foundations of Chimney 3 on its southern side. It was 0.8m x 0.8m, and excavated to a depth of 0.95m below current ground level (23.09m AOD;

Phase 5-7: Chimney 3 dates to c. 1900 and was built contemporary with the fishery salt pans. The infill material of black clinker silt could easily be part of a contemporary infilling or date to any time from the 20th century. The ferrous metal pipes are of unknown function, but simply be water pipes.

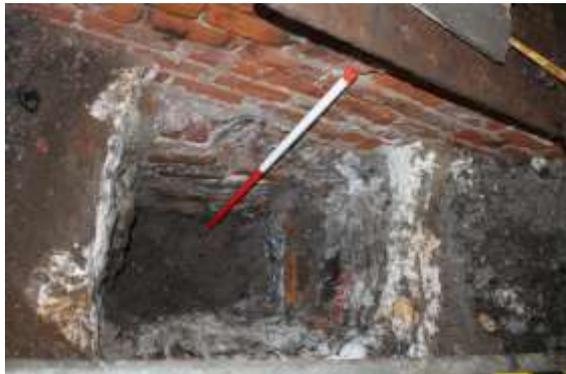
5.40: Test Pit 26, south-east facing

A mixed clinker slag ash material (452) was located at the base of the trench. This formed a concreted formation level for the base of runs between flues 6134, 6135. The flue 6134 was built on a series of rough hand-made brick footings with lime/ salt

mortar (453). The remainder of the test pit was infilled with a layer of white accumulated salt between the salt run (6150).

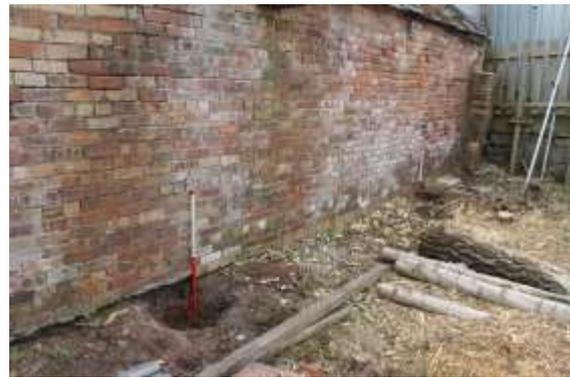
5.41: Test Pit 27 and 28, North Wall of SH1, west facing

Test Pit TP27 was excavated to investigate the foundations of the north wall of Stove House 1 (Link Block) on its northern side. It was 0.5m x 0.45m, and excavated to a depth of 0.4m below current ground level (AS003 above, AS028; 5.41, 5.42). The test pit was filled by compact red-brown sand at its base (453). This was overlain by loose brown sand-silt (454). The remains of the northern wall of SH1 (6505, see below) consisted of machine pressed red brick in the English Garden Wall bond. It was supported by a ferrous metal

beam (455) that ran east-west under the wall level with the ground.

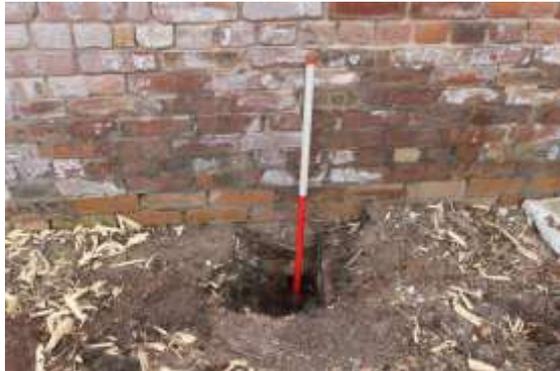
5.43: Test Pit 28, south facing

Test Pit TP28 was excavated to investigate the foundations of the north wall of Stove House 1 (Link Block) on its northern side. It was 0.5m x 0.35m, and excavated to a depth of 0.4m below current ground level (AS003 above, AS028; 5.41, 5.43). The remains of the northern wall of Stove House 1 (6505, see below) were supported on shallow footings (456). These consisted of three courses of machine pressed red brick in English Garden Wall bond sat on top of a thin layer of

concrete. The wall ran east-west. Running north-south, perpendicular and abutting this wall were the remains of a further machine pressed red brick wall in English Garden Wall bond (457). It survived to a height of three courses but its foundations were not located. The remainder of the test pit was filled with loose brown sand-silt (458).

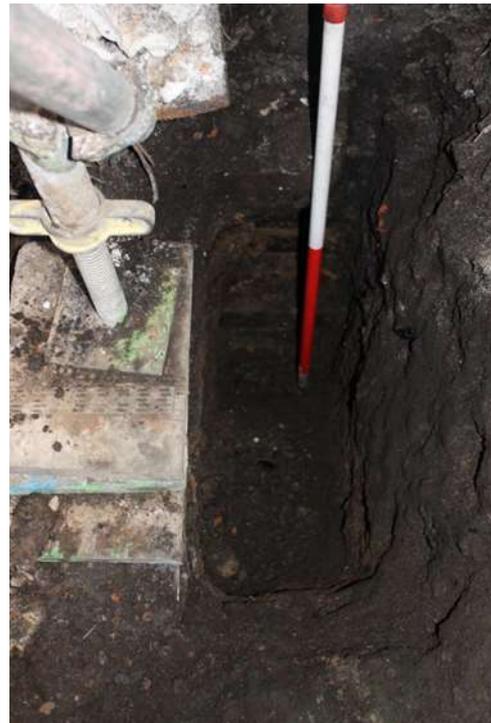
5.44: Test Pit 29, west side of Chimney 2, west facing

Test Pit TP29 was excavated to investigate the foundations of Chimney 2 on its western side. It was 2.0m (E-W) x 0.5m (N-S) in size and excavated to a depth of c. 0.75m below current ground level (AS003 above, BS101; 5.44). The base of the chimney (6430, see below) was supported on a corbel of three steps (459). These consisted of three courses of machine pressed red brick. From here it was carried up a further 0.75m in height. The area was back-filled with compact black-brown clinker ash silt material (460). Overlying this was a deep pile of salt residue (461) to a depth of c. 0.6m piled against the western face of Chimney 2.

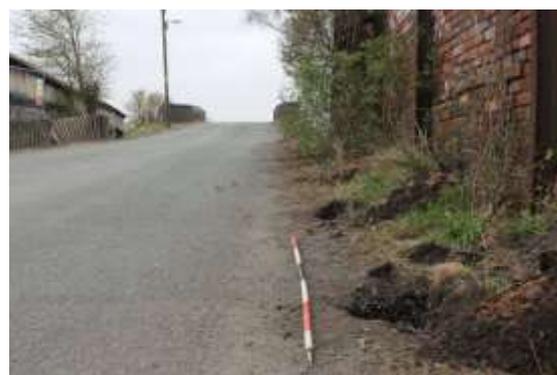
6.2: Fence Posts 1-10, north facing

The fence posts were located in a line along Ollershaw Lane, 0.75-1.0m to the west of the Link Block and Stove House 3 wall, 2.0-2.2m apart. FP1 was the most northerly and FP10 the southernmost (see AS003 above; 6.2, 6.3). The ground sloped markedly from the bridge over the canal in the north to the entrance to the Salt Works at the south by as much as 1.0m (26.81m AOD to 25.99m AOD). Each fence post was approximately 0.3m x 0.3m x 0.6m deep.

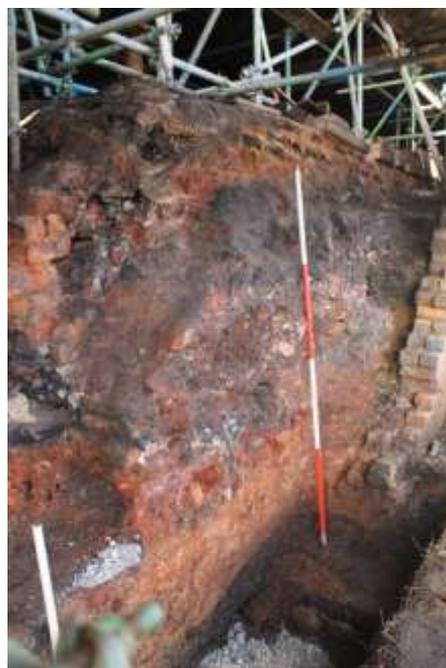
7.1: Conglomerate build 3005 of Stove House 4, north-west facing

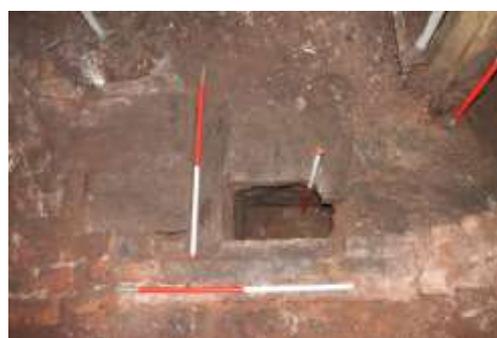
7.2: Foundation of wall 6268, on western side, south facing

eastern part. On the western side its foundations were three courses wide, extended to a depth of 23.80m AOD and were stepped at the base (7.2). On the eastern side it was of similar construction but set slightly to the north (7.3). The ditch floor surfaces on either side (6221, 6260), abutted the wall. The sill beams of hurdle frames 6276 and 6278 overlay the ditch floor and were both keyed in to wall 6268 at its base (see 7.4). The wall continued up from the foundation, but the weight of conglomerate material 3005 had caused the wall to bulge dramatically on either side. At the very western end the northern exterior of the wall had been filled with loose brown silt material (3008).

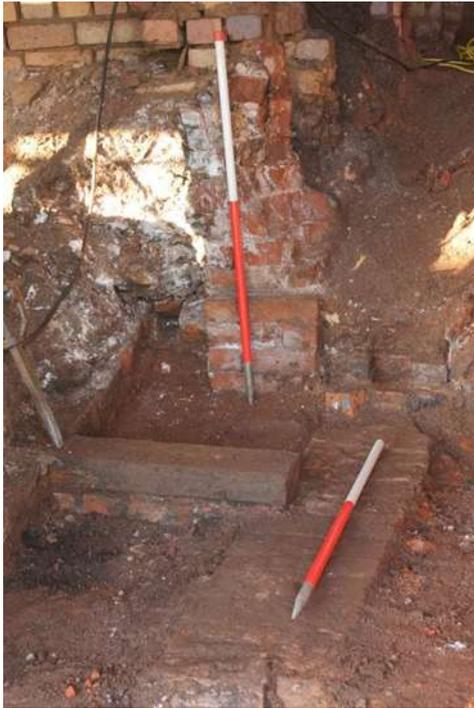
7.3: Foundation of wall 6268 on eastern side, west facing

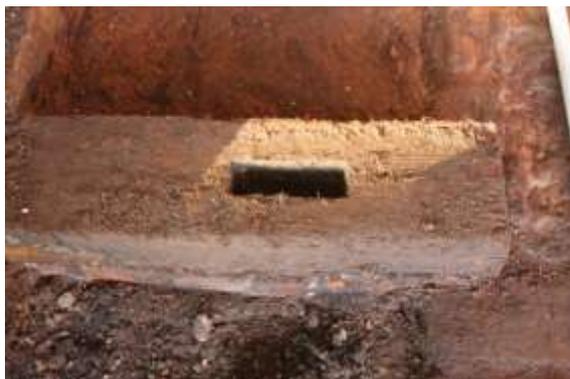
7.4: Sill beam of hurdle 6278, with mortice, inserted in wall foundation 6268

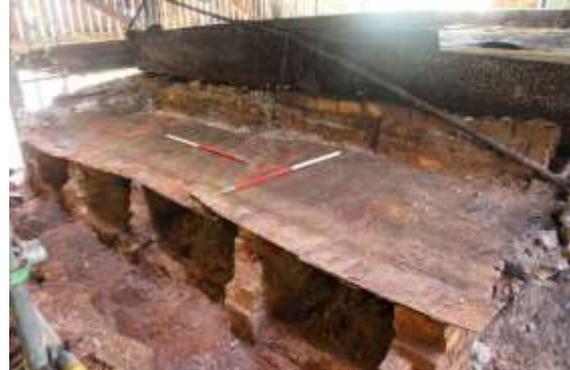
7.5: Four flues at rear of Pan 4, south-east facing

The central area of wall 6268 was a void to allow hot air from the stove to pass through a series of four flues to the flues within Stove House 4 (7.5). These flues were constructed directly on top of conglomerate layer 3005. They consisted of the side walls of the stove (western 6282, eastern 6283), two further walls on the exterior (3011, 3012) that formed a dead draft at the sides of the stove and three central rib walls one course wide (6284, 6285, 6286). From here they passed under the main body of wall 6268 via four openings. The openings had a lintel above formed by a series of four I-beams (3008) on top of which were two ferrous metal plate (3009, see Plate 7.6, 7.7). Wall

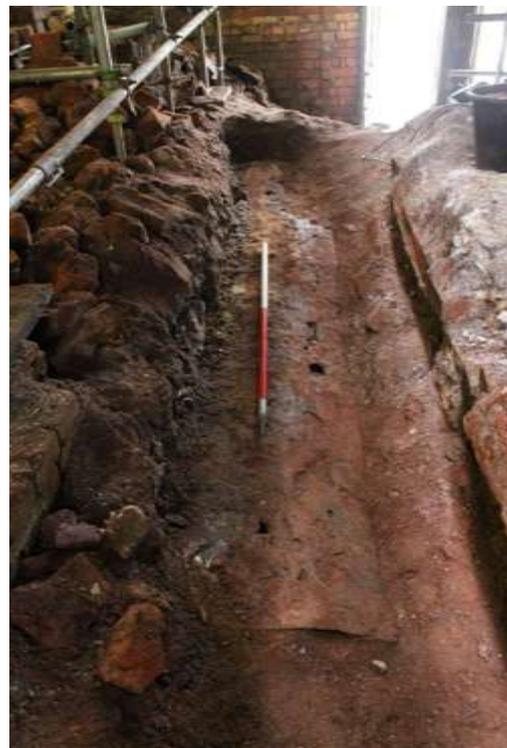
7.6: Ferrous metal plate and I-beam lintels, east facing

6268 continued up from the lower foundations and was built on top of lintel 3009 originally. By 2012 the wall had entirely collapsed. The rib walls and I-beams had decayed and caused wall 6268 to buckle and collapse.

pressure on the external walls of the stove house causing them to bulge. Secondly, ferrous metal used as lintels for flues in the design of the partition wall 6268 of Pan/ Stove House 4 corroded due to the effect of salt impregnation. These two causes resulted in the walls buckling and eventually collapsing. The use of ferrous metal I-beams (6374, 6375) in the south-east corner of Stove House 4 was a rudimentary attempt at preventing collapse. The collapse witnessed in Pan and Stove House 4, has also occurred in Pan and Stove Houses 3 and 5.

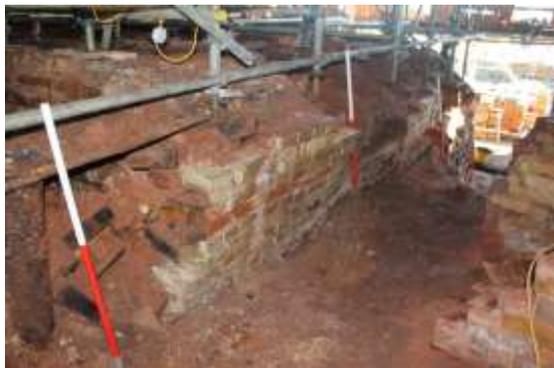
7.8: Interior flue wall 3006, north-east facing

The four flues (formed by walls 3011, 3012, 6284, 6285, 6286) passed to an end flue (6398) that ran along the southern end of Stove House 4, located below the floor level. The northern side of this end flue was formed of machine pressed yellow bricks in English bond (3006; 7.8), which had partially collapsed at the western end. There was some indication of intermediate walls and a more complex structure to this end flue. No trace of this

could be seen during excavation and it is likely that these walls were temporary or deigned to support the flue walls above. The end flue was covered by a series of ferrous metal plates (6407, see Volume IV).

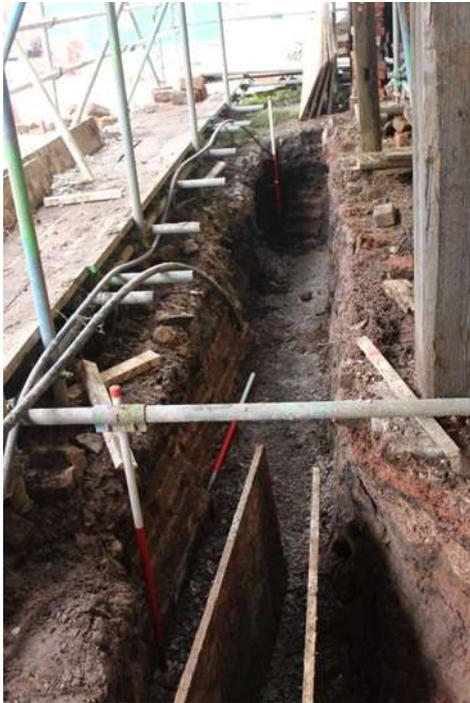
7.9: Wall 3003 and 3004, south facing

Overlying the walls were a clean sterile grey sand-silt, 0.40m deep (3001). At the northern end of the trench was a layer of crushed red brick waste (3007), 0.15m deep, that extended for 8m, north-south, along the trench. At the southern end of the trench a dirty mixed black brown silt rubble layer (3000) overlay the trench. Within Stove House 4 at the northern end of the trench, layer 3007 was overlain by a thick conglomerate material of brick, ash, waste salt, and clinker concreted together

with lime/ cement (3005, see 7.9). The layer was c. 2m deep and formed the bulk of the interior of Stove House 4 and the formation level for the Stove House 4 flues (6390-6396).

Phase 4: Foundation walls 3003 and 3004 form part of the southern pair of Butter Pans, upstanding remains of which are located to the east, adjacent to the Nodding Donkey. Remains of the northern pair of fishery pans were revealed in the northern end of Trench 2 of the evaluation (see Section 4 above). Layer 3002 appears to have acted as an overall hardcore level for the site at this time. It was also encountered in Test Pit TP20 (408).

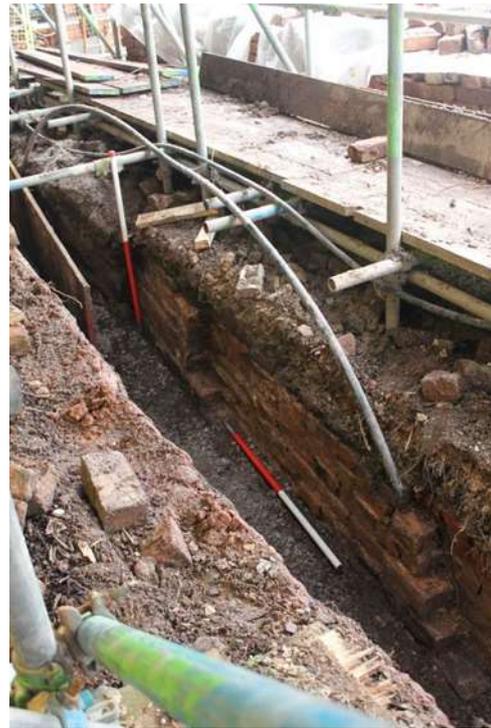
7.10: Wall 3003, north facing
