THE ALLIANCE AND LION SALT WORKS, MARSTON, NORTHWICH

SCHEDULED MONUMENT NO 34985-002

VOLUME III: THE ARCHAEOLOGICAL EXCAVATIONS, 1992-2015

REPORT NO 2015-01

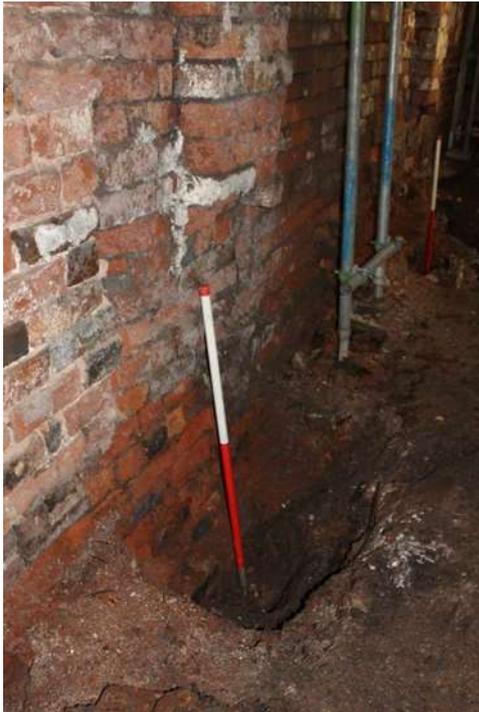
7.11: Trench HC3, through Flue 6133, south-east facing

They were excavated through a loose brown brick rubble silt material (3013) filling Flue 6133. These revealed the lower footings of wall 6120 had partially decayed, in the location of where brickwork of Flue 6133 would have butted up against the wall.

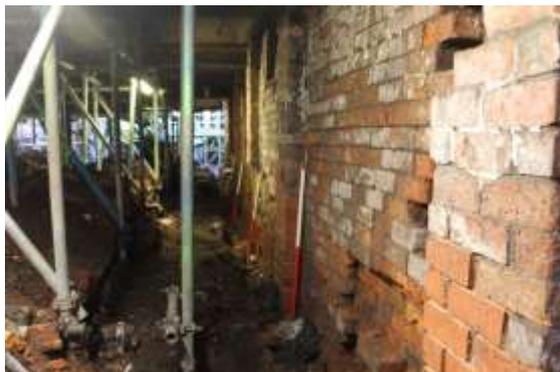
7.12: HC03, Footings on the eastern side of Stove House 3, north facing

Two shallow excavations were conducted in Stove House 3 along the eastern wall in order to provide concrete footings for brick piers where these had decayed (see AS004 above, AS032, AS043). The pits were adjacent to the first and second pier from the southern end of wall 6120. They were each 1.1-1.2m (north-south) and 0.8m (east-west), excavated to a depth of 0.60m (25.79m AOD). The pits were joined and extended to form a shallow trench along the western side of wall 6120, 0.8m wide (east-west), excavated to a depth of 0.60m (25.79m AOD, see 7.11, 7.12, 7.13).

Phase 5-7: Wall 6120 dated to the beginning of Phase 5 and c. 1900 as part of the original construction of Stove House 3. The decay on the walls can be attributed to the presence of a flue along the side of the wall. Salt infiltration into the brickwork had caused it to decay and shatter.

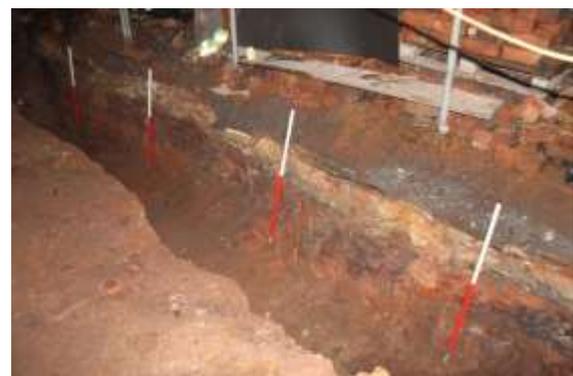
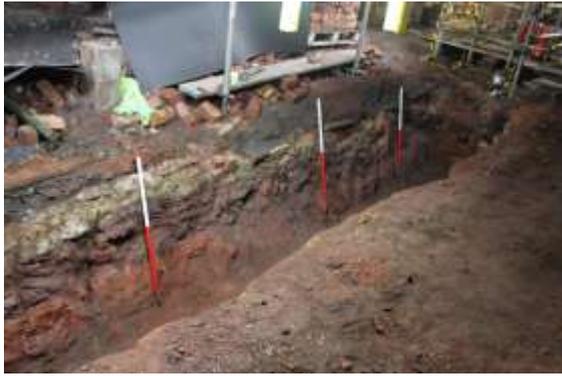
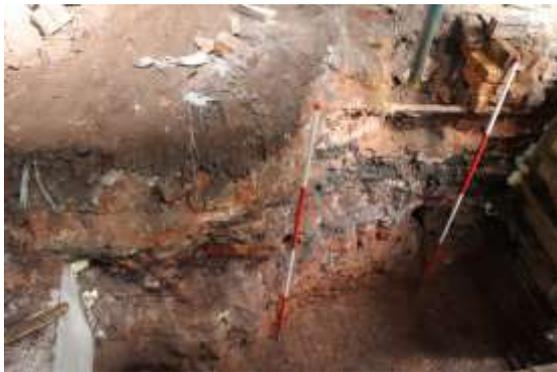
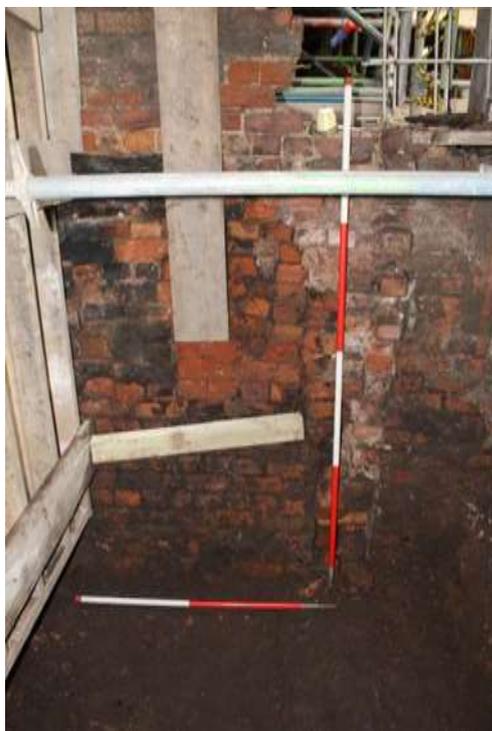
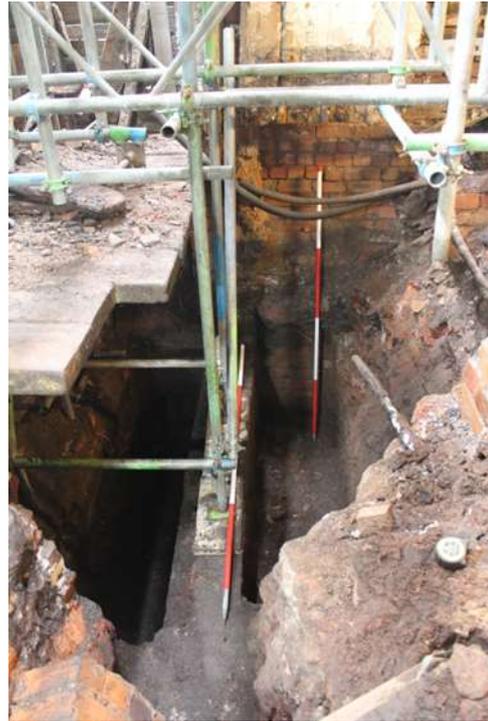
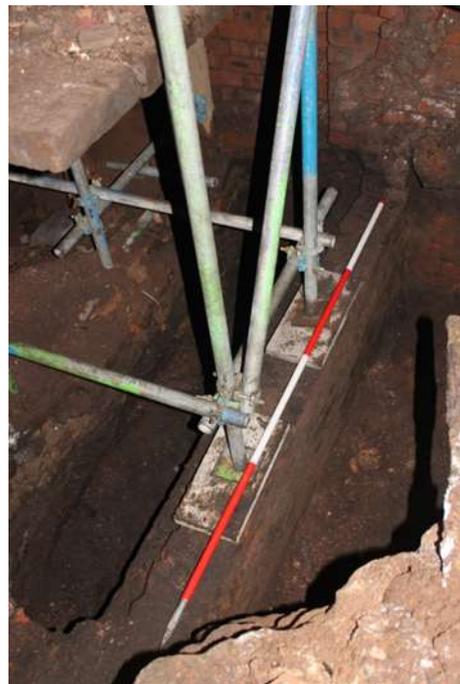
The restoration of Pan and Stove House 3 involved the rebuilding of east-west internal wall 6026. In order to do this a new concrete foundation and mass concrete retaining wall was to be constructed in order to stabilise the foundations in this location. The existing wall 6026 was dismantled to foundation level and a trench excavated to accommodate the construction of the foundation. The trench was 14.5m long (east-west). It consisted of two larger areas either side of the pan 2.0m (north-south) by 2.5m (east-west) on the west side and 1.9m (north-south) by 4.2m (east-west) on the east side, both excavated to a depth of 23.75m AOD. Between these two areas was a narrower strip 1.0m wide excavated to a depth of 25.0m AOD (see AS004 above, AS043, AS046; 7.14, 7.15, 7.16, 7.17, 7.18, 7.19).

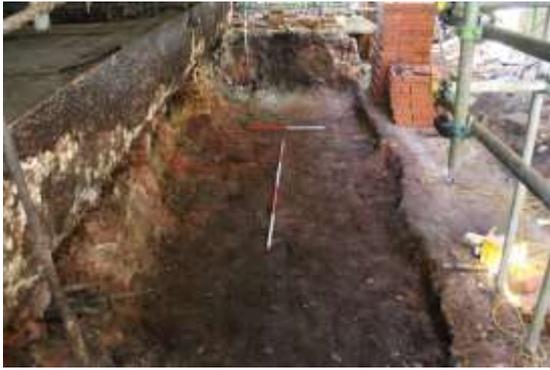
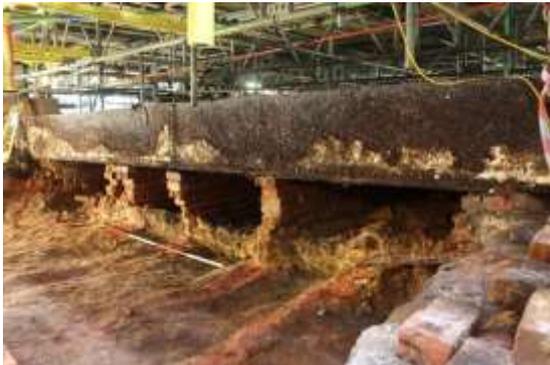
A series of six flues ran north-south under Pan 3, and passed to the north under the wall of Stove House 3 6026 (see 7.20, 7.21). These were formed from a series of seven flue walls (6075-6081) that survived to full height under the pan. These survived to the north of the pan as poorly formed foundations of machine pressed red brick, two skins thick. The flues continued north under Stove House 3 wall 6026 but stop-ended shortly to the north. Between the outer flue walls (6075, 6081) and the outer stove wall (6056, 6059) were the dead drafts. These were filled by black clinker ash material (3040, 3041). The flues themselves were

filled by grey ash and silt material with loose red sandstone rubble (3032-3037). North of Pan 3 the upper part of the flues had collapsed and were covered by here the flues had collapsed the crushed red sandstone and brick with silt layer (3038) and a yellow white clay layer (3039). Originally the flues between Pan 3 and Stove House 3 wall 6026 were covered by a series of ferrous metal plates (3015, see 7.22, 7.23, 7.24), 6.5m (east-west) by 2.2m (north-south). These had corroded badly and survived in a very fragmentary state. The clay (3039) appeared to be a puddling material designed to seal the plates to prevent the loss of flue gases. Adjacent to Pan 3, a low, single-skin, narrow strip wall (3016) was built-up to the base of the pan to seal any gaps where flue gases could potentially escape. The collapsed plates were covered with loose layer of mixed-brown, silt-sand rubble and degraded ferrous metal (3014).

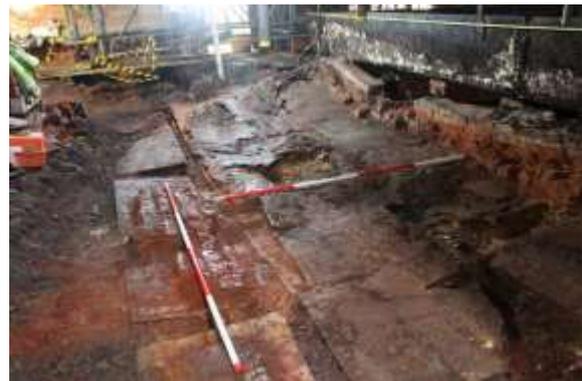
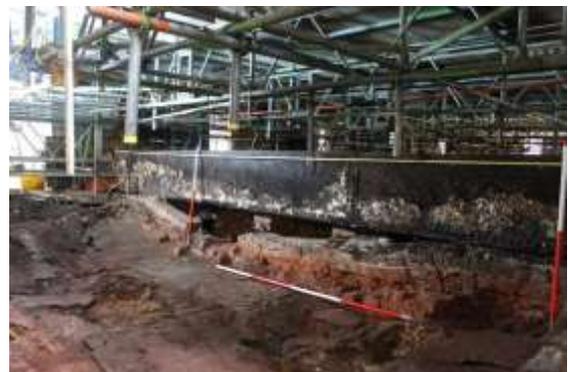
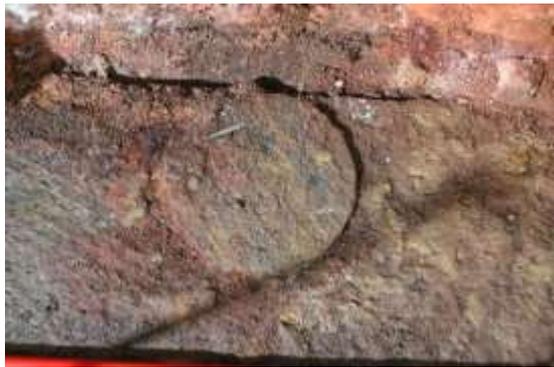
7.22: HC04, Wall Foundation Pan House 3/ Stove House 3, collapsed metal sheets over flue runs, east facing

7.23: HC04, Wall Foundation Pan House 3/ Stove House 3, collapsed metal sheets over flue runs, south-east facing

7.24: HC04, Wall Foundation Pan House 3/ Stove House 3, coter patch within metal sheets

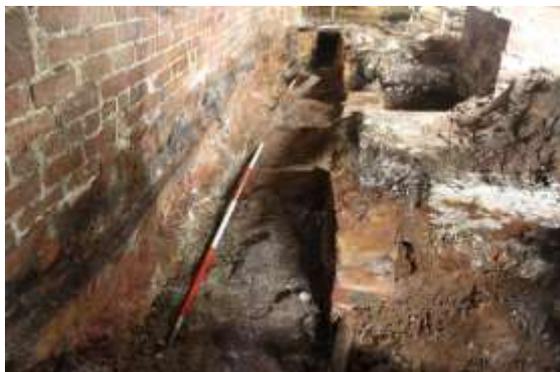
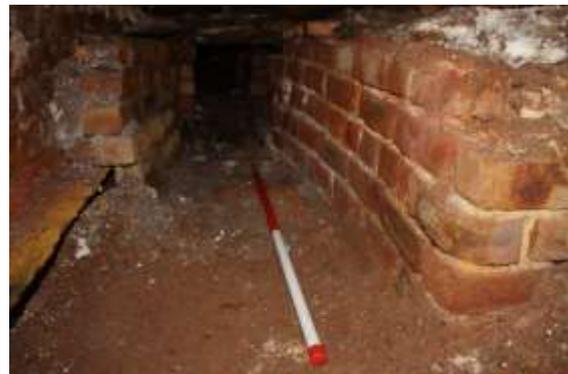
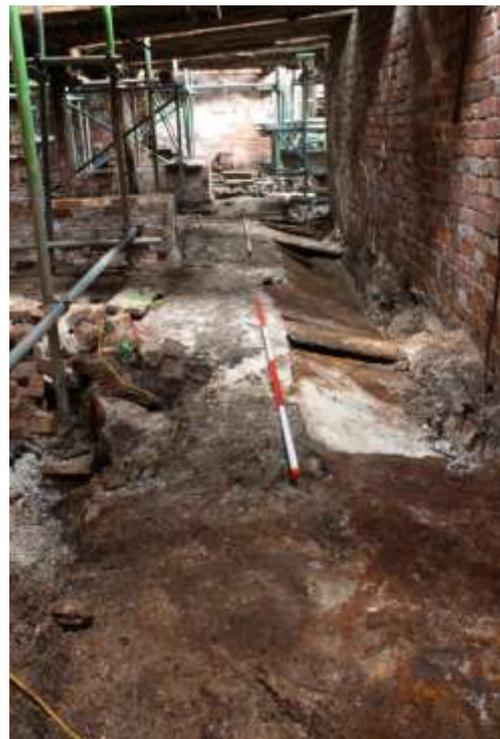
North of Stove House 3 wall 6026, the conglomerate red sandstone material (3044) was covered by the flues of Stove House 3. At the southern end, a single below-ground flue ran east-west (6140; c. 1m in width, see CWAC 2012-006; 7.25, 7.26, 7.27), capped by a series of eighteen corroded rectangular ferrous metal plates, with smaller ridged rectangular ferrous metal spacers (6148). These have collapsed and form an uneven floor level. Like the flue plates to the south, heat-affected yellow clay (3045) appears to have acted as a seal to prevent flue gases escaping.

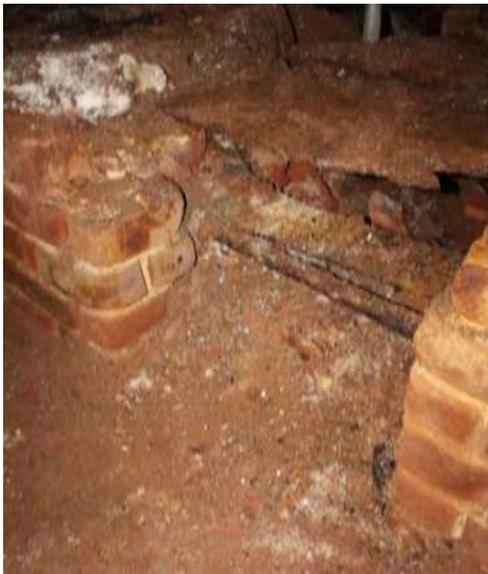
7.28: HC04, Wall Foundation Pan House 3/ Stove House 3, flue at south end of SH3, north facing

Extending north from this east-west flue (6140) were a series of seven north-south flues (6133-6139, see CWAC 2012-006 for details, e.g. 7.28) of Stove House 3 constructed of machine-pressed red brick. Excavation has shown that at the southern end, these flues were stop ended above the ground, but were open, with a metal bar across the flues below-ground as they passed into cross flue 6140. Flue 6140, continued around to the west to join flue 6139. It was filled with black

clinker ash and salt waste material. At the eastern end flue 6140, turned to the north as 6133. This was filled by black clinker ash material. Between each flue was a ditch containing layers of accumulated and hardened salt (6149-6154), which survive to over 1m in depth below the current floor level.

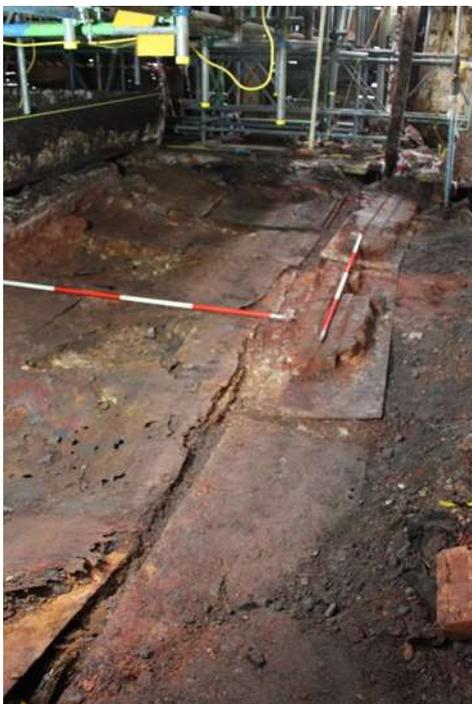
7.29: HC04, Wall Foundation Pan House 3/ Stove House 3, plates under wall, west facing

Stove House 3 southern wall 6026 was built on a substantial foundation wall three courses wide. This was visible on the western and eastern sides to a depth of c. 23.75m AOD. It extended for c. 2.3m on the western side and c. 4.8m on the

eastern side. In the centre the flue walls (6133-6139) carried on through under the wall. A series of three pairs of ferrous metal joists with ferrous metal plates on top (3017, 3018, 3019) were built on top of the flues (7.29). This formed the base for Stove House 3 wall 6026. The metal plates had been affected by salt corrosion and collapsed.

Phase 5-7: The excavations have shown that the flues passed under Stove House 3 wall in a manner similar to those in Stove House 4. The effect of salt corrosion on the ferrous metal plates within the wall had caused the centre of the wall to subside and this may have occurred before in the past. It is therefore unclear if this arrangement dates back to the late-1890s or has been rebuilt since.

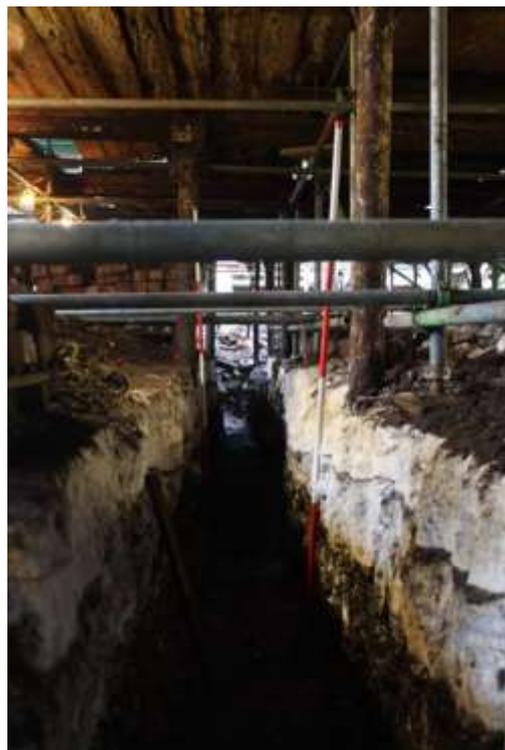
7.30: HC05, Stove House 3 steelwork footings (west), Section S1, north facing

Two strip foundations were excavated north-south along the length of Stove House 3. The western of these was excavated between the 2nd and 3rd flues (6138 and 6137, Section S1; see AS004 above, AS043, AS044; 7.30, 7.31). The excavation was 19.5m in length, c. 1.0m wide and c. 1.2m deep.

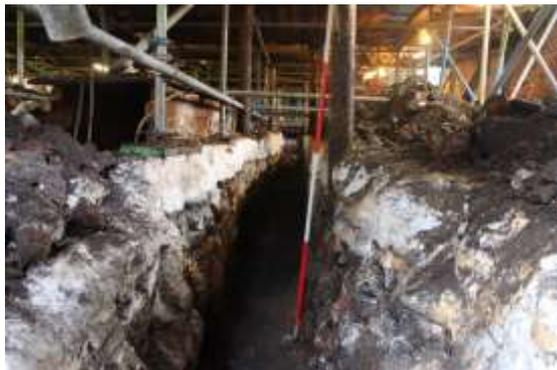
7.31: HC05, Stove House 3 steelwork footings (west), Section S1, south facing

Section S1: The earliest deposits revealed in the excavations were conglomerate material of red sandstone and salt (3054). At the northern end, c. 18m from the southern end it gave way to loose mixed rubble slate and brick (3055). This provided the base for the footings of the flues (6137, 6138).

Within the flues was a mixed salt and clinker material (3056) at the southern end. Above this was a layer of pure white salt (6153).

Three columns (6159, 6165, 6171) were set directly into this material. Where the salt had reacted with the base of the column they had become severely corroded and in places completely decayed. This had caused many of the structural problems with the support of the roof of the floor above.

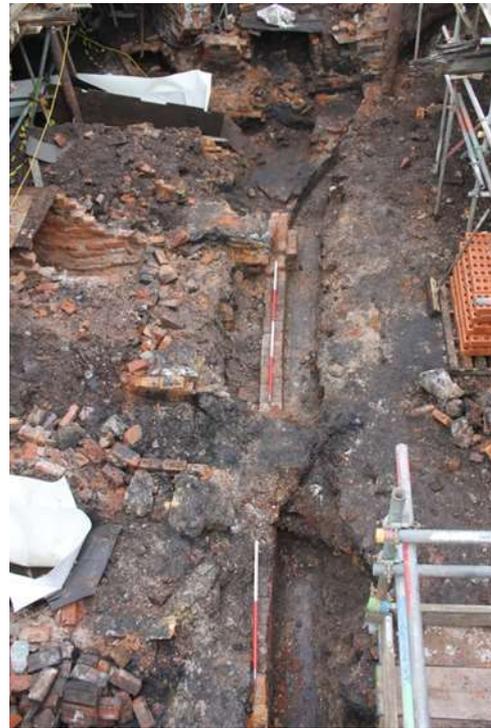
7.32: HC06, Stove House 1/ Stove House 3, wall foundation 3020, west facing

The upper courses were partially decayed. Along the northern side were a series of three piers. It was excavated to a depth of c. 0.80m.

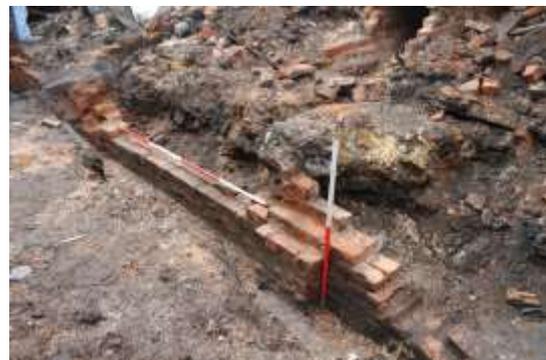
7.33: HC06, Stove House 1/ Stove House 3, wall foundation 3020, south-east facing

The southern wall of Stove House 1/ northern wall of Stove House 3 and the floor above had almost entirely collapsed. It was dismantled during work prior to rebuilding. The foundations of the wall were excavated in order to rebuild above them. The earliest remains consisted of an east-west wall foundation (3020; see AS004 above, AS043, AS063, AS064; 7.32, 7.33) that turned to the north-west and connected with wall 6500 the western curved gable wall of Stove House 1. It consisted of hand-made red brick in English Garden Wall bond, two skins wide and surviving to a height of ten courses.

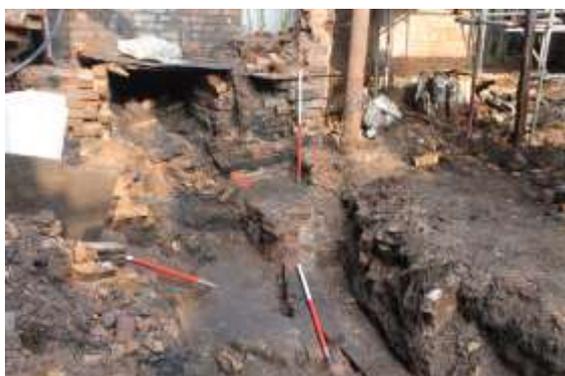
7.34: HC06, Stove House 1/ Stove House 3, wall foundation 3020/ 3021 west facing

Abutting the wall and extending to the south-west was a second wall (3021; 7.34) that connected to wall 6098 the north-western wall of Stove House 3. It was built of machine-pressed red brick in English Garden Wall bond, three skins thick and survived to eight courses in places. These walls had been entirely reduced in height and replaced by a later phase of north-south aligned flues (7.35, 7.36, 7.37). These equated to the flues of Stove House 1 (6512-6517) and Stove House 3 (6133-6137, 6139) described previously (see Volume IV).

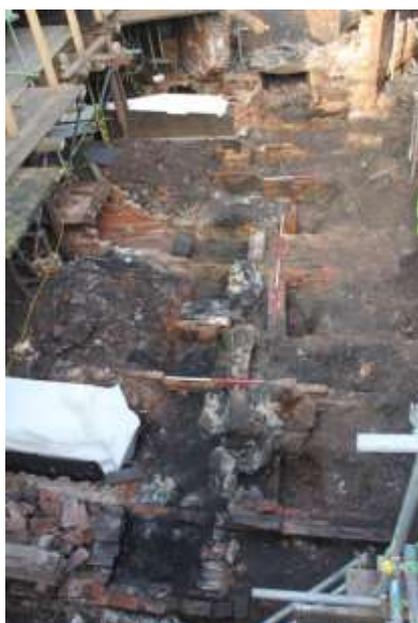
7.35: HC06, Stove House 1/ Stove House 3, north-south flues, west facing

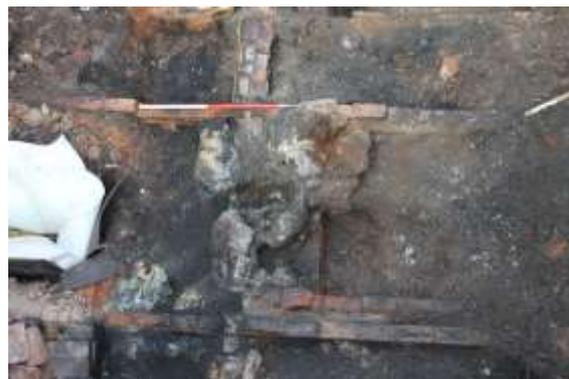
7.36: HC06, Stove House 1/ Stove House 3, north-south flues, overhead

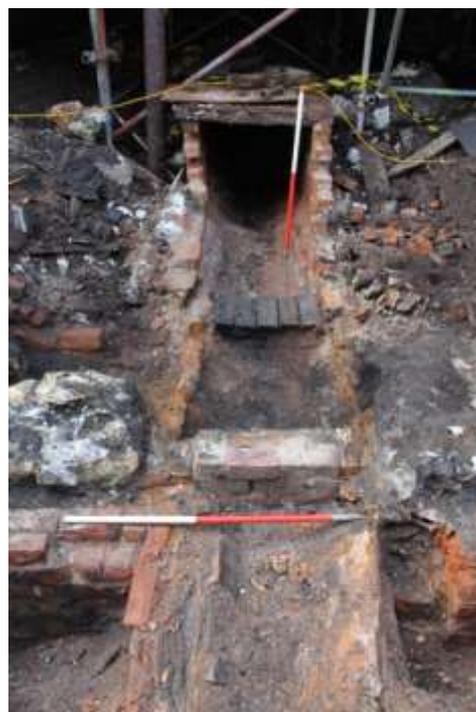
7.37: HC06, Stove House 1/ Stove House 3, north-south flues, south facing

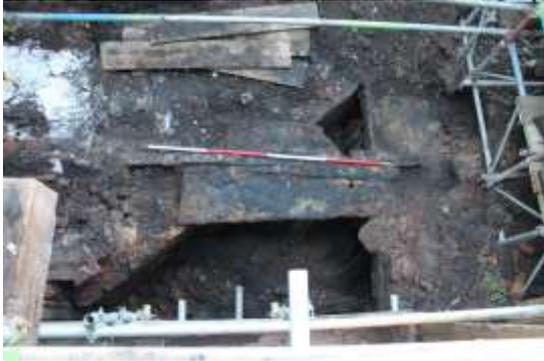
7.38: HC06, Stove House 1/ Stove House 3, metal plates 6528, 6529 over tunnel, west facing

At the eastern end of the arrangement, ferrous metal plates (6528, 6529) had been inserted to allow the flues to extend over the entrance to the tunnel (described in greater detail below, Section HC29; 7.38, 7.39). Two ferrous metal plates aligned north-south overlapped each other. The brickwork of flue 6133/ 6517 was built directly on top of the metal plate.

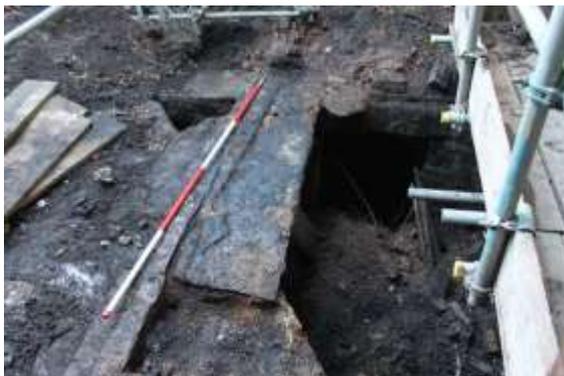
7.39: HC06, Stove House 1/ Stove House 3, metal plates 6528, 6529 over tunnel, north facing

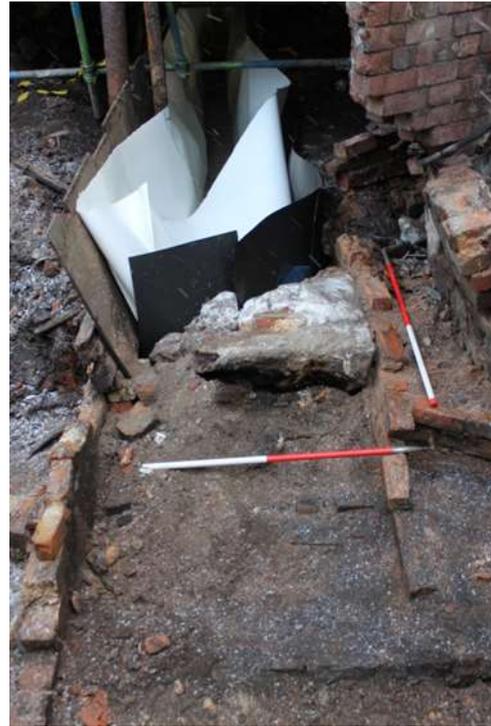
7.40: HC06, Stove House 1/ Stove House 3, flue 6139 under wall 6098, south facing

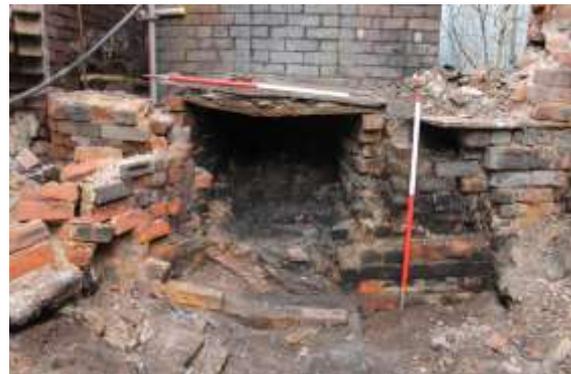
7.41: HC06, Stove House 1/ Stove House 3, flues entering Chimney 1, west facing

directly entered the eastern side of Chimney 1 as two loosely constructed flue walls (3028) with a ferrous metal plate on top (3031). To the east and in front of the flue was a remnant of loosely laid brick floor (3030). The remainder of the flues (6134-6137; 6513-6516) continued straight through north-south.

In the final phase of work at the site, the north-south flues described above were blocked by short lengths of loosely built stub walls of red brick and blue-black engineering bricks (e.g. 3022, 3023, 3024, 3025, 3026) to create an east-west northern end wall to Stove House 3 (6141; see Volume IV). This survived to a height of three to four courses in places. It continued through to the eastern side of Chimney 1 where it had been loosely keyed in to flue 3028 described above (see 7.40, 7.41).

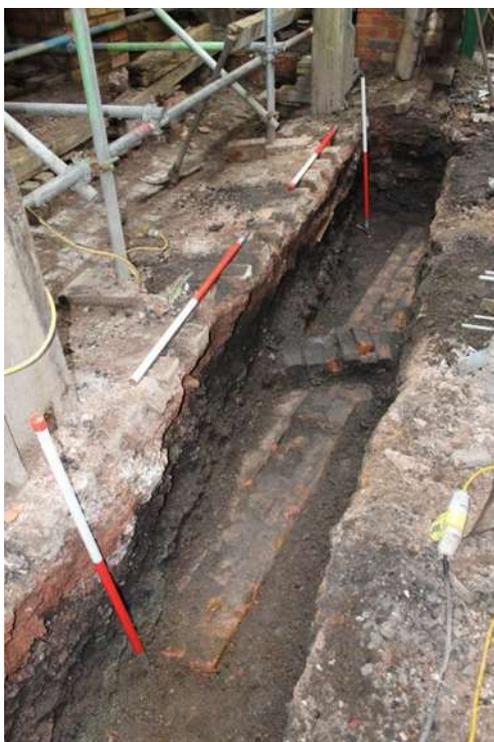
7.42: HC07, Pan House 4, Strip Footing (west), sill wall 6219, south facing

A strip foundation was excavated along the western side of Pan House 4 beneath the dismantled remains of sill wall 6219. It was c. 11.00m long (north-south) and 0.8m wide (east-west), and excavated to an approximate depth of 0.95m below ground level (see AS004 above, AS047, AS051).

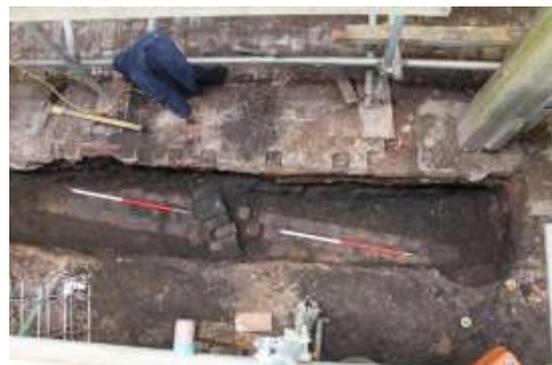
7.43: HC07, Pan House 4, Strip Footing (west), sill wall 6219, overhead

At the southern end at the base of the excavations were a series of two walls (7.42, 7.43). Running SSW-NNE was a hand-made red brick wall foundation, three courses wide (3050). It corresponded with a wall excavated in Test Pit TP17 (391). This hand-made red brick wall foundation (391) in English bond, was corbelled at the base. It was aligned at an angle to PH4, SSW-NNE, with a cross-wall perpendicular aligned WNW-ESE. Overlying this wall was a second, shallow cross-wall, made of a single skin of bricks laid on-side (3051). The function of this wall is unclear.

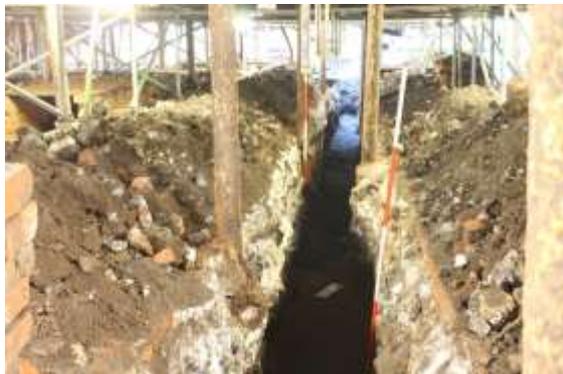
7.44: HC08, Stove House 3 steelwork footings (east), Section S2 north facing

Two strip foundations were excavated north-south along the length of Stove House 3. The eastern of these was excavated between the 5th and 6th flues (6135 and 6134; Section S2). The excavation was 19.5m in length, c. 1.0m wide and c. 1.2m deep (see AS004 above, AS043; 7.44, 7.45).

Section S2: The earliest deposit was again conglomerate red sandstone and salt material (3057). Built on this layer were the footings of flues 6134 and 6135. Between the flues was a layer of mixed salt and clinker material (3058), c. 0.3m deep. This was overlain by a layer of pure white salt (6150). Seven columns (6155, 6158, 6161, 6164, 6167, 6170, 6173) were set directly

into this material. Where the salt had reacted with the base of the column they had become severely corroded and in places completely decayed. This had caused many of the structural problems with the support of the roof of the floor above.

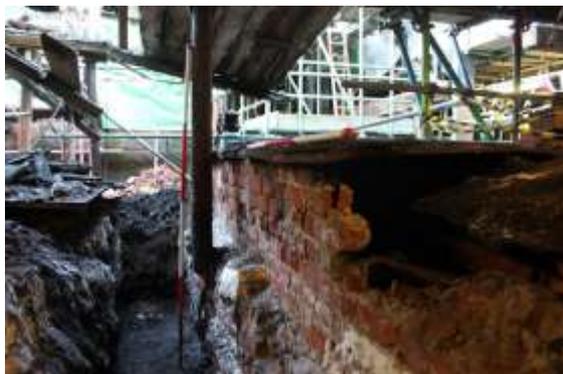
7.45: HC08, Stove House 3 steelwork footings (east), Section S2, north facing

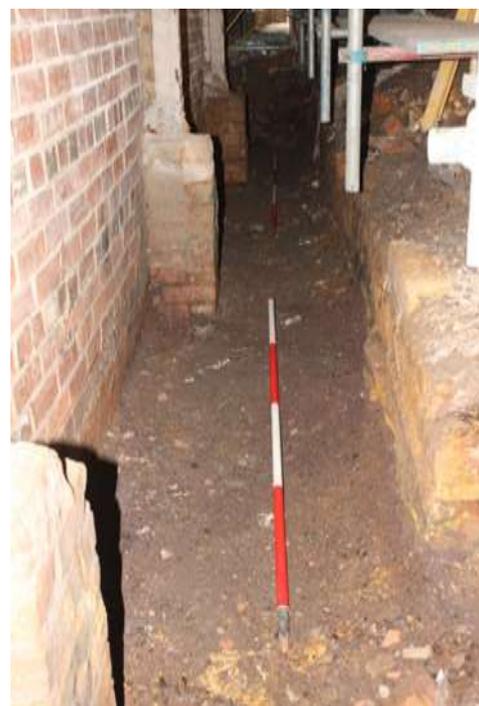
7.46: HC09, Stove House 4 steelwork footings (west), Section S3, north facing

Three strip foundations were excavated north-south along the length of Stove House 4. The western of these was excavated adjacent to the shared wall with Stove House 3 (6088) and along the line of flue 6396. (Section S3). The excavation was 19.0m in length, c. 1.0m wide and c. 1.1m deep (see AS004 above, AS057, AS058; 7.46, 7.47, 7.48, 7.49).

The excavation revealed the construction of wall 6088 had a series of brick piers, 0.3m wide that supported the vertical rails (6125-6130) up the side of the wall. The interior build of the stove house consisted of a conglomerated black clinker silt (3186). This was located below brick floor 6413 between flues 6395 and 6396. The flue walls of 6396 were supported on a series of three discontinuous walls of hand-made red brick (3187). The interior of the flue was filled with loose black clinker silt and ash (3188).

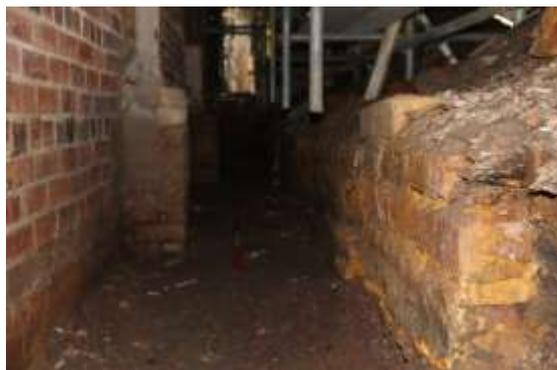
7.47: HC09, Stove House 4 steelwork footings (west), Section S3, north facing

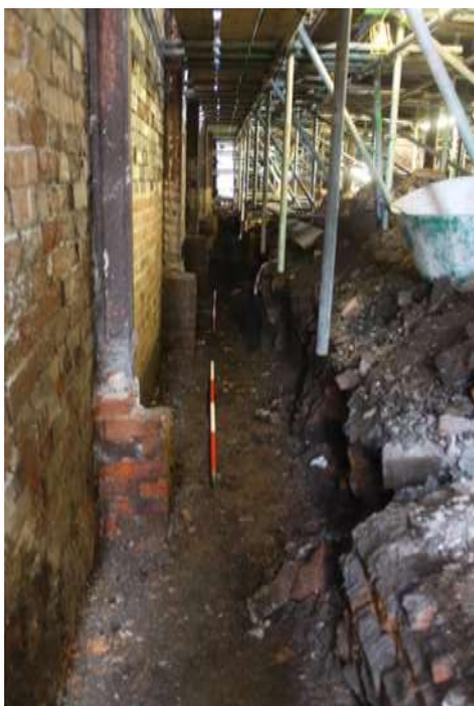
7.48: HC09, Stove House 4 steelwork footings (west), Section S3, north facing

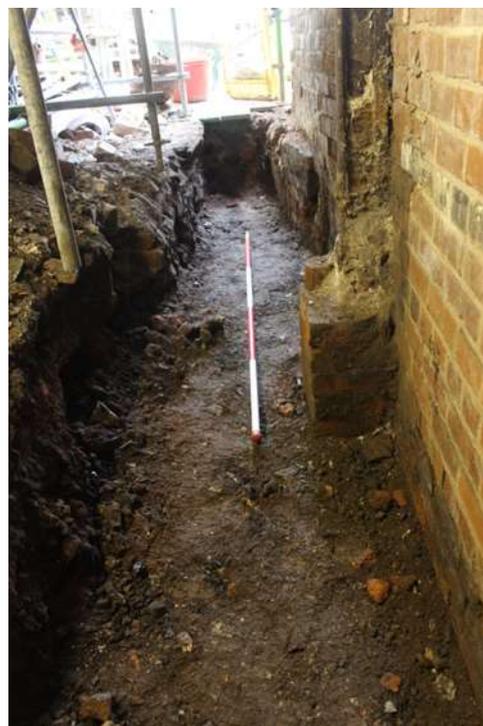
7.49: HC09, Stove House 4 steelwork footings (west), Section S3, north facing

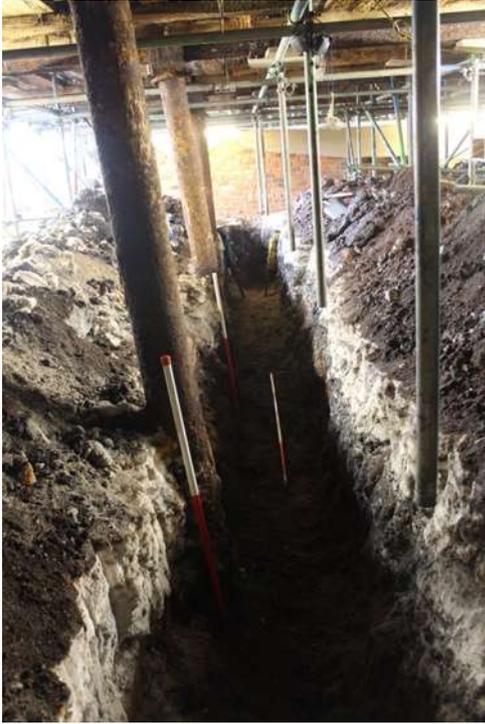
7.50: HC10, Stove House 4 steelwork footings (central), Section S4, north facing

Three strip foundations were excavated north-south along the length of Stove House 4. The central of these was excavated between the 3rd (6394) and 4th (6393) flues (Section S4). The excavation was 19.0m in length, c. 1.0m wide and c. 1.1m deep (see AS004 above, AS057, AS059; 7.50, 7.51, 7.52).

The lowest excavated layer within the stove house was a solid dark clinker material mixed with ash (3190). This was overlain by a narrow layer of mixed concreted clinker and salt (3191). Set within this conglomerate were the remains of the ferrous

metal columns supporting the roof above (5109, 6374, 6376, 6379, 6382, 6385, 6388). The columns had largely decayed below ground level due to the corrosive effect of the salt. Finally on top of this was a layer of pure white salt (3192).

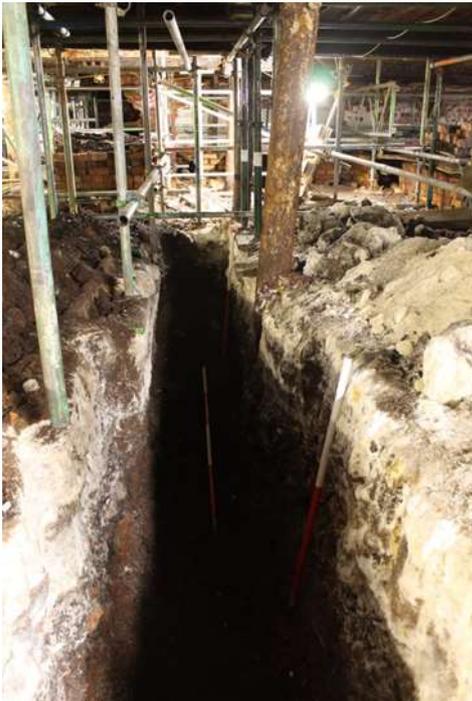
7.51: HC10, Stove House 4 steelwork footings (central), Section S4, south facing

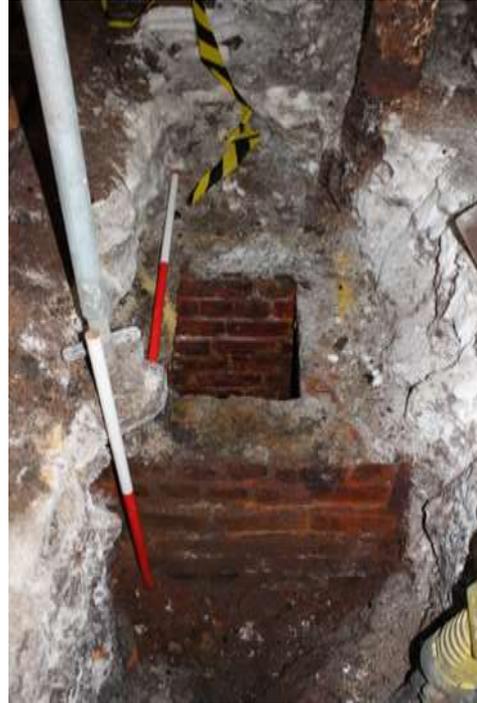
7.52: HC10, Stove House 4 steelwork footings (central), Section S4, brick sump 3189, south facing

The earliest deposit was a brick lined sump (3189; 7.53, 7.54, 7.55). It was located 8m north of the southern wall (6268). It was built of hand-made brick in English Garden Wall bond. It was 1.0m x 1.0m and c. 2.9m in depth. Its top was at 26.24m AOD at the top and its base was at 23.34m AOD. It contained liquid organic residues at the base.

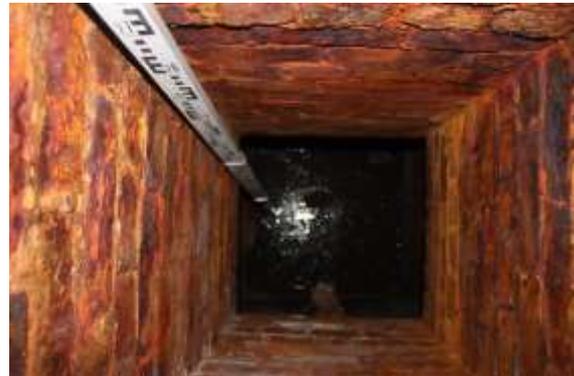
7.53: HC10, Stove House 4 steelwork footings (central), Section S4, brick sump 3189, south facing

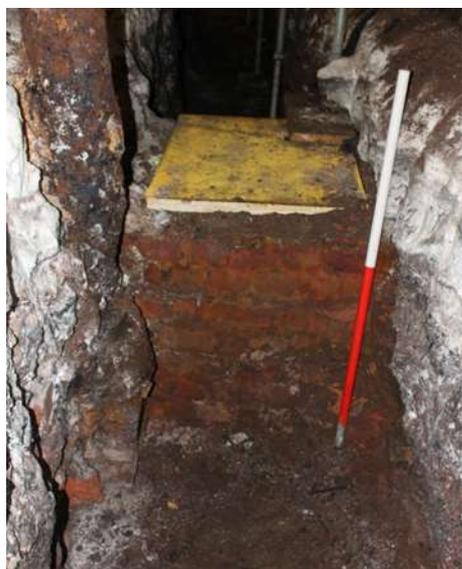
7.54: HC10, Stove House 4 steelwork footings (central), Section S4, brick sump 3189, south facing

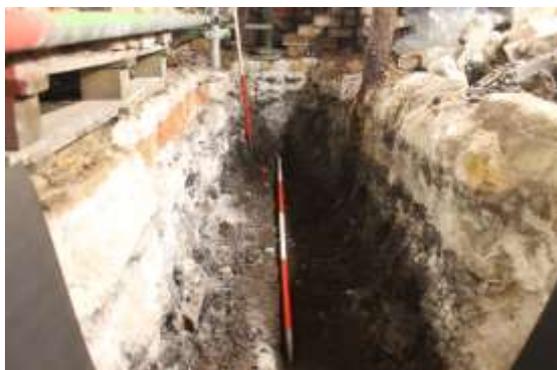
7.55: HC10, Stove House 4 steelwork footings (central), Section S4, northern section, north facing

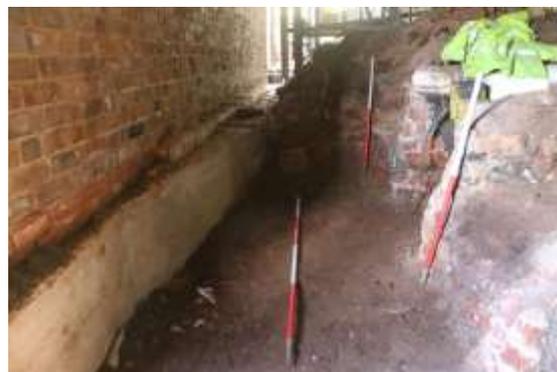
7.57: HC11, Stove House 4 steelwork footings (east), Section S5, south section, west facing

Three strip foundations were excavated north-south along the length of Stove House 4. The eastern of these was excavated between the 5th (6392) and 6th (6390) flues (Section S5). The excavation was 19.0m in length, c. 1.0m wide and c. 1.1m deep (see AS004 above, AS057, AS060; 7.56, 7.59). Two extensions were added to this main footing. At the south was an east west footing (7.57, 7.58), 1.6m (north-south) by 5.3m (east-west) immediately to the north of wall (6268).

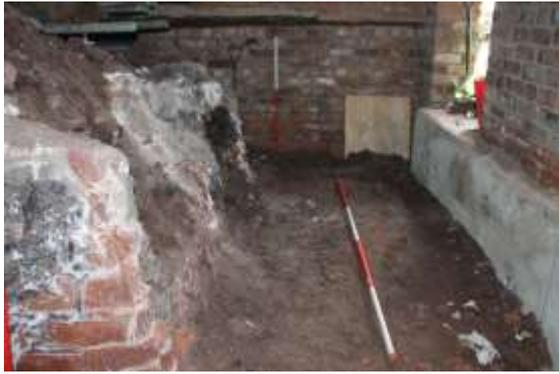
7.58: HC11, Stove House 4 steelwork footings (east), Section S5, south section, east facing

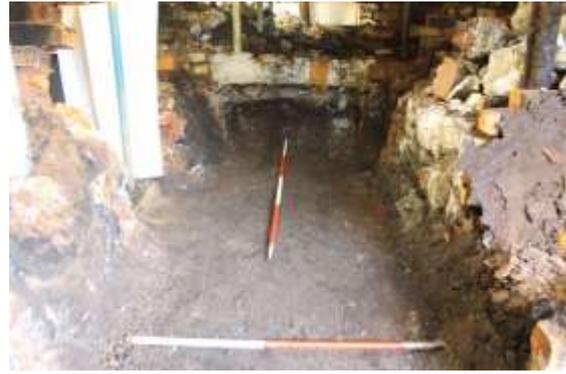
7.60: HC11, Stove House 4 steelwork footings (east), Section S5, north section, west facing

At the northern end the extension formed an H-shaped plan (7.60, 7.61, 7.62, 7.63, 7.64). Initially it was orientated east-west, 1.4m (north-south) by 5.7m (east-west). There was a second parallel strip footing between the 6th (6391) and 7th (6390) flues, 5.7m (north-south) by 0.8m (east-west).

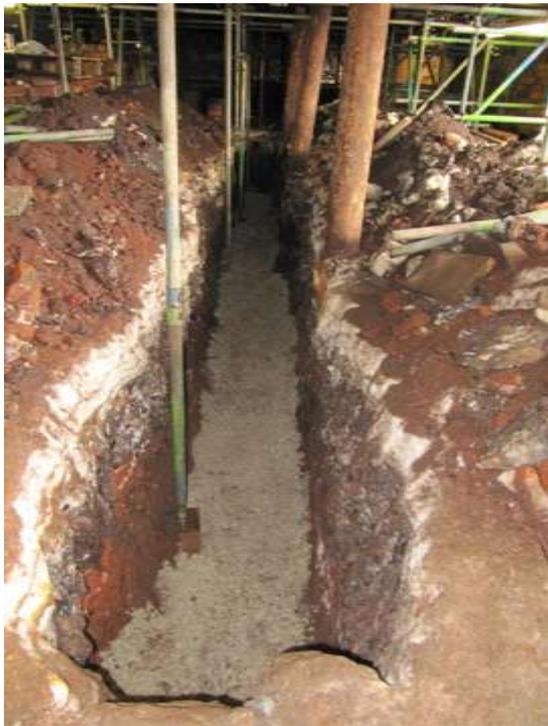
7.59: HC11, Stove House 4 steelwork footings (east), Section S5, central section, south facing

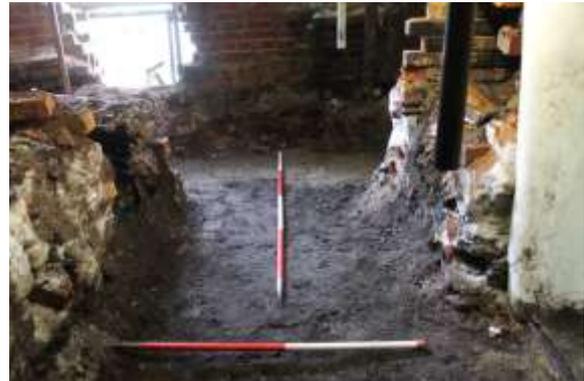
7.61: HC11, Stove House 4 steelwork footings (east), Section S5, north section, east facing

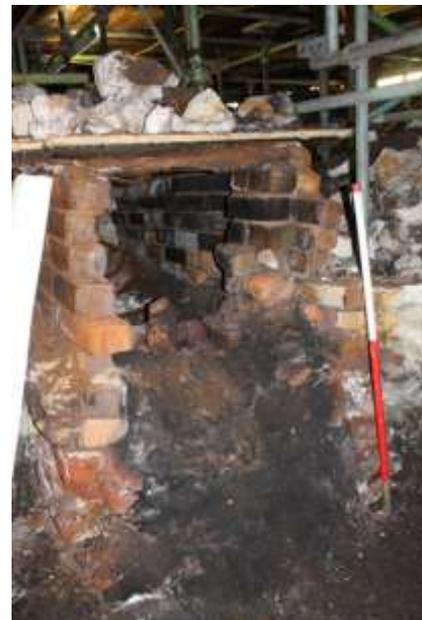
7.62: HC11, Stove House 4 steelwork footings (east), Section S5, north section, dismantled flue, south facing

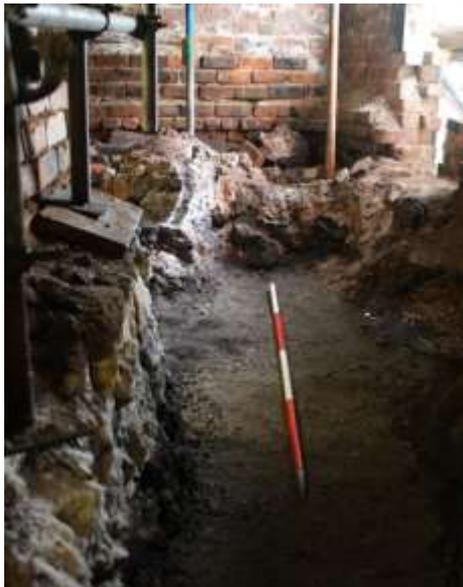
7.63: HC11, Stove House 4 steelwork footings (east), Section S5, north section (east), north facing

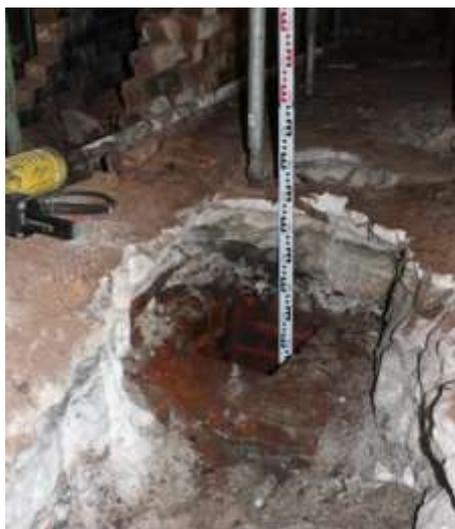
7.64: HC11, Stove House 4 steelwork footings (east), Section S5, sump 3193, north facing

The earliest deposit was another square, brick lined sump (3193; 7.64, 7.65) located 13m north of the southern wall (6268). It was built of hand-made red brick in English Garden Wall bond. It was 1.0m x 0.9m and c. 2.7m deep (26.405m AOD at the top, 23.705m AOD at the base).

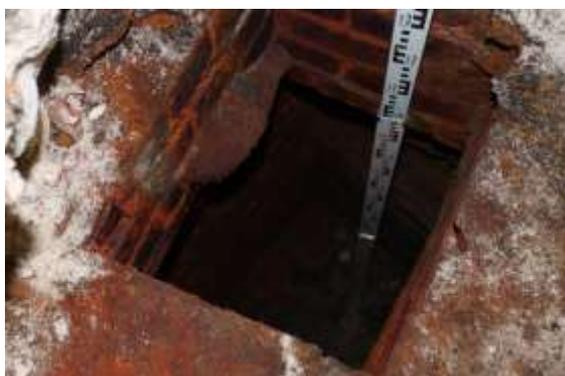
7.65: HC11, Stove House 4 steelwork footings (east), Section S5, sump 3193, north facing

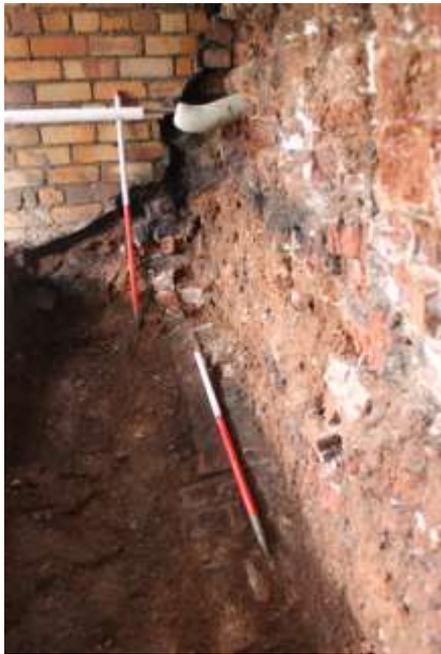
7.66: HC12-1, Post-excavation after removal of wall 3059, south facing

A series of five footings (HC12-1, HC12-2, HC12-3, HC12-4, HC12-5) were excavated to provide concrete support for the eastern side of Kiln 4. These were approximately 1.2m x 1.0m and excavated to a depth of 1.0m (see AS004 above, AS047, AS053, AS055). At the base of the excavation were the remains of an earlier wall (3059) for Kiln 4. These were machine pressed red brick in English Garden Wall bond, two skins thick. The wall dog-legged at the northern end (HC12-1, see 7.66, 7.67), and extended up to the southern wall of Stove House 4. The wall continued to the south in line with the later stove wall. It was visible collapsing to the east in excavations HC12-2, HC12-3 and HC12-4 (7.68, 7.69, 7.70, 7.71). At the end of the pan it turned to the west and formed the southern (front) end of the stove. The wall was originally recorded in the section of Kiln 4 as 6279.

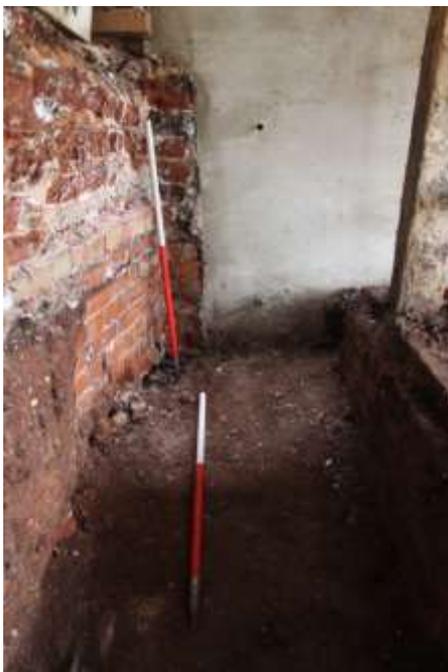
7.67: HC12-1, Post-excavation after removal of wall 3059, north facing

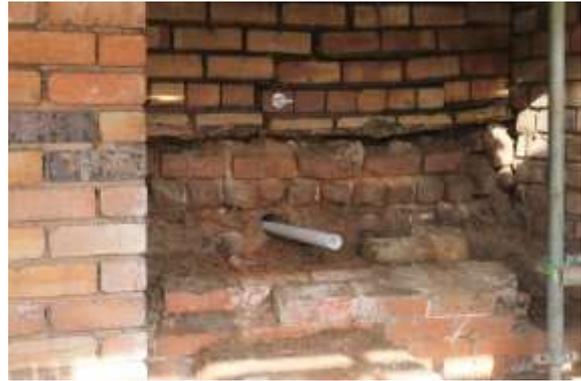
7.68: HC12-4, Remains of earlier wall 3059, west facing

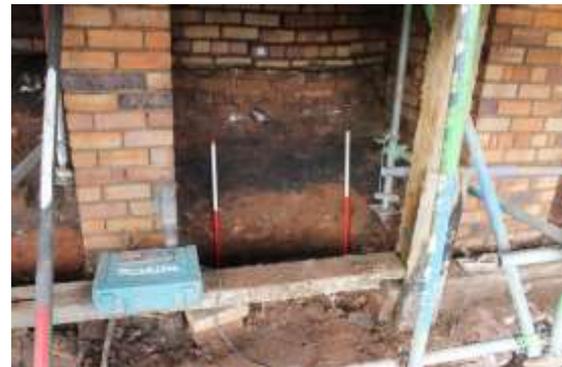
7.69: HC12-4, Post-excavation after removal of wall 3059, west facing

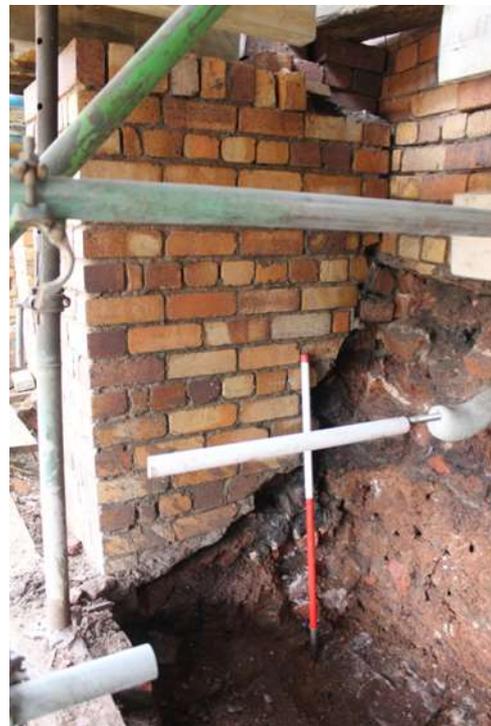
7.70: HC12-1, Post-excavation after removal of wall 3059, south facing

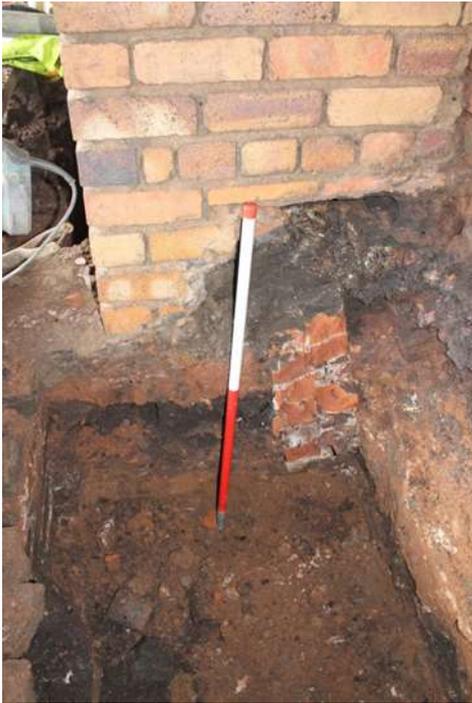
7.71: HC12-2, Post-excavation after removal of wall 3059, south facing

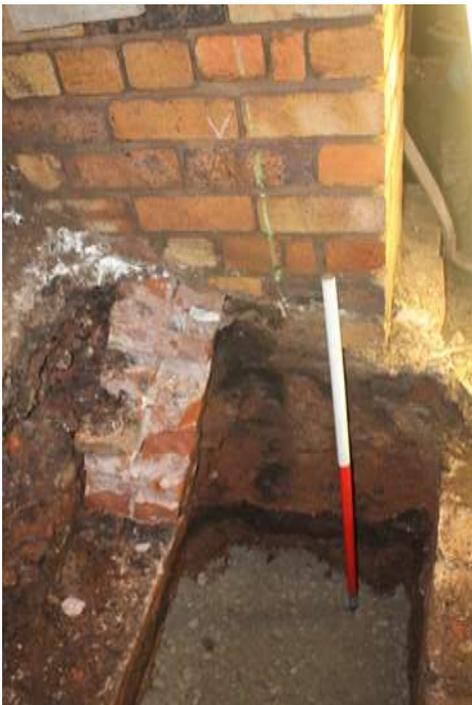
7.72: HC12-4, Post-excavation wall 3059 and pier 3060, north facing

Two brick piers, c. 0.60-0.80 x 0.50m in size supported the wall to the east (3060, 3061, 7.72, 7.73).

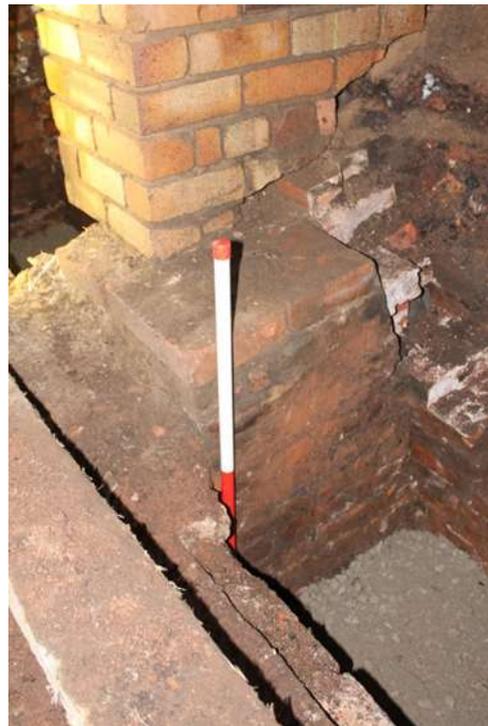
7.73: HC12-4, Post-excavation after removal of wall 3059 and pier 3060, south facing

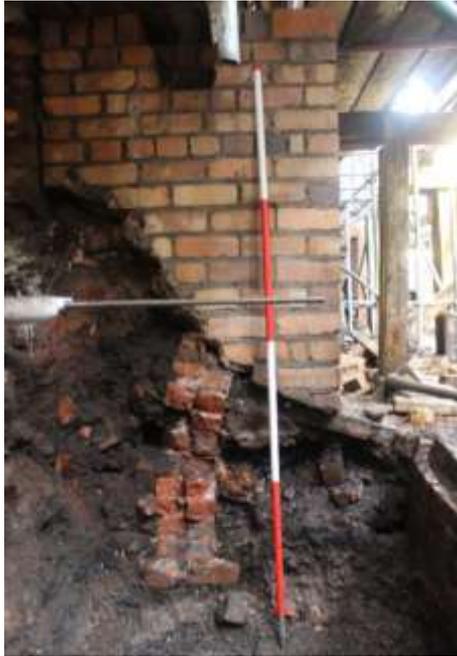
7.74: HC13-1, Post-excitation after removal of wall 3068, south facing

Like the eastern side of Kiln 4, a brick footing (3068) for an earlier stove was visible. This was built of machine-pressed red brick in course English Garden Wall bond, three skins thick. In all excavations (HC13-1 to HC13-5, 7.74, 7.75, 7.76, 7.77) it had begun to collapse east to west. This was originally visible in the section of Kiln 4 as 6277. At the southern end two, machine-pressed red brick piers (3070, 3071, 7.78, 7.79) had been built to support the wall. At the northern end it dog-legged and tied into the southern wall of Stove House 4 (7.80).

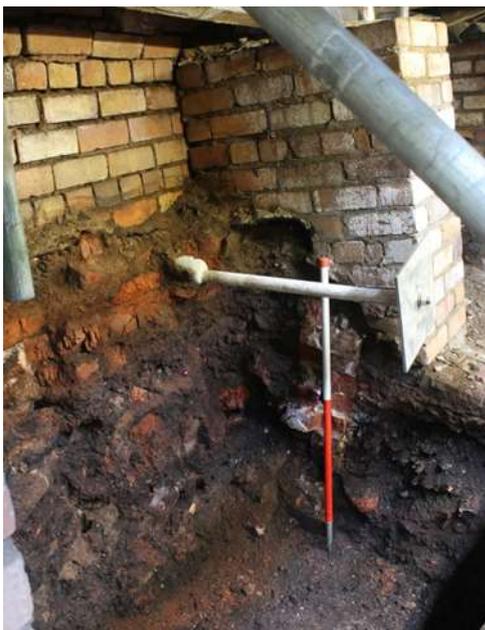
7.75: HC13-2, Post-excitation after removal of wall 3068, south facing
