THE ALLIANCE AND LION SALT WORKS, MARSTON, NORTHWICH

SCHEDULED MONUMENT NO 34985-002

VOLUME III: THE ARCHAEOLOGICAL EXCAVATIONS, 1992-2015

REPORT NO 2015-01

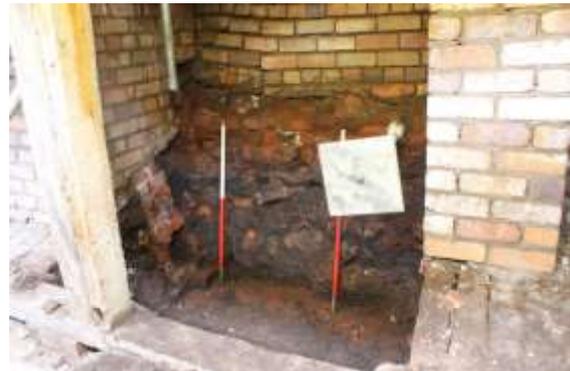
7.76: HC13-3, Post-excitation after removal of wall 3068, east facing

Like the eastern side of Kiln 4, a brick footing (3068) for an earlier stove was visible. This was built of machine-pressed red brick in course English Garden Wall bond, three skins thick. In all excavations (HC13-1 to HC13-5, 7.74, 7.75, 7.76, 7.77) it had begun to collapse east to west. This was originally visible in the section of Kiln 4 as 6277. At the southern end two, machine-pressed red brick piers (3070, 3071, 7.78, 7.79) had been built to support the wall. At the northern end it dog-legged and tied into the southern wall of Stove House 4 (7.80).

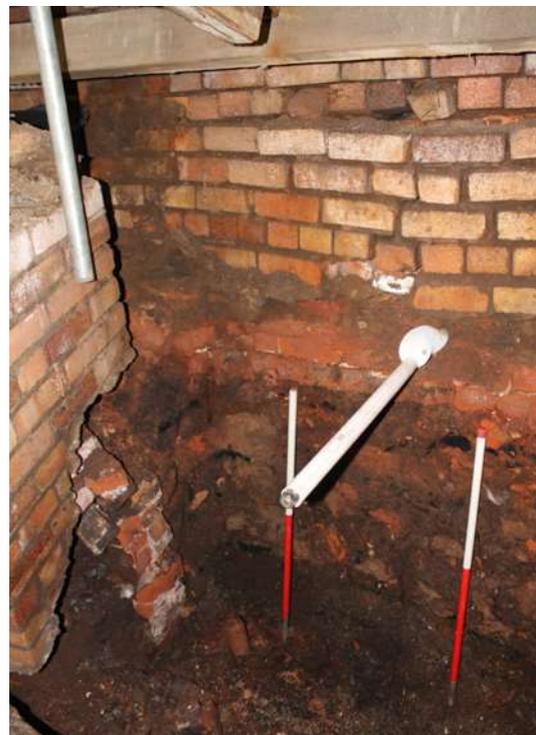
7.77: HC13-3, Post-excitation after removal of wall 3068, collapse of pier, east facing

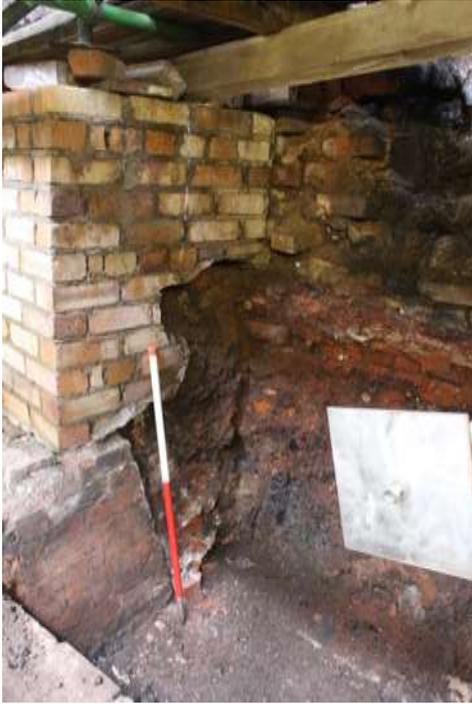
7.78: HC13-4, Post-excavation after removal of wall 3068, pier 3070, north-east facing

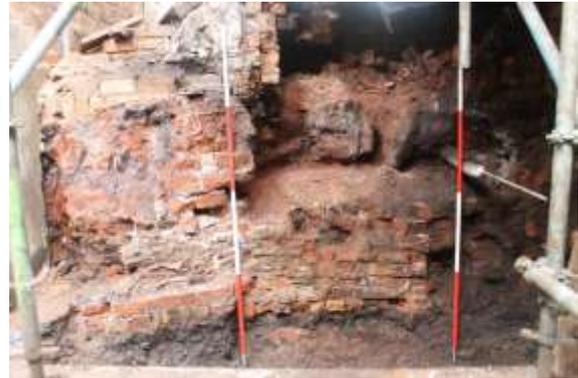
7.80: HC13-1, Post-excavation after removal of wall 3068, west facing

Above these earlier brick walls were the remains of the rebuilt kiln, made of machine-pressed yellow brick in English Garden Wall (6282). This was supported by a series of four brick piers of the same material (6280). The ditch of machine-pressed red brick (6261) was built over the underlying remains.

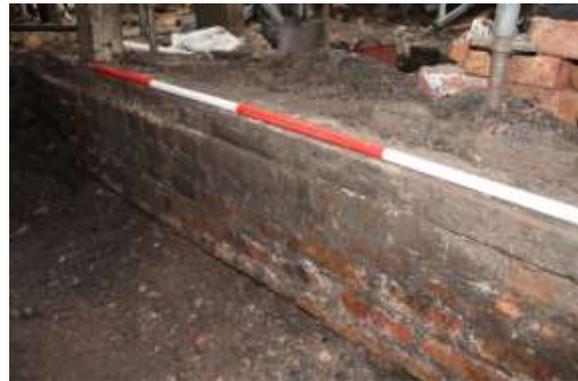
7.81: HC13-1, Post-excavation, wall 3072, west facing

To the west of the earlier wall and running parallel to it was a sill wall (3072, 7.81) built in machine pressed red brick in English Garden Wall bond. The area between these walls was filled with black clinker ash material (3069, east of kiln wall; 3073, west of kiln wall).

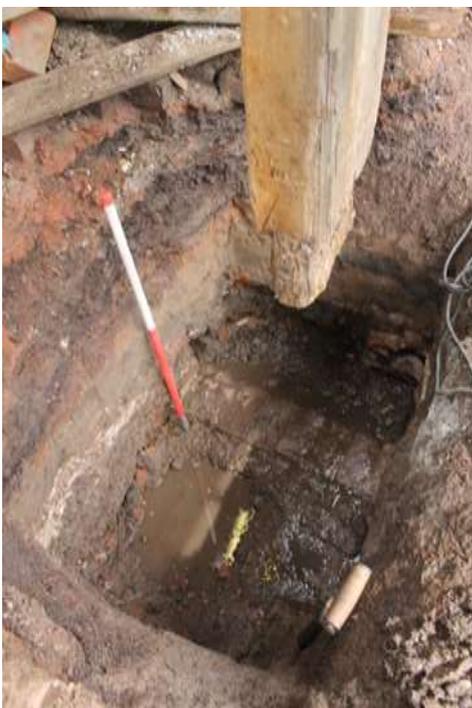
7.82: HC14-4, Post-excavation, wall 3074, 3075, north-west facing

At the very southern end c. 1.25m below ground level was an east-west machine pressed red brick wall foundation, two skins wide (3074), abutting and perpendicular to this was a north-south wall foundation of machine-pressed red brick, also two skins wide (3075, 7.82). Behind the walls was a fill of black clinker silt (3076) that contained intact clay tobacco pipe dating to the earlier years of the 20th century. These walls and the remainder of the excavations were filled with layers of mixed rubble and grey cement hard-core material (3002), clean sterile grey sand-silt, 0.40m deep (3001) and a layer of crushed red brick waste (3007), 0.15m deep (e.g. HC14-2, 7.83). The brick ditches (6260) were built on top of this material. These were identical to layers encountered in excavations HC2.

Phase 4: The walls (3074, 3075) appear to relate to foundations of the southern Butter Pans, also located as walls 3003 and 3004 in adjacent excavations HC2. Upstanding remains of these are located to the east, adjacent to the Nodding Donkey (1017, 1051). The fishery pans were demolished or adapted in the 1930s to 1940s to make way for Pan House 4. The south-eastern Butter Pan had been demolished in around 1937 to 1938 to allow for a new brine bore-hole and the building of the Pump House (see section 6 below). The south-western fishery pan survived until at least the late 1940s when it was visible on aerial photographs of the site.

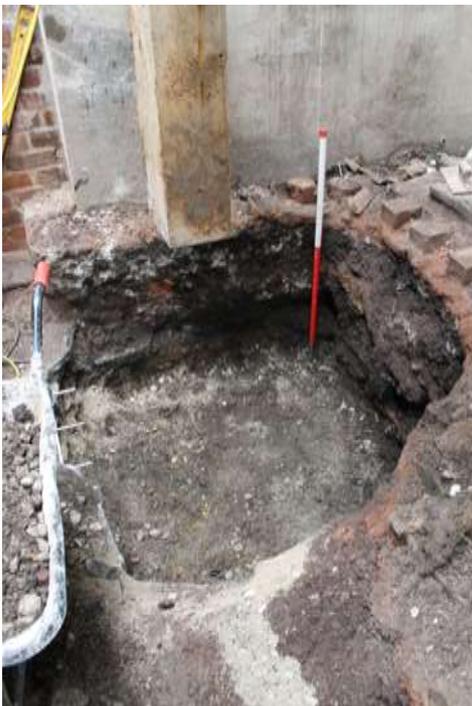
7.84: HC15-1, Post-excavation, north facing

designed to provide concrete pads for posts supporting the main trusses of Pan House 4 (see AS004 above, AS047, AS051). The trenches were filled initially by a layer of black clinker silt (3051). At the northern end (Trench HC15-1, 7.84) the black clinker silt (3058) formed the base for a rough remnant of brick floor surface (3113).

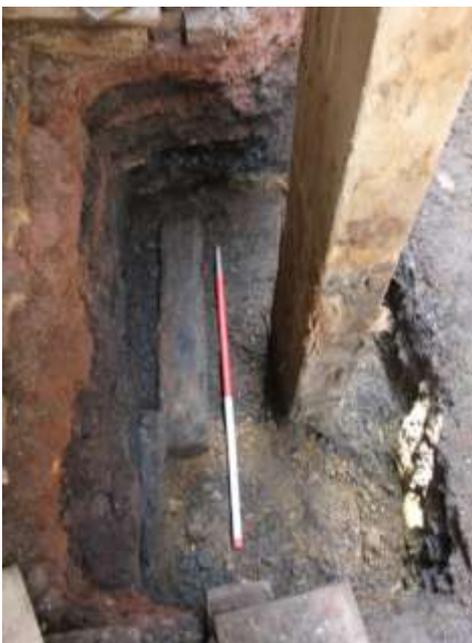
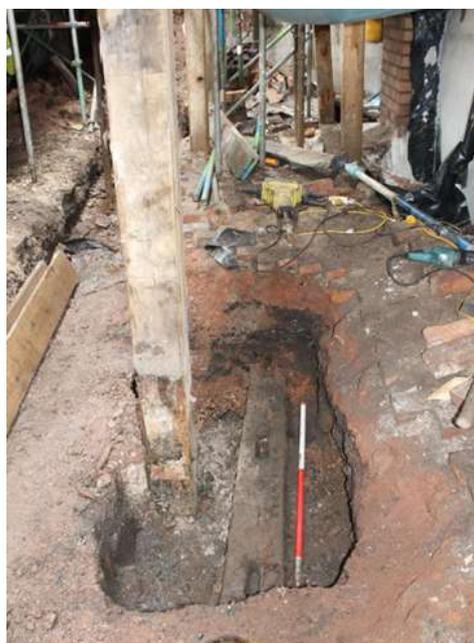
7.85: HC15-2, Post-excavation, sill beam 3077, south facing

Located in trenches HC15-2 and HC15-3 was the remnant of a timber sill beam (3077; 7.85, 7.86). It was originally supported by a NNE-SSW beam, over which were a series of three wooden pads acting as packers (in HC15-3 but not located further north in HC15-2). Above this was the sill beam which had a series of three tenons for studs above. The structure appeared to be a timber continuation of wall 3050 located in excavations HC07.

7.86: HC15-3, Post-excavation, sill beam 3077, north facing

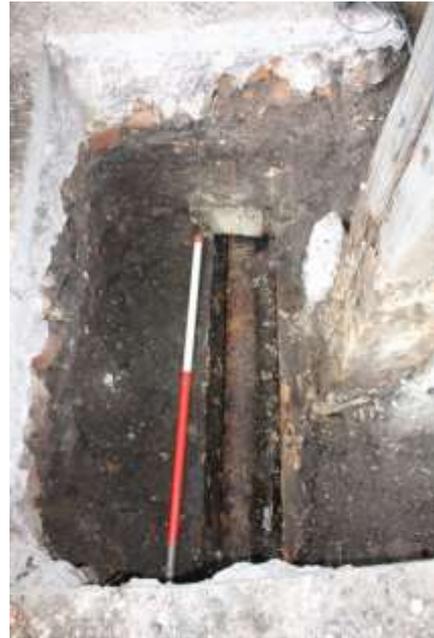
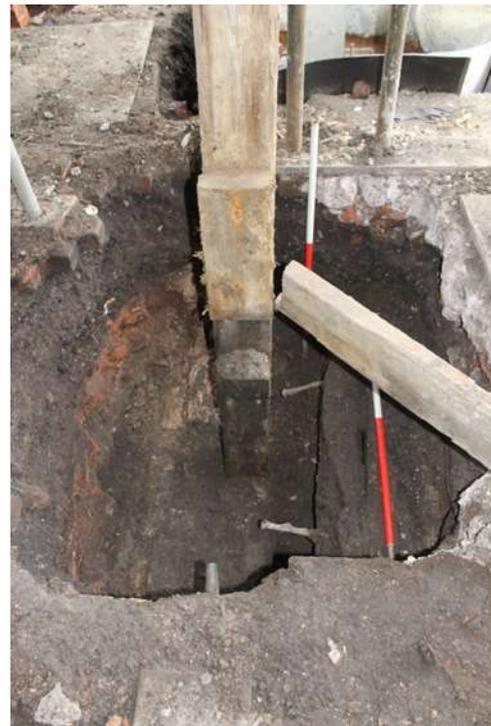
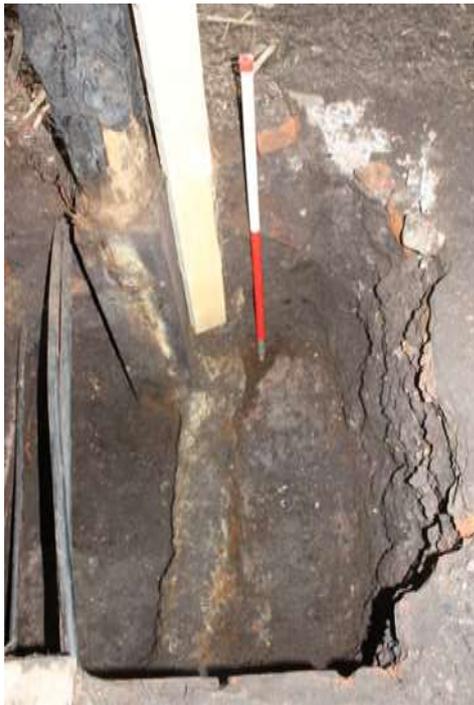
A machine-pressed red brick wall foundation (3079, 7.87), three courses wide, ran east-west across the site. It was visible in trenches HC16-1, HC16-2 and HC16-3. Parallel and to the south of this was a cast-iron brine pipe (3081, 7.88, 7.89, 7.90), 200mm in diameter. It ran east-west before emerging from the ground vertically in excavation HC16-3 (6261, 7.90) and emptying into Pan 4. It was surrounded by a large wooden trough of elm (3080), 400mm x 400mm cross-section, with a lid 150mm thick.

7.88: HC16-1, Post-excitation, brine pipe 3081, elm trough 3080, west facing

7.89: HC16-2, Post-excitation, elm trough 3080, east facing

7.90: HC16-3, Post-excitation, brine pipe 3081, east facing

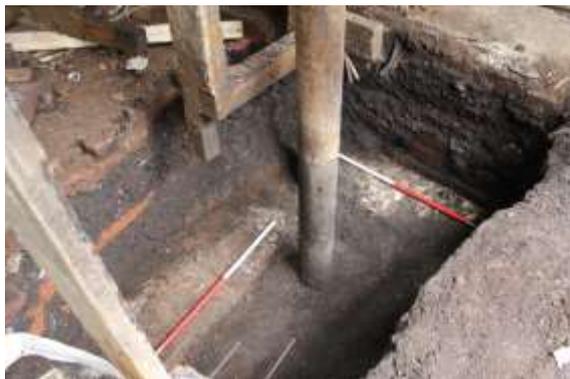
7.91: HC16-4, Post-excitation, mortar spreads 3121, 3122, 3125

In trench HC16-4 there were a series of three mortar spreads (3121, 3122 and 3125; 7.91) that may have related to wall foundations and earlier brick floor surfaces. Spread 3121 was aligned in a similar direction to wall foundation 3079, whilst spread 3122 was perpendicular to it, running north-south. A two inch wide timber (3123) and small brick pier (3124) sat on top of this spread. Spread 3125 was isolated and did not seem to be aligned with any walls.

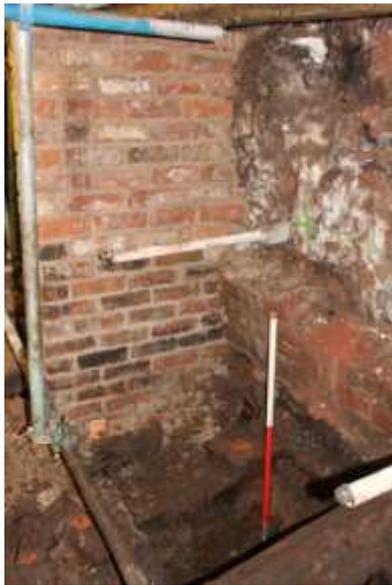
7.92: HC17-1, Post-excitation, south-west facing

The excavations contained yellow-brown silt at the northern end (3086, Trench HC17-1, 7.92) and southern end (3099, Trench HC17-9) that was overlain by brown clinker silt (3088). This was covered by the remains of the brick floor (3085) throughout. The brick floor was covered throughout by brown silt rubble material (3084).

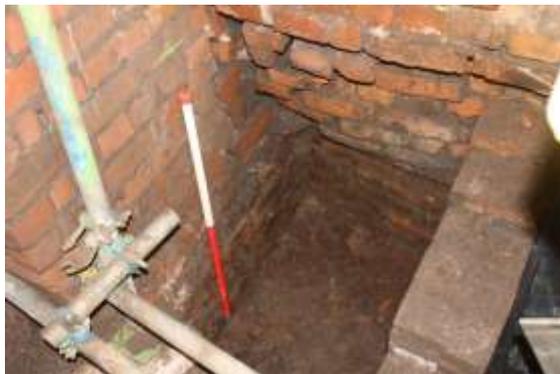
7.93: HC17-7, Post-excitation, west facing

At the southern end the remnant of an earlier pan, was visible as lower brickwork of machine-pressed red brick in English bond (3089, e.g. HC17-7, 7.93) and an associated brick pier. Located in Trench HC17-1 at the north was a similar brick pier of machine-pressed red brick (3087). Built on top of these earlier remains were the eastern wall of Stove 3 (6059) and brick piers (6058). These had partially collapsed at the southern end (Trenches

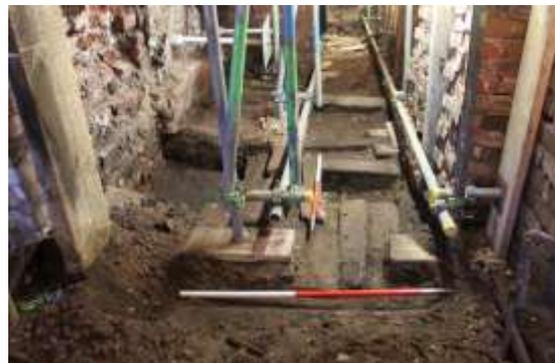
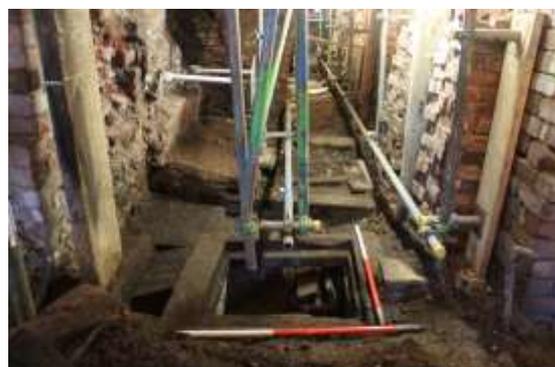
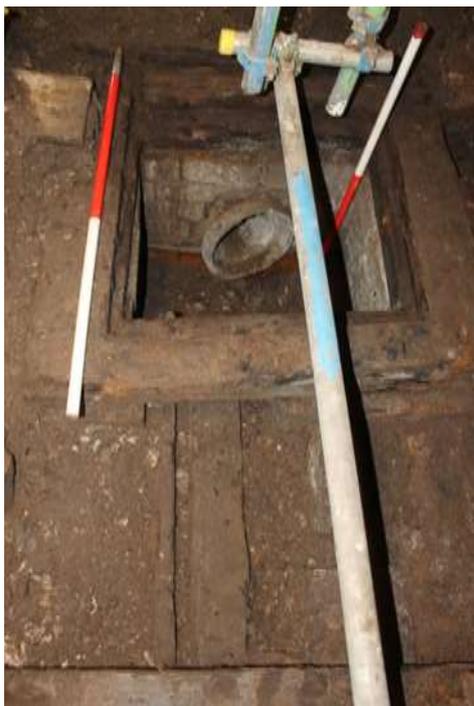
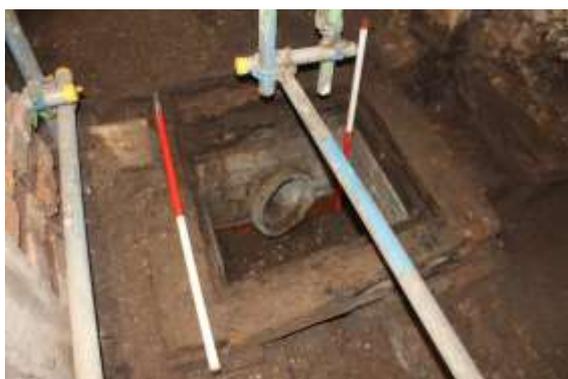
The brick pier above (6058), also overlay a rectangular brick sump (3095), in the south-eastern corner (Trench HC17-9, 7.94, 7.95, 7.96, 7.97, AS039). It was made of machine-pressed red brick, 0.80m x 0.80m in size. On top of the sump was a square wooden frame (3096), with a lid made of five, 3" thick timbers (3097). Entering the sump from the north from brick ditch (3085) was a wooden drain, with a square cross-section made from four planks (3098). The sump drained to the south via a large ceramic drain (3101) that passed to the south-east. The sump had become back-filled with brown humic material (3100).

7.94: HC17-9, Post-excitation, sump 3095, 3096, north facing

7.95: HC17-9, Post-excitation, sump 3095, 3096, north facing

7.96: HC17-9, Post-excavation, sump 3095, 3096, south facing

7.97: HC17-9, Post-excavation, sump 3095, 3096, south facing

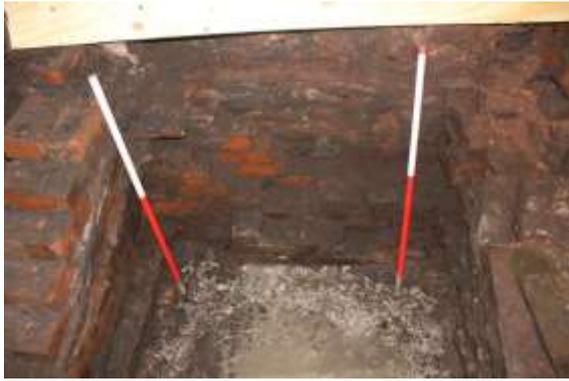
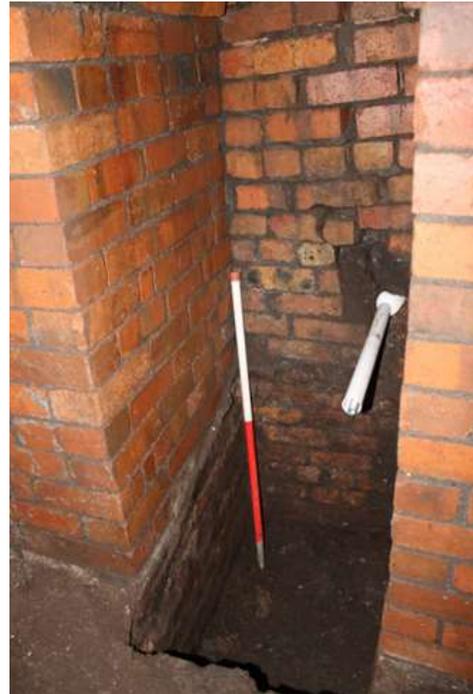
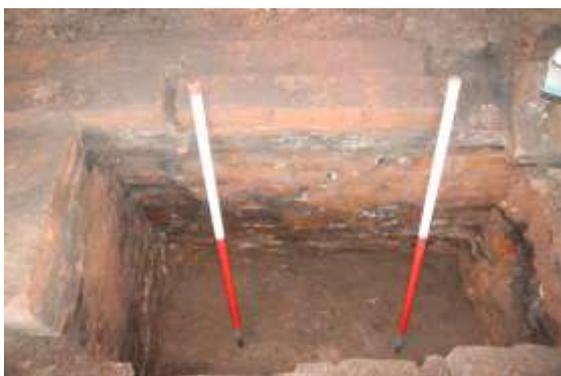
Above this were the excavated remains of the stove wall (6056) and piers (6055). In the majority of trenches (HC18-1 to HC18-7, 7.100, 7.101) the wall foundations continued to the base of the excavations. The excavations themselves were filled with loose brown clinker silt (3102). This was covered by the sloping sides of the brick ditches (6057). The final pier (6055) at the southern end was dismantled and rebuilt.

7.98: HC18-8, Post-excavation, wall foundation 3103, east facing

7.101: HC18-2, Post-excavation, wall foundation 3103/ 6056, east facing

7.100: HC18-7, Post-excavation, wall foundation 3103, east facing

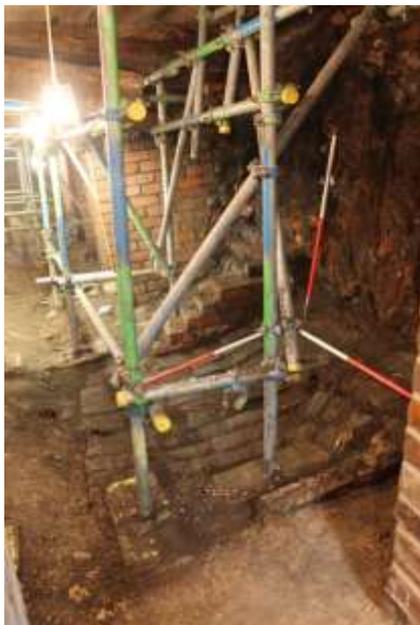
7.99: HC18-8, Pre-excavation, dismantled stove wall and piers 6055, 6056, north-east facing

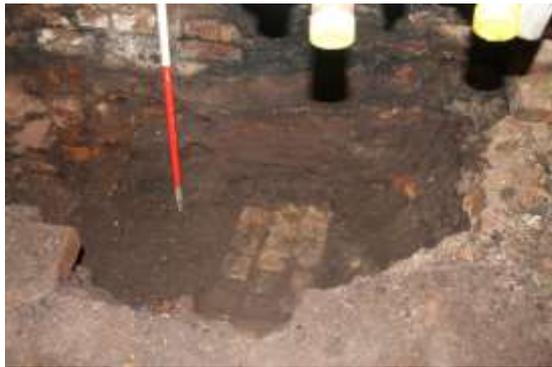
The excavations were conducted in three separate parts (HC19-1, HC19-2, HC19-3; see AS004 above, AS029, AS035). At the base of the central excavation (HC19-2) was the remains of NNE-SSW wall foundation of hand-made red brick, three skins wide (3108, 7.102). This was overlain by firm grey sand silt (3105) and brown sand silt clinker (3104). The brick rib walls running along the stove forming the internal flues, were visible as deeper foundations within the build-up inside the stove (7.103). These brick rib foundations (3106, 3107, 3109, 3110) were two bricks wide. They supported the very shallow footings, less than two courses deep, of the stove wall (6060).

7.102: HC19-2, Post-excitation, wall foundation 3108, north facing

Phase 4: The NNE-SSW wall foundation 3108 appears to relate to the remains of the Rhomboid building visible on the 1898 Ordnance Survey map of the site. It would appear to be the western wall of this building. The function of this building is unknown but it is probable that it related to a large, open, salt store that was used from c. 1895 until it was replaced by the south-western and south-eastern fishery pans. This salt store would have been superseded by the Coronation Salt Store by around 1910-1920.

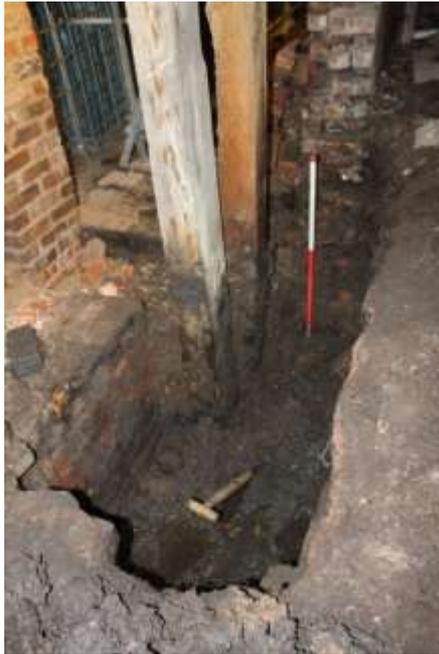
7.104: HC20-1, Post-excavation, overall, north facing

The earliest deposits at the southern end (Trench HC20-1, 7.104), was highly waterlogged grey sand silt (3112), found at a depth of 0.7m + below the current ground level. This deposit was also found at a depth of 0.8m+ below current ground level at the northern end (Trench HC20-2).

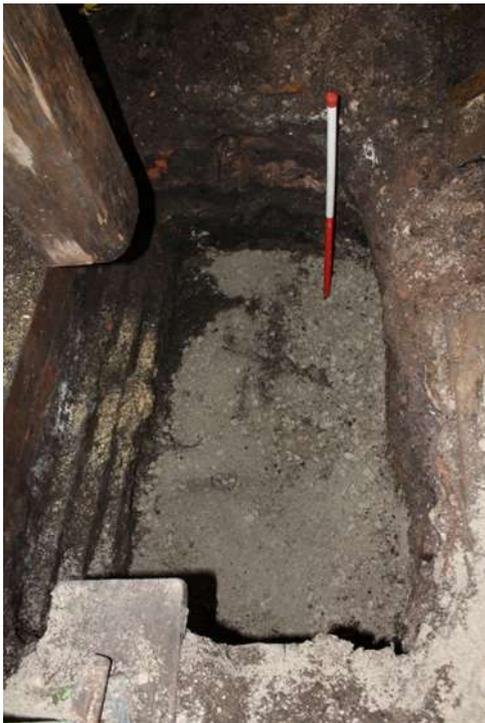
7.105: HC20-2, Post-excavation, overall, north facing

The corbelled, machine-pressed brick, footing of the eastern wall (6014, 7.105) was located at 0.75m below the surface of trenches HC20-1 and HC20-2. It was removed during excavation. The foundation was filled around by black clinker silt (3111, 3116). The layer of black clinker silt was also visible in the very southern excavations (3126, HC20-3; HC20-4). At the northern end a layer of crushed brick and rubble (3115) was located 0.3m below the surface.

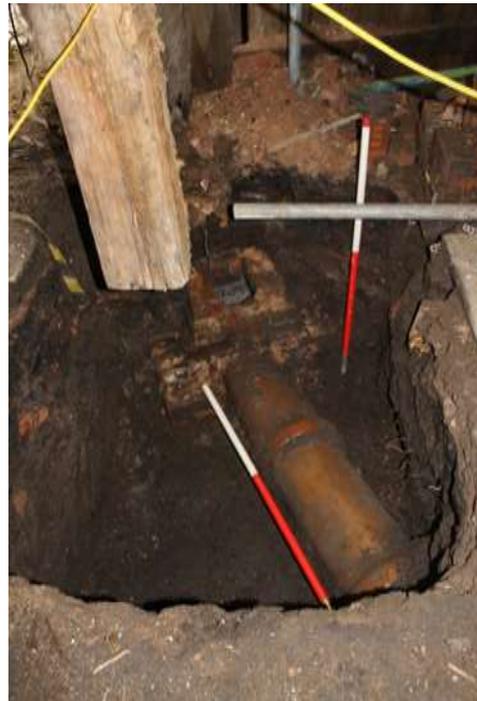
7.106: HC20-3, Post-excavation, ceramic drain 3127, south facing

The ceramic drain accommodated an east-west running cast-iron brine pipe (3157, 7.107), 160mm in diameter. Like other encountered sections of the pipe, it was housed in a partially decayed wood box (3158), cross-section 600mm. It was located at a depth of 0.65m below the ground and appeared to be a continuation of a brine pipe (3081) located to the east in trenches HC16-1, HC16-2 and HC16-3. It emerged from the ground towards the north-west as vertical brine pipe (6423), which fed the pan via a cast-iron brine pipe (5035) that has been removed and stored.

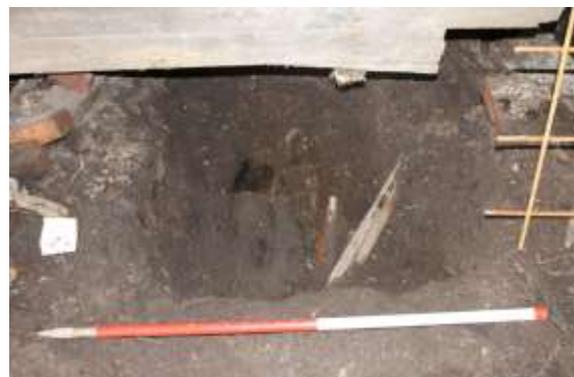
7.107: HC20-4, Post-excavation, brine pipe, 3157, west facing

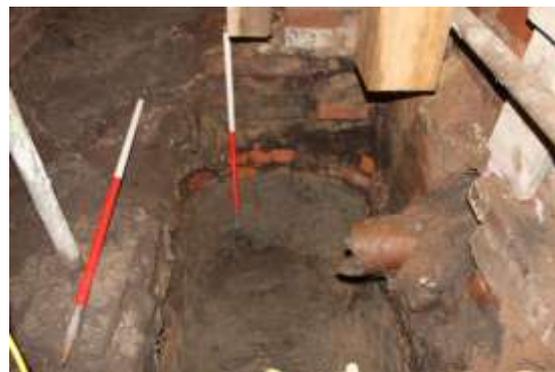
7.108: HC21-1, Post-excavation, south facing

The earliest deposits were grey clay-silt (3131) at the base of trench HC21-1 (7.108). A similar layer was encountered at the northern end of the hurdles (3135, HC21-2). This was overlain by black-clinker silt rubble (396, 3132) on which a degraded brickwork floor (3133) was built in the south-west corner. A wooden sill beam (397), 0.08m in depth and at least 0.40m in length was built on top of this floor. It was bonded to, and formed the base of post 6041. In the south-east corner a layer of brick and concrete (395, 3133) formed the base for post 6040. The remainder of the southern trench was filled with brown silt-sand rubble (394, 3134).

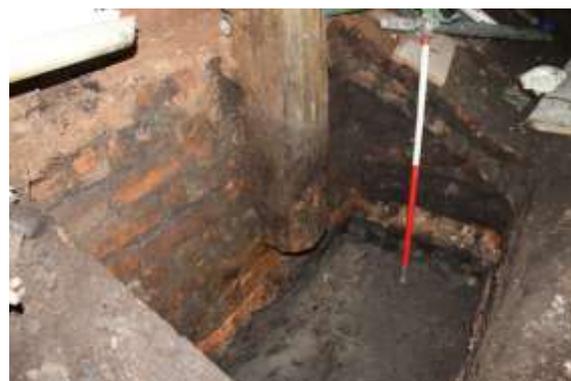
7.109: HC21-2, Post-excavation, north facing

At the northern end of the hurdles (Trench HC21-2, 7.109), the trench was filled with loose black-brown silt-rubble over which was built the bricks of the ditch (6057).

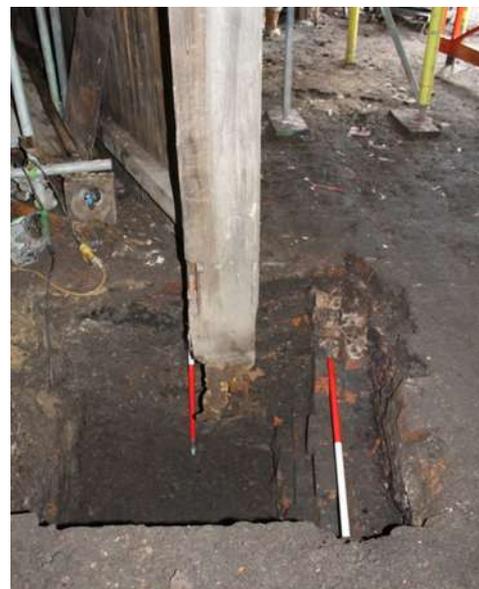
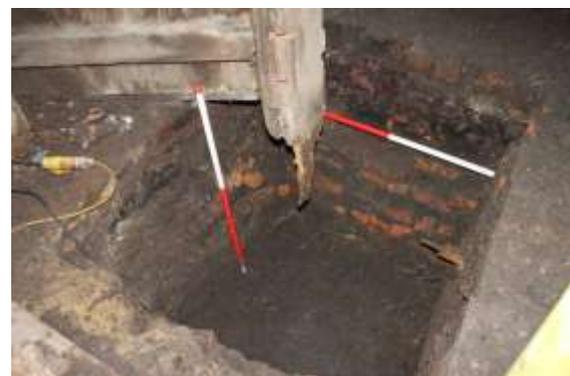
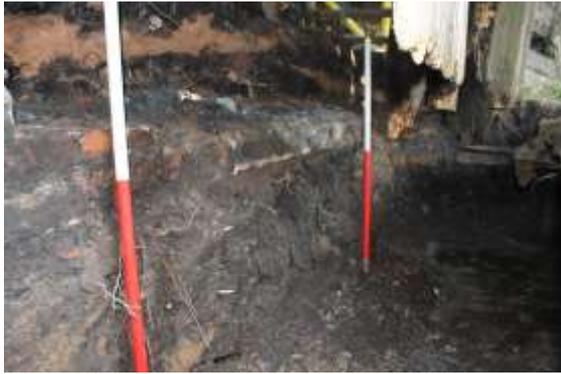
running wall foundation was located in trenches HC22-1 and HC22-3 (7.110, 7.111, 7.112). It was represented by a machine pressed red brick wall foundation (3138) on the southern side of HC22-1, which had three corbels at its base. It was more clearly visible as upstanding wall 6005 in the south-west corner of Pan House 3. This had an awkward junction with the western side of the pan house and was clearly part of a pre-existing layout. This wall had a foundation of seven courses, with three corbels at its base in trench HC22-3. The north-south return of this wall (6009) appeared to continue to the south as a foundation wall (3149) visible in the western section of HC22-3. It was constructed of machine-pressed red brick and survived for three courses only.

7.110: HC22-1, Post-excavation, wall foundation 3138, east facing

7.111: HC22-1, Post-excavation, wall foundation 3138, south-east facing

7.112: HC22-3, Post-excitation, wall foundation 6009, east facing

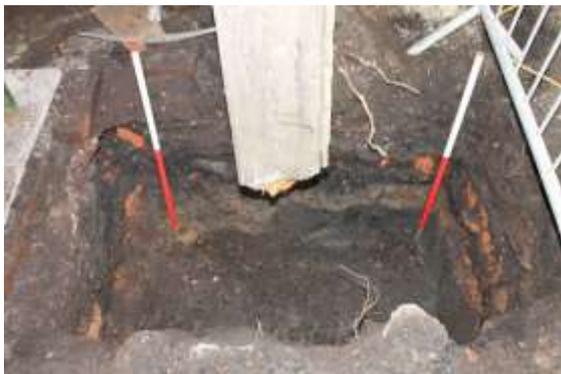
7.113: HC22-2, Post-excitation, floor surface 3143, north facing

The ground above this wall was filled with brown brick-rubble and silt (3139, HC22-1), yellow-brown clay rubble (3141, HC22-2) or loose brown silt and clinker (3145, HC22-3). In the south-east trench (HC22-2) there was evidence for a shallow layer of clinker silt (3142) on which was built a discontinuous machine-pressed red brick floor surface (3143, 7.113) at a depth of 0.45m below the ground surface. This was covered by a general layer of black clinker silt (3144).

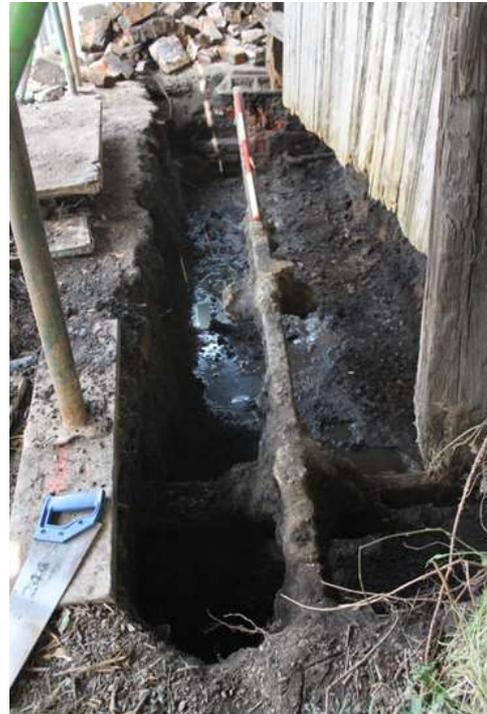
In the larger excavation HC22-3, the remains of the mineral rail tracks were uncovered just below the surface. They consisted of a single rail track (3146, 7.114) aligned WNW-ESE to the south of Pan House 3. It was supported by a total of four cast iron chairs (elements that connect to the sleepers) were originally located equidistant along the rail at distances of three feet (0.92m). Two were present *in situ* whilst two had collapsed. The wooden sleepers underneath had almost entirely decayed, with only small remnants visible. At the western end of the trench was ferrous metal cleat or buffer (3147, 7.115) that acted as the end point of the

7.114: HC22-3, Post-excitation, rail 3146, west facing

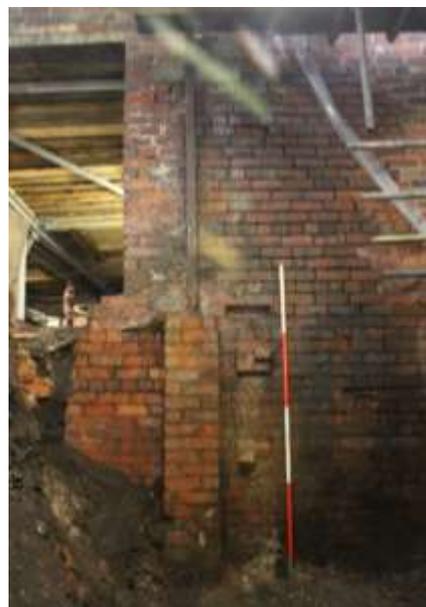
7.116: HC23, Stove House 4, north wall excavations, remains of SH4/ SH3 wall, west facing

Within the western side of the excavations were the earliest deposit, a deep layer of black-brown, brick rubble and silt (3237) forming the lowest levels of Stove House 4 (7.116, 7.117, 7.118,

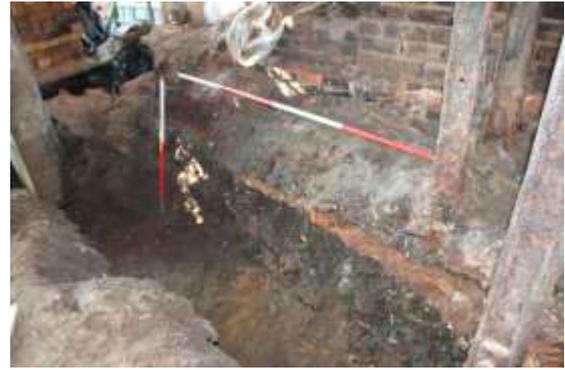
7.121: HC23, Stove House 4, north wall, eastern deposits, south-east facing

On the eastern side of the excavations (7.120, 7.121) the earliest deposits were a concreted, red clinker-ash material (3152) with black clinker-ash layer (3153) above, to a depth of c. 0.8m below ground level. This formed the base for a series of ferrous metal plates (3151, 7.122). They extended for 3.0m from north-eastern corner, under the northern wall (6331, see 7.123) of Stove House 4. This was machine-pressed red brick, two courses wide, with three courses at the base.

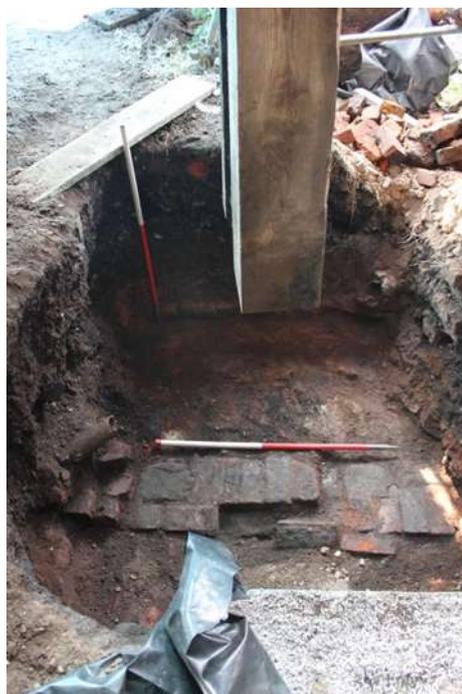
7.124: HC24-1, Post-excavation, wall foundations 3161, 3162, east facing

the earliest deposits were a north-south wall foundation (3161), of machine-pressed red brick, 3 skins (0.35m) wide, which survived to three courses high. A second north-south wall foundation (3162), also of machine-pressed red brick, lay to the east and was visible in the section. It also survived to a height of three courses. There was a distance of 0.75m between the two. These appeared to have been the dismantled remains of an earlier structure, which directly underlay the foundations of SH4, East and North Wall (6301, 6331). Subsequently a cast-iron brine pipe (3163), 4½" diameter, ran south-east to north-west across the trench. It was damaged and removed during excavation. These features were covered with a layer of mixed brown silt rubble layer (3164). Above this was loose brick and clinker ash layer (3156) that covered the Loading Bay under-croft.

Phase 6: The wall foundations (3161) and (3162) located in Trench HC24-01 and brick paviour (3293) relate to earlier structures prior to the construction of Stove House 4. The likelihood is that they are the fragmentary remains of the kiln walls of the North-West Fishery Pans. Other remains of the fishery pans have been located at greater depth and have generally been much better preserved. However, the orientation and location appear to be correct.

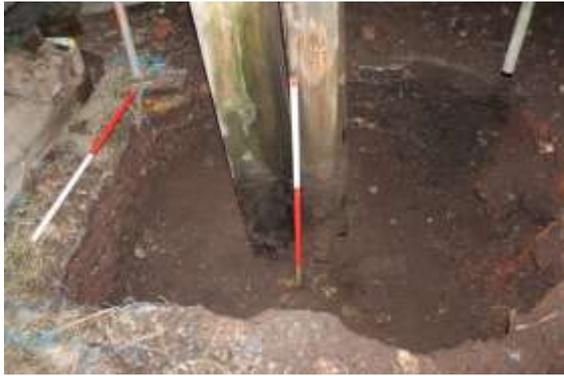
7.125: HC24-2, Post-excavation, south facing

The base of Trench HC24-02 (7.125), the eastern central posts (6441, 6442, 6443), contained a discontinuous and fragmentary brick paviour of re-used bricks and half-bricks (3293). These were machine pressed red brick with a rectangular frog. They extended for c. 1.7m across the trench. This was again covered with a black clinker silt layer (3292) equivalent to 3156 above.

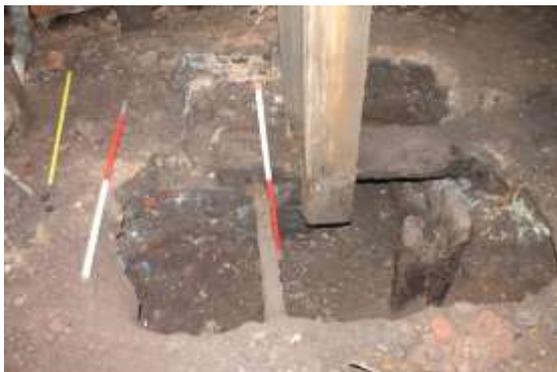
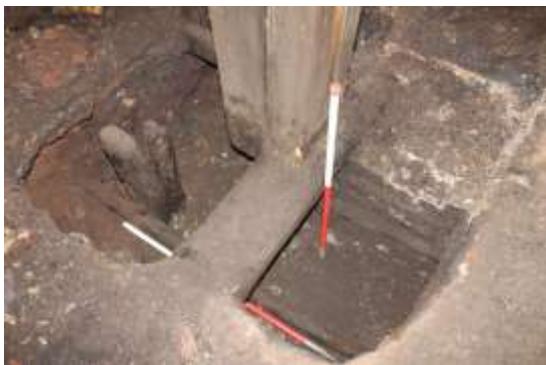
7.126: HC24-3, Post-excavation, sill beams 3298, 3294, brick pier 3299, west facing

Trench HC24-03 (7.126, 7.127), the west central posts (6444, 6445, 6446), contained a large brick pier (3299) in the south-western corner. It was constructed from machine pressed red brick laid in rough courses. Overlying this and supporting the post above were a series of sill-beams. The lowest of these (3296) ran east-west, c. 0.7m below the ground level, and was 240 x 60mm cross-section. It abutted a series of two rotten posts in the north-east corner (3297). The main structural posts (6444, 6445, 6446) itself, was supported by two sill beams. The first (3298) ran east-west and rested

on brick pier (3299). Perpendicular to this and orientated north-south was a further larger sill-beam (3294). The posts (6444, 6445, 6446) rested directly on this sill-beam (3294). The trench was filled by a layer of black clinker silt (3295).

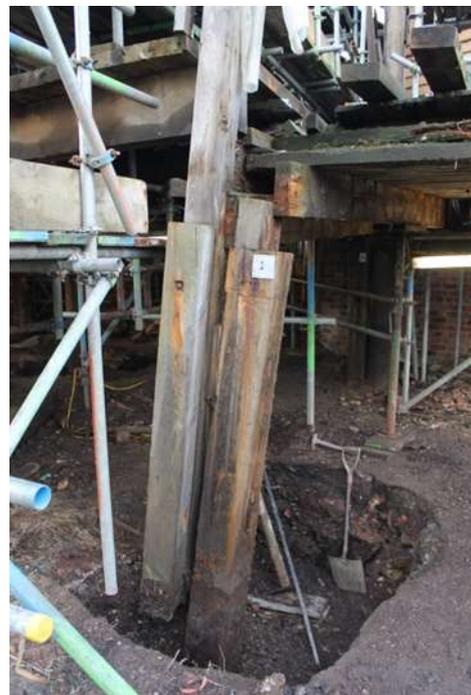
7.128: HC24-4, Post-excavation, south-west facing

There was no evidence for a brick floor surface in north-east Trench HC24-04 (7.128). Instead it was again a layer of black clinker silt (3199), equivalent to 3156 and 3292 described above. This material sloped south-north towards the edge of the Loading Bay (north side) as if it had been eroded away. Subsequently a layer of mixed clinker, slit and rubble (3200) had been used to level out the ground. A further layer of black clinker silt (3201) overlay this.

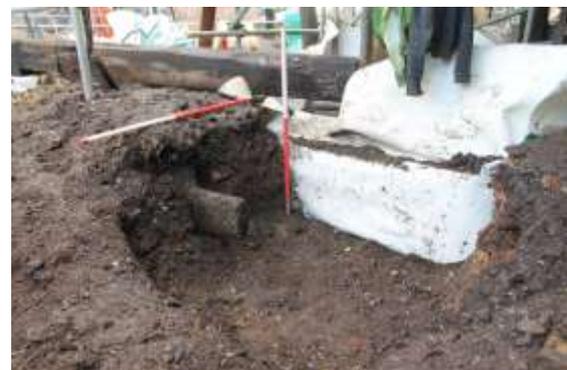
7.129: HC24-5, Post-excavation, south-east facing

This trench was extended to the north as HC24-05 (7.129) to allow a footing for the bridge. It was of a single homogenous fill of black clinker silt (3202) as above. Within this was a single east-west orientated wooden plank (3203) that acted as a retaining wall for the material in a similar manner to timbers 5159 (see Loading Bay area, see Volume IV).

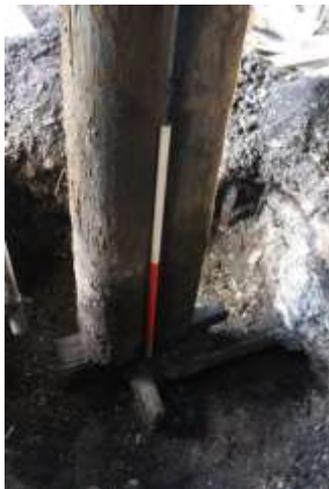
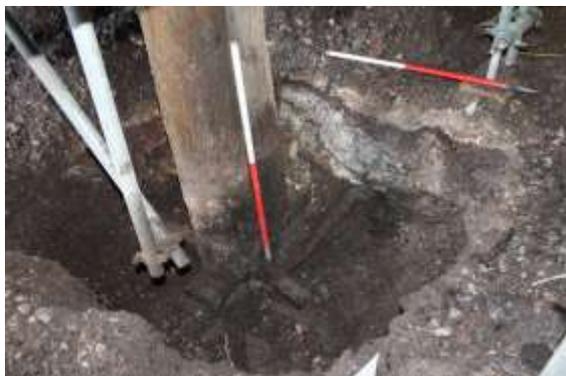
7.130: HC24-6, Post-excavation, sill beams 3204, 3205, south-east facing

Trench HC24-06 (7.130, 7.131), the north-west post (6449, 6450), contained two sill beams. The first was orientated east-west and was 60mm x 240mm in cross-section, (3204), the second was orientated north-south and was 40mm x 200mm in cross-section (3205). Where the two sill-beams intersected was a wooden pad (3206), and the posts (6449, 6450) were supported above. The area was covered by black clinker silt (3207). On the northern side, this was overlain by a large

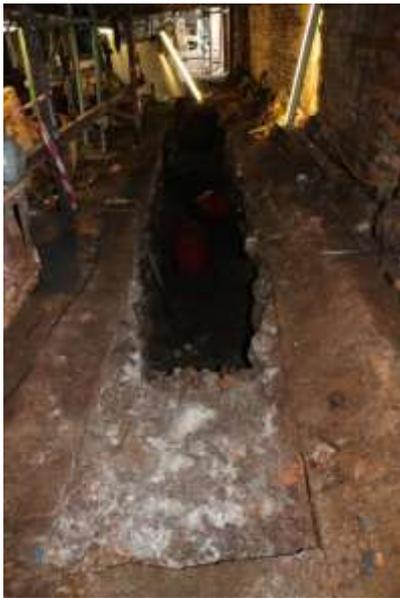
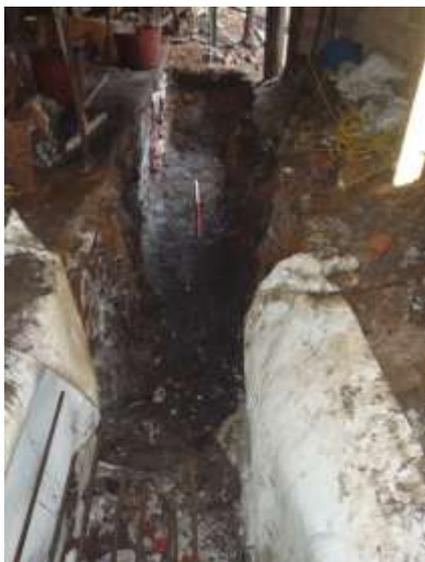
7.132: HC25, Post-excitation, northern end, south facing

This involved the excavation of three strip footing for steel supports in Stove House 2, of which this was the western footing. The footing was 1.0m wide (east-west) and 17.0m long (north-south), in two parts, the northern 12.3m long and the southern 4.7m long (see AS004 above, AS067, AS068; 7.132, 7.133). It was excavated to a depth of 1.1m. The excavations were undertaken from July to September 2013.

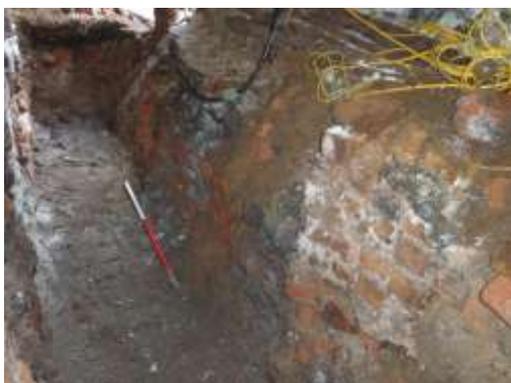
7.134: HC25, Post-excitation, east facing section at southern end, south-west facing

The earliest deposit within the trench was a red sand layer (3244) located at the very southern end of the trench (see 7.134). To the north were the remains of the original, east-west orientated, northern wall of Stove House 1/ Stove House 2 were represented by hand-made red brick walls (3243), and (3245). Both were nine courses high and two skins thick seen in either section. South of the wall was a layer of salt, clinker and brick rubble (3239).

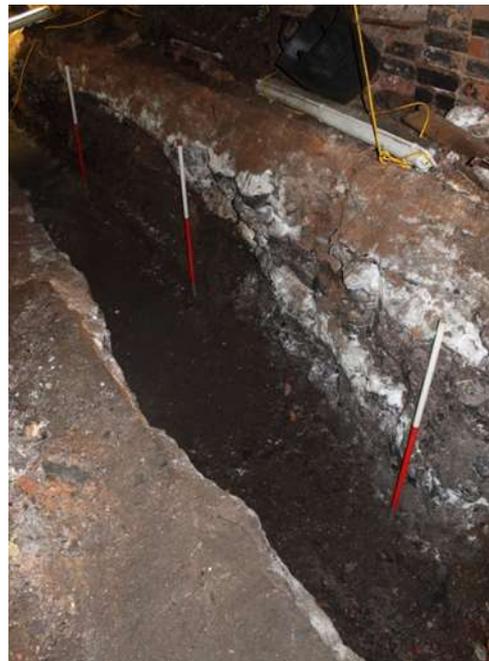
7.135: HC25, Post-excitation, east facing section at northern end, south-west facing

North of wall 3243/ 3245 was a concreted salt rubble layer, containing salt blocks, red sandstone and visible tip lines (3167). Within this layer in patches was loose clinker ash (3168), suggestive of tip lines (e.g. 7.135). A shallow flue wall of machine-pressed red brick (3169), 2 courses deep, orientated north-south ran on the eastern side of the trench.

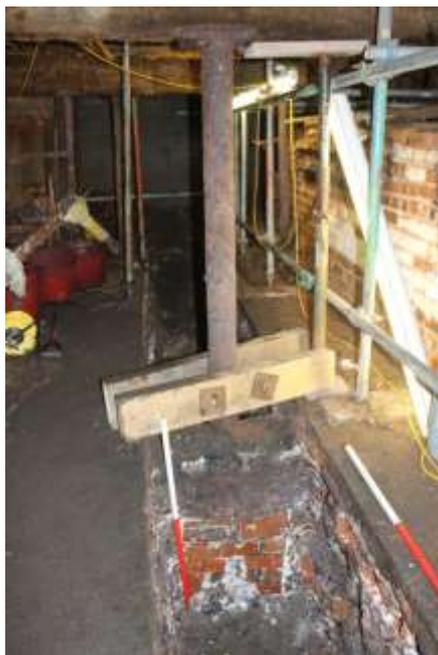
7.139: HC26, Post-excavation, northern end, brick pier 3233, north facing

Two hand-made red brick piers (3233, 3234, 7.139) to support the original columns, were located to the northern end of the trench. These were two skins in width. The trench was filled with a combination of a loose black clinker deposit (3232, 3248) at the northern end. At the northern end two intermittent flues (3231, 3251) ran north-south either side of the trench. They were a single skin thick and survived to a maximum height of

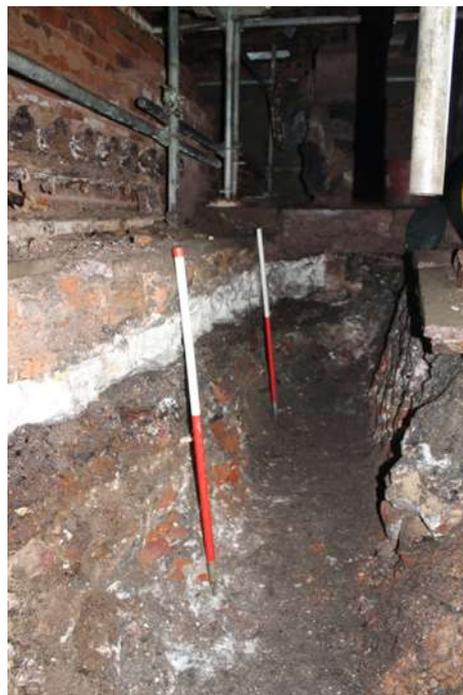
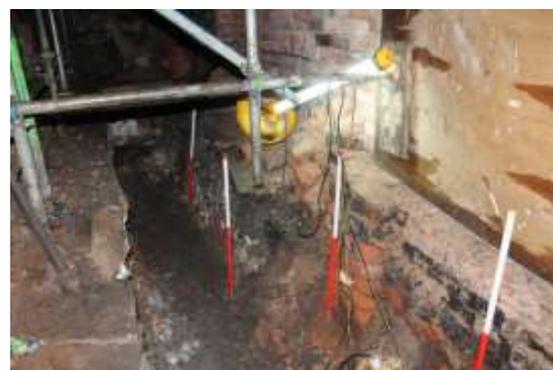
7.140: HC27, Post-excavation, northern end, north facing

This involved the excavation of three strip footing for steel supports in Stove House 2, of which this was the eastern footing (see AS004 above, AS067, AS070; 7.140, 7.141, 7.142, 7.143, 7.144, 7.145). The footing was 1.0 to 1.5m wide (east-west) and 15.4m long. It was excavated to a depth of 1.1m.

It was clear that during excavation at the northern end of the trench a north-south flue had been disturbed. Like the flues encountered in Stove House 3 and 4 the composition of the material within and without the flues was different. A single flue appeared to run along the exterior of the building. The material here consisted of conglomerated rubble and silt under flue (3252), overlain by black ash and silt layer (3253). The eastern side of this flue was represented by the foundation for Stove House 2, eastern wall (6568, see 7.141, 7.142). It consisted of pier and panel,

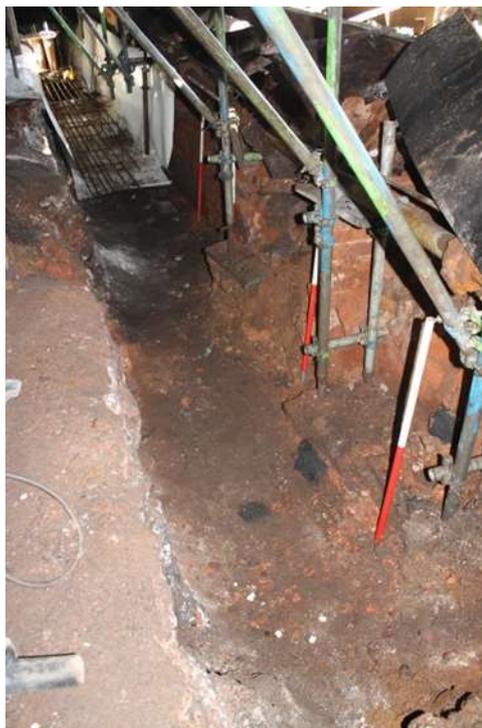
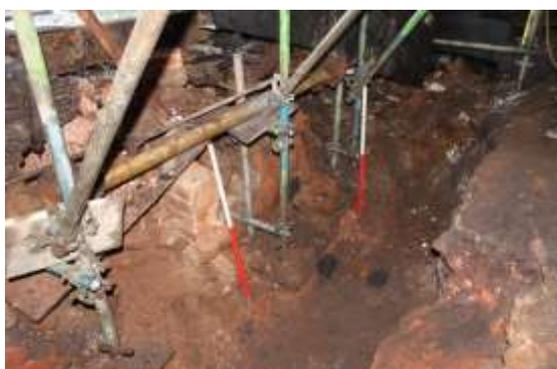
7.144: HC27, Post-excavation, central section, north facing

Cut across these layers was an east-west flue from Pan 2 to the main large flue (6679, see 7.143, 7.144). This was filled with conglomerated salt fill of flue (3262) and loose brick rubble and red sand fill (3257). No evidence for the northern wall of Stove House 1/ Stove House 2 was visible in this trench and it is presumed that it had been removed by later activity. However, the material south of flue (6679) was a mixed salt, clinker and brick rubble layer (3263), similar to (3239) and (3249). The trench was covered by a skimmed concrete floor (3254), with noticeable voiding where salt layer (3258) had dissolved.

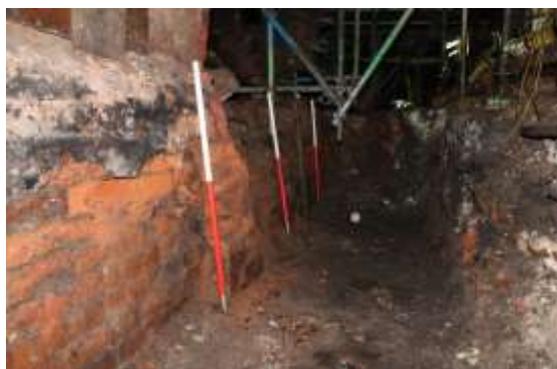
7.142: HC27, Post-excavation, central section, south facing

hand-made, red-brick, wall foundation (3255, 3256), with a flue (see below, 6679) to Pan 2 inserted through it. On the western side was a remnant machine-pressed red brick flue wall (3264) that ran for 3.5m before dog-legging 0.7m to the west. Outside of these flues in the ditch was a deposit of loose brick and salt (3260), this was overlain by a black clinker-silt and rubble layer (3259). Above this was a white hard salt layer (3258).

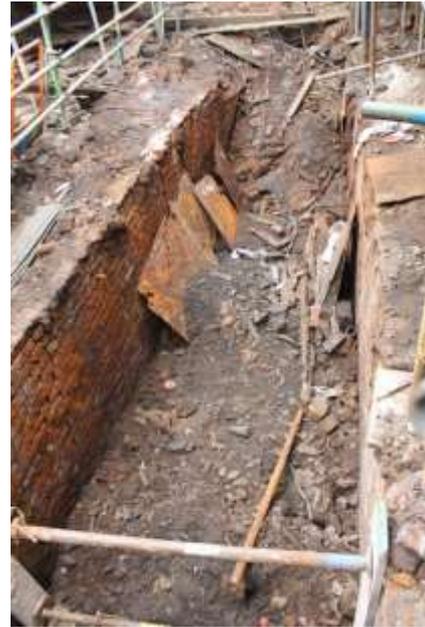
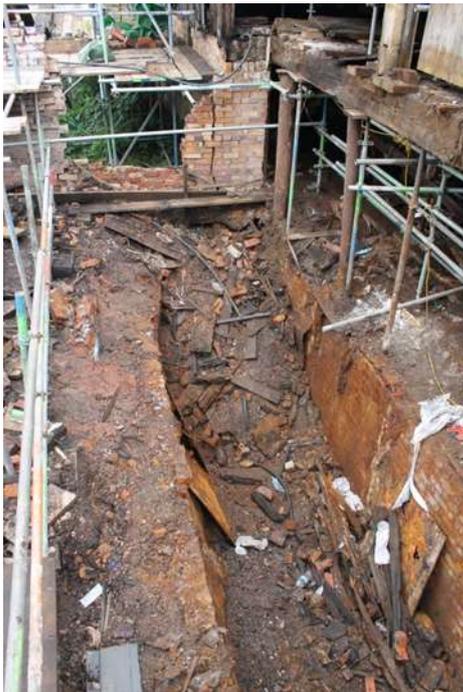
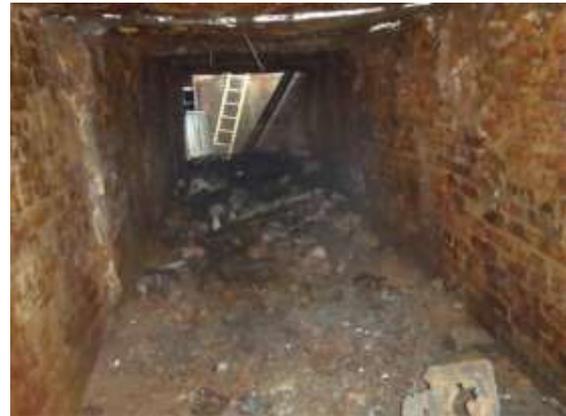
7.148: HC29, The tunnel walls, north facing

Both western and eastern walls were of hand-made red brick in English Garden Wall bond (6526, 6527; recorded during excavation as 3179, 3180 respectively, 7.148, 7.149, 7.150). They were covered by series of six ferrous metal I-beams (3178), orientated east-west. The beams were 2.5m long, 100mm (4") x 110mm (4½"). Bridging between the I-beams were a series of seven ferrous metal plates over tunnel, c. 2.50m wide (east-west), c. 1.10m long (north-south, 3172, 7.151, 7.152, 7.153). At the southern end was an upturned ferrous metal 'kicker' plate (3182, 6529, 7.154), made of an angle iron, 2.50m x 0.3m x 0.1m, which formed a trough. Besides this was a brick wall of hand-made red brick (3181), 2 courses wide, 2 courses deep, orientated east-west. A separate brick paviour of hand-made red brick (3173, 7.153), stretcher bonded, on-side, was laid over the tunnel further north. The most northern sheet had collapsed and rubble had piled up within the tunnel.

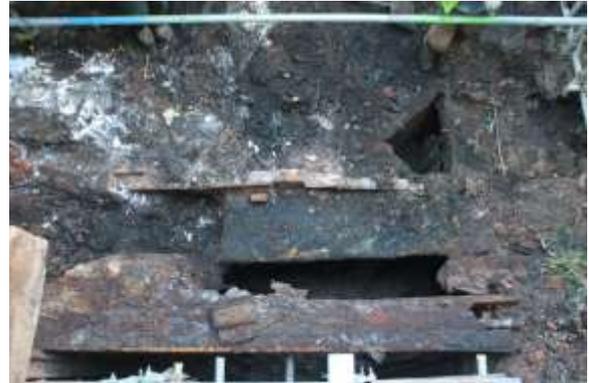
7.155: HC29, The tunnel entrance, plates 6525, 6528, west facing

To the south was the tunnel entrance which had a lintel made of two ferrous metal I-beams overlaid by a single sheet of ferrous metal (6525, see 7.155). In the entrance this cover was a sheet of ferrous metal (6528), with a single small hole presumed to be for drainage.

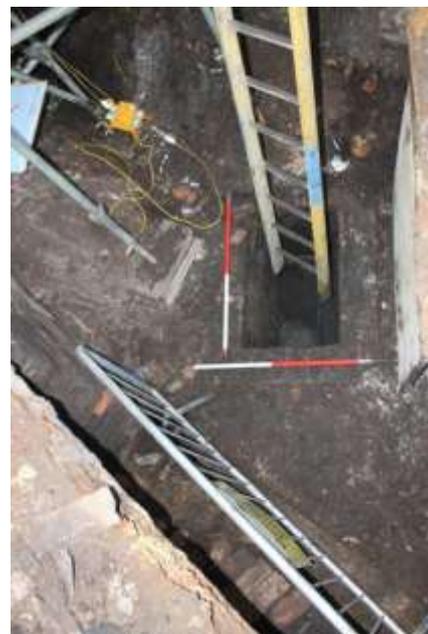
7.156: HC29, The tunnel, sump 3301, south-east facing

Located at the entrance to the tunnel at its base was a machine-pressed, red-brick sump (3301; see 7.156, 7.157). The sump was orientated south-east to north-west and was 0.95m x 0.65m in size and 0.8m deep. It was built two skins wide. At the base was a ceramic drain (3302) that continued to the north-west and south-east respectively.
