THE ALLIANCE AND LION SALT WORKS, MARSTON, NORTHWICH

SCHEDULED MONUMENT NO 34985-002

VOLUME III: THE ARCHAEOLOGICAL EXCAVATIONS, 1992-2015

REPORT NO 2015-01

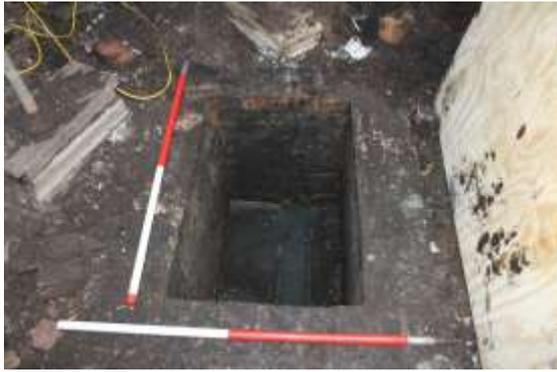
7.157: HC29, The tunnel, sump 3301, south-east facing

Located at the entrance to the tunnel at its base was a machine-pressed, red-brick sump (3301; see 7.156, 7.157). The sump was orientated south-east to north-west and was 0.95m x 0.65m in size and 0.8m deep. It was built two skins wide. At the base was a ceramic drain (3302) that continued to the north-west and south-east respectively.

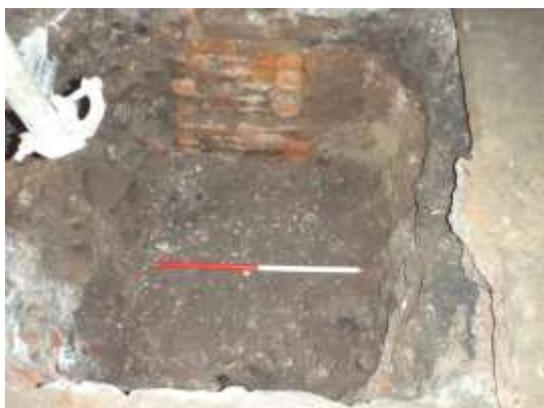
7.159: HC30-2, Post-excitation, brick pier 3222, south facing

The north-east pad in Stove House 2, Trench 30-2 (7.159) was 1.45m x 1.45m and 1.25m deep. The earliest deposit was black clinker silt (3223). Through this was the cut (3224), for hand-made red brick post pier (3222). This was 3 courses wide and 10 courses high. It was overlain by clayey sand (3221), and black clinker silt and ash (3220). The remains of collapsed flues were represented by black clinker silt and crushed brick deposit (3219). This was covered by a skimmed concrete floor, 0.09m thick (3218).

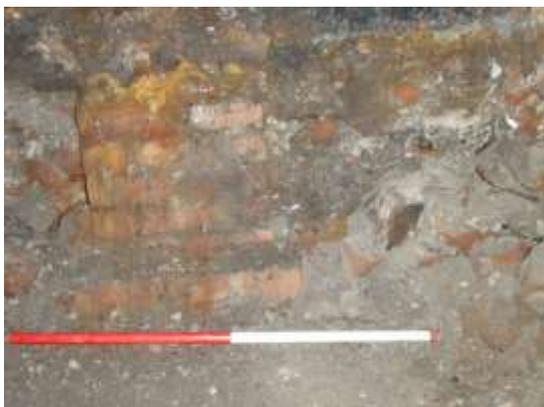
7.160: HC30-3, Post-excitation, brick pier 3228, south facing

The south-west pad in Stove House 2, Trench 30-3 (7.160) was 1.5m x 1.45m and 1.05m deep. The earliest deposit was hand-made red brick pier (3228), for an original post. It was six courses deep, and five skins wide. It was overlain by black ash, clinker and crushed brick deposit, 0.76m thick (3227) and black ash and clinker deposit, 0.2m thick (3226). Above this was the skimmed concrete floor, 0.08m thick (3225).

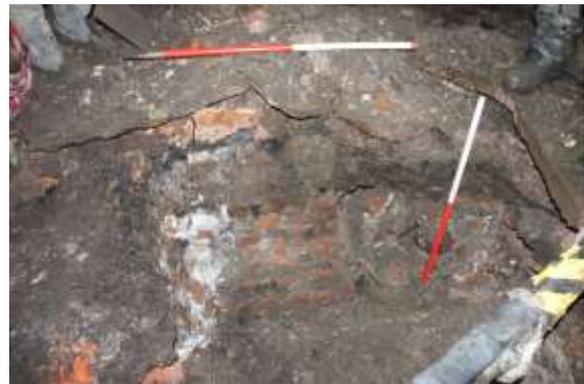
7.161: HC30-4, Post-excitation, pier 3290, south facing

The south-east pad in Stove House 2, Trench 30-4 (7.161) was 1.3m x 1.5m and excavated to a depth of 1.1m. The earliest deposit was hand-made red brick pier (3290), seven courses high, for an original post. This was overlain by a hard salt layer, 0.72m deep (3291) and loose clinker, ash and brick rubble fill, 1.14m deep (3289). The area was covered by skimmed concrete floor (3225).

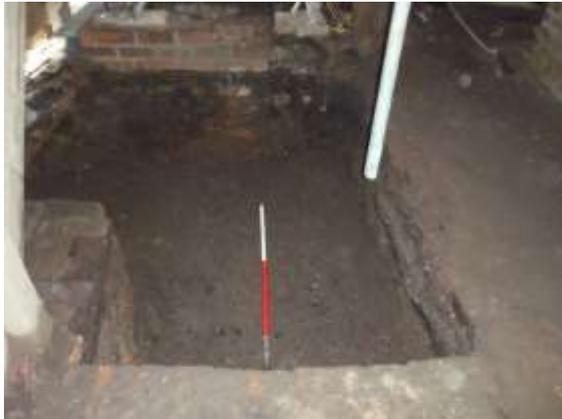
7.162: HC31, Post-excavation, lift pit, west facing

(3185), 1.30m x 1.30m in size, 2 skins thick (7.162). The brick sump drained to the south-west with an inlet from the east and north. Within brick floor 3183 were the remains of two wooden posts (3277, 3282, 7.163), 0.18m x 0.18m in size. These represented the remains of wooden structures to the south of Pan 3.

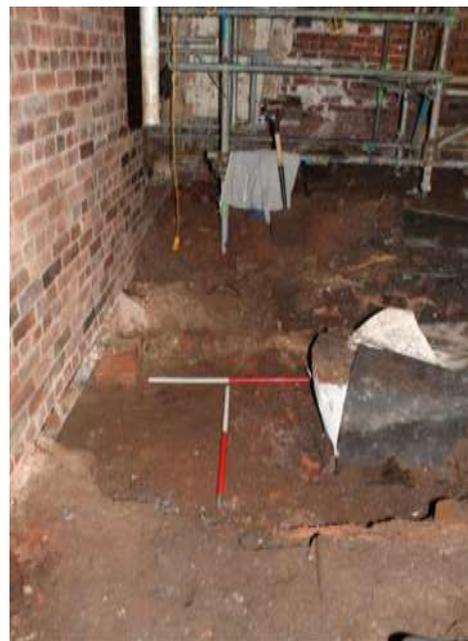
7.164: HC32, Post-excavation, west facing

This involved the excavation for a concrete base, to support a new disabled lift in SH3. The excavation was 1.5m (north-south) x 2.0m (east-west) and 1.0m deep (AS029; 7.164). The work was undertaken in October 2013.

The excavations were undertaken through areas that had previously been excavated as part of the work for the wall between Pan House 3 and Stove House 3 (HC04, see above). No new deposits were encountered during the work and the deposits were excavated through backfill of the previous excavations.

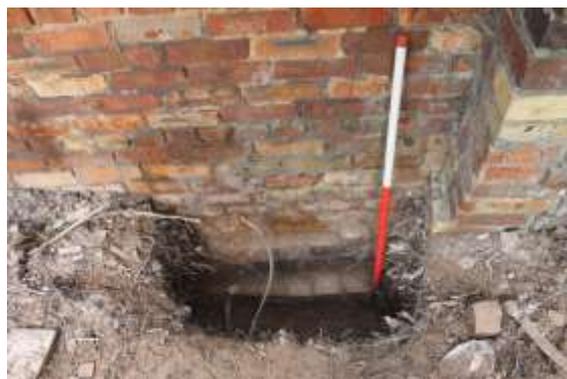
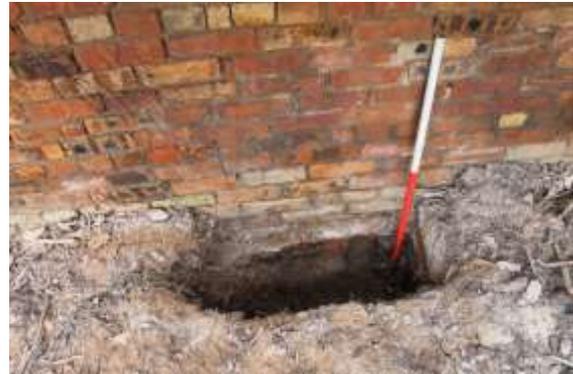
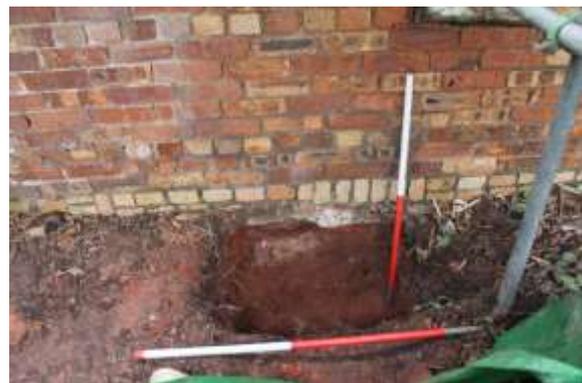
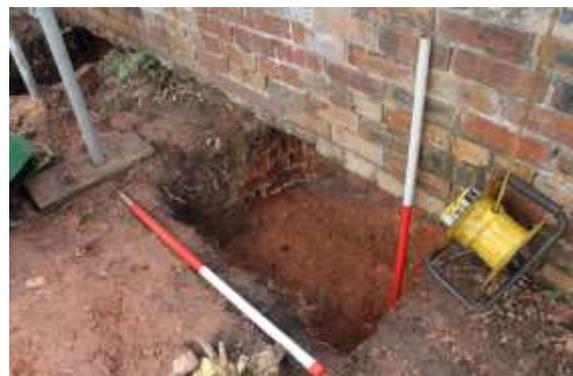
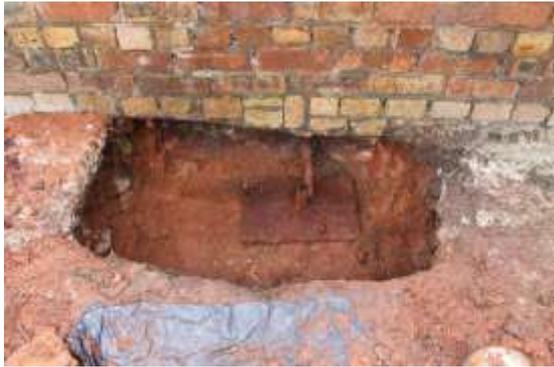
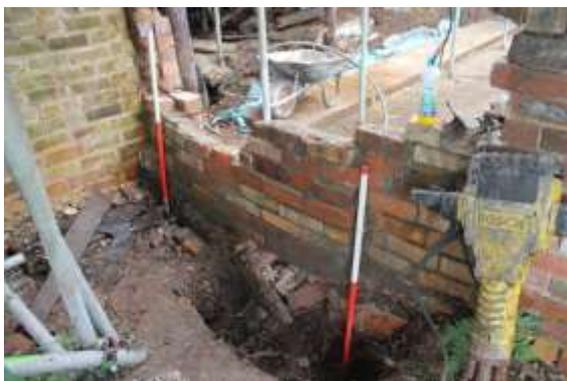
This involved the underpinning of the northern wall of SH1. This was done by ‘hit-and-miss’ excavation under sections of the wall. The excavation was 13.5m long (east-west) in total but consisted of six trenches, each trench being between 1.0 and 3.0m in size and 1.0-1.5m (north-south; see AS004 above, AS062, AS066; 7.168, 7.169, 7.170, 7.171, 7.172, 7.173). The excavations were undertaken in October 2013.

The excavations revealed the degraded hand-made red brick wall foundations (3283), below main build of Stove House 1 North Wall, 6505. These were corbelled on western side. Extending to the north from the wall was short wall

foundation (3300) running north-south. It was made of machine pressed red brick and two skins wide, it was only excavated to two courses. It was probably associated with the remains of Pan House 1 in the pan garden prior to its demolition.

Phase 4: It is likely that wall foundations (3283), relate to the earliest build of Stove House 1. These foundations were contemporary with a large ferrous metal beam (429), seen in Test Pit 24 beneath Stove House 1, northern wall. This indicated the location of the tunnel entrance from the north (see HC29 above). Close examination of the wall, has revealed a minimum of two phases visible in the existing wall (see Volume IV). It would appear that it has been rebuilt a number of times during its lifespan, often in patchwork form.

Short wall foundation (3300) appears to relate to a north-south wall, one of the few remains of the stove of Pan House 1. Photographs from the 1972⁴⁶ suggest that the stove was entirely dismantled and pan dismantled for scrap/ reused elsewhere in the works. Fragmentary remains of the pan house

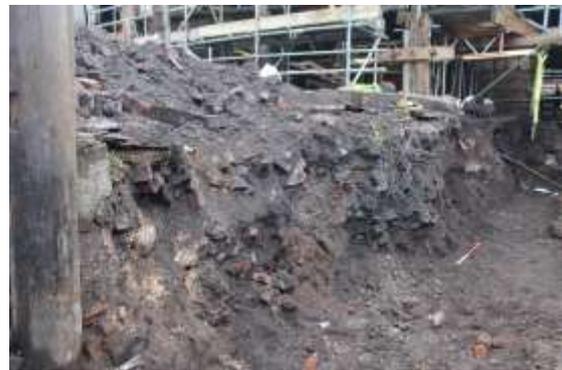
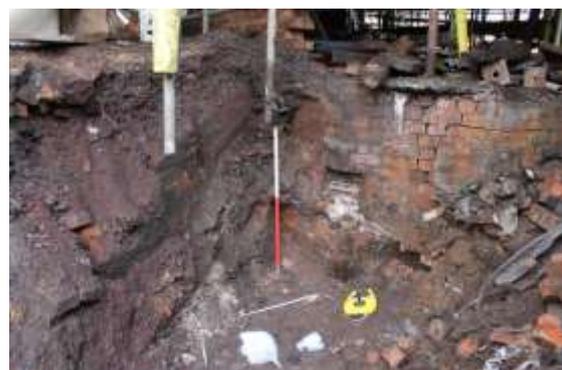
In order to retain the northern side of the Loading Bay it was necessary to build a large retaining wall of mass concrete. This was 11.5m long (east-west) and 1.3m wide (north-south), with a dog-leg within its plan. It was 1.8m deep (see AS004 above, AS067, AS074; 7.174, 7.175). The work was undertaken in February 2014.

The earliest deposit was a hand-made, red-brick, wall foundation (3274, see Plate 5.13.164), extending from SH2 western foundation wall 3255 to the east. It extended for c. 1.0m, and was 3 courses deep. It was overlain by a layer of loose cinder and clinker material, located at the base of the Loading Bay, c. 1.0m deep (3269). Over this was a deposit of brick-rubble, ash and clinker

Phase 4/5: Wall foundation (3274) is almost certainly part of the original laying out of Stove House 1 or Stove House 2 in the late 19th century.

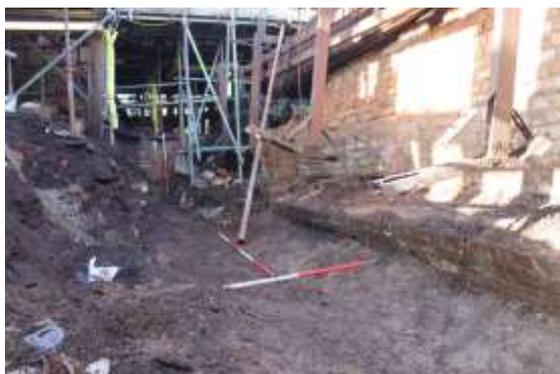
7.176: HC35, Post-excitation, Pan 2, southern ditch, west facing

The ditch of Pan 2 was uncovered during the work north of the retaining wall (7.176). This was overlain by layers of debris associated with the collapse of Pan House 2 (7.177).

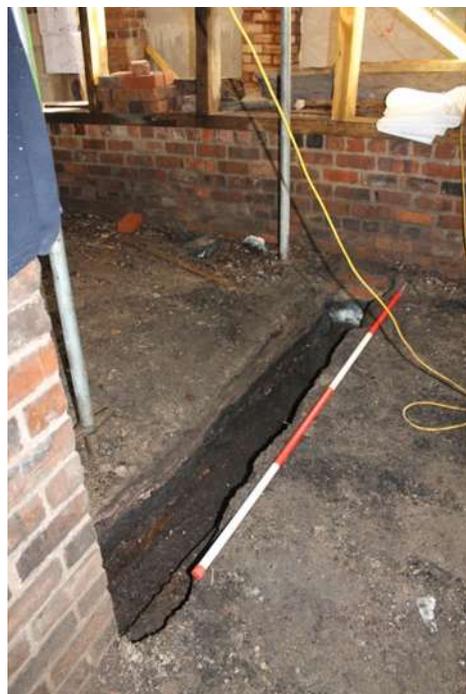
7.178: HC36, Post-excitation, east facing

This involved the excavation of a short strip footing between Pan House 3 and Pan House 4. The strip footing was designed to accommodate a low wall to seal the under-croft of the walkway between the two buildings. The strip footing was 0.4m wide (north-south) and 2.7m long (east-west). It was excavated to a depth of 0.5m (AS042; 7.128). The work was undertaken in October 2013.

cover, 0.30m wide and orientated north-south (3281). At the western end was a machine-pressed, red-brick, sill-wall foundation, 0.96m long and orientated east-west (3278). Parallel and to the south of this was a wood sill beam (3280), orientated east-west, located under southern section. The entire trench was covered by a black ash and clinker deposit (3279).

Phase 4-7: The drain (3281) and wall foundations (3278) are difficult to phase accurately and may relate to the period when the large warehouse known as the Rhomboid Building was built, or be later structures associated with Pan House 3 or Pan House 4.

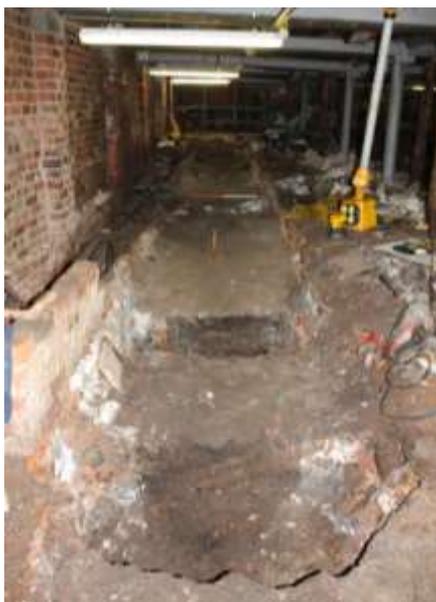
7.179: HC37, Post-excavation, western walkway excavation, Stove House 3, north facing

A series of walkways were inserted at flue level throughout Stove House 3. It was necessary to excavate a series of footings to support the metal frames and the footprint of these walkways, in order to allow a +2.0m clearance below the historic beams. The first walkway in Stove House 3 was located between the 1st and 2nd flues from the west (7.179), entering from the south-western doorway. It was c. 1.20m wide (east-west) and for a distance of c. 15.4m (north-south).

The western walkway was excavated through the hard salt layer (6154) located in the ditches between the 1st flue (6139) and 2nd flue (6138). The walkway was excavated to a depth of 25.70m AOD.

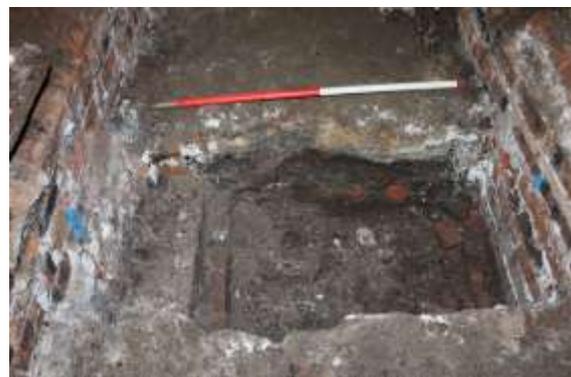
7.180: HC37, Post-excavation, detail of footing, west excavation, Stove House 3, south facing

A second walkway entered from the south-eastern doorway and ran parallel to the wall along the eastern side of the room. It was again c. 1.20m wide and extended the entire length of the room exiting via a doorway to the north (AS029; 7.180, 7.181). The walkways were excavated to a depth of c. 0.30m deep below the level of the ditches. In addition a total of 5 footings on the western side and seven footings on the eastern side were excavated below this level (see 7.182). These were 1.20m x 0.50m in size and excavated to a depth of 0.50m deep (beyond the depth of the walkway). The walkway footings were excavated in November and December 2013.

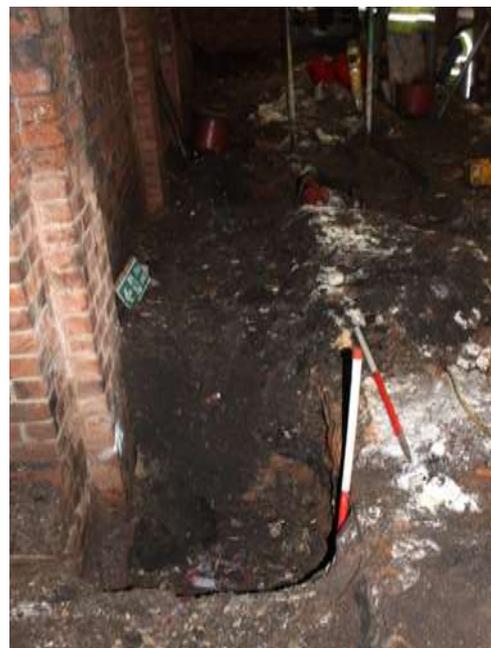
7.181: HC37, Post-excavation, eastern walkway excavation (central), Stove House 3, south facing

The eastern walkway removed the remains of the very eastern flue (6133) to a depth of 25.65m AOD. The remains excavated had already been heavily disturbed during the excavation to repair the wall between Stove House 3 and 4 (recorded and discussed above as HC03 above). Further deposits were removed but these consisted of loose brown brick rubble silt material (3013) that filled Flue 6133, the brick remains of flue 6133 (these were highly degraded machine-pressed red brick), and salt deposits (6149).

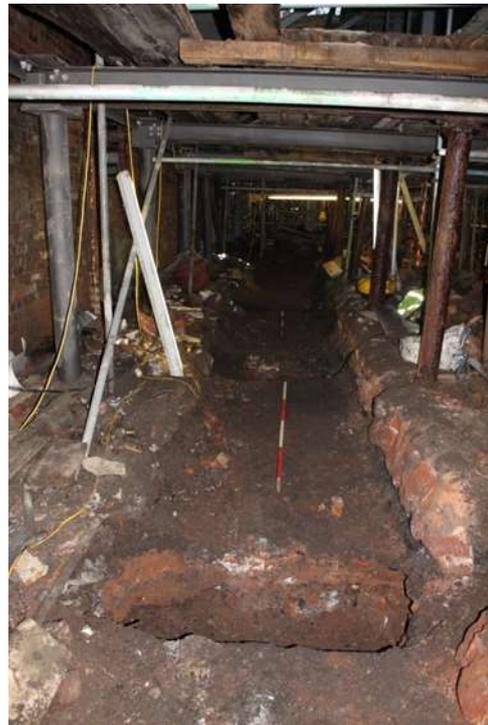
7.183: HC38, Walkway excavations in Stove House 4, north facing

A walkway was inserted at flue level through Stove House 4. It was necessary to excavate a series of footings to support the metal frames and the footprint of this walkway, in order to allow a +2.0m clearance below the historic beams. The walkway in Stove House 4 was located between the 1st flue (6396) and partially removed the buried remains of the 2nd flue (6395) from the west. It entered from the south-western doorway, and exited via the doorway to SH3 within the western wall. It extended for a distance of c. 16 m (north-south), and was c. 1.20m wide (east-west) and widened to c. 2.80m the southern end (see AS044; 7.183).

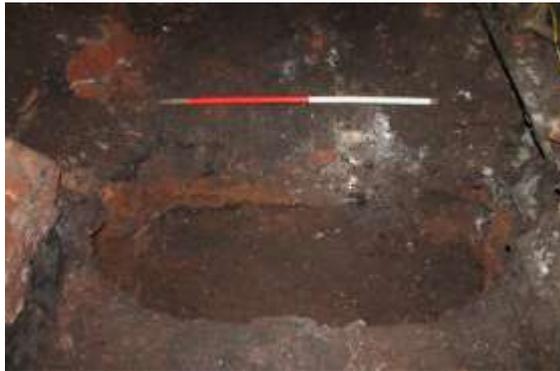
7.184: HC38, Walkway excavations in Stove House 4, footing detail, north facing

Again the walkway was excavated to a depth of c. 0.30m below the level of the ditches. In addition a large excavation was undertaken (HC39-1) at the northern end to accommodate two footings of the walkway. This was over-excavated due to the loose nature of the fills. A further four footings were excavated to the south (see 7.184). These were 1.20m x 0.50m in size and excavated to a depth of

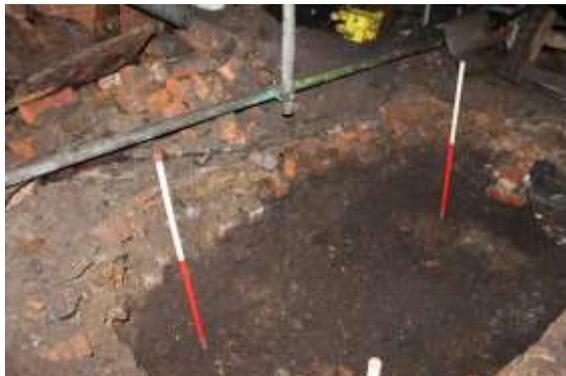
7.185: HC38, Walkway excavations in Stove House 4, northern end, north-west facing

0.50m deep (beyond the depth of the walkway). The walkway footing was excavated in November and December 2013. The earliest deposit uncovered was loose layer of clinker silt material and brick rubble (3284), excavated at the far northern end of the trench to a depth of c. 0.8m (see 7.185). This was overlain by a salt layer (3287) between the flues 6395 and 6396. Over this were the remains of brick floor surface 3285/ 6413 (see 7.185).

This was visible at the northern end of the excavation predominantly and within the remains of excavation (HC39-1). The remains of brick flue 6395 were removed on the eastern side to a depth of 25.70m AOD. Internally this contained a loose fill of clinker and silt (3286).

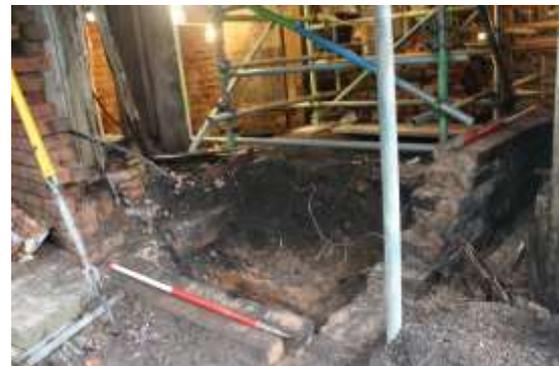
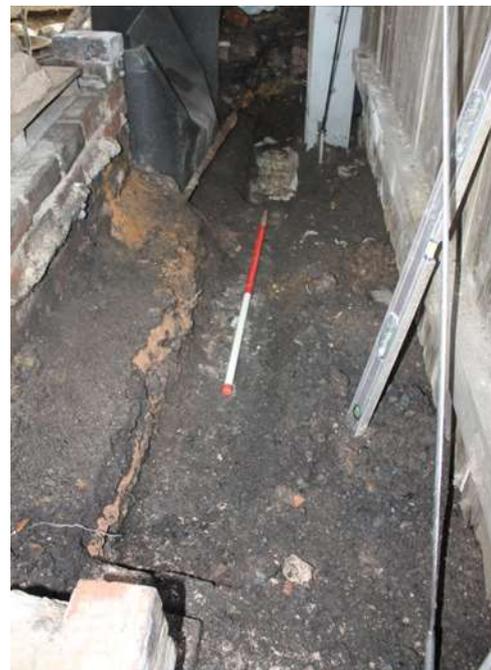
This wall foundation was located in the south-western corner of Pan House 3. The wall was dismantled and excavated to the level of the footing. It was subsequently rebuilt (AS015; 7.186, 7.187). The work was initially undertaken in October 2012 and was completed in January 2014.

The earliest deposit was mixed grey-brown clay silt (3140, also seen in HC22-2). Through this was cut the machine-pressed, red-brick, wall foundation for upstanding wall 6005/ 6009 in the south-west corner of Pan House 3. It initially ran north-south before turning WNW to ESE and continuing to Trench HC22-1 (equivalent to 3138).

The WNW to ESE running wall foundation is contemporary with the very earliest period of the works, possibly dating to the period when this was land associated with the Red Lion Hotel. The 1868 map shows a clear boundary wall at the southern end of the site running along the northern side of the Accommodation Road.

Phase 7: The WNW to ESE running wall foundation 6005/ 6009 had clearly been rebuilt above foundation level.

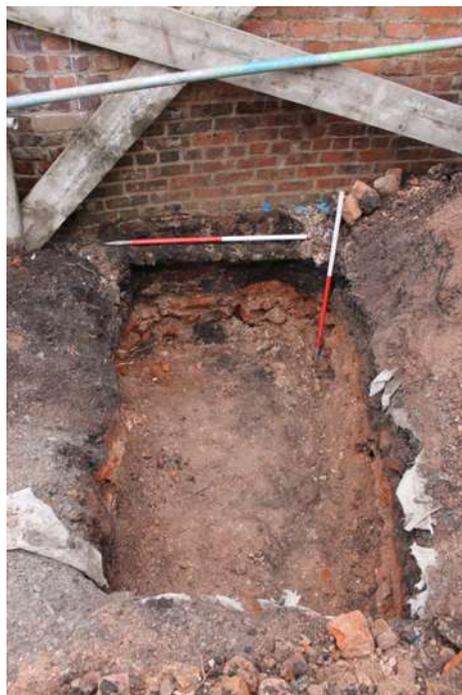
7.188: HC40, Post-excavation, SH4 East Buttress excavations, section 1, west facing

The earliest deposits were red sand and crushed brick rubble layer (3288), at least 0.4m deep that covered the base of the trench. This was overlain by a deposit of brown mixed silt, clinker and rubble

(1059), 0.20m deep, that covered the remainder of the Loading Bay.

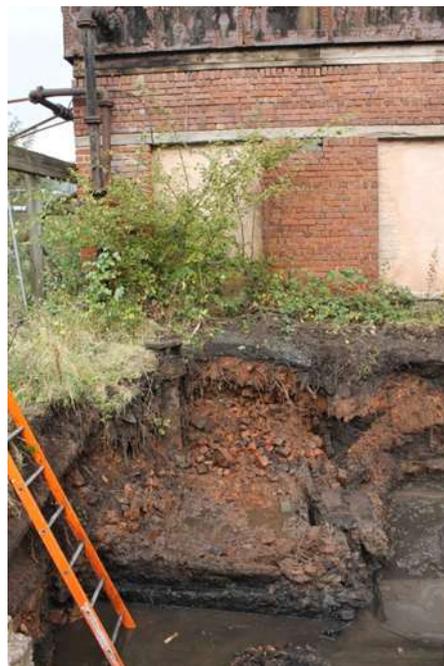
8.1: Brine Shaft 1012, north facing

In the north- western corner of the trench were the remains of the brine shaft (1012; 8.1, 8.2, 8.3). This consisted of a wood lined rectangular structure, c. 2.5m in diameter. The wood lining consisted of two skins of wooden planks, stacked on edge and half-lap jointed at the corners. The

planks were 2.5-3" thick. The shaft was in-filled with loose red-brown silt and brick rubble (1015).

Phase 4: The brine shaft (1012) belongs to the start of the Red Lion Inn. It is presumed to be the one described in 1894. It corresponds closely to the location on the 2nd Edition Ordnance Survey Map of 1898.⁴⁹ The wood lining is almost certainly original and its state reflects the water logged saline preservation conditions. The shaft would appear to have been lined initially with wood. It is not clear how far the wood lining extended down the shaft, but it is highly probable that it continued until solid bedrock was encountered.

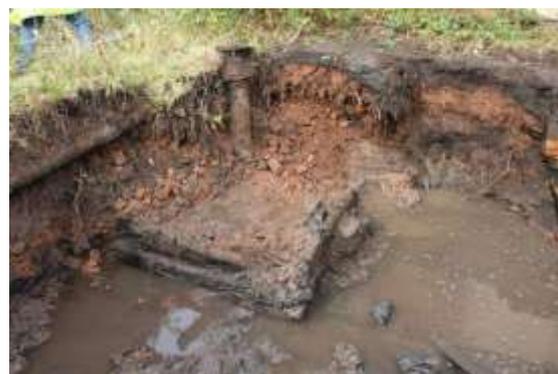
8.2: Brine Shaft 1012, north-west facing

Two large ferrous metal pipes (1004, 1005, see 8.2, 8.4) with bore-holes down the centre and substantial collars round the top, were inserted vertically into the brine shaft presumably to accommodate the pumping mechanism. These were 0.35m in diameter externally and 0.18m internally down the bore-hole. They extended all the way to the surface and were visible in plan prior to excavation.

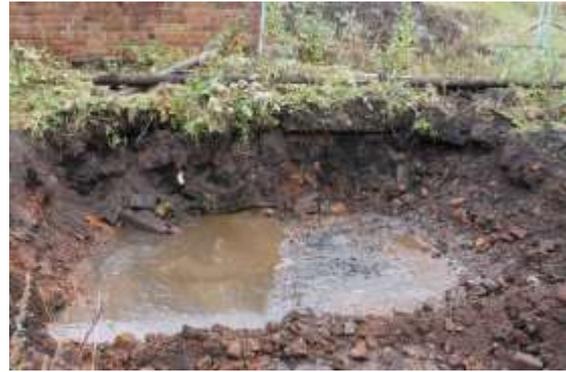
8.5: Floor surface, 1008, east facing

The brine shaft appears to have been originally surrounded by a floor surface formed of machine-pressed bricks in the Stretcher bond, laid on-side (1008; 8.5). This layer extended for 2.5m south of brine shaft 1012. It was located 0.9m below the current ground level (23.20m AOD).

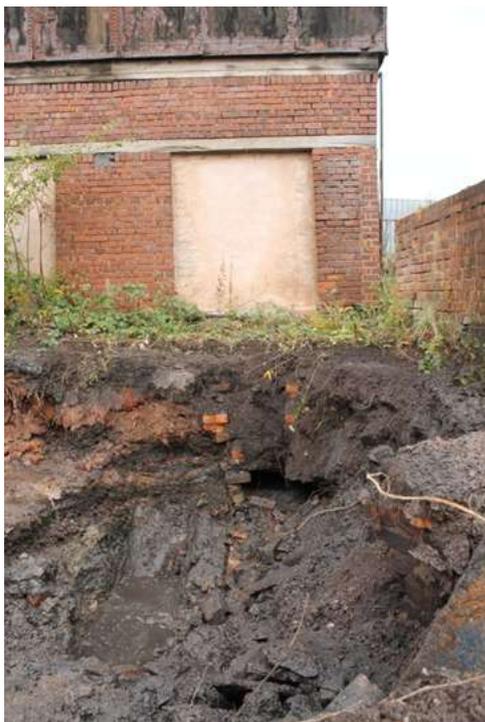
8.6: Flue 1009/ 1010, north facing

On the eastern side of the excavation area were the remains of a flue (8.6, 8.7) that ran initially north-south from the eastern side of the Engine House, before turning north-east to south-west within the area of excavation and heading in the direction of Chimney 2. The flue consisted of two walls (1009, 1010), 0.85m apart, of machine pressed red brick in Stretcher bond, two skins thick. A series of ferrous metal plates (1011) were situated between the flue walls. They were supported by a series of re-used ferrous metal spikes (1054). The plates were generally 0.95 x 0.45m in size and 1/2" to 5/8" (12-15mm) thick. A void was located at the below these metal plates that was filled by a loose sludge of water mixed with clinker ash (1016). This clinker ash was also located above the ferrous metal plates but was much drier in this location.

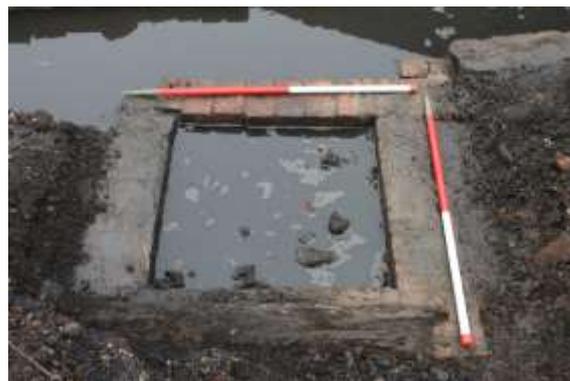
8.8: Square brick foundation, 1053, north-west facing

The flue continued to the south and was situated adjacent to a square brick foundation, two skins thick of machine-pressed red brick in English bond (1053; 8.8, 8.9). A single piece of wood covered the upper surface on the southern side. The centre of the brick foundation was filled with black ash-silt material (1056). The flue was blocked at the south-western end by a single skin of bricks (1055).

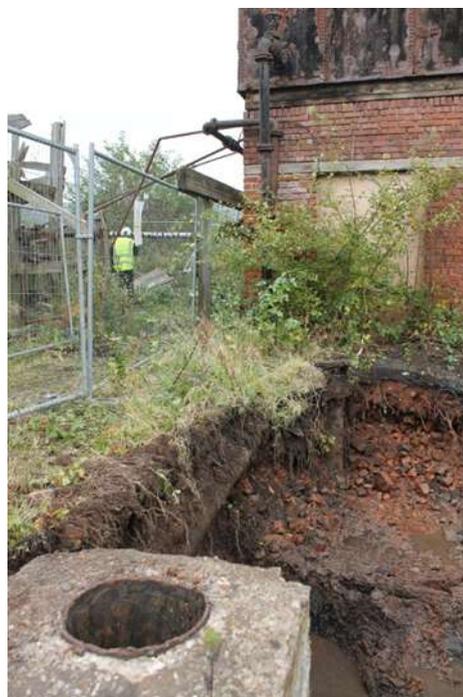
8.10: Ferrous metal bore-hole, north facing

Located centrally were the remains of a ferrous metal bore-hole (1006, 8.10) that was associated with the electric pump adopted in the 1960s. The brine shaft was surrounded by a square concrete base 0.4m high (24.35m AOD on its top).

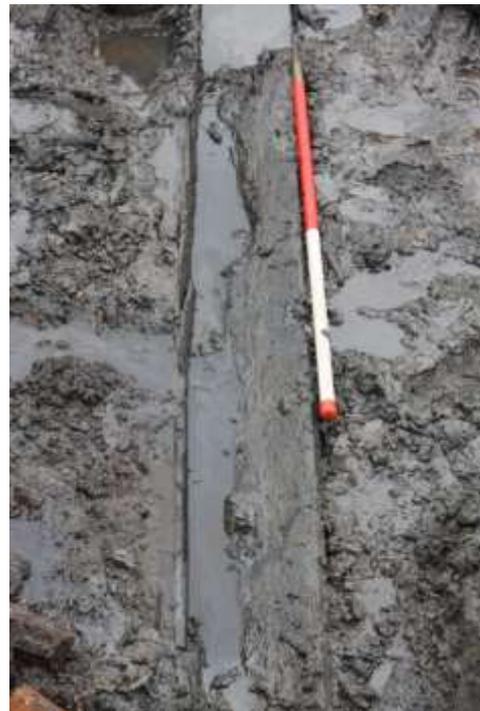
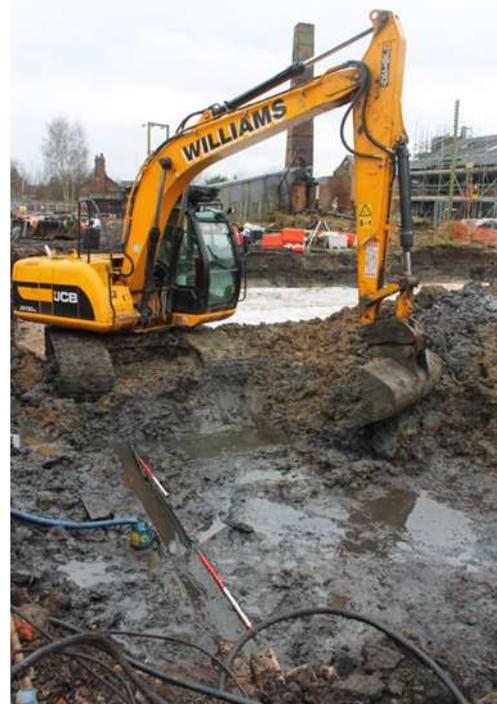
8.11: WB03, Wooden box drain, 1063, south facing

8.12: WB03, Wooden Box drain, 1063, during excavation

aligned north-south (AS079; 8.11, 8.12). It was 0.30m wide and c. 4.0m long, with a depth of 0.25m. On initial analysis the wood appears to be oak (*Quercus*). This continued across the area from the south, on the same alignment as drain 2017 (see Section 9 below), but to the south-east. It continued to the north where it was seen in section (see Trench WB3 below). A brick-lined drain, c. 0.6m wide (1061) ran east-west and was located under the eastern wall of Stove House 5. This was connected to a single bricked lined manhole (1062; 8.13) and was located directly under the Stove House 5 wall foundations.

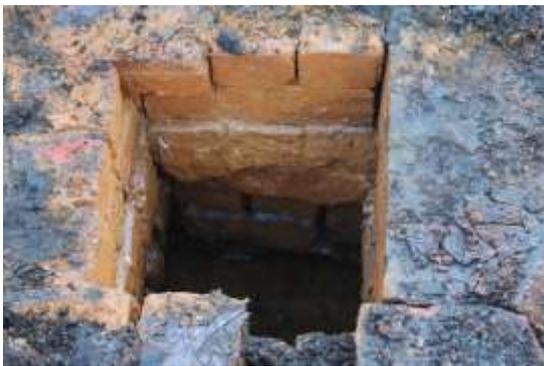
8.13: WB03, Brick lined manhole, 1062, under Stove House 5, east wall, east facing

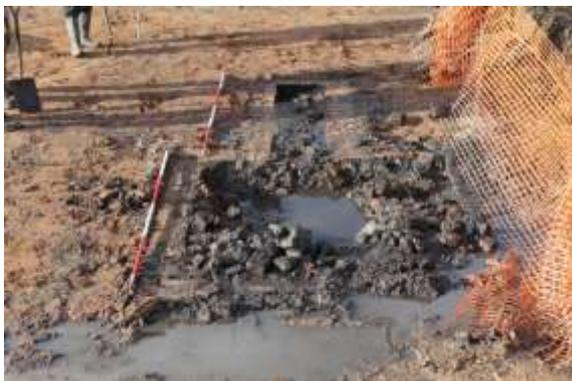
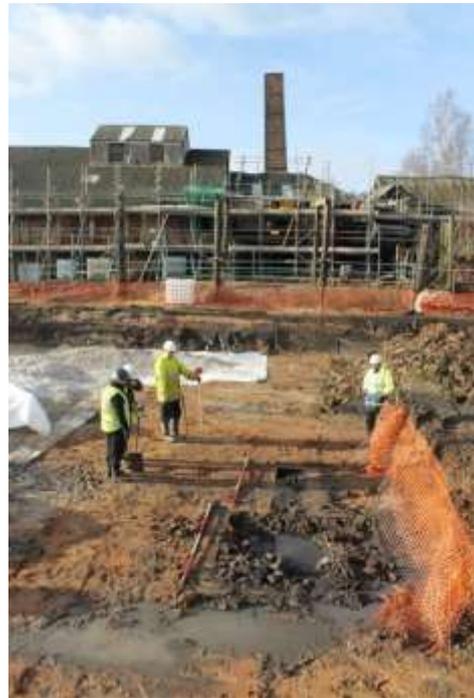
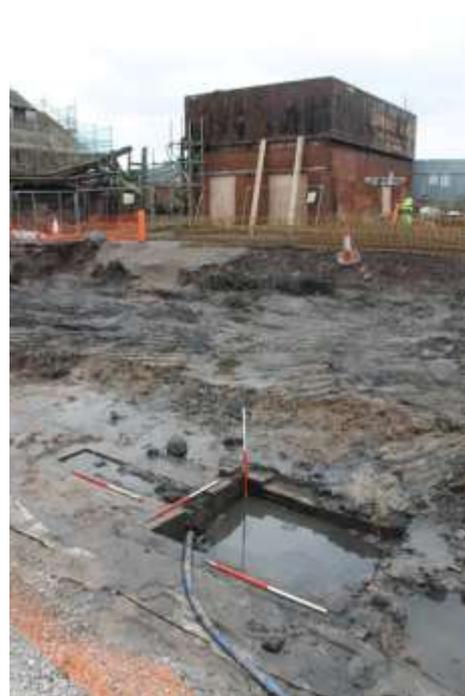
8.14: WB03, Stove House 5 watching brief, final strip, brick structure 1064, west facing

Located centrally and cutting the natural subsoil was a brick-built structure (1064; AS078; 8.14, 8.15, 8.16). Constructed in hand-made red brick and orientated east-west, the structure represented the remains of a pit. It was in two parts, to the west was a narrower brick pit 0.98m (N-S) x 2.10m (E-W) that led directly into a larger rectangular pit 1.50m (N-S) x 1.65m (E-W). It survived after excavation to a depth of 0.44m (21.77m AOD). Both elements had a machine-

pressed brick-lined floor. It was located adjacent Building 1 in the area of the site where floor remains were absent (2080).

8.15: WB03, Stove House 5 watching brief, final strip, brick structure 1064, west facing

8.16: WB03, Stove House 5 watching brief, final strip, brick structure 1064, north-west facing

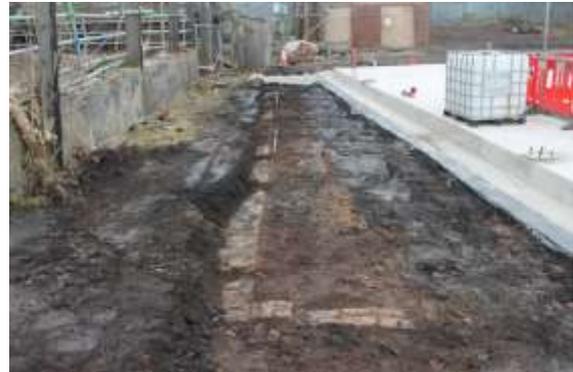
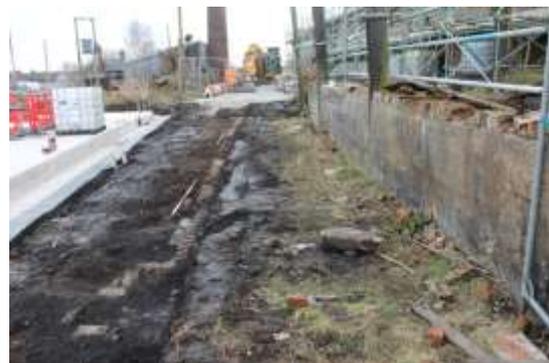
Located within the area were the remains of a fragmentary wall foundation (1069), orientated north-south, which ran for c. 14.0m. It turned east-west at its northern end (1070), was highly disturbed and fragmentary (see AS005 above, 8.19, 8.20). It was c. 1.5m long. It was constructed of three skins of machine-pressed red brick.

Phase 5: The brick walls related to the eastern side of the north-eastern of four 'fishery' pans constructed around 1900. The main wall 1069 related to the western stove wall. The smaller

8.19: WB05, SH5, west strip, North-East Fishery Pan, north facing

8.20: WB05, SH5, west strip, North-East Fishery Pan, south facing

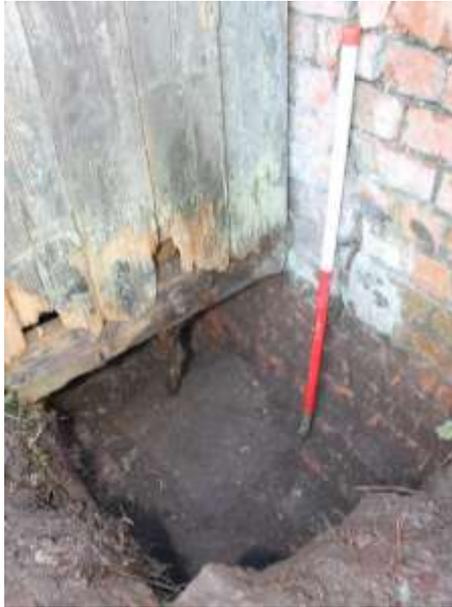
8.21: Trench WB06-01, west facing

Trench WB06-01 (8.21) was located on the northern side of the Pump House under the central post. The earliest deposit was the former eastern wall of the South-East Butter Pan (1071) that was on the western side of the trench (recorded elsewhere, Area G3, Section 10 below).

At the base of the trench was a small brick pier, two courses high, (1077). Adjacent to it, and designed to support the post of the Pump House was a grey flagstone (1076). The remainder of the trench was filled with black brown clinker and silt layer (1071).

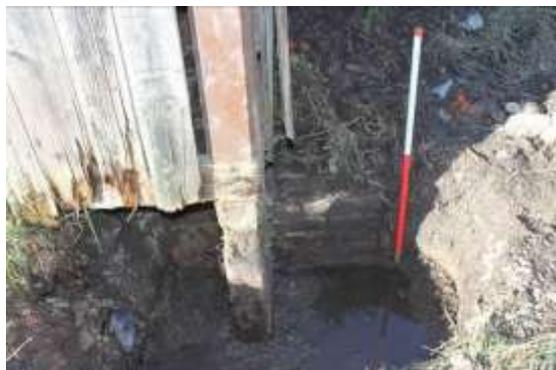
8.22: Trench WB06-02, west facing

Trench WB06-02 (8.22), was located on the northern side of the Pump House under the north-east post. A single feature was located in the western section of the trench; a brick pier, 690mm wide, 5 courses high, (1078). The remainder of the trench was filled with black brown clinker and silt layer (1072).

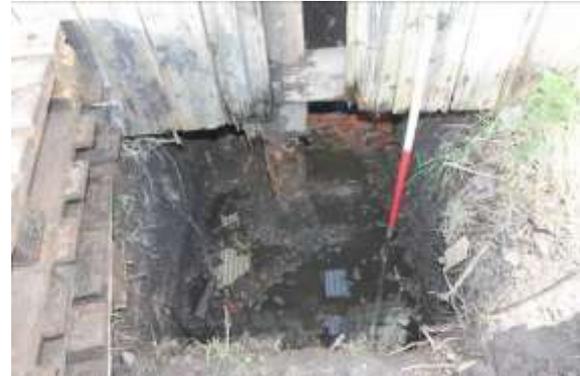
8.23: Trench WB06-03, west facing

Trench WB06-03 (8.23), was located on the western side of the Pump House under the central post. The earliest feature was located in the western section of the trench; a brick pier, 860mm wide, 4 courses high, (1079). Over this and resting

on it was a ferrous metal brine pipe, 180mm diameter, with a 260mm flange (1080). This ran north-south and appeared to head towards pier (1078) in Trench WB06-02. The trench was filled with black brown clinker and silt layer (1073).

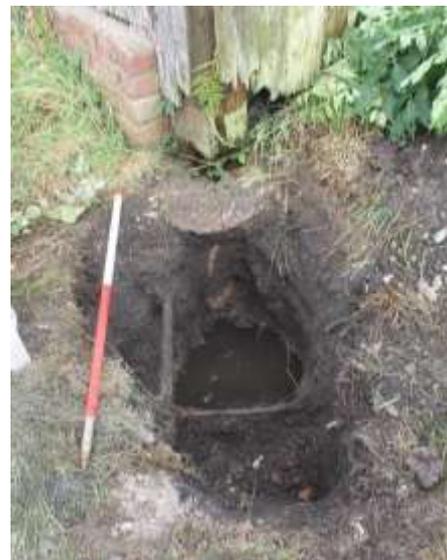
8.24: Trench WB06-04, north-west facing

Trench WB06-04 (8.24), was located on the western side of the Pump House under the south-west post. The earliest feature was a ferrous metal steam pipe (1081), 40mm diameter, 700mm long, aligned south-east to north-west. In the north-west corner of the trench was a later mass concrete block, 700mm high, 800mm long, 400mm wide (1083). Over this was a small stub wall, of machine-pressed red brick, 4 courses high, (1082). This formed the southern sill of the Pump House. The remainder of the trench had been filled with black brown clinker and silt layer (1074). This had been disturbed in the south-east corner by a High Voltage electricity cable laid in 2006.

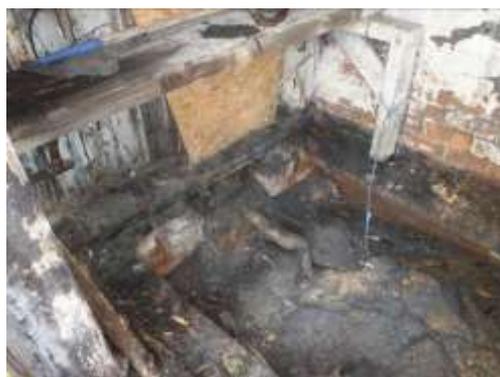
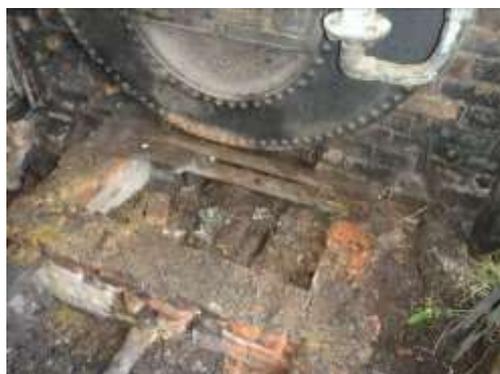
8.25: Trench WB07, coal shed interior, south-east facing

8.26: Trench WB07, coal shed, cast iron pipe 1088

Trench WB07-01 was located within the interior of the Coal Store (8.25, 8.26). In front of the boiler were a series of three walls. A low brick wall of

machine-pressed, red brick (1094), orientated north-south, was in front (east side) of boiler. Extending east-west were two machine-pressed, red-brick walls (1091, 1092), 6 courses high and 2 skins wide, that formed side wall beneath the Coal Store floor. Between these was a further wall of machine-pressed, red-brick, 6 courses high, and 2 skins wide, that was a cross wall beneath the Coal Store floor (1090). At the eastern end was another two low, machine-pressed, red-brick walls (1096, 1097) forming the eastern sill wall of Coal Shed. The voids beneath the floor and between these walls contained a cast-iron pipe (1088), running east-west, centrally, from the base of the Boiler, designed for the discharge of water (8.26). Black ash and clinker deposit (1098) filled the space below the floor boards. Wooden boards were located, against the southern, eastern and northern wall of the Coal Store (1087, 1089, 1095). Ferrous metal plates, in front of Boiler (east side, 1093), were part of former cover for whole floor. Some had been replaced by a series of wooden floor boards (1086).

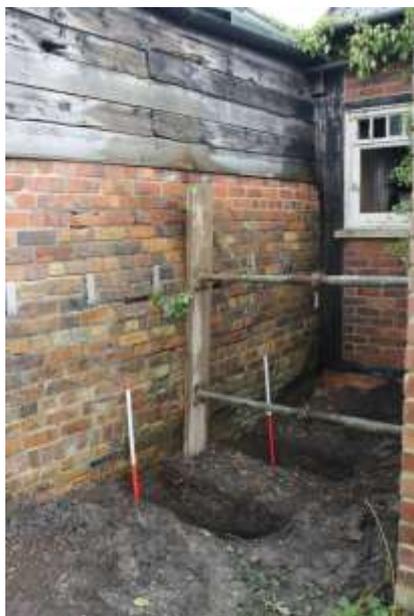
8.27: WB07, boiler house buttresses, north-east facing

Trench WB07-02/03 were located south of the Boiler House (8.27). Both revealed the remains of the foundations of the southern wall of the Boiler House (6800). It had two brick corbels at the base. Otherwise the trench was filled by a layer of black-

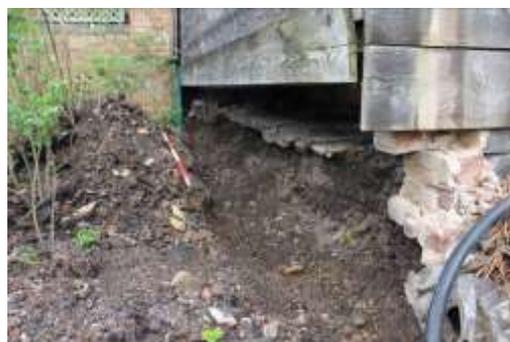
The work involved the excavation of a strip footing to support the sill wall [6884] along the southern end of the Smithy. The trench was 5.20m long and 0.80m wide. It was excavated to a depth of 0.70m. The work was undertaken in March 2014. The earliest deposit was a layer of crushed clinker and slag residues (1101) beneath Smithy to form base for the floors. This was at least 0.70m deep. On either side of the trench were the remains of the sill walls of the Smithy (6870, 6884, 6889). The remains of 15 floor boards of Smithy Store 2 (6917) covered the trench.

8.28: WB08, Smithy foundation, southern end, west facing

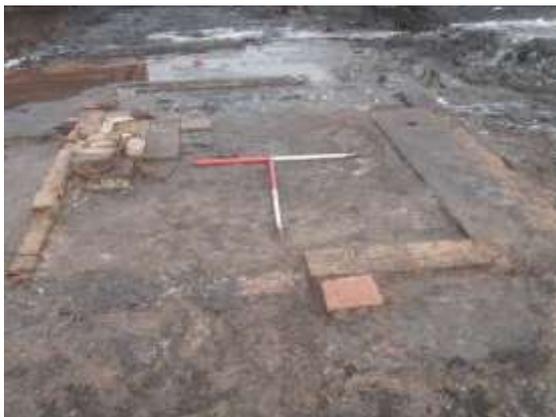
Set into the south-eastern wall at floor level was a 2.35m x 0.5m sandstone block (9.3), which incorporated a rectangular recess carved into it for a machine setting. At its south-western end were four small holding down bolts, and at the north-eastern end it had two holes drilled into of 100mm and 30mm diameter respectively.

9.3: Building 1 south-east room looking north-east, showing the hearth on left and machine bed on right

A service trench (2110) containing a lead pipe (2108) was exposed immediately to the south-east of the building. The pipe was evidently plumbed into the smaller of the two holes in the block and the remains of a ceramic drain were observed below it leading from the larger hole.

The principal smithy building (Building 18) comprised two main rooms, together with two smaller rooms and an outshut. The north-eastern main room contained a stone foundation bed for an item of machinery, which was serviced with a water supply and drainage, and a hearth. The latter incorporated refractory bricks, suggesting that it had been designed to withstand temperatures that were considerably higher than those generated in a domestic fireplace. It is thus likely to represent the remains of a small furnace, consistent with those employed typically for smithing. The remains of the two open-fronted rooms are consistent with workshops or storage areas.

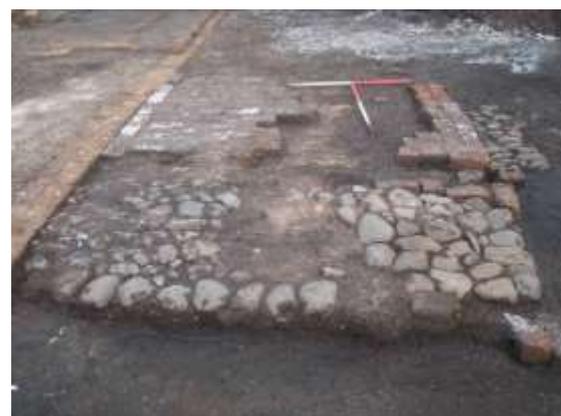
The remains of a small cobbled yard (2072), and a brick-built outshut comprising walls 2068, 2070 and 2071, was exposed to the south-east of Building 18 (9.4). The yard only survived in the southern corner of the building complex, but may have continued originally to the south-west, where disturbed cobbles were excavated. The brick outshut measured 2.2m square, contained a brick floor (2069), and was open to the north-east.

9.4: Brick outshut and cobbled next to Building 1 looking north-east

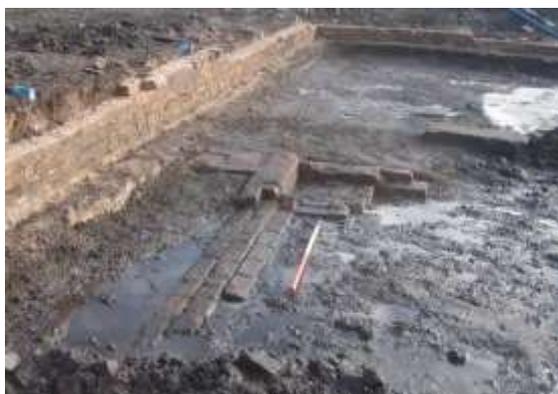
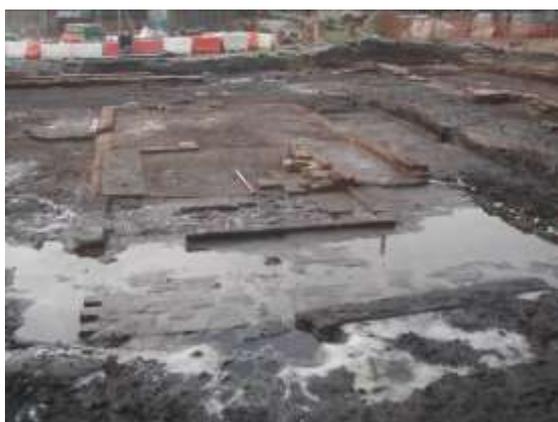
An L-shaped section of brick walling, which represented the remains of a smaller building (Building 17),⁵³ lay to the north-east of the Building 18 (9.5, 9.6). This section of wall ran 1.8m aligned south-west/north-east, in line with the wall 2047 of Building 18, and then returned to the north-west for a distance of 3.1m. It had been truncated at its north-western and south-eastern ends. The south-western wall of Building 17 was probably represented by wall 2052, although only fragmentary remains survived. Building 2 would have measured at least c. 4.9m x 2.9m.

9.5: The brick-built foundations of Building 17 looking east

9.6: North-western wall of Building 17, with Building 18 in background, looking south-west

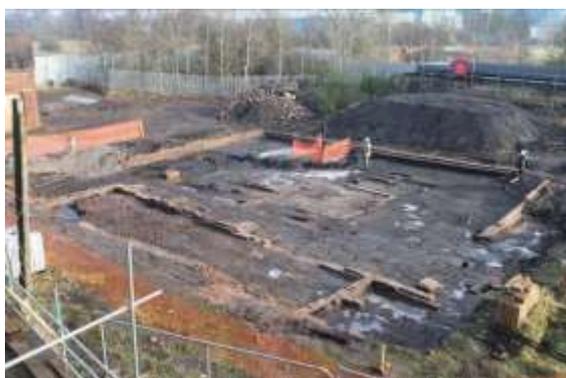
The excavation area was largely enclosed by a two-course wide wall of machine-made bricks (2001), which formed a square structure measuring 18.8m x 18.5m, although excavation extended slightly beyond this footprint to the north-west and south-west (9.7). The position of wall 2001 corresponded with the footprint of Stove House Five depicted on historical mapping. Wall 2001 had been built on a concrete foundation (2002) that splayed out a further 100mm from the wall.

9.7: Outer walls are Stove House 5, with Buildings 17 and 18 in the centre and the North-East Fishery Pan in the foreground, looking east

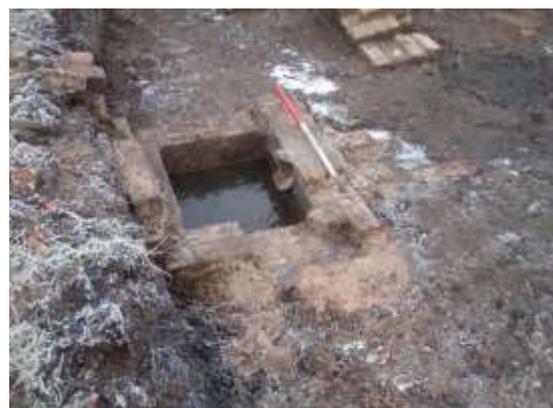
A brick-built manhole (2111) measuring 0.83m x 0.63m had been inserted through the wall on its south-eastern side, affording access to a ceramic drainage pipe that ran beneath the wall. Another manhole (2004) was exposed in the south-western part of the excavation area, immediately beyond wall 2001. Manhole 2004 measured 1.2m x 1.1m and comprised machine-made bricks (9.8). It acted as a junction for three ceramic drainpipes (2007, 2009 and 2011). Drain 2007 approached from the north-west, drain 2009 from the south-east, and drain 2011, which showed some evidence of brick lining, from the north-east.

9.8: Manhole 2004, looking north-west

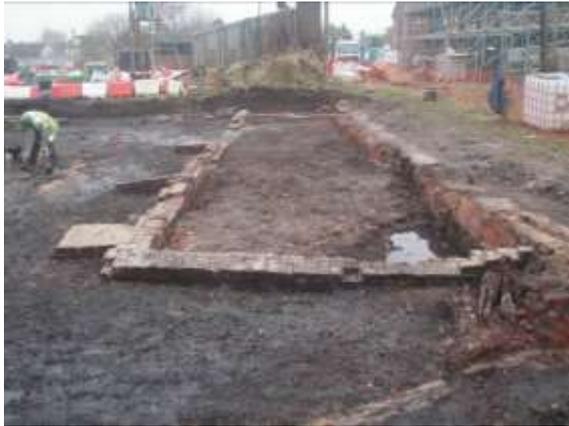
A series of brick walls exposed along the north-western side of the excavation area formed a rectangular structure that almost certainly represented the remains of the south-western fisheries salt pan depicted on historic mapping. The main wall (2024) of this salt pan ran north-east/ south-west for 16.2m, and was three courses wide (9.9). At the south-western end wall 2022 continued to the north-west for a distance of 3.8m, where brick wall 2021 extended to the south-west. A short stub of internal walling (2023) ran southwest from wall 2022 (9.10). These walls formed a 3.8m wide chamber at the south-western end of the structure. The south-western end of this chamber had been destroyed by the insertion of drain 2007, and thus its original length could not be determined accurately. The north-eastern end of wall 2024 extended beneath later wall 2001, where it was truncated; the entire north-western part of the structure had evidently been removed. Nevertheless, it is likely that the 3.8m width of the north-west chamber represented the full original width of the fisheries pans.

9.9: Fishery salt pan, showing wall 2024 extending along the centre of the excavated area, with the remains of the furnaces on the left, looking south-west

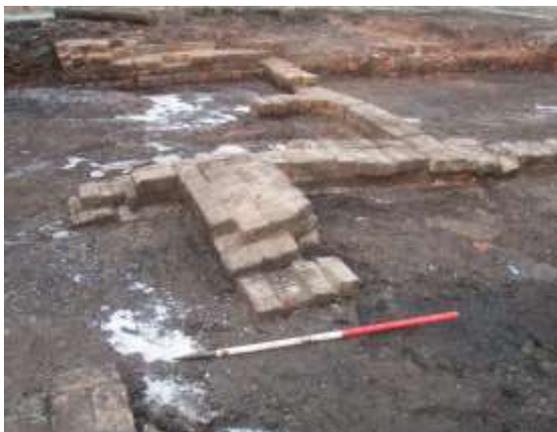
9.10: The north-western end of the fishery pan, looking north-west

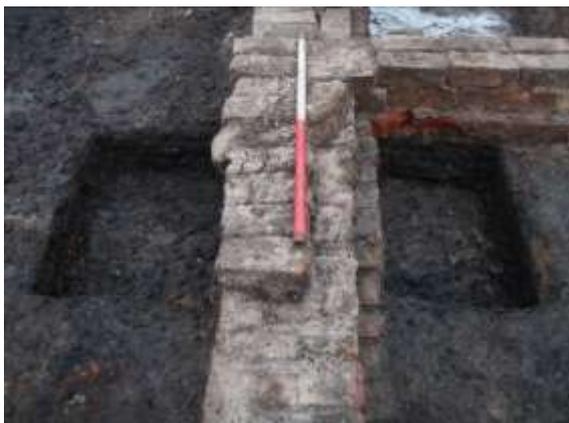
9.11: Limited excavation across wall 2024, looking south-west

Limited manual excavation across wall 2024 provided a vertical section of the sequence of deposits within the fisheries pans (9.11). Inside the main structure was a 30mm thick lens of

compacted mixed clay and sand with abundant stone and brick fragments (2018). Outside the main structure, and in the area of the pan furnaces, was a 35mm thick band of mixed clay with brick fragments (2019), which retained some evidence of heating. Below this on both sides was a 150mm thick layer of smooth, black ashy clay (2082), into which wall 2024 had been cut, with an 80mm thick layer of compact cinders and crushed brick (2081) below. Below this was a layer of compact grey clay with abundant fragments of brick, stone and slate (2083), which was also observed across the south-western part of the excavated area immediately above the natural clay.

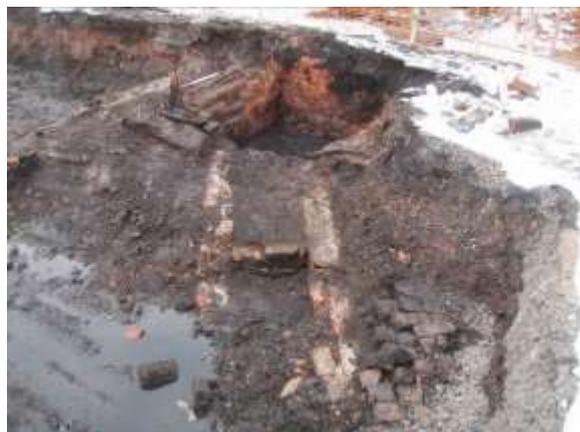
The remains of a rectangular chimney (2033) fitted apertures for two flues were revealed immediately to the north-east of the fishery pan (9.12). The chimney comprised a 2.0m x 1.8m brick inner structure surrounded by an outer shell of concrete, into which a cast-iron pipe was set around the internal brick structure. A 0.95m wide brick flue (2034) extended into the chimney from the east, probably from the boiler below the brine tank. This flue had been blocked subsequently with brick (2112), probably when the 'nodding donkey' was installed in 1938. The second flue (2114) was 1m wide and entered the chimney from the north-west, probably from the furnaces associated with a second fisheries pan. This flue was not blocked, indicating that it remained in use

until the fisheries pans were demolished between 1947 and 1954. Neither the chimney nor the flues were excavated entirely during the excavation. Immediately to the north of flue 2034 was a rough brick surface (2086), which may have formed part of a surface surrounding the brine shaft and the associated pipes.

9.12: Chimney 2033 and blocked flue 2034, looking west

In 1938, the original steam pump for the brine shafts was replaced with the 'nodding donkey' to the south-west. This rendered the boiler and engine below the brine tank redundant, and resulted in the blocking of flue 2034. The flues from the pan furnaces were still in use at this time, and thus flue 2114 would have remained open.
